Lower Duwamish Waterway Group

WATERWAY USER SURVEY AND ASSESSMENT OF IN-WATER STRUCTURES— DATA REPORT

**U.S. Environmental Protection Agency
Region 10**

July 2, 2018

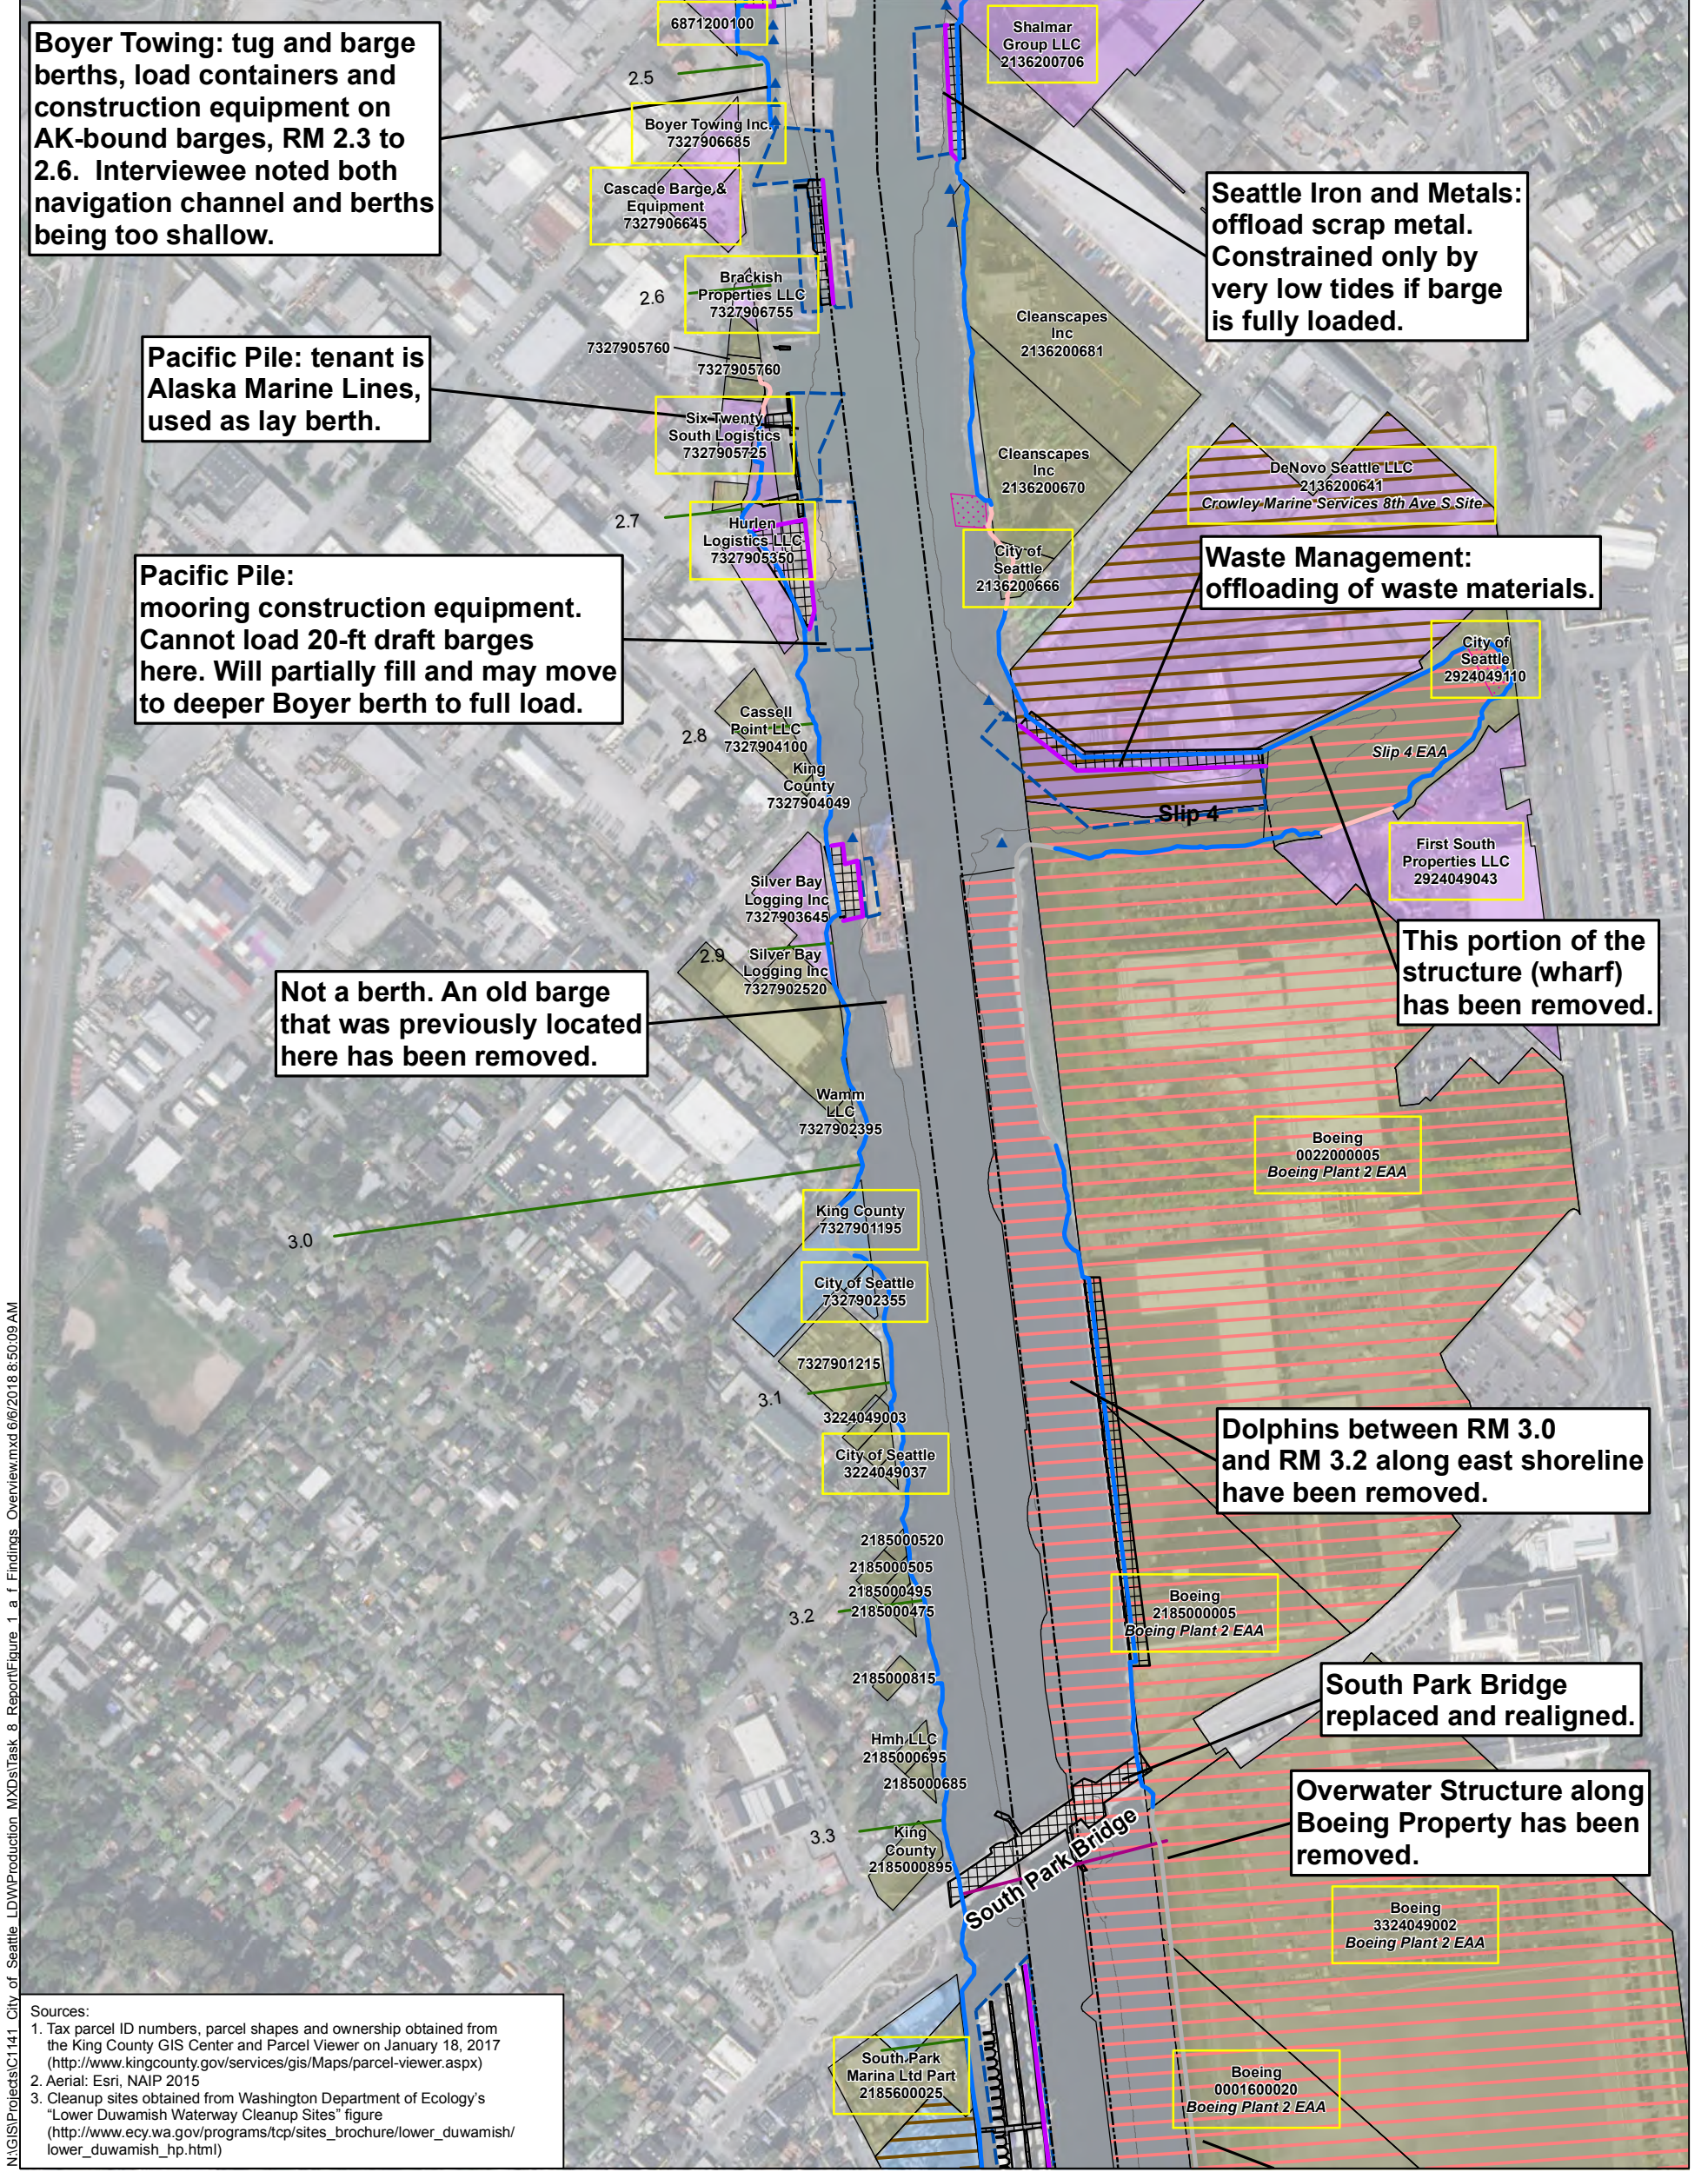
Figure 1d.
 Overview of Waterway User Survey and Structures Assessment Findings

Boyer Towing: tug and barge berths, load containers and construction equipment on AK-bound barges, RM 2.3 to 2.6. Interviewee noted both navigation channel and berths being too shallow.

Pacific Pile: tenant is Alaska Marine Lines, used as lay berth.

South Park Bridge replaced and realigned.
