Appendix F

Structures Inspection Forms

Sediment Cleanup of Upper Reach of Lower Duwamish Waterway, Phase I/II

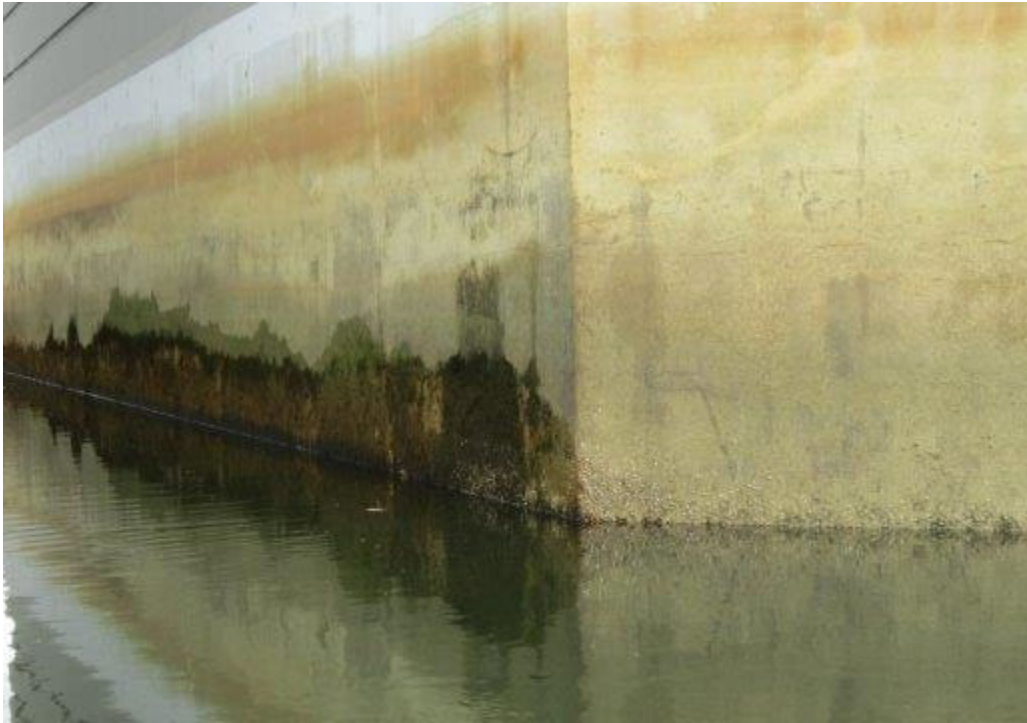
ST02-07: West Bascule Pier (southeast side)

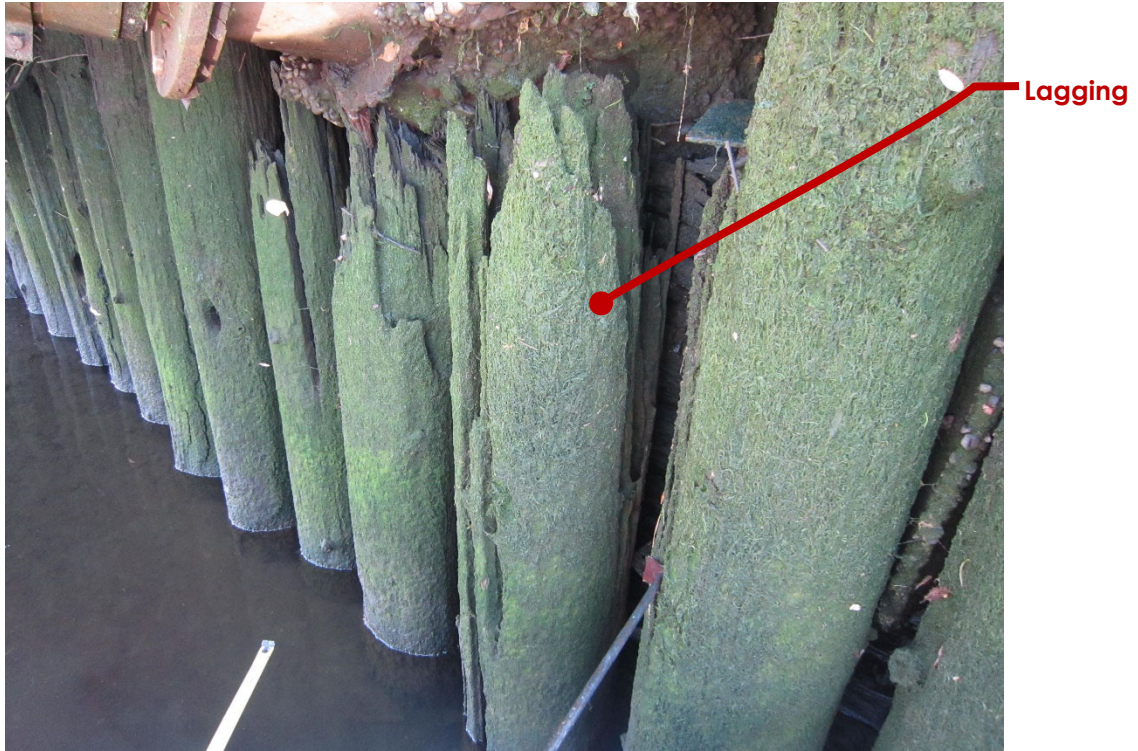
- In the bank, protection consists of closely spaced timber stub piles with timber lagging behind the piles (Photos 19 to 25).
- The tops of the piles are generally rotted or splintered, but the lower sections appear sound (Photos 20 to 25).
- Lagging in a number of areas are rotted and soil erosion through the bulkhead was observed (Photos 22 to 25).
- Pile embedment and the condition below mudline are not known.

Photo ST03-25: Bulkhead Lagging Beneath Outfall

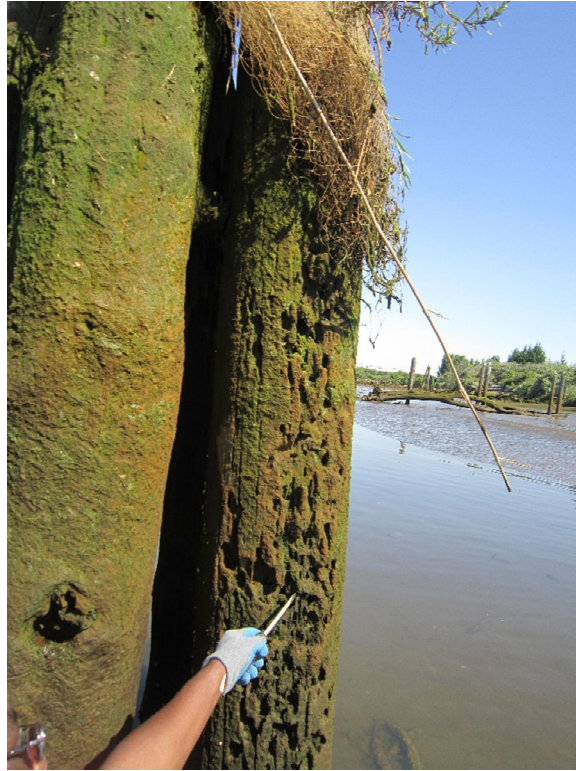
- Along the south and west side of the pier are several 7-timber treated pile dolphins; some are missing piles. The dolphins are still in use (Photo 1, 2, and 5).
- The cluster of piles are strapped together with a combination of fiber and/or strand wire rope. Some straps are broken or missing (Photos 5 and 6).
- Some piles are eroded and have lost material thickness. However, the core appear to be sound (Photo 7).

Photo ST04-07: Closeup of Pile Damage

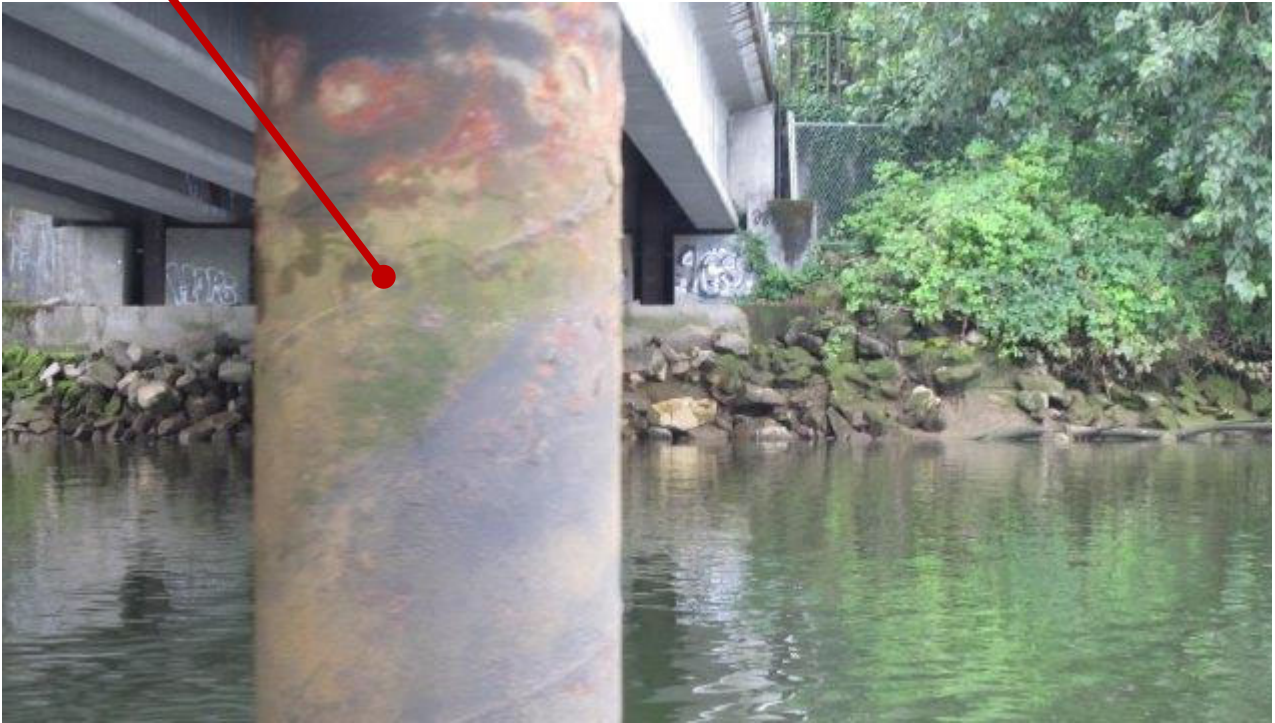
Photo ST08-05: West Bent (Looking West)

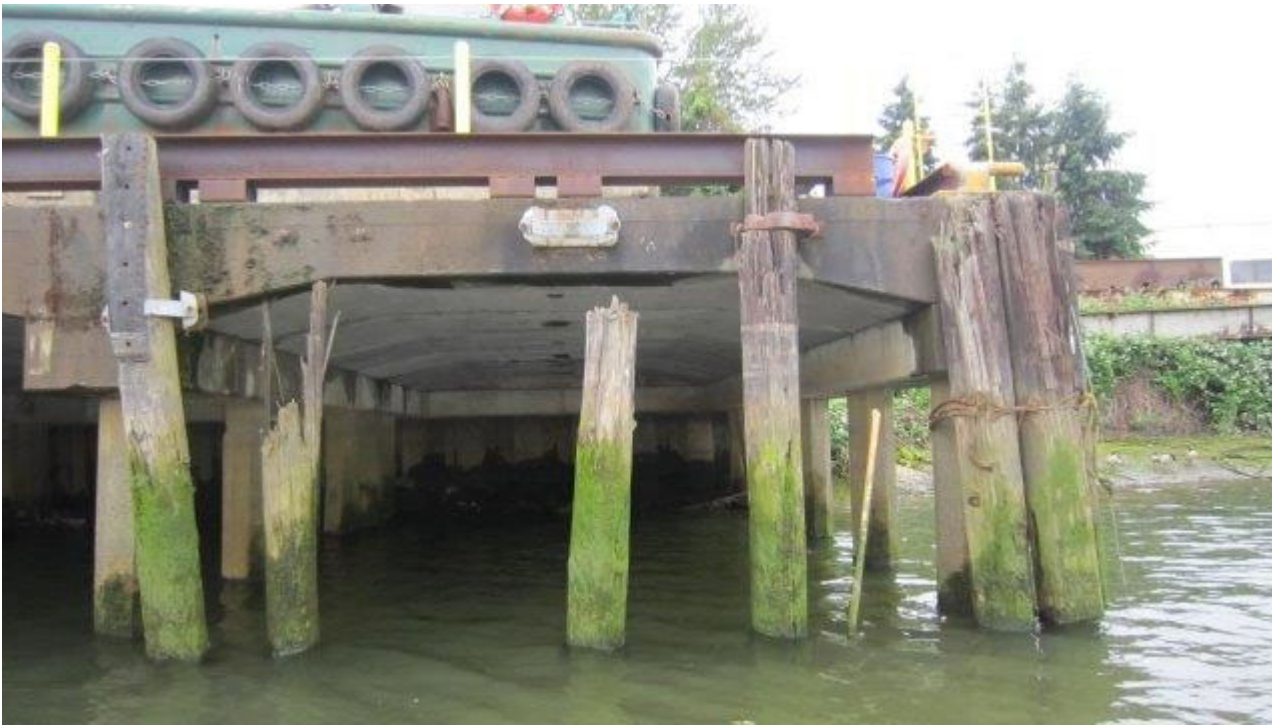
Photo ST16-016: Pier 4 Pier Deck (North Most, Looking West)

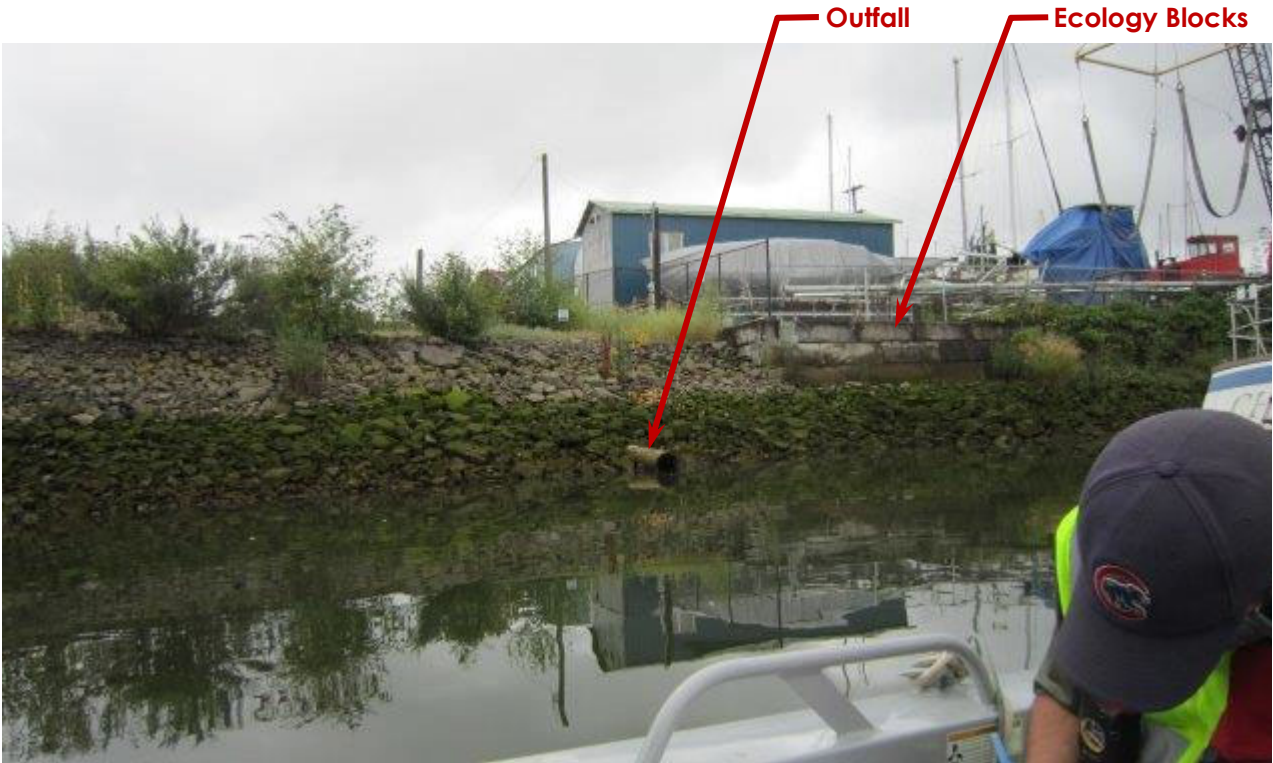
Photo ST20-01: Retaining Wall Bulkhead (Looking Northwest)

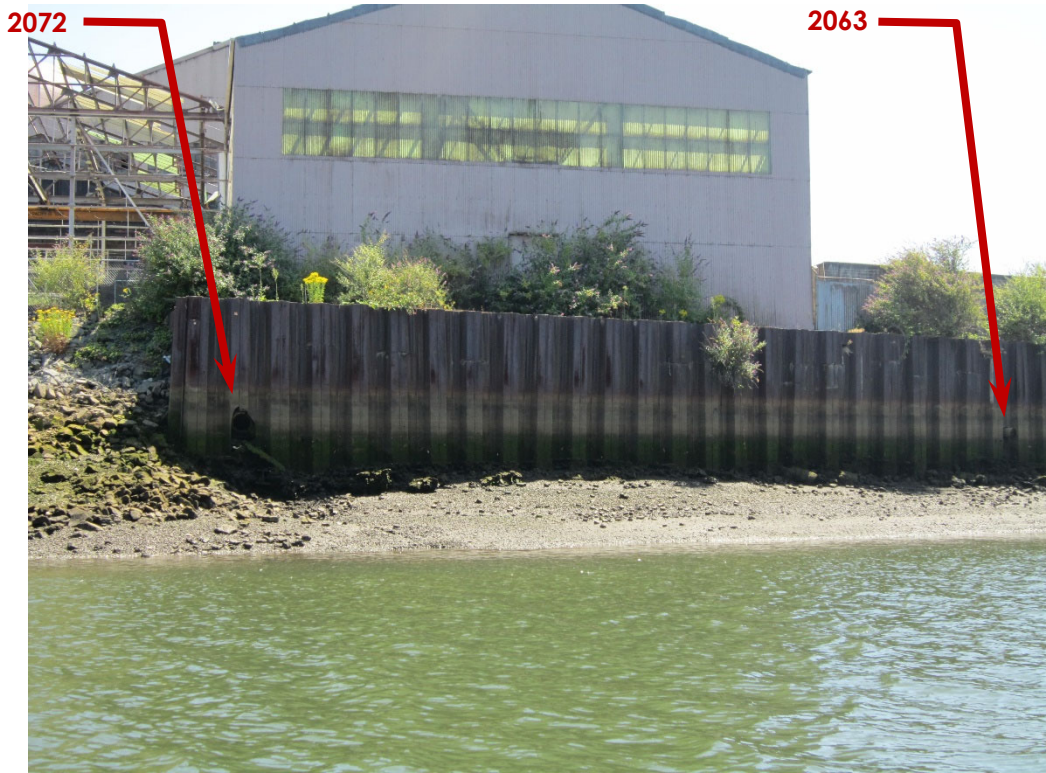
2072-01: Concrete Outfall at Low Tide

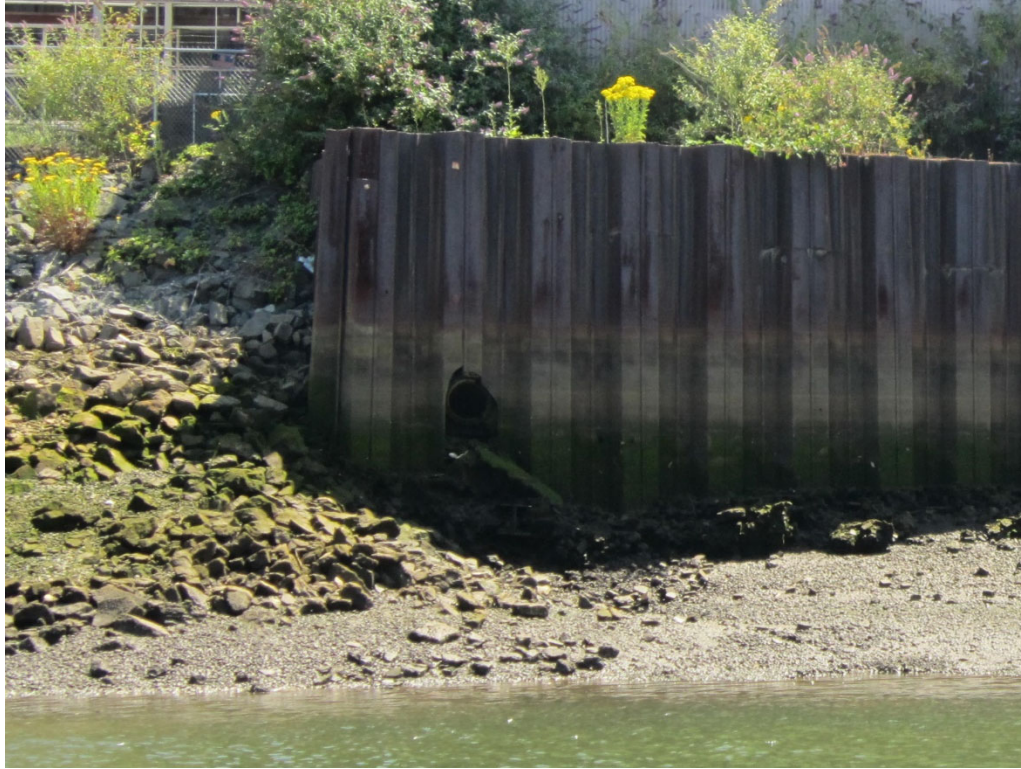
2072-03: Concrete Outfall at Low tide

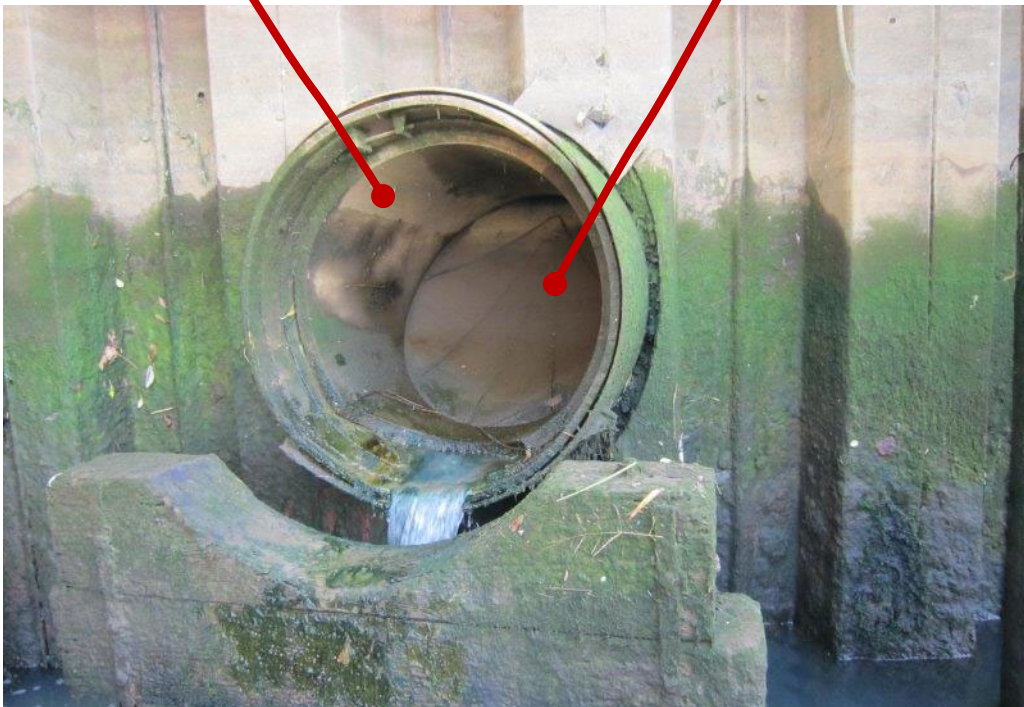
2062-04: Pipe End

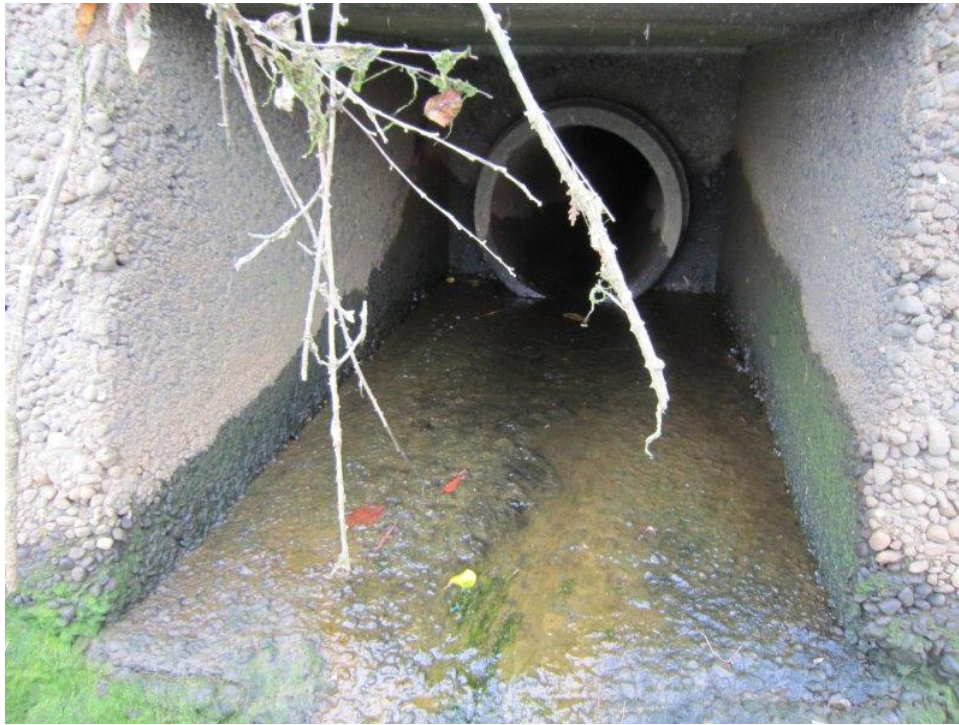
2073-03: Close Up of Outfall

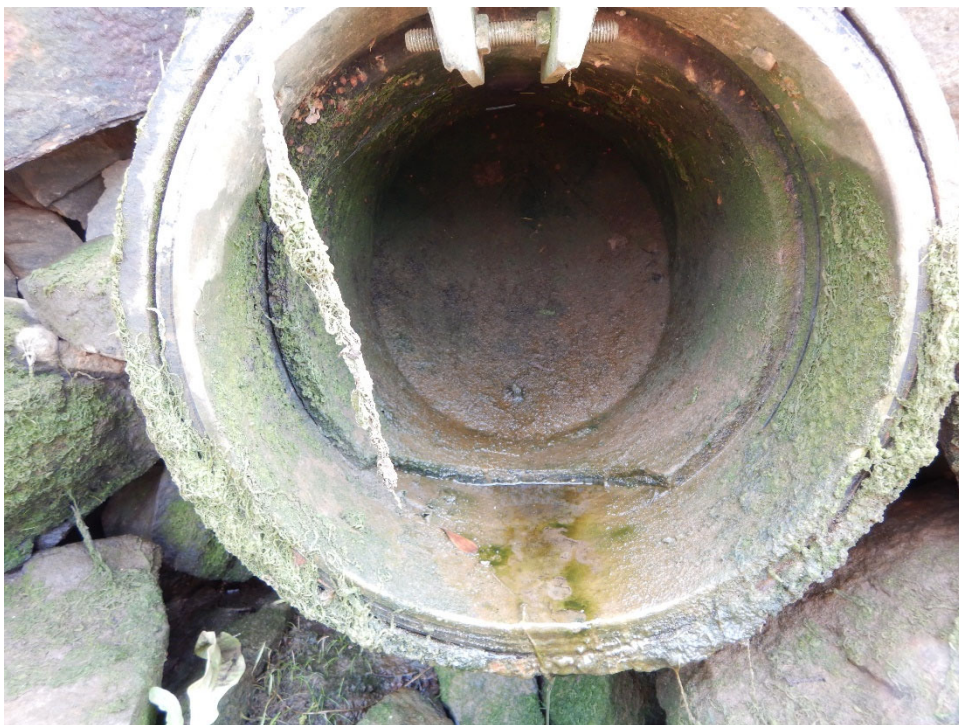
Photo 2092-04: Outfall Closeup

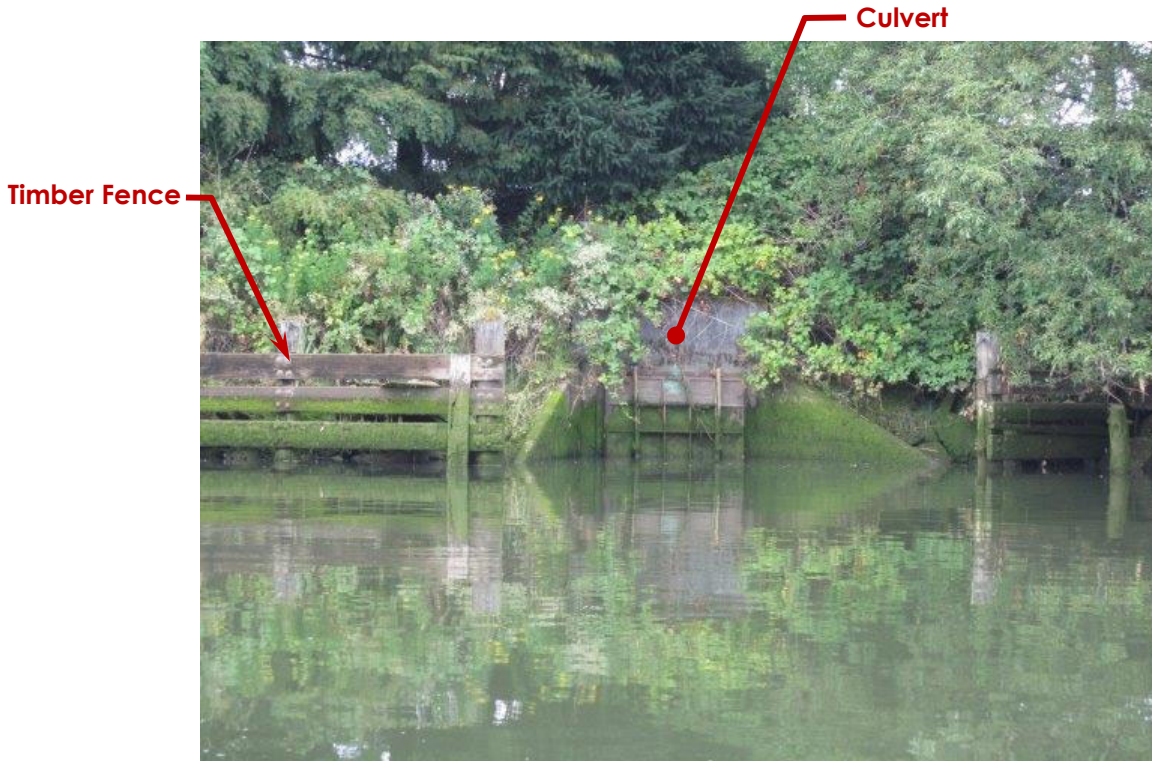
Photo 2095-01: Culvert (Looking East)

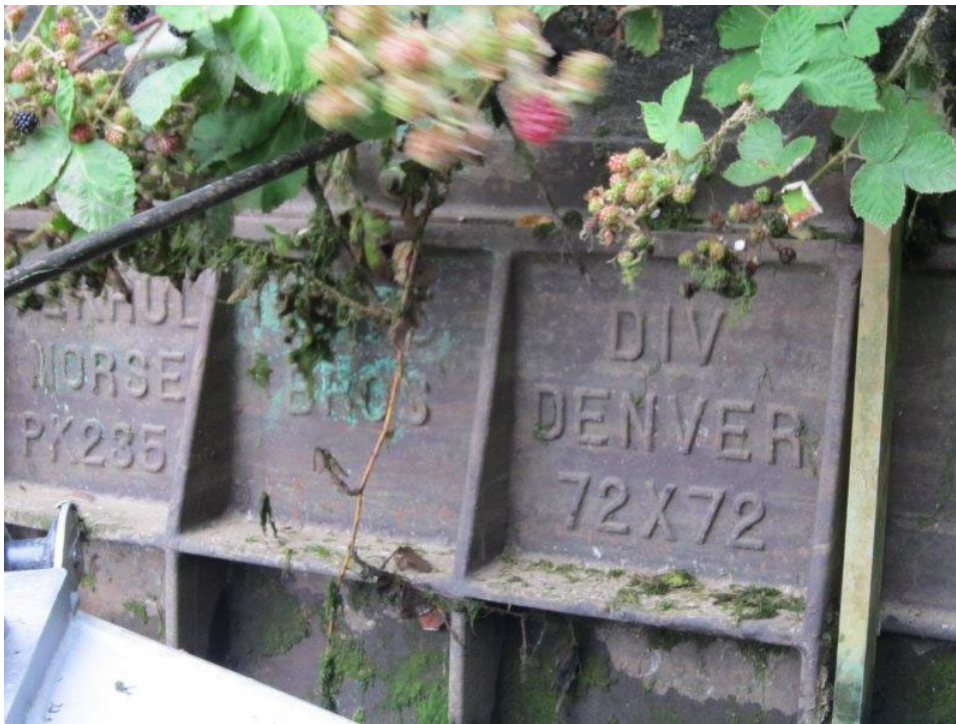
Photo 2095-04: Cast Iron Gate

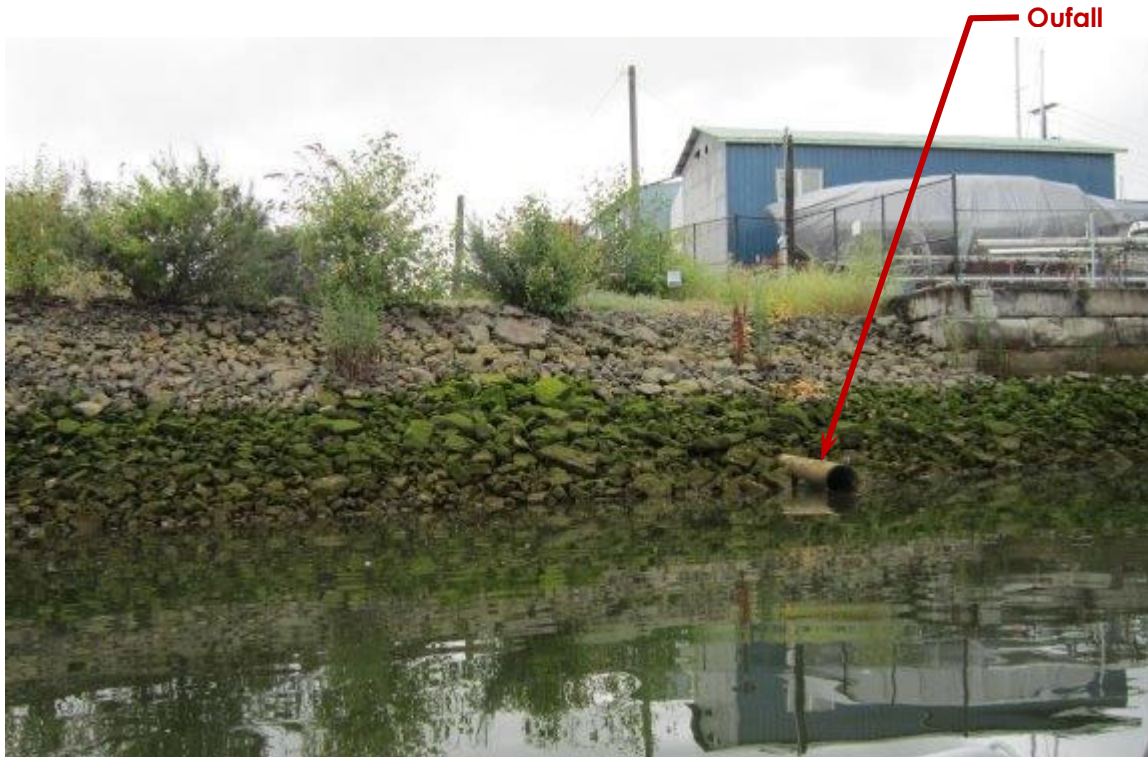
Photo 2214-01: Outfall (Looking West)

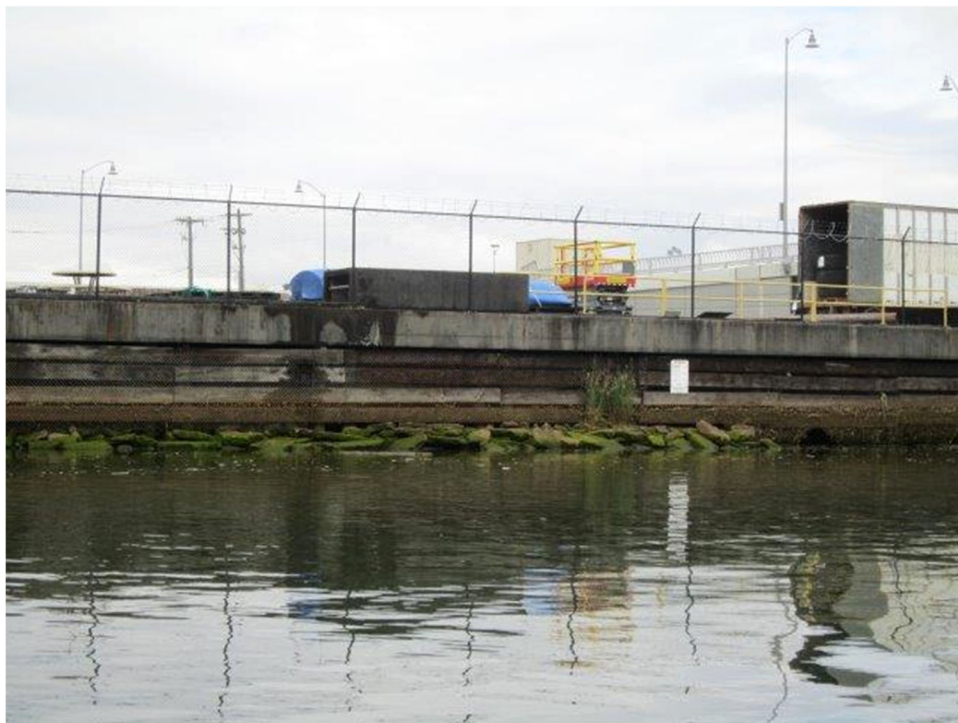
Photo ST38-06: South Apron

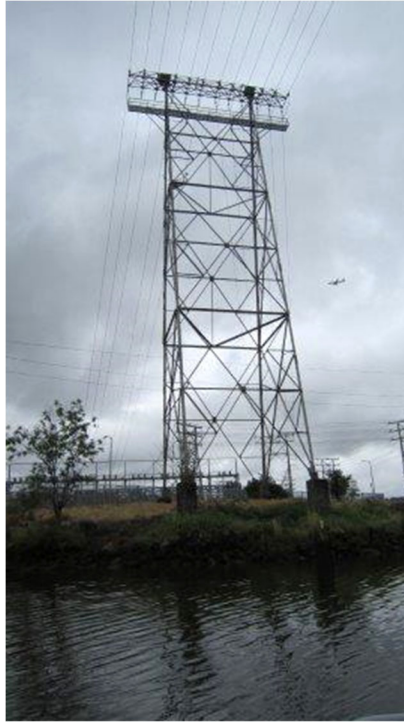
Photo ST06-05: West Tower (Looking West)

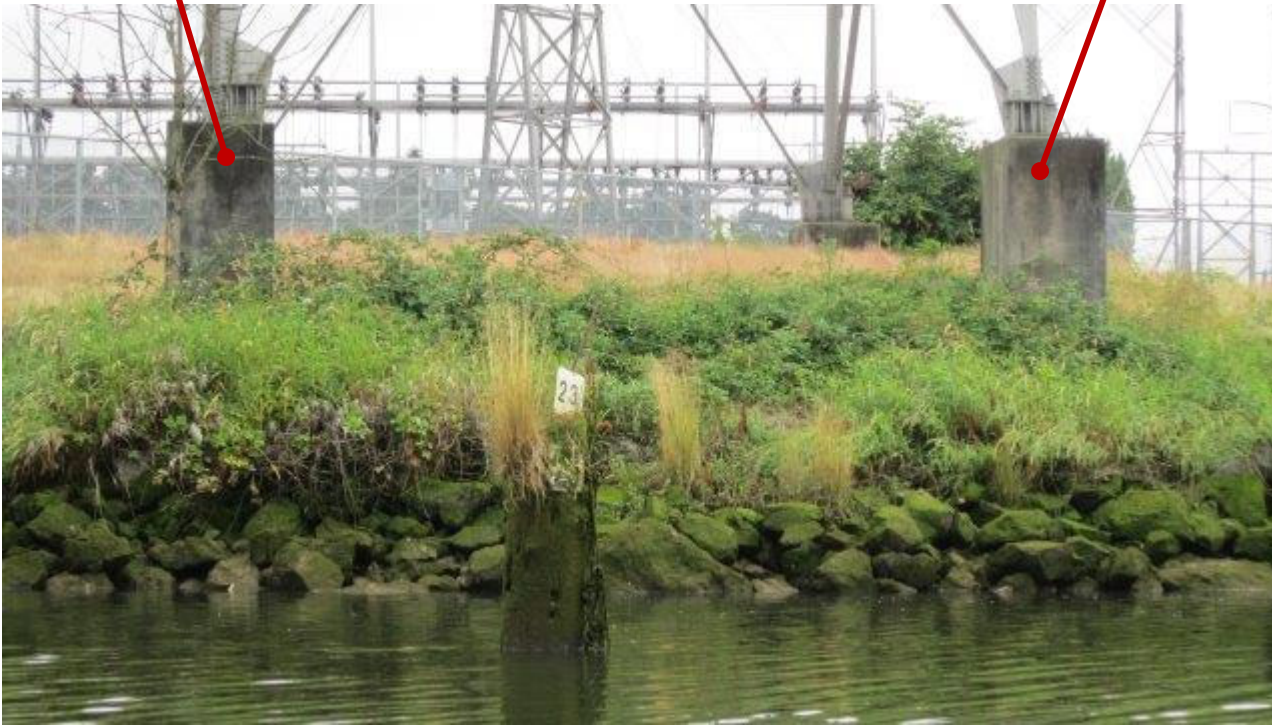
Photo ST06-06: West Shoreline

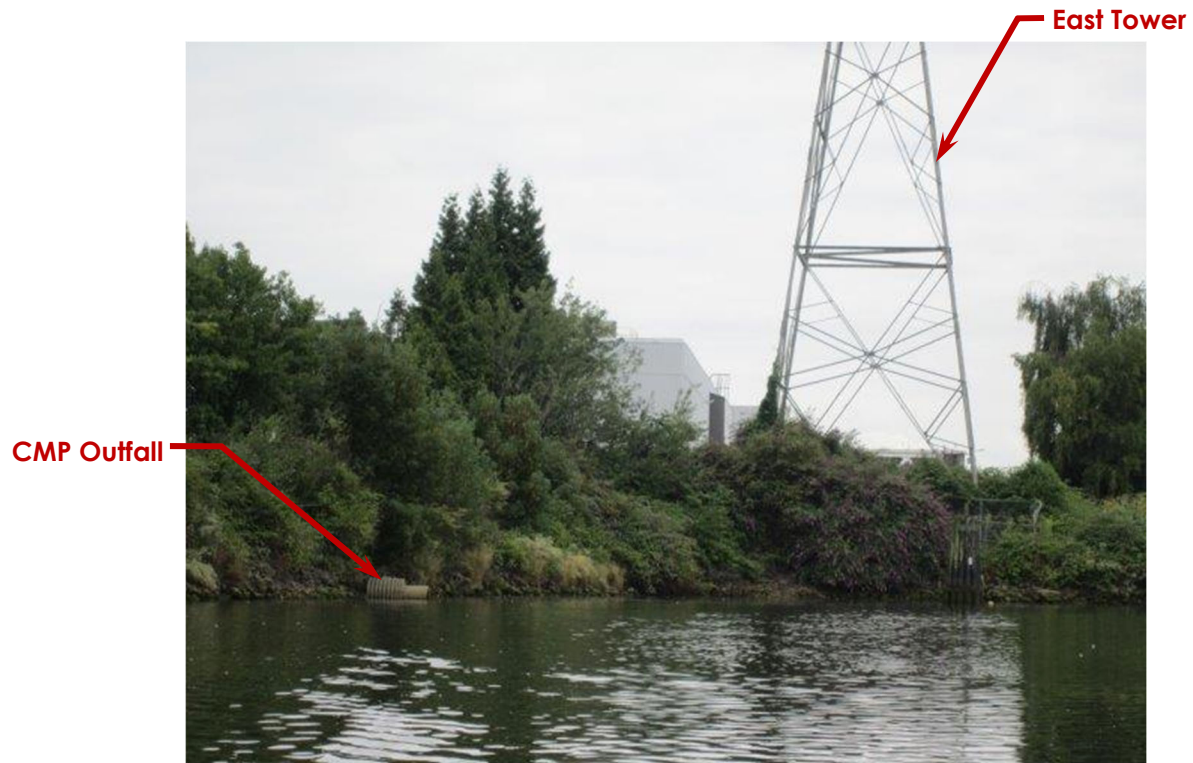
Photo ST06-07: East Shoreline

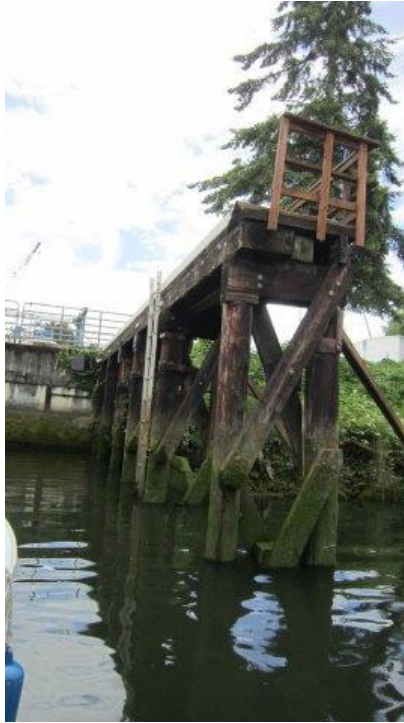
Photo ST14-03: North Bents

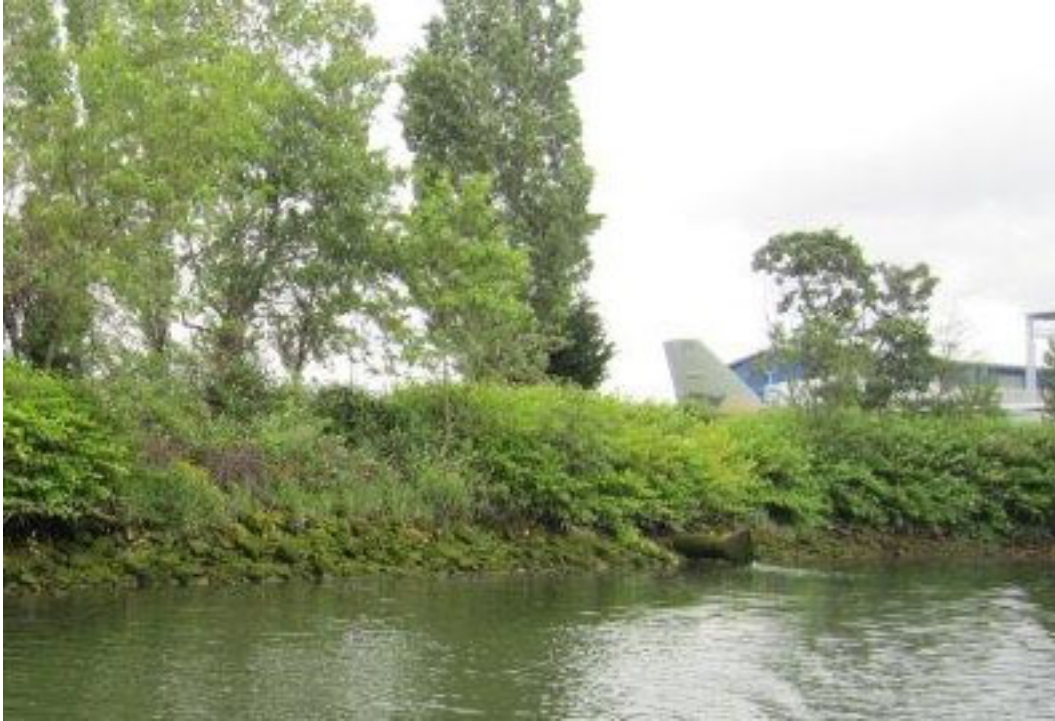
Photo 2080-01: Outfall (Looking North)

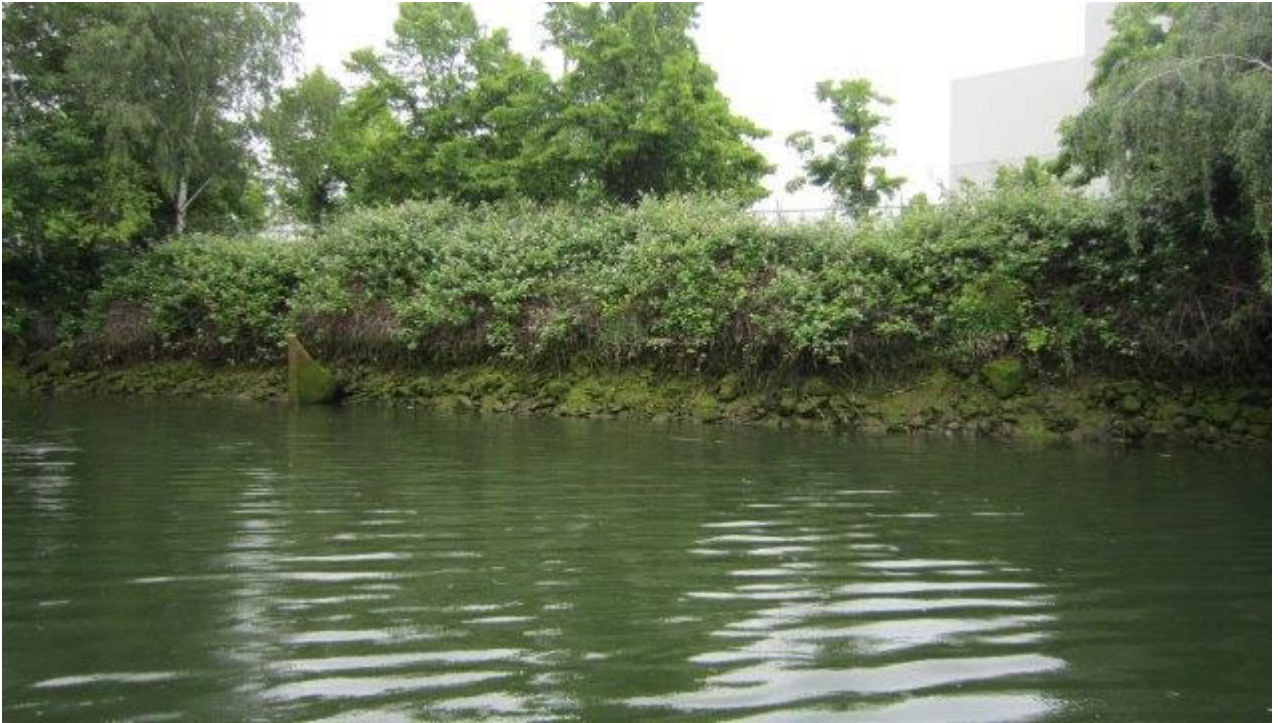
- Support stability of pipe overhang is beyond the riprap shoreline.

Photo 2081-01: Outfall (Looking North)

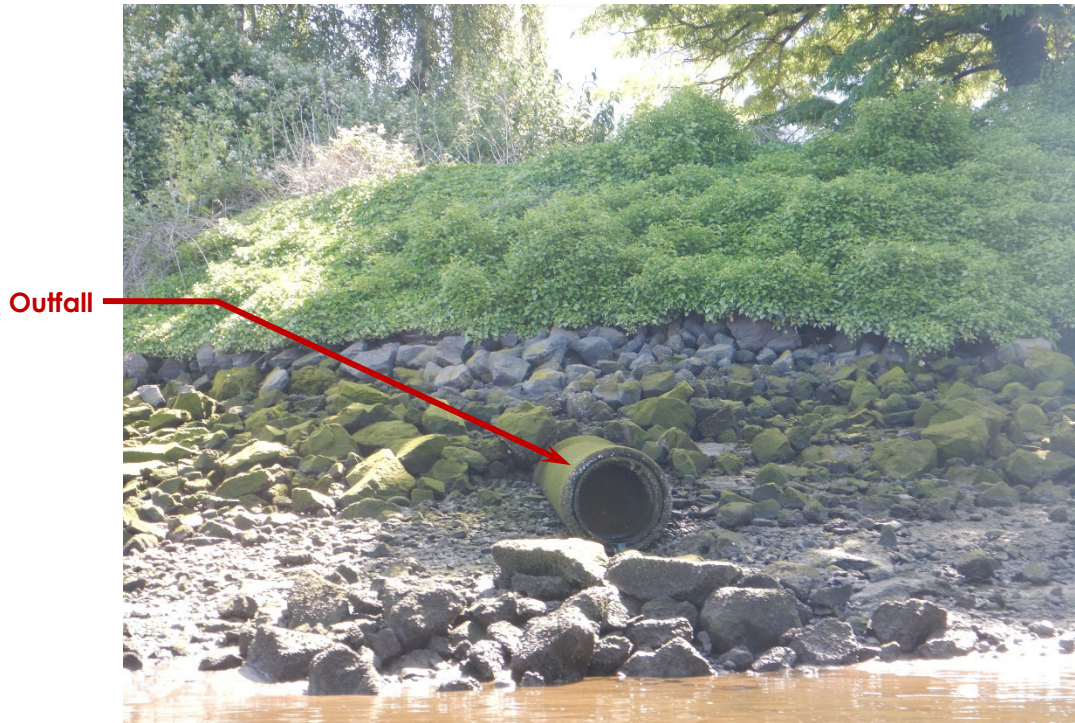
Photo 2087-01: Outfall (Looking East)

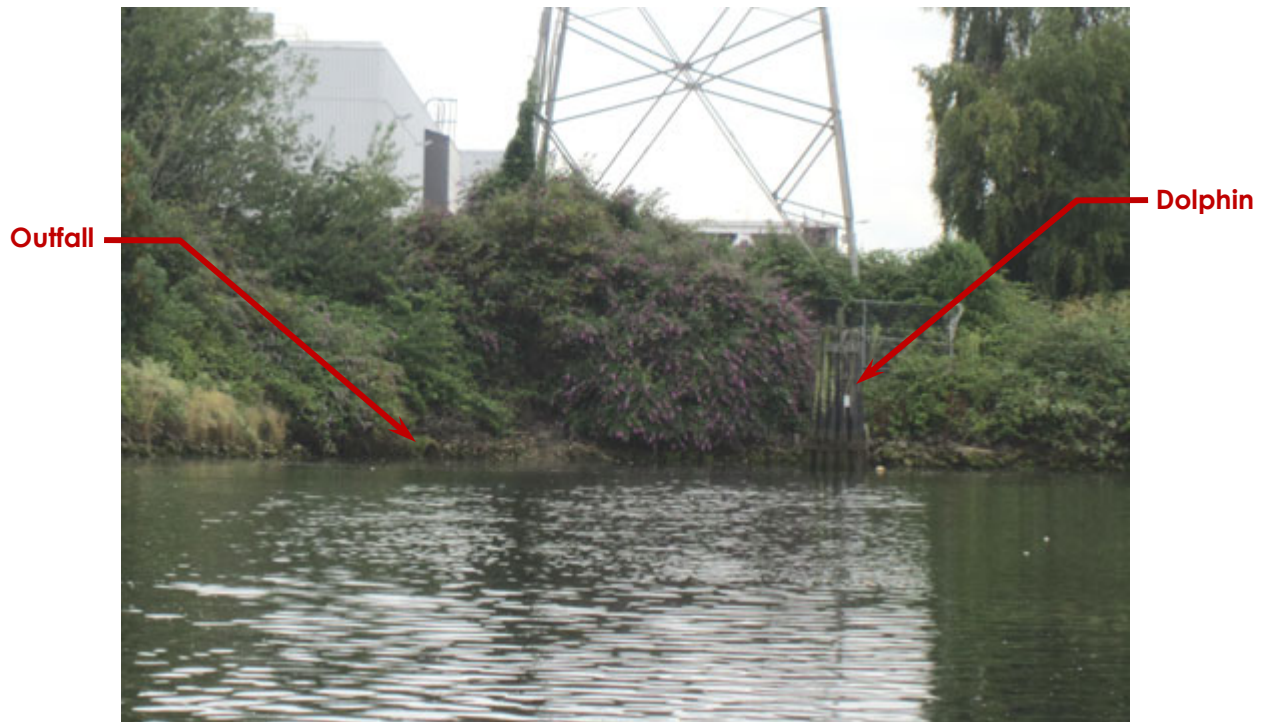
Photo 2088-01: Outfall North of Dolphin (Looking East)

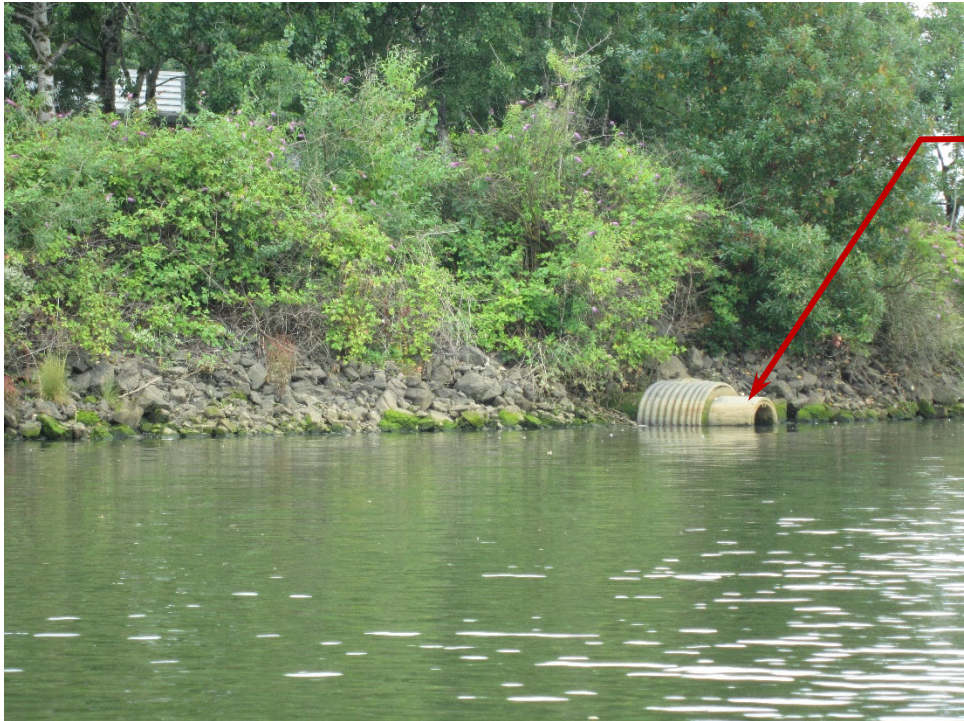
Photo 2089-01: Outfall (Looking Southeast)

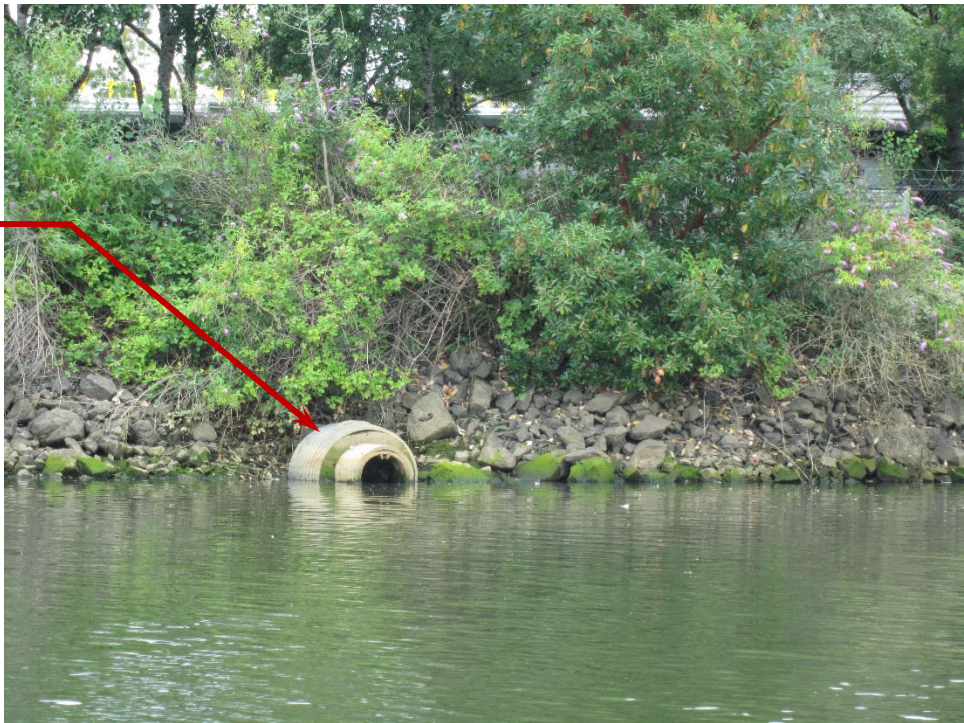
Photo 2089-02: Outfall (Looking East)

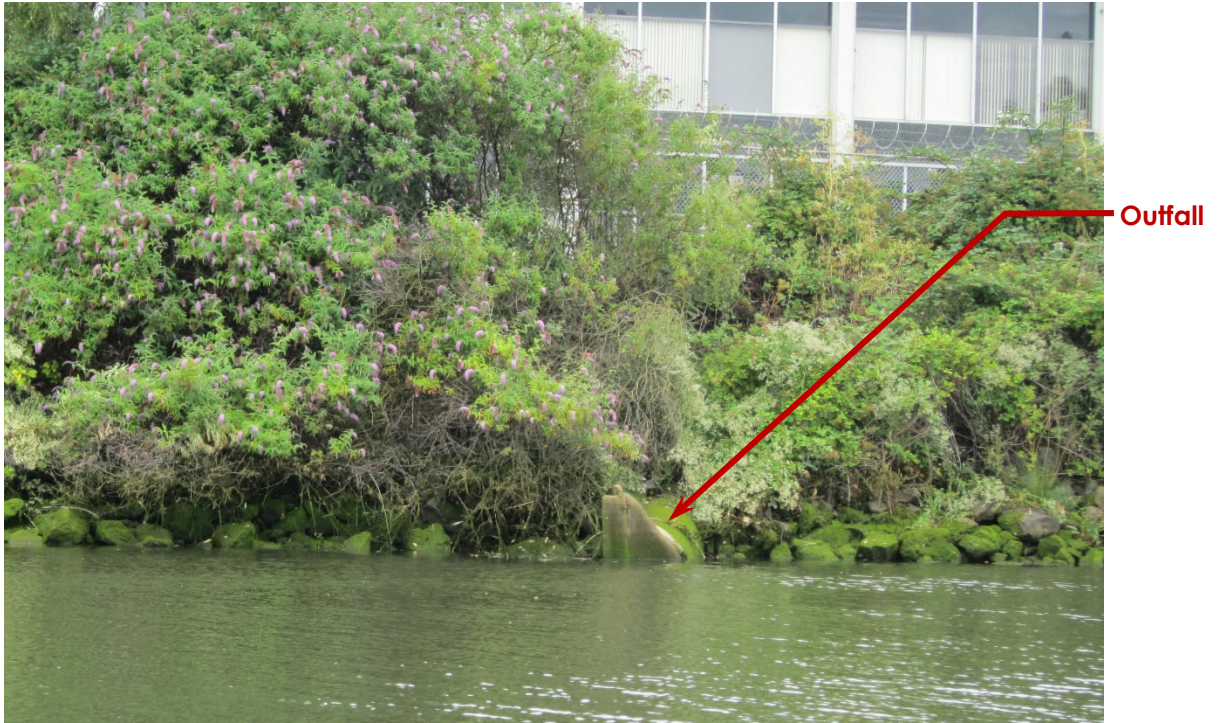
Photo 2090-01: Outfall (Looking East)

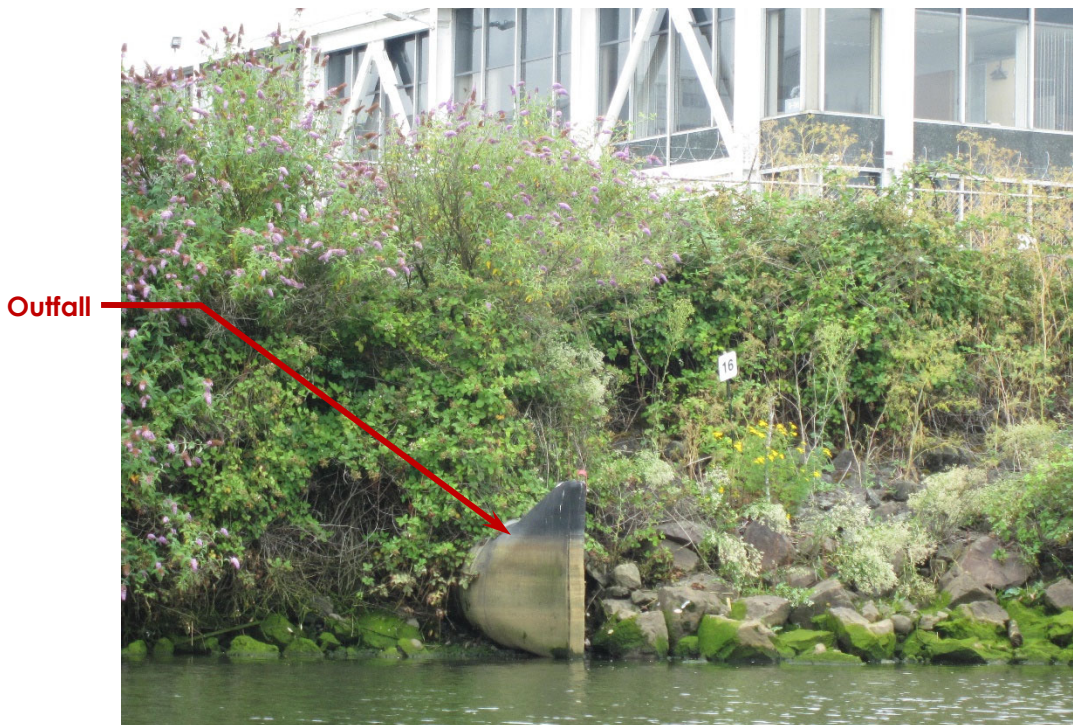
Photo 2090-02: Outfall

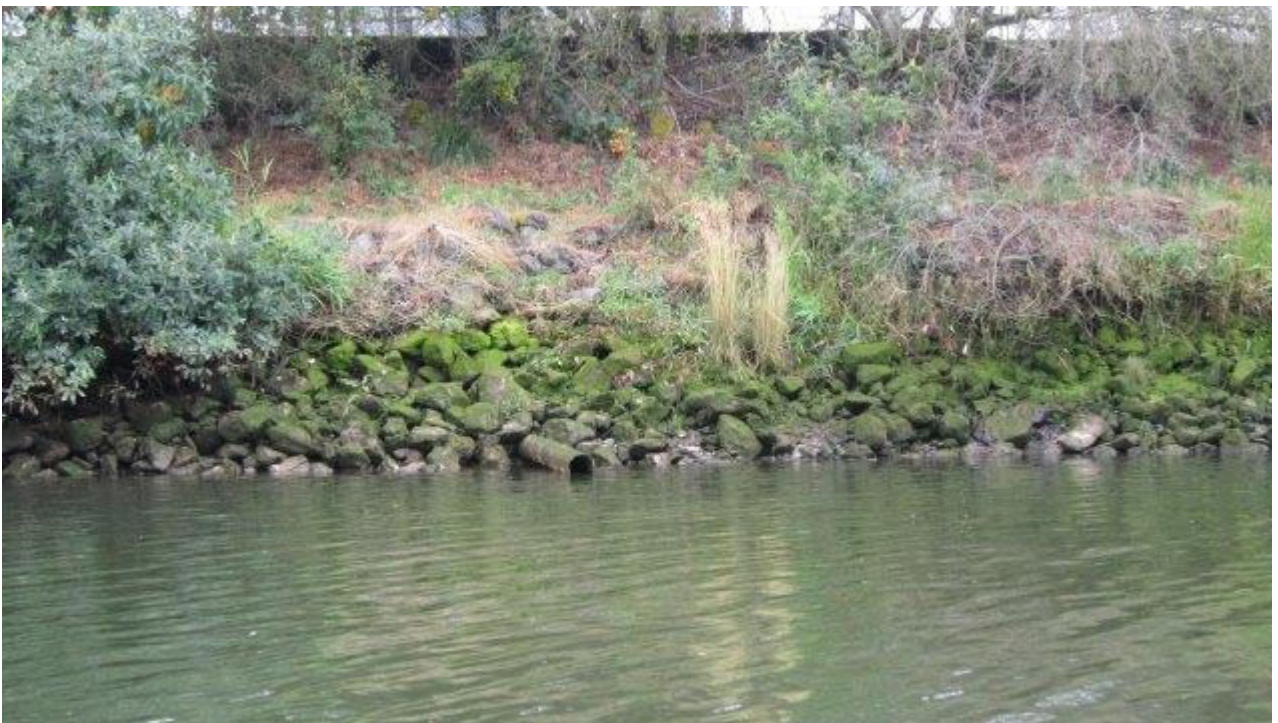
Photo 2098-02: Outfall (Looking West)

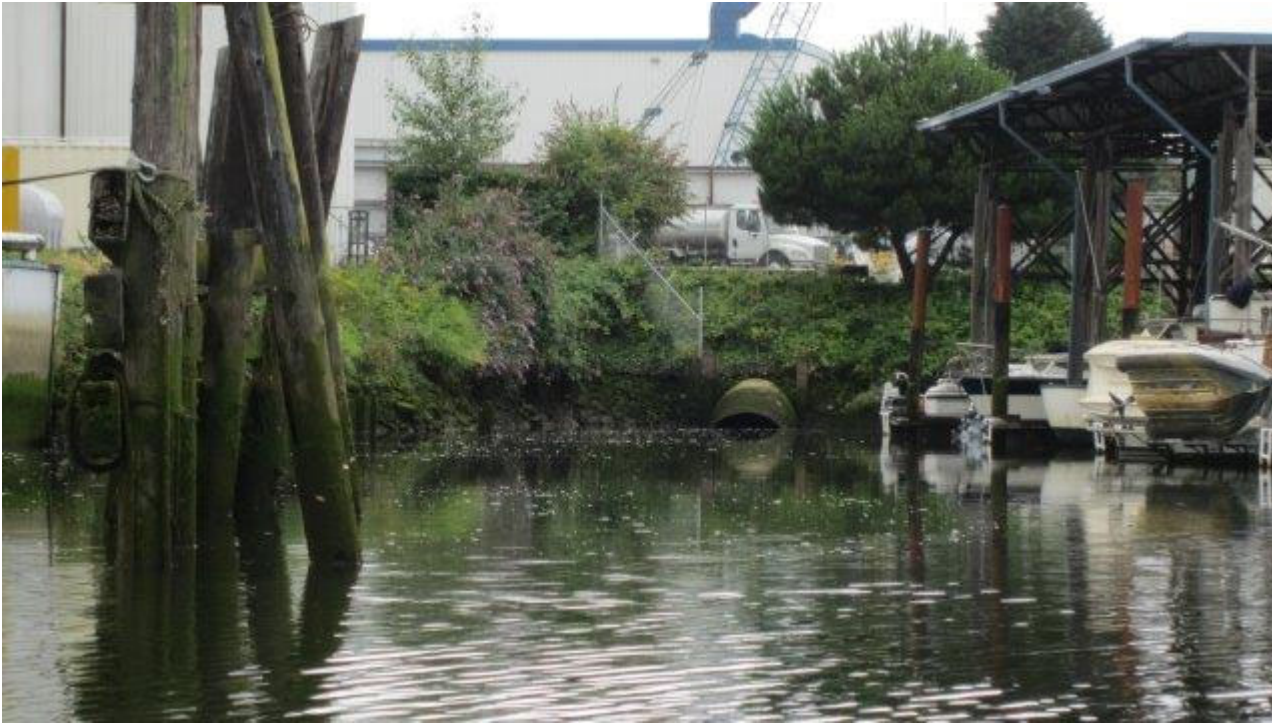
Photo 2100B-01: Outfall at High Tide Level
