Appendix F

Structures Inspection Forms

Sediment Cleanup of Upper Reach of Lower Duwamish Waterway, Phase I/II

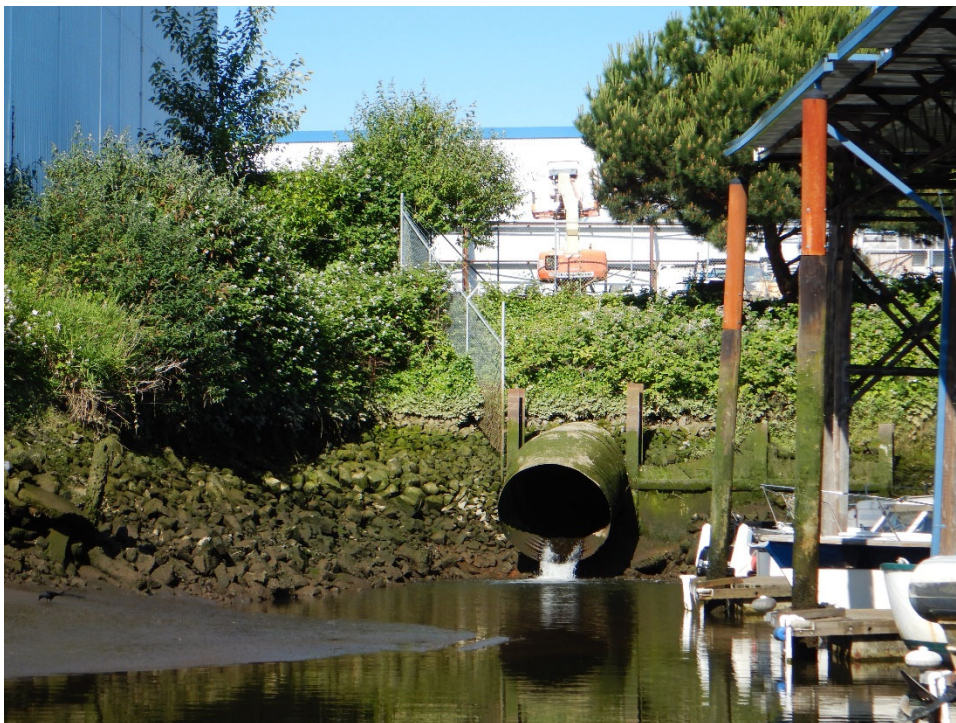
Photo 2100B-02: Outfall at Low Tide Level

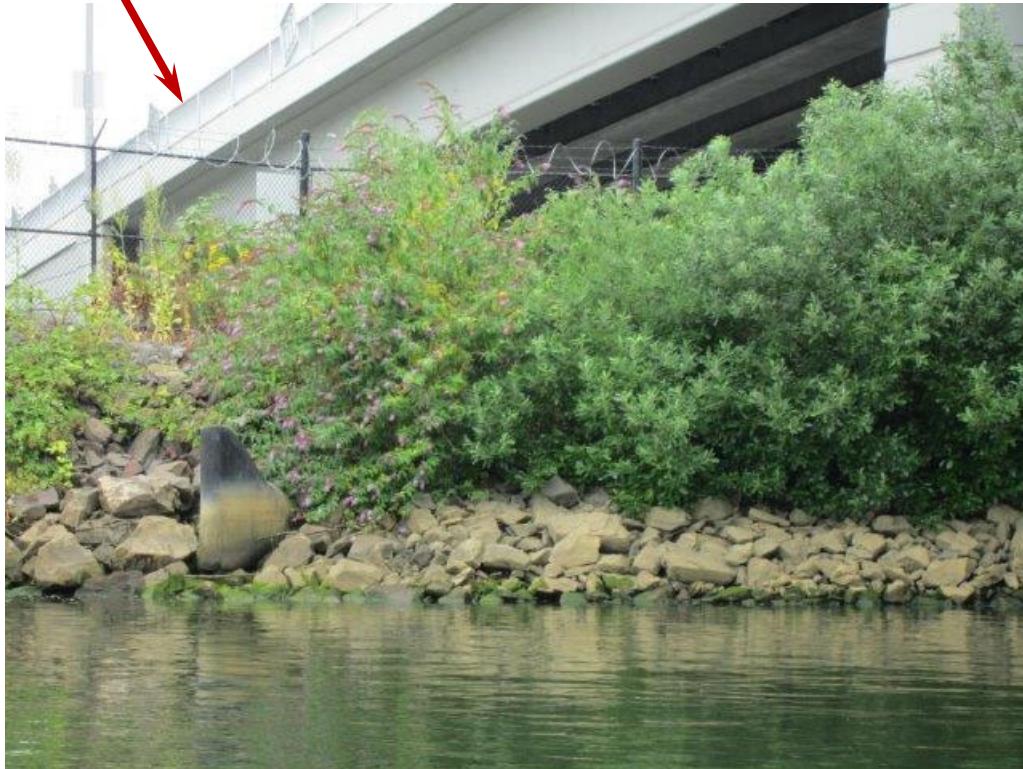
3031-02: Outfall (Looking Northeast)

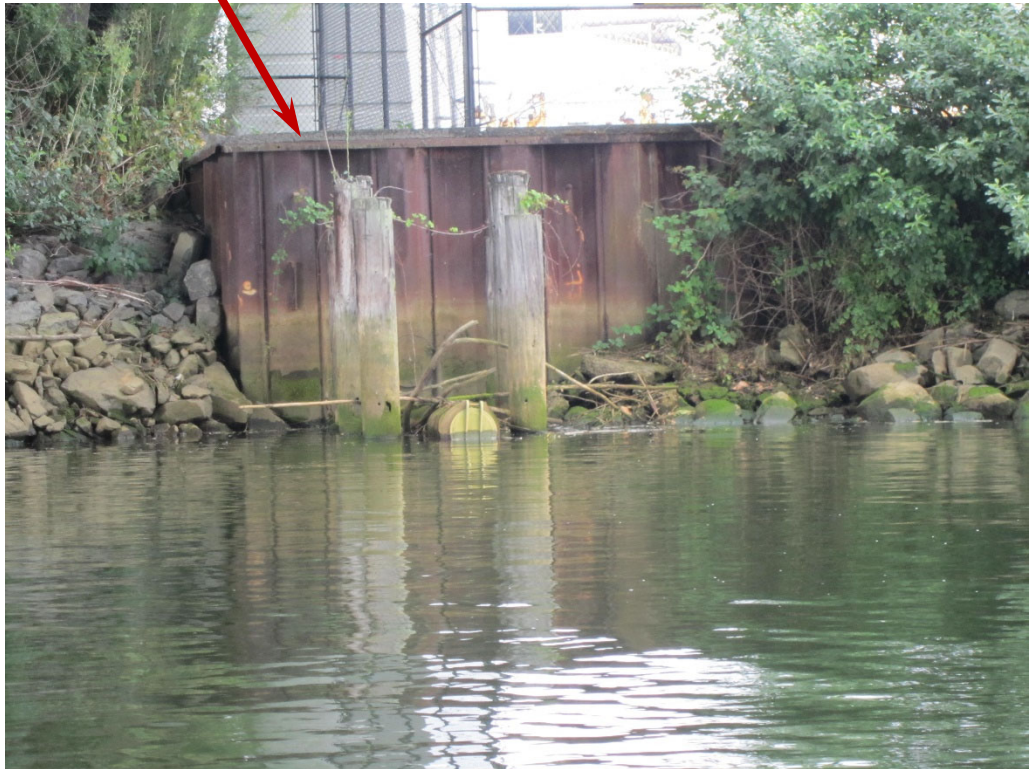
3032-02: Outfall Structure

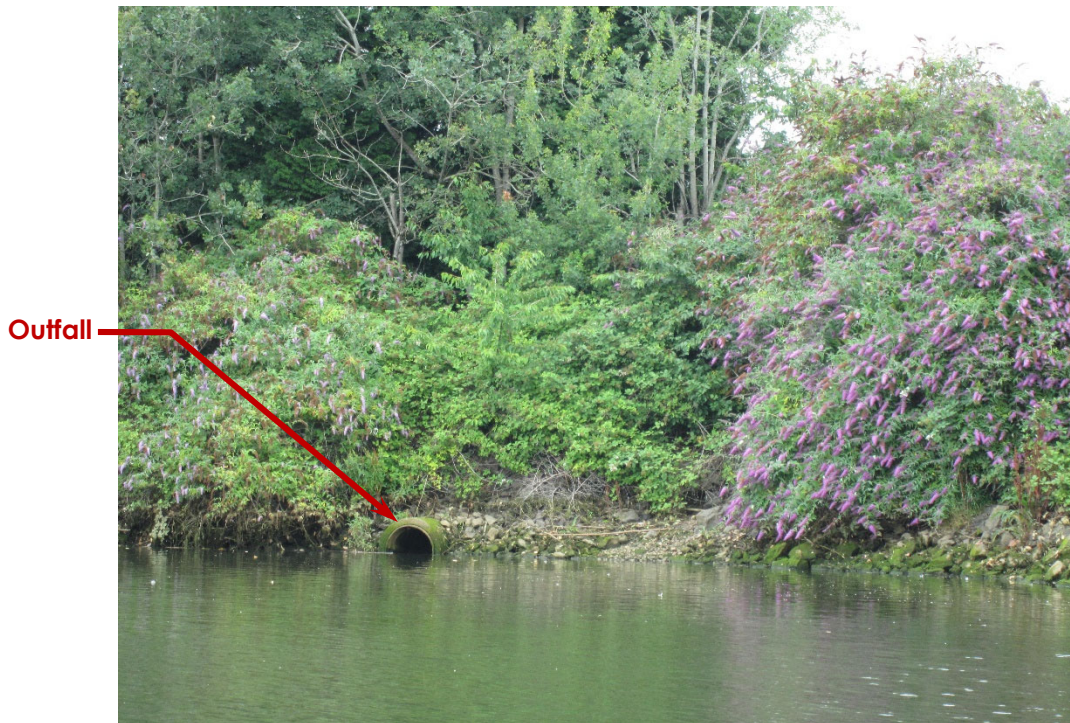
Photo BDC-1-02: Outfall South of Dolphin (Looking East)

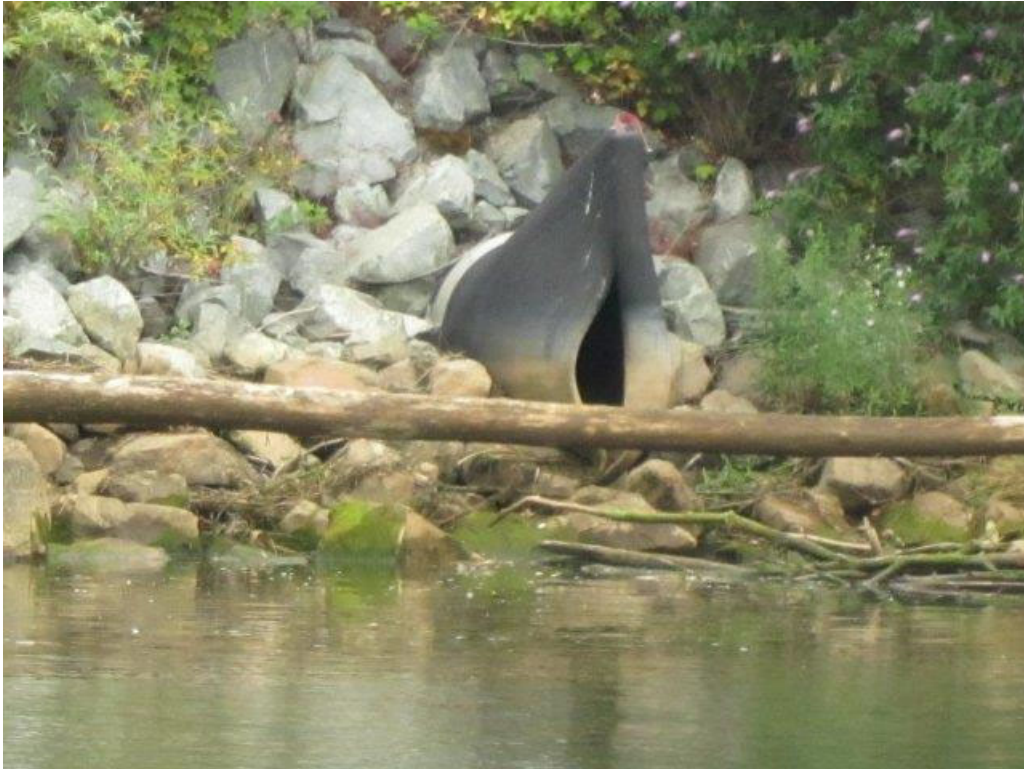
Boeing Plant 2 ————— **Boeing 1-01: Outfall North of Building**

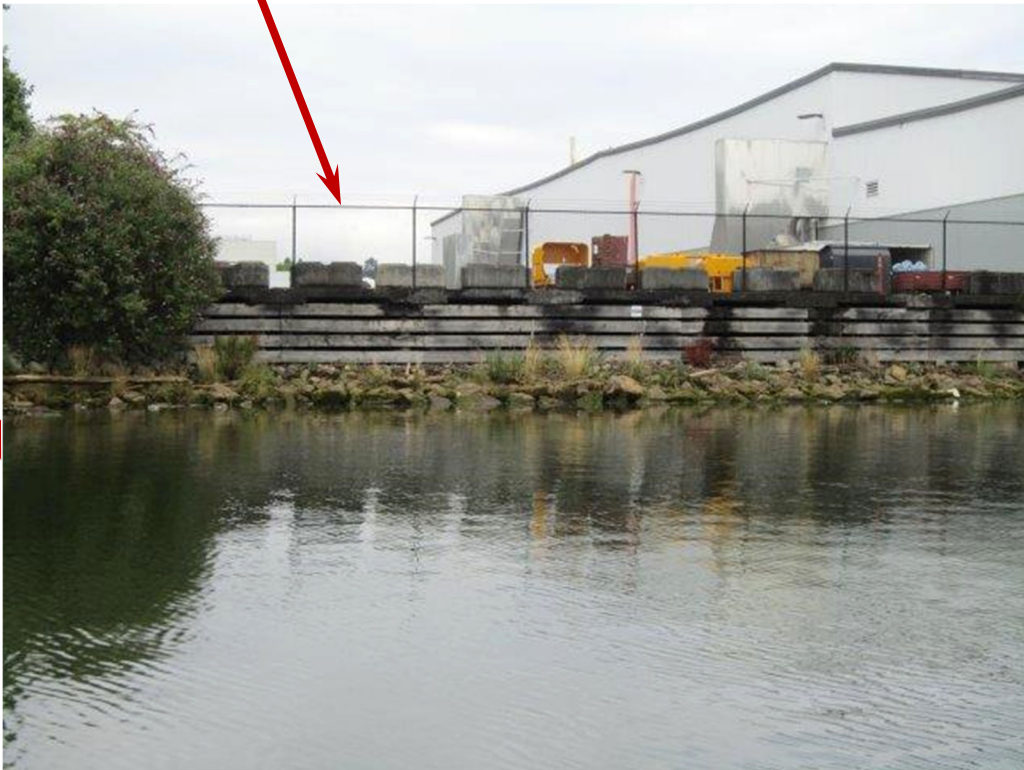
Boeing 1-02: North End of Building

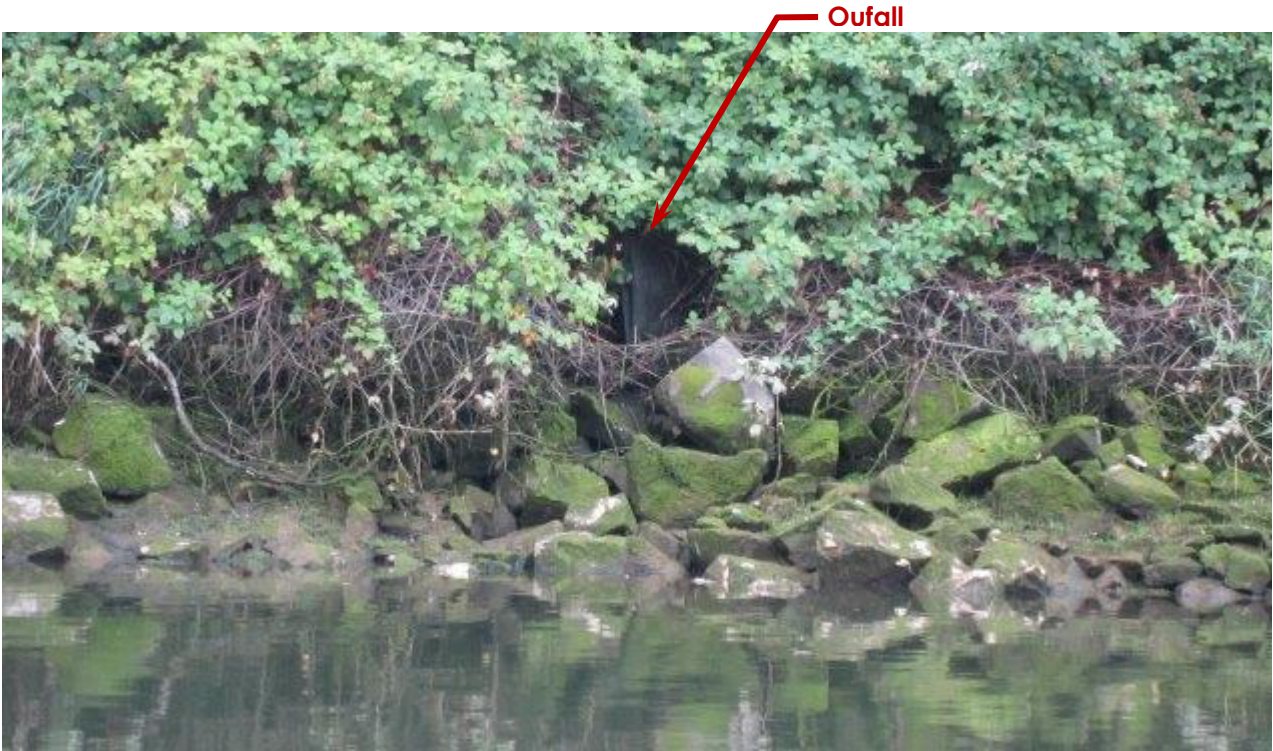
Photo Ditch #2-01: Outfall (Looking West)

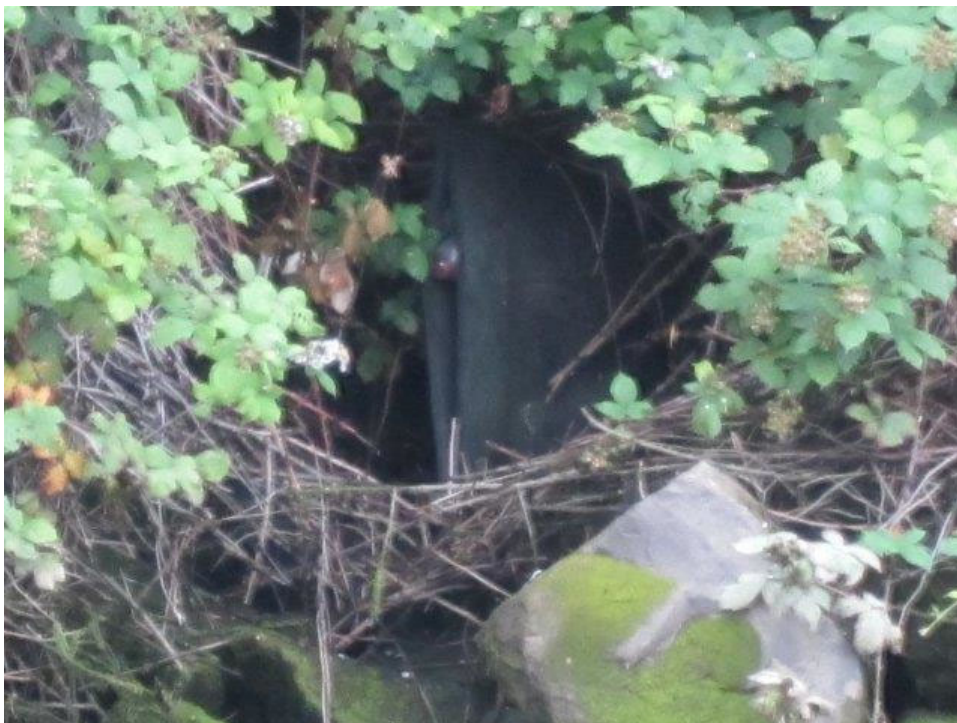
Photo Ditch #2-02: Enlarged Outfall Valve

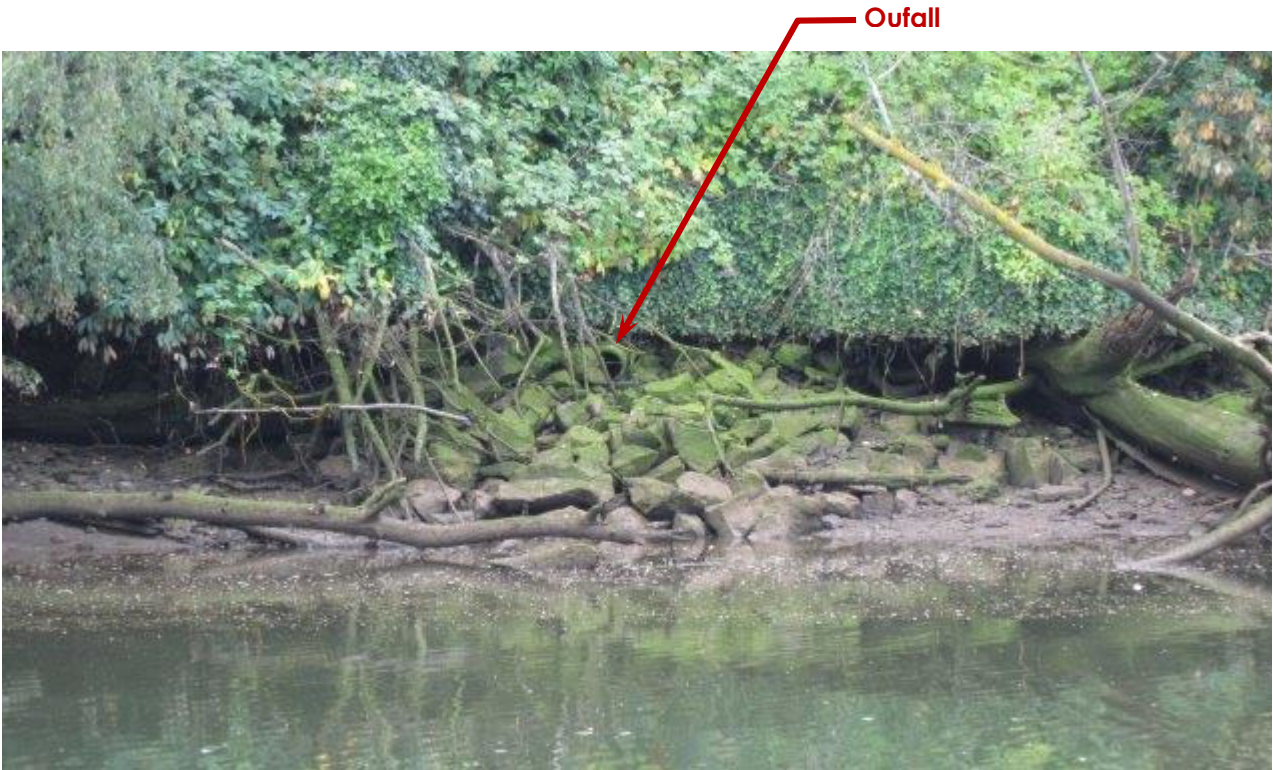
Photo SP3-01: Outfall (Looking West)
