Appendix H

Sediment Thickness Inspection Results, Field Logs, and Pictures

LDW Upper Reach Phase II PDI: Sediment Thickness Over Armored Banks (Jet Probe)

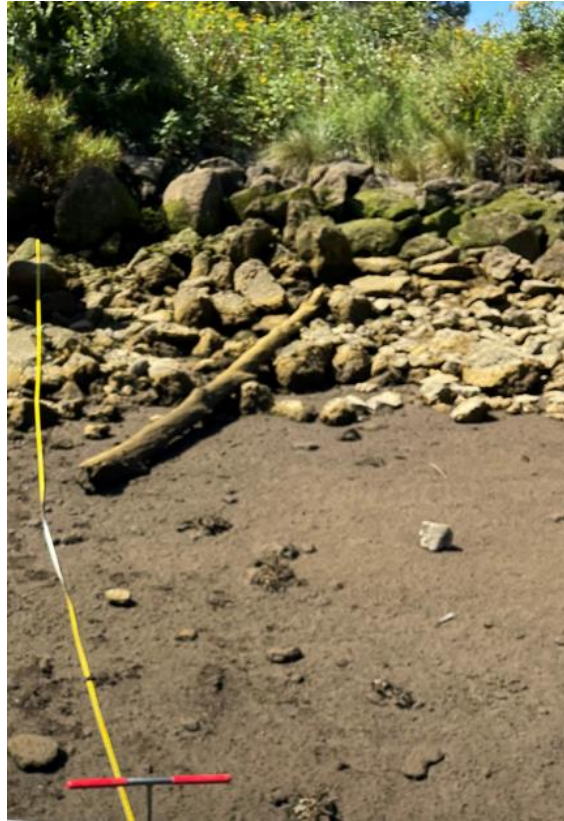
Figure H-1
Transects Near RM 3.3W, Typical Surface Conditions Along Transects

Sediment thickness probing was conducted along two transects on the west bank of the upper reach near river mile (RM) 3.3. The transects began approximately 15 ft downslope from the vegetation line. Visual observations of surface debris and armoring throughout the area generally included small river rock and concrete debris for the uppermost 15 ft of the transects, with no sediment covering the armoring. From 15 to 20 ft downgradient of the beginning of the transects, the observed surface material was predominately sediment and gravel, with sediment thickness above armoring ranging from approximately 1.5 to 4 ft. Beyond 20 ft downgradient of the beginning of the transects, no refusal was encountered, indicating the toe of armoring.

During sediment thickness probing, stiff sand layers and layers suspected to be wood debris were encountered throughout the area. Additional details for all transects within this area can be found in the field forms (Attachment H-1). Map H-1 illustrates the approximate toe of armoring and the sediment thickness at each probed location, as identified during the sediment thickness investigation. Figure H-1 depicts the typical surface conditions encountered along the transects near RM 3.3W.

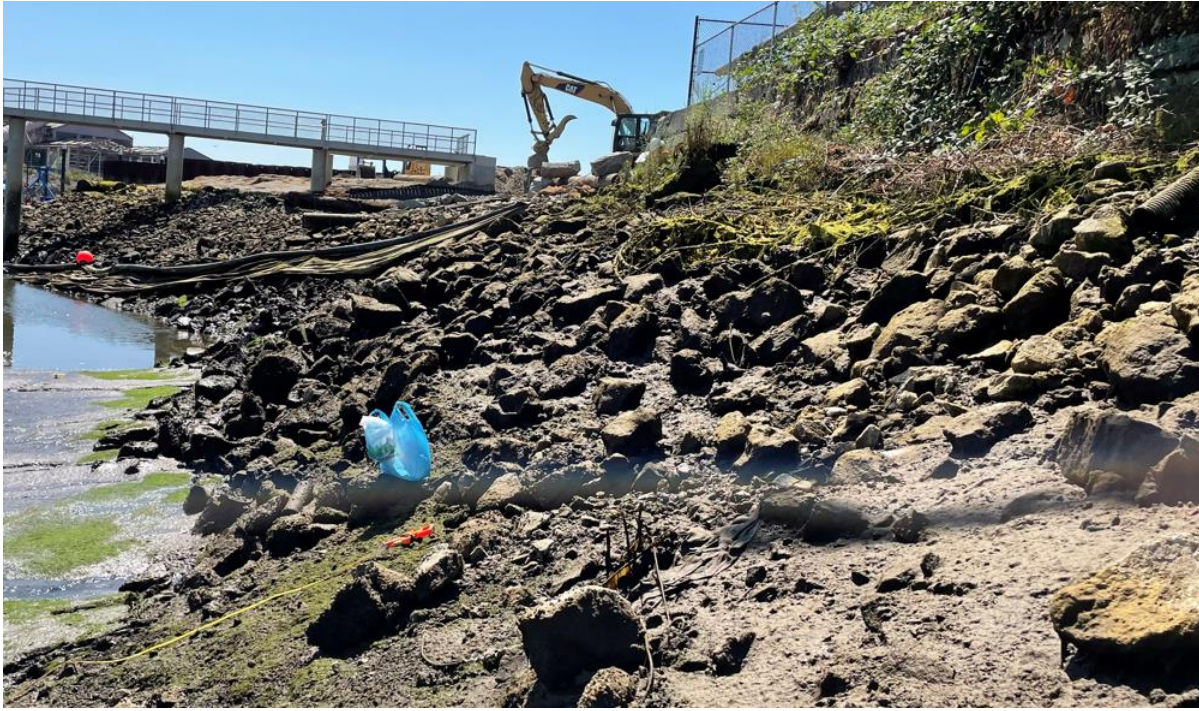
Figure H-2 Transects Near RM 3.5W, Typical Surface Conditions Along Transects

Sediment thickness probing was conducted along two transects on the west bank of the upper reach near RM 3.5. The transects began approximately 5 ft upslope of the lowest elevation visually observed edge of riprap armoring, where the sediment met the riprap. Riprap armoring extended from the beginning of the transect approximately 30 ft up a steep slope and terminated at a bulkhead. From the beginning of the transect to approximately 5 ft downgradient, the observed surface material consisted primarily of riprap at both transects with no sediment overlay. The distance down the transect to no refusal was approximately 6 to 9 ft downgradient, indicating the assumed toe of armoring. It is assumed that the existing armoring is mostly visible within this area, with very little sediment overlying the armoring. Additional details for all transects within this area can be found in the field forms (Attachment H-1). Map H-2 illustrates the approximate toe of bank armoring and the sediment thickness at each probed location, as identified during the sediment thickness investigation. Figure H-2 depicts the typical surface conditions encountered along the transects near RM 3.5W.

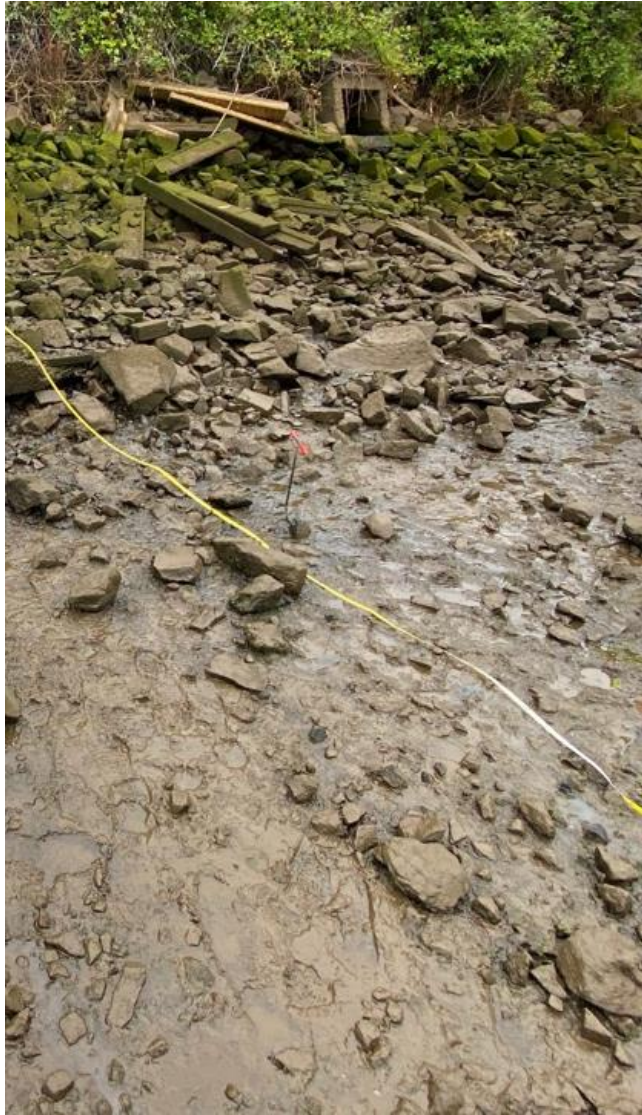
Figure H-3
Transects Near RM 3.9E, Typical Surface Conditions Along Transect

Sediment thickness probing was conducted along one transect on the east bank of the upper reach near RM 3.9. The transect began at the vegetation line with riprap extending approximately 5 ft upslope of the vegetation line. From the beginning of the transect to approximately 5 ft downgradient, the observed surface material was riprap greater than 1 ft in diameter, with no sediment overlay. At approximately 20 ft downgradient of the beginning of the transect, 0.5 ft of sediment was measured, with an observed surface of sediment with small pebbles and gravel. The distance down the transect to no refusal was 24 ft, indicating the toe of armor. Additional details for the transect within this area can be found in the field forms (Attachment H-1). Map H-3 illustrates the approximate toe of bank armoring and the sediment thickness at each probed location as identified during the sediment thickness investigation. Figure H-3 depicts the typical surface conditions encountered along the transects near RM 3.9E.

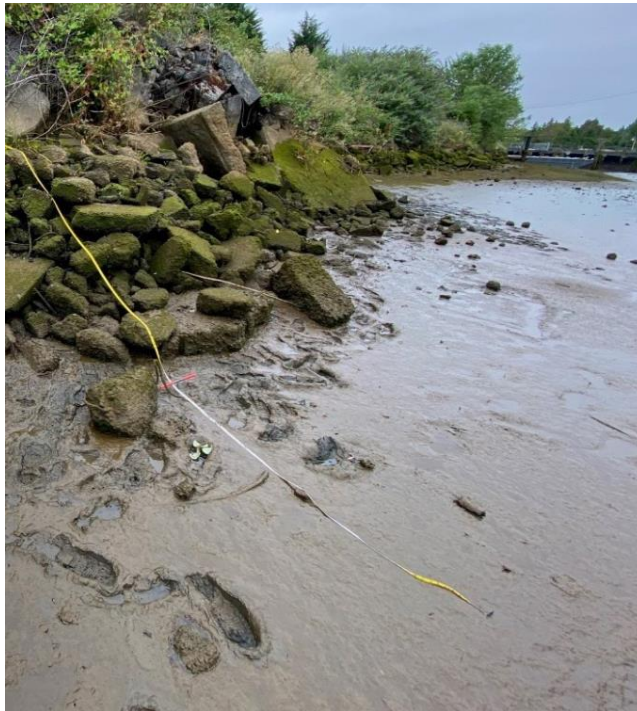
Figure H-4
Transects Near RM 4.1E, Typical Surface Conditions Along
Transects

Sediment thickness probing was conducted along 10 transects on the east bank of the upper reach near RM 4.1. Visual observations of surface material and armoring throughout the upgradient portions of the area generally included riprap and smaller rocks, with concrete debris observed sporadically at some transects. The transects typically began near the lowest elevation visually observed edge of the riprap armoring, where the sediment met the riprap or near the vegetation line. Sediment thickness above armoring within the upper portions of the transects typically ranged from 0.17 to 2.2 ft. The distance downgradient along the transect to no refusal varied throughout the area from approximately 8 to 21 ft downgradient, indicating the toe of armoring. During the

sediment thickness probing, some stiff sand layers were encountered. Additional details for all transects within this area can be found in the field forms (Attachment H-1). Map H-4 illustrates the approximate toe of bank armoring and the sediment thickness at each probed location as identified during the sediment thickness investigation. Figure H-4 depicts the typical surface conditions encountered along the transects near RM 4.1E.

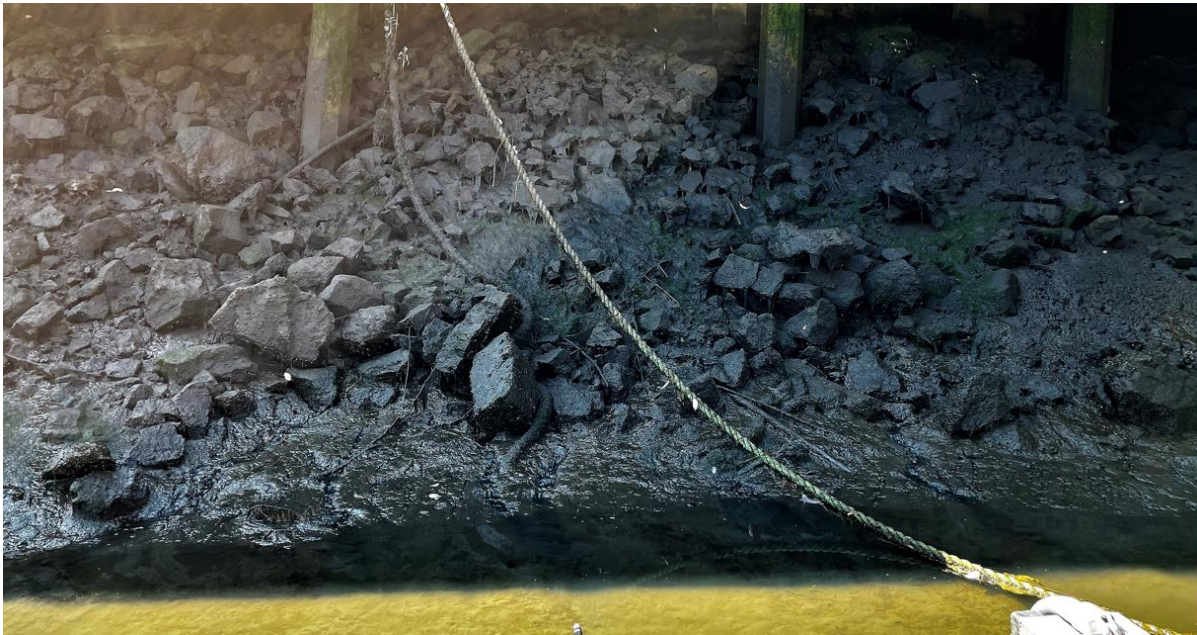
Figure H-5
Transects Near RM 4.2E, Typical Surface Conditions Along Transects

The investigation area on the east bank of the upper reach near RM 4.2 (and within Slip 6) was not accessible on foot. Therefore, jet probing was conducted from a watercraft along two transects within this area. The slope was armored with riprap, beginning at a bulkhead on the upgradient side and extending to the water level on the downgradient side. The transects began 30 to 40 ft downslope of the bulkhead, where the riprap met the waterline. From the beginning of the transect to approximately 15 ft downgradient, sediment thickness ranged from 0 to 6.33 ft, with the refusal interpreted to be gravel and riprap. Probing continued to approximately 20 to 25 ft downgradient. Refusal was encountered downgradient of the assumed toe of armoring. Reasons for refusal beyond the interpreted toe of armoring were judged to be a stiff clay/silt layer and gravel. The jet probe was not able to penetrate this layer, but the audible feedback provided by the probe was indicative of gravel. Additional details for all transects within this area can be found in the field forms

(Attachment H-1). Map H-5 illustrates the approximate toe of bank armoring and the sediment thickness at each probed location as identified during the sediment thickness investigation. Figure H-5 depicts the typical surface conditions encountered along the transects near RM 4.2E.

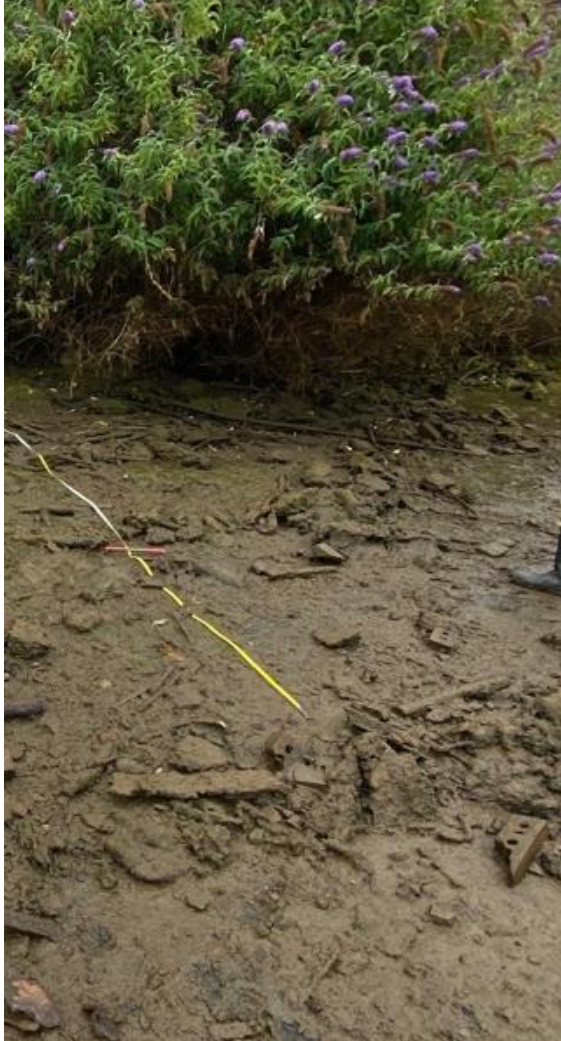
Figure H-6
Transects Near RM 4.6E, Typical Surface Conditions Along
Transects

Sediment thickness probing was conducted along three transects on the east bank of the upper reach near RM 4.6. Visual observations of surface material throughout the upgradient portions of the area generally included mixed debris (surficial metal and concrete debris), organics, and sediment. Armoring was not visually apparent on the surface. All transects began at the vegetation line, with steep banks continuing 5 to 10 ft upgradient of the vegetation line. Sediment thickness above refusal within the upper portions of the transects typically ranged from 2.5 to 4 ft. While refusal due to scattered debris and consolidated sand layers was encountered during some probes, it is assumed that continuous armoring does not exist within this area. Additional details for all transects within this area can be found in the field forms (Attachment H-1). Map H-6 illustrates the sediment thickness at each probed location as identified during the sediment thickness investigation. Figure H-6 depicts the typical surface conditions encountered along the transects near RM 4.6E.

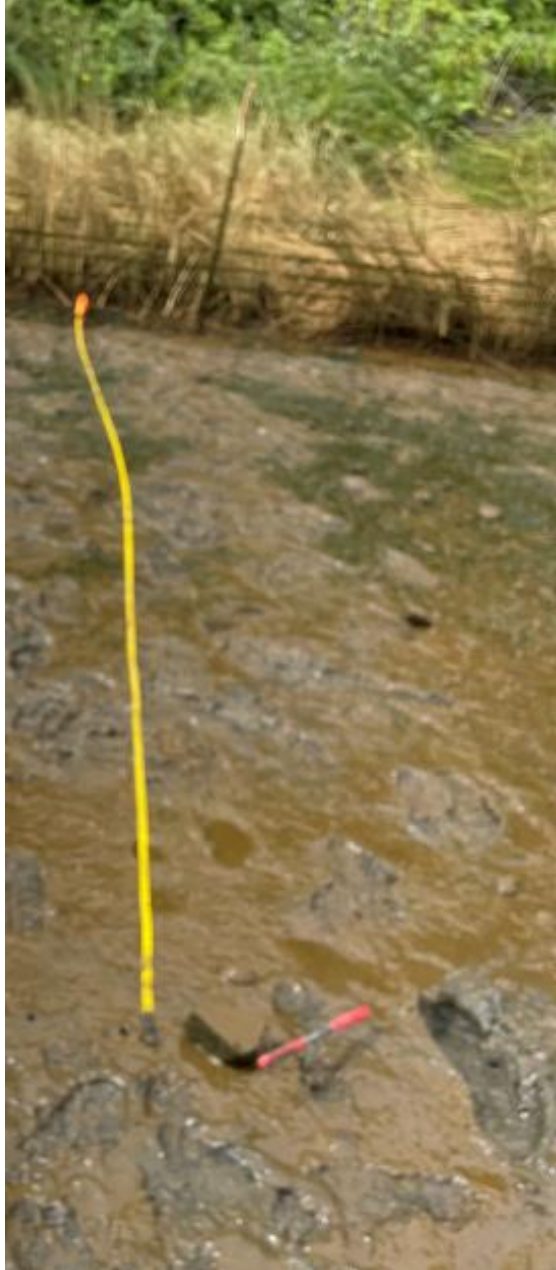
Figure H-7
Transects Near RM 4.7W, Typical Surface Conditions Along
Transects

Sediment thickness probing was conducted along two transects on the west bank of the upper reach near RM 4.7. Visual observations of surface material included small, scattered rocks approximately 1 to 3 in. in diameter, but consistent armoring was not apparent. The transects typically began near the downgradient edge of the vegetation line. During the sediment thickness probing, wood or stiff layers were encountered and led to refusal, but it is assumed that continuous armoring does not exist within this area. Additional details for all transects within this area can be found in the field forms (Attachment H-1). Map H-7 illustrates the sediment thickness at each probed location as identified during the sediment thickness investigation. Figure H-7 depicts the typical surface conditions encountered along the transects near RM 4.7W.

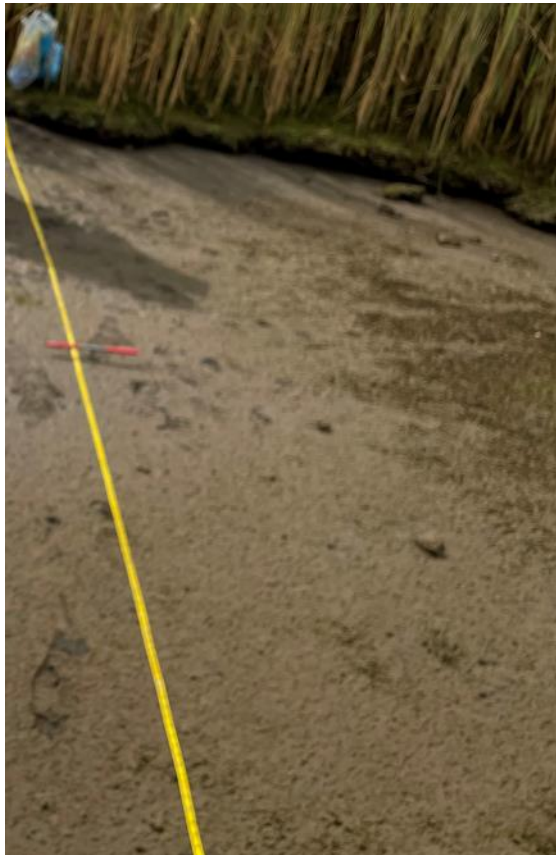
Figure H-8
Transects Near RM 4.8W, Typical Surface Conditions Along
Transects

Sediment thickness probing was conducted along five transects on the west bank of the upper reach near RM 4.8. The surface was relatively bare, with little to no debris or armoring present. The transects typically began near the downgradient edge of the vegetation line. During the sediment thickness probing, stiff sand layers were encountered, and some sporadic hard contacts below grade

led to refusal. However, continuous armoring was not encountered within this area. Additional details for all transects within this area can be found in the field forms (Attachment H-1). Map H-8 illustrates the sediment thickness at each probed location as identified during the sediment thickness investigation. Figure H-8 depicts the typical surface conditions encountered along the transects near RM 4.8W.

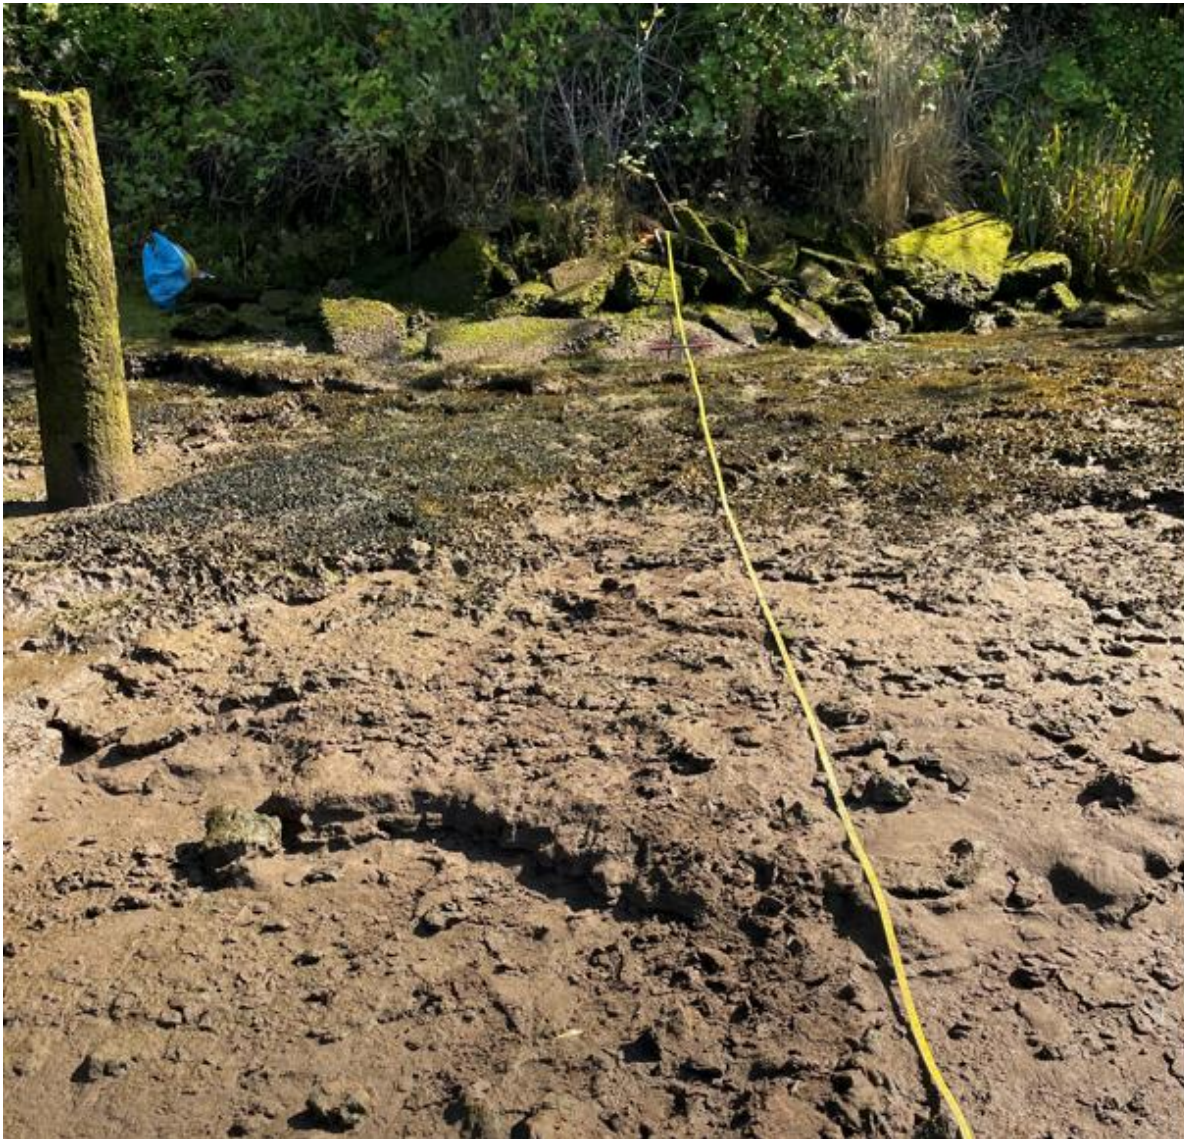
Figure H-9
Transects Near RM 4.9E, Typical Surface Conditions Along Transects

Sediment thickness probing was conducted along 10 transects on the east bank of the upper reach near RM 4.9. Visual observations of the surface included armoring throughout the upgradient portions of the area and sporadic concrete and wood debris at some transects. The transects typically began near the lowest elevation visually observed edge of the riprap armoring, where the sediment met the riprap. Sediment thickness above armoring within the upper portions of the transects typically ranged from 0.25 to 3 ft. The distance down the transect to no refusal varied throughout the area from approximately 0 to 30 ft downgradient, indicating the toe of armoring.

During the sediment thickness probing, some stiff sand layers were encountered. Additional details for all transects within this area can be found in the field forms (Attachment H-1). Map H-9 illustrates the approximate toe of bank armoring and the sediment thickness at each probed location as identified during the sediment thickness investigation. Figure H-9 depicts the typical surface conditions encountered along the transects near RM 4.9E.
