Appendix C-1
Phase I Bank Visual Inspection
Observations and Photographs

This appendix provides detailed results of Lower Duwamish Waterway (LDW) middle reach Phase II Pre-Design Investigation (PDI) bank inspections that were conducted to satisfy data quality objectives (DQOs) 11 and 14. The Phase II inspections focused on areas with remedial action level (RAL) exceedances based on the Phase I dataset, and included a field visit at low tide to document bank conditions and measure the thickness of sediment over armoring (where applicable), and a desktop analysis of oblique and ortho-aerial photographs.

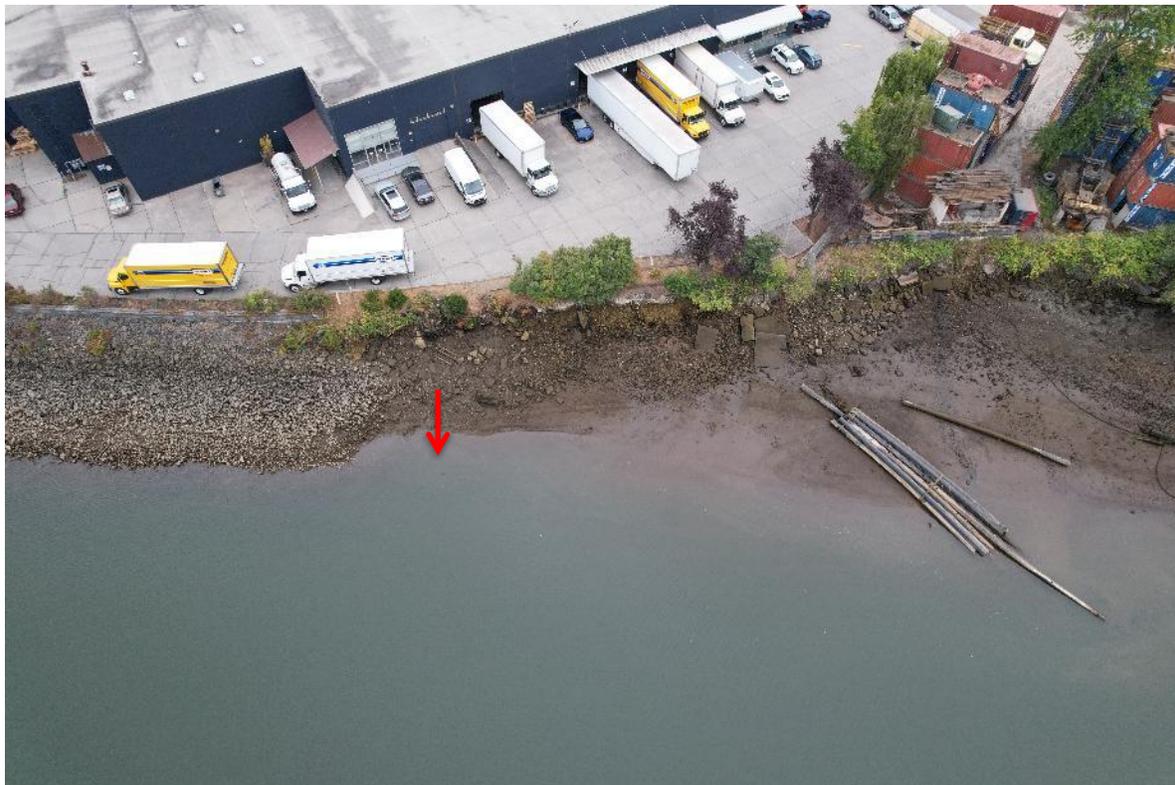
Figure C-2-1
Oblique Photograph for RAL Exceedance Area 33

Visual observations through desktop analysis of the shoreline noted an armored slope along the upgradient portions of the area. Armoring consisted of riprap and concrete pieces. Debris in the area included concrete slabs, timber, and metal pilings.

Sediment thickness probing was conducted along one transect on the bank of RAL Exceedance Area 33. Visual observations during probing included concrete and sporadic rock in the upgradient portions. The transect began near the lowest elevation of visually observed rock/debris and continued downgradient in 5-foot increments (0, 5, 10 and 15 feet). All sediment thickness measurements along this transect were less than 1 foot. Additional details for the transects can be found in the shoreline conditions forms (Attachment C-2-1). Figure C-2-1 displays a drone oblique for RAL Exceedance Area 33 and the red arrow depicts the approximate location and direction of the sediment thickness probing transect.

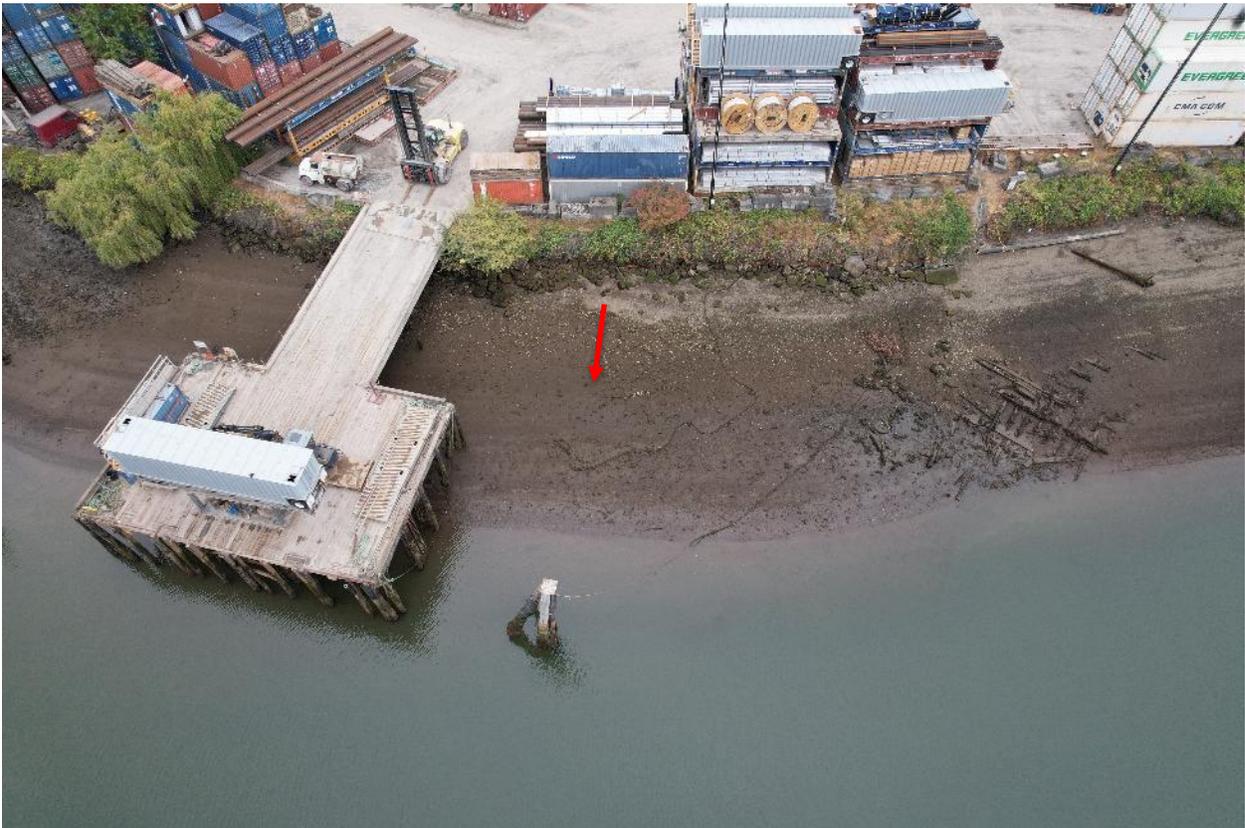
Figure C-2-2
Oblique Photograph for RAL Exceedance Area 31

Visual observation from desktop analysis of the shoreline noted an unarmored slope along the upgradient portions of the area. Sporadic rock and concrete were noted at the edge of the vegetation line. Debris in the area included ropes and timber. The RAL exceedance area is south (to the right on Figure C-2-2) of a pier and dolphin.

Sediment thickness probing was conducted along one transect on the bank of RAL Exceedance Area 31. Visual observations during probing included concrete and sporadic rock in the upgradient portions, with no overlying sediment. The transect began near the lowest elevation of visually observed vegetation. Sediment thickness at the edge of vegetation ranged from 2.5 to 3 feet. Probing continued 5 feet downgradient the sediment thickness is 0.5 foot. Further downgradient (10- and 15-foot) sediment thickness ranged from 2.5 to 3 feet. Additional details for the transect can be found in the shoreline conditions form (Attachment C-2-1). Figure C-2-2 displays the drone obliques for RAL Exceedance Area 31 and the red arrow depicts the approximate location and direction of the sediment thickness probing transect.

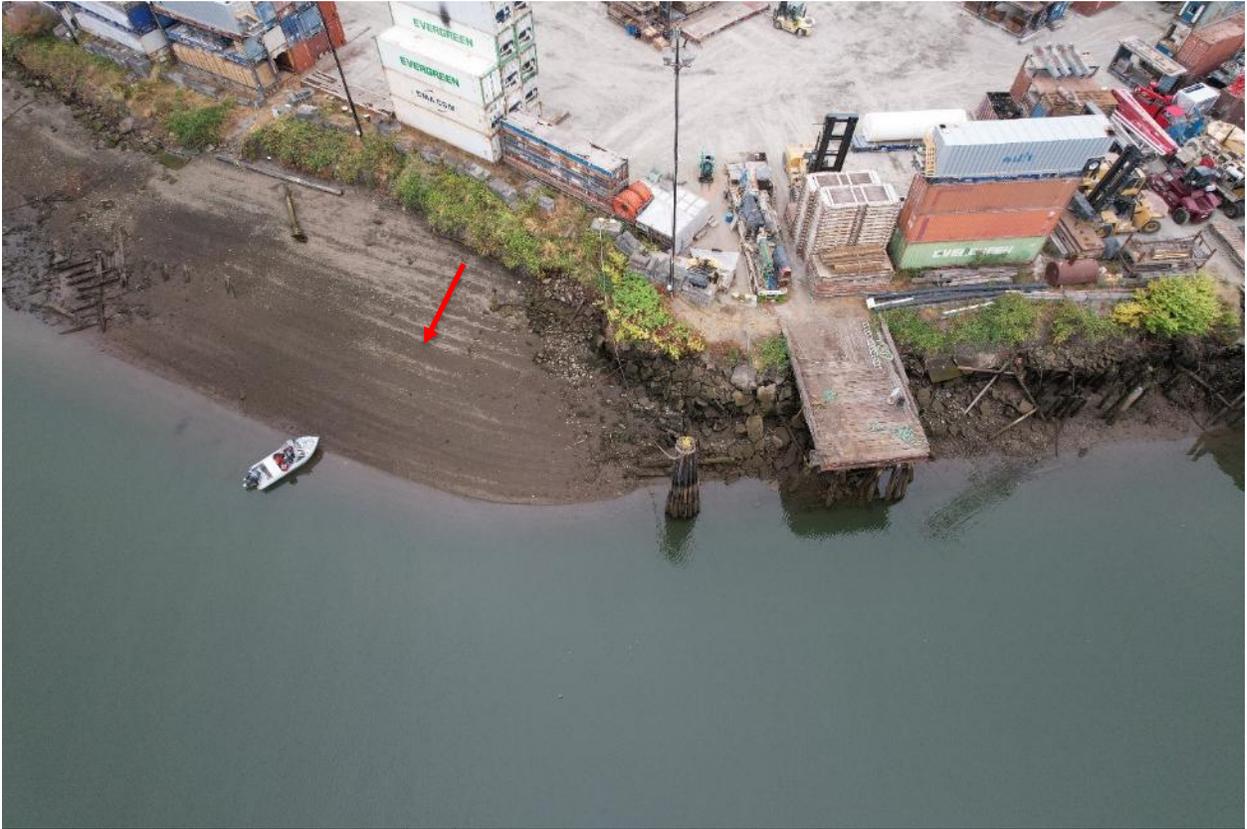
Figure C-2-3
Oblique Photograph for RAL Exceedance Area 30

Visual observation from desktop analysis of the shoreline noted an unarmored slope and armored slope along the upgradient portions of the area. Armoring consisted of riprap and concrete pieces mainly around the pier structure towards the south end of the RAL Exceedance Area. In the armor area debris such as concrete slabs, ropes, and timber were noted. The north end of the RAL Exceedance Area is unarmored with sporadic rock minimal debris (metal pipes).

Sediment thickness probing was conducted along one transect on the bank of RAL Exceedance Area 30. Visual observations during probing included concrete and sporadic rock in the upgradient portions, with no overlying sediment. The transect began near the lowest elevation of visually observed vegetation. Sediment thickness at the edge of vegetation is 3 feet. Probing continued 5 feet downgradient the sediment thickness is 0.6 foot. Further downgradient (10- and 15-foot) sediment thickness is 2.5 feet. Additional details for the transect can be found in the shoreline conditions form (Attachment C-2-1). Figure C-2-3 displays the drone obliques for RAL Exceedance Area 30 and the red arrow depicts the approximate location and direction of the sediment thickness probing transect.

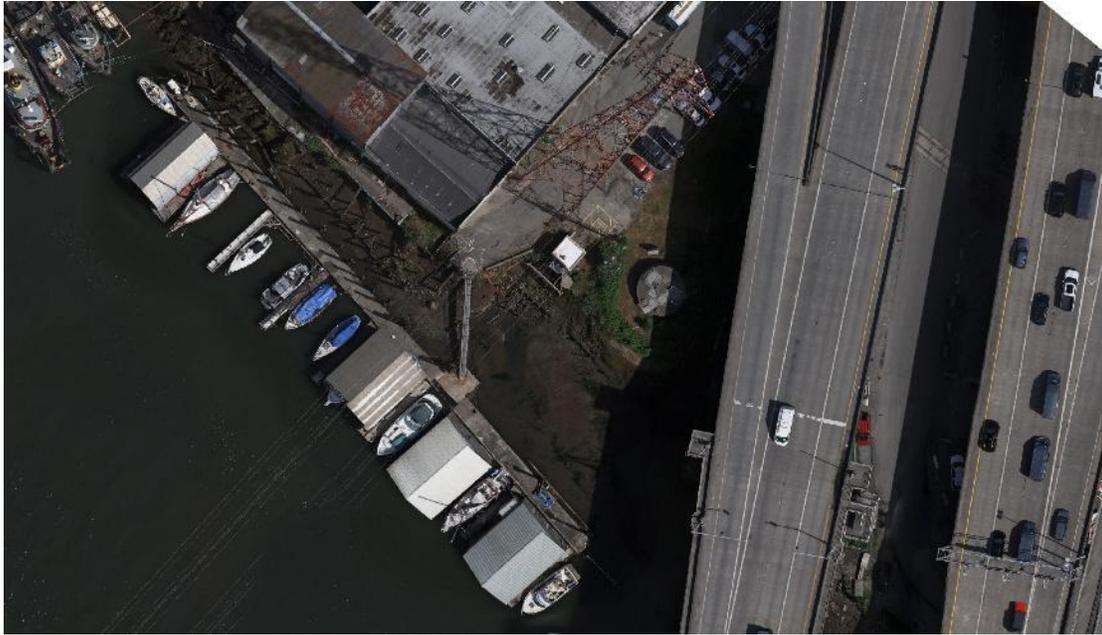
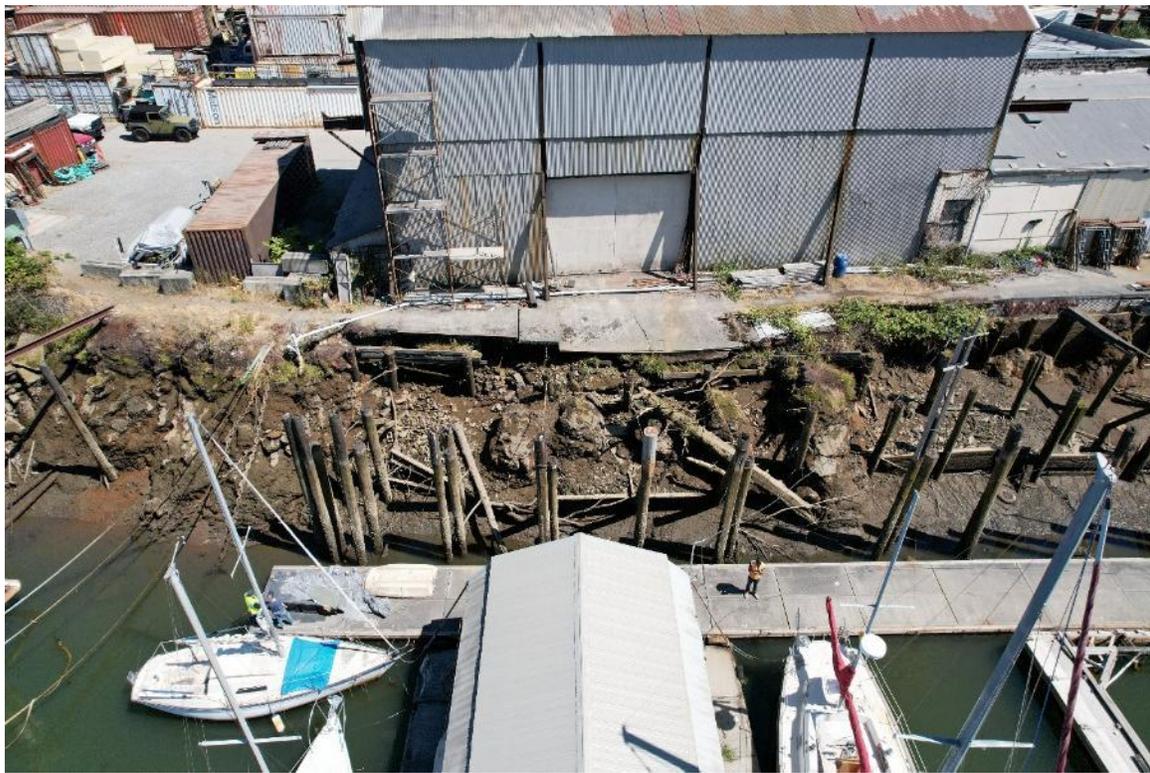
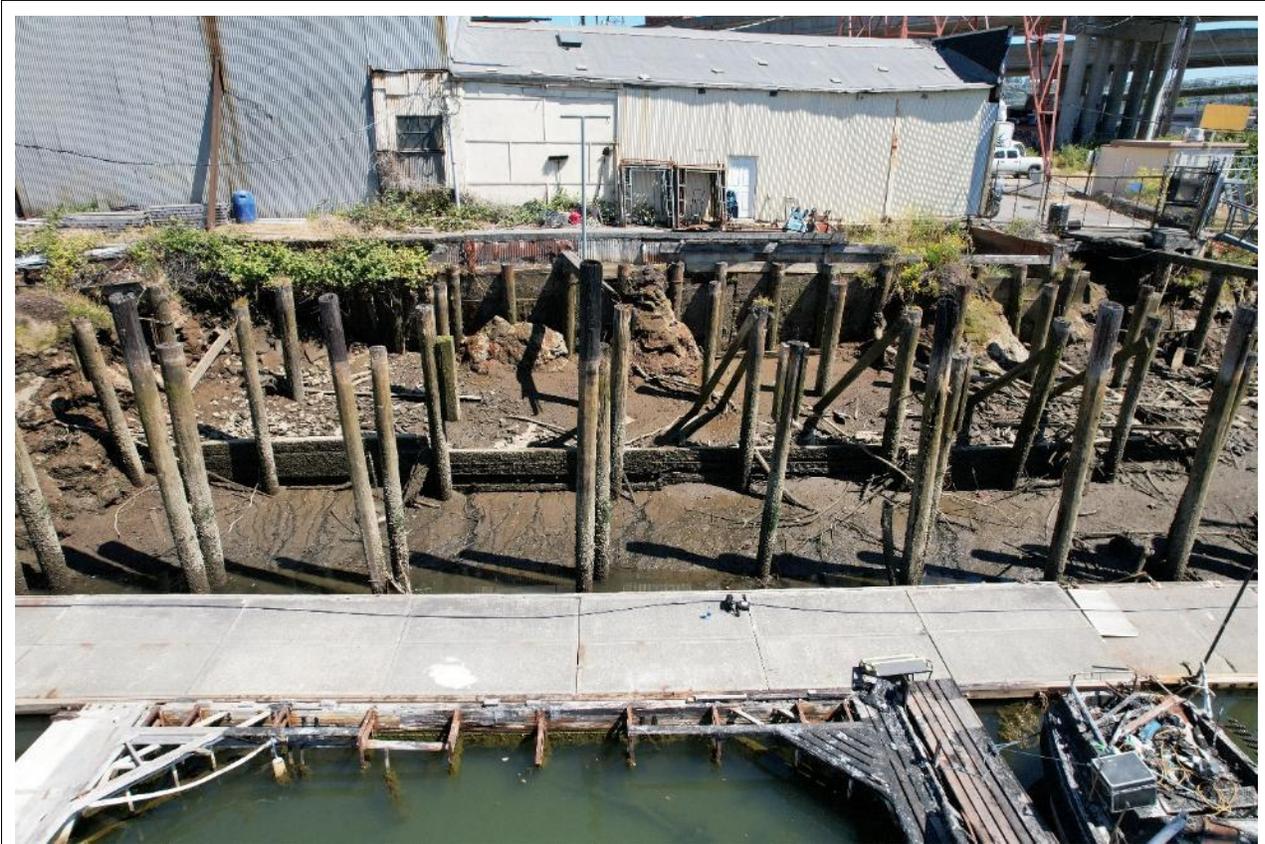
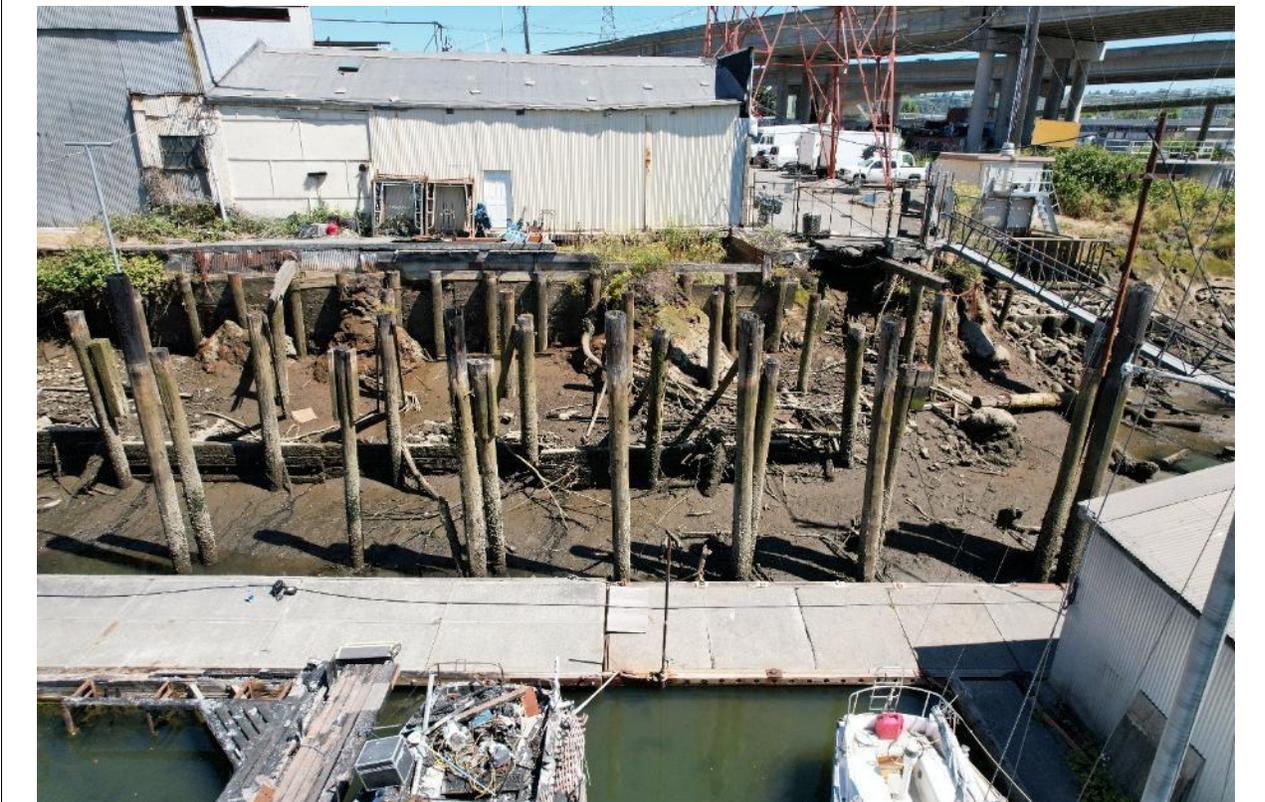
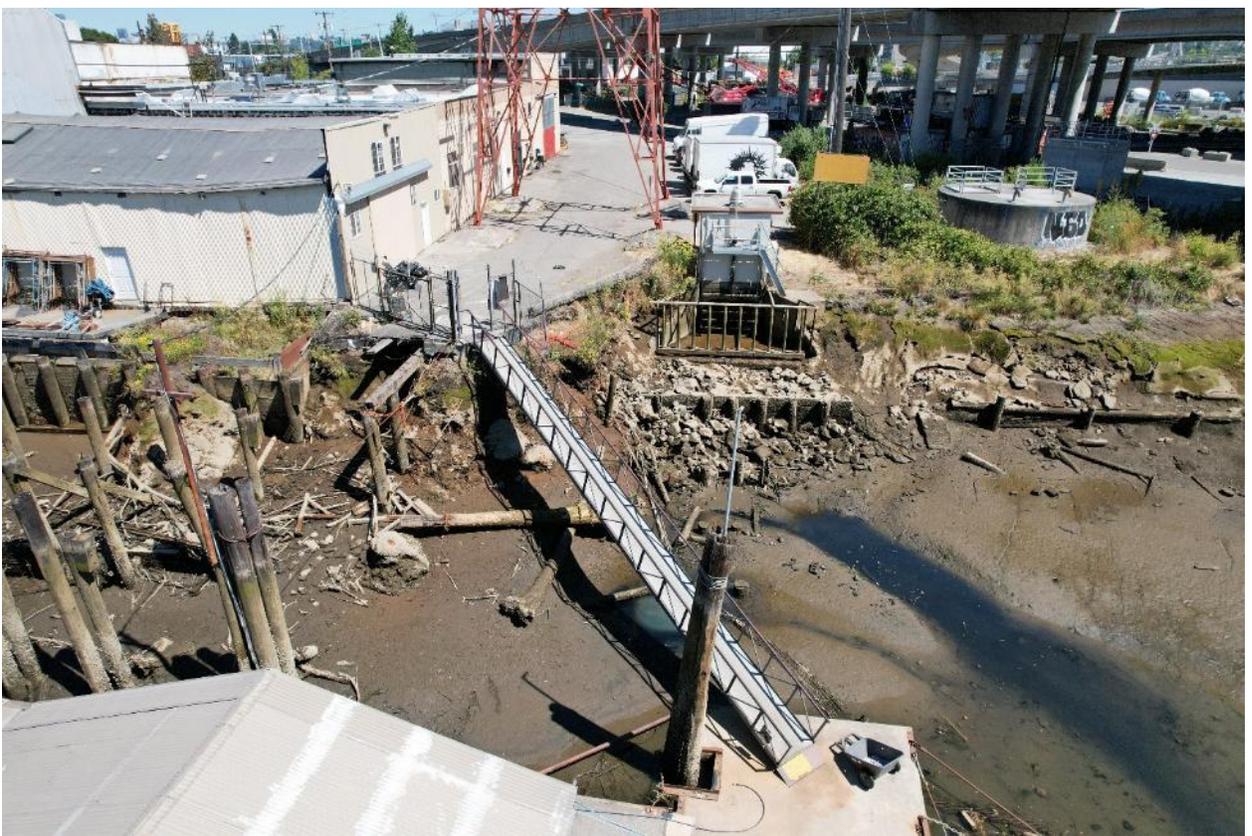
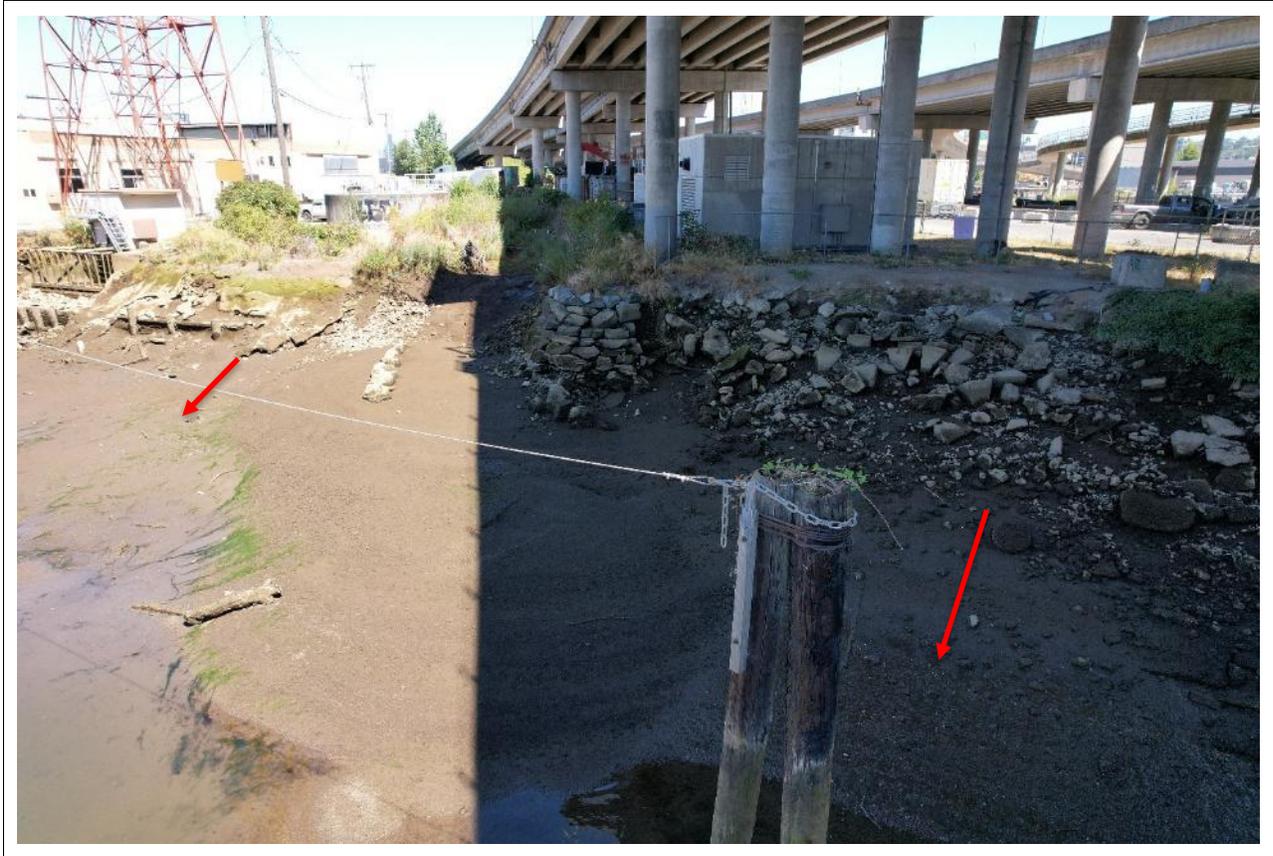
Figure C-2-4
Ortho-aerial and Oblique Photographs for RAL Exceedance Area 29 Displayed from Downriver (Left) to Upriver (Right)

Visual observation from desktop analysis of the shoreline noted the bank included areas that were armored, unarmored, and included a timber bulkhead. Concrete and timber debris were noted on the upgradient portions of the area. The RAL exceedance area includes floating structures offshore, abundant pilings, and an outfall (Outfall 2501). Desktop analysis occurred throughout the RAL exceedance area and was supplemented with field notes in the southern portion. The northern end of the RAL exceedance area was inaccessible during the vegetation and sediment thickness probing investigation.

Sediment thickness probing was conducted along two transects on the bank of RAL Exceedance Area 29. Sediment thickness probing only occurred on the southern end of the RAL exceedance areas. Visual observations during probing included concrete and sporadic rock in the upgradient portions, with no overlying sediment. The transects began near the lowest elevation of visually observed concrete and rock and no refusal was encountered. Probing continued 5 feet downgradient where no refusal was encountered. Additional details for all transects within this area can be found in the shoreline conditions form (Attachment C-2-1). Figure C-2-4 displays the drone obliques for RAL Exceedance Area 29 and the red arrows on the last photograph depict the approximate location and direction of the sediment thickness probing transects.

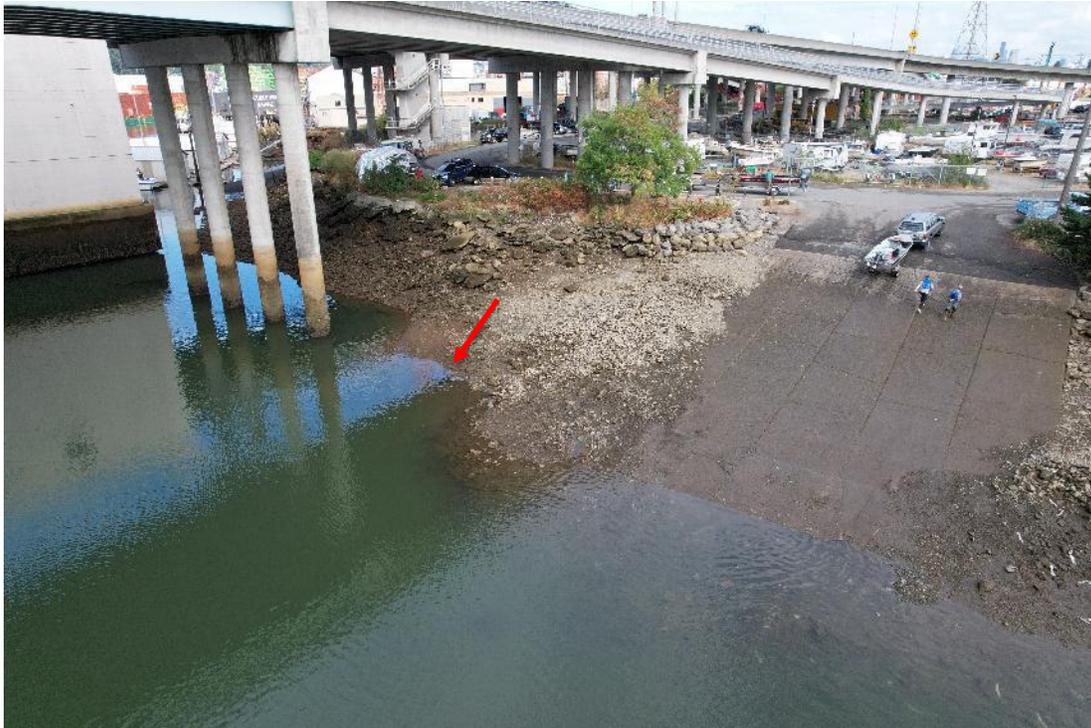
Figure C-2-5
Oblique Photograph for RAL Exceedance Area 27

Visual observations from desktop analysis of the shoreline noted an unarmored slope of the north end of a paved boat ramp. Large concrete debris were noted on the upgradient portions of the area, along wood debris further downgradient. The RAL exceedance area is under the First Avenue Bridge and include structures such as bridge foundations.

Sediment thickness probing was conducted along one transect on the bank of RAL Exceedance Area 27. The transect began near the lowest elevation of visually observed debris. Visual observations during probing included sporadic rock and concrete debris in the upgradient portions. Sediment measured between concrete debris was generally 0.5 foot or less in thickness. Probing continued downgradient in 5-foot intervals. Sediment thickness continued to be approximately 0.5 foot or less. The surface substrate transitioned to a silty sand overlaying a gravelly substrate. Brick and wood debris were observed while probing. Reason for refusal was typically due to compact sediment or encountering debris. Additional details for the transect can be found in the shoreline conditions form (Attachment C-2-1). Figure C-2-5 displays the drone obliques for RAL Exceedance Area 27 and the red arrow depicts the approximate location and direction of the sediment thickness probing transect.

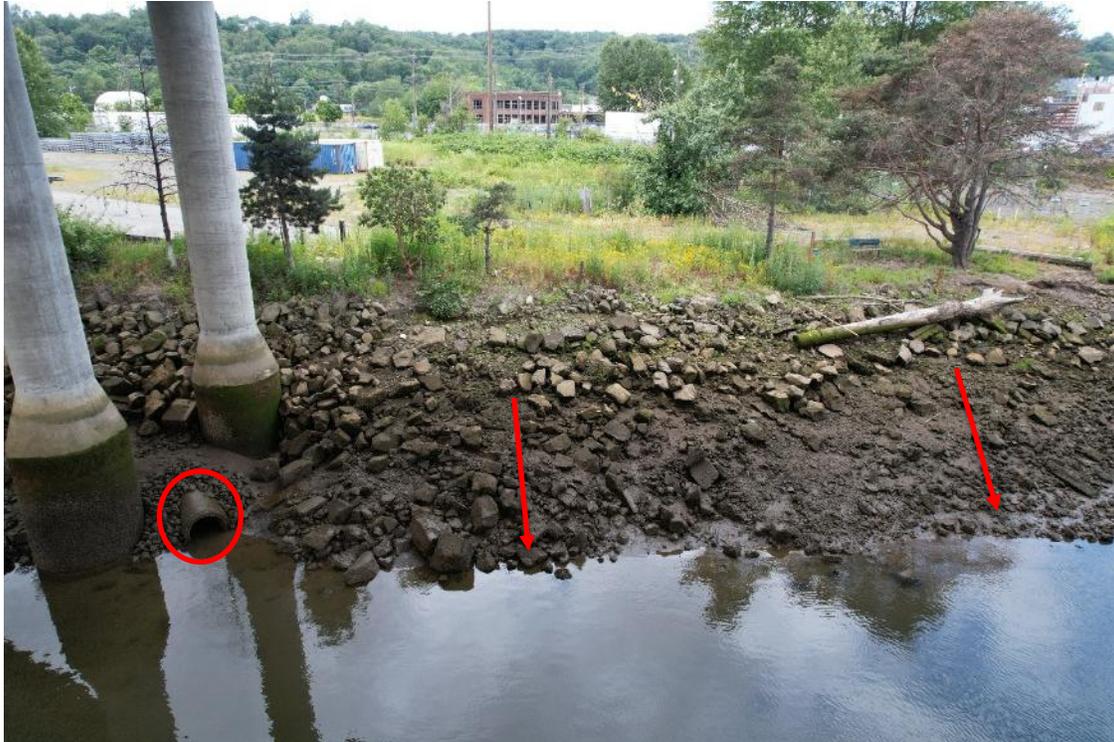
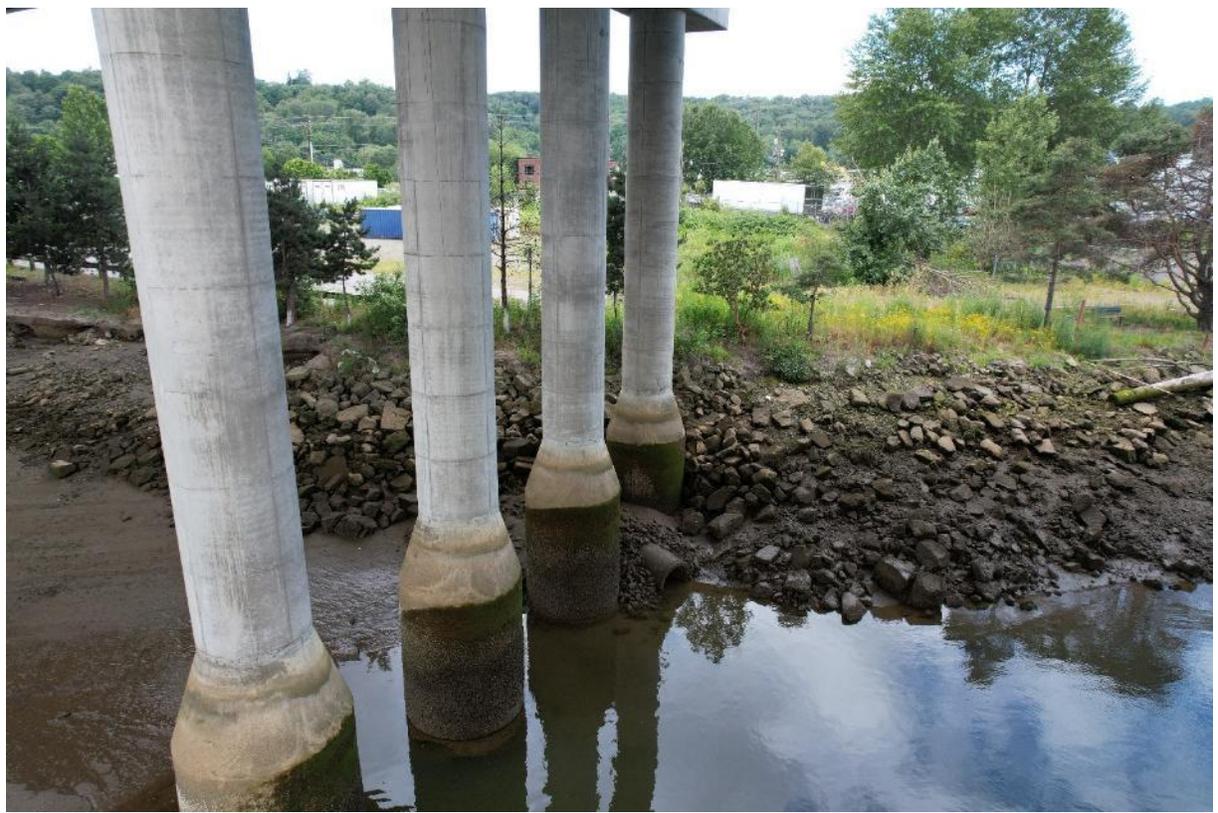
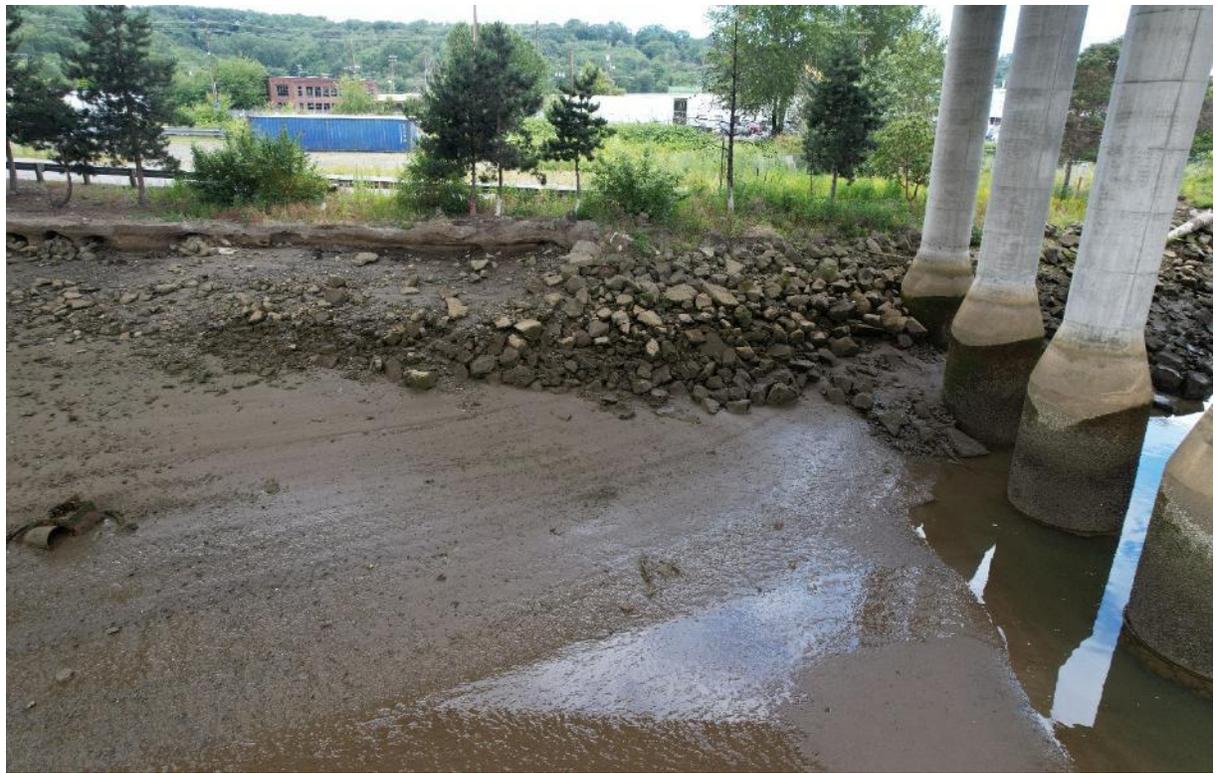
Figure C-2-6
Oblique Photographs for RAL Exceedance Area 26 Displayed from Upriver (Left) to
Downriver (Right)

Visual observations through desktop analysis of the shoreline noted an armored slope along the upgradient portions of the area. Armoring consisted of riprap and concrete pieces. There was no debris noted throughout the RAL exceedance area. The RAL exceedance area is under the First Avenue Bridge and include structures such as bridge foundations and Outfall 2506.

Sediment thickness probing was conducted along two transects on the bank of RAL Exceedance Area 26. Transects began near the apparent high water markings on the rocks. Visual observation of surface debris and armoring throughout the area generally included sporadic rock, concrete debris, and riprap in places in the upgradient portions, with no sediment covering the armoring. Downgradient of the armoring and concrete debris surface material transitioned to sandy silt. No refusal was encountered when probing. Additional details for all transects within this area can be found in the shoreline conditions forms (Attachment C-2-1). Figure C-2-6 displays the drone obliques for RAL Exceedance Area 26 and the red arrows depict the approximate location and direction of the sediment thickness probing transects.

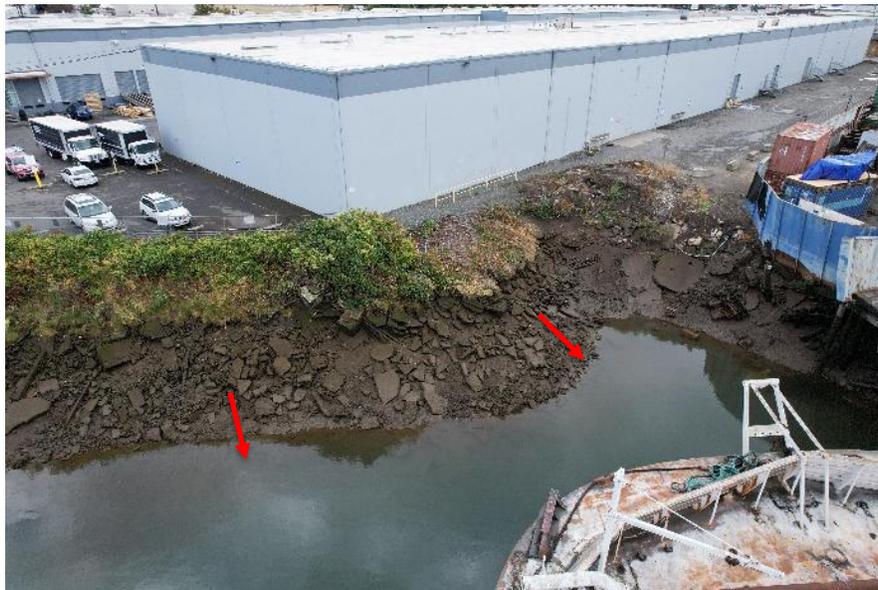
Figure C-2-7
Oblique Photograph for RAL Exceedance Area 24

Visual observations through desktop analysis of the shoreline noted an unarmored bank with abundant debris along the upgradient portions of the area. Debris was observed throughout the RAL exceedance area included wood and metal pieces, large concrete slabs, and bricks. The RAL exceedance area includes portions under a pier with a timber bulkhead structure on the upgradient portions under the pier.

Sediment thickness probing was conducted along two transects on the bank of RAL Exceedance Area 24. Transects began roughly 15 feet from the edge of vegetation. Due to health and safety concern the transect began where the slope flattened. Visual observation of surface debris and armoring throughout the area generally included sporadic rock and abundant concrete debris in the upgradient portions. Sediment measured between concrete debris was generally 0.5 foot or less in thickness roughly 5 feet downgradient from transect start the observed surface substrate transition to a gravelly sand and sediment thickness was typically 1.5 feet. Roughly 10 feet of downgradient sediment thickness was approximately 2 feet of soft sediment prior to hitting a hard refusal layer. Reason for refusal was typically due to compact sediment. Additional details for both transects can be found in the shoreline conditions forms (Attachment C-2-1). Figure C-2-7 displays the drone obliques for RAL Exceedance Area 24 and the red arrows depict the approximate location and direction of the sediment thickness probing transects.

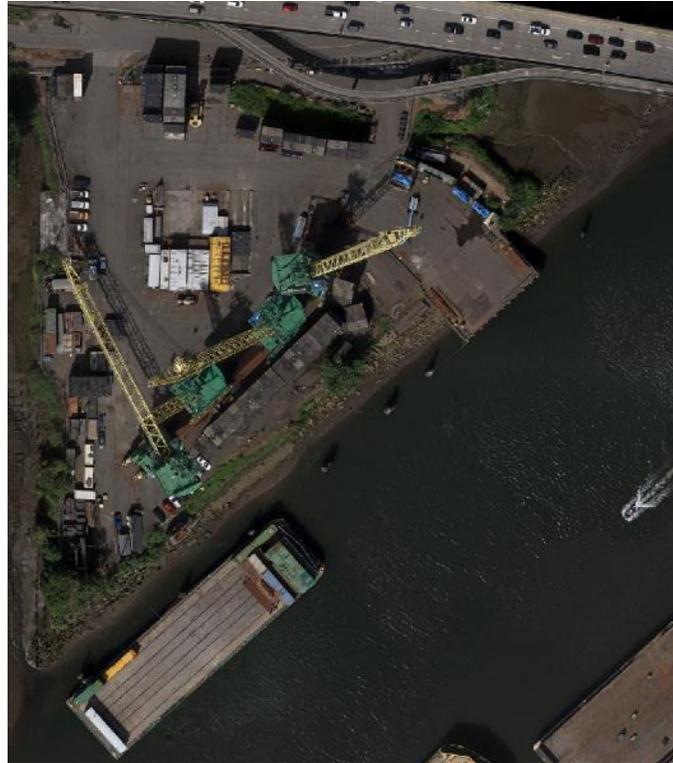
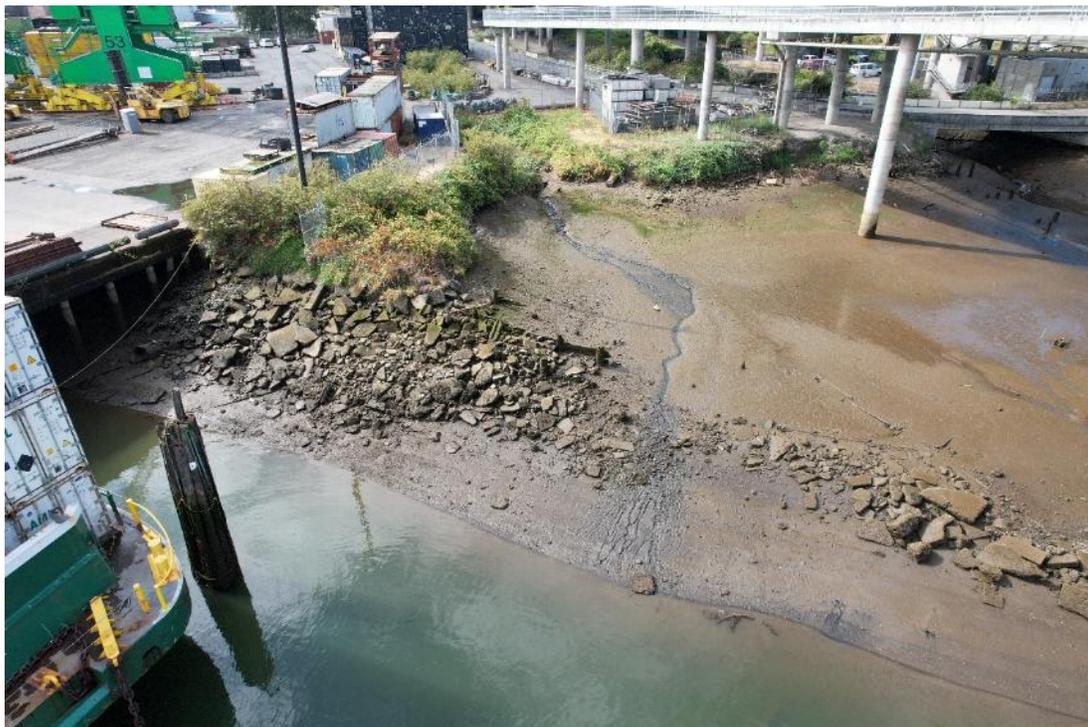
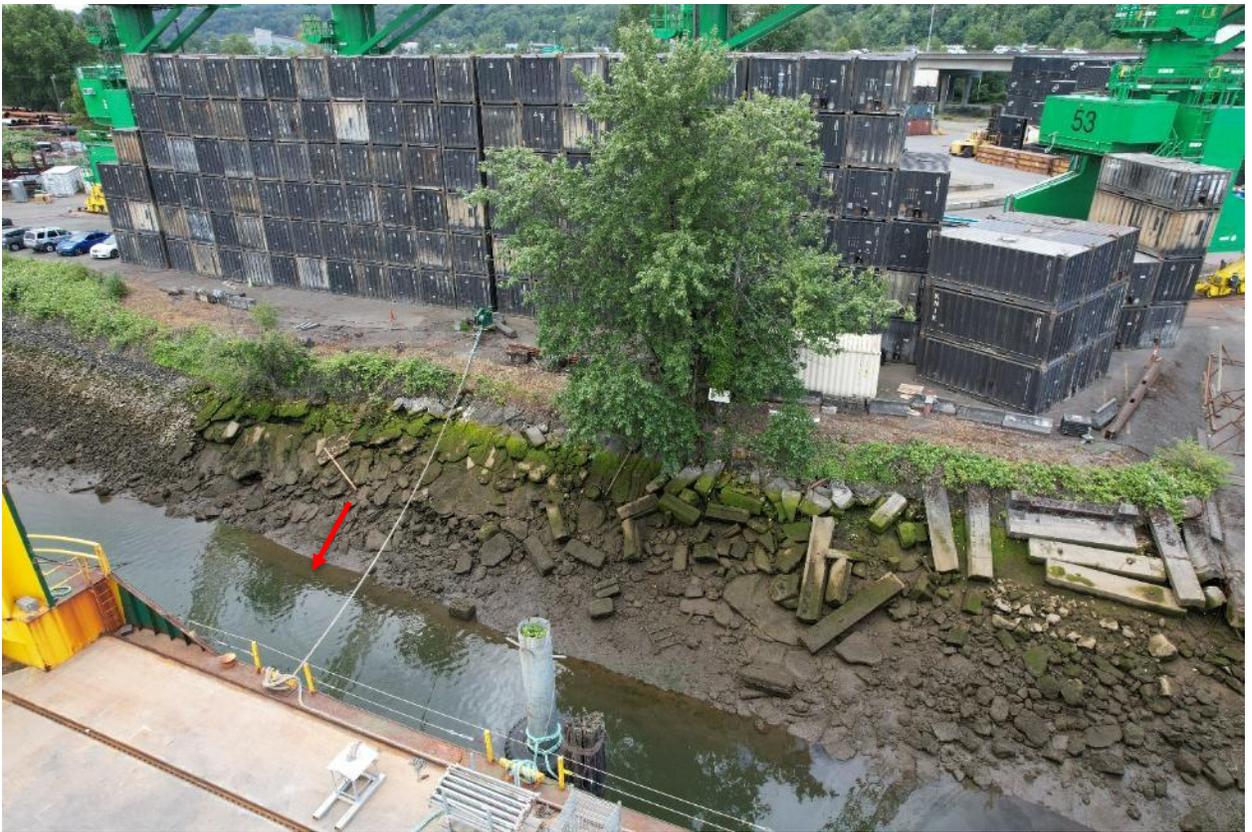
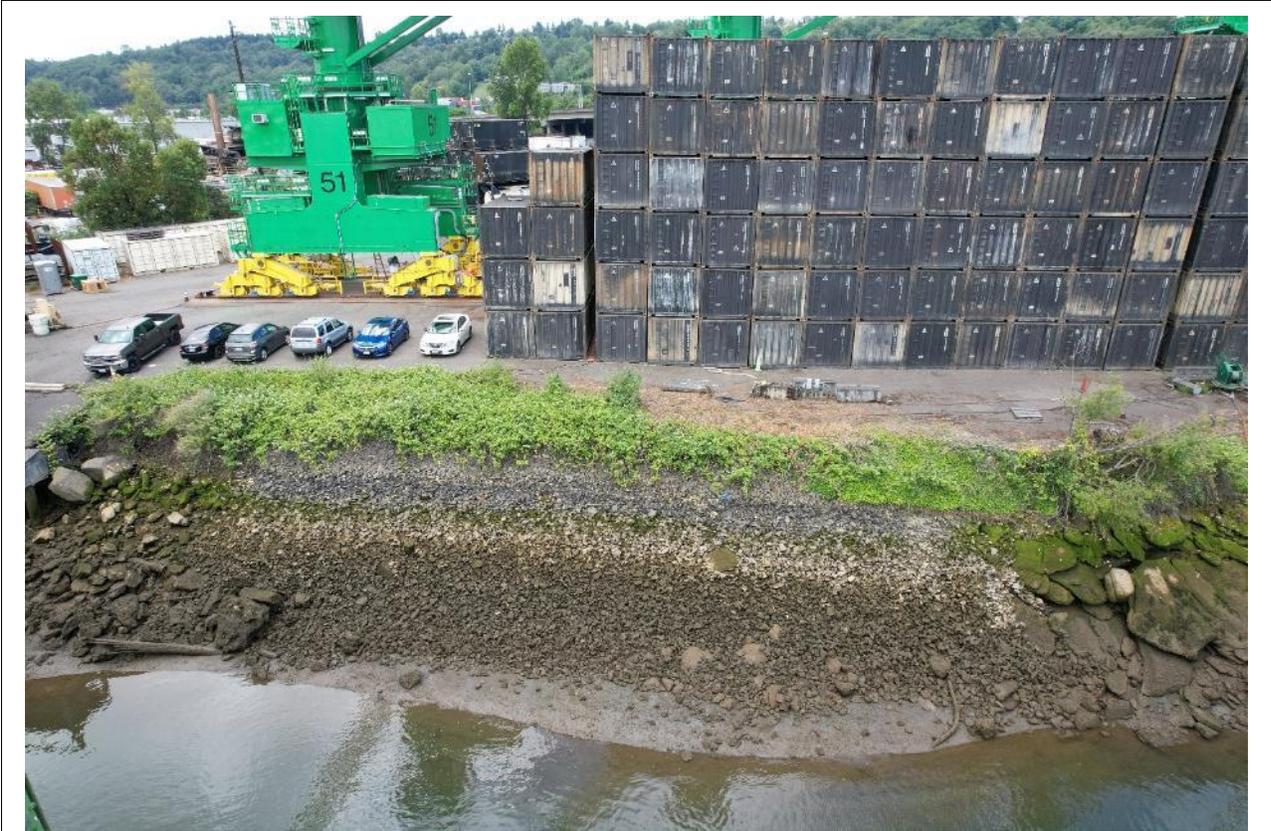
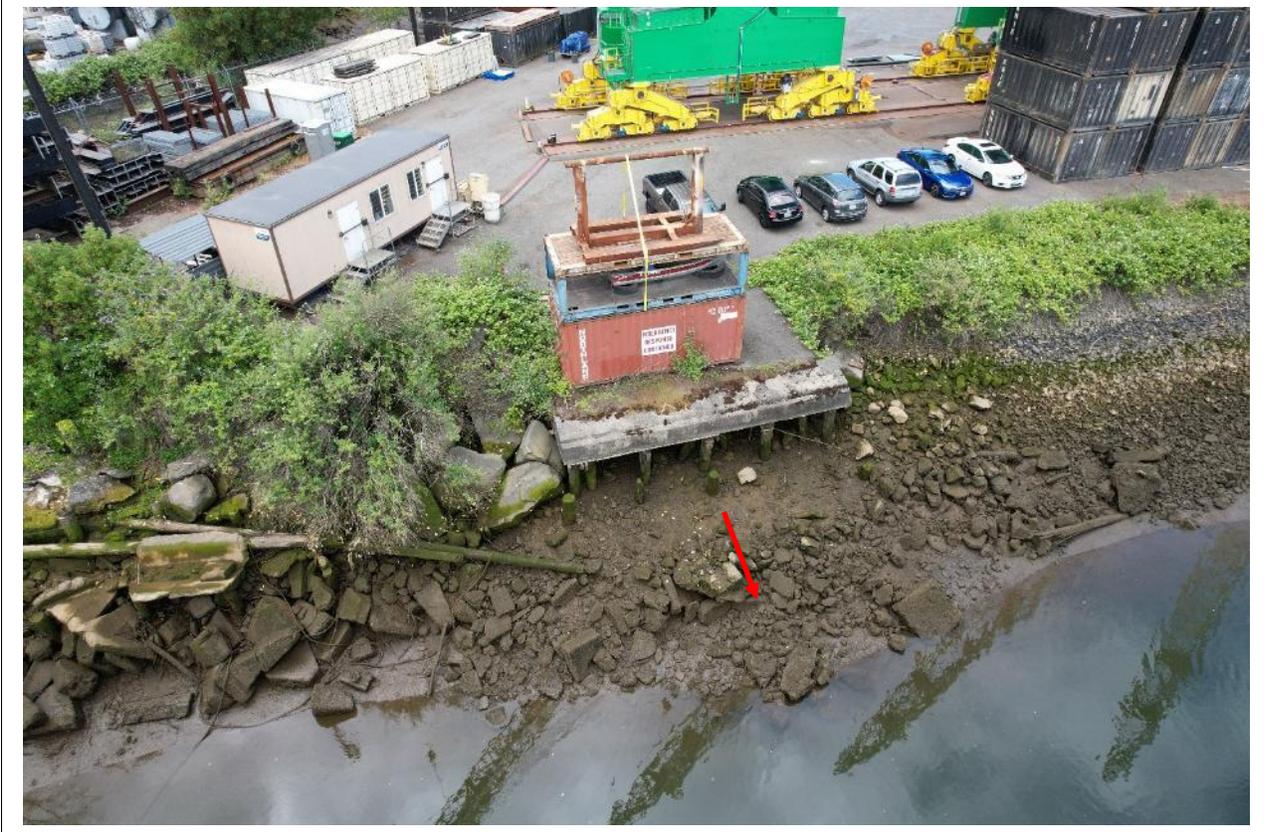
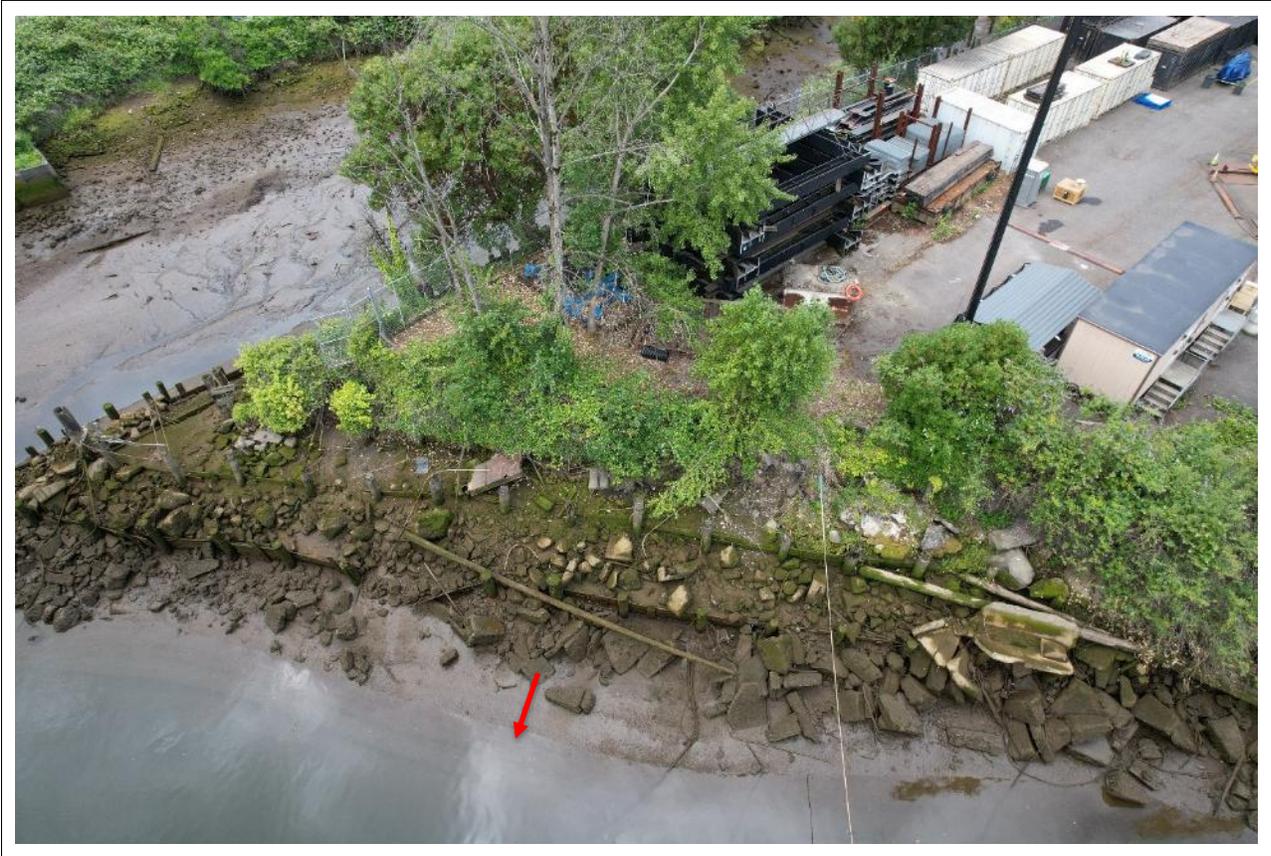
Figure C-2-8
Ortho-aerial and Oblique Photographs for RAL Exceedance Area 21 Displayed from Upriver (Left) to Downriver (Right)

Visual observation through desktop analysis of the shoreline noted armoring along the upgradient portions of the area. Armoring ranged from scattered riprap and concrete to an engineered riprap shoreline. Debris throughout the RAL Exceedance Area include scattered concrete (broken pieces, slabs, and columns) and occasional metal and wood pieces. The southern end of the RAL Exceedance Area contains a double tiered timber bulkhead starting just below the vegetation line. Other structures within the RAL Exceedance Area include an outfall (2508) and pier on the north end of the area

Sediment thickness probing was conducted along four transects on the bank of RAL Exceedance Area 21. Visual observation of surface debris and armoring throughout the area generally included sporadic rock and concrete debris in the upgradient portions, with no sediment covering the armoring. Downgradient of the armoring and concrete debris surface material predominantly consisted of a soft sandy silt. The transect began near the lowest elevation of visually observed armoring, no refusal was encountered. Additional details for all transects within this area can be found in the shoreline conditions form (Attachment C-2-1). Figure C-2-8 displays the drone obliques for RAL Exceedance Area 21 and the red arrows depict the approximate location and direction of the sediment thickness probing transects.
