Appendix C-1
Phase I Bank Visual Inspection
Observations and Photographs

This appendix provides detailed results of Lower Duwamish Waterway (LDW) middle reach Phase II Pre-Design Investigation (PDI) bank inspections that were conducted to satisfy data quality objectives (DQOs) 11 and 14. The Phase II inspections focused on areas with remedial action level (RAL) exceedances based on the Phase I dataset, and included a field visit at low tide to document bank conditions and measure the thickness of sediment over armoring (where applicable), and a desktop analysis of oblique and ortho-aerial photographs.

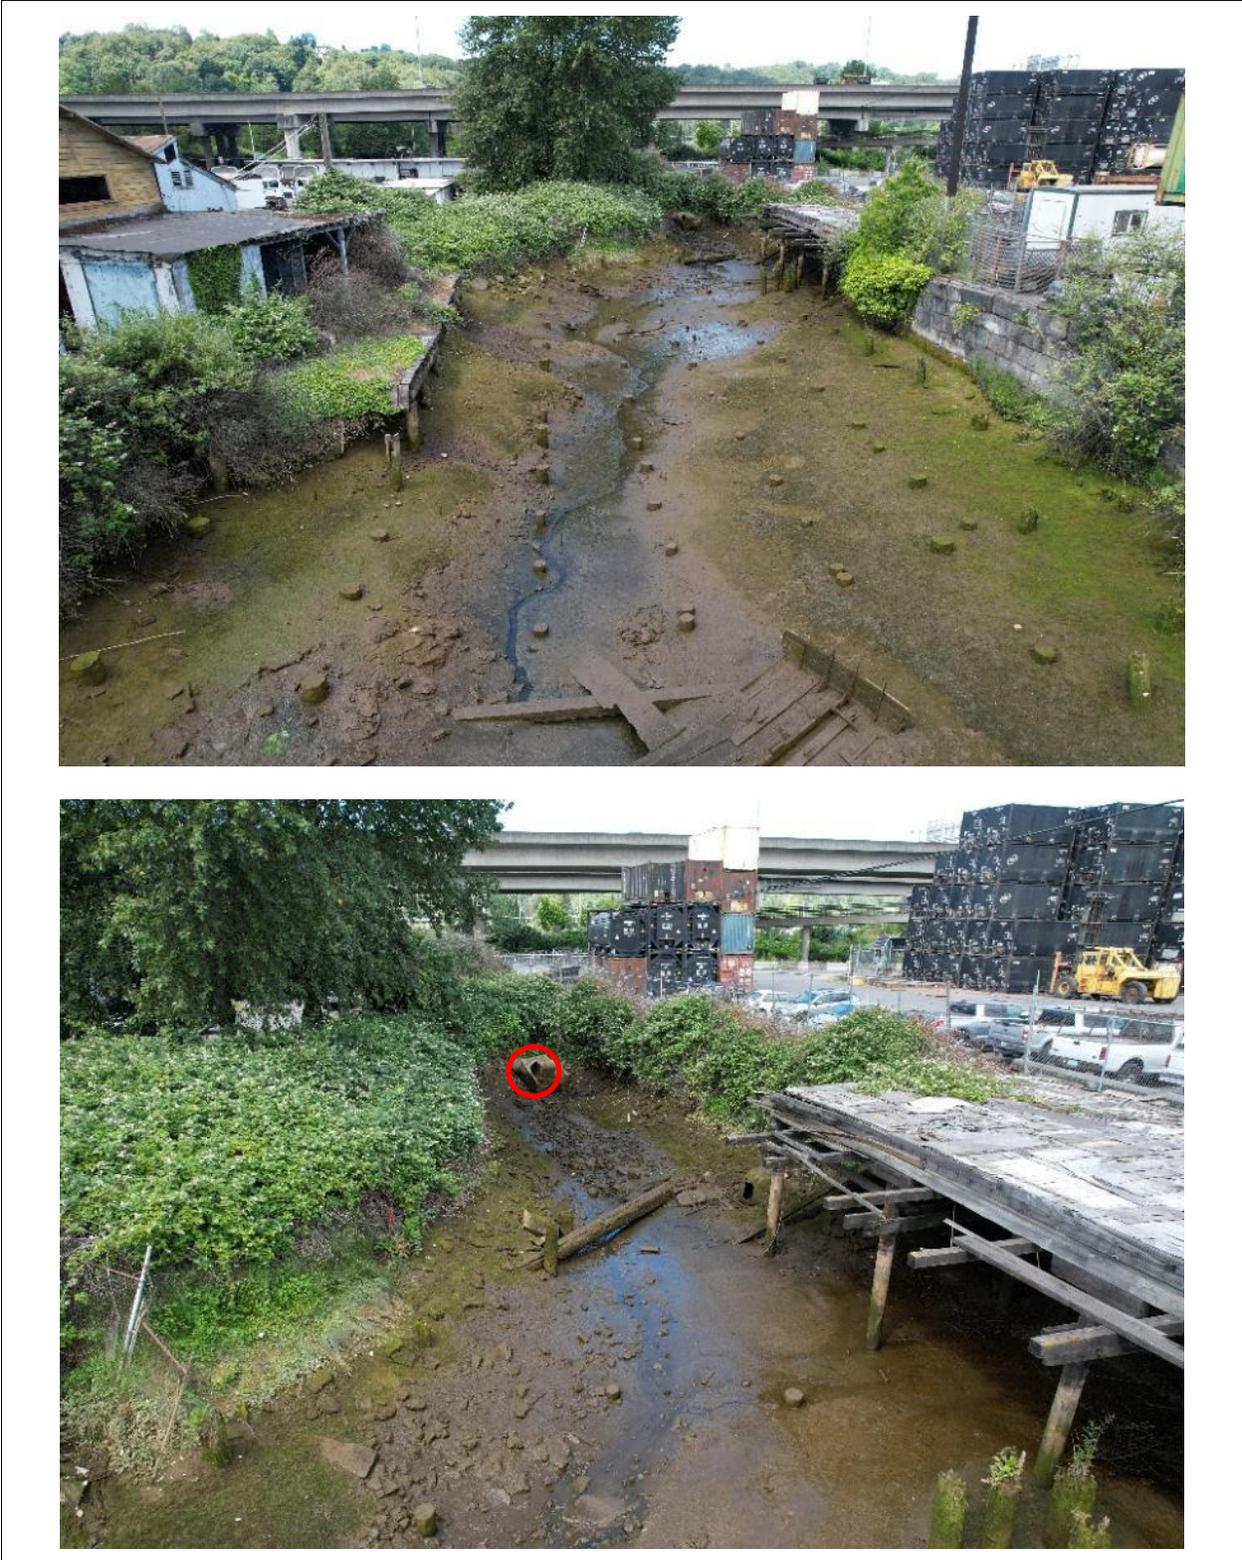
Figure C-2-9
Oblique Photographs for RAL Exceedance Area 20

Visual observation through desktop analysis of the shoreline noted armoring along the upgradient portions of the area. Armoring generally included riprap and large slabs on concrete. Abundant debris throughout the area include broke timber pilings, ecology blocks, scattered wood, and timber cross beams along the inlet bottom. Additionally, there are an abundance of timber pilings cut at the mudline. Structures along the north bank include an ecology block wall and a timber pier. The RAL exceedance area contains two outfalls (2120 and 2118), circled in Figure C-2-9. Structures along the south bank include a timber pier and ecology block wall.

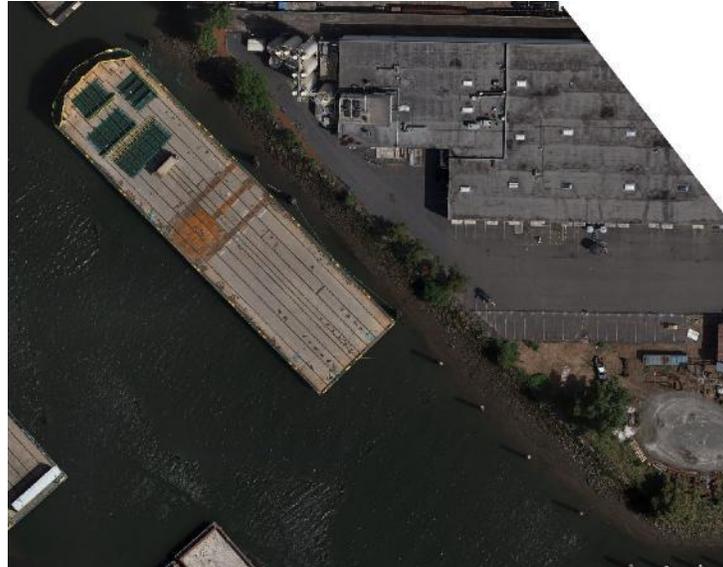
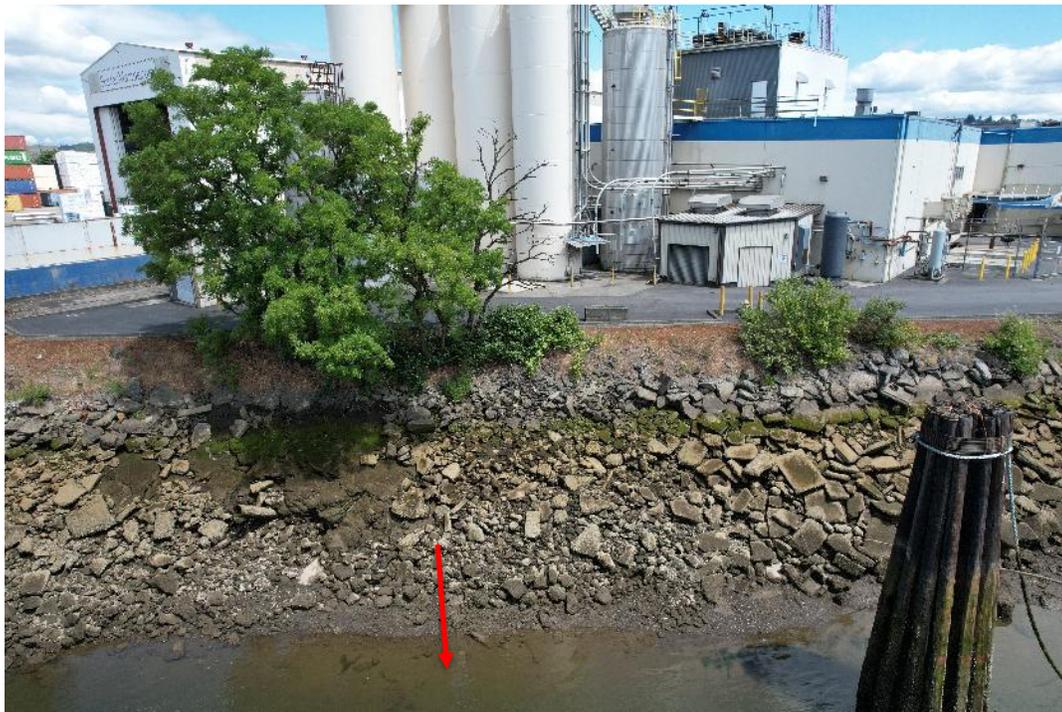
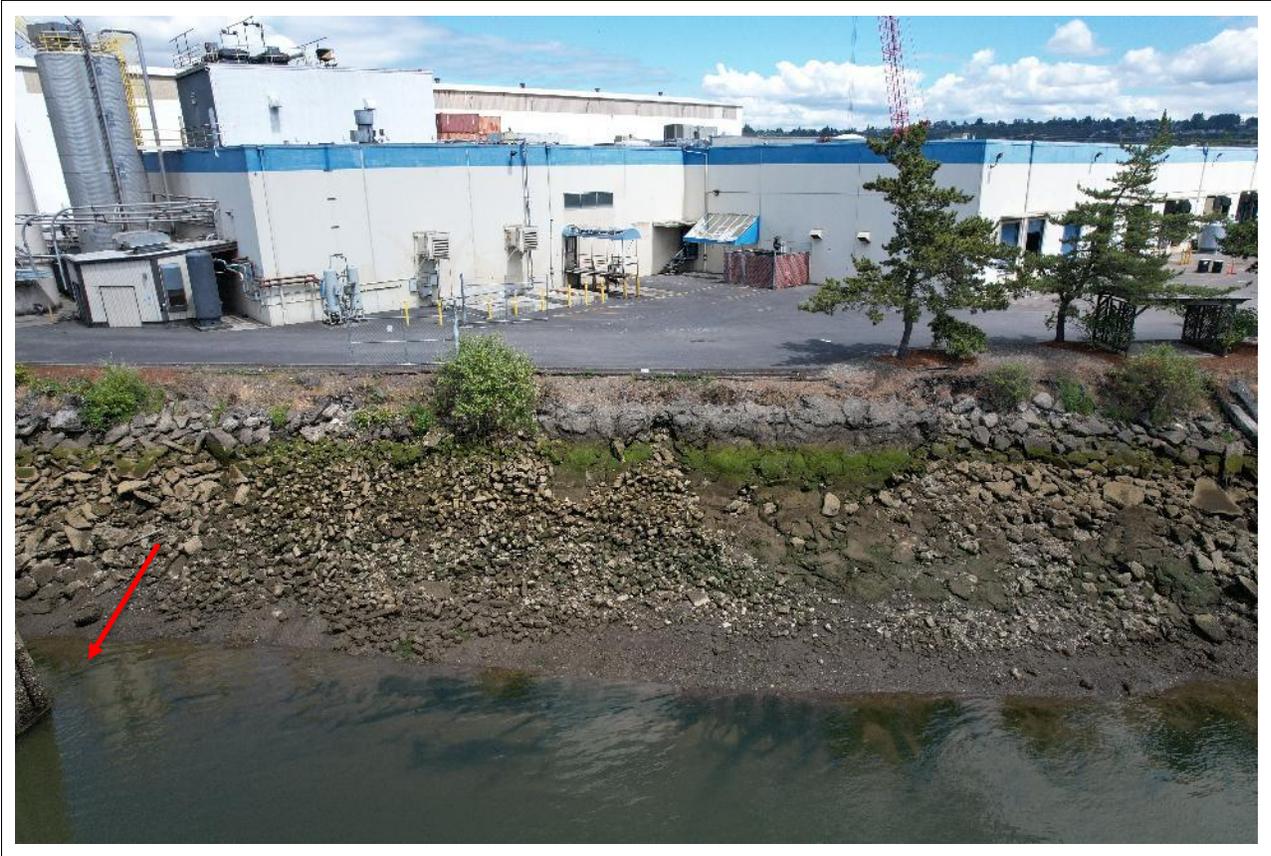
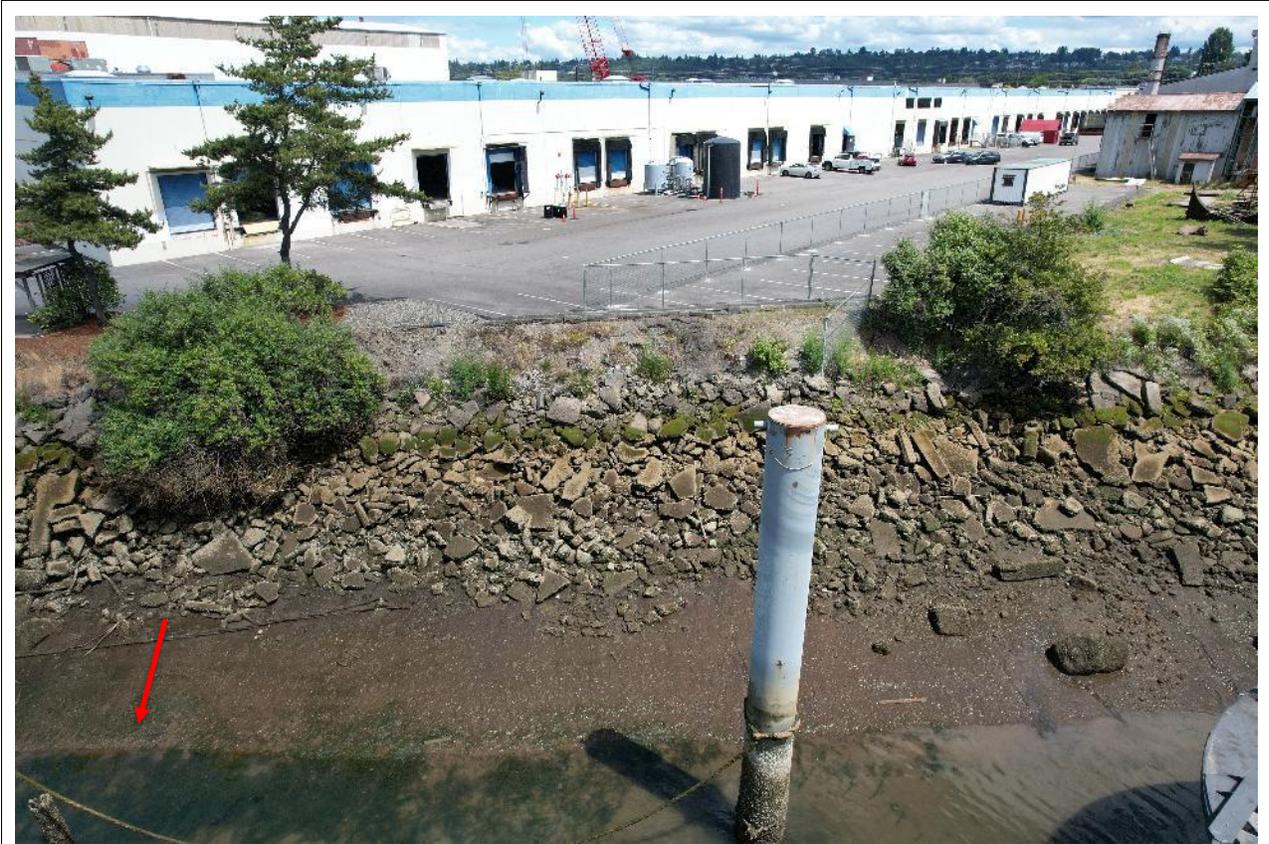
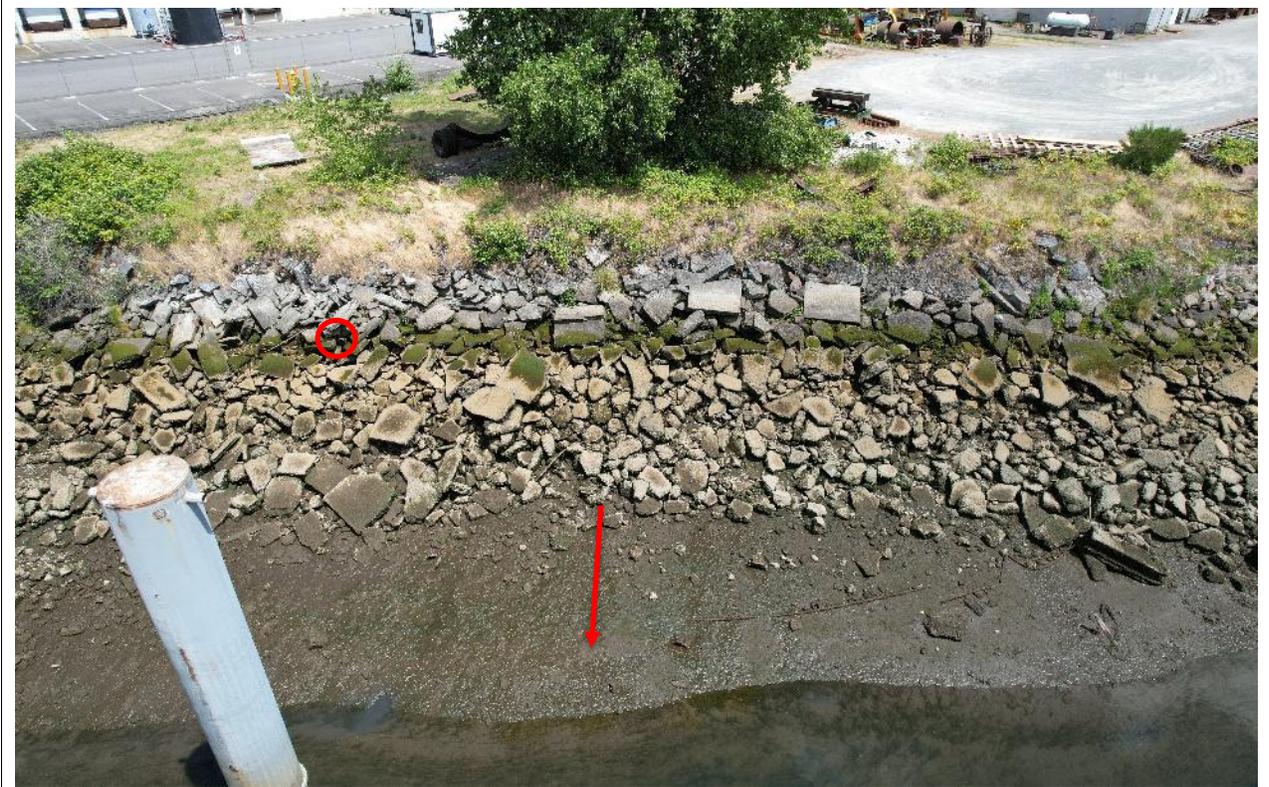
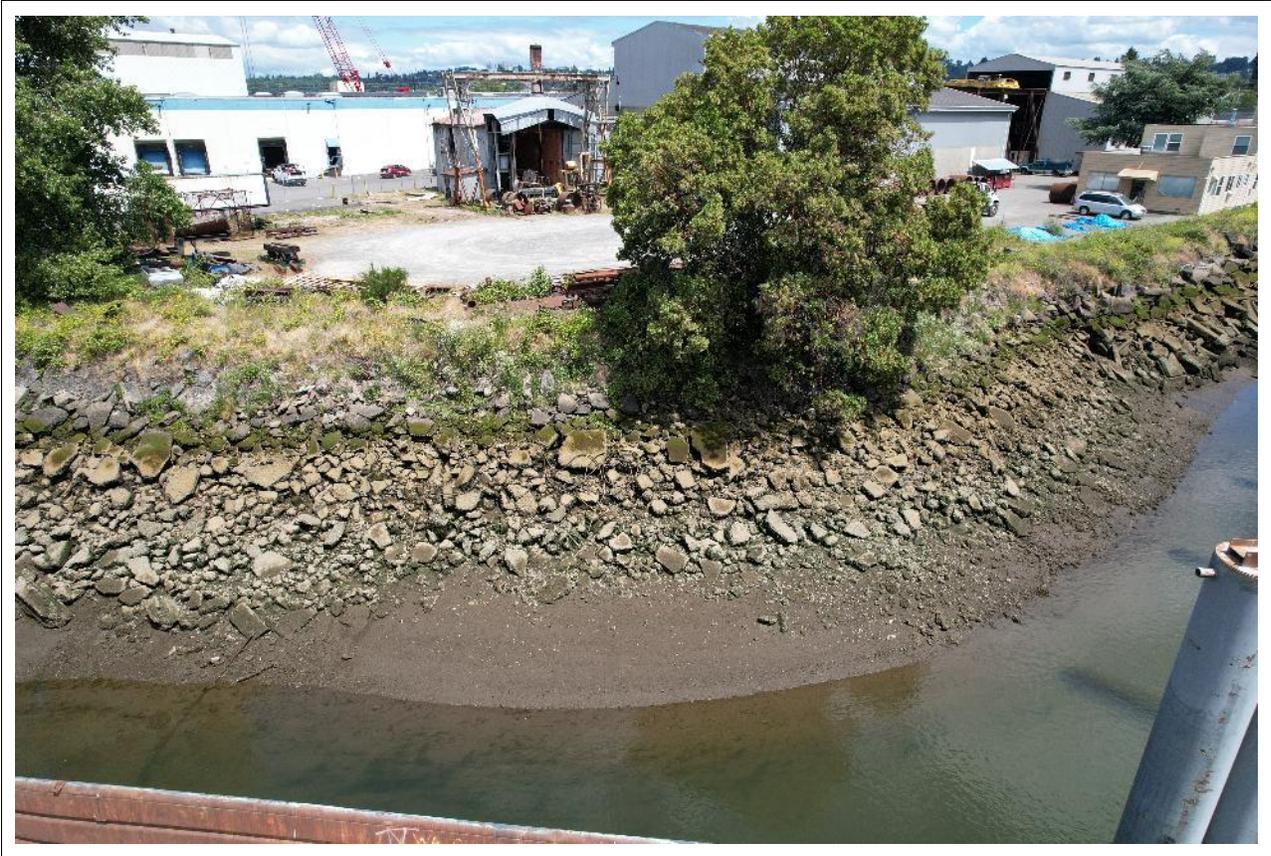
Figure C-2-10
Ortho-aerial and Oblique Photographs for RAL Exceedance Area 18/19/22 Displayed from
Downriver to Upriver

Visual observation through desktop analysis of the shoreline noted armoring along the upgradient portions of the area. Armoring generally included riprap and large chunks of concrete. Debris throughout the RAL exceedance area include concrete with rebar, occasional metal pieces, and scattered rope. The RAL exceedance area contains one outfall (Dawn Foods) circled in Figure C-2-10.

Sediment thickness probing was conducted along four transects on the bank of RAL Exceedance Area 18/19/22. The transects typically began near the lowest elevation of visually observed armoring. Visual observation during probing generally noted debris and armoring throughout the upgradient portions generally included rock and large concrete slabs. Sediment thickness between the armoring pieces were generally approximately 0.5 foot or less, just downgradient of the edge of armoring, sediment thickness ranged from 2.5 to 3 feet. Roughly 5 feet downgradient of the edge of armoring, no refusal was observed. Observed surface material downgradient of armoring predominantly consisted of gravel and silty sand with shell fragments. Additional details for all transects within this area can be found in the shoreline conditions forms (Attachment C-2-1). Figure C-2-10 displays the drone obliques for RAL Exceedance Area 18/19/22 and the red arrow depicts the approximate location and direction of the sediment thickness probing transects.

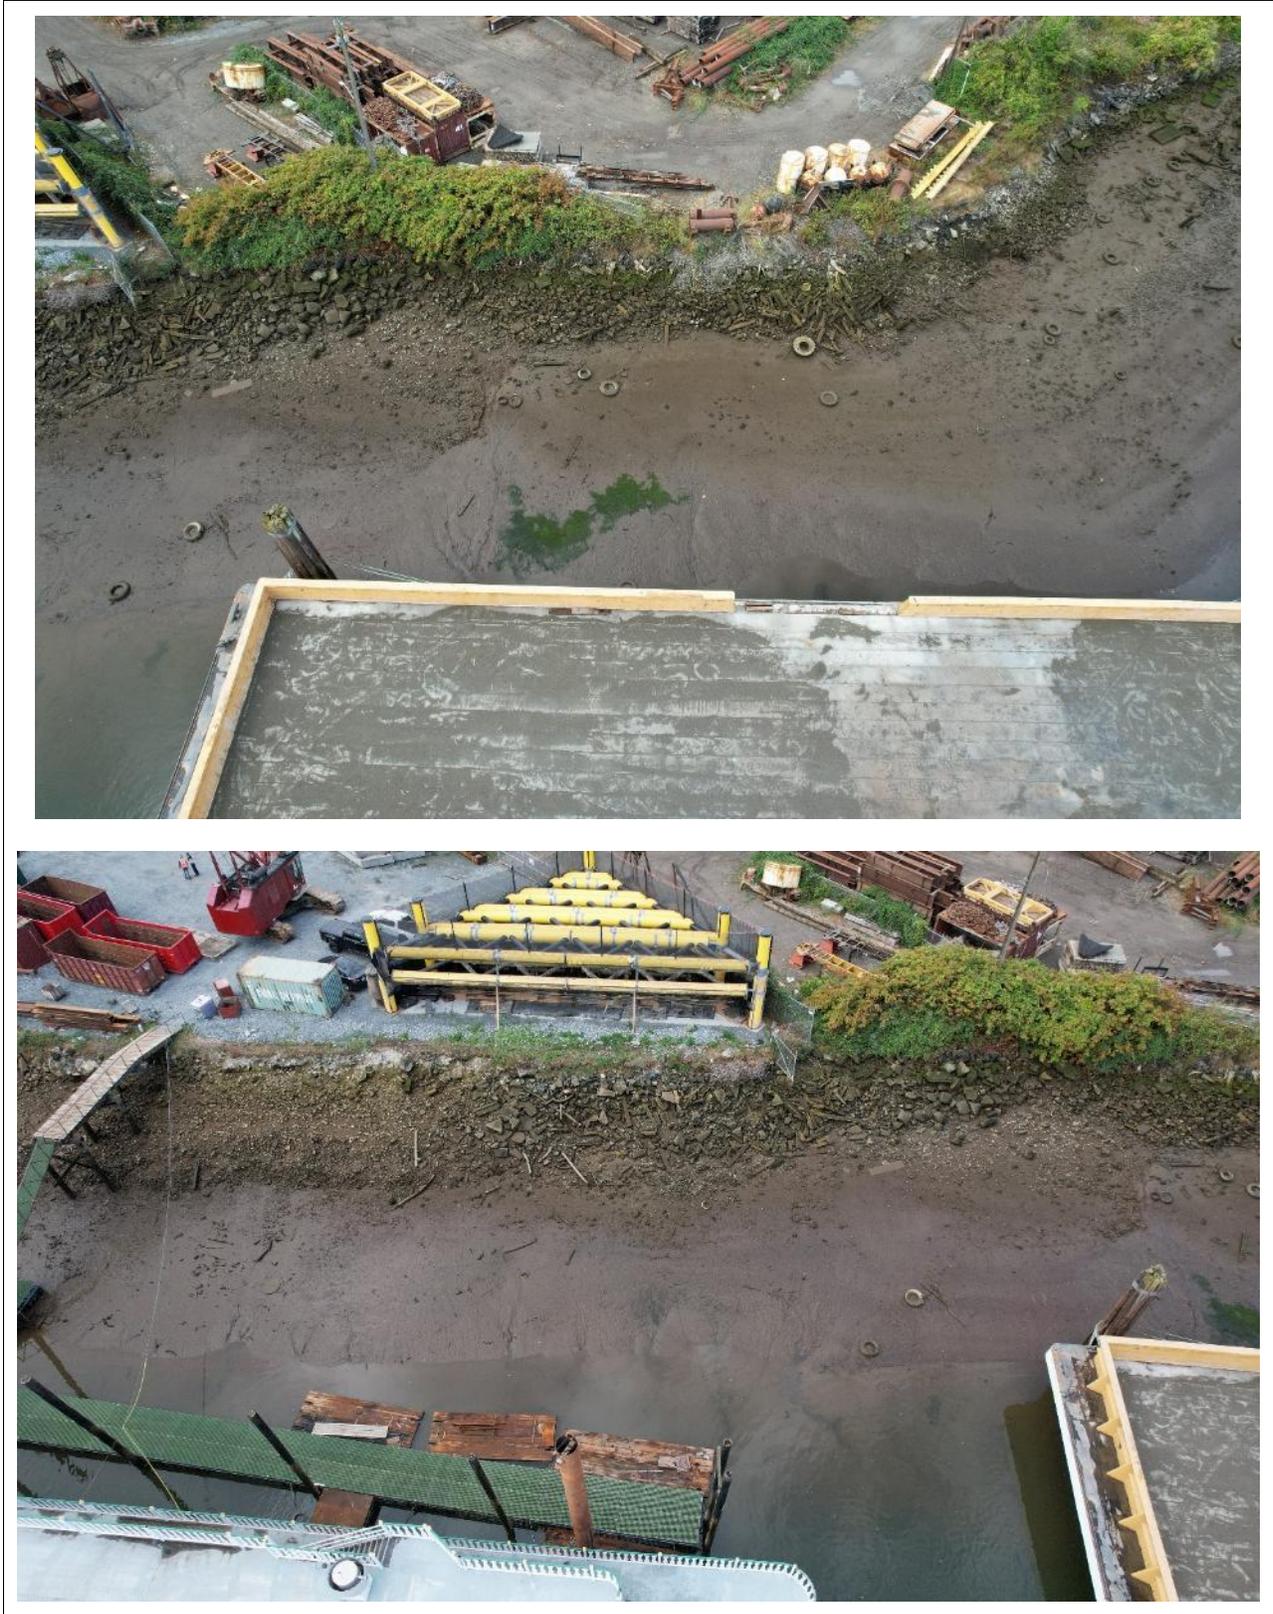
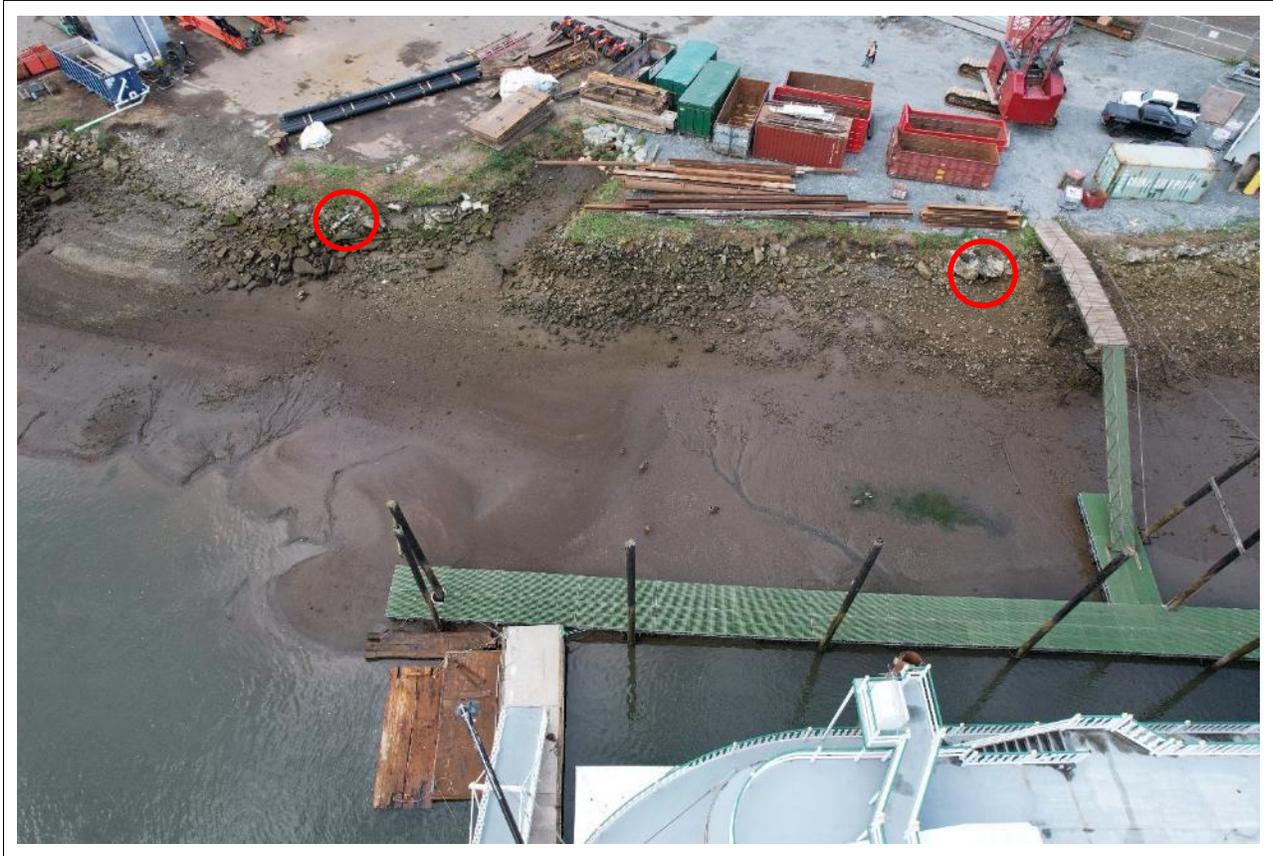
Visual observation through desktop analysis of the shoreline noted armoring along the upgradient portions of the area. Armoring generally included riprap and concrete debris. Abundant debris throughout the area include scattered wood and tires throughout the bank. Structures along the bank include a floating pier, timber pilings, and timber dolphins. The RAL Exceedance Area contains two outfalls (2116 and Boyer-1), circled in Figure C-2-11.

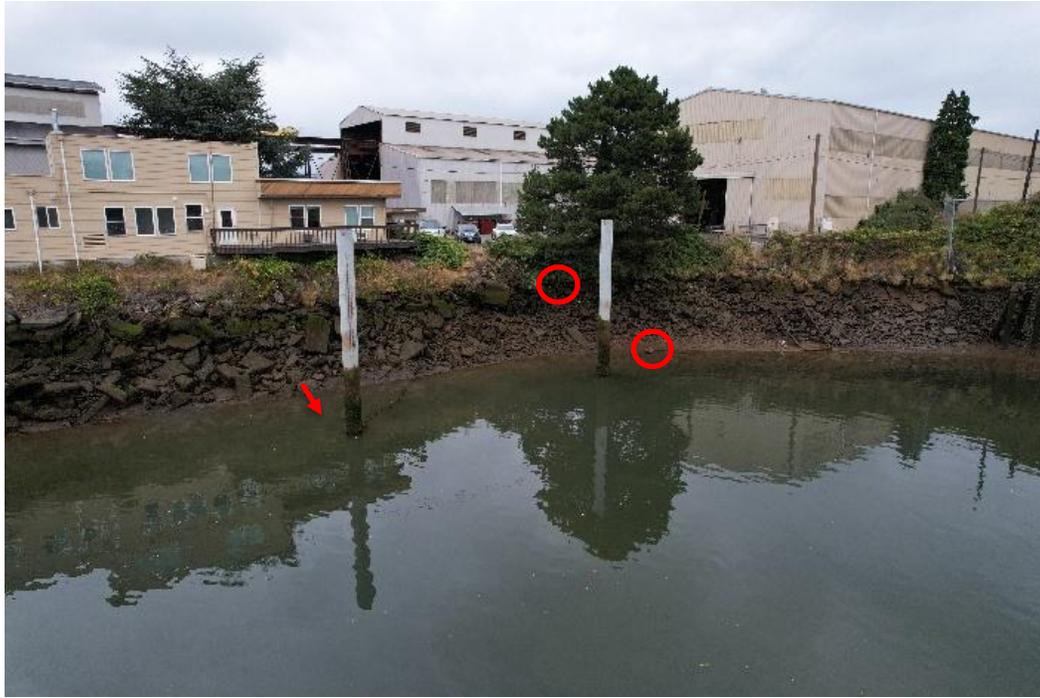
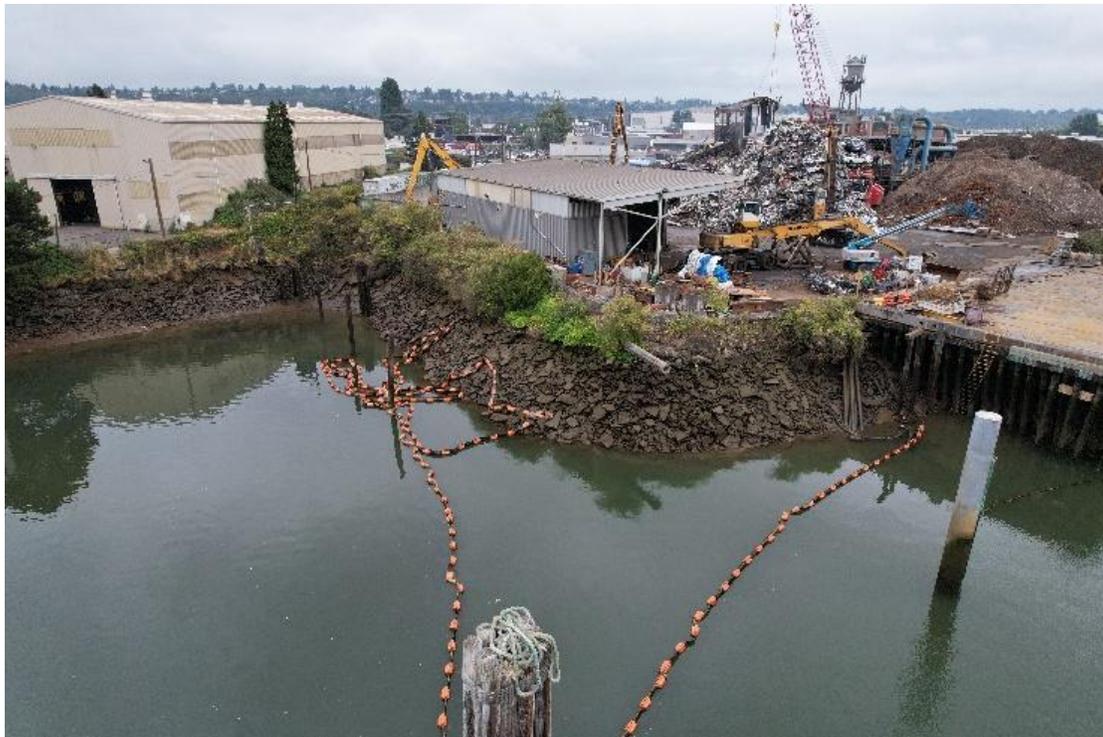
Figure C-2-12
Oblique Photographs for RAL Exceedance 15 Displayed from Downriver (Left) to Upriver (Right)

Visual observations through desktop analysis of the shoreline noted armoring throughout the upgradient portions of the area. Armoring generally included riprap and large chunks of concrete. Debris throughout the RAL exceedance area includes concrete slabs and occasional metal pieces. The RAL exceedance area contains four outfalls, and Outfalls SBW-B and 2028 were visually confirmed in photographs (circled in Figure C-2-12).

Sediment thickness probing was conducted along one transect on the northern bank of RAL Exceedance Area 15, which was the only portion that wasn't too steep for the field crew to traverse. Transects began roughly 15 feet from the edge of vegetation. Visual observation during probing noted debris and armoring throughout the upgradient portions generally included rock and large concrete slabs, with no sediment covering the armoring. Sediment thickness between the armoring pieces was generally 0.5 foot or less, just downgradient of the edge of armoring, sediment thickness was 1 to 1.5 feet; the reason for refusal was assumed to be armoring. The eastern corner of the bay was inaccessible due to soft sediment. Additional details for the transect can be found in the shoreline conditions form (Attachment C-2-1). Figure C-2-12 displays the drone obliques for RAL Exceedance Area 15 and the red arrow depicts the approximate location and direction of the sediment thickness probing transect.

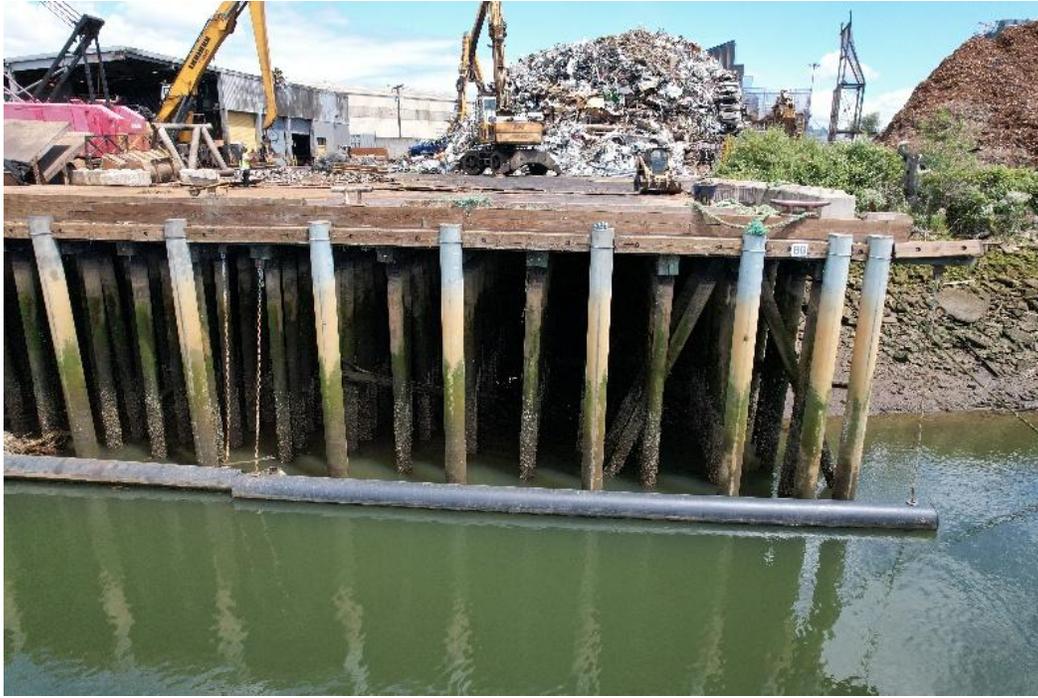
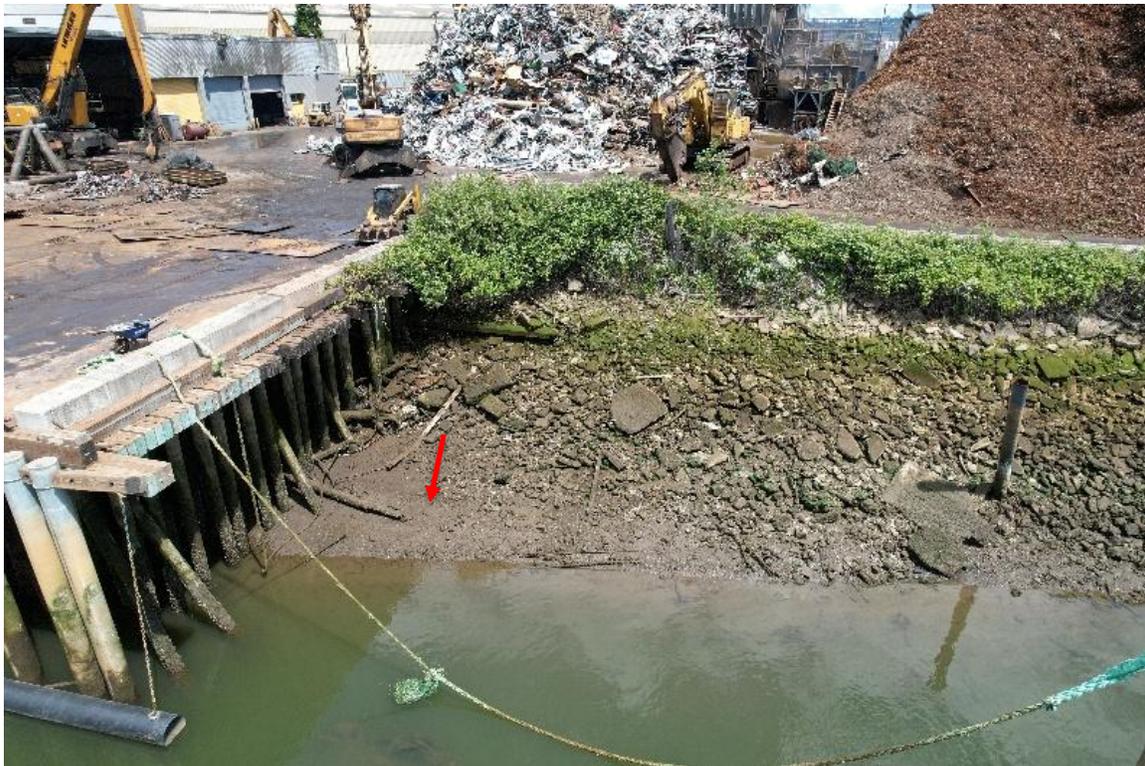
Figure C-2-13
Oblique Photographs for RAL Exceedance Area 14 Displayed from Downriver (Left) to
Upriver (Right)

Visual observation through desktop analysis of the shoreline noted debris armoring throughout the upgradient portions of the area. Armoring generally included bricks, concrete chunks, and rocks. Debris throughout the RAL exceedance area includes wood and occasionally metal pieces. The RAL exceedance area is bordered by a pier on the north end.

Sediment thickness probing was conducted along one transect on the bank of RAL Exceedance Area 14. The transect began near the lowest elevation of visually observed armoring (where the armoring met the sediment). Visual observation during probing noted debris and armoring throughout the upgradient portions generally included rock and concrete debris, with no sediment covering the armoring. Sediment thickness between the armoring pieces was 3 feet. At 5 feet downgradient no refusal was encountered. Reason for refusal was due to concrete or rock. Additional details for the transect can be found in the shoreline conditions form (Attachment C-2-1). Figure C-2-11 displays the drone obliques for RAL Exceedance Area 14 and the red arrow depicts the approximate location and direction of the sediment thickness probing transect.

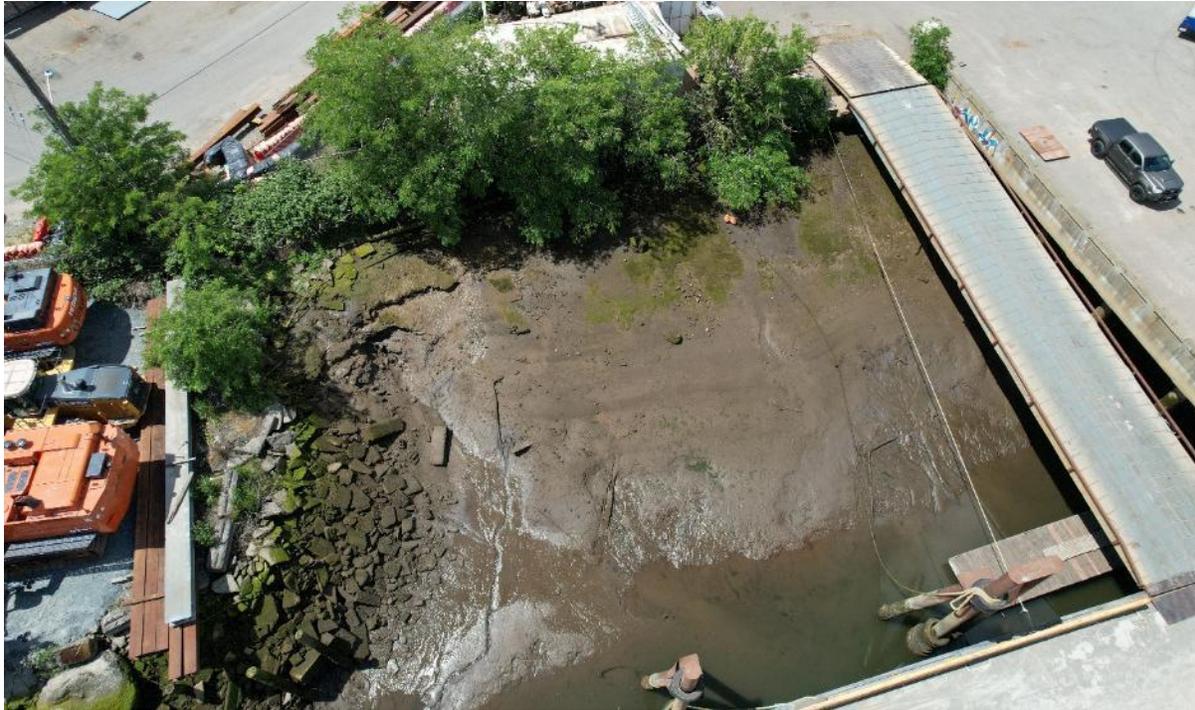
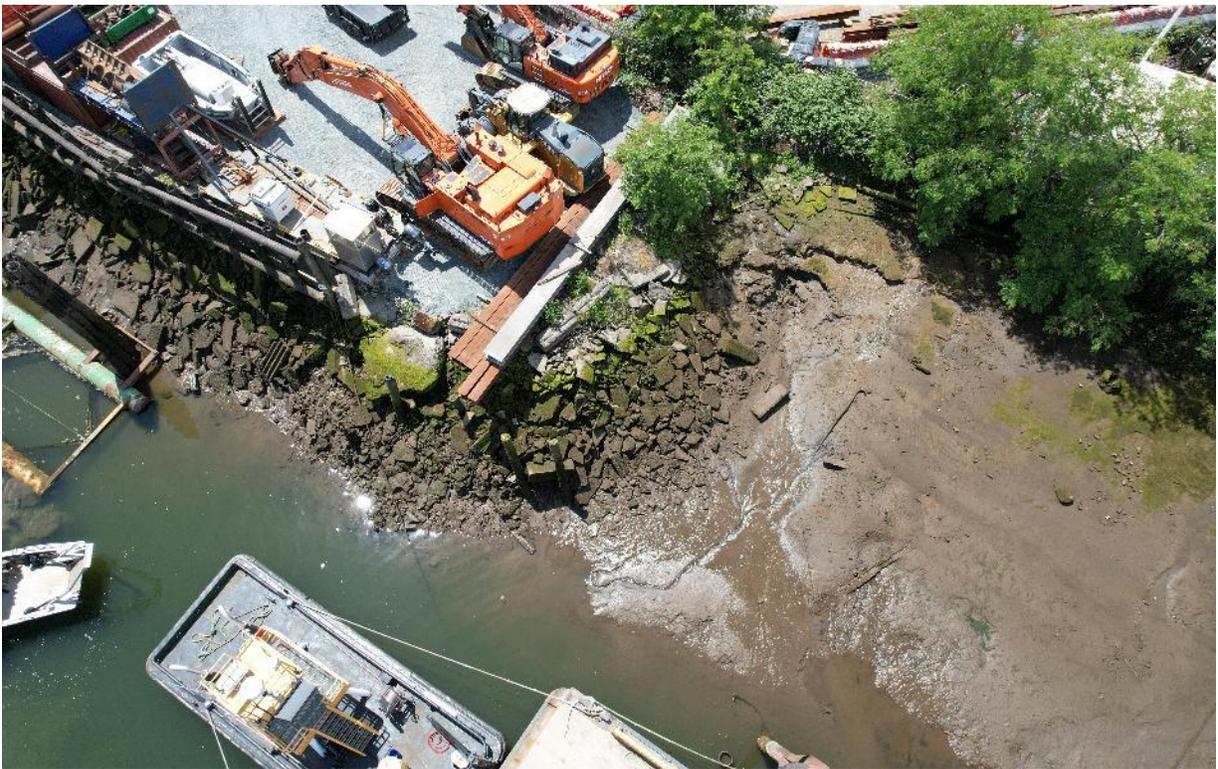
Figure C-2-14
Oblique Photographs for RAL Exceedance Area 12 Displayed from Upriver (Left) to
Downriver (Right)

Visual observation through desktop analysis of the shoreline noted armoring along the upgradient portions of the area. Armoring generally included riprap and concrete debris. Some debris was observed on the upgradient portions of the area, debris included scattered wood and concrete. Structures within the area include dolphins, and timber pilings. Structures bordering on the south is a timber bulkhead and to the north include a pier.

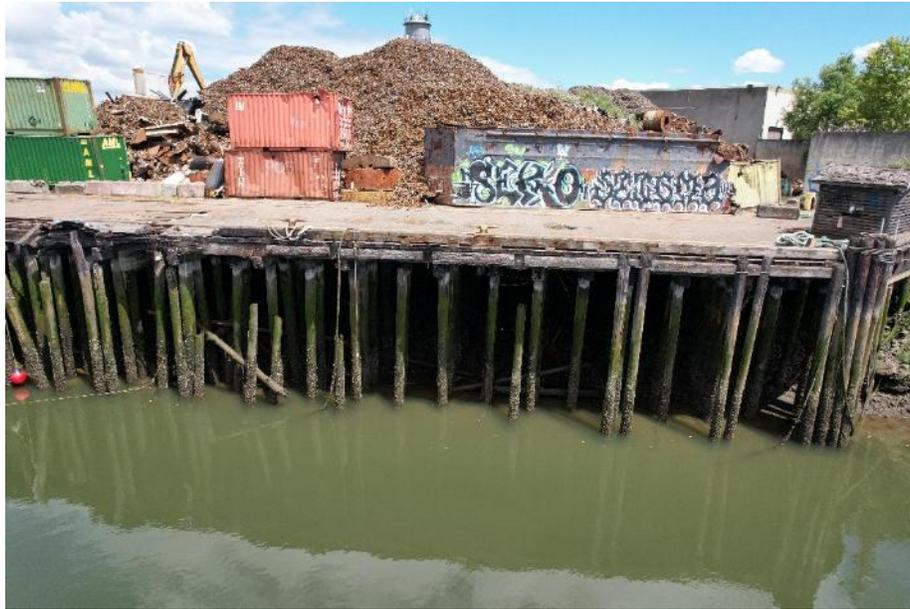
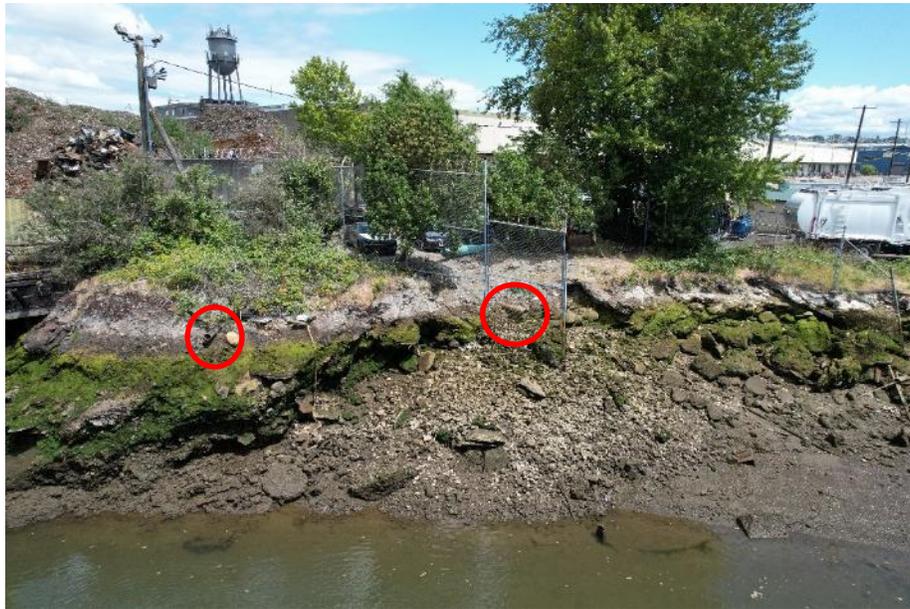
Visual observation through desktop analysis of the shoreline noted armoring along the upgradient portions of the area. Armoring generally included riprap under the wharf and concrete south of the wharf. Debris throughout the area include some scattered wood and concrete throughout the bank. Structures along the bank include a wharf. The RAL exceedance area contains three outfalls (2035, 2036, and 2037), circled in Figure C-2-15.

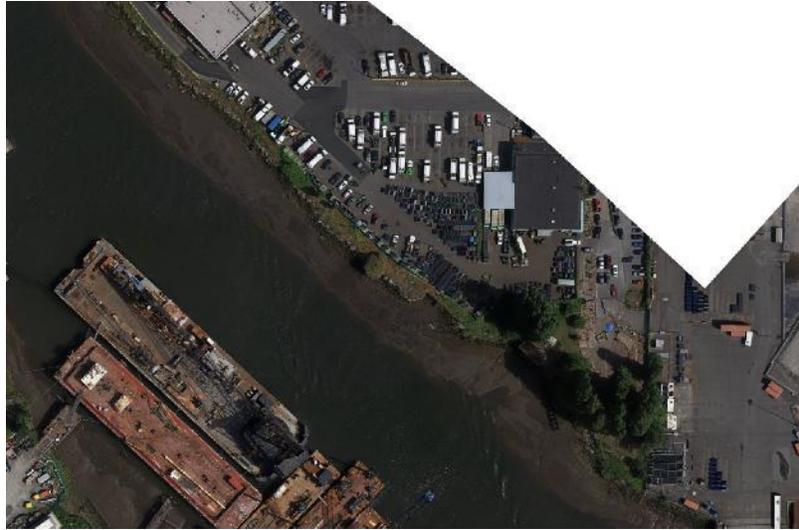
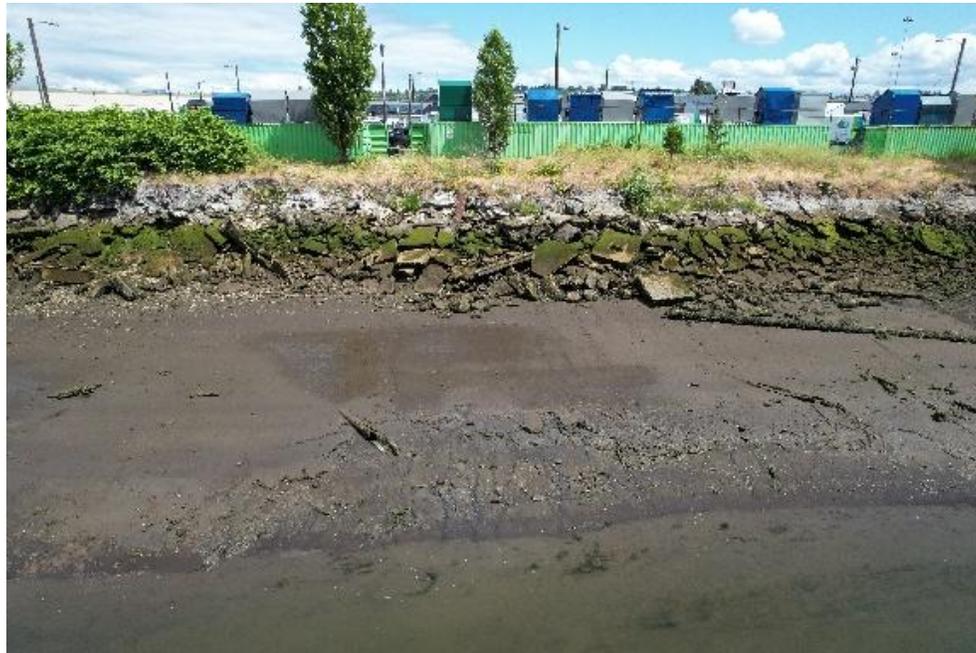
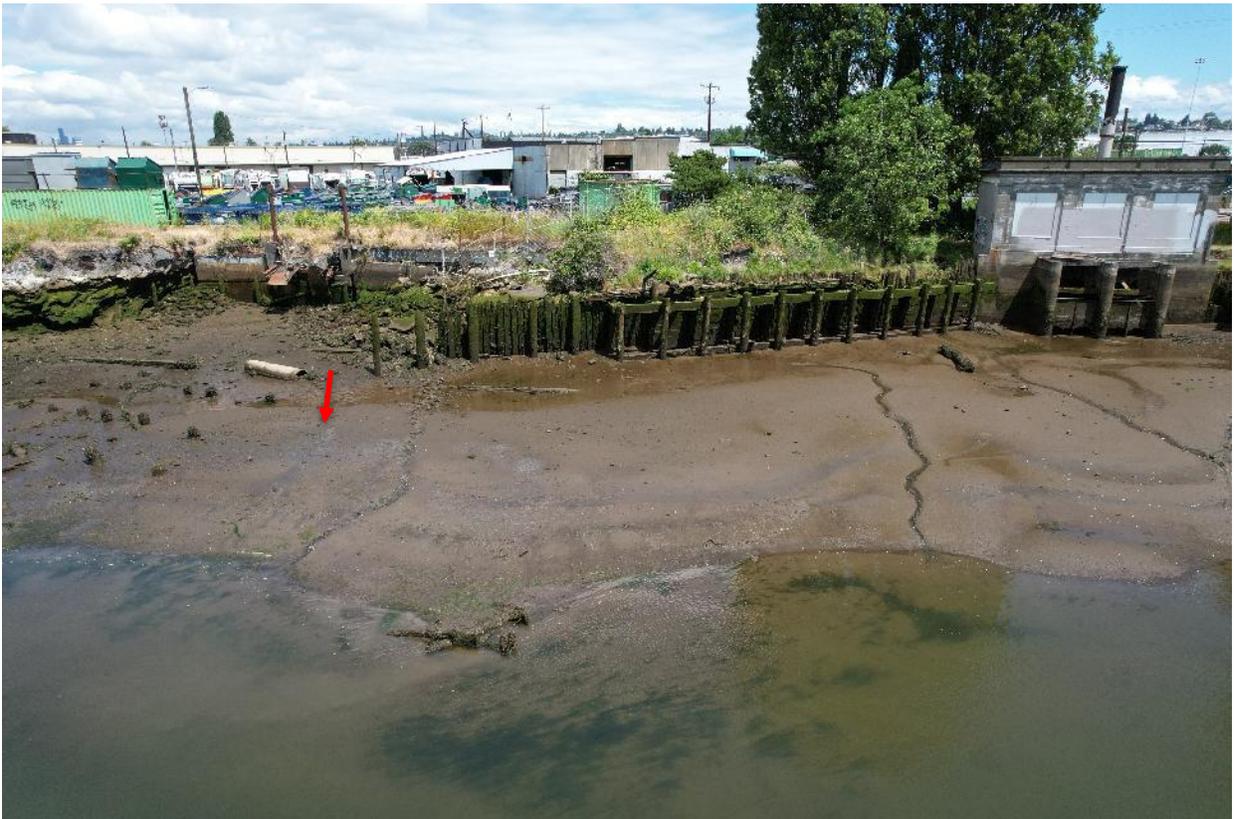
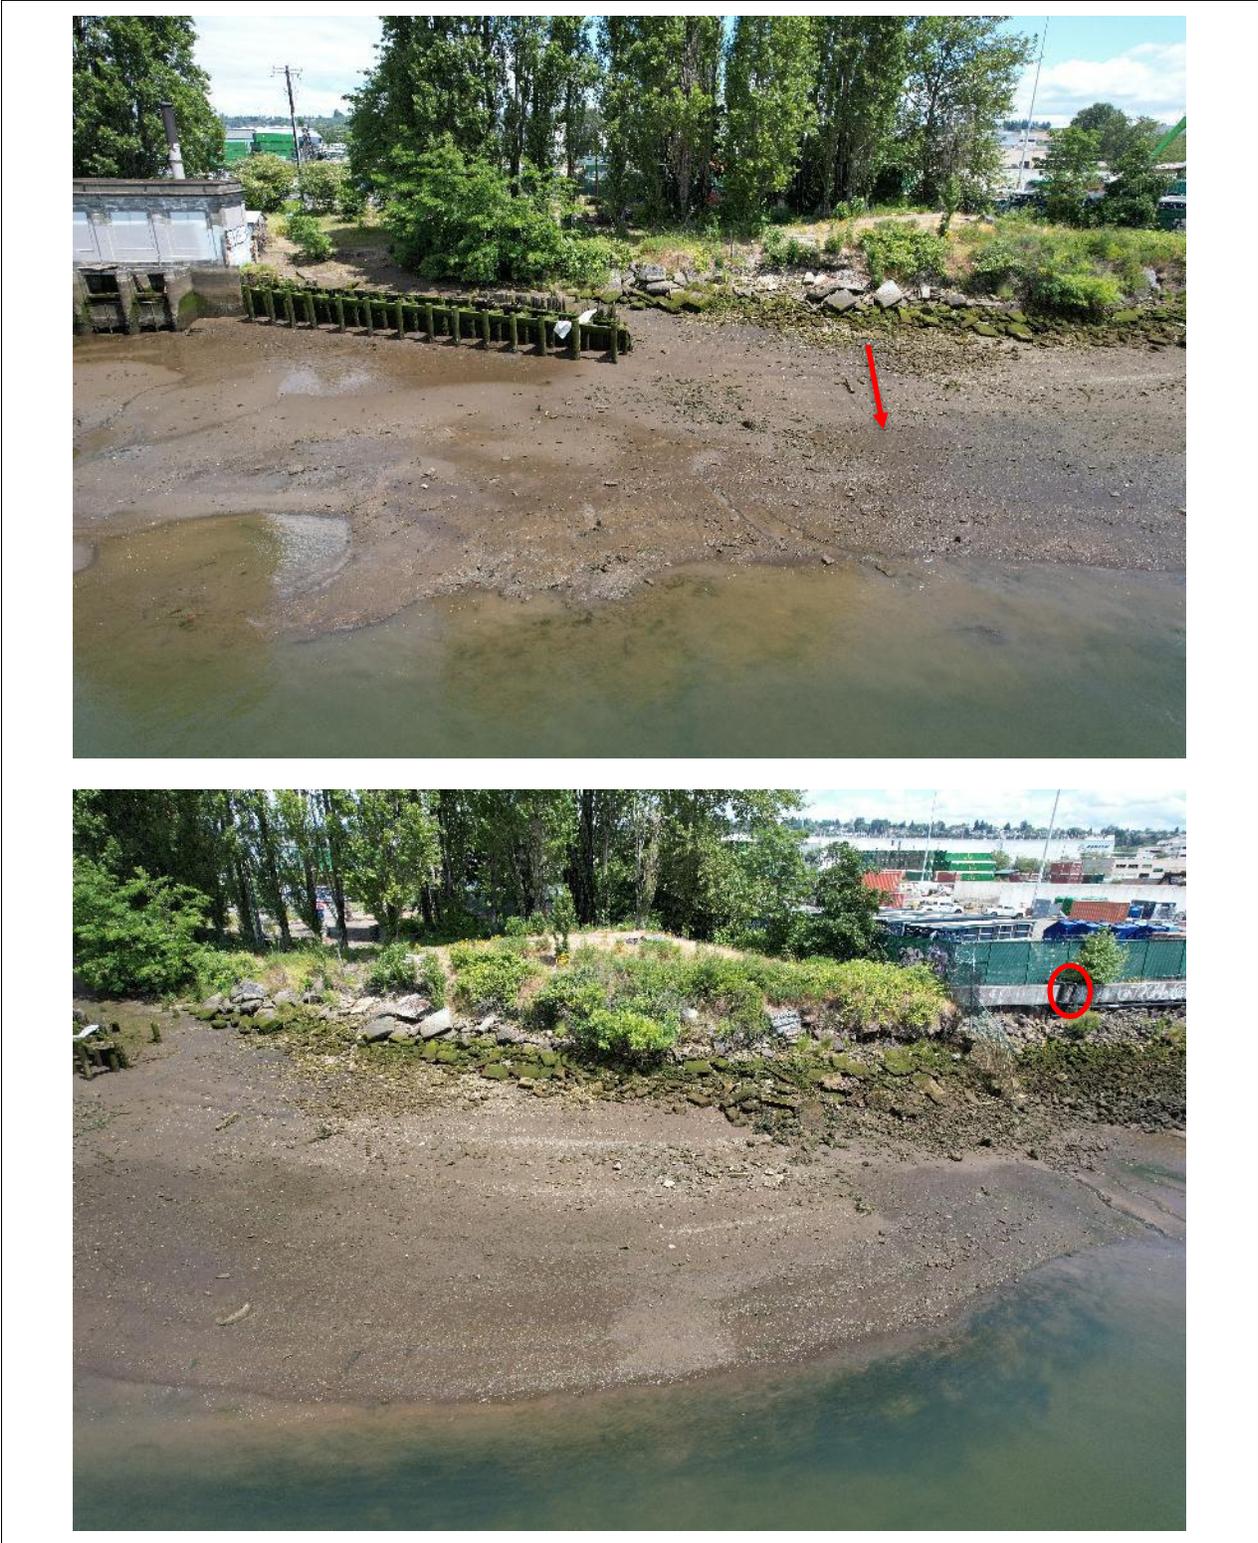
Figure C-2-16
Ortho-aerial and Oblique photographs for RAL Exceedance 9 Displayed from Downriver (Left) to Upriver (Right)

Visual observation through desktop analysis of the shoreline noted armoring through a majority of the upgradient portions of the area. Armoring generally included sporadic riprap, bricks, and large concrete debris. Additionally, a timber bulkhead spans roughly 80 feet on either side of the Georgetown pump station with no armoring down gradient. Debris throughout the RAL exceedance area includes wood (broken pilings, pilings cut at the mudline, and branches), bricks, and occasional metal pipes. Observed surface material was predominately sand with silt. Structures along the bank include the historic intake structure building. The RAL exceedance area contains three outfalls. One outfall (DuwReload) was visually confirmed in photographs circled in Figure C-2-16.
