Appendix C-1
Phase I Bank Visual Inspection
Observations and Photographs

This appendix provides detailed results of Lower Duwamish Waterway (LDW) middle reach Phase II Pre-Design Investigation (PDI) bank inspections that were conducted to satisfy data quality objectives (DQOs) 11 and 14. The Phase II inspections focused on areas with remedial action level (RAL) exceedances based on the Phase I dataset, and included a field visit at low tide to document bank conditions and measure the thickness of sediment over armoring (where applicable), and a desktop analysis of oblique and ortho-aerial photographs.

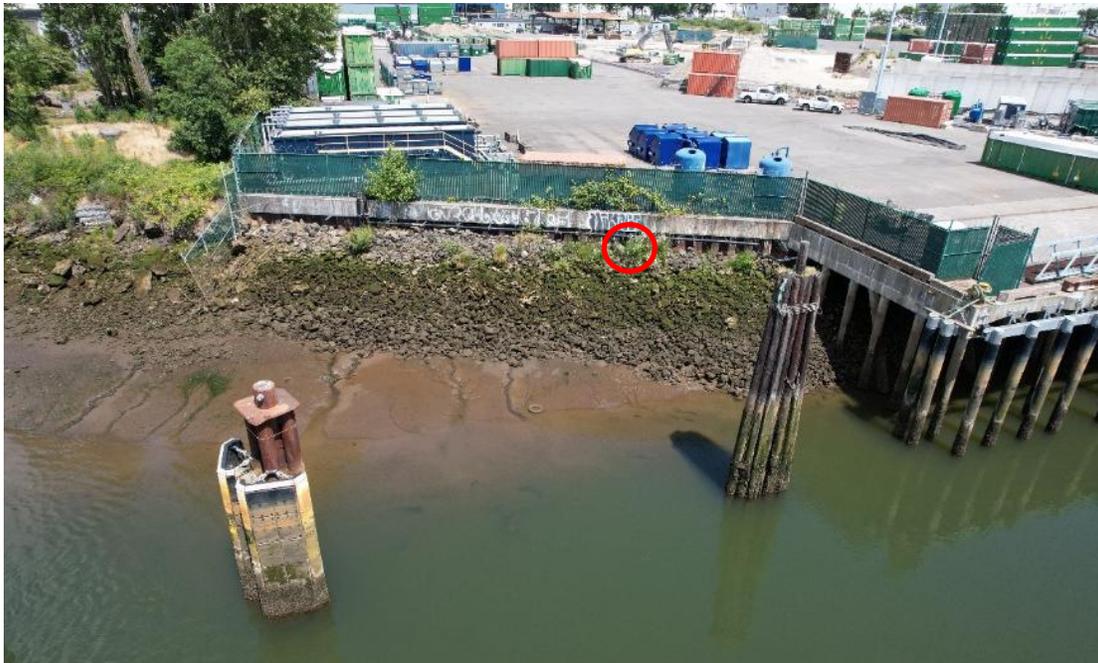
Figure C-2-17
Oblique Photographs for RAL Exceedance Area 8

Visual observation through desktop analysis of the shoreline noted armoring along the upgradient portions of the area. Armoring generally included riprap with a bulkhead. Trace debris were observed in the area (tires). Structures along the bank include a timber piling and wharf to the south of the area. The RAL exceedance area contains one outfall (2042), circled in Figure C-2-17.

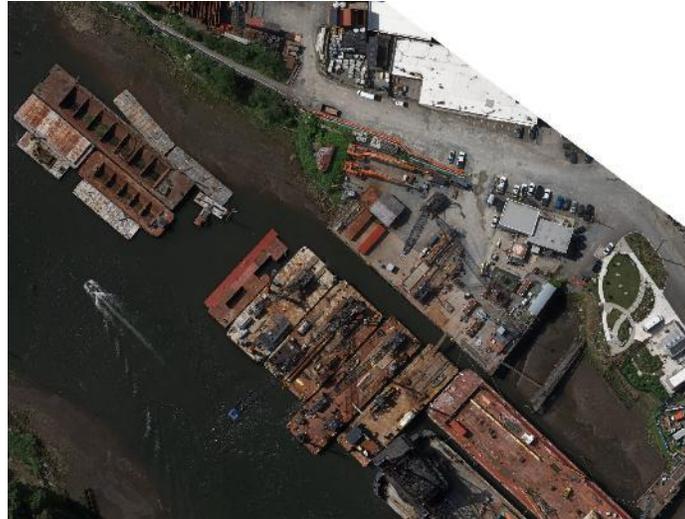
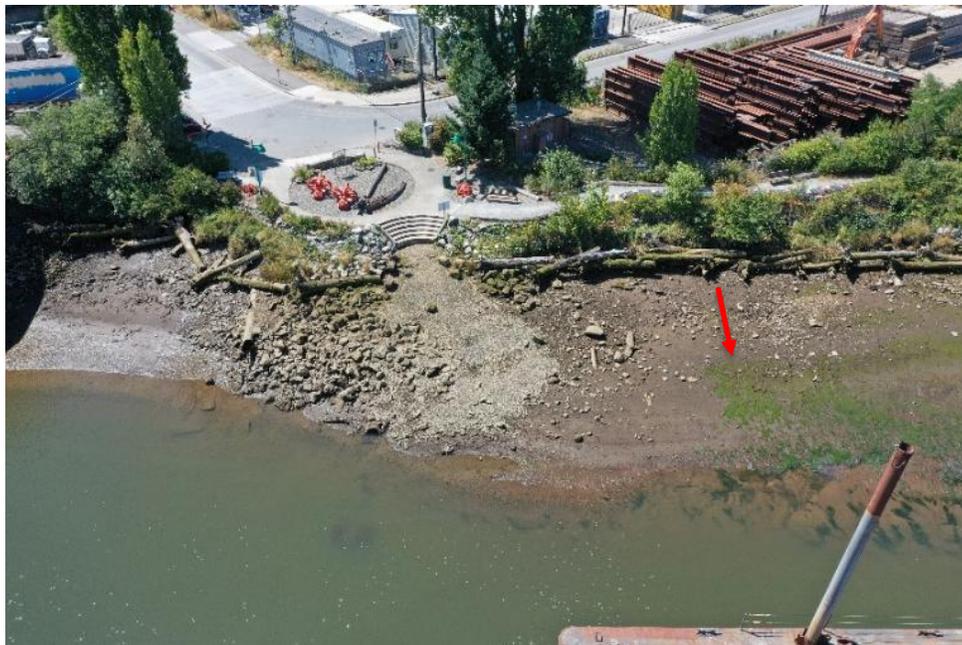
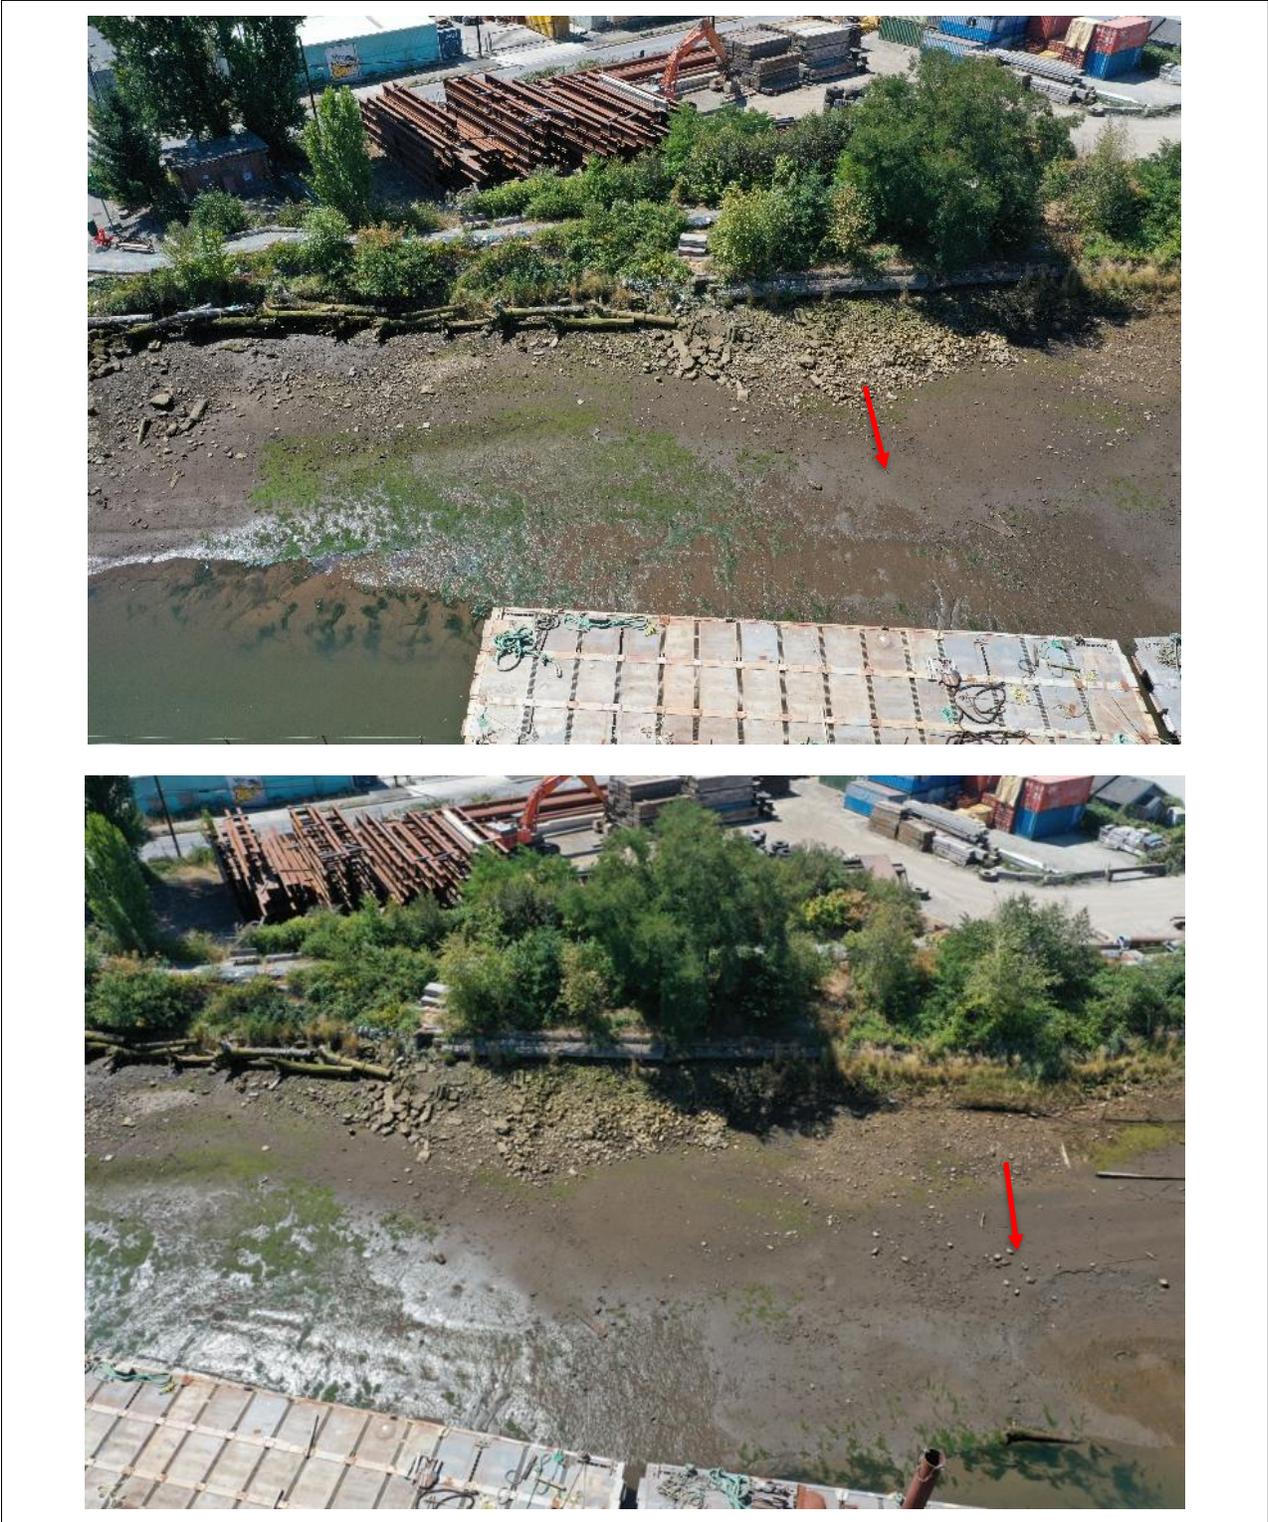
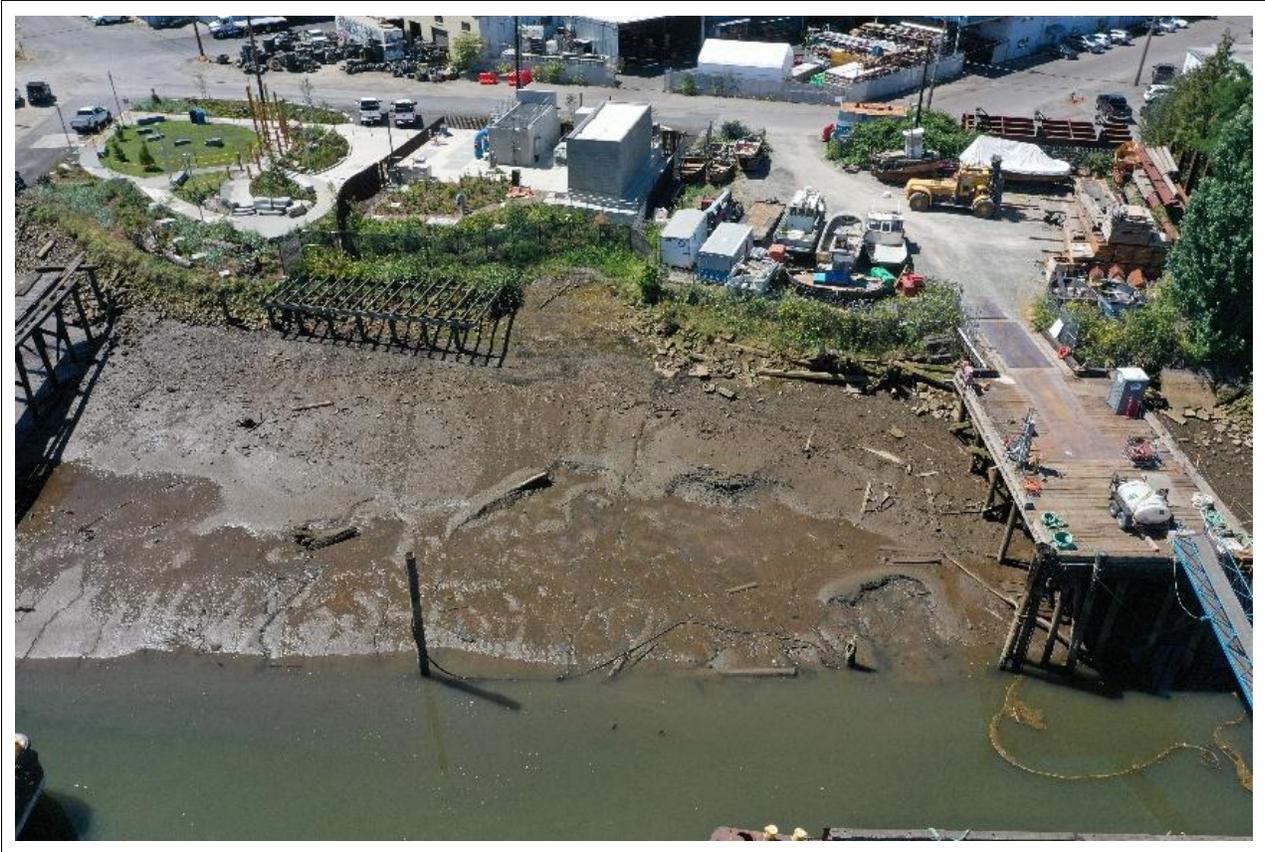
Figure C-2-18
Ortho-aerial and Oblique Photographs for RAL Exceedance 5 Displayed from Upriver (Left) to Downriver (Right)

Visual observation through desktop analysis of the shoreline noted debris and armoring through the upgradient portion of the area. Armoring generally included sporadic riprap and smaller rocks, and large woody debris installed for habitat on the southern end of the RAL exceedance area. Debris throughout RAL exceedance area included wood and concrete (broken pilings, slabs, and sporadic ecology blocks). The RAL exceedance contains a pier around RM 2.7W and Outfall 2112 (circled in Figure C-2-18) just north of the pier.

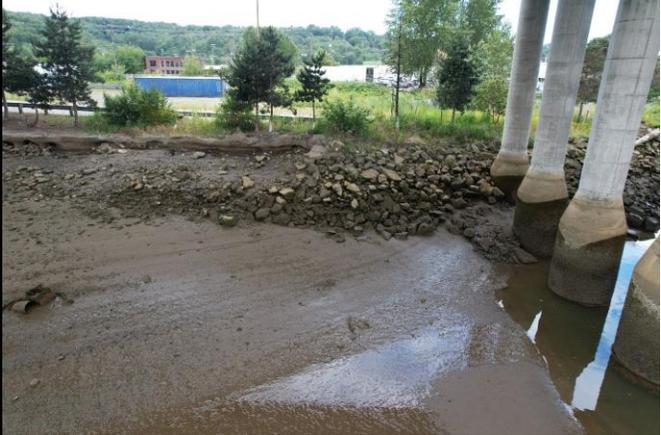
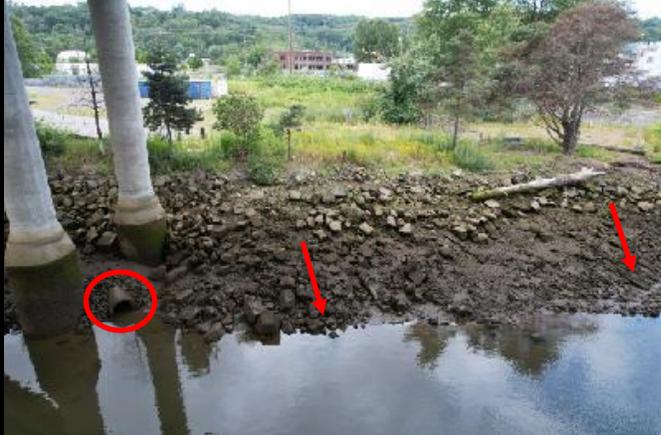
Project	Lower Duwamish Waterway Middle Reach PDI Phase II		Date	July 22, 2024
Crew	Anchor QEA			
RAL Exceedance Area	Phase I: 26		Time	11:10
	Revised in Phase II: NA			
Transect(s)	A and B		Tide	-1.5 ft MLLW
Sediment Thickness				
Probing Location	Probing Depth Refusal	Assumed refusal Reason	Notes	
Between rocks (0 ft) Continued in 5ft increments to water	No refusal	NA	Large cobble and concrete engineered armoring at the top of the shore that seems to be on top of sand/silt; transitions to gravel with some cobble mixed in then to soft sand/silt. A sheen was observed on the sediment on the probe after pulling from the sediment.	
Bank Features Inspection				
Class	Present (Y/N)	Notes		
Woody Vegetation	Y	Shrubs (Himalayan and butterfly bush) and trees (shore pine) along top of bank		
Bank Armoring	Y	Engineered concrete armoring that transitions to gravel, then soft sand/silt		
Above ground Utilities	Y	Outfall 2506

Debris	Y	Wood debris on bank		
Structures	Y	First Avenue Bridge foundations		
Fencing	N			
Paving	Y	Paved trail and fenced property		
Other	N			
Photographs

RAL Exceedance Area 26 looking northwest		RAL Exceedance Area 26 looking northwest with approximate transect locations (and outfall circled)

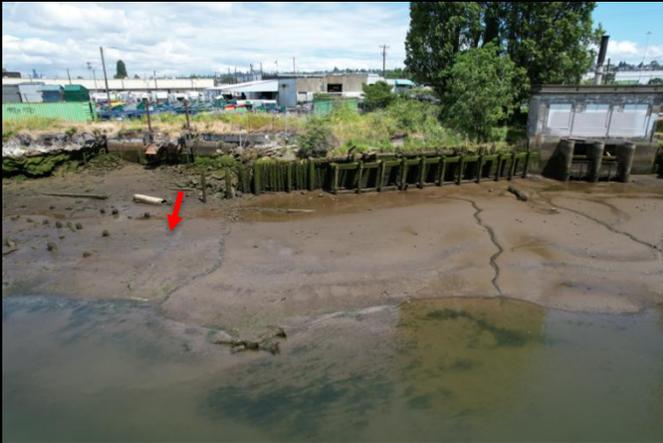
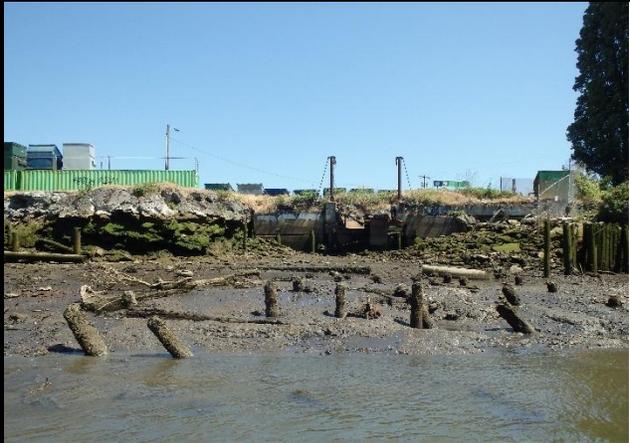
Project	Lower Duwamish Waterway Middle Reach PDI Phase II		Date	July 22, 2024
Crew	Anchor QEA			
RAL Exceedance Area	Phase I: 9		Time	13:23
	Phase II: 9			
Transect(s)	B		Tide	-2.6 ft MLLW
Sediment Thickness				
Probing Location	Probing Depth Refusal	Assumed refusal Reason	Notes	
Edge of armored slope (between armoring):	1 in	Armoring (hit hard stone/concrete)	Broken concrete armor that transitions to gravel then soft silts and sands.	
5 ft from armored slope:	3 in	Compact sediment		
10 ft from armored slope:	0.5-1 ft	Compact sediment		
Bank Features Inspection				
Class	Present (Y/N)	Notes		
Woody Vegetation	Y	Shrubs (butterfly bush) and trees (black locust, Lombardy poplar, madrone) at top of bank.		
Bank Armoring	Y	Non-engineered broken concrete armor that transitions to gravel then soft silts and sands.		
Above ground Utilities	N			
Debris	N			
Structures	Y	Large broke concrete slabs on armored slope. Eroded pile area structure on bank.

Aerial looking northeast showing approximate transect location		RAL Exceedance Area 9 looking east
