Appendix D

Structures Inspection Results

FACILITIES CONDITION ASSESSMENT REPORT, PHASE I/II

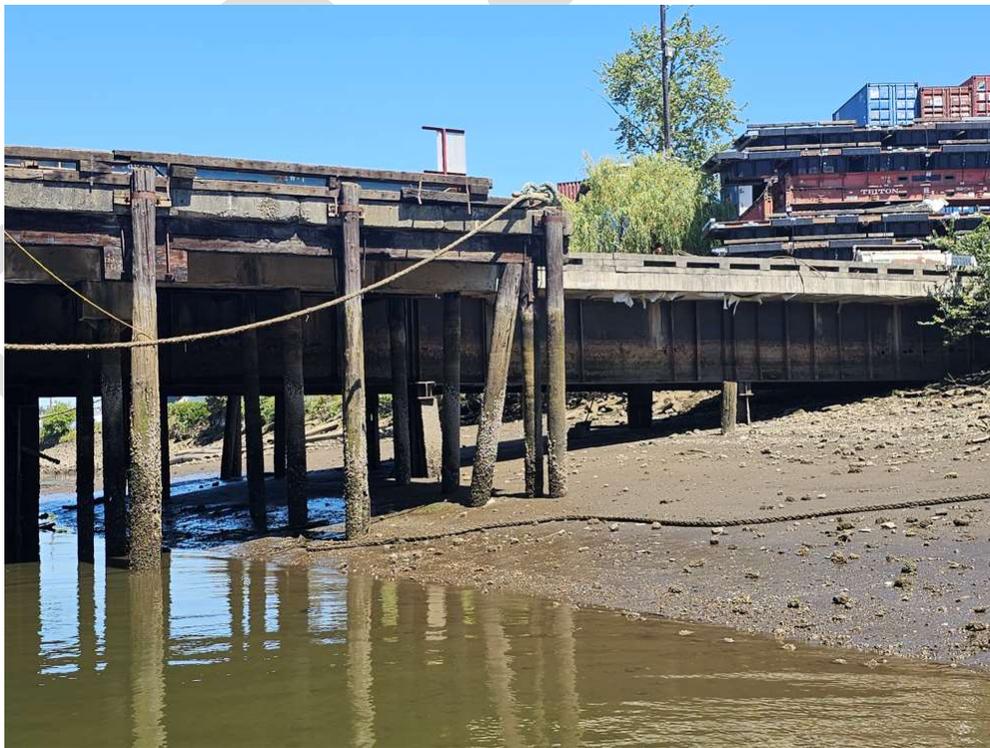
Photo ST01-01: T-Pier south elevation

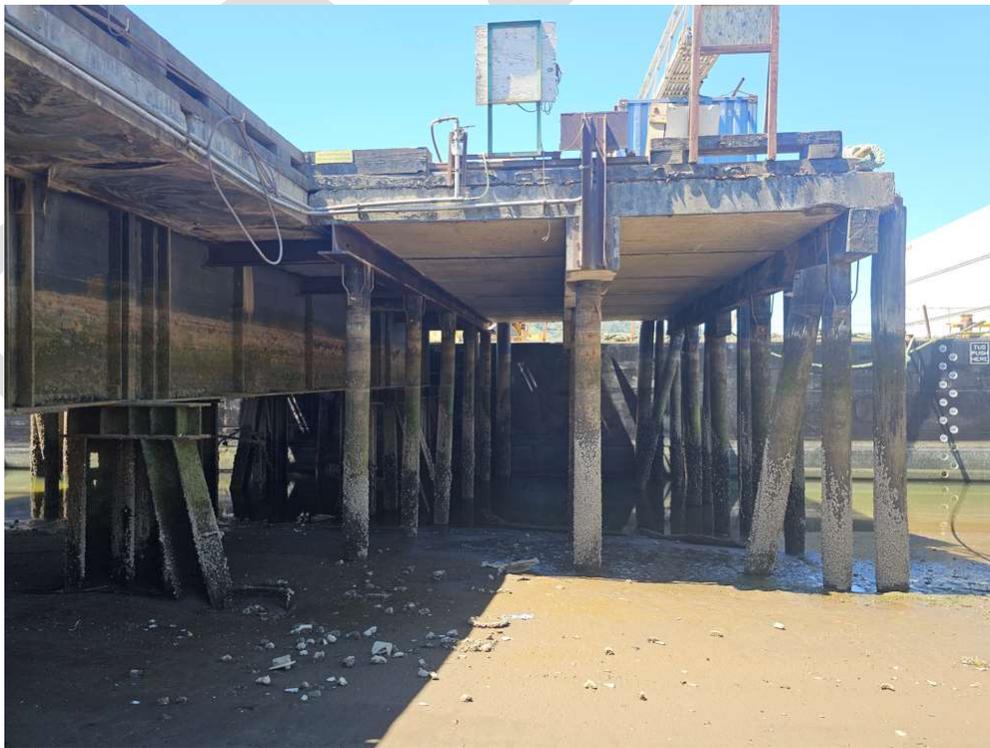
- The steel piles and steel pile caps are in good condition. (Photos 3 to 5)
- It appears that the concrete pile caps and concrete deck are recently constructed and are in good condition. (Photos 4 to 6)
- The plate girders are supported on braced steel piers; the abutment material could not be observed. The web of the plate girders are severely corroded and exhibit a significant loss of material. (Photos 6 to 9)
- The fender piles appear to be in good condition.
- Straddling the pier are a 7-pipe pile steel dolphin to the east and a 4-pipe pile steel dolphin to the west. The piles are in good condition. (Photo 1)
- The bank is armored with a combination of concrete apron and brick rubbles. (Photo 9)

Photo ST01-03: T-Pier south side looking northwest

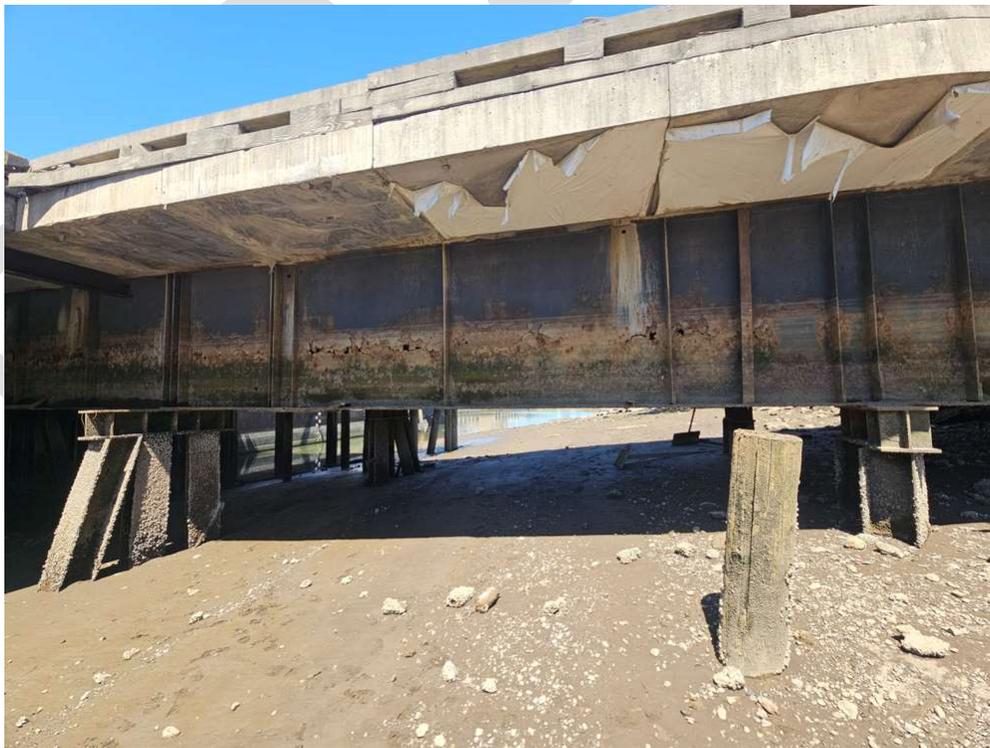
Photo ST01-05: T-Pier looking north

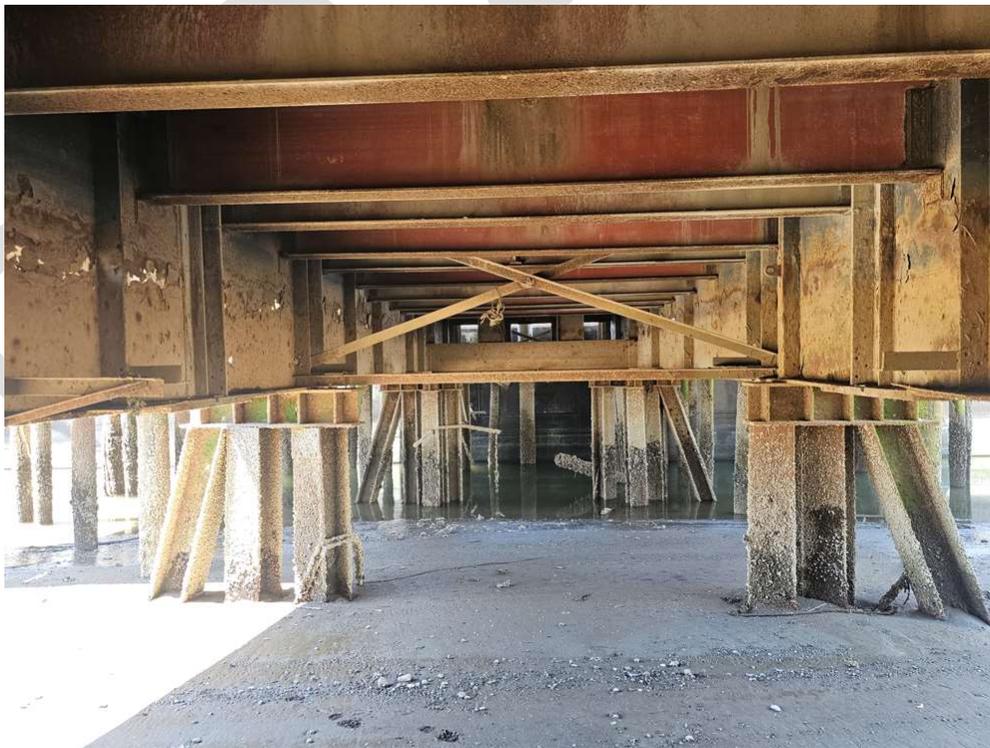
Photo ST01-07: T-Pier south plate girder

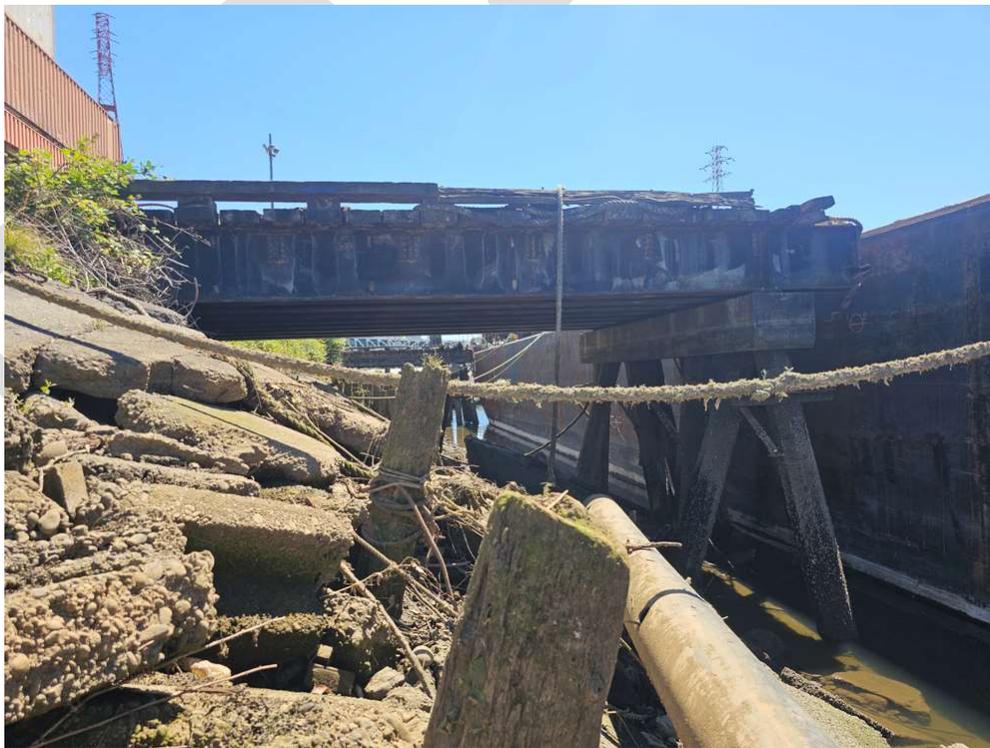
Photo ST01-09: T-Pier approach bridge abutment

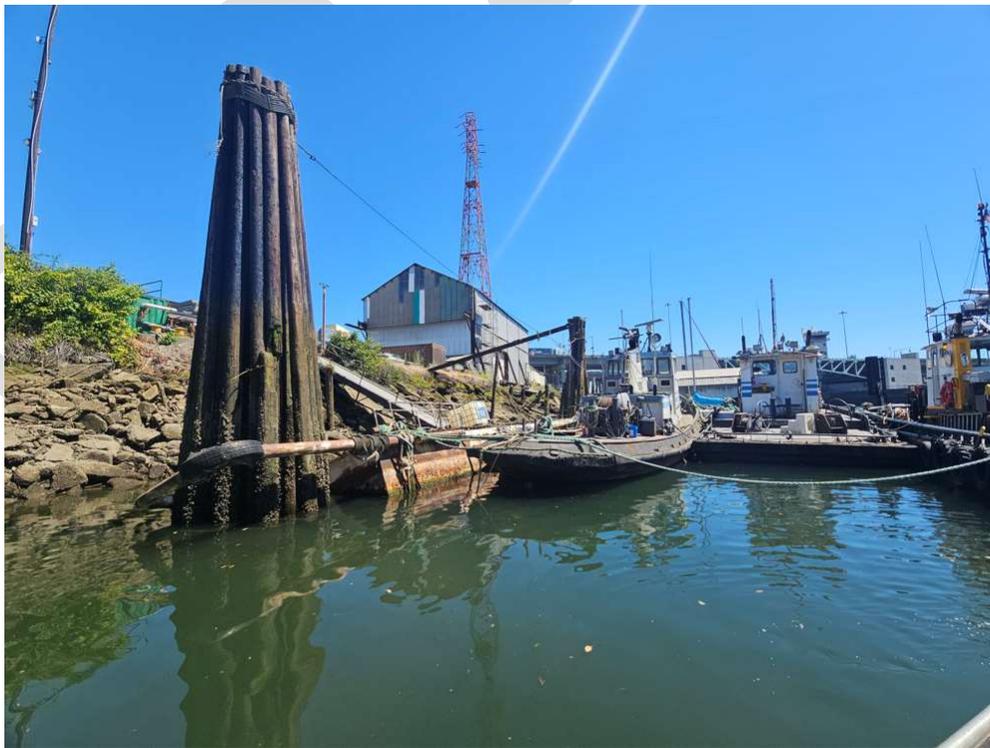
Photo ST01-13: South end of south pier looking east

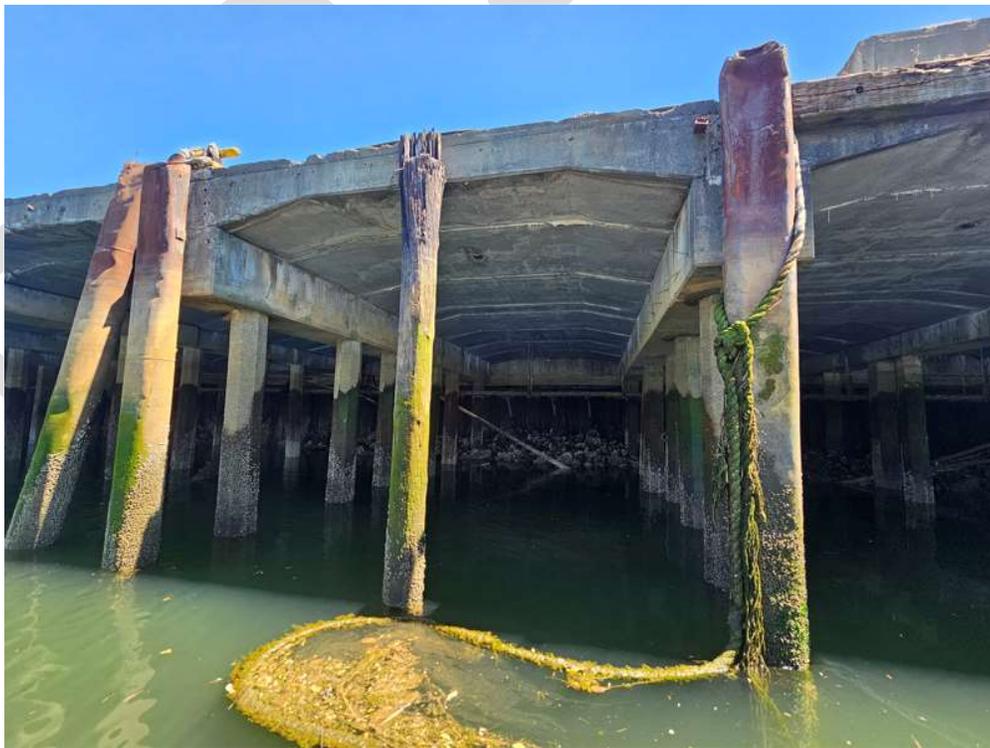
Photo ST04-05: Enlargement of Photo ST04-02 showing debris and riprap

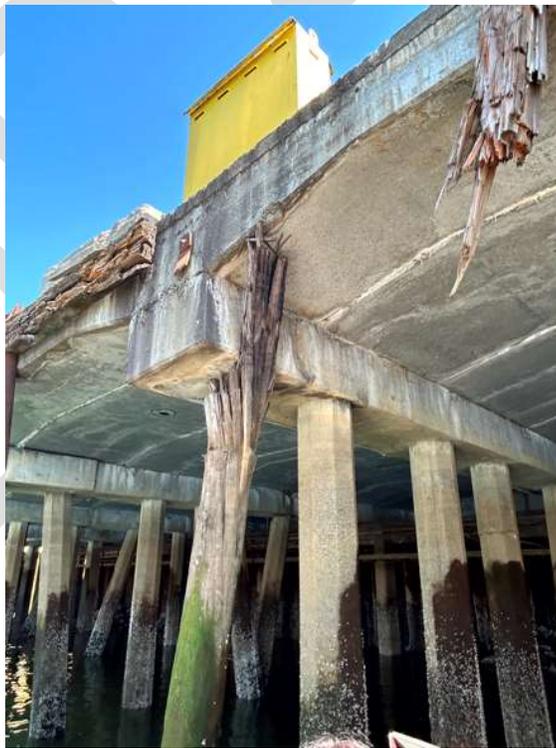
Photo ST04-11: Typical pile cap

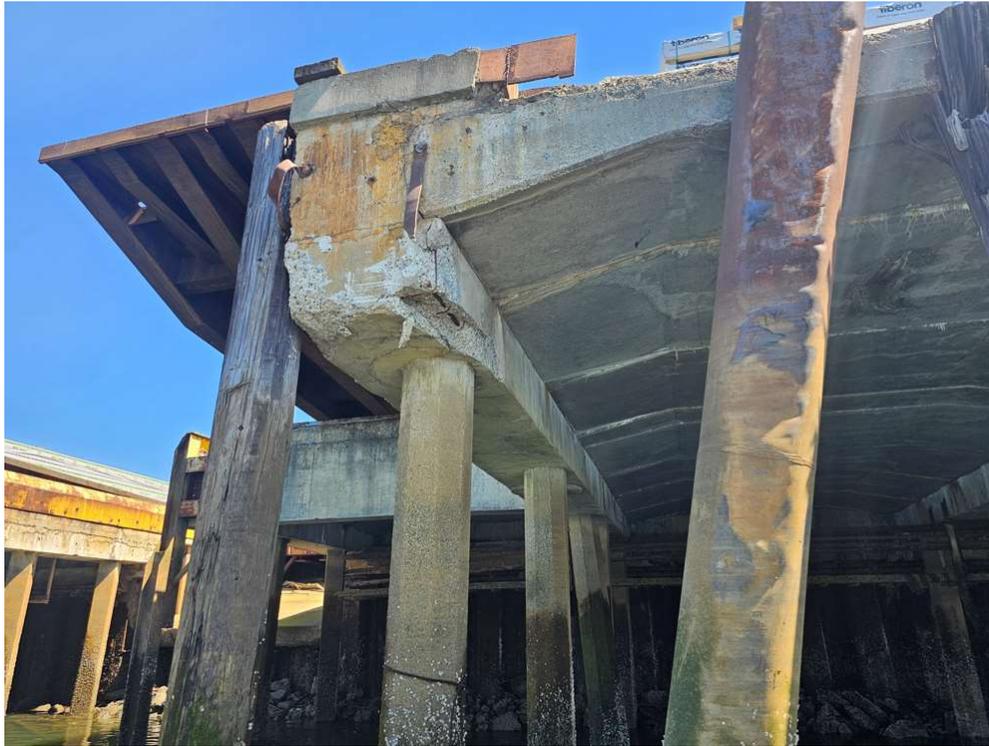
Photo ST04-15: Pile cap damage (north end of wharf)

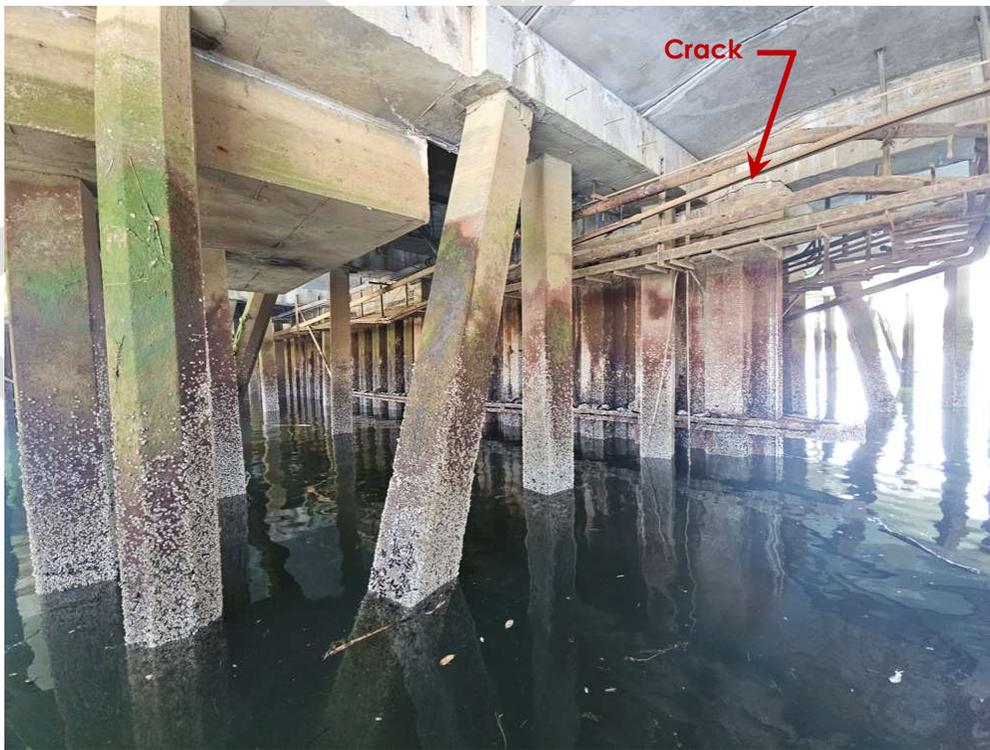
Photo ST04-21: Slip 3 (looking east)

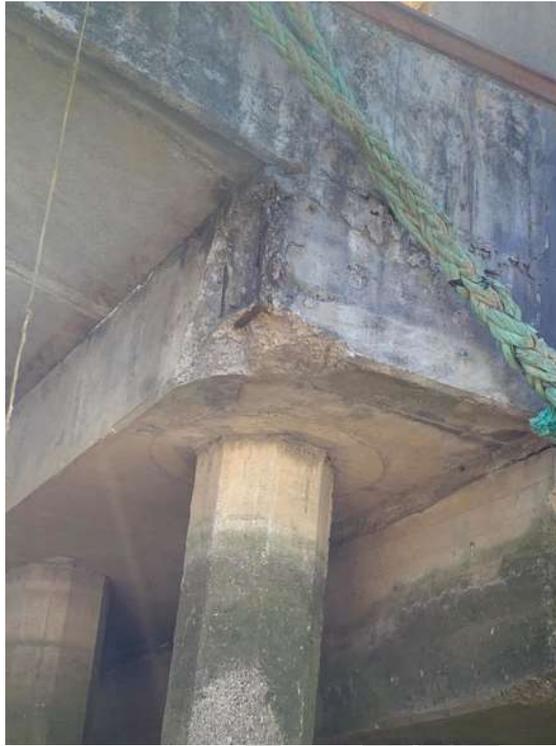
Photo ST04-23: Pile cap damage at wharf south side of Slip 3

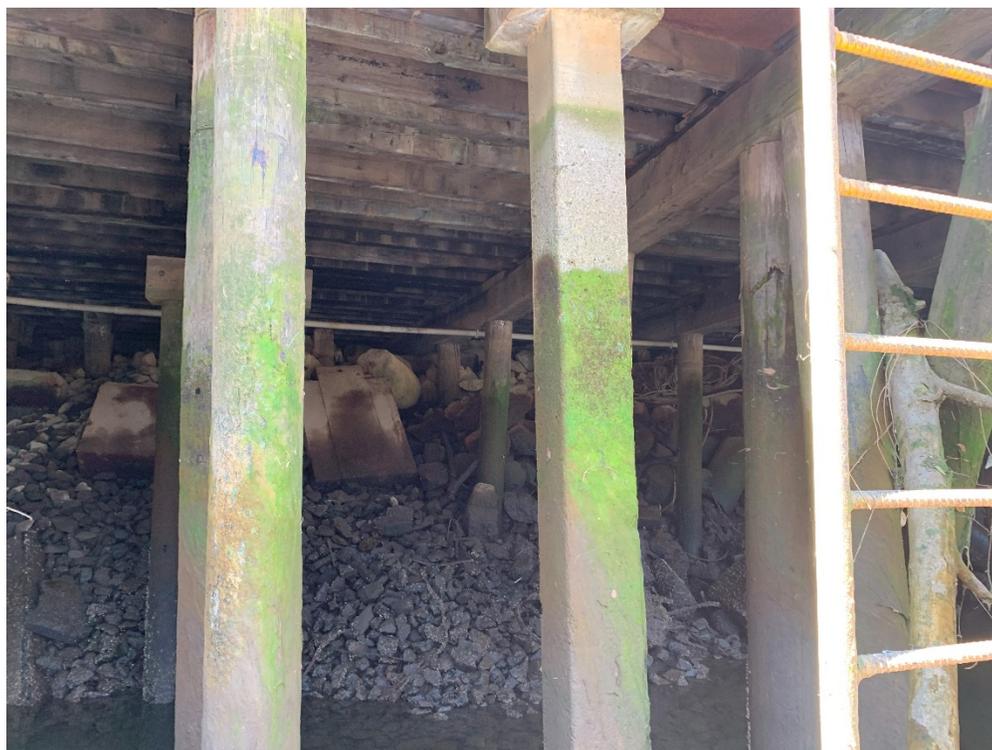
Photo 4: Debris

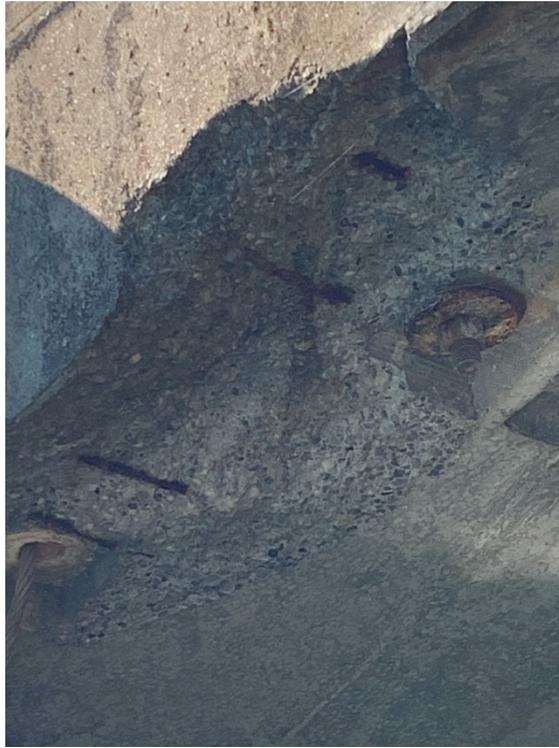
- Concrete spall and exposed rebar could potentially reduce strength in the deck.
- Extent of spall could not be tested visually, and further spalling is possible.
- Structural analysis is required to determine the strength of affected sections.

Photo 3: Spall on Deck Soffit with Exposed Rebar

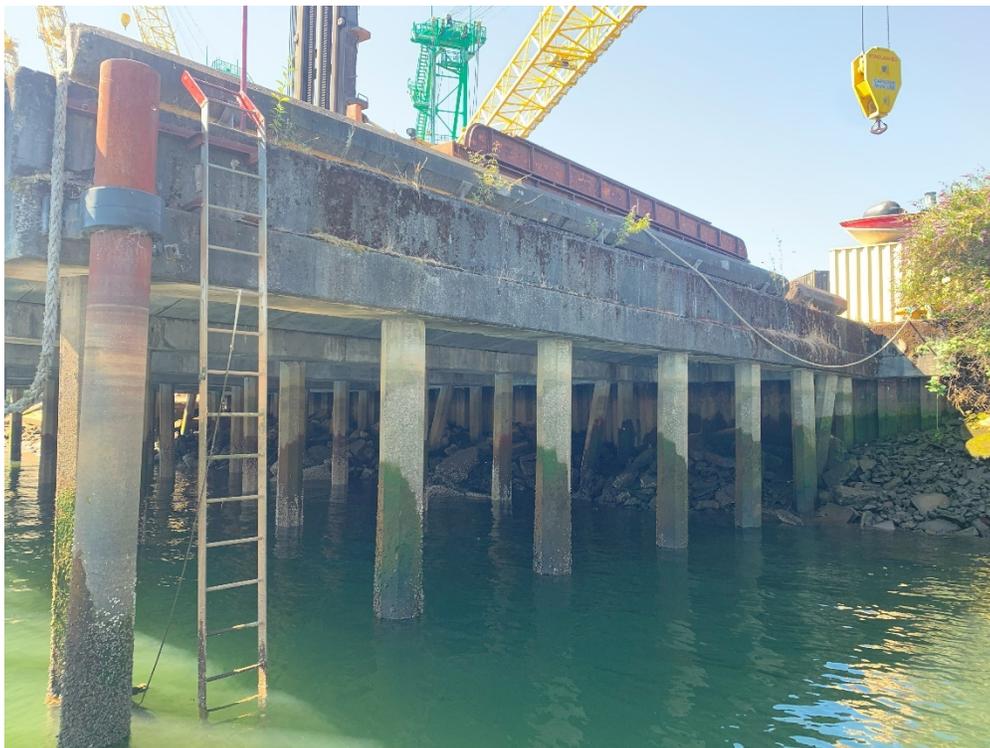
Photo 4: Reinforced Concrete Piles at North End

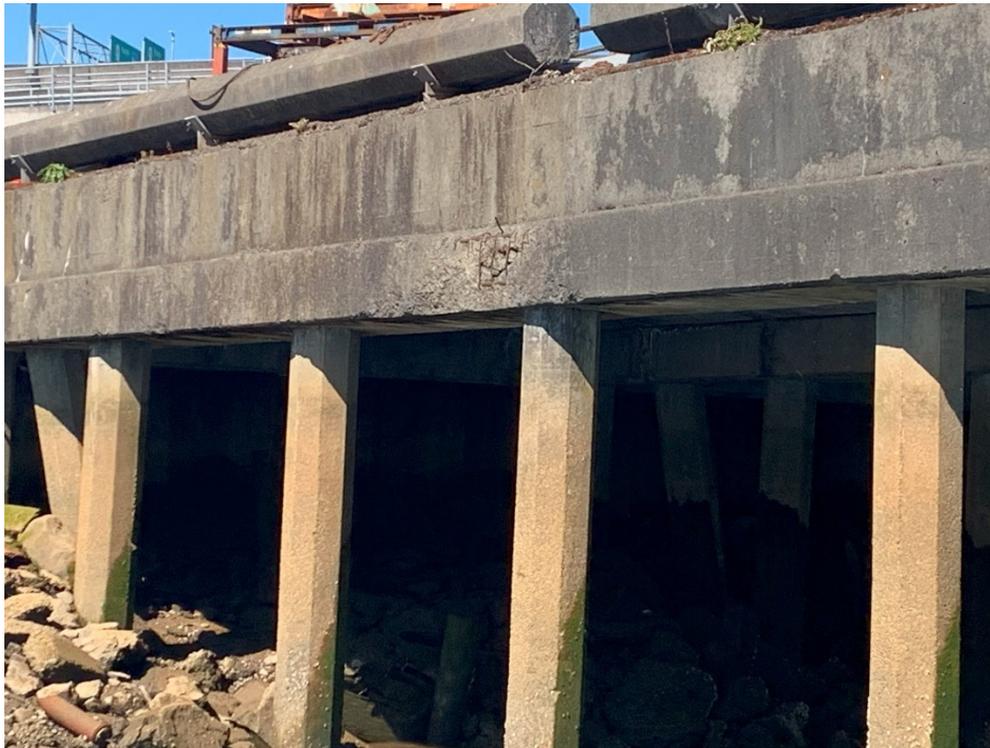
Photo 5: Spall on Cross Beam with Exposed Rebar
