Appendix I

Vegetation Observations

A visual inspection of shoreline vegetation along the upper reach of the Lower Duwamish Waterway was conducted by boat on June 20 and July 1, 2021, as part of the Phase II Pre-Design Investigation (PDI). This inspection built on the information collected during the PDI Phase I visual bank inspection but focused on areas where remediation is anticipated to occur. The inspection included the collection of photographs and detailed observations to document shoreline vegetation within the Phase I remedial action level (RAL) exceedance areas along the upper reach. During the planning phase of the program, periods of predicted daytime moderately low tides (i.e., low enough to observe bank conditions while still being accessible by boat) were identified as potential survey dates, and actual inspection dates were selected based on forecasted weather conditions and team availability.

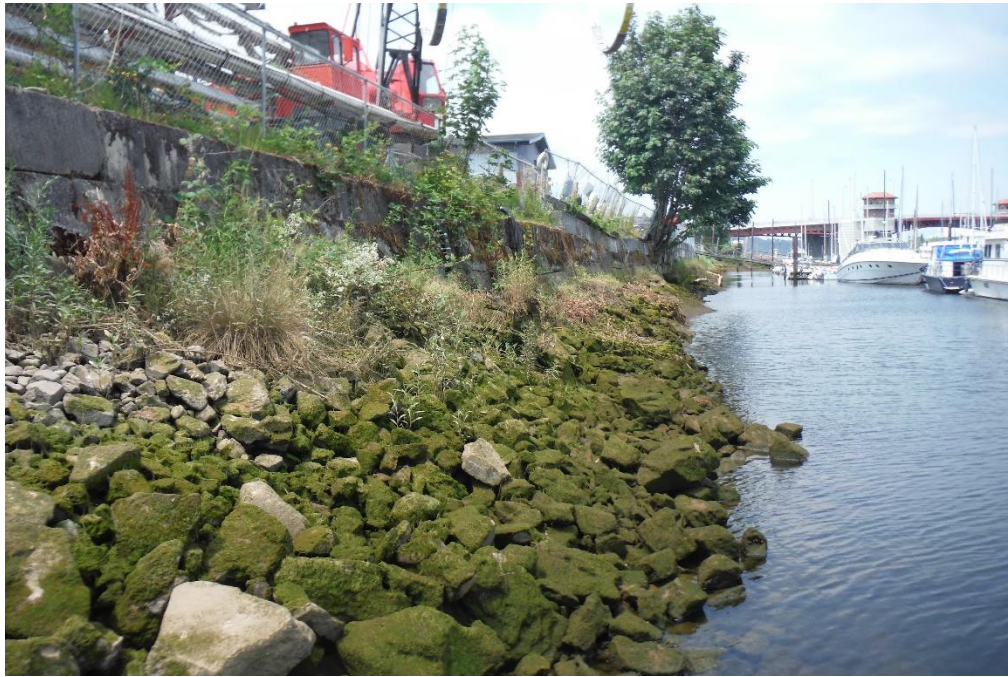
Photograph I-1
Representative Vegetation Conditions at RM 3.5W

River Mile ¹	Location Along Bank	Substrate/ Structure	Species	%	Notes
3.5W	Top of bank	Chain link fence above ecology block wall	ACMA	5	Sparse vegetation due to ecology block wall and riprap
			HYPE	1	
			RUAR	1	
			LASE	1	
			LACO	1	
	Middle of bank	Ecology block wall	-	-	No vegetation
	Toe of bank	Medium rip rap	LELA	5	Algal mat and barnacles on subtidal riprap. Small woody debris at high tide line
RUOC			1		
SYLA			5		
3.8E-a	Top of Bank	Sheetpile wall	BUDA	75	Vegetation only at top of wall extending east 50 ft to staging area
			RUAR	15	
			POBA	5	
			HYPE	5	
	Middle of bank	Sheetpile wall	-	-	No vegetation
Toe of bank	Sheetpile wall	-	-	No vegetation

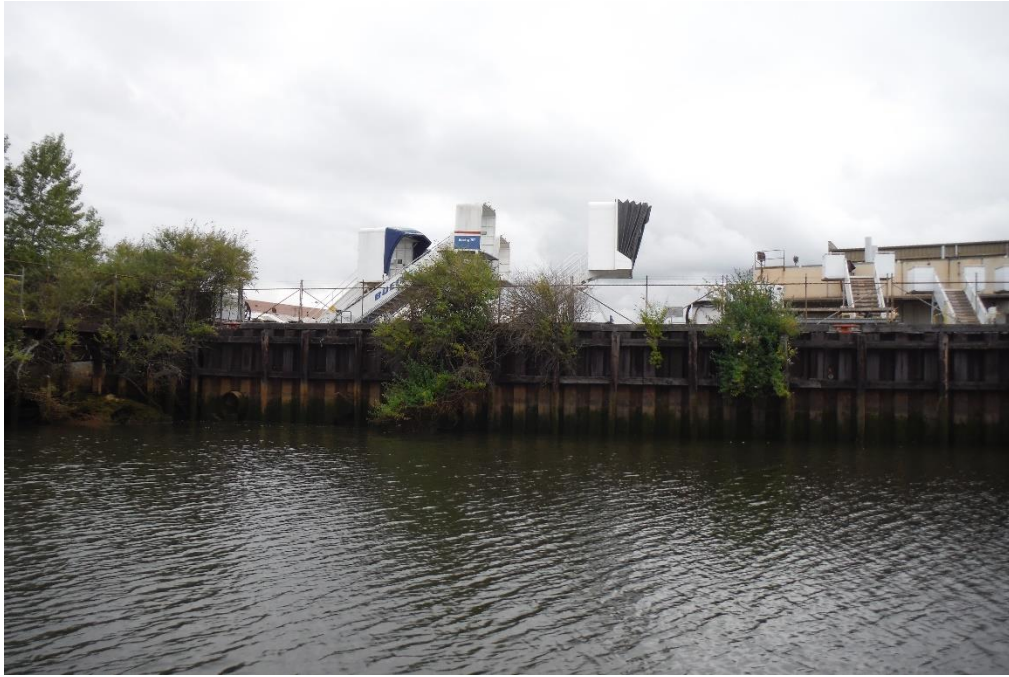
Photograph I-3
Representative Vegetation Conditions at RM 3.8W-b

River Mile ¹	Location Along Bank	Substrate/ Structure	Species	%	Notes
3.8E-b	Top of bank	Sheetpile wall	BUDA	5	Sparse vegetation
	Middle of bank	Sheetpile wall	-	-	No vegetation
	Toe of bank	Gravel and fines	-	-	No vegetation

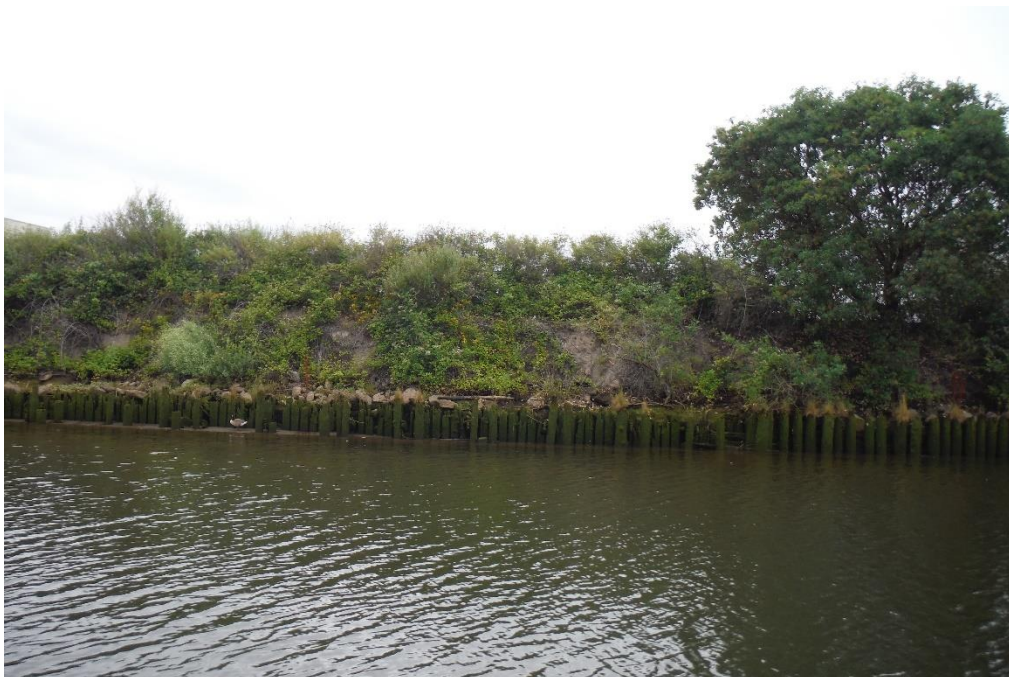
Photograph I-4
Representative Vegetation Conditions at RM 3.8E-c

3.8E-c	Top of bank	Eroded wooden bulkhead with layers of fill and soil	BUDA	60	Vertical slope of eroding fill
			RUAR	10	
			RULA	10	
			ARME	5	
	Middle of bank	Eroded fill from top of bank, 45% of the slope	RUAR	45	Middle of bank held in place by downslope eroded bulkhead
			LELA	5	
			BUDA	5	
			POPA	5	
			FRLA	5	
	Toe of bank	Rock, gravel, and fines	SYLA	5	Aster growing within bulkhead piles

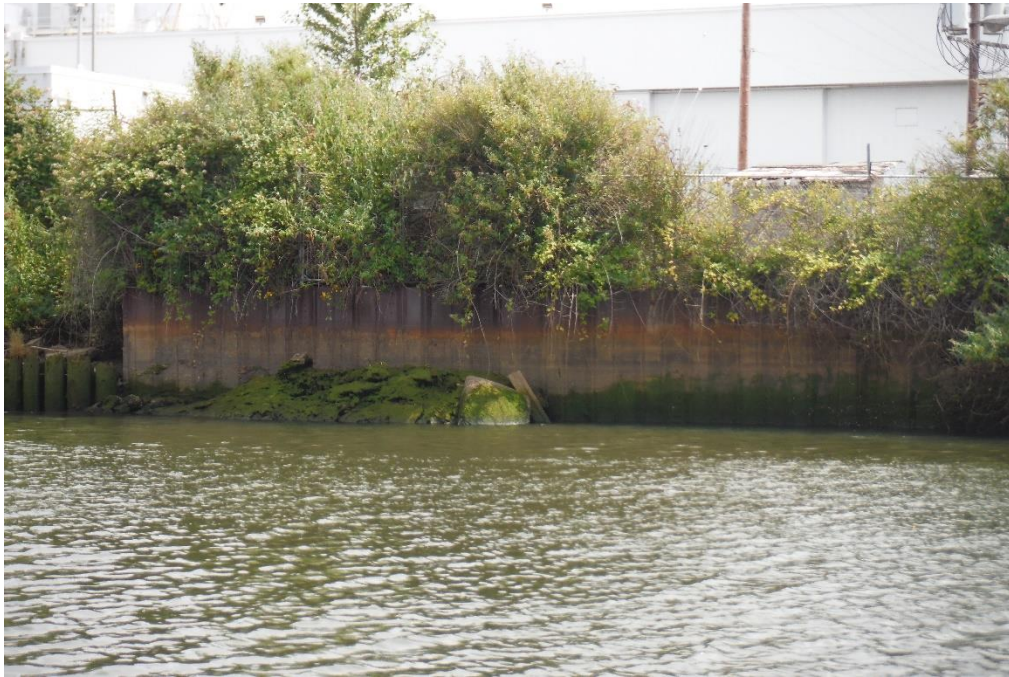
Photograph I-5
Representative Vegetation Conditions at RM 3.8W-d

3.8E-d	Top of bank	Sheetpile wall	BUDA	50	Vegetated top of bank is only 5 to 10 ft deep
			RUAR	40	
			BEPA	5	
			POBA	5	
	Middle of bank	Sheetpile wall	-	-	No vegetation
Toe of bank	Rock, gravel, and fines	-	-	No vegetation

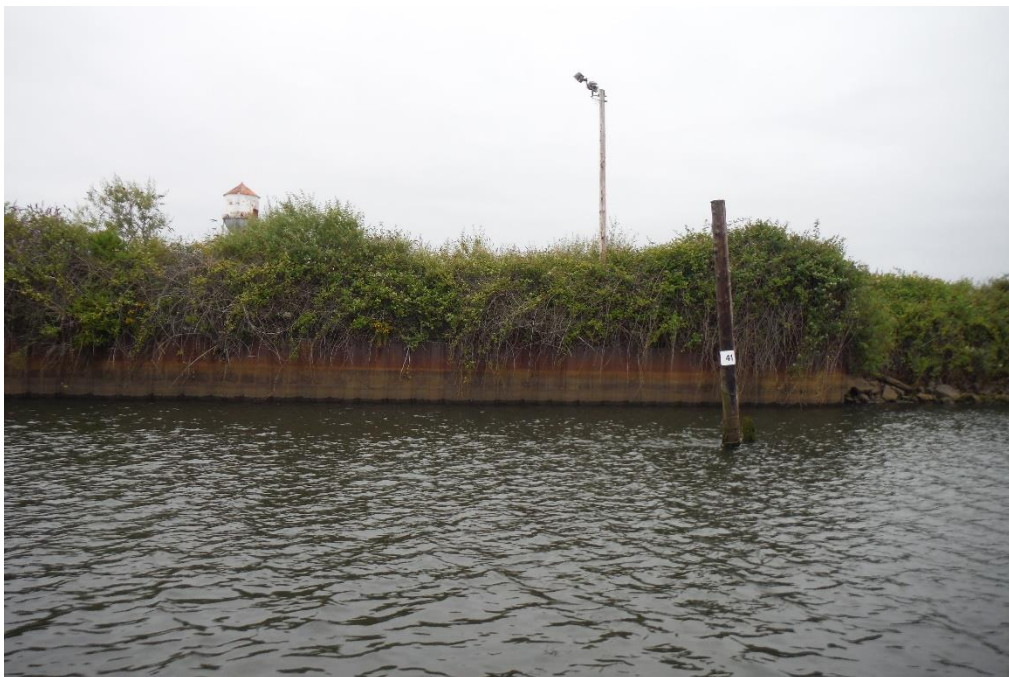
Photograph I-6
Representative Vegetation Conditions at RM 3.9E

3.9E	Top of bank	Sheetpile wall	BUDA	90	Vegetated top of bank is only 5 to 10 ft deep
			RUAR	10	
	Middle to bank	Sheetpile wall	-	-	No vegetation
	Toe of bank	Rock, gravel, and fines	-	-	No vegetation

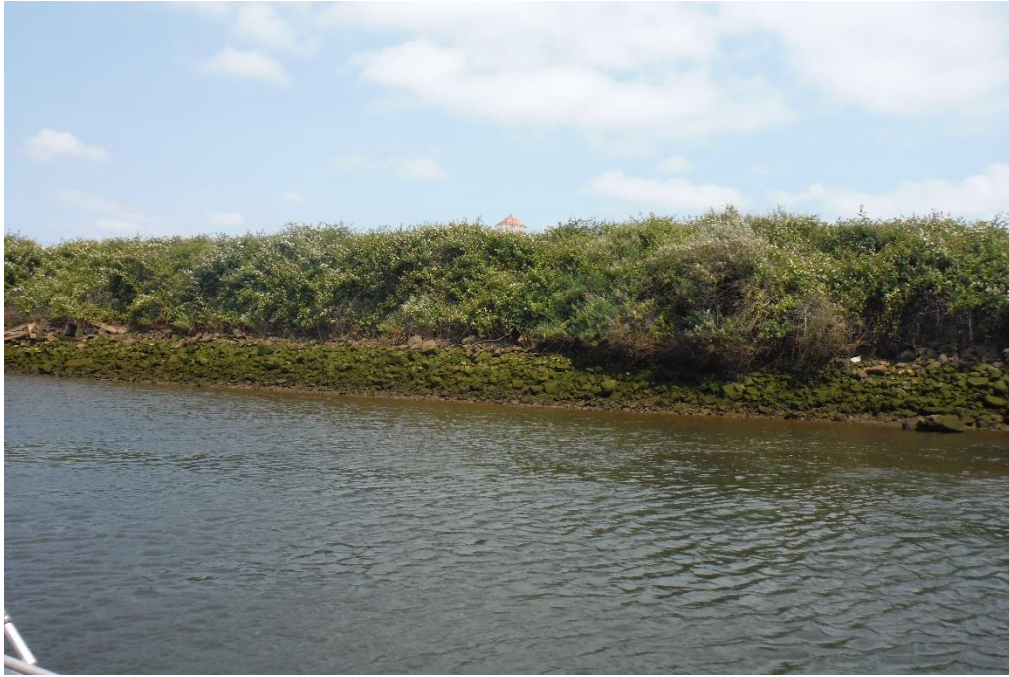
Photograph I-7
Representative Vegetation Conditions at RM 4.0E

4.0E	Top of bank	Medium riprap	RUAR	75	Vegetated top of bank is only 5 to 10 ft deep
			BUDA	24	
	Middle of bank	Medium riprap	RUAR	50	Dense shrubs
			BUDA	40	
			LELA	10	
Toe of bank	Riprap	-	-	Algal mat on riprap

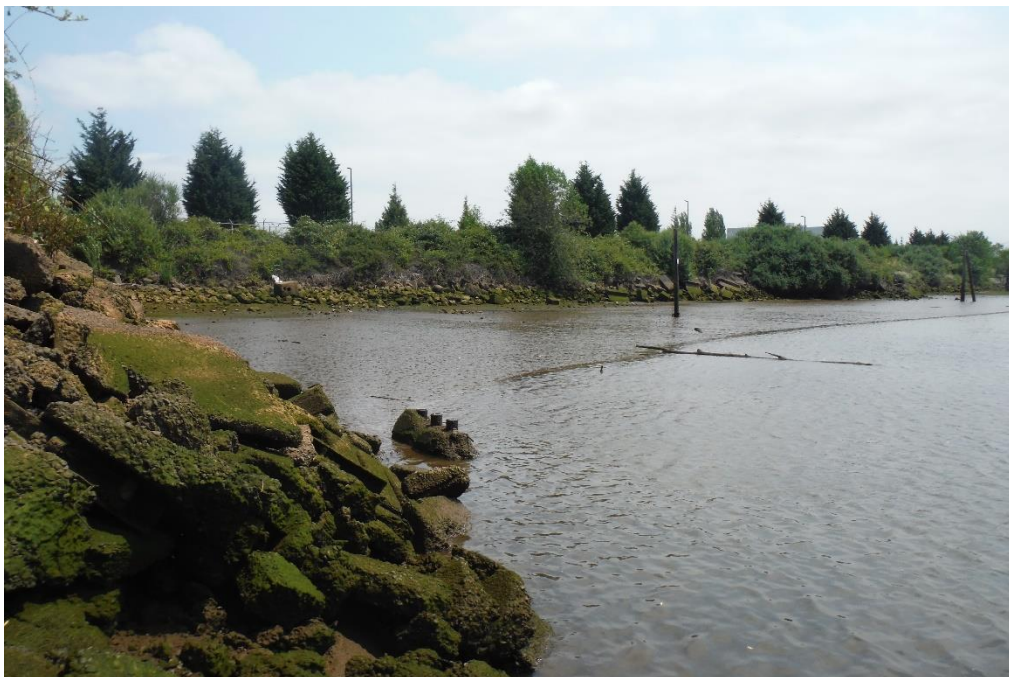
Photograph I-8
Representative Vegetation Conditions at RM 4.1E

River Mile ¹	Location Along Bank	Substrate/ Structure	Species	%	Notes
4.1E	Top of bank	Riprap, concrete debris, and fill	BUDA	45	Vegetated layer extends east 20 to 30 ft from top of bank. There is a canopy, shrub, and herb layer.
			FRLA	5	
			POBA	5	
			CULE	5	
			RUAR	10	
			RULA	5	
			HEHE	10	
			HYPE	5	
	PONI	10	Mix of riprap and debris		
	Middle of bank	Riprap, concrete debris, and fill		RUAR	30
				RULA	20
				PONI	5
				FRLA	5
				LELA	5
LASE			5		
Toe of bank	Loose riprap, rock, gravel, sands, and fines	BUDA	30	Substrate is mix of fill and fines (50/50)	
		RUOC	10		
		IRPS	5		
		ALPL	5		
		POPA	5

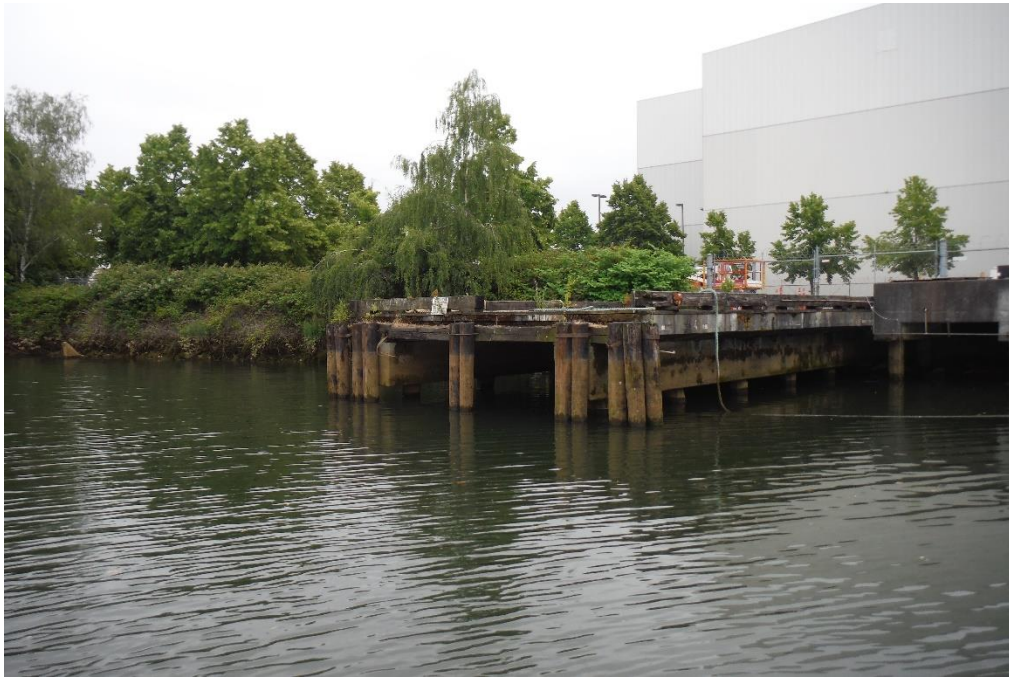
Photograph I-9
Representative Vegetation Conditions at RM 4.2E

4.2E (Slip 6)	Top of bank	Elevated pier	-	-	No vegetation
	Middle of bank	Open	-	-	No vegetation
	Toe of bank	Deepwater	-	-	No vegetation
4.6E	Top of bank	Parking lot bulkhead, riprap, and concrete slabs	BUDA	80	Very dense vegetation
			RUAR	20	
	Middle of bank	Riprap with 40%	BUDA	100	Very dense vegetation
	Toe of bank	Rock, gravel, and fines	-	-	No vegetation

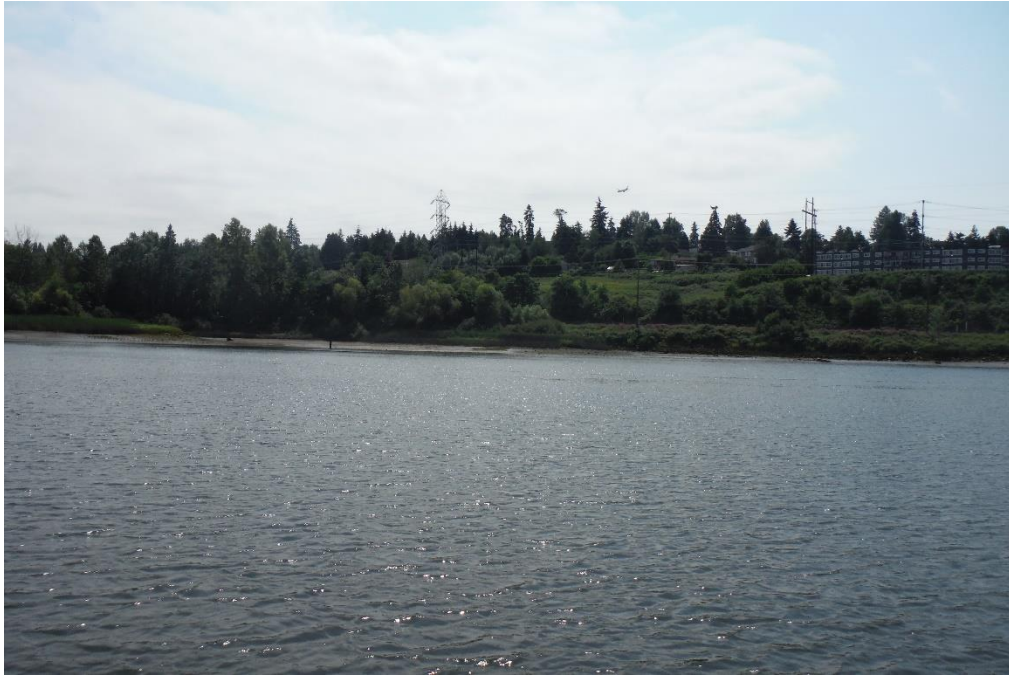
Photograph I-11
Representative Vegetation Conditions at RM 4.7W

4.7W	Top of bank	Native substrate	ALRU	40	Native substrate and vegetation
			BEPA	20	
			SASC	15	
			HOB1	10	
			PHAR	10	
			COSI	5	
	Middle of bank	Gravel, sand, and silt	TYLA	20	Native substrate and vegetation
			SCVA	20	
			CALY	40	
	Toe of bank	Silt	SCVA	10	Algal mat in depressions, piles in the nearshore
CALY			10

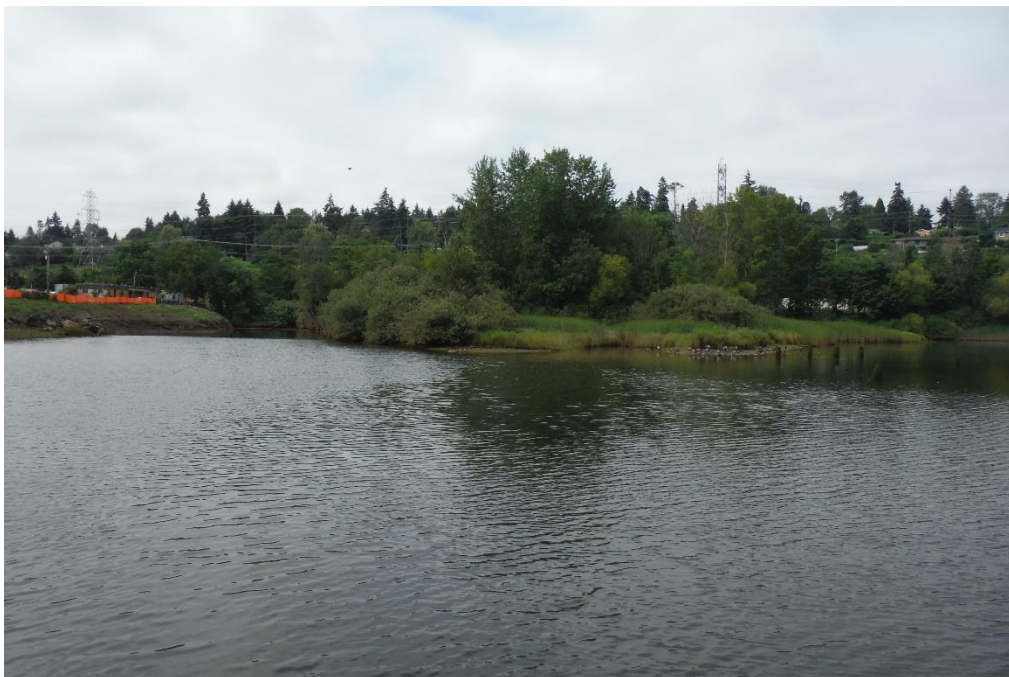
Photograph I-12
Representative Vegetation Conditions at RM 4.8W

River Mile ¹	Location Along Bank	Substrate/Structure	Species	%	Notes	
4.8W	Top of bank	Native substrate	ALRU	20	Native substrate and vegetation	
			BEPA	20		
			SASC	10		
			HODI	5		
			PHAR	40		
				COSI	5	
	Middle of bank	Gravel, sand, and silt	TYLA	5	Native substrate and vegetation	
			PHAR	20		
			SCVA	20		
			CALY	40		
Toe of bank	Silt	SCVA	10	Algal mat in depressions, piles in the nearshore		
		CALY	10

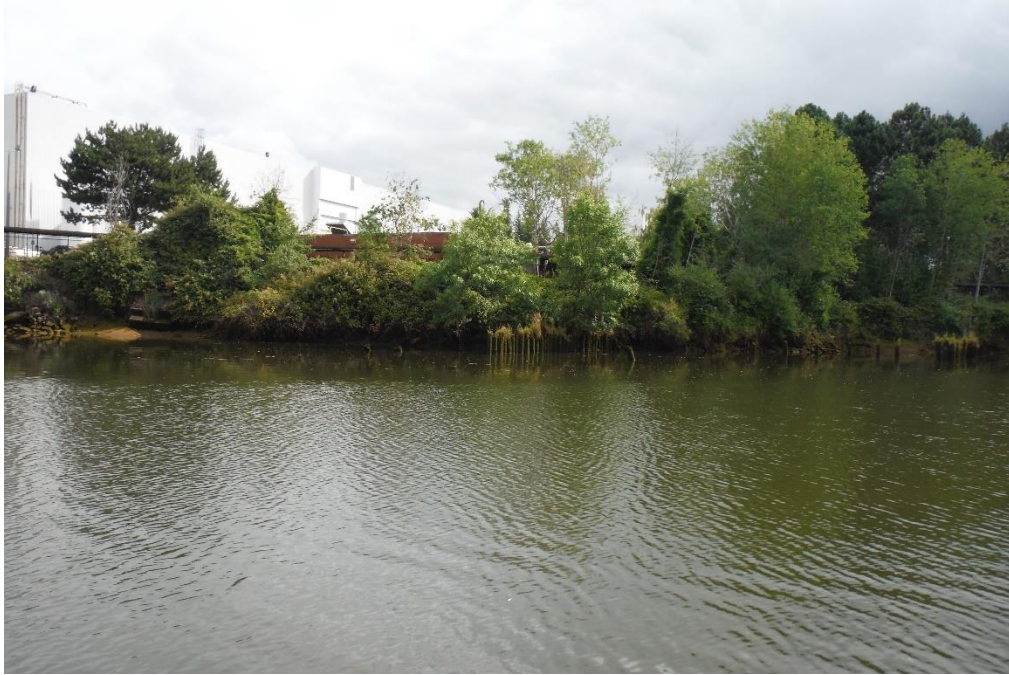
Photograph I-13
Representative Vegetation Conditions at RM 4.9E-a

4.9E-a	Top of bank	75% riprap, 25% concrete blocks	PICO	5	Mix of trees and shrubs extending to paved trail	
			RUAR	25		
			POTR	30		
			BUDA	20		
	Middle of bank	Some riprap with exposed soil	FRLA	10	Scattered trees and saplings	
			RUAR	60		
			BUDA	20		
	Toe of bank	Piles, riprap, gravels, and fines	SYLA	10	Aster rooted in the piles

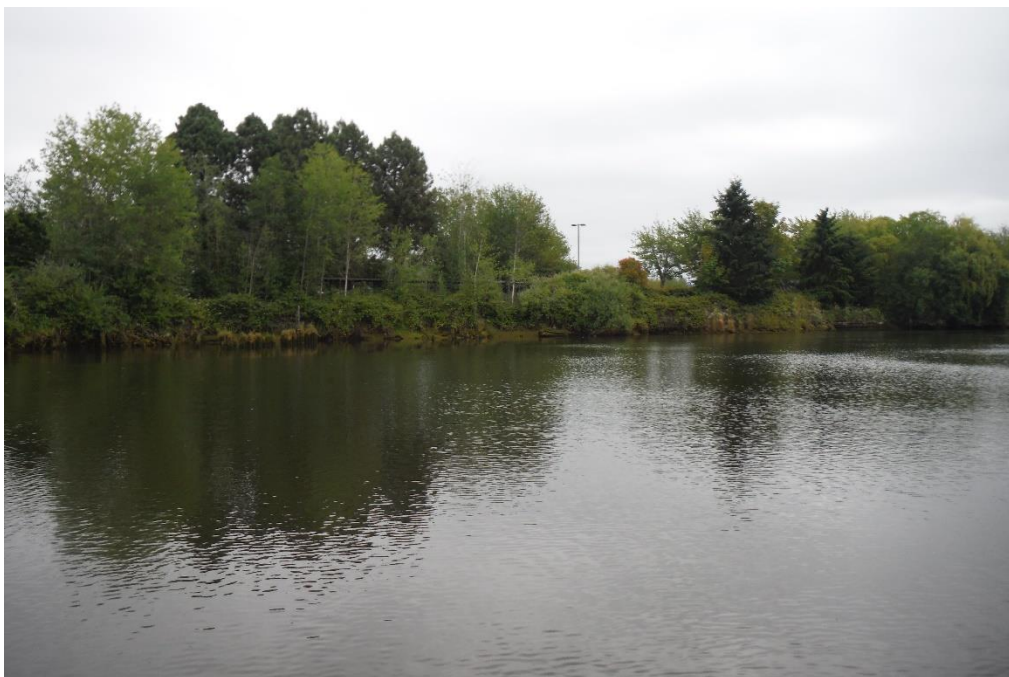
Photograph I-14
Representative Vegetation Conditions at RM 4.9E-b

4.9E-b	Top of bank	25% riprap, 25% steep soil	PICO	20	Mix of trees and shrubs
RUAR				25		
POTR				50		
FRLA				5		
Middle of bank		Soil with rock	RUAR	50	-	
Toe of bank		Piles, riprap, gravel, and fines	SYLA	5	Aster rooted in piles, algal mat on riprap	
			JUEF	5		
			IRPS	10		
			POPA	10

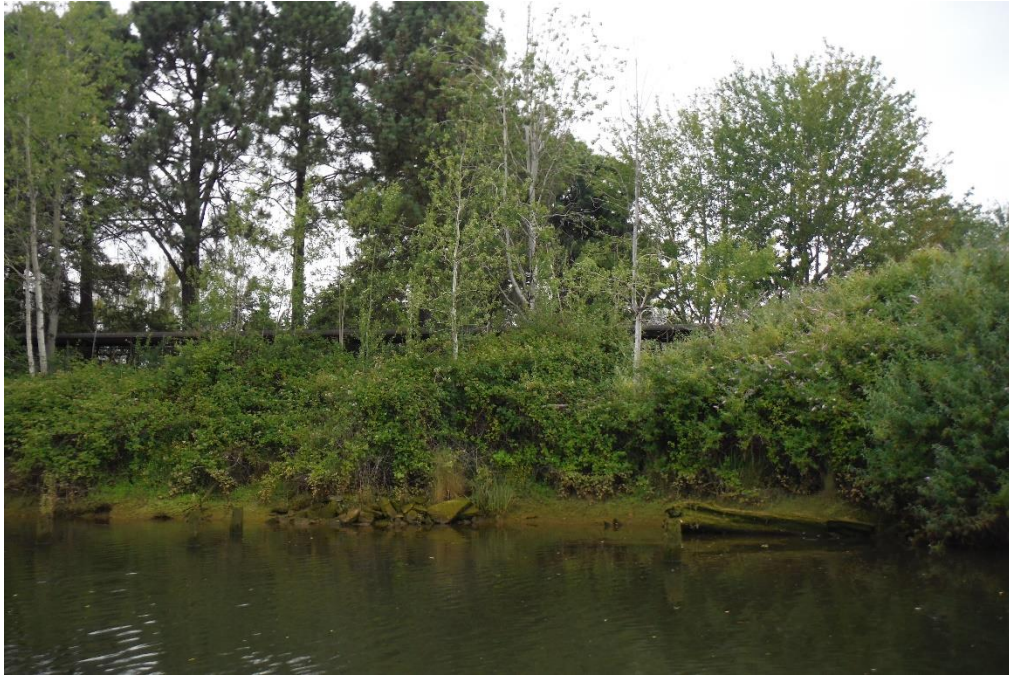
Photograph I-15
Representative Vegetation Conditions at 4.9E-c

4.9E-c		Top of bank	75% soil, 20% riprap, 5% piles	PSME	25	-
	ACMA			40		
	RUAR			25		
	Middle of bank	Steep exposed soil	RUAR	40		
			LELA	10		
			HYPE	10		
	Toe of bank	High tide bench with piles	IRPS	5		
			POPA	10		
			ALPL	5

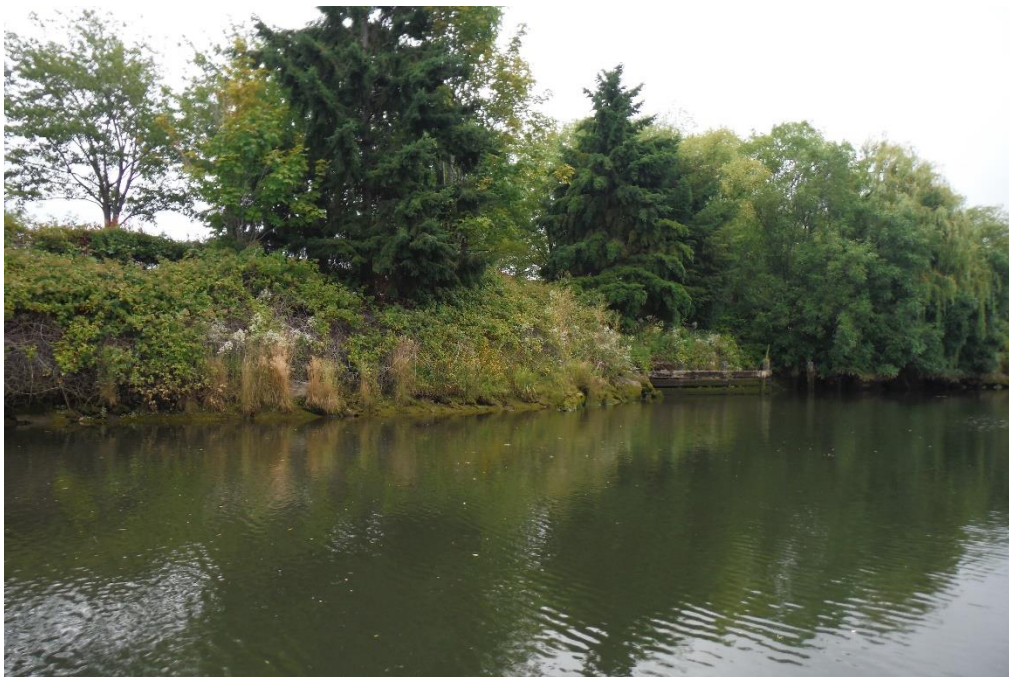
Photograph I-16
Representative Vegetation Conditions at RM 4.9E-d

4.9E-d	Top of bank	Concrete slabs and large riprap	SALA	50	Large debris	
			FRLA	50		
	Middle of bank	Concrete slab and large riprap	RUAR	20	80% bare ground	
			BUDA	5		
	Toe of bank	Concrete slab and large	CALY	5	Algal mat on riprap	
			SYLA	5
