# Appendix G

## Vegetation Observations

# 1 Introduction

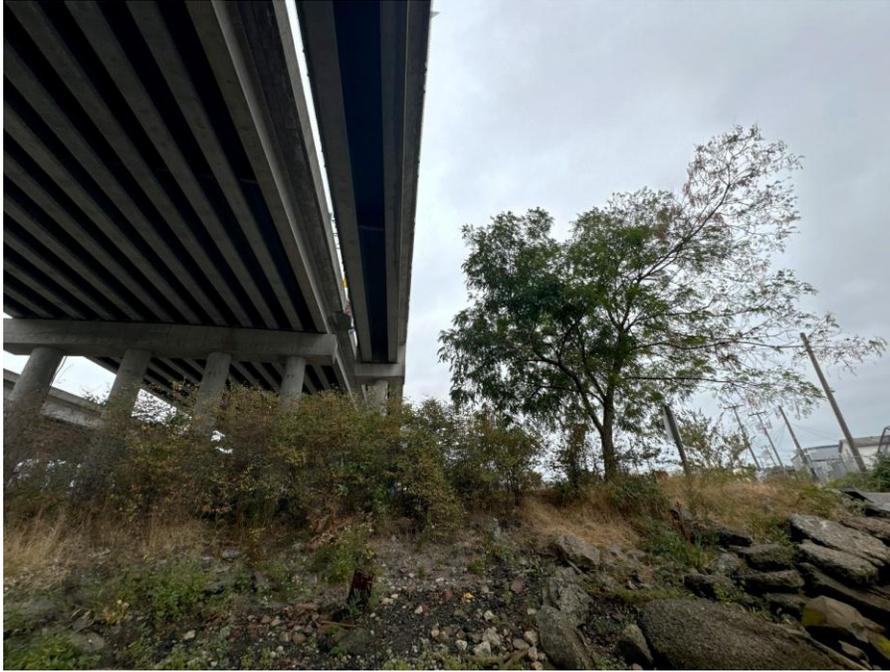
**Photograph G-5**  
**Representative Vegetation Conditions at Phase I RAL exceedance area 27 (RM 2.0E)**

Phase I RAL Exceedance Area <sup>1</sup>	RM <sup>2</sup>	Location Along Bank	Substrate/Structure	Species	% of Cover <sup>3</sup>	Notes
27 (29)	2.0E	Top of bank	Fill, pavement	BUDA*	10	Previously restored area at top of bank. Planted vegetation (e.g., snowberry, SYAL, and ocean spray, HODI) appear stressed with browning leaves and bare branches.
				RUAR*	20	
				ARSU	10	
				CHNO*	1	
				SYAL	10	
				HODI	10	
				PRDO*	5	
Middle of bank	Riprap, quarry, concrete poured over timber.	-	-	No vegetation		
Toe of bank	Sand, gravel, and fines	-	-	No vegetation		
21 (24 and 27)	2.2W	Top of bank	Chain link fence and ecology blocks	RUAR*	50	Native vegetation showing signs of stress with two dead black cottonwood trees (POBA). Vegetation along entire shoreline between containers and top of bank.
				SCAC	1	
				LELA*	1	
				ARSU	1	
				BUDA*	10	
				ALRU	1	
				TAVU*	1	
				CYSC*	1	
				POBA	15	
				HEHE*	15	
				SASC	5

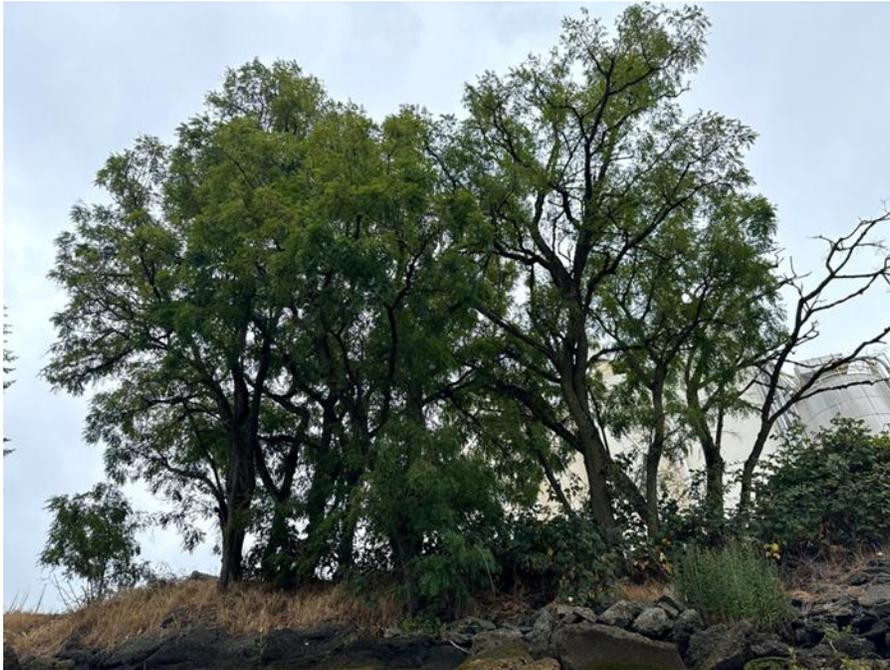
**Photograph G-10**  
**Representative Vegetation Conditions at Phase I RAL exceedance area 18/19/22**  
**(RM 2.2-2.3E)**

Phase I RAL Exceedance Area <sup>1</sup>	RM <sup>2</sup>	Location Along Bank	Substrate/Structure	Species	% of Cover <sup>3</sup>	Notes
18/19/22 (23)	2.25E	Top of bank	Chain link fence along portion; vegetation in narrow strip between pavement and top of bank.	PSME	5	Sparse vegetation between trees, possibly maintained for landscaping along portions.
				ARME	5	
				ROPS*	5	
				RUAR*	10	
				BUDA*	10	
				DACA*	1	
				ESCA	1	
				TAOF*	1	
				PICO	10	
				RHMA	5	
				MAFU	5	
		SASC	5			
		POBA	5			
Middle of bank	Broken concrete	ULLA	1	Interspersed algae along debris and rocks		
		FUDI	1			
		PHYL	10			
Toe of bank	Fines	-	-	No vegetation		
15 (20)	2.35E	Top of bank	Fill, pavement	RUAR*	50	Vegetation in narrow space between pavement and top of bank.
				DACA*	5	
				CAOB	1	
				BUDA*	5	
				PICO	10	
				HEHE*	30	
				TAVU*	1	
				PIGL	1	
		Middle of bank	Broken concrete, riprap	ULLA	1	Interspersed algae along debris and rocks

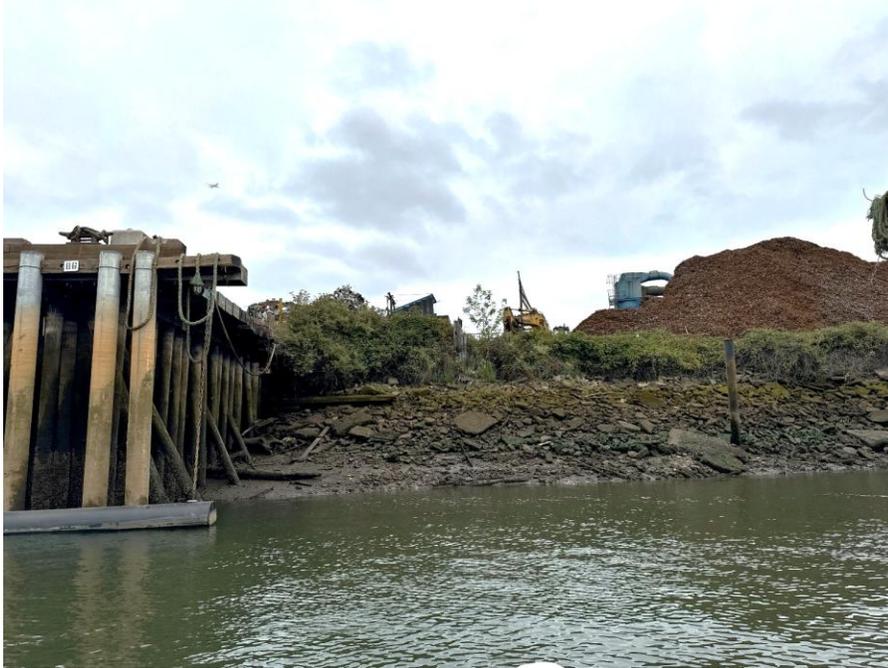
**Photograph G-13**  
**Representative Vegetation Conditions at Phase I RAL exceedance area 14 (RM 2.4E)**

PHYL	5	
Toe of bank	Fines	-	-	No vegetation		
14 (NA)	2.45E	Top of bank	Fill, pavement	RUAR*	70	Narrow space for vegetation between industrial property use and top of bank.
				BUDA*	10	
				TAVU*	1	
				LELA*	5	
		ACCI	1			
	Broken concrete	ULLA	1

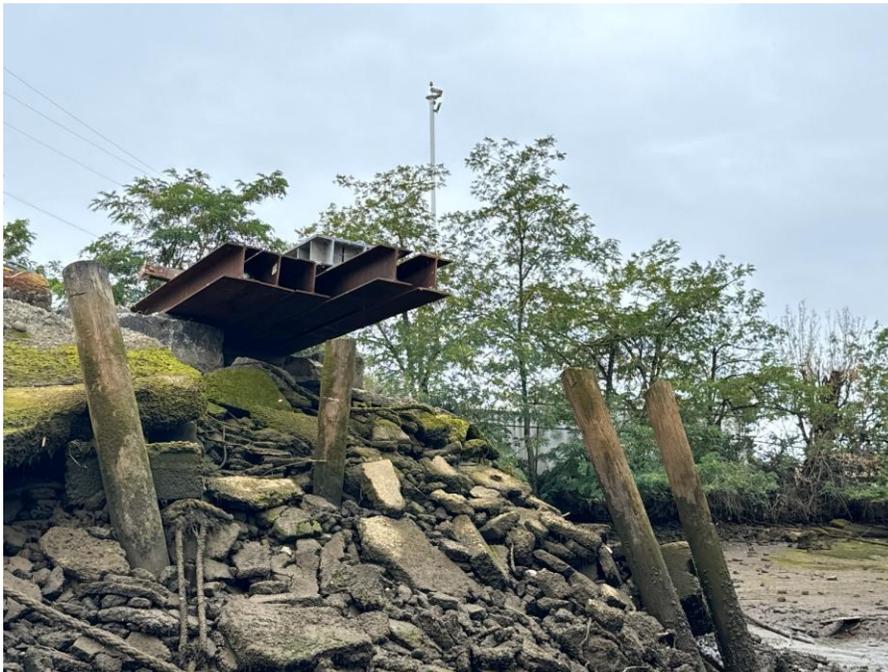
**Photograph G-14**  
**Representative Vegetation Conditions at Phase I RAL exceedance area 12 (RM 2.5W)**

Phase I RAL Exceedance Area <sup>1</sup>	RM <sup>2</sup>	Location Along Bank	Substrate/Structure	Species	% of Cover <sup>3</sup>	Notes
		Middle of bank		PHYL	5	Interspersed algae along debris and rocks
		Toe of bank	Sand, gravel, and fines	-	-	No vegetation
12 (17)	2.5W	Top of bank	Fill, pavement	ROPS*	80	Shoreline dominated by invasive tree with minimal other vegetation
				CIAR*	1	
				ARSU	1	
		Middle of bank	Broken concrete	PHYL	5	Algae along rocky substrate and debris
		Toe of bank	Fines	-	-	No vegetation
11 (13, 16)	2.55E	Top of bank	Fill, pavement	POCU*	10	Sparse vegetation along top of bank
				RUAR*	5	
				DACA*	1	
				PONI*	5	
		Middle of bank	Broken concrete	PHYL	5	Algae along rocky substrate and debris
		Toe of bank	Sand and fines	-	-	No vegetation
9 (9)	2.7E	Top of bank	Fill, pavement	ARME	5	Narrow band of vegetation along the shoreline until reaching the Georgetown Pump Station in Gateway Park North, which has a wider buffer containing a mix of native and non-native trees, shrubs, and ground cover.

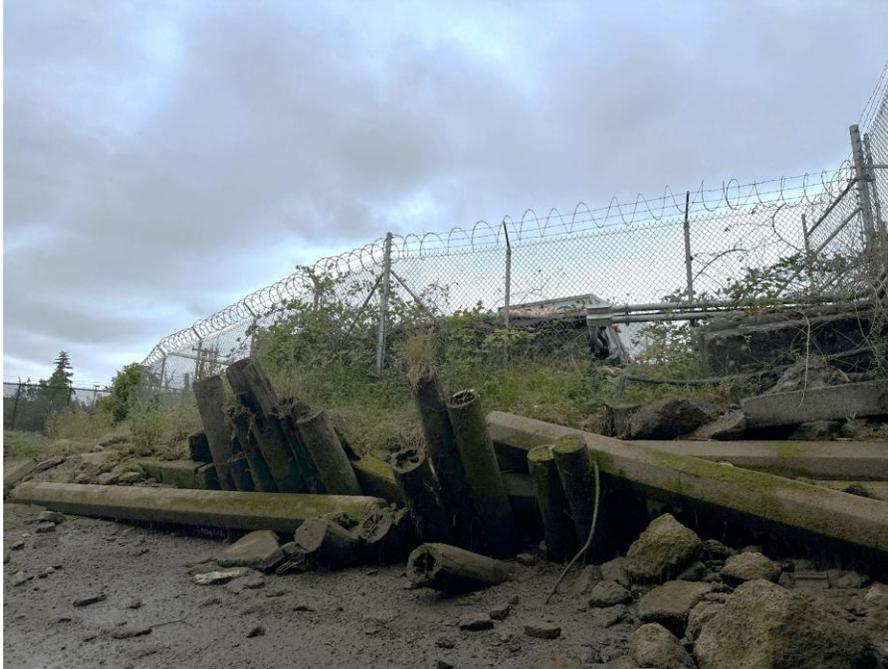
**Photograph G-15**  
**Representative Vegetation Conditions at Phase I RAL exceedance area 5 (RM 2.7W)**

BUDA*	10	
				RUAR*	15	
				TAVU*	1	
				DACA*	5	
				PONI*	20	
				Middle of bank	Broken concrete, riprap	-
		Toe of bank	Sand, gravel, and fines	-	-	No vegetation
5 (6 and 8)	2.75W	Top of bank	Chain-link fence along downstream end; fill, pavement along entire surveyed portion	RUAR*	20	Previously restored area at top of bank along upstream portion of surveyed area that has
				ROPS*	10	
				PONI*	5	
				HEHE*	5

Phase I RAL Exceedance Area <sup>1</sup>	RM <sup>2</sup>	Location Along Bank	Substrate/Structure	Species	% of Cover <sup>3</sup>	Notes
				POCU*	5	several non-native species present throughout. Downstream portion has narrow vegetated area between industrial use and top of bank.
				ARSU	1	
				PSME	1	
				ALRU	5	
				TAVU*	1	
				SCAC	10	
				CAOB	10	
				PIGL	1	
				SASC	5	
		POBA	5			
		Middle of bank	Broken concrete columns, riprap, quarry spall, and creosote wood debris	PHYL	5	Algae along rocky substrate and debris
		Toe of bank	Sand and fines	-	-	No vegetation
20 North (24 North)	2.2W	Top of Bank	pavement, chain-link fence, concrete wall	RUAR*	80	Shoreline dominated by invasive species with other minimal vegetation
				HEHE*	5	
				Unknown grass	1	
				BUDA*	5	
				PICO	1	
				ARME	1	
				PEMA*	1	
				TYLA	1	
				SYCH	1	
				SOOL*	1	
		POBA	5			
				Middle of bank	Broken concrete, cobble	-
		Toe of bank	Sand, mud	-	-	No vegetation
