Map I-27. Stormwater drainage lines on the Jorgensen Forge facility and along the Boeing Plant 2/Jorgensen Forge boundary

Map I-28. Surface sediment and drainage basin information for the Boeing Isaacson/Central KCIA SCA

Map I-31. Surface sediment information for the Slip 6 SCA

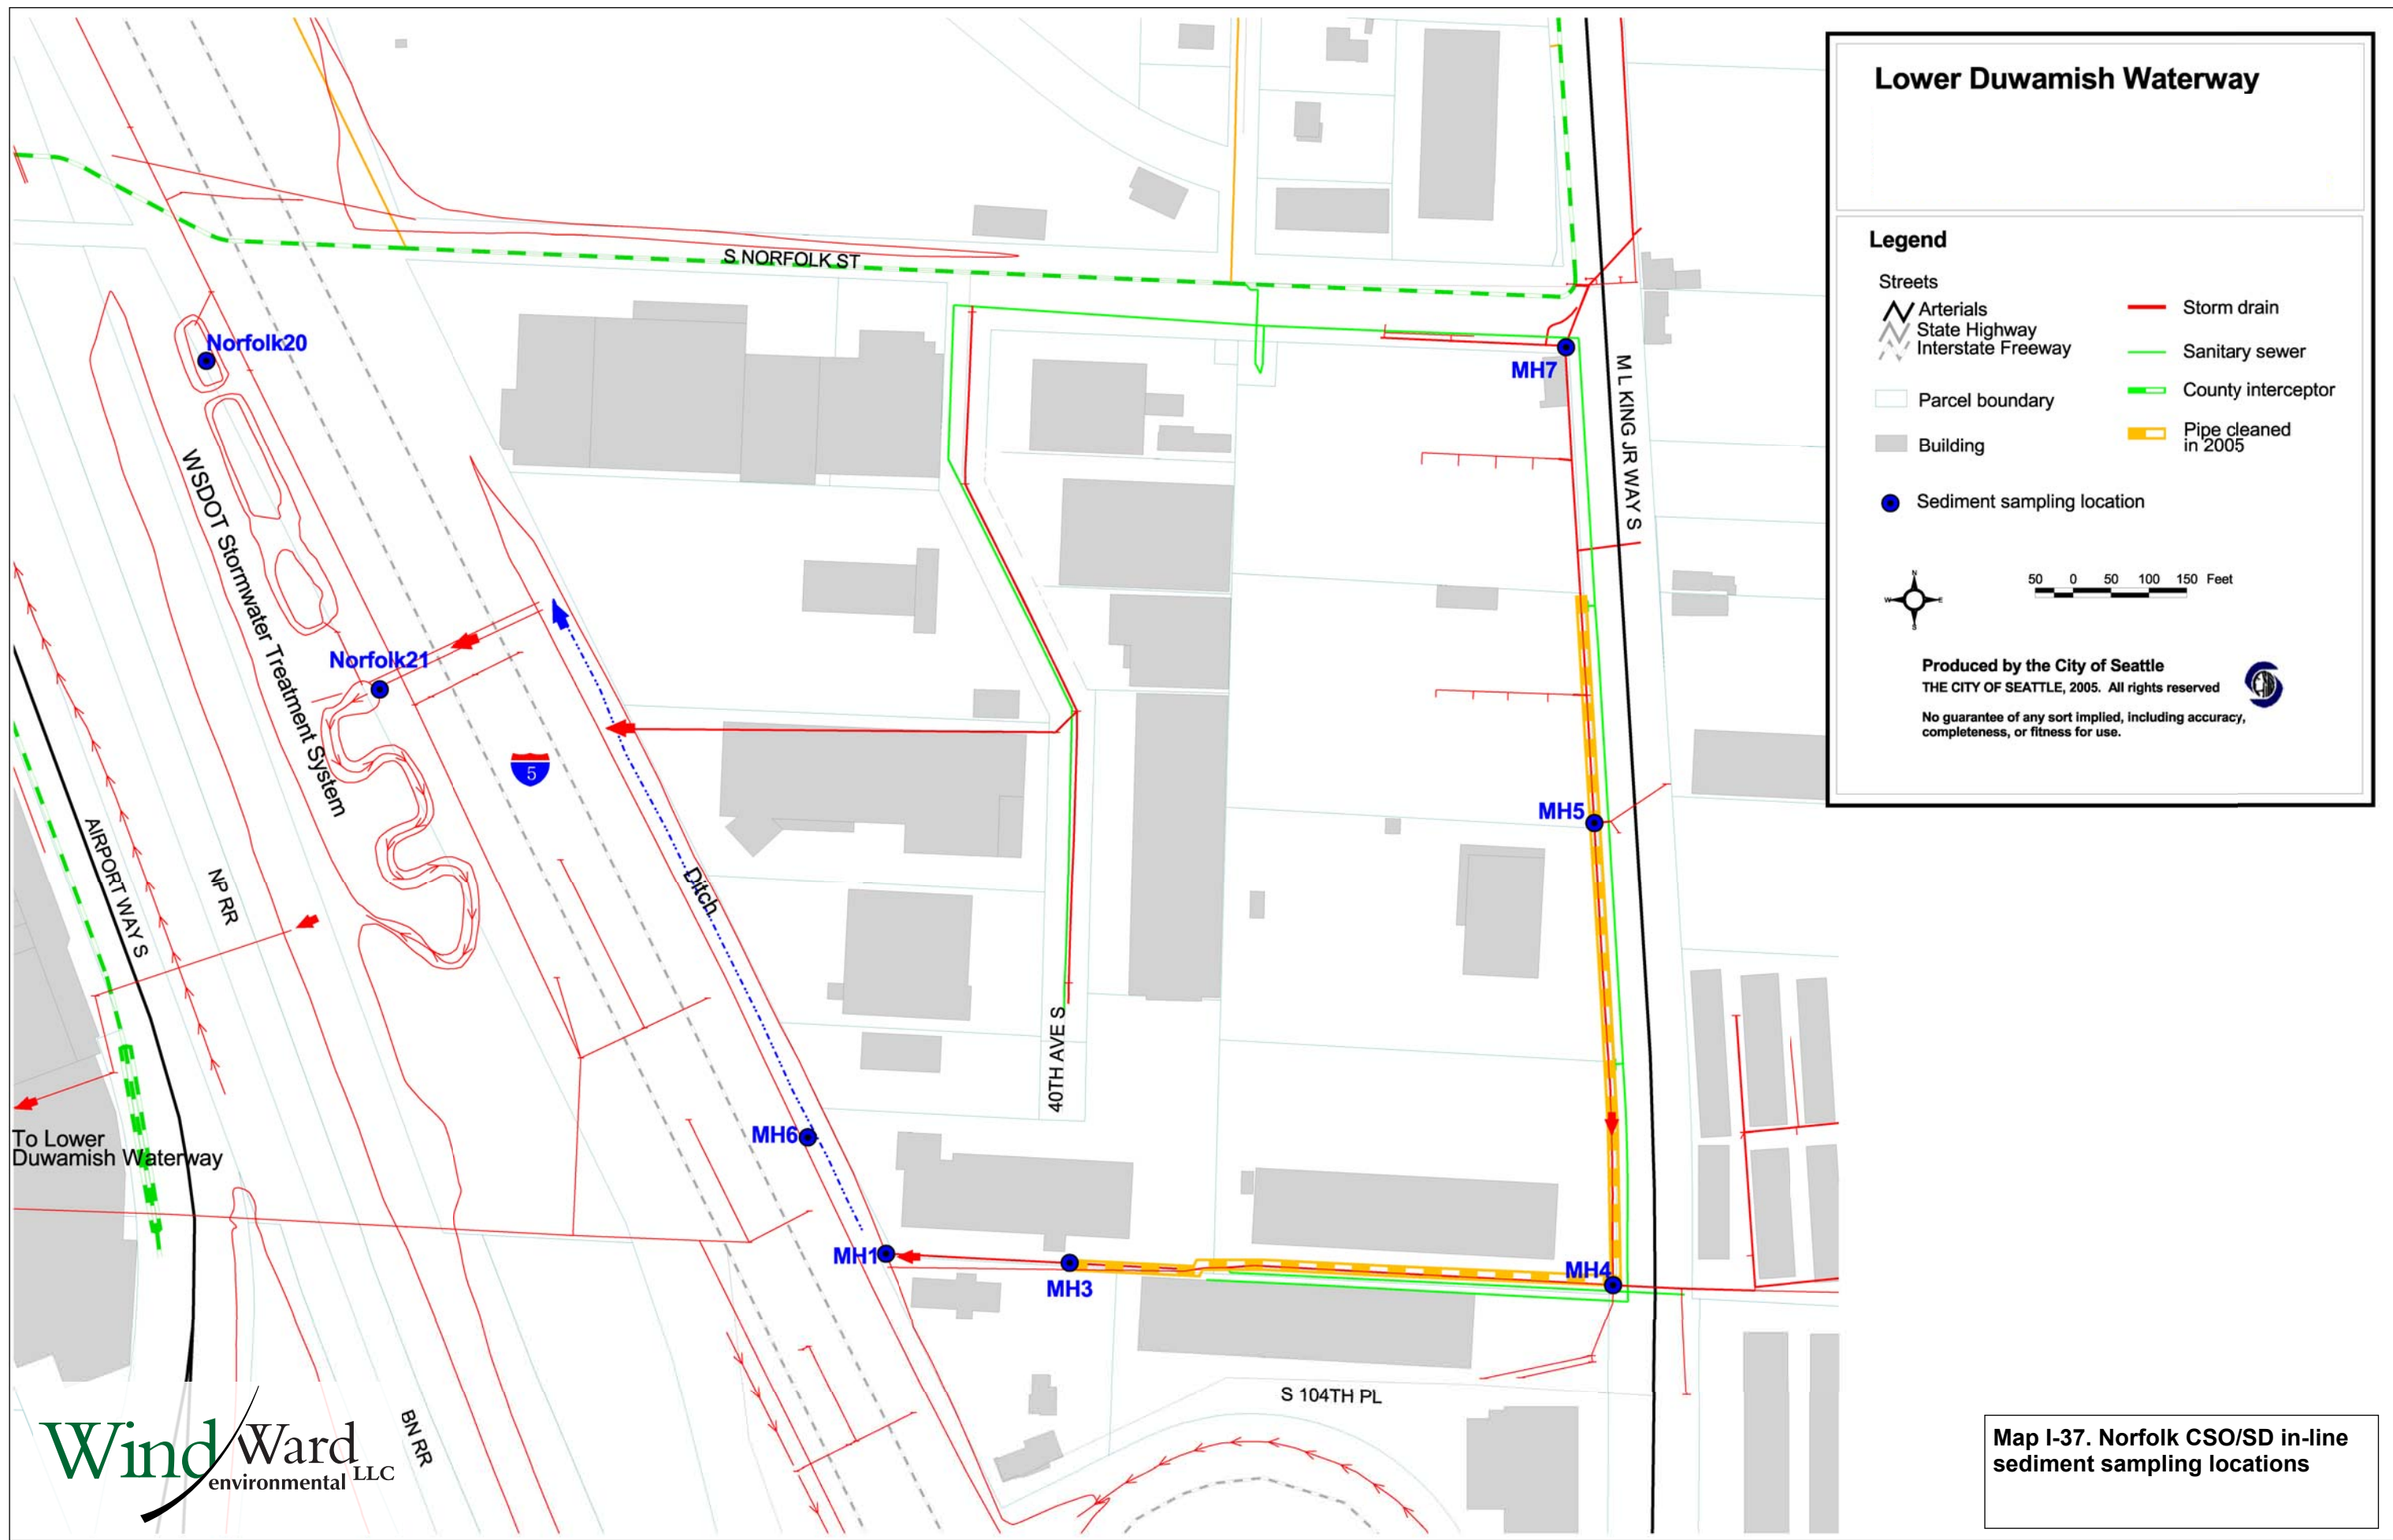
Map I-37. Norfolk CSO/SD in-line sediment sampling locations

Outfalls shown were identified during a City of Seattle low-tide survey in 2003 (Herrera 2004). Some locations were initially identified using drainage maps from Ecology's NPDES permit files and other relevant agency databases. These locations were later surveyed in the field. Review of agency files and interviews with agency and LDWG personnel provided additional outfall-specific information. Some locations were field-verified by LDWG members; some additional outfall locations were identified during these subsequent verifications. The outfall layer is meant to serve as a snapshot of outfall conditions at the time the survey was completed (2003).

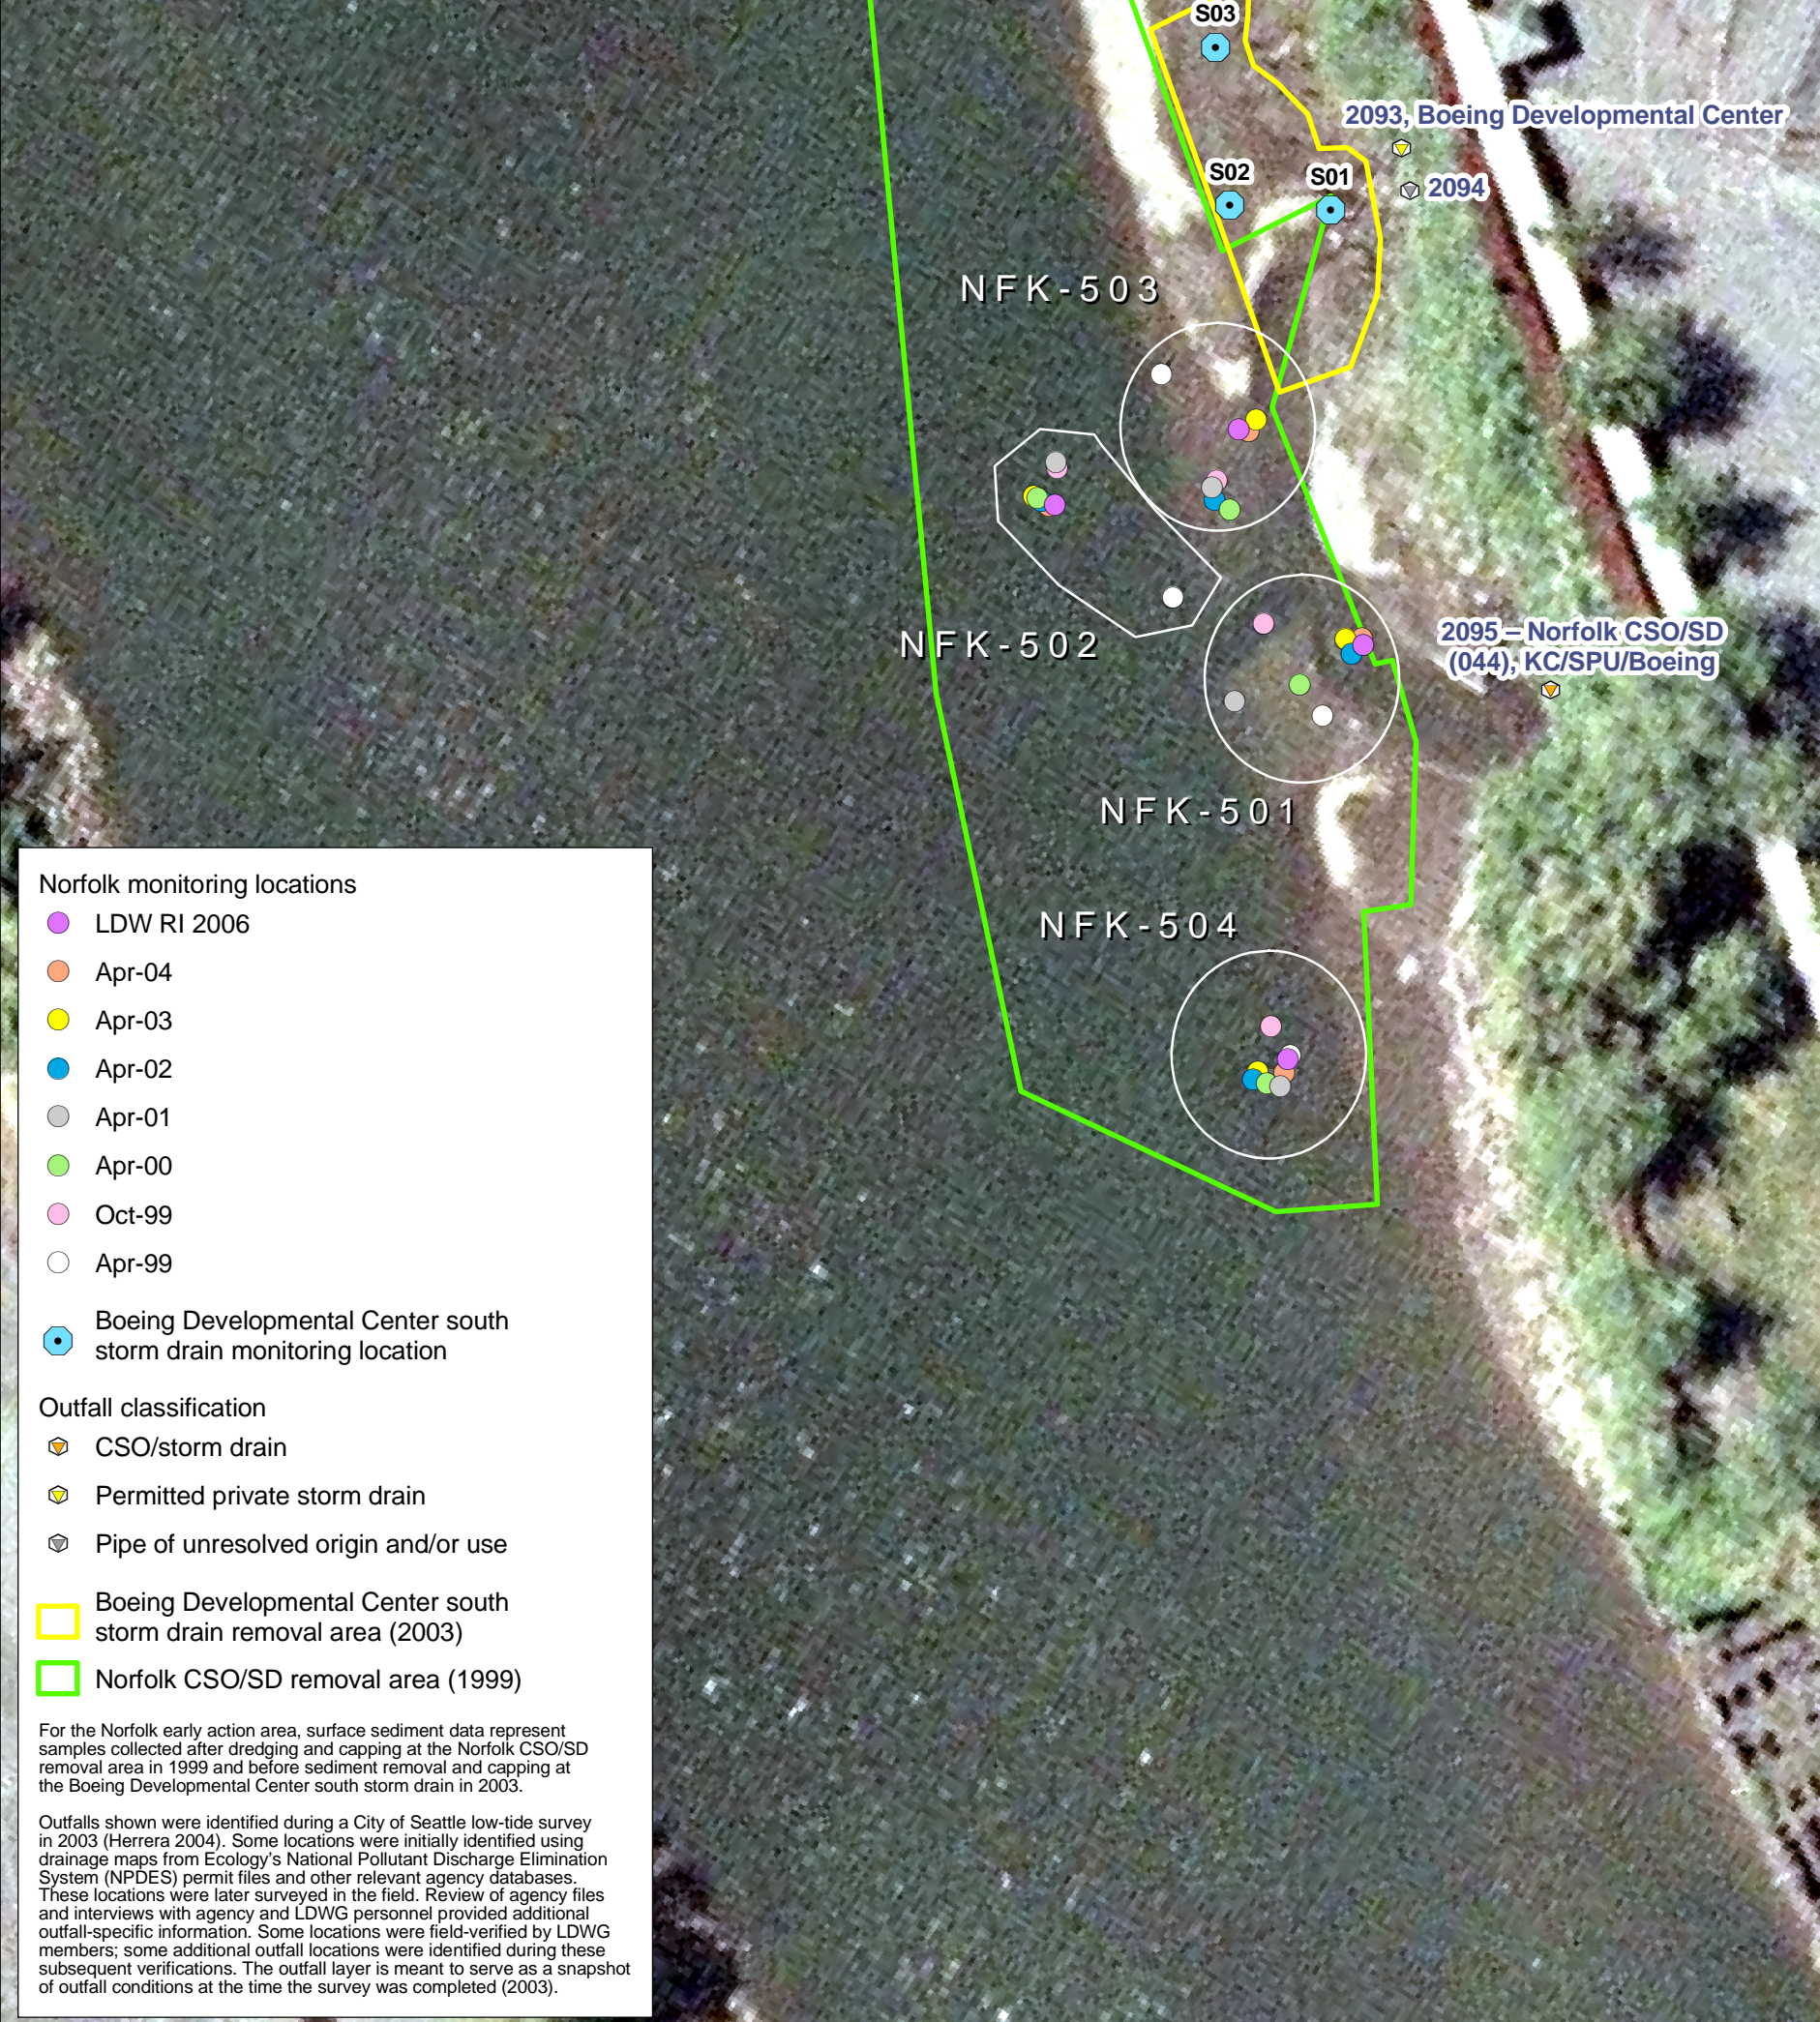
Map I-38. Surface sediment monitoring locations at Norfolk CSO/SD and Boeing Developmental Center South storm drain

Norfolk monitoring locations

- LDW RI 2006
- Apr-04
- Apr-03
- Apr-02
- Apr-01
- Apr-00
- Oct-99
- Apr-99
- Boeing Developmental Center south storm drain monitoring location

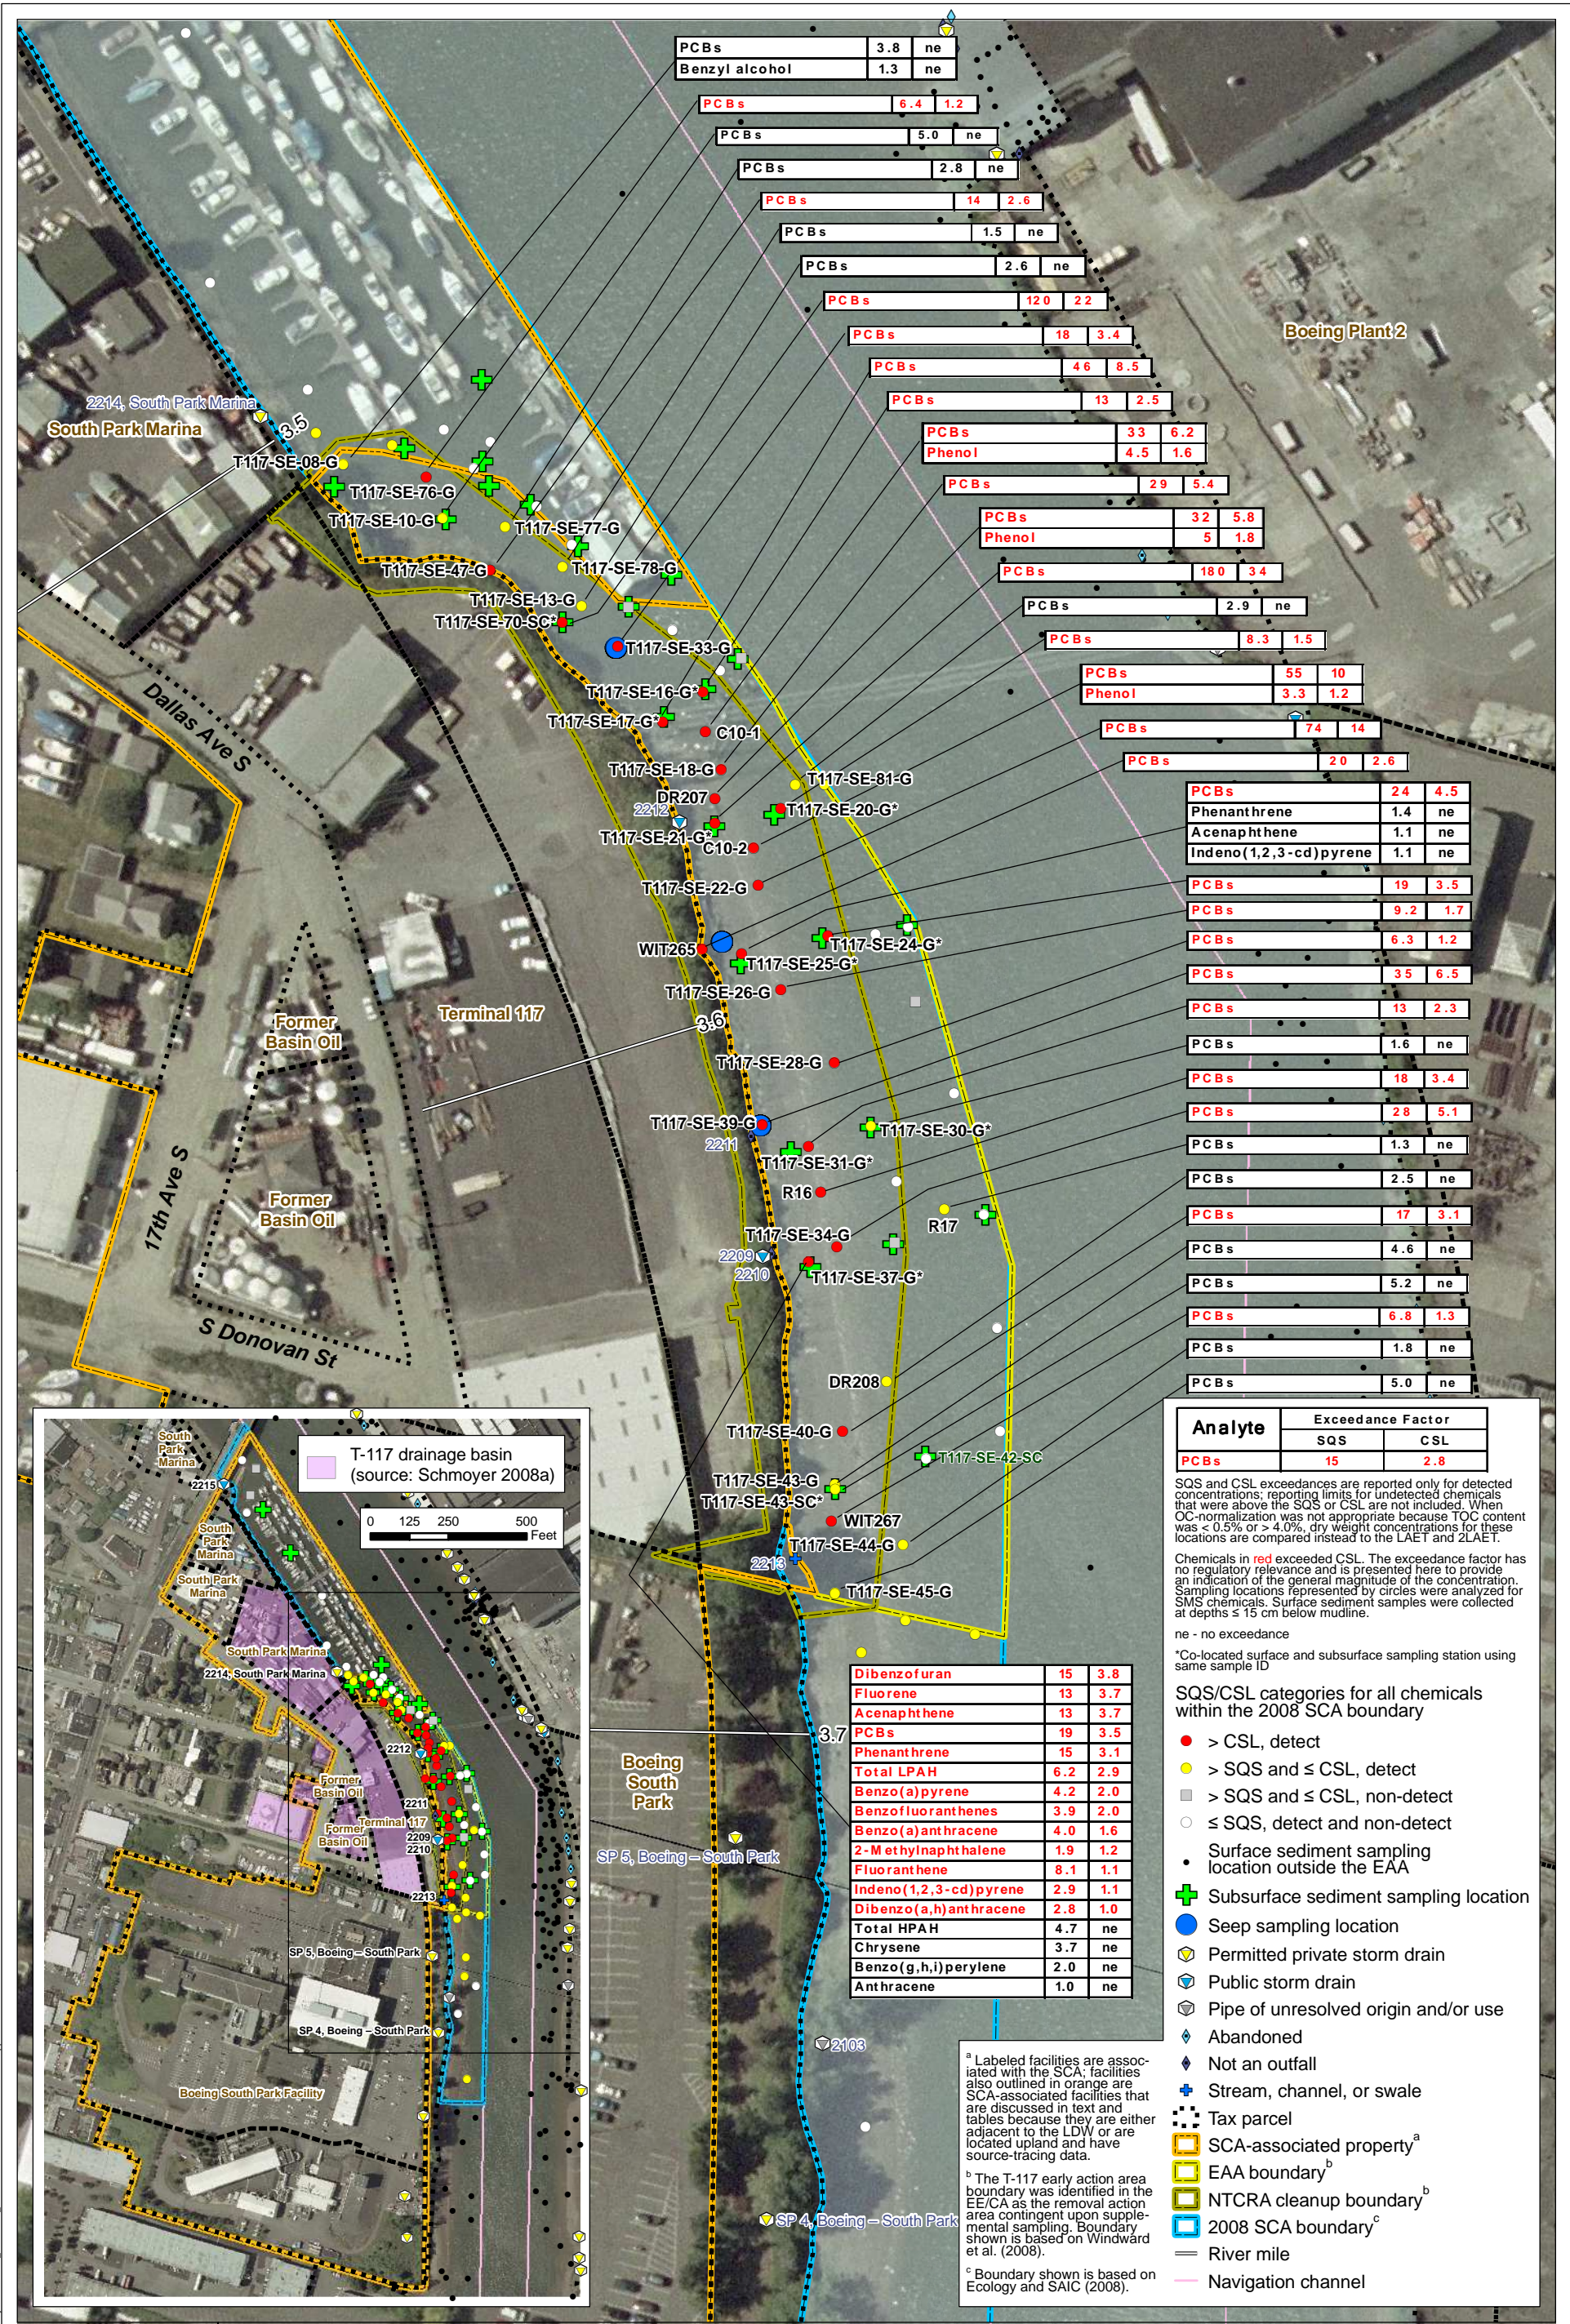
Map I-47. Surface sediment and drainage basin information for the T-117 SCA

PCBs	3.8	ne
Benzyl alcohol	1.3	ne

PCBs	6.4	1.2
------	-----	-----
