Lower Duwamish Waterway Group

TECHNICAL MEMORANDUM: LDW SANDPIPER PRESENCE AND HABITAT SURVEY RESULTS FINAL

August 27, 2004

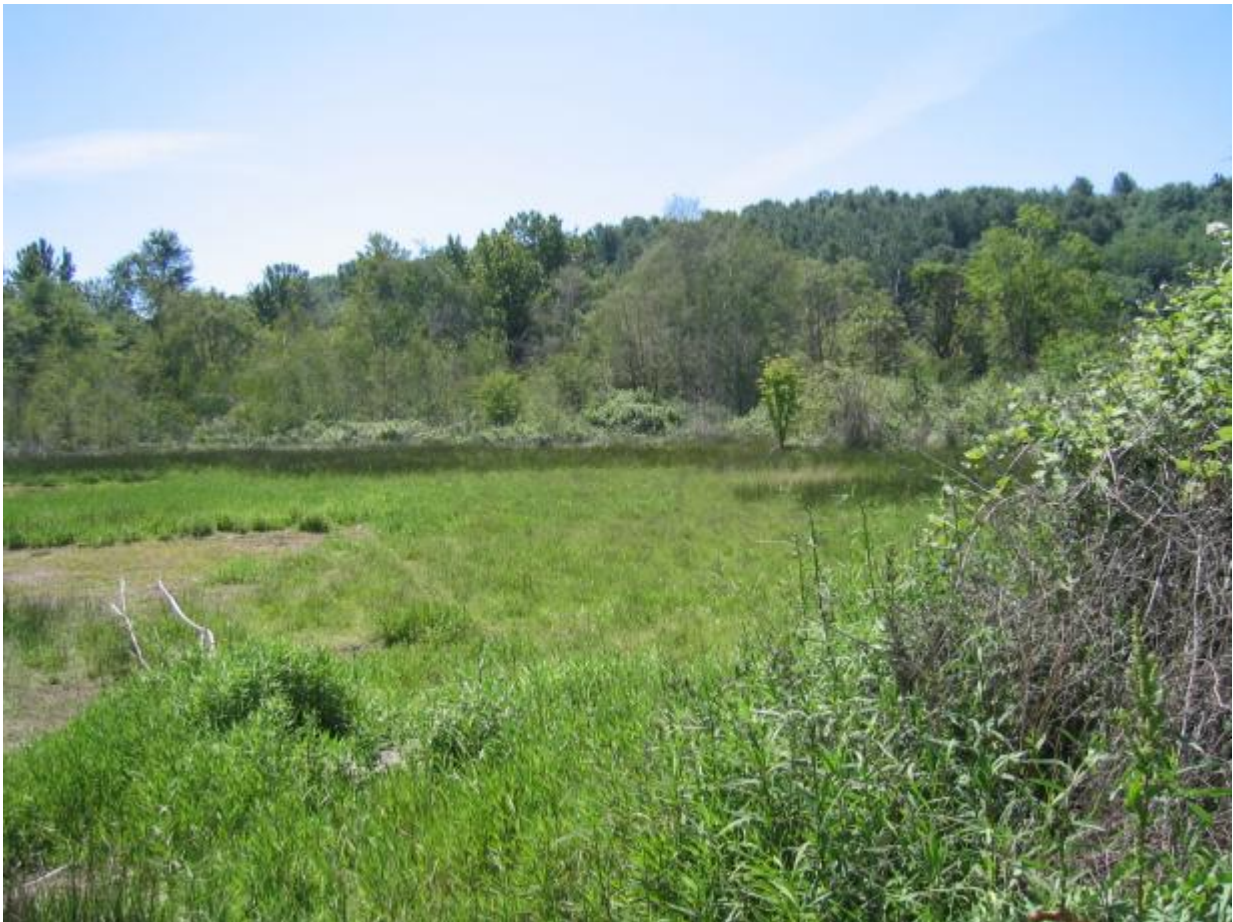
Figure 3-2. High quality nesting habitat on the northern end of Kellogg Island
(Photograph by Matthew Boyle)

The following areas were observed to have the best quality nesting habitat

- ◆ the fringe of saltmarsh on the north side of Kellogg Island (RM 0.7 to 0.9)
- ◆ the T-105 restored salmon rearing channel (western shoreline RM 0.4)
- ◆ the Herring's House restored off-channel emergent marsh (western shoreline RM 0.5)
- ◆ the channel beneath 1st Avenue South Bridge (western shoreline RM 2.1)
- ◆ the Hamm Creek restoration site (western shoreline RM 4.3)

- ◆ the western shoreline of Turning Basin 3 (RM 4.6 to RM 4.9).

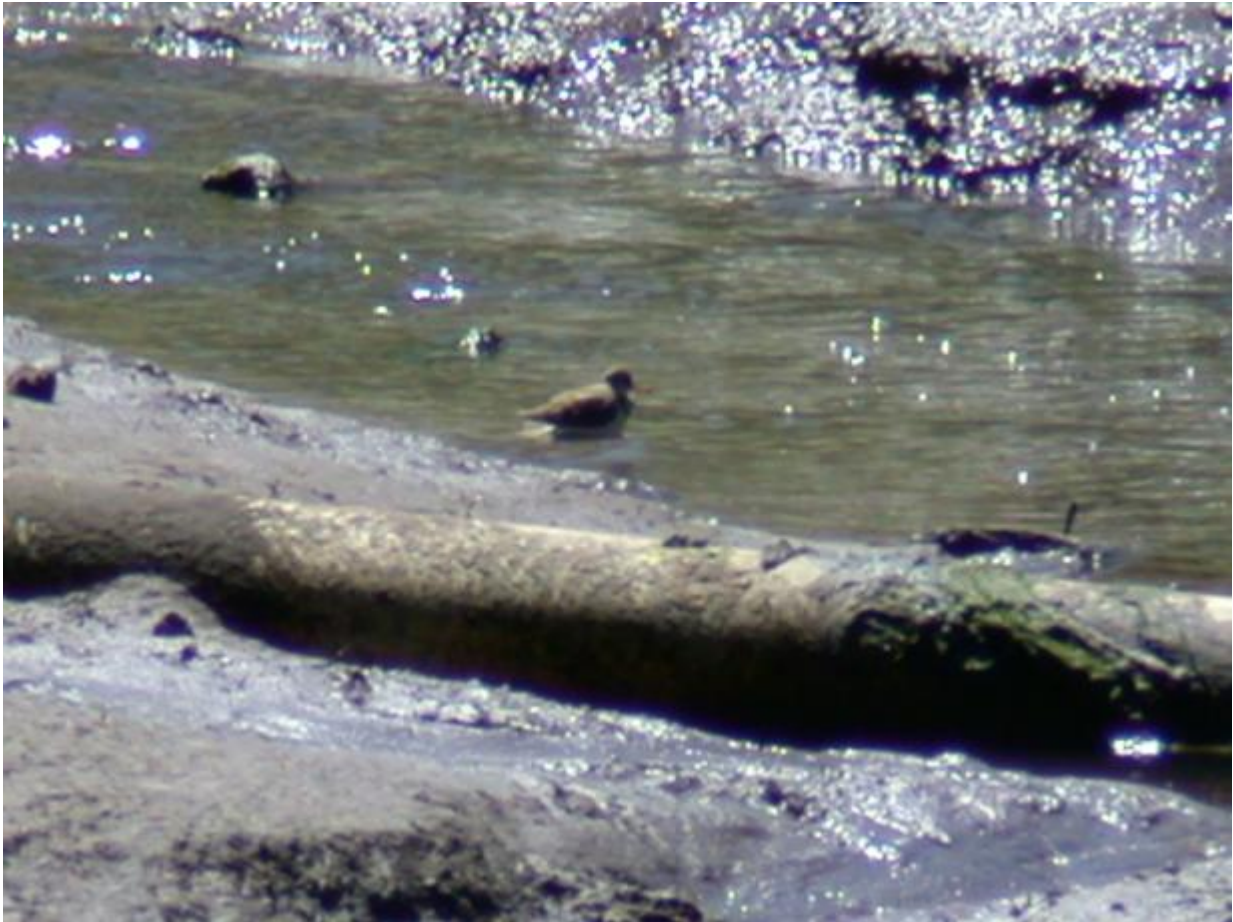
**Figure 3-4. Photograph of spotted sandpiper foraging in stream underneath
1st Avenue South bridge**

Figures 3-4 and 3-5 are photos of spotted sandpipers observed along the LDW under the 1st Avenue South Bridge, and at RM 2.3 on the western shoreline, respectively. Twenty-two of the 30 spotted sandpiper observations were of sandpipers foraging on either mudflats or saltmarshes within the intertidal zone. Three observations were of sandpipers foraging in saltmarsh away from the waterline, and two were in unspecified habitat away from the waterline. Two observations were audio only, and

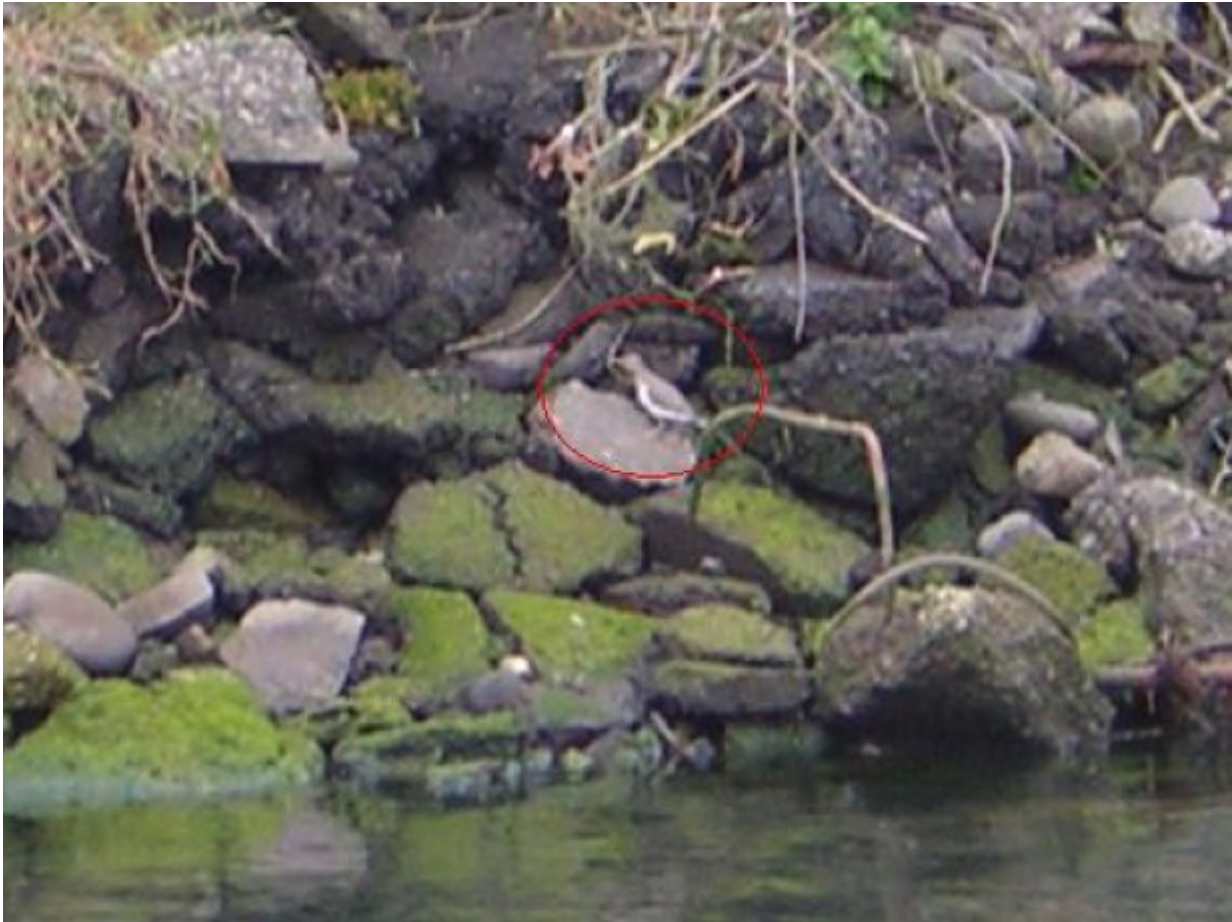
Figure 3-5. Photograph of spotted sandpiper foraging in riprap at RM 2.3
(Photograph by Windward)

one observation was of a flying sandpiper. Most sandpipers were observed near high quality nesting habitat identified in the habitat survey. The farthest distance that a sandpiper was observed from high quality nesting habitat was 0.53 miles. Consistent with the generally lower quality nesting habitat on the eastern shoreline (Figures 3-1a and 3-1b), fewer spotted sandpipers were observed on the eastern than the western shoreline of the LDW. However, no distraction displays or other indications of nesting were observed. The only observed difference in sandpiper sightings relative to tidal cycle was that sandpipers were observed foraging in riprap four separate times during high and medium tides, but none were observed foraging in riprap at low tide.

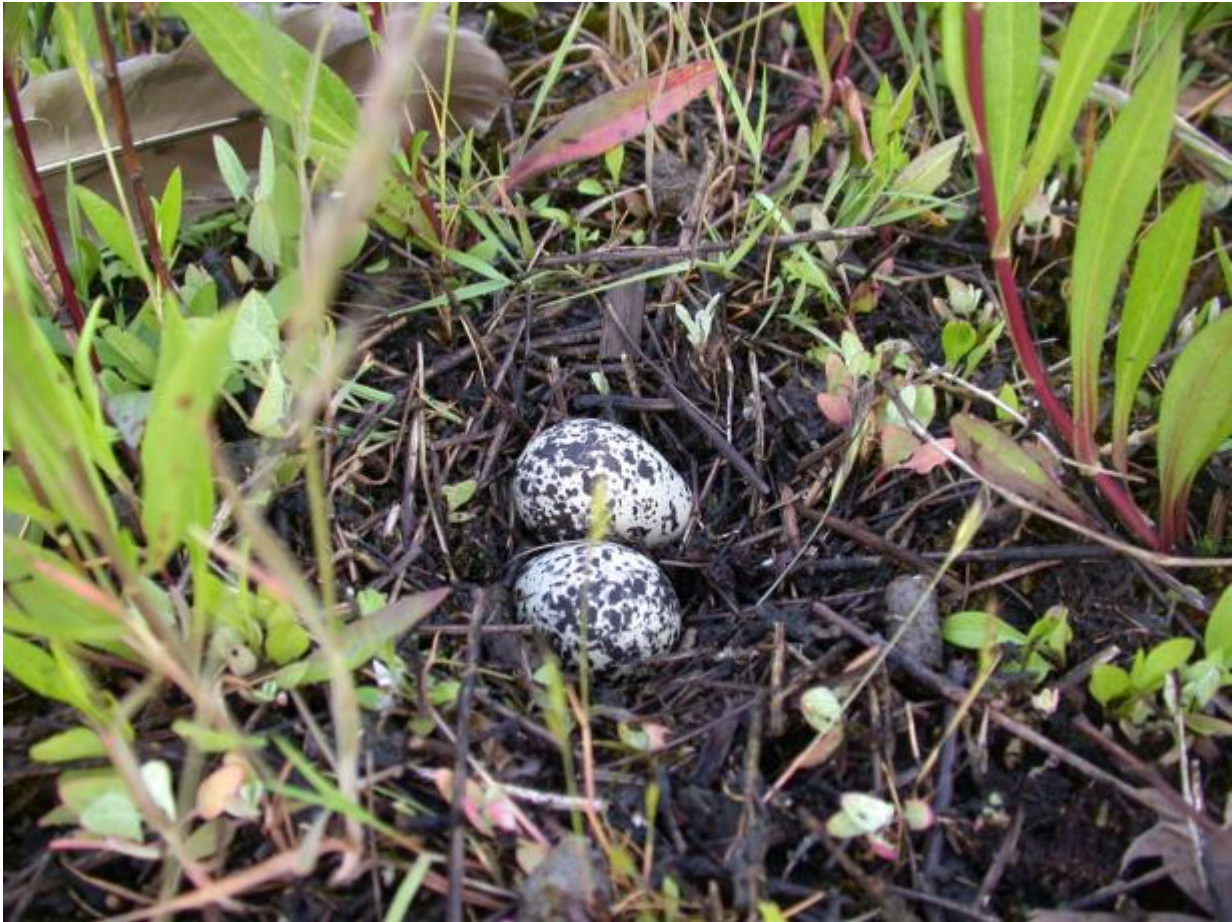
Figure 3-6. Photograph of a killdeer nest on Kellogg Island
(Photograph by Kevin Li)

The only shorebirds observed other than spotted sandpipers were killdeer (Figures 3-3a and 3-3b), which were observed 31 times (Table 3-4). Killdeer were observed in the same general locations as spotted sandpipers, but killdeer were more numerous, with as many as 10 individuals seen in a single observation on the northeast shoreline of Kellogg Island. Killdeer were confirmed to nest on Kellogg Island through observation of a killdeer leaving its nest (Figure 3-6). Killdeer were generally observed foraging near the water's edge. They were observed foraging exclusively on or near mudflats and in the tall saltmarsh on the northern end of Kellogg Island. Killdeer observations did not appear to be strongly influenced by tidal stage, although the most observations were June 4 during low tide (Table 3-4).
