**Owner:** King County

**Project:** Lower Duwamish Waterway ENR/AC Pilot

## Weekly Photo Log – LDW ENR/AC Pilot

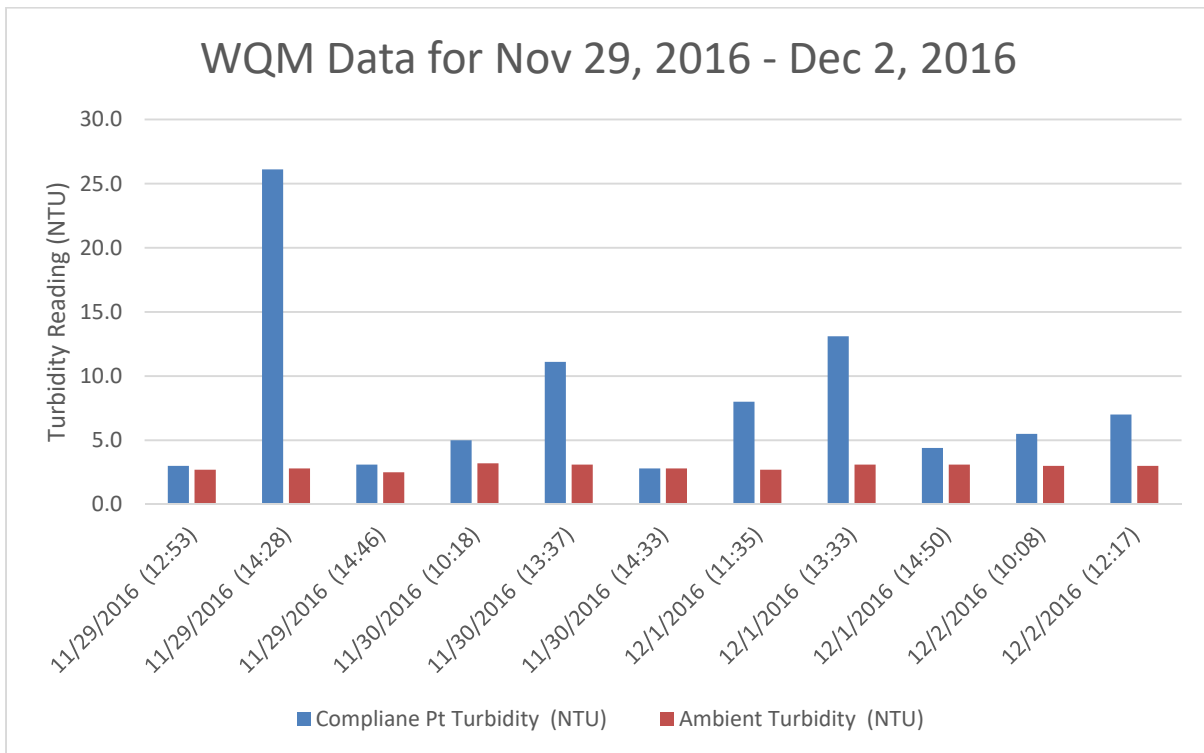
Figure 1: Water Quality Monitor Data Summary for Week Ending December 2, 2016

- Nov 29, 2016: Compliance point was 23.3 NTU above ambient during the 14:28 monitoring event. Placement had already stopped to relocate from the Sand + AC test plot to the Gravelly Sand + AC test plot when notification of exceedance was received.

- Nov 30, 2016: Compliance point was 8.0 NTU above ambient during the 13:37 monitoring event. Placement operations halted for ~28 minutes. Operations started again after WQM vessel verified that WQ was within allowable tolerances.

- Dec 1, 2016: Compliance point was 5.3 NTU above ambient during the 11:35 monitoring event. Placement operations halted for ~21 minutes. Operations started again after WQM vessel verified that WQ was within allowable tolerances.

- Dec 2, 2017: Compliance point was 10.0 NTU above ambient during the 13:33 monitoring event. Placement operations halted for ~68 minutes. Operations started again after WQM vessel verified that WQ was within allowable tolerances.

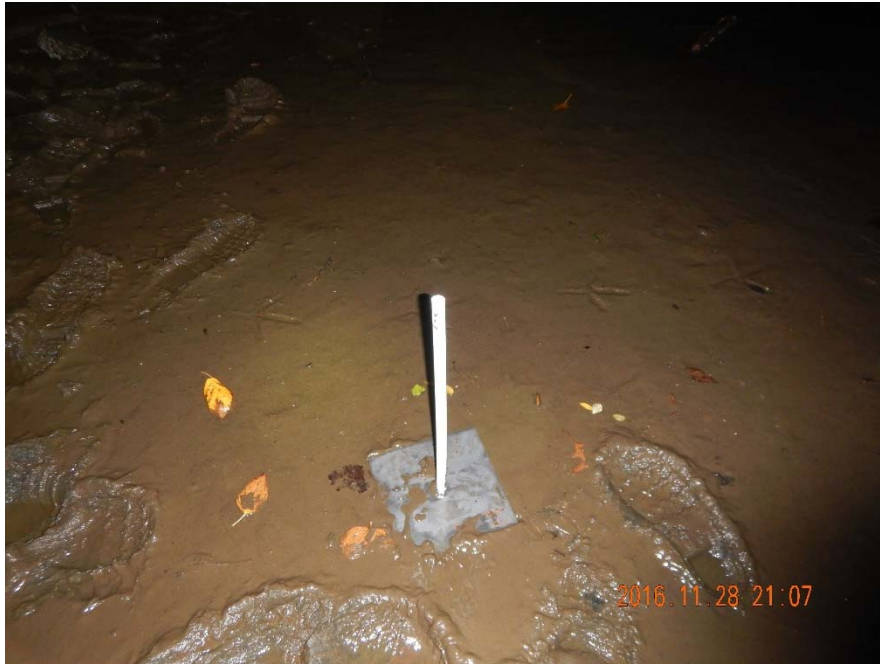
**Photo 1-A:** Example of a stake placed in the intertidal plot that will be used to measure the cap thickness. All stakes extended 18 inches above the mudline.

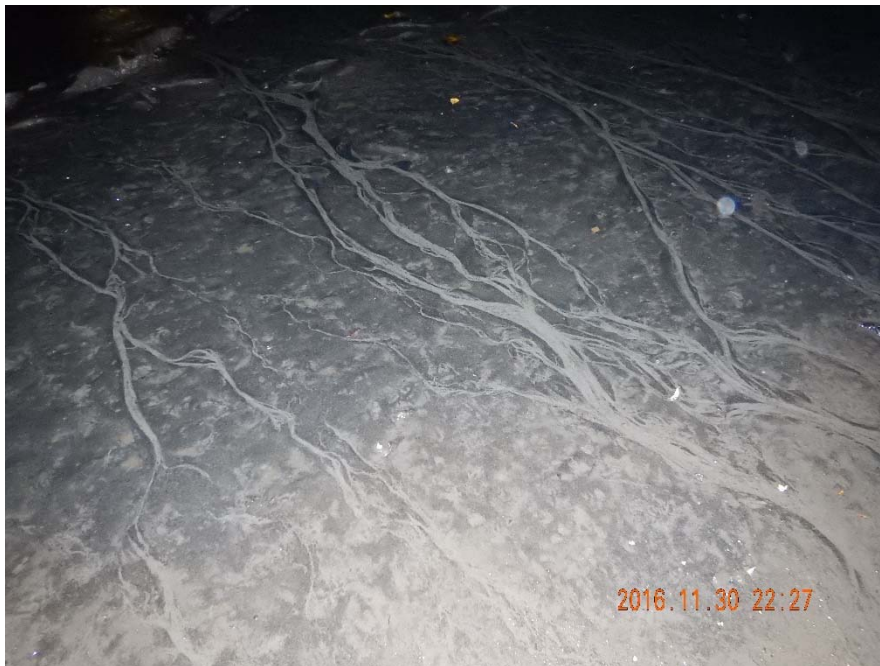
**Photo 1-B:** Activated carbon settled outside of the placement plot. This is approximately 15 feet outside of the placement area.

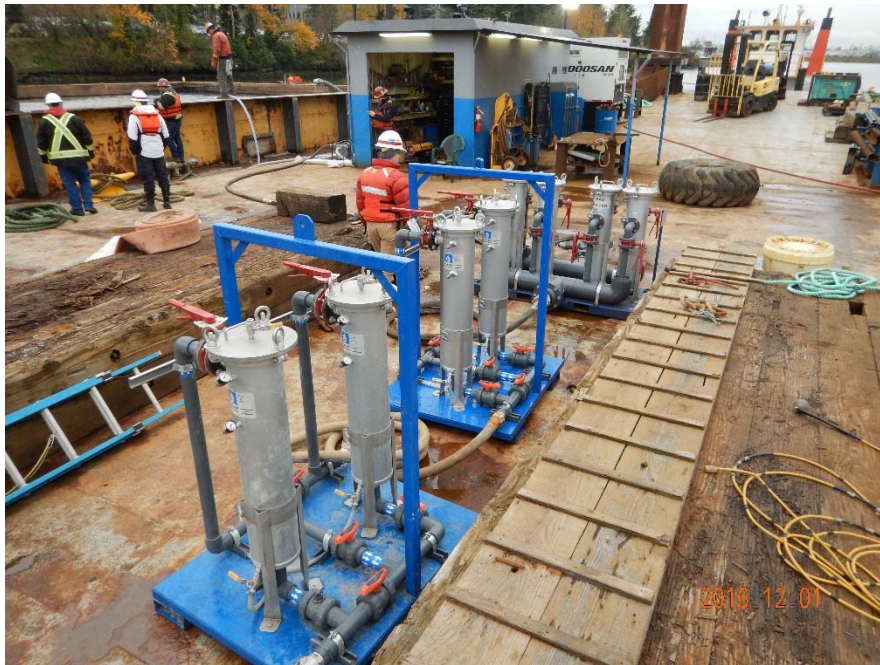
Problems Encountered	Date	Required Action	Date Completed
Turbidity plume while pumping out of the barge.	11/30/2016	Replace 25 micron filter in filters with 1 micron filters. Recycle water back into barge before discharging in the river.	12/1/2016

**Photo 2-A:** The bag filter system used for barge water filtration. The four furthest filters had 25 micron bag filters initially but were replaced with 1 micron filters after a turbidity plume was observed during barge pumping.

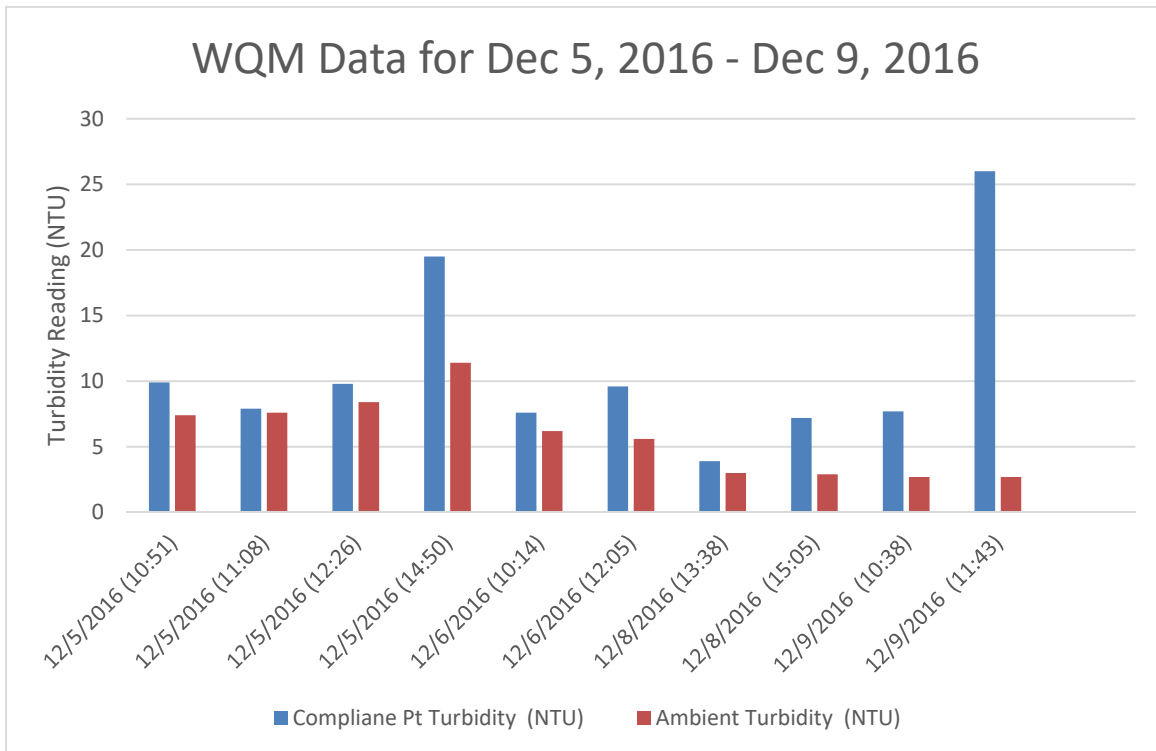
*Figure 1: Water Quality Monitor Data Summary for Week Ending December 9, 2016*

- Observed non-construction-related events that impacted water quality.
  - None
- Summary of water quality criteria violations and actions taken.
  - Dec 5, 2016: Compliance point was 8.1 NTU above ambient during the 14:50 monitoring event. Placement operations halted for ~14 minutes. Operations started again after WQM vessel verified that WQ was within allowable tolerances.

- Dec 9, 2016: Compliance point was 5.0 NTU above ambient during the 10:38 monitoring event. Placement operations halted for ~13 minutes to move the barge and while waiting for waiting for other marine traffic to clear the area. Operations started again after WQM vessel verified that WQ was within allowable tolerances.

- Dec 19, 2016: Compliance point was 5.3 NTU above ambient during the 11:43 monitoring event. Placement operations halted for ~48 minutes. Operations started again after WQM vessel verified that WQ was within allowable tolerances.

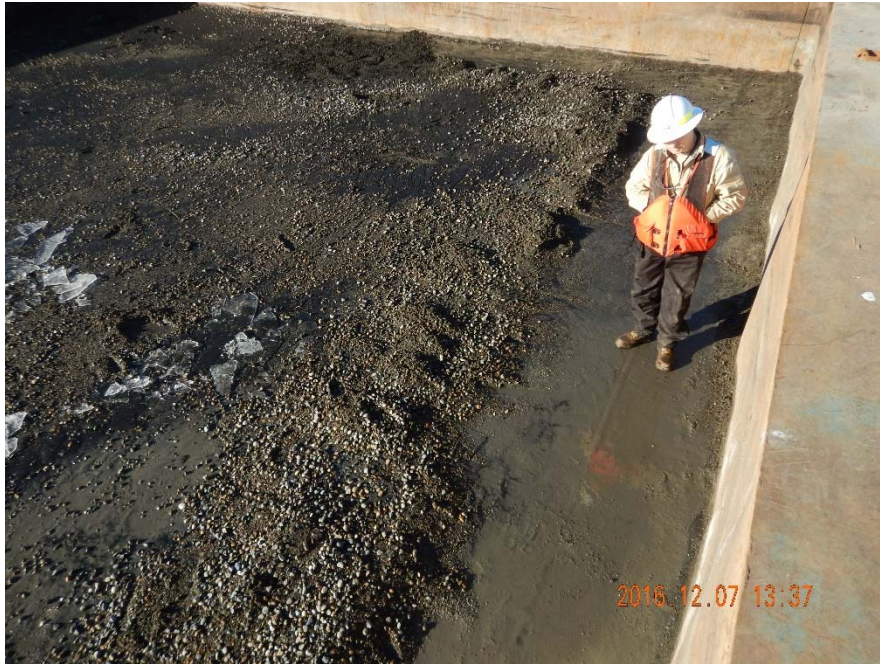
**Photo 1-A:** KC Rep visually inspects remaining Gravelly Sand + AC in the KP-2 barge.

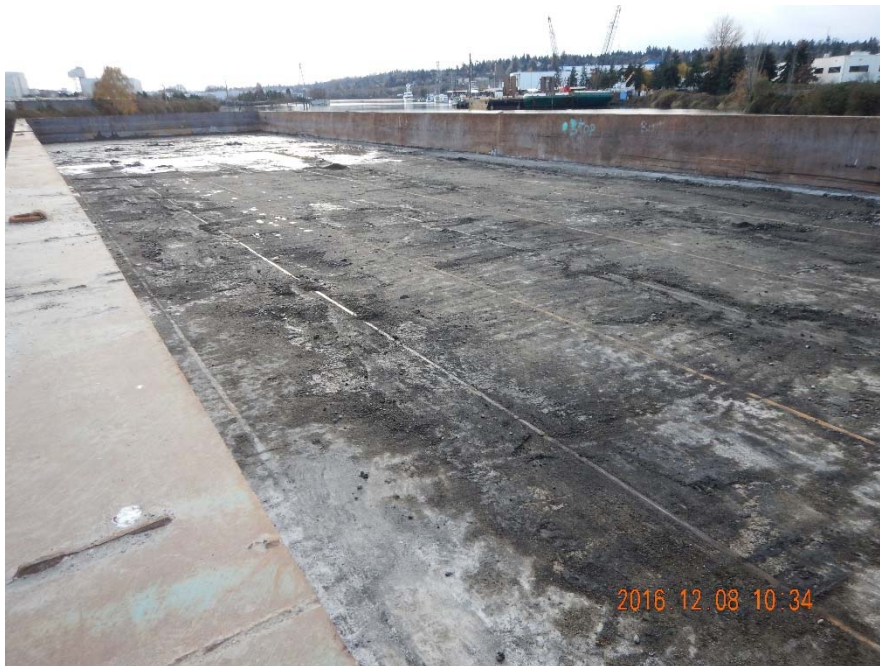
**Photo 1-B:** KP-2 material barge after all of the Gravelly Sand + AC was placed.

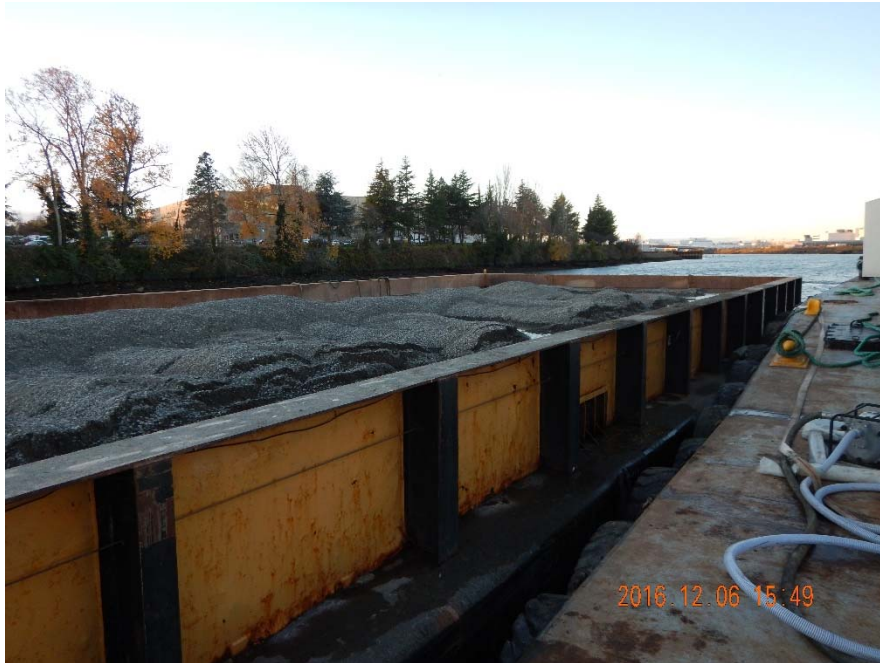
**Photo 2-A:** KP-3 material barge arrives on-site with Gravelly Sand. The excavator knocked down the wind rows prior to soaking.

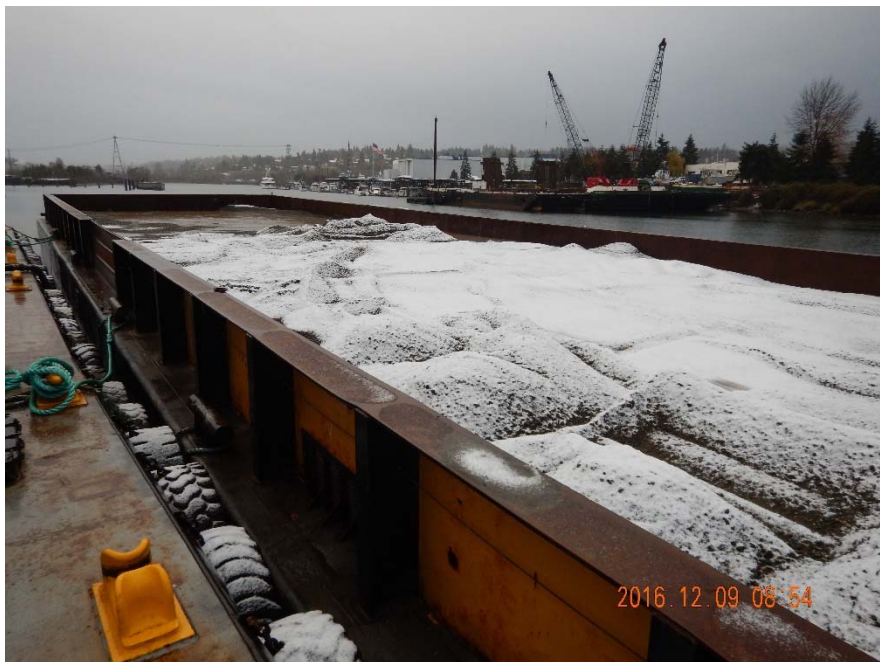
**Photo 2-B:** Overnight snow covered the exposed gravelly sand in the KP-3 materials barge. Weather conditions did not impact operations.

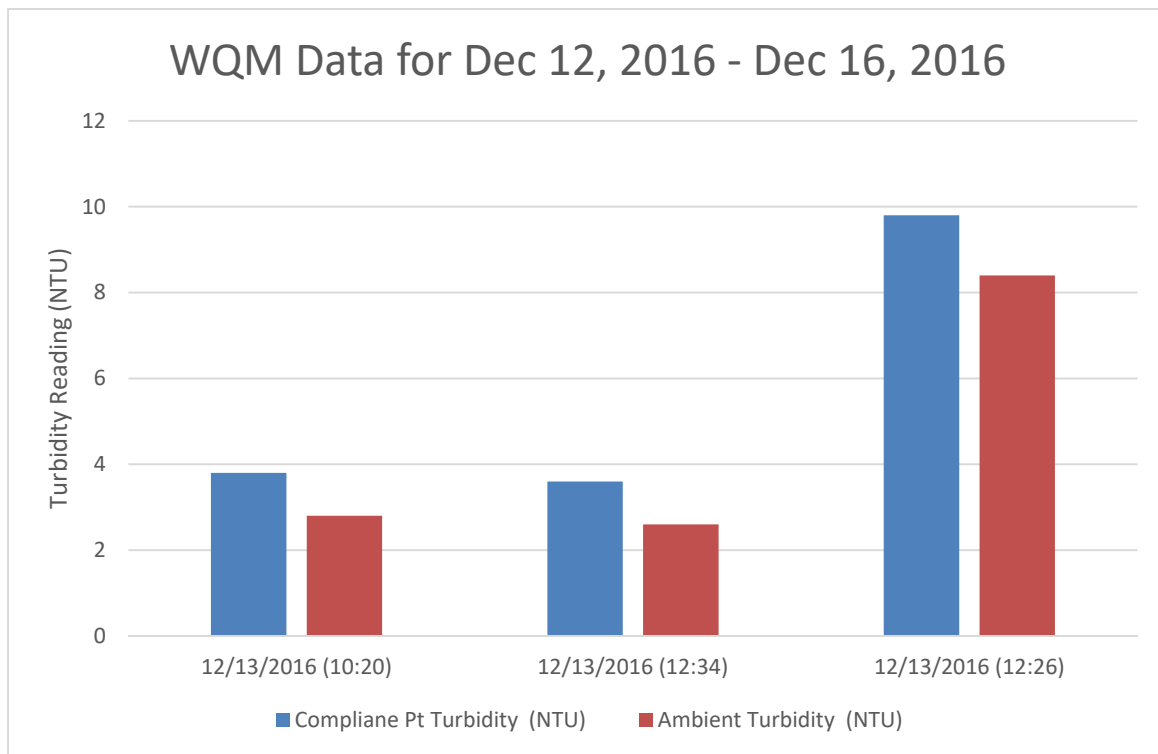
*Figure 1: Water Quality Monitor Data Summary for Week Ending December 16, 2016*

- Observed non-construction-related events that impacted water quality.
  - None
- Summary of water quality criteria violations and actions taken.
  - No exceedances observed.

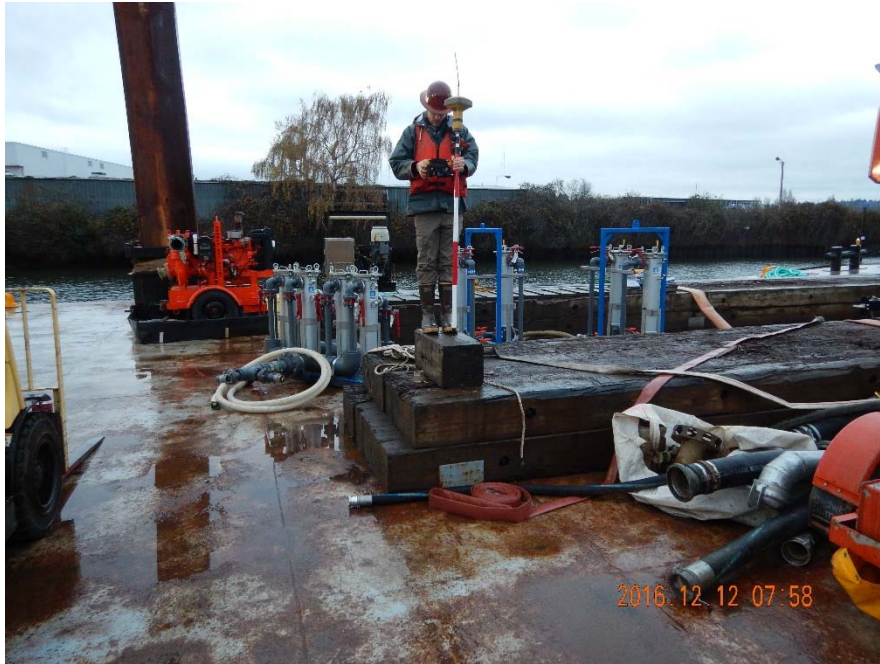
**Photo 1-A:** PPM field engineer performing bucket calibration check.

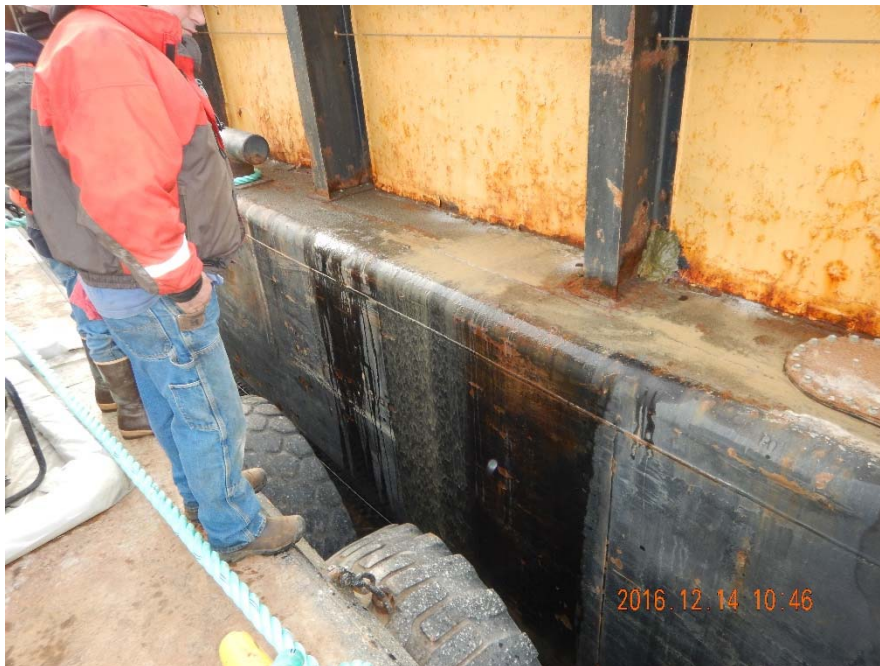
Problems Encountered	Date	Required Action	Date Completed
The excavators alternator failed and had to be replaced.	12/12/2016	Replaced alternator	12/12/2016
KP-3 barge leaking turbid water. Turbid leaks have only been observed after material at the base of the bin wall has been removed.	12/14/2016, 12/15/2016	PPM will continue to monitor for leaks. Leaks were and will continue to be plugged immediately after being observed.	12/14/2016, 12/15/2016
Ran out of GS before finishing subplot. This is related to the out of spec condition detailed below.	12/15/2016	Ordered additional 200 tons material loaded when scour plot GS was loaded.	12/15/2016

**Photo 1-B:** Leak observed mid-barge after the material at the base of the bin wall was removed.

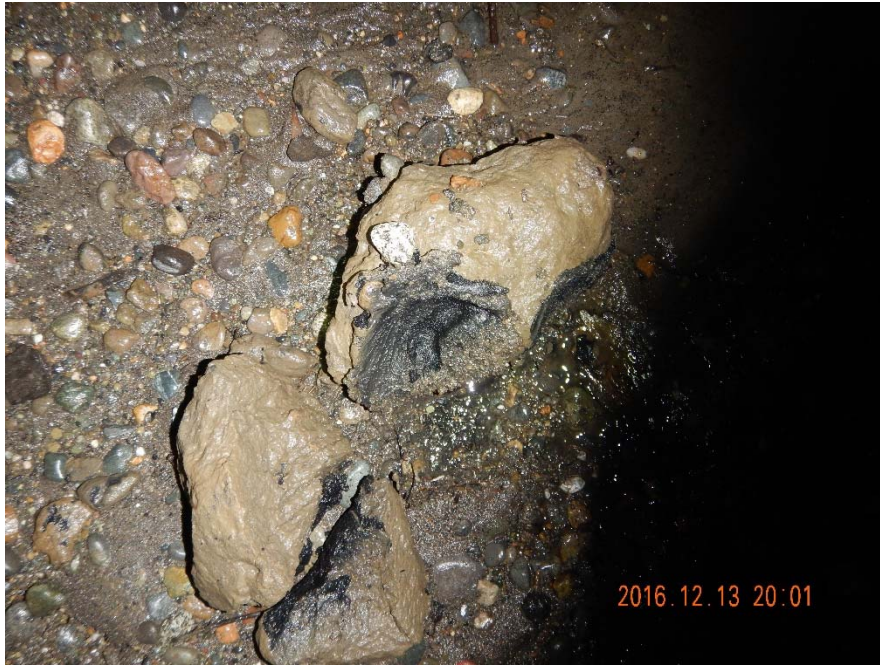
- Surveying (Performed at the end of each shift. Attached is the Dec 15, 2016 survey)
  - Monitoring Activities:
    - DOF and AMECFW representatives performed a visual inspection and grade stake measurement during the evening low tides that occurred on Dec 13<sup>th</sup> and Dec 15<sup>th</sup>.  
During the visual inspection objects thought to be rocks greater than 2 inches in diameter up to approximately 6 inches in diameter were observed on and upstream of the GS+AC subplot. After further investigation it was determined that these objects were not rock but were comprised of blackish, soft, fine to medium grained material. These objects may be comprised of AC and fine silts. See Photos 2-A and 2-B showing observed objects.

**Photo 2-A:** Rock shaped object observed in the GS+AC subplot.

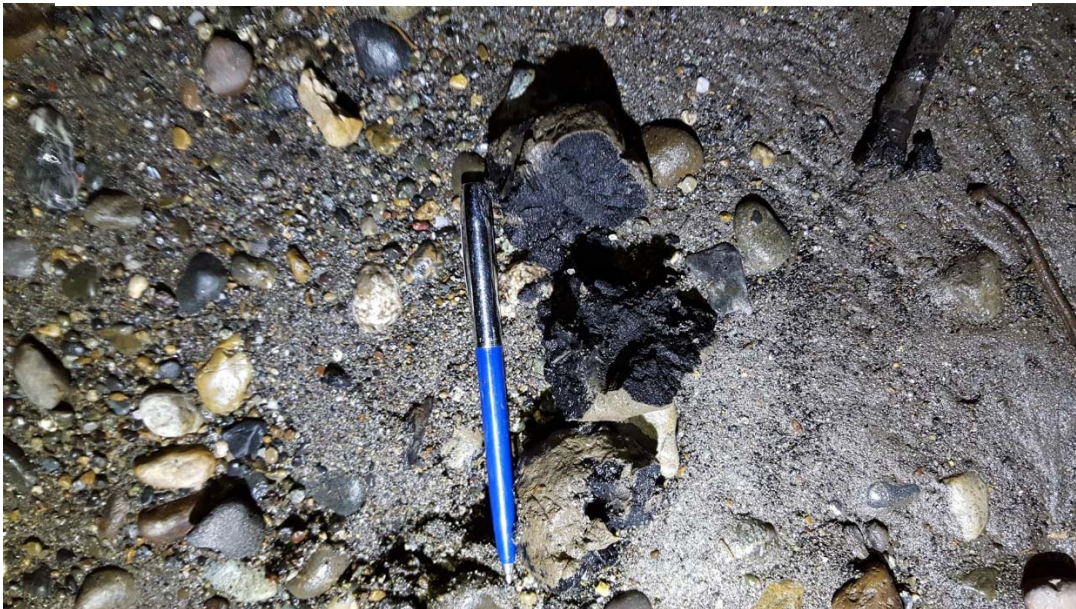
**Photo 2-B:** Rock shaped object split in half.
