Owner: King County

Project: Lower Duwamish Waterway ENR/AC Pilot

Dates: January 9, 2017 to January 13, 2017

ENHANCED NATURAL RECOVERY
 ACTIVATED CARBON PILOT STUDY
 DUWAMISH WATERWAY
 CONTRACT # C00992C15

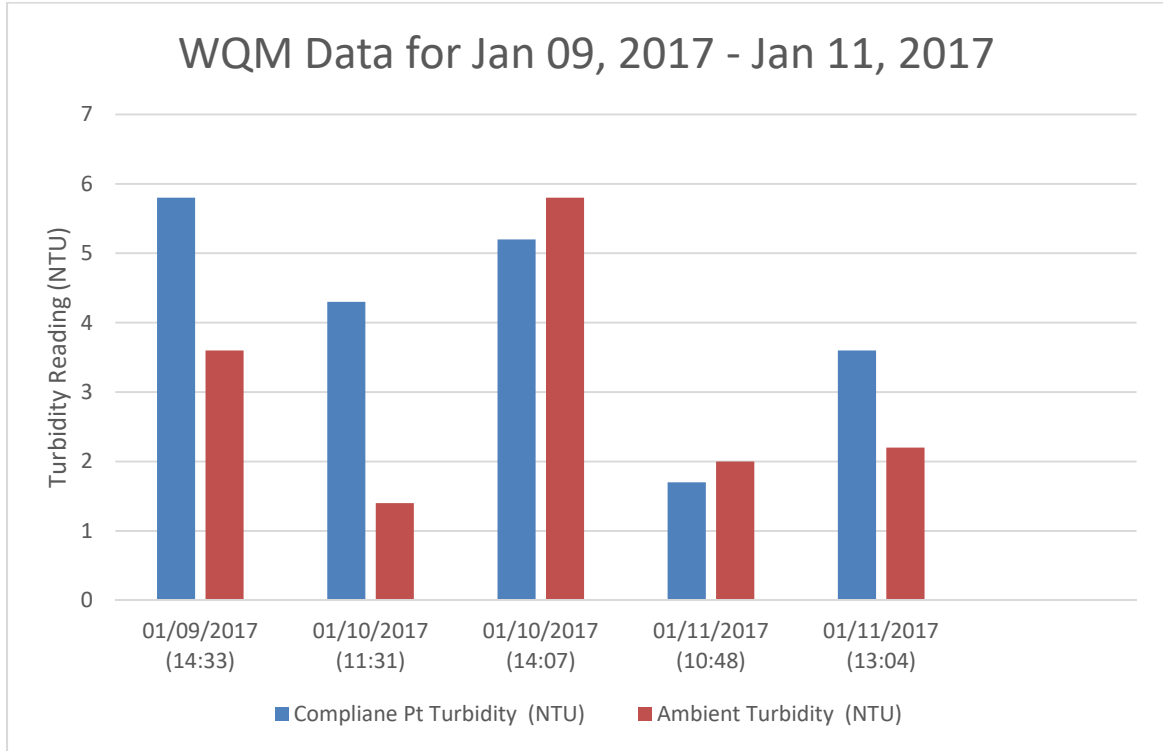
- No exceedances at the 150 or 300 foot compliance points to report during the 5 monitoring events that took place during the week. The table below summarizes the WQM data.

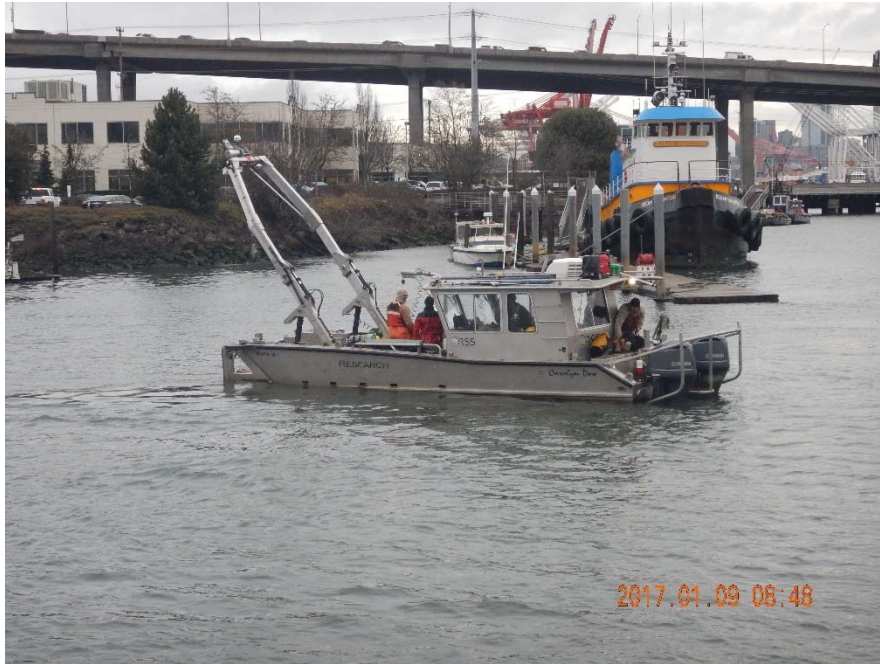
Photo 1-A: RSS dive boat prepping to perform post placement stake measurements.

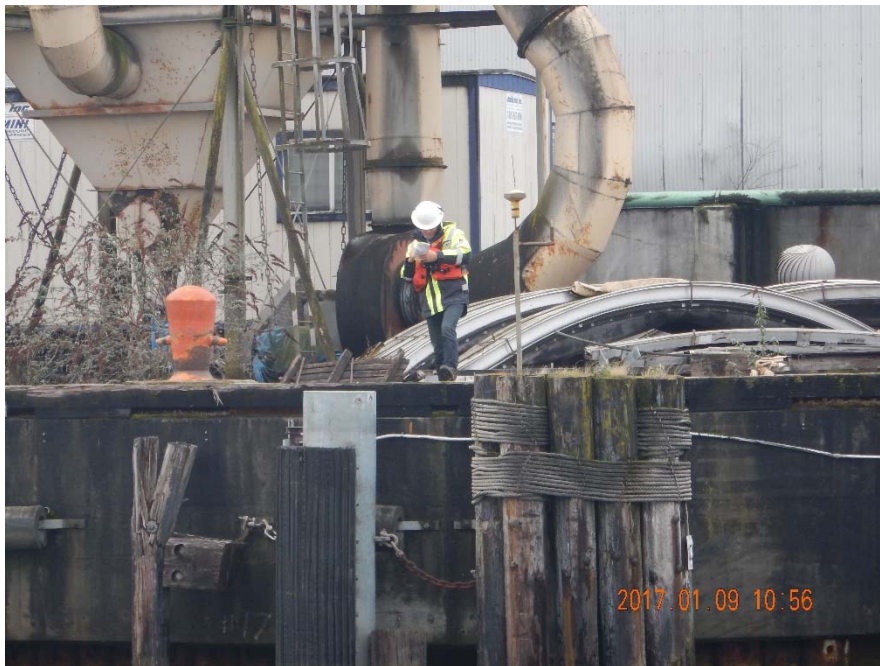
Photo 1-B: Terrasond representative establishing RTK GPS base station at Lafarge dock prior to placement activities at the Sub-tidal plot.

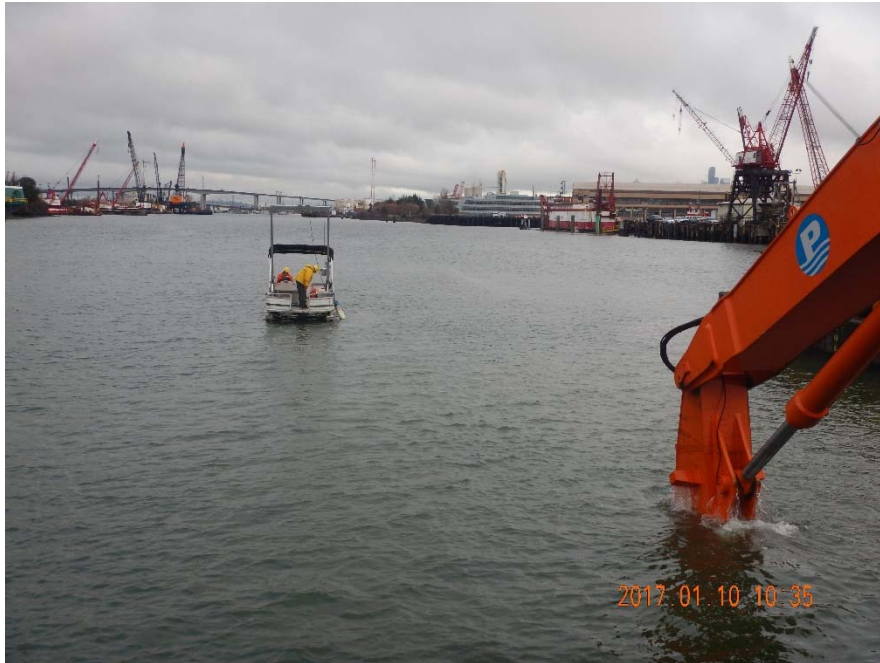
Photo 2-A: AMECFW performing WQM downstream of placement activities at the Sub-tidal plot.

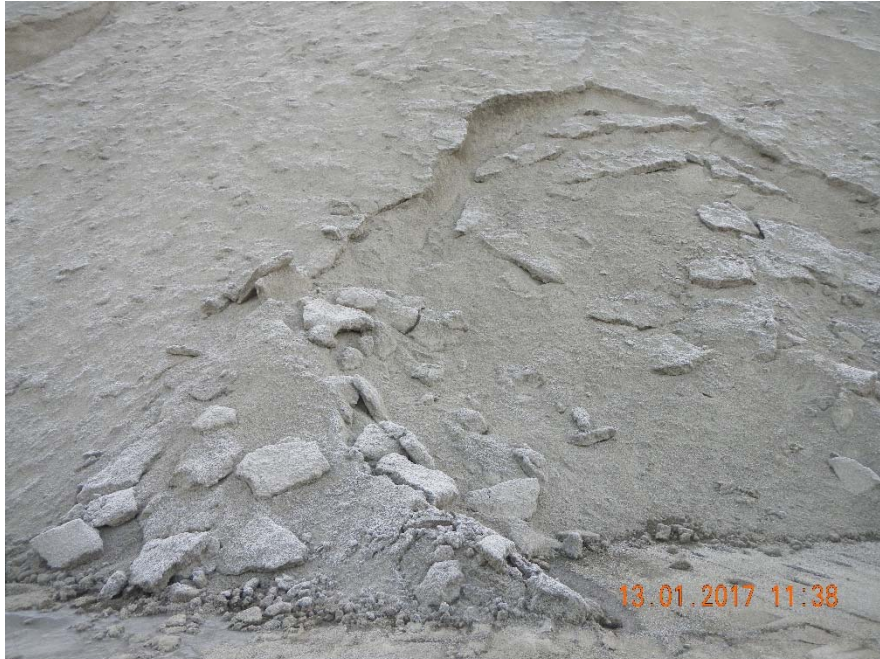
Photo 2-A: Sand ENR stockpile at the Cal-Portland's Dupont facility. Note the blocks of frozen sand. These blocks of frozen sand made loading difficult.

Problems Encountered	Date	Required Action	Date Completed
Frozen blocks of sand at the Cal-Portland Dupont facility made loading of the KP-3 more difficult. The freezing conditions increased the loading time from approximate 1 hour to more than 3 hours.	01/13/2017	No action required. Freezing conditions only increased the time it took to load the barge. If sand was to be amended with AC it would be difficult to

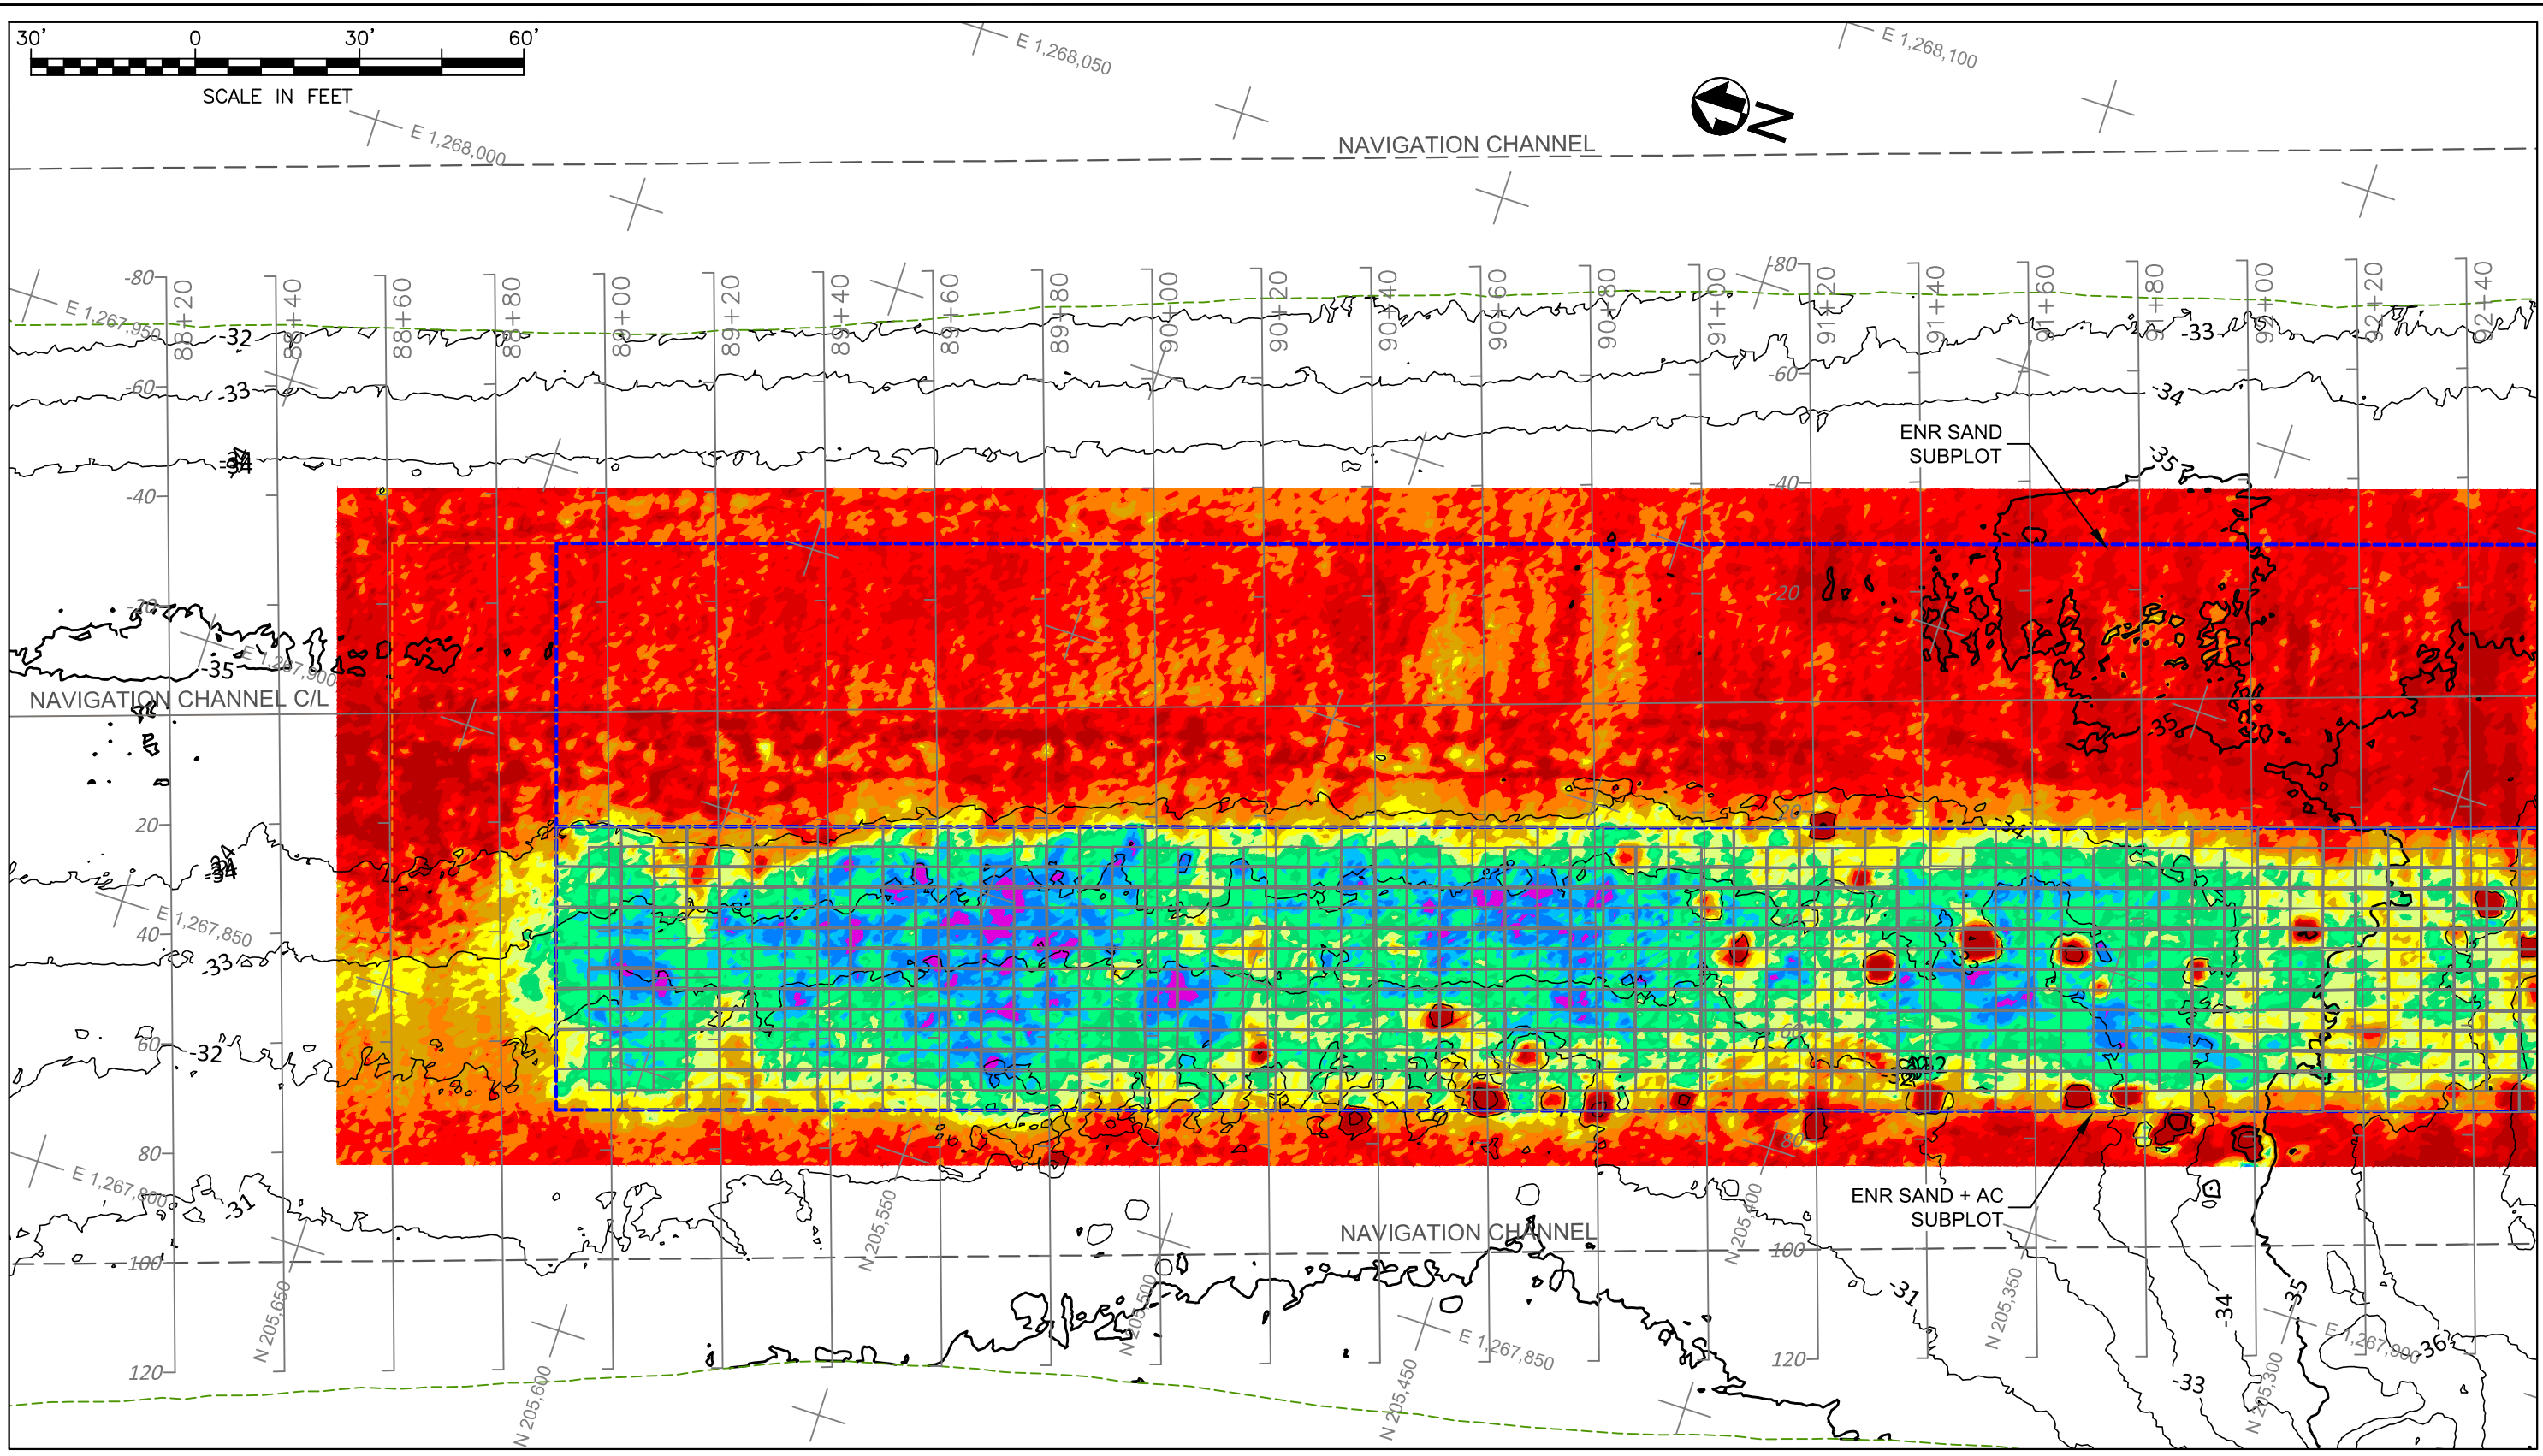
SHEET 1 OF 5

MATERIAL THICKNESS (PRE VS CURRENT) TARGET ONE	LEGEND - - - - - SUBPLOT LIMIT - - - - - OPTIONAL EXCESS MATERIAL PLACEMENT - - - - - CURRENT SURVEY EXTENT - - - - - EXISTING STRUCTURES AND EACH - - - - - SURVEY CONTOURS 5' INDEX INTERVAL □ BUCKET PLACEMENT MARK	SURVEY CONTROL LAFARGE 1 N: 205,146.676 E: 1,267,790.900 19.327 LAFARGE 2 N: 205,410.665 E: 1,267,710.952 19.072
--	---	---

MULTIBEAM HYDROGRAPHIC SURVEY
 SUBTIDAL PLOT PROGRESS

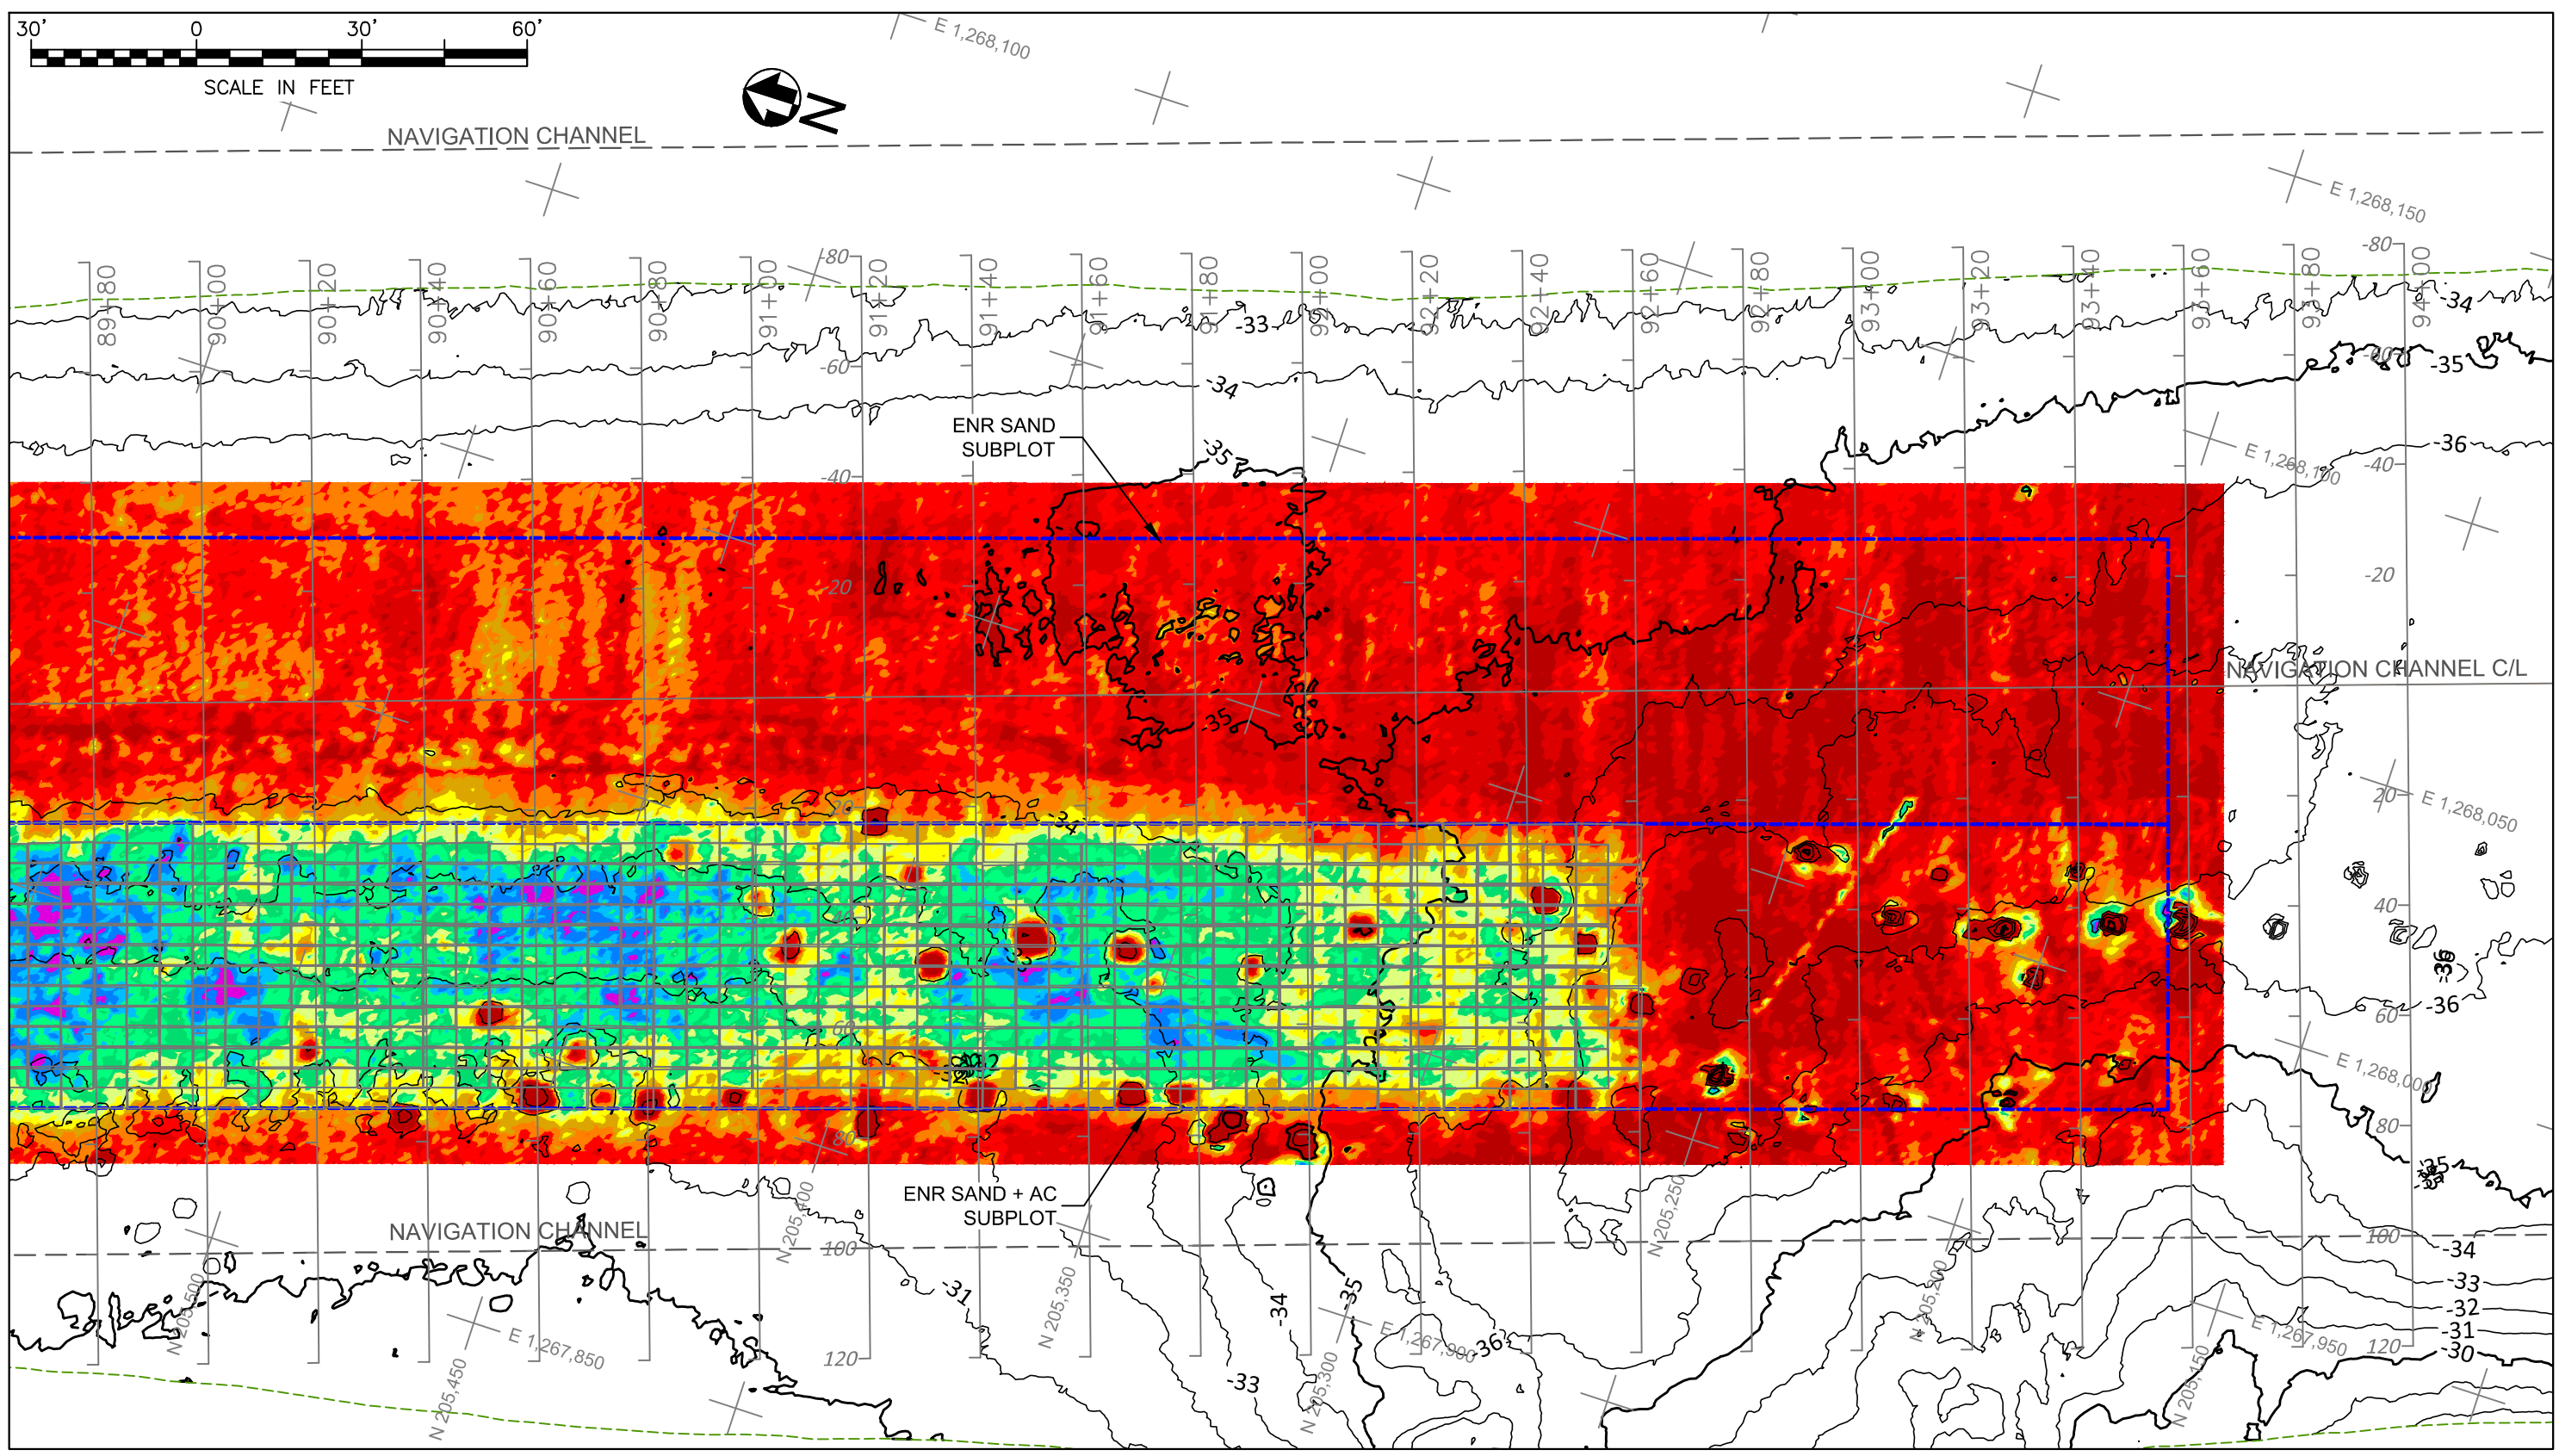
SHEET 2 OF 5

MATERIAL THICKNESS (PRE VS CURRENT) 	LEGEND 	SURVEY CONTROL LAFARGE 1 N: 205,146.676 E: 1,267,791.900 19.327
		LAFARGE 2 N: 205,410.665 E: 1,267,710.952 19.072

MULTIBEAM HYDROGRAPHIC SURVEY
 SUBTIDAL PLOT PROGRESS

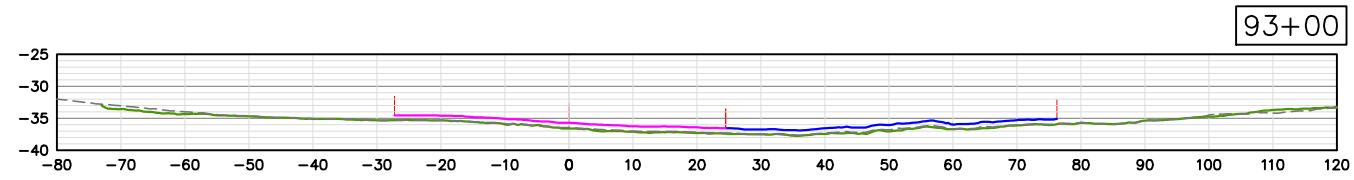
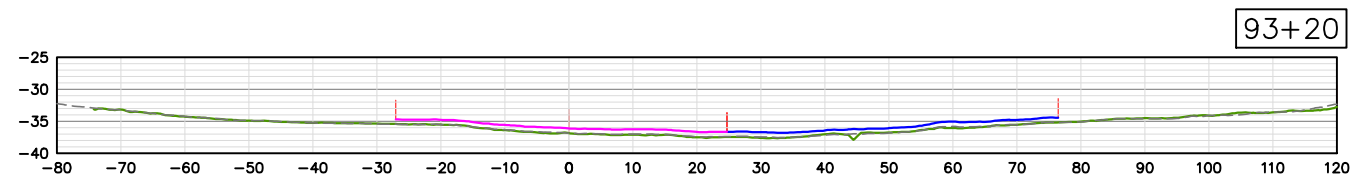
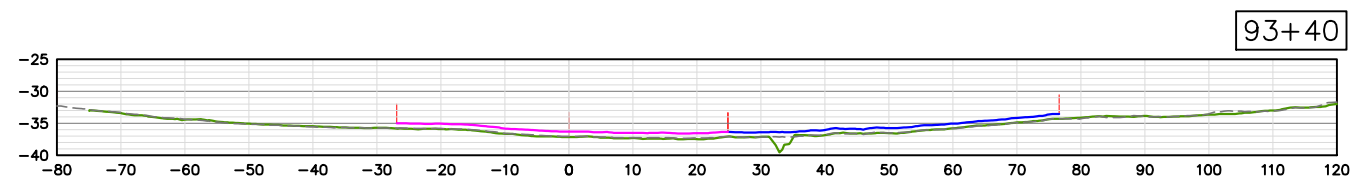
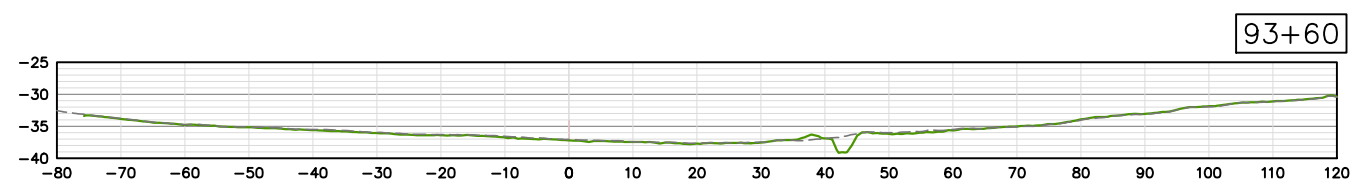
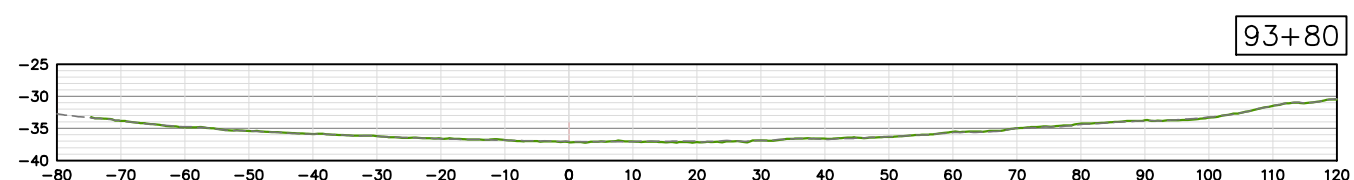
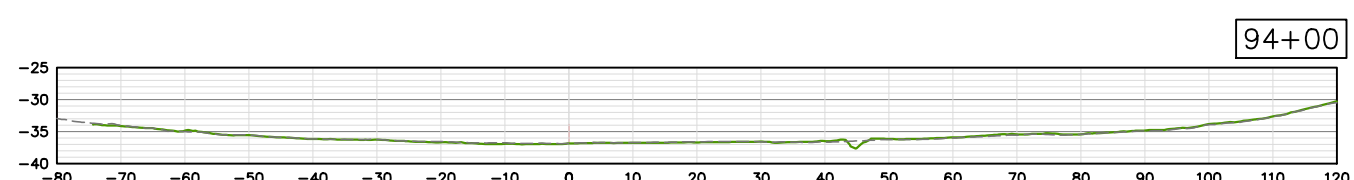
SHEET 5 OF 5

- SAND+AC SUBPLOT ECHENT (09 INCHES)
- SAND SUBPLOT ECHENT (09 INCHES)
- CURRENT SURVEY
- - - PRE-SURVEY (DEC 29, 2016)

MULTIBEAM HYDROGRAPHIC SURVEY
 SUBTIDAL PLOT PROGRESS

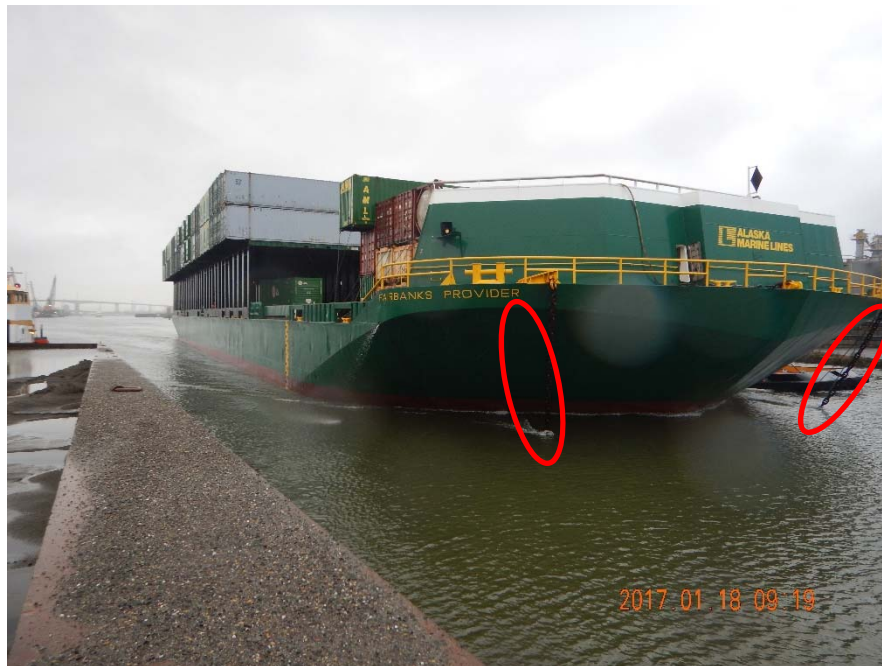
Photo 1-B: Barge traffic on the waterway passing on the east side of the material barge. Note the tow bridle hanging down into the water from the bow (circle in red).

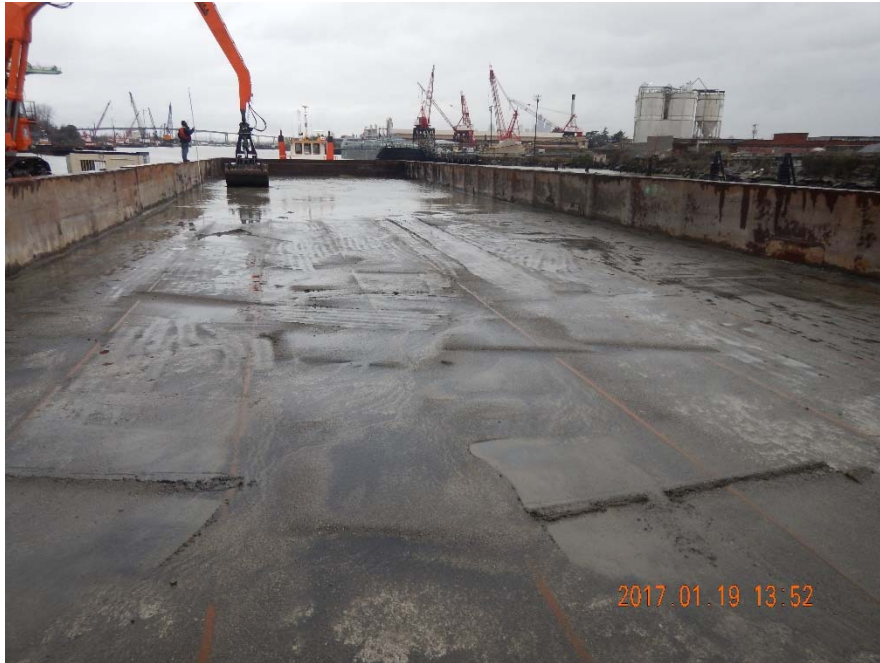
Photo 2-A: Cleanup of the KP-2 (Sand+AC ENR Material barge).

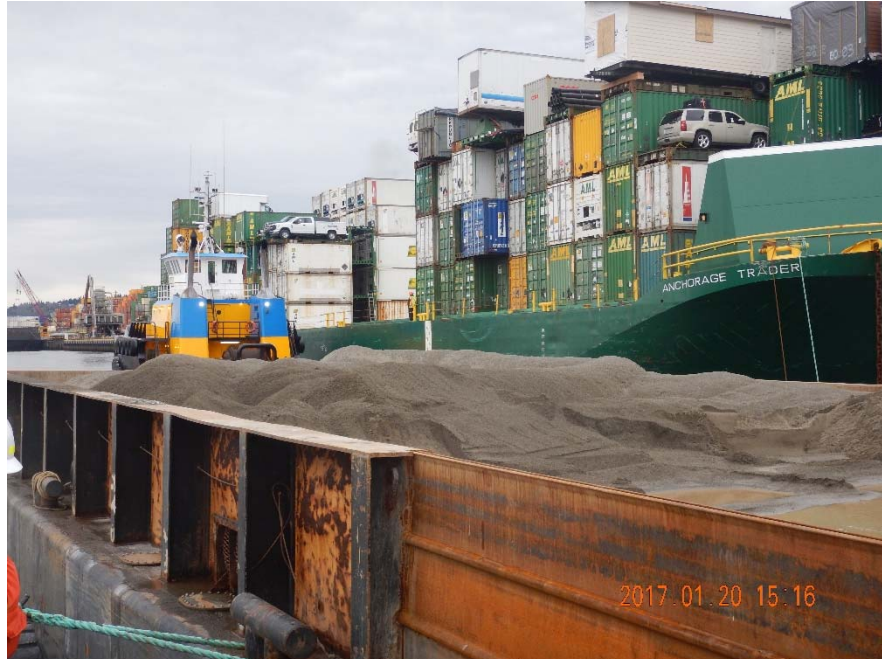
Photo 2-A: KP-3 (Sand barge) proximity to the AML's barge Anchorage Trader. Western Towboat tug shown (yellow and blue paint) is in the process of tying up to the barge to take it downstream to Elliott Bay.

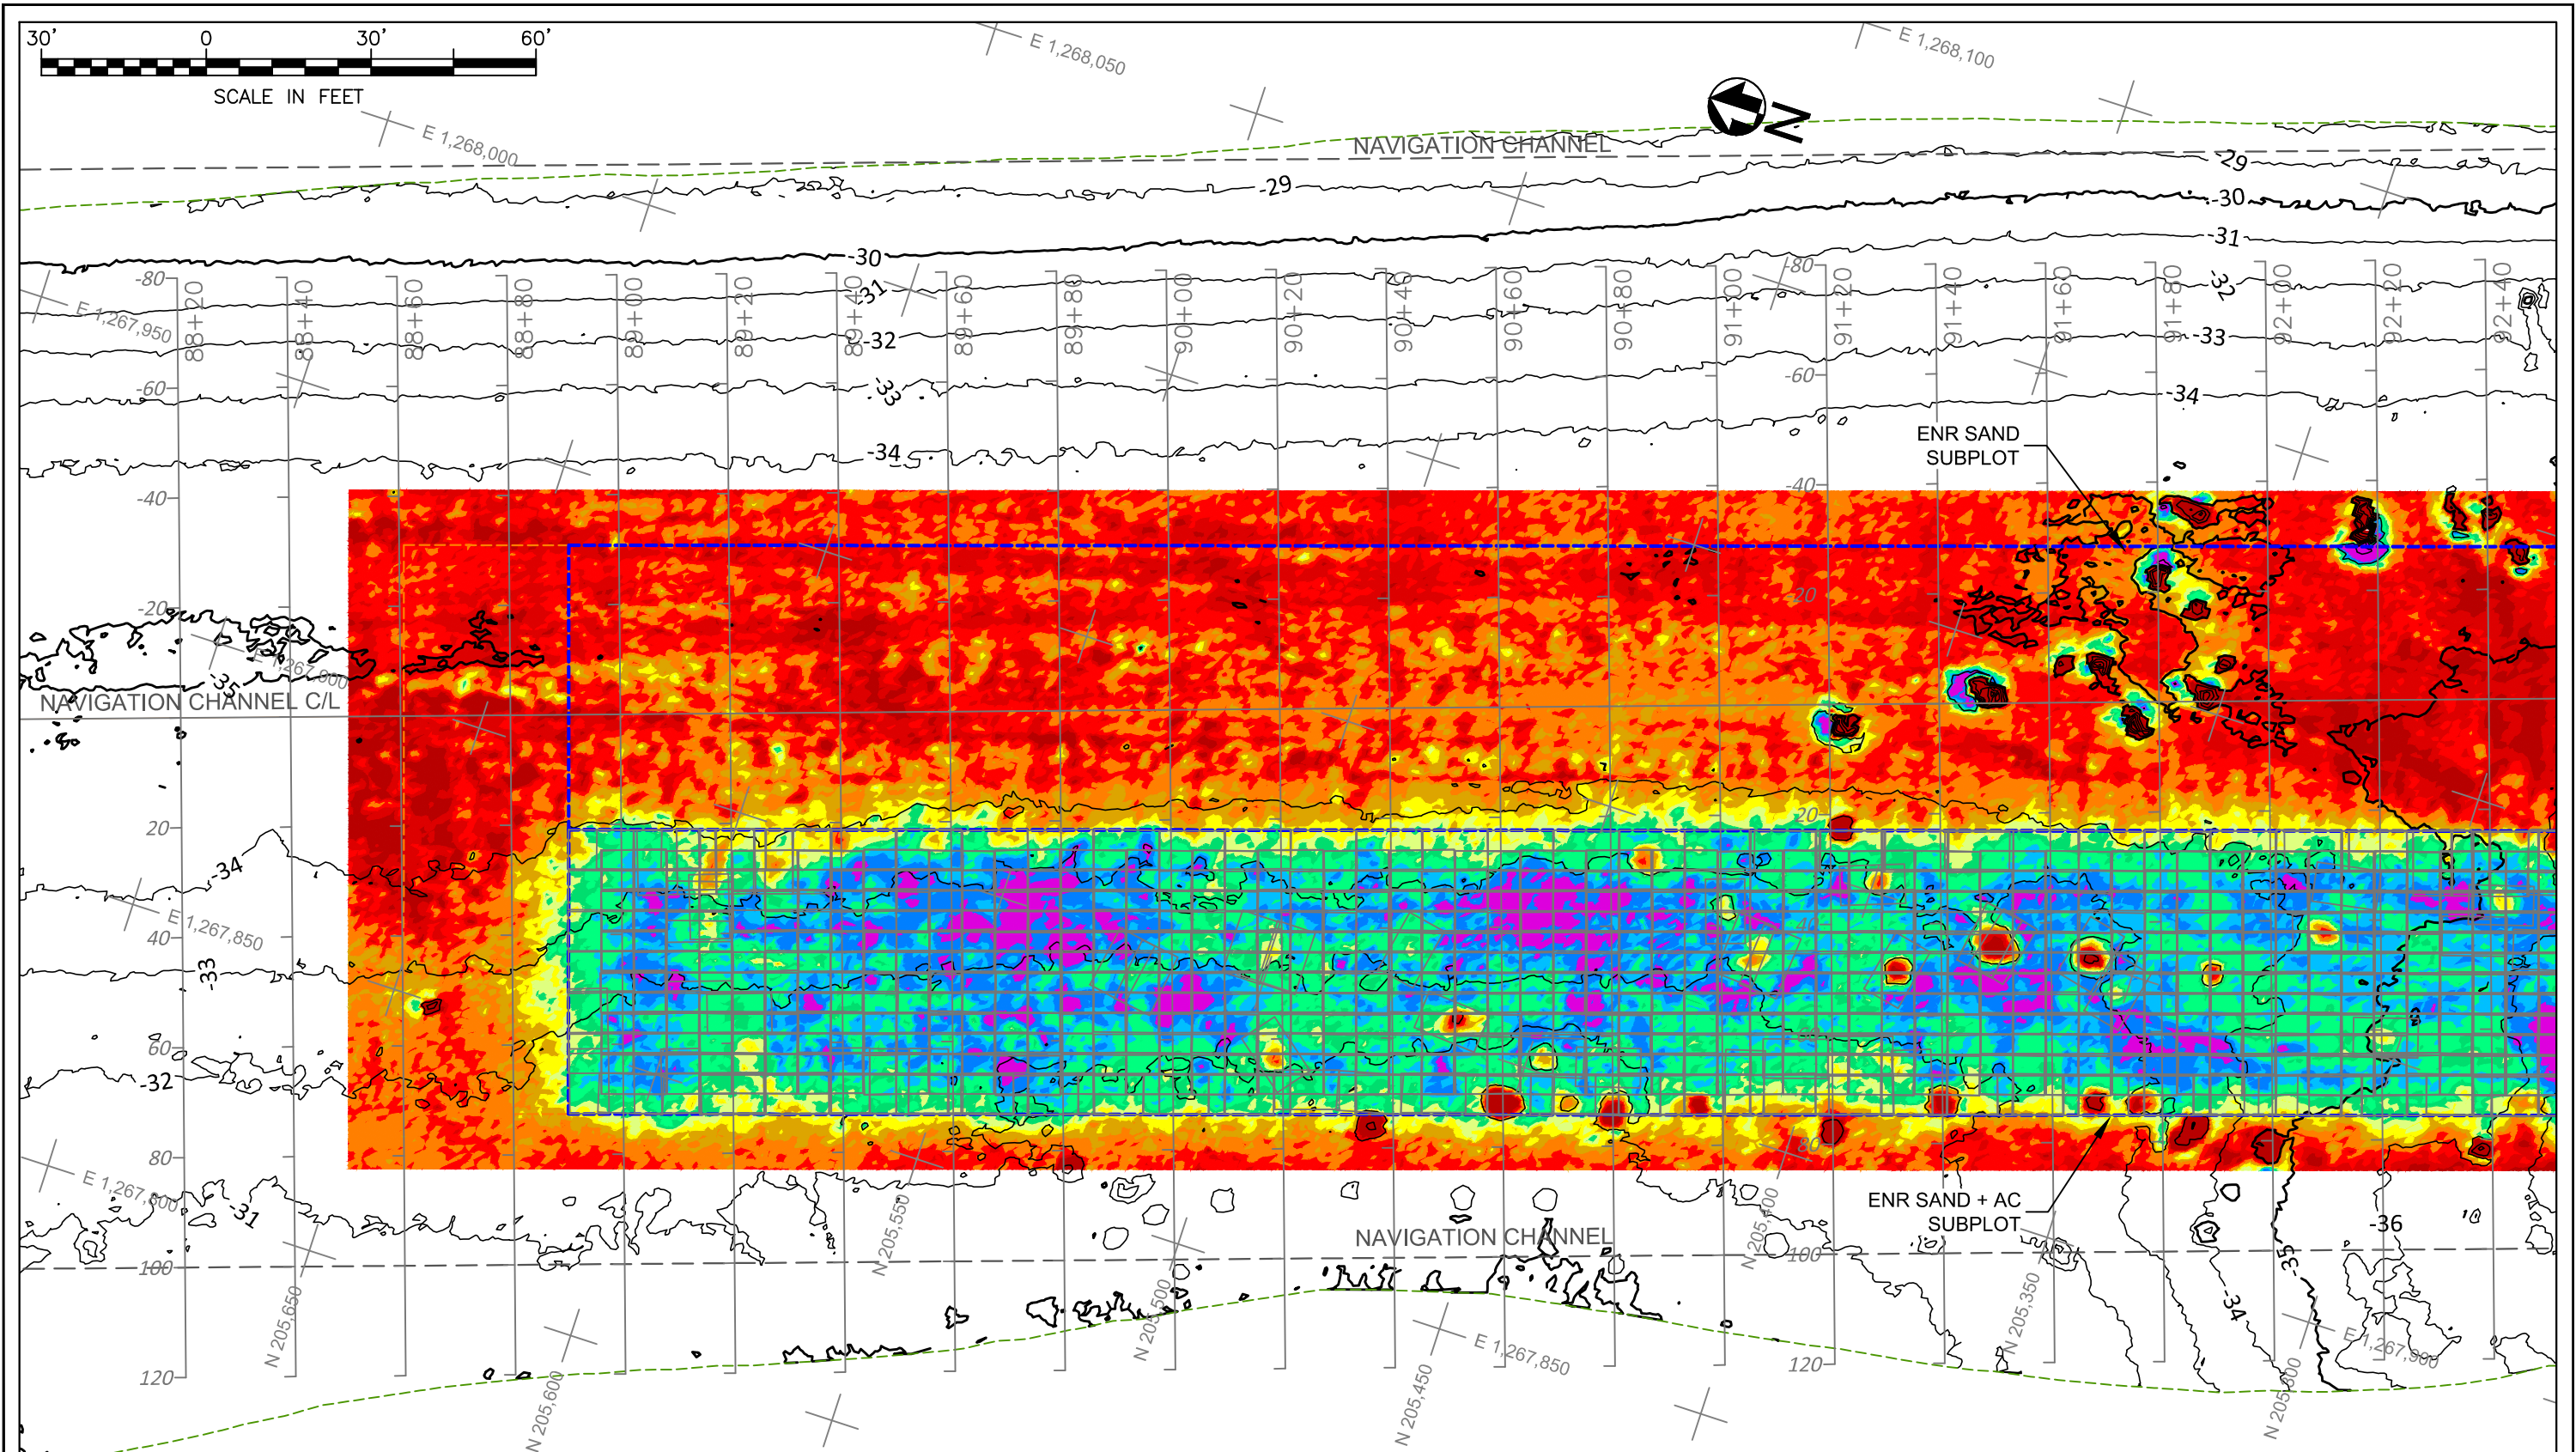
SHEET 1 OF 5

MATERIAL THICKNESS (PRE VS CURRENT) 	LEGEND 	SURVEY CONTROL LAFARGE 1 N: 205,146.676 E: 1,267,790.900 19.327 LAFARGE 2 N: 205,410.665 E: 1,267,710.952 19.072
	TARGET ONE

MULTIBEAM HYDROGRAPHIC SURVEY
 SUBTIDAL PLOT PROGRESS

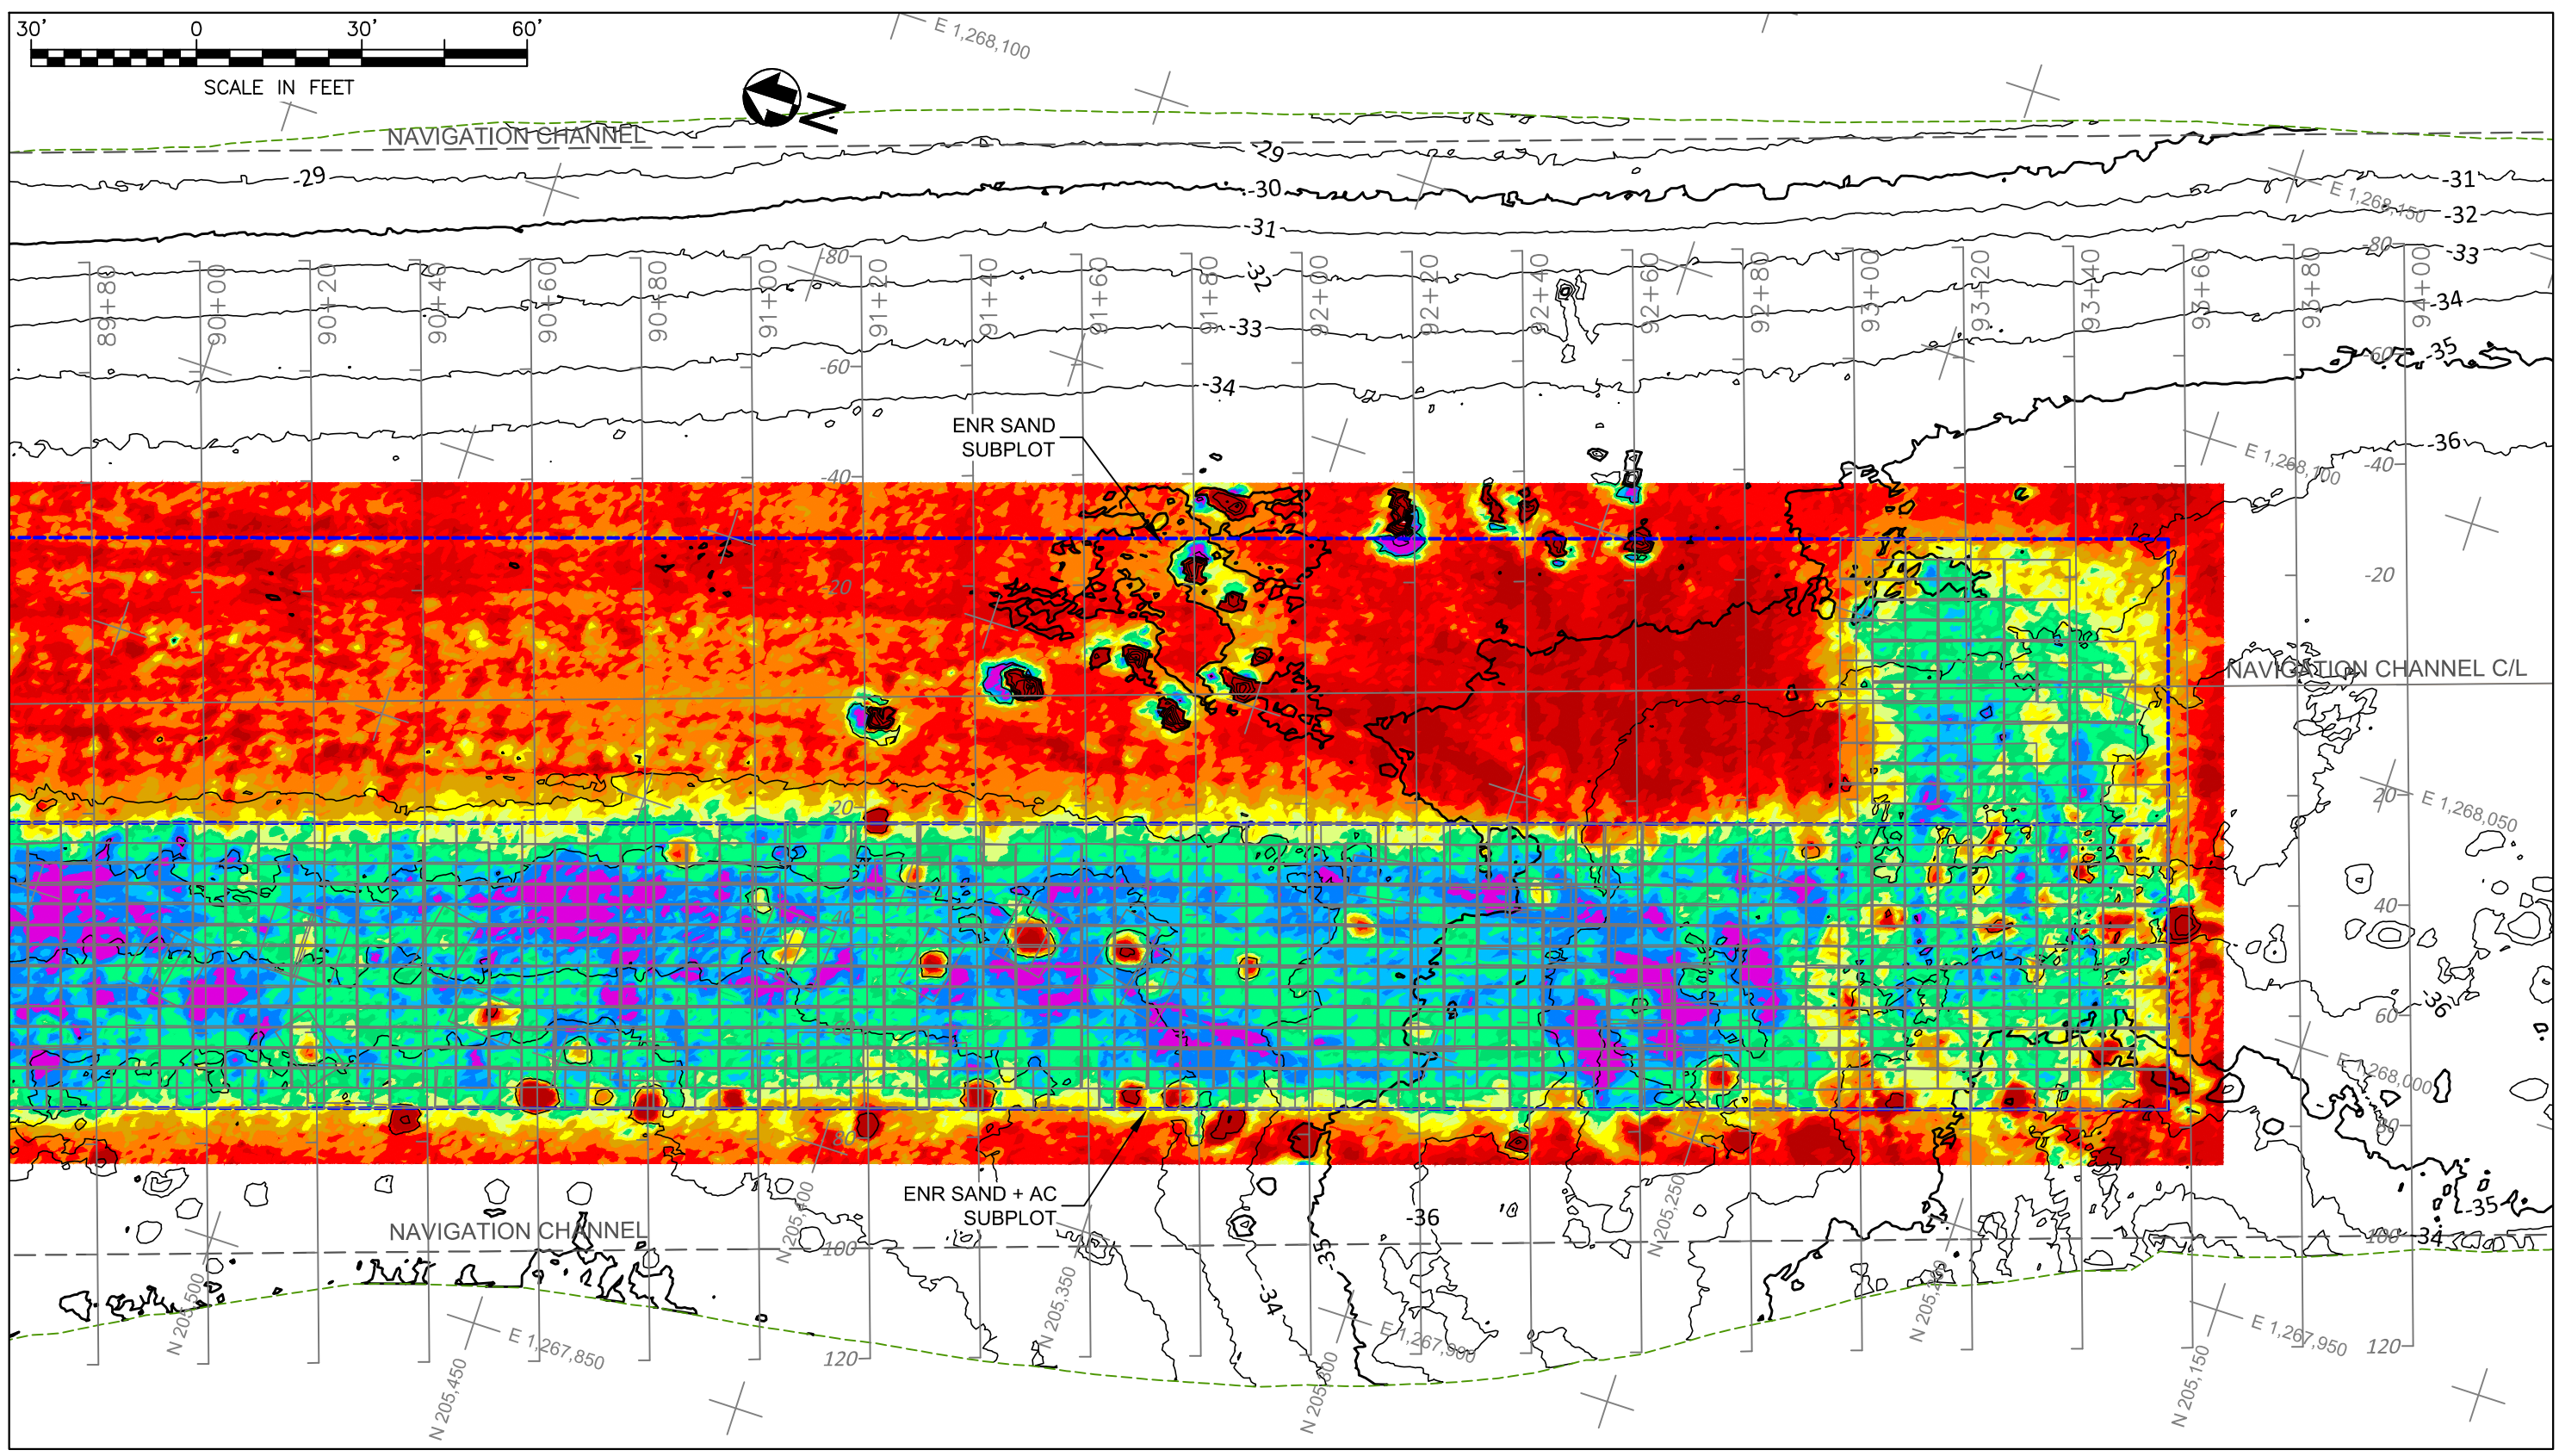
SHEET 2 OF 5

MATERIAL THICKNESS (PRE VS CURRENT) 	LEGEND
	SURVEY CONTROL LAFARGE 1 N: 205,146.676 E: 1,267,791.900 19.327 LAFARGE 2 N: 205,410.165 E: 1,267,710.952 19.072

MULTIBEAM HYDROGRAPHIC SURVEY
 SUBTIDAL PLOT PROGRESS
