Owner: King County

Project: Lower Duwamish Waterway ENR/AC Pilot

Dates: January 9, 2017 to January 13, 2017

ENHANCED NATURAL RECOVERY
 ACTIVATED CARBON PILOT STUDY
 DUWAMISH WATERWAY
 CONTRACT # C00992C15

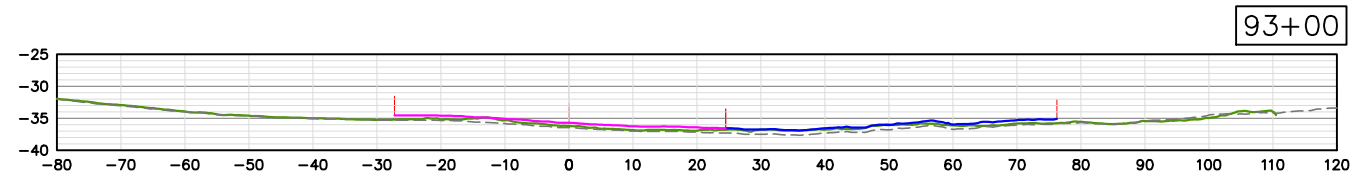
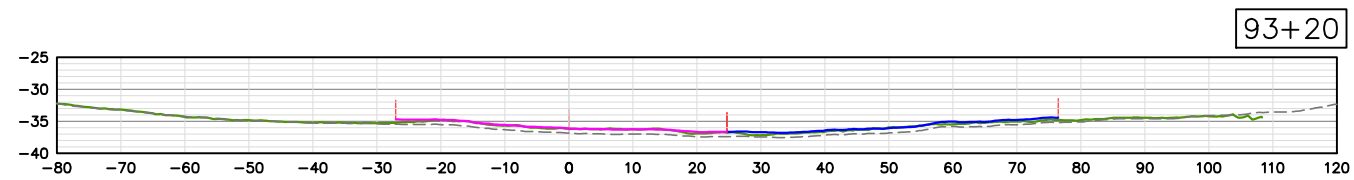
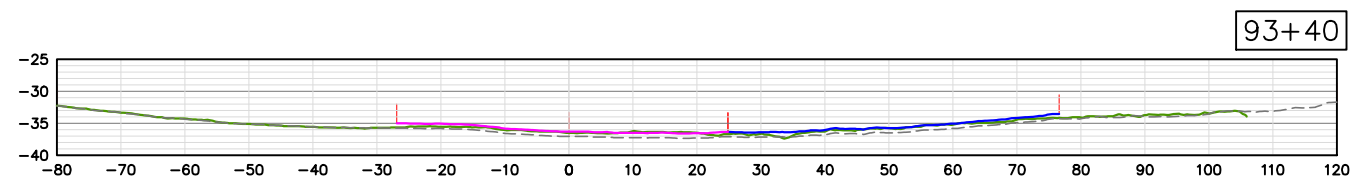
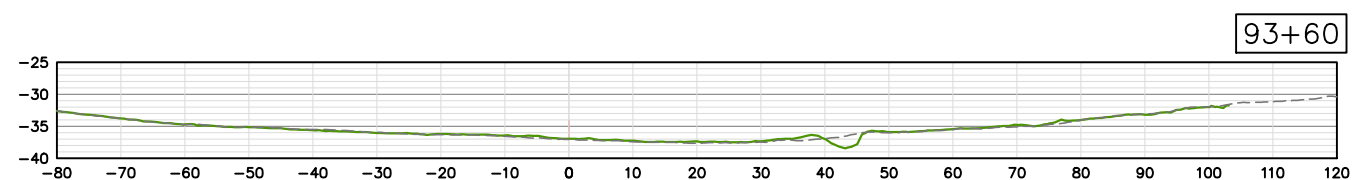
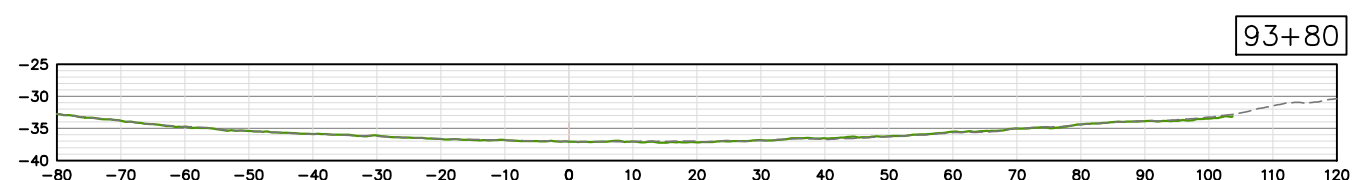
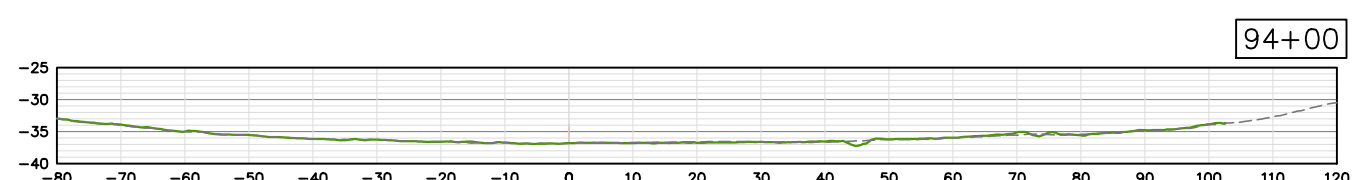
SHEET 5 OF 5

- SAND+AC SUBPLOT ECHENT (0.9 INCHES)
- SAND SUBPLOT ECHENT (0.9 INCHES)
- CURRENT SURVEY
- - - PRE-SURVEY (DEC 29, 2016)

MULTIBEAM HYDROGRAPHIC SURVEY
 SUBTIDAL PLOT PROGRESS

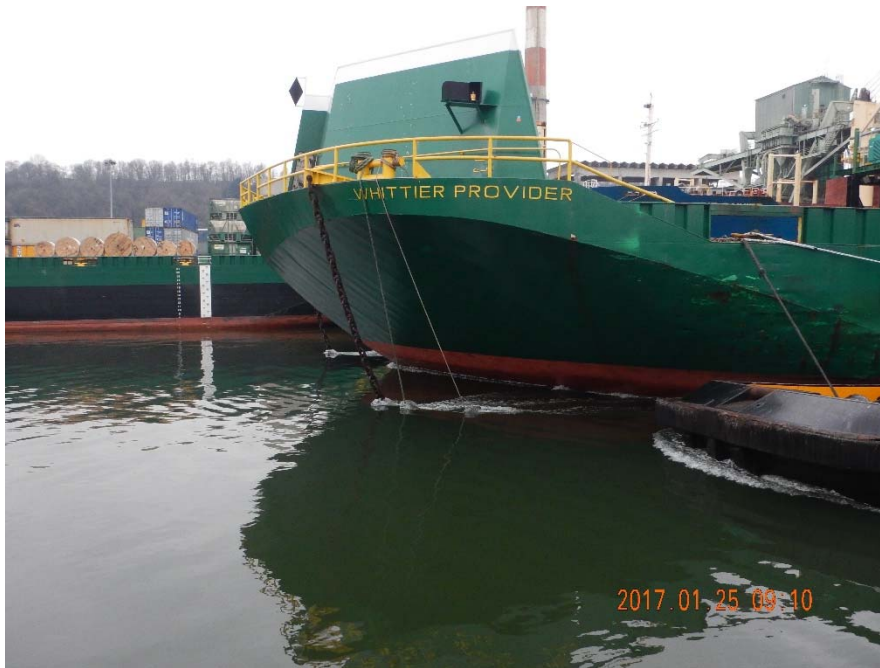
Photo 1-A: AML barge Whittier Provider being taken upstream with bridle chains hanging from bow.

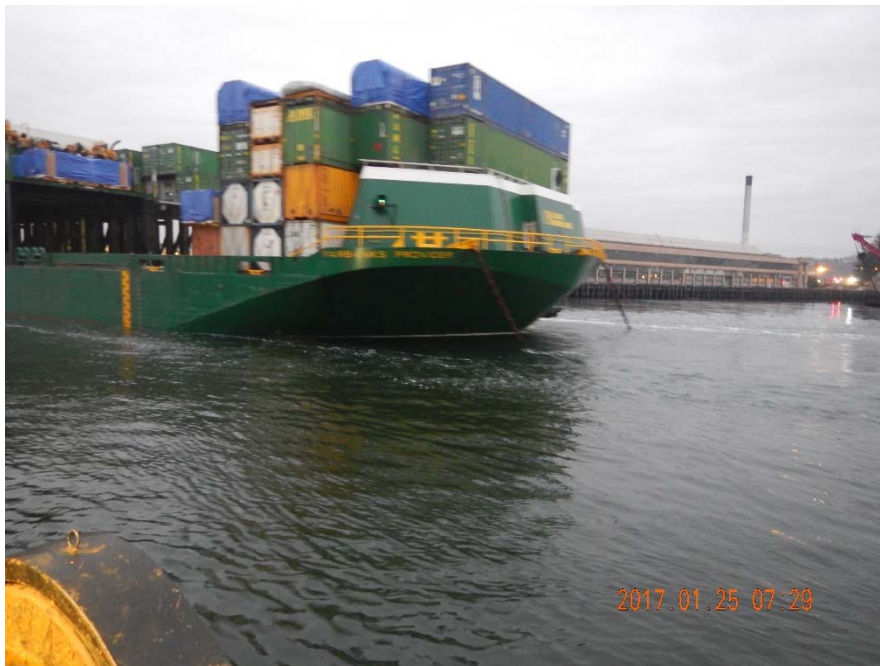
Photo 1-B: AML barge Fairbanks Provider being taken upstream with bridle chains hanging from bow.

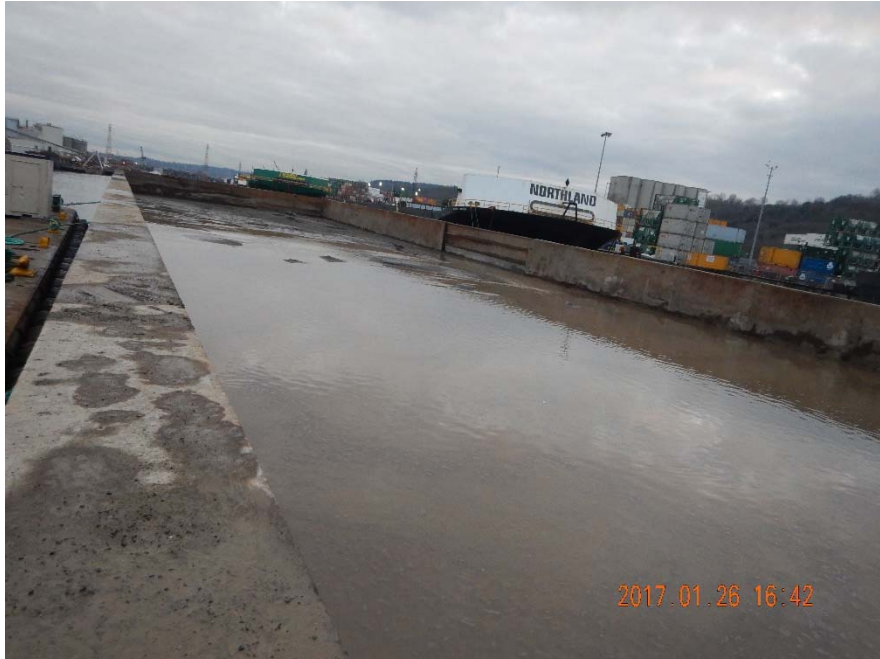
Photo 2-A: KP-3 barge after the last of the Sand ENR material has been placed.

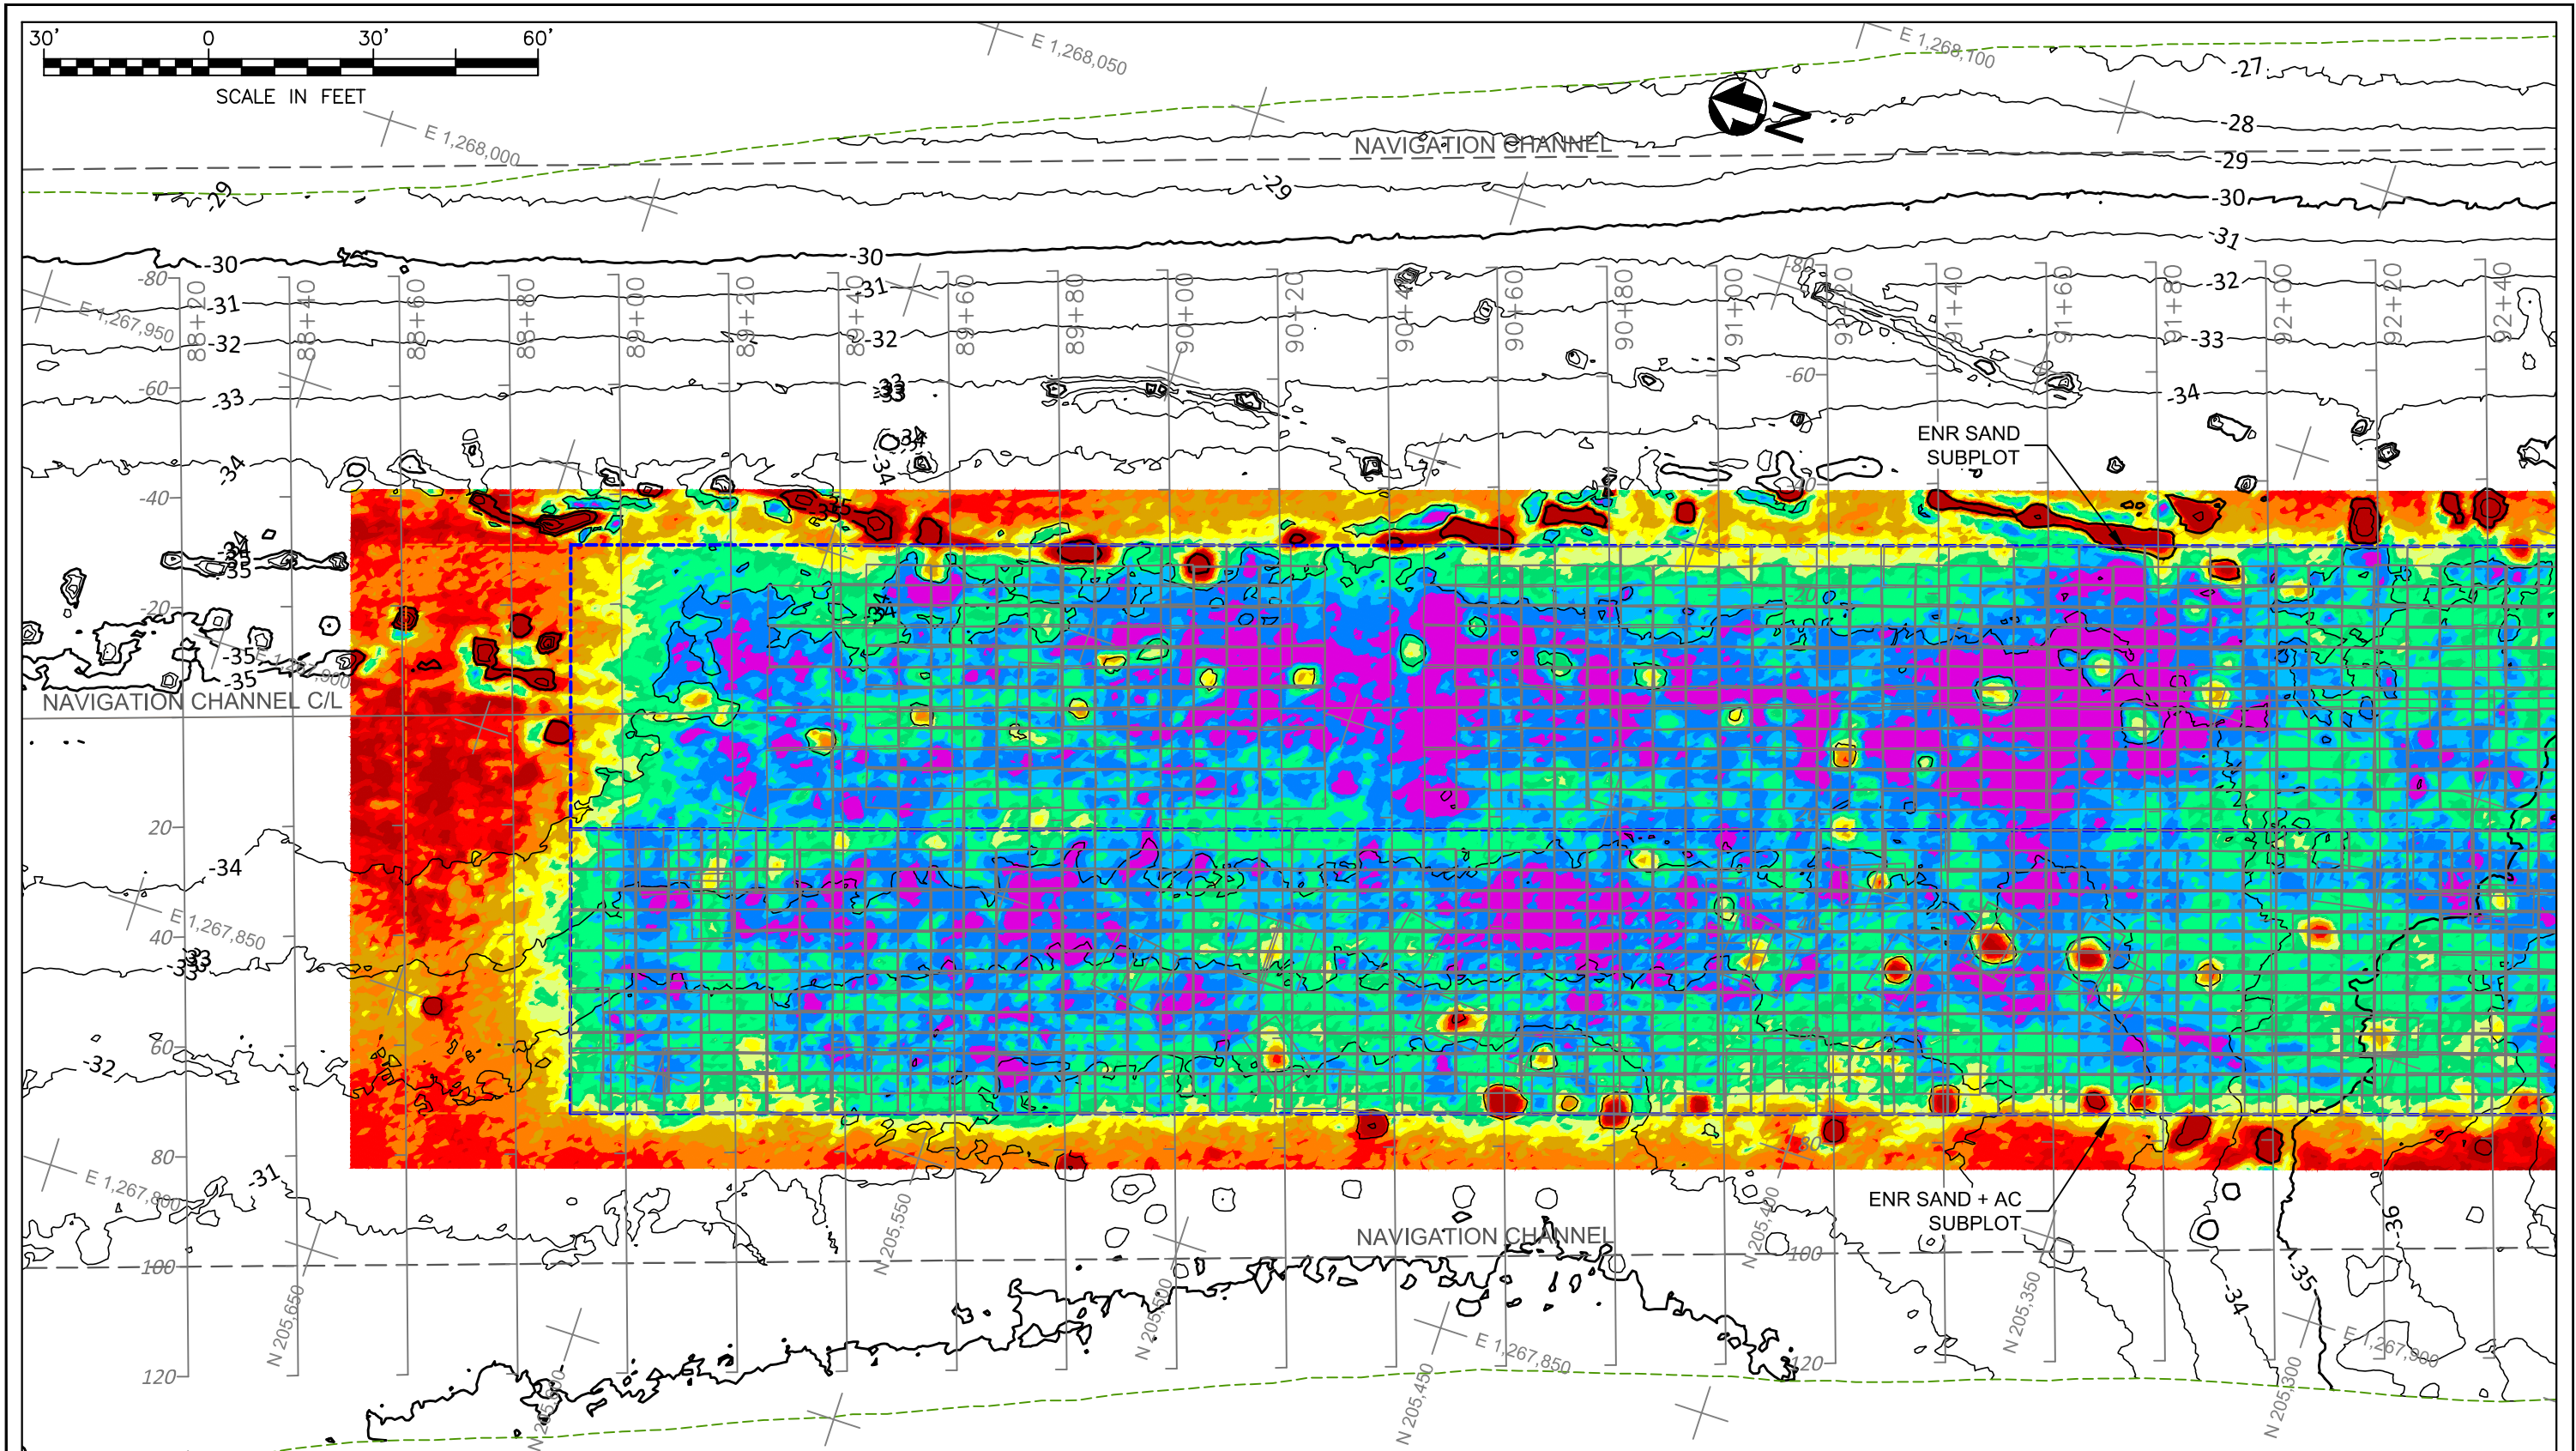
SHEET 1 OF 5

MATERIAL THICKNESS (PRE VS CURRENT) TARGET ONE	LEGEND - - - - - SUBPLOT LIMIT - - - - - OPTIONAL EXCESS MATERIAL PLACEMENT - - - - - CURRENT SURVEY EXTENT - - - - - EXISTING STRUCTURES AND EACH - - - - - SURVEY CONTOURS 5 MINUTE INTERVAL □ BUCKET PLACEMENT MARK	SURVEY CONTROL LAFARGE 1 N: 205,146.676 E: 1,267,791.901 19.327 LAFARGE 2 N: 205,410.165 E: 1,267,710.952 19.072
--	---	---

MULTIBEAM HYDROGRAPHIC SURVEY
 SUBTIDAL PLOT POST-PLACEMENT

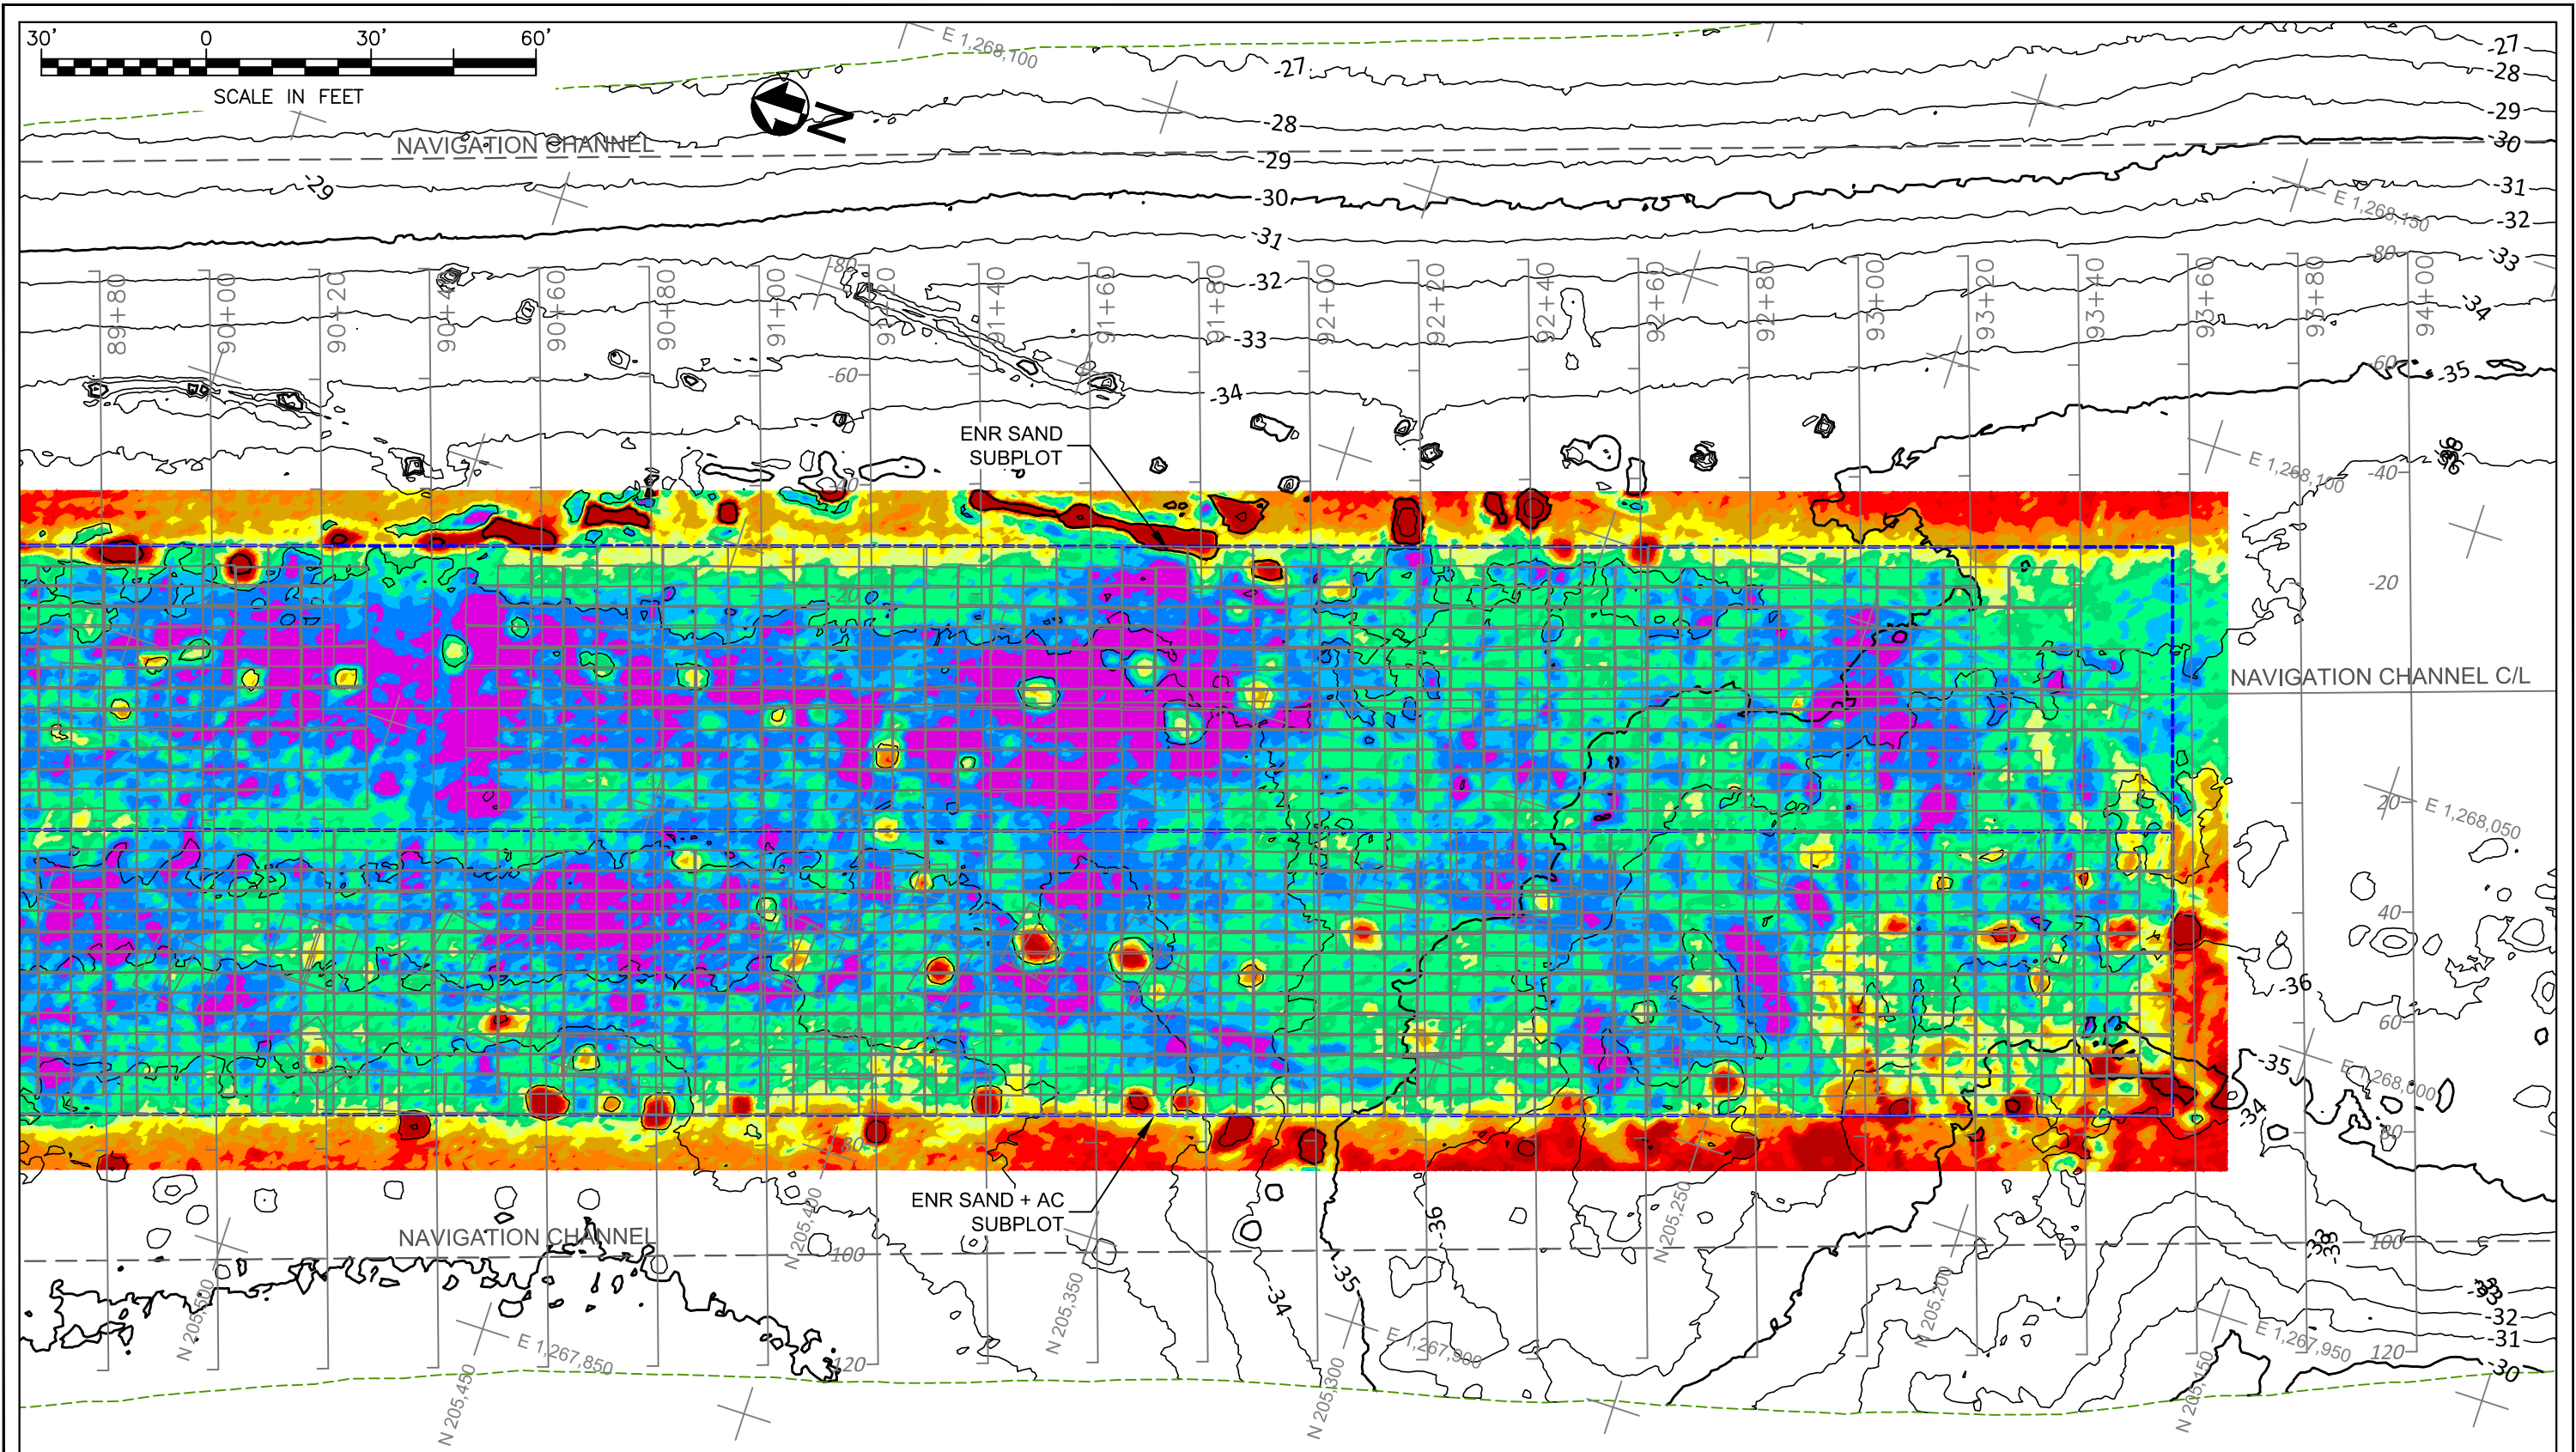
SHEET 2 OF 5

MATERIAL THICKNESS (PRE VS CURRENT) 	LEGEND 	SURVEY CONTROL LAFARGE 1 N: 205,146.676 E: 1,267,791.900 19.327 LAFARGE 2 N: 205,410.65 E: 1,267,710.952 19.072
	TARGET ONE

**MULTIBEAM HYDROGRAPHIC SURVEY
 SUBTIDAL PLOT POST-PLACEMENT**
