APPENDIX F

Sediment Profile Image/Plan View Image Reports
(Baseline and Year 1)

BASELINE SPI/PV DATA REPORT

ENHANCED NATURAL RECOVERY/ACTIVATED CARBON PILOT STUDY
LOWER DUWAMISH WATERWAY

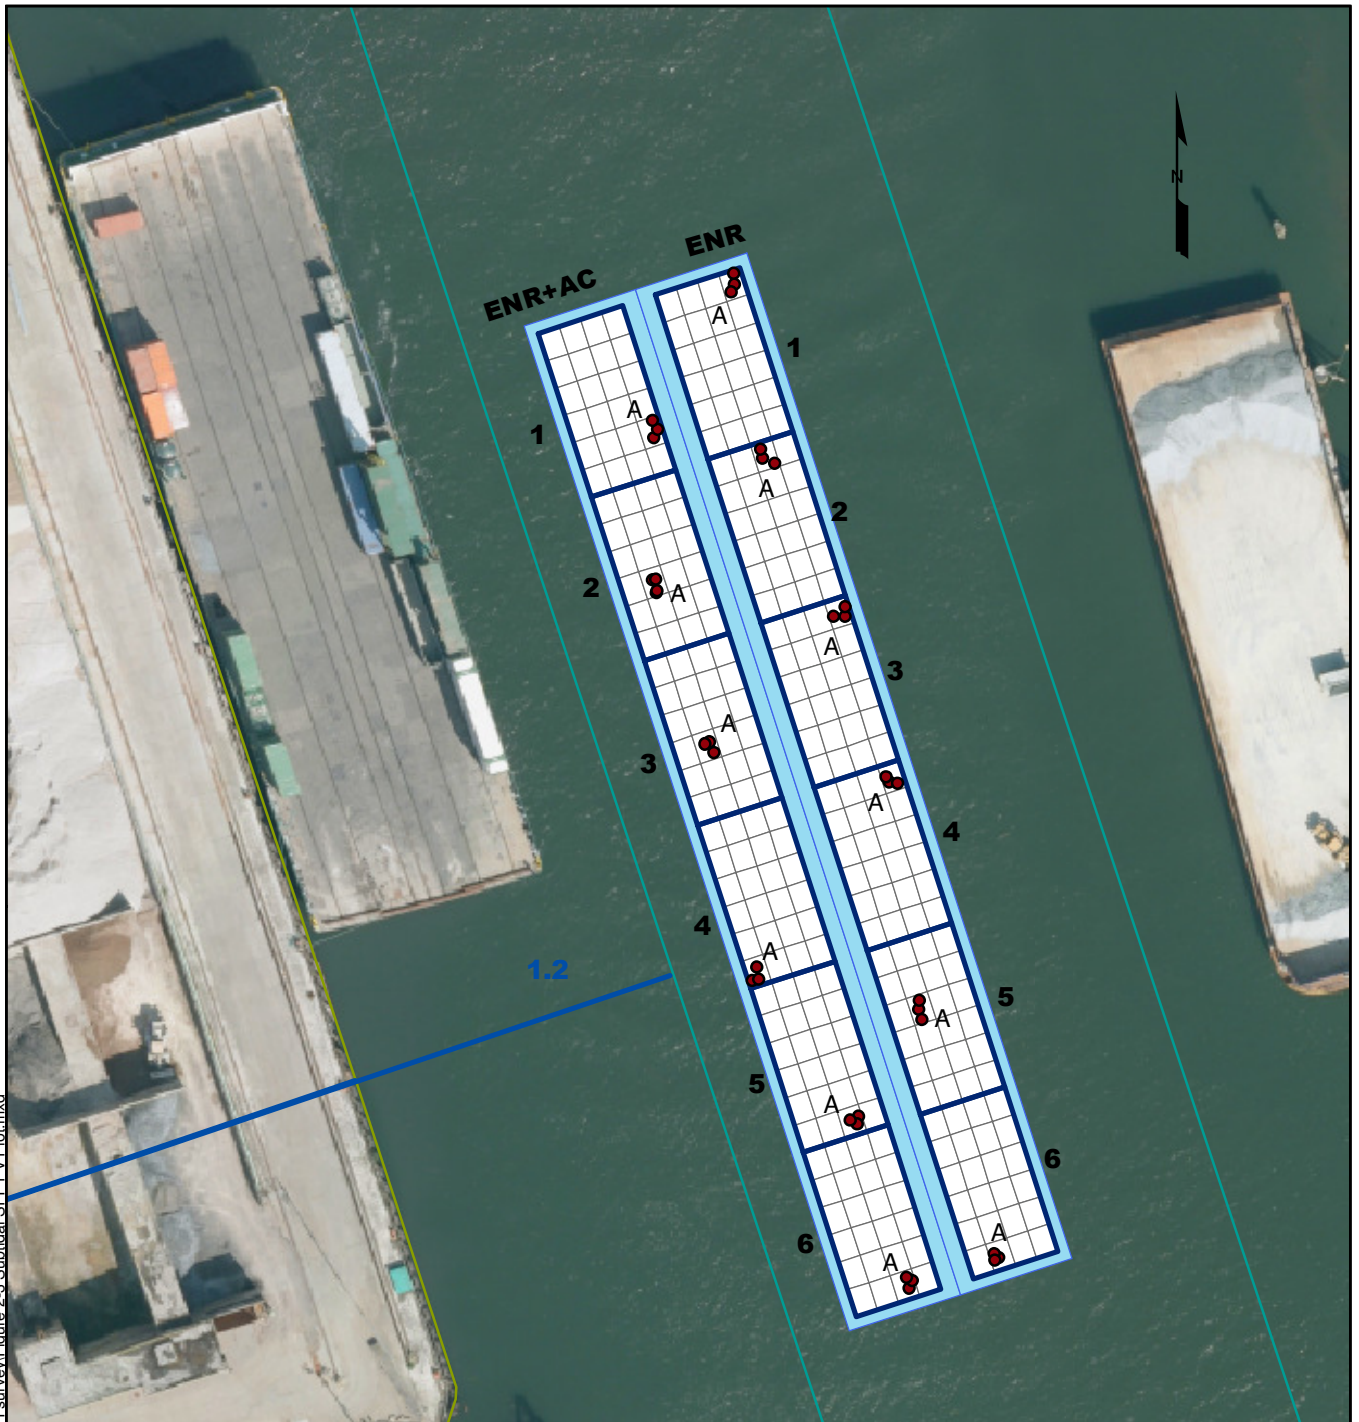
Sample locations consist of Proj Code (LDW), Event (BA), Plot (IN, SC, SU), Subplot (ENR, ENR+AC), Grid cell (1-6), and Location (A, B, C) e.g., LDW-BA-IN-ENR+AC-6-A

● SPI and PV Survey Locations (July 2016)

For the most part, the SPI/PV images from the subtidal plot show surface sediments are mixtures of ENR materials and silt. The ENR+AC material is not evident in grid cells 5 and 6 in the ENR+AC subplot (Figure 2-3) and has reportedly been disturbed by barge chain dragging (Amec et al. 2016b).

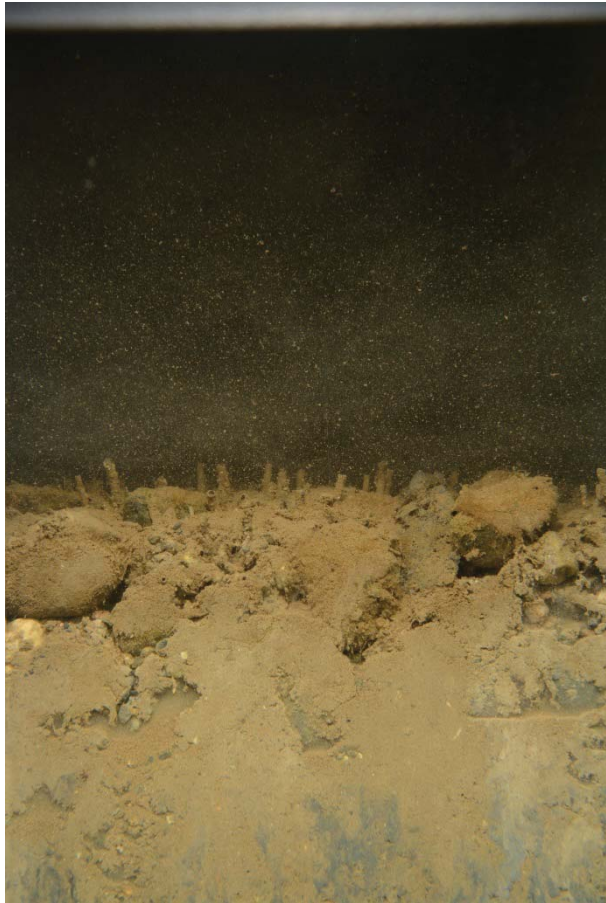
Figure 3-1.

Three SPI images from IN-ENR showing a cobble and silt (left), fine/medium sand and silt (middle), and coarse sand and silt mixtures (right). Width of each image = 14.42 cm. ENR/AC Pilot Study Lower Duwamish Waterway

Evidence of the ENR material (i.e., sands and gravels) was observed in at least one SPI replicate from all twelve stations sampled in the intertidal ENR subplot. Figure 3-1 shows three SPI images which illustrate the range of textures and ENR material and ambient sediment mixtures observed in this subplot. Table 3-1a includes a column noting these textures. Table 3-1a also includes an ENR Layer Thickness column. In all cases where the ENR material was evident in an image, it extended to the bottom of the SPI prism window and so is noted as > P (greater than penetration) in the data tables. The average penetration depth (cm) for each image is also included in the tables. Images in which ENR material was not evident are indicated by an LNA (layer not apparent) in the table. It is likely that ENR material is present below the depth of camera penetration for the 10 of 36 images from this subplot when ENR was not apparent. The image from station Y1-IN-ENR-6-B in Figure 3-2 is an example of a SPI image when ENR is not evident. Figure 3-3 is a PV image from the same station and clearly shows the presence ENR gravel and sands on the sediment surface. PV images from all stations where the ENR material was not seen in all SPI replicates (stations IN-ENR 3-B, 4-B, 5-A, 5-B, 6-A, and 6-B, Table 3-1a) show the presence of coarse-grained material (sand and gravel) on the sediment surface (Table 3-1b). Finally, the SPI prism penetration depth for this subplot averaged 5.1 cm (Table 3-7). This is notably less than the baseline average depth of 9.7 cm and further points to the presence of coarse-grained ENR material throughout the area below the prism penetration depth where coarse-grained ENR material is not visible in the SPI image.

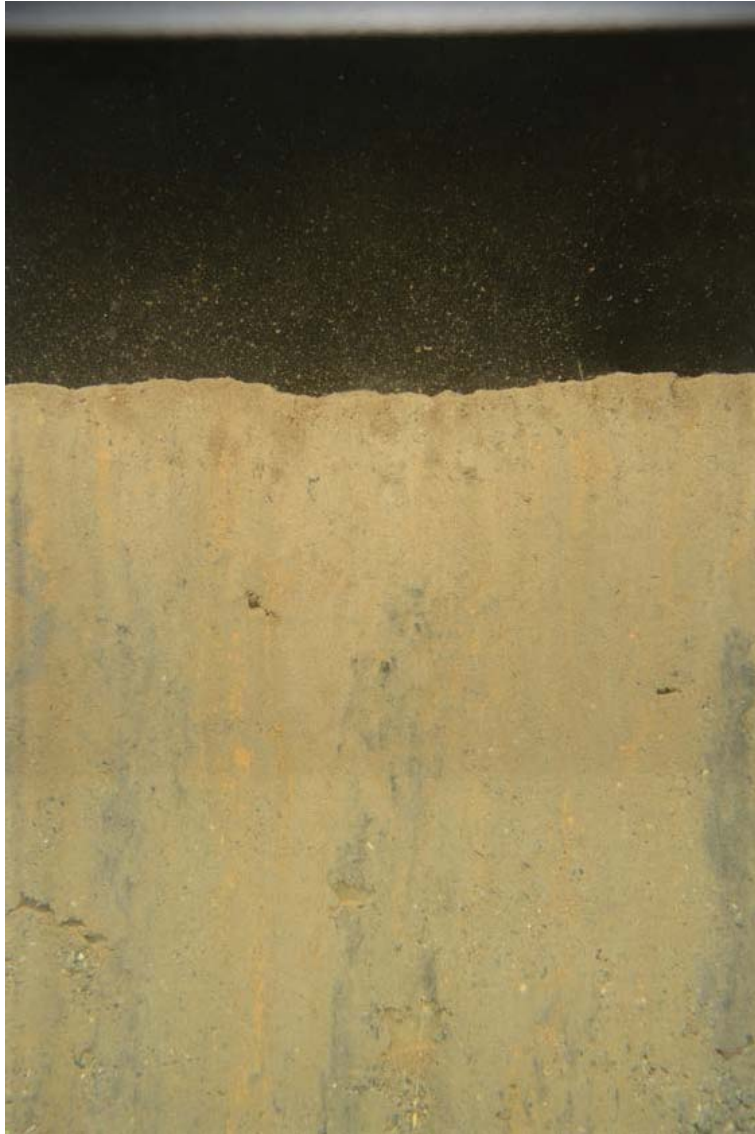
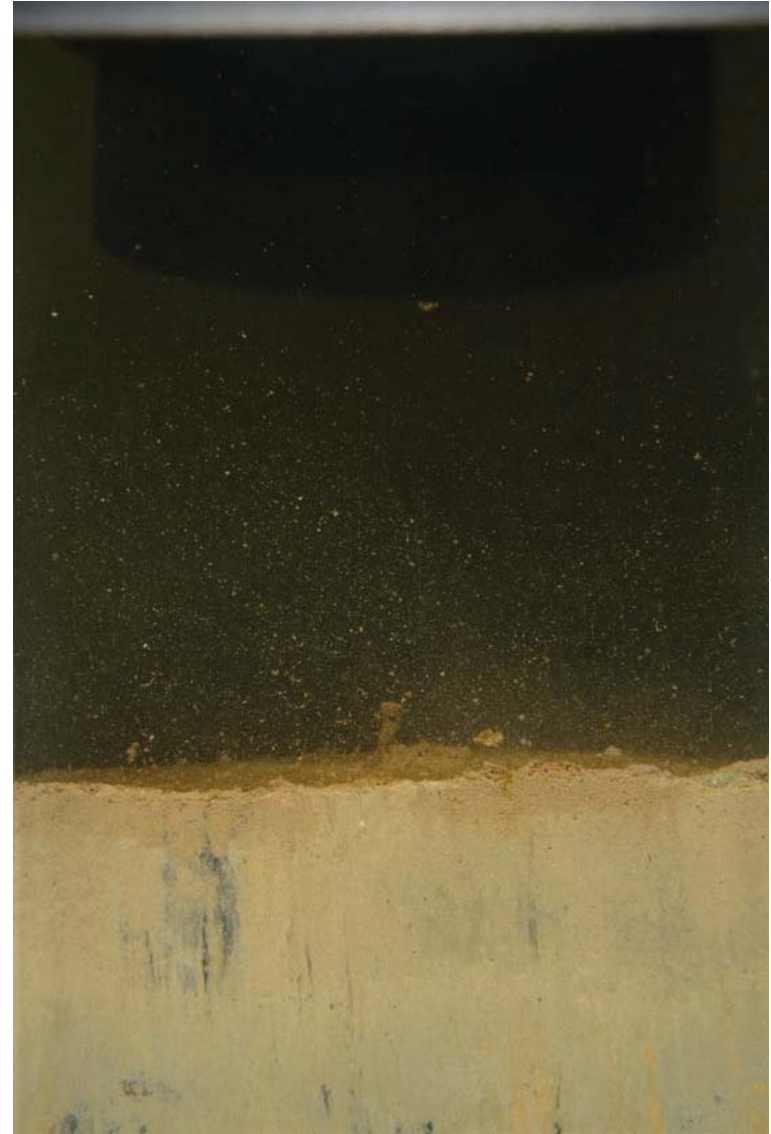
Figure 3-2.

Image 1-A-R3 (left) shows 6 cm of silt over an ENR sand and silt mix. Image 6-B-R2 shows 6 cm of silt with no evidence of ENR material. Width of SPI images = 14.42 cm.
ENR/AC Pilot Study Lower Duwamish Waterway

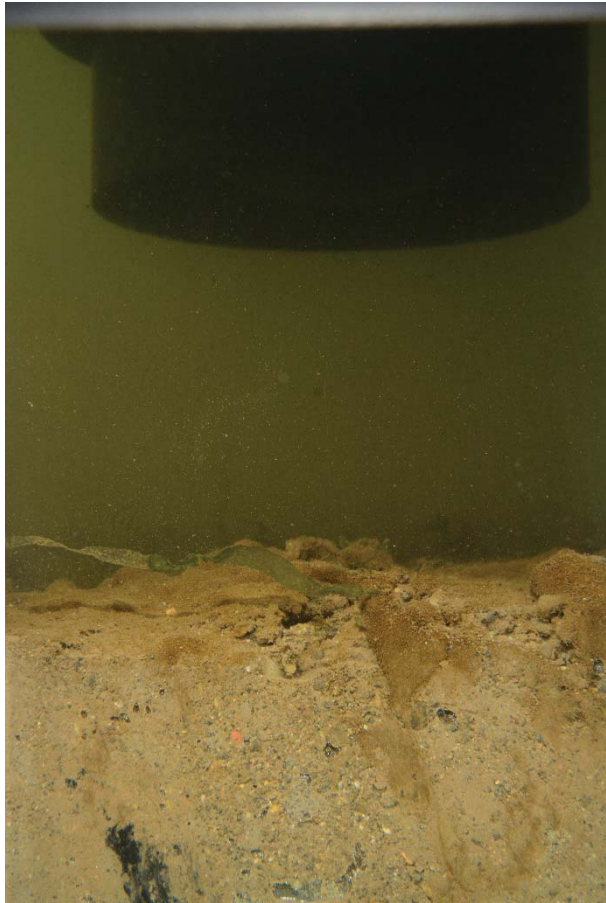
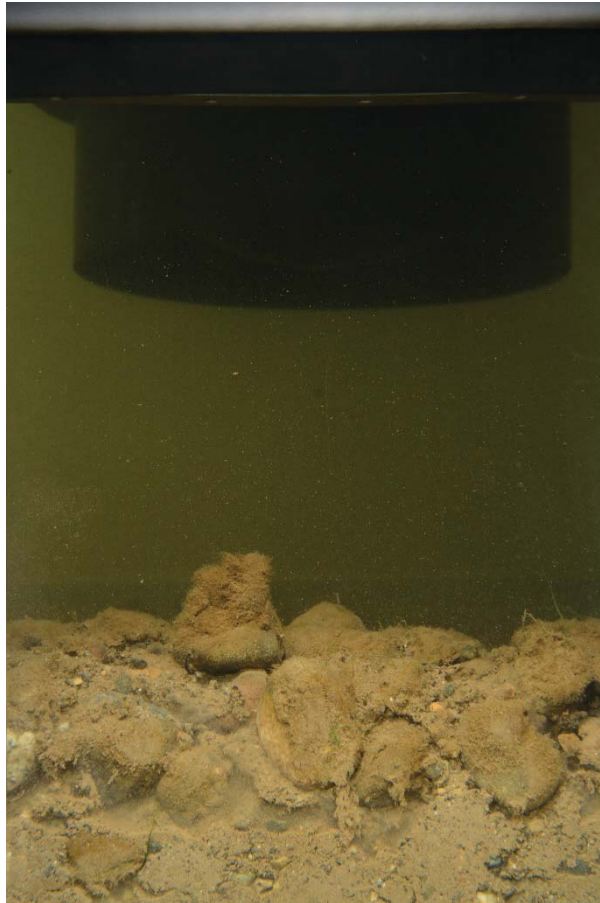
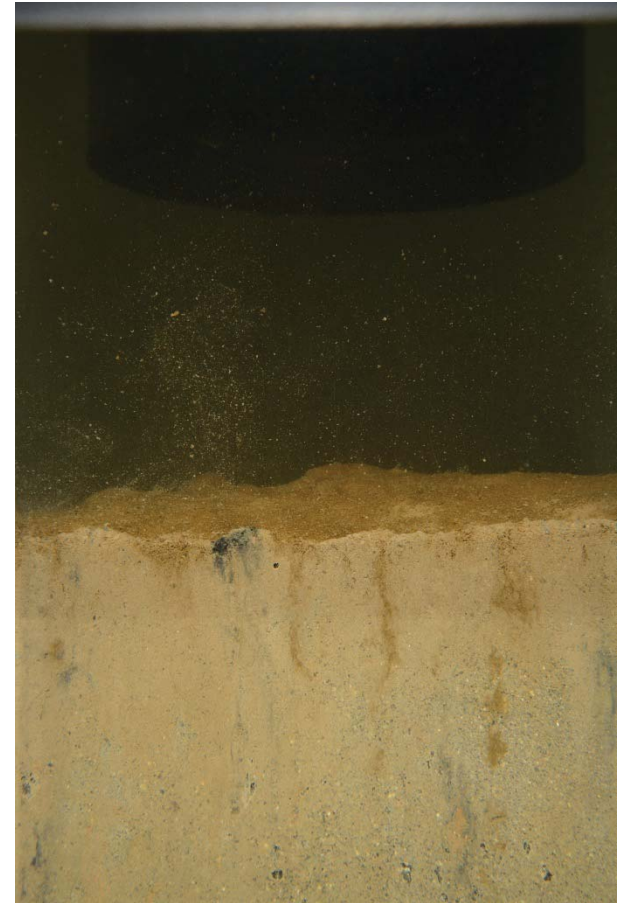
Figure 3-4.

Three SPI images from IN-ENR+AC showing a coarse sand and silt (left), gravel, sand, and silt (middle), and medium sand and silt mixtures (right). Image width = 14.42 cm.
ENR/AC Pilot Study Lower Duwamish Waterway

The SPI/PV results from this subplot are similar to the intertidal ENR only subplot. Evidence of the ENR+AC layer (i.e., sands and gravels) greater than prism penetration was observed in all but two of the SPI images (Table 3-2a³). Both of those replicates were from Station 6-A and two of the three PV images from that location show widespread gravel (draped in silt) on the sediment surface. The SPI prism penetration depth for this subplot ranged from 2.3 to 9.0 cm with an average value of 5.6 cm, this compares to the baseline average of 9.7 cm (Table 3-7). As noted above, this points to the presence of coarse-grained ENR material just below the sediment surface throughout the area.

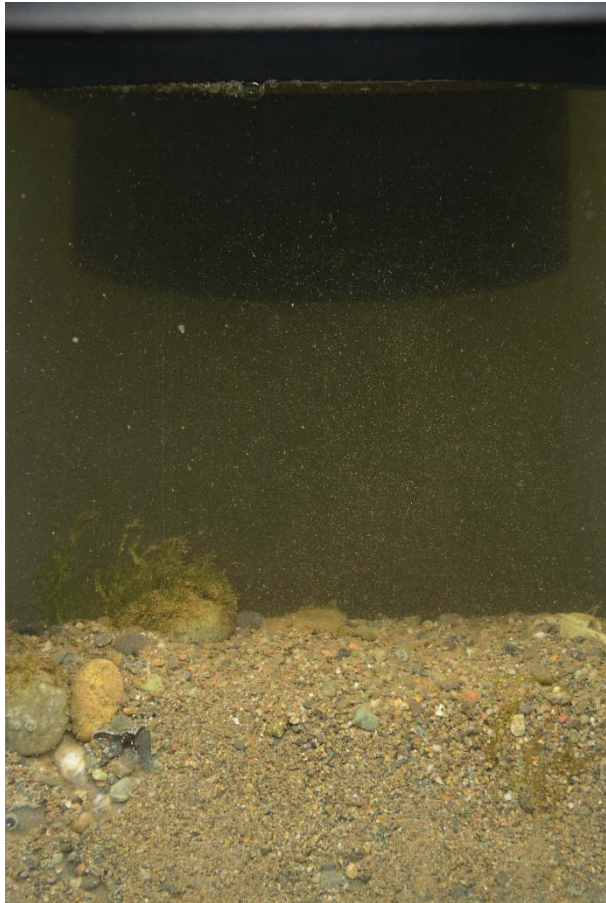
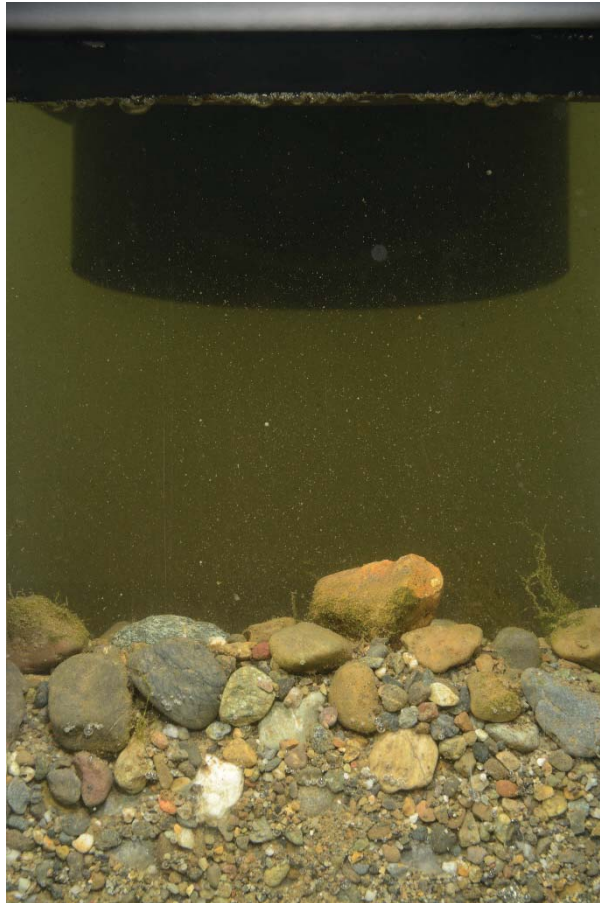
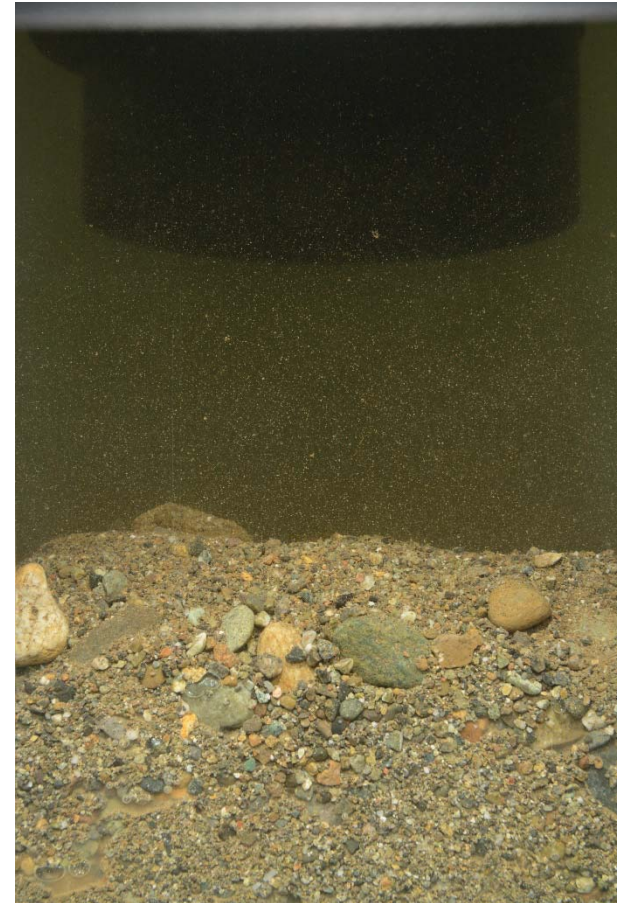
Figure 3-5.

Three SPI images from IN-ENR+AC-4-A showing ENR+AC material with minimal inputs or mixing with ambient fine-grained sediments. Width of each image = 14.42 cm.
ENR/AC Pilot Study Lower Duwamish Waterway

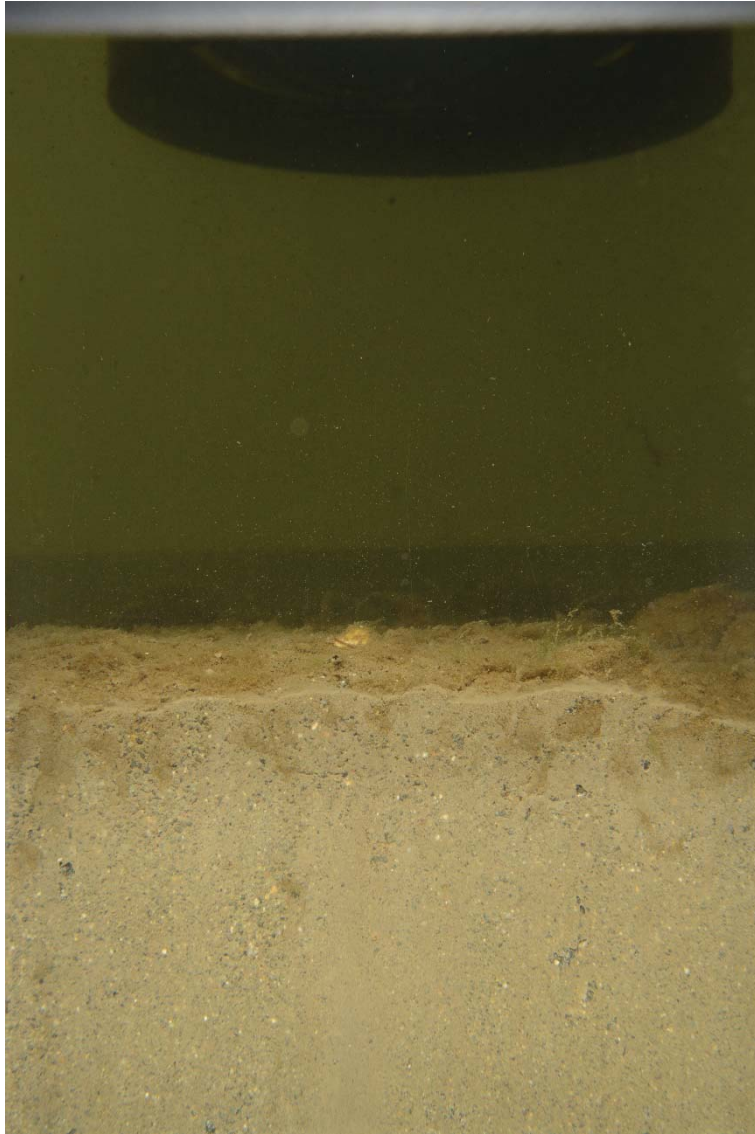
Figure 3-6.

Both images, ENR 2A-R3 and ENR+AC 2B-R3 show sand and silt mixtures with black, sand-sized particles throughout the profile. Width of SPI images = 14.42 cm.

Fine to coarse sand-sized black particles, possibly GAC, are evident in some of the IN-ENR+AC images with sand and silt mixtures. However, black, sand-sized particles are also observed in some of the images from the IN-ENR subplot with sand and silt mixtures (Figure 3-6). This

precludes drawing conclusions about whether the observed dark particles are GAC or natural, dark, lithic sands.

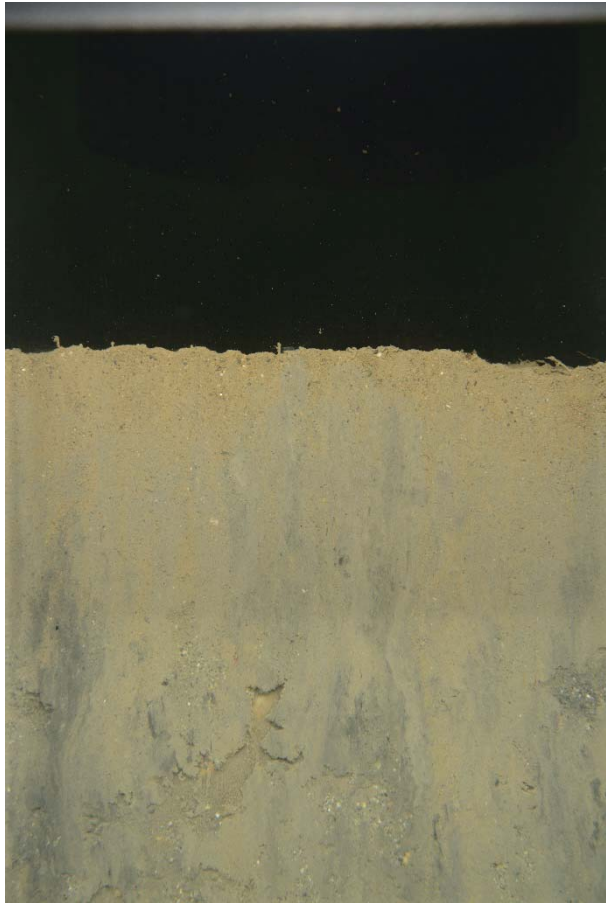
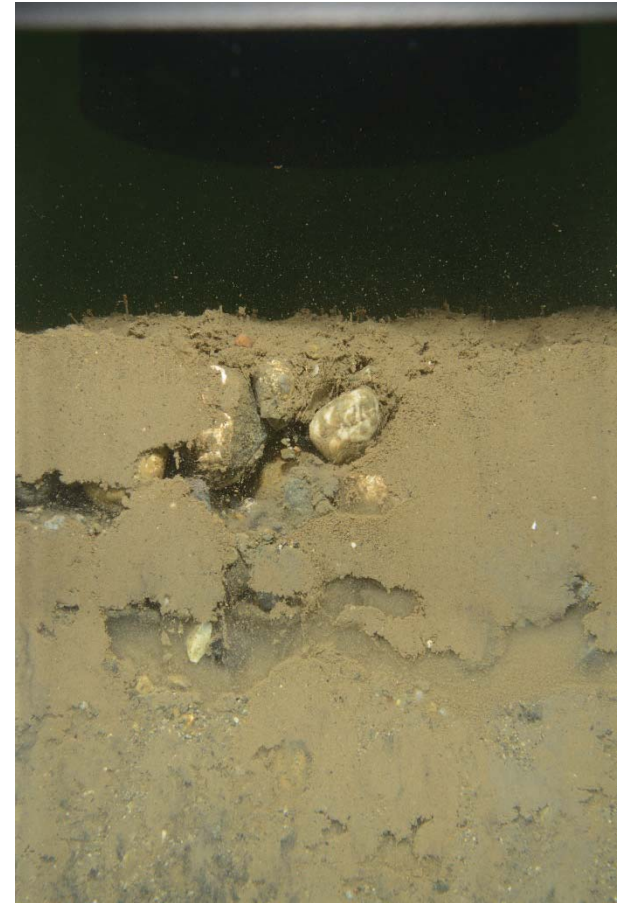
Figure 3-7.

Three SPI images from the SC-ENR subplot showing the predominately fine-grained texture at this site. Width of each image = 14.42 cm.

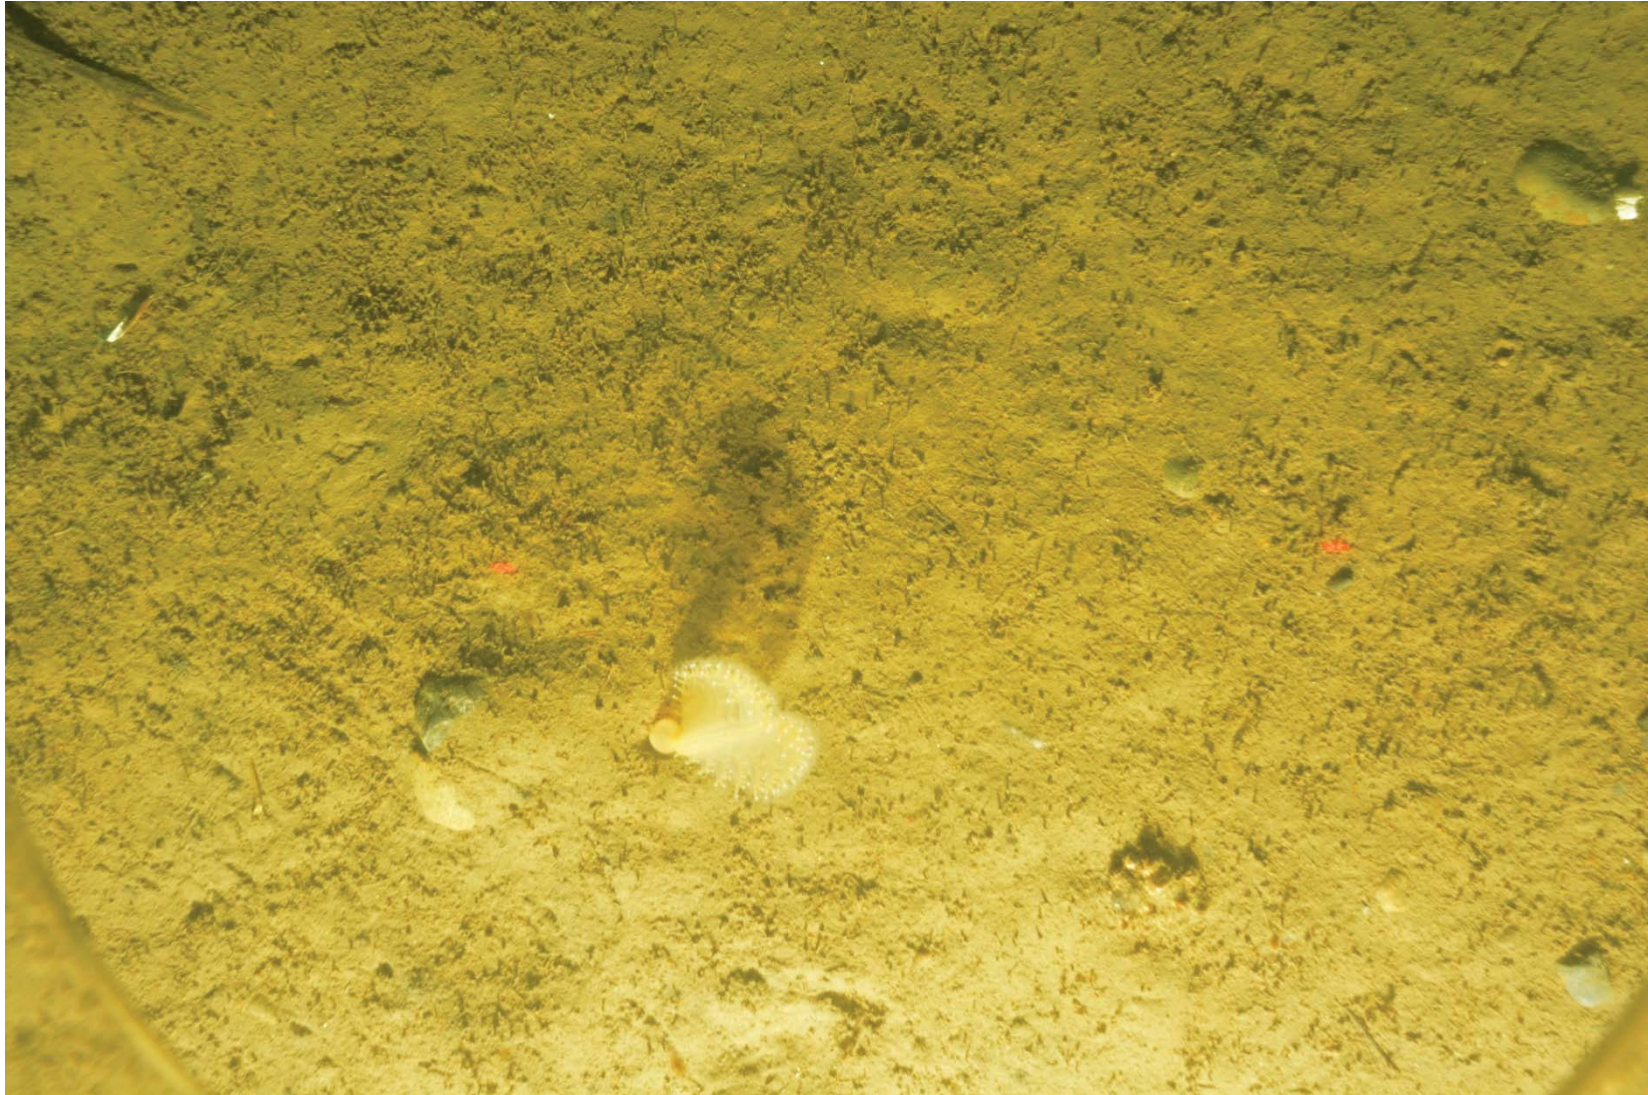
Figure 3-8.

Plan view image of the SC-ENR subplot showing widespread surface worm tubes, tracks, and a sea pen, as well as some ENR gravel. Scale: the red laser dots are 26 cm apart.
ENR/AC Pilot Study Lower Duwamish Waterway

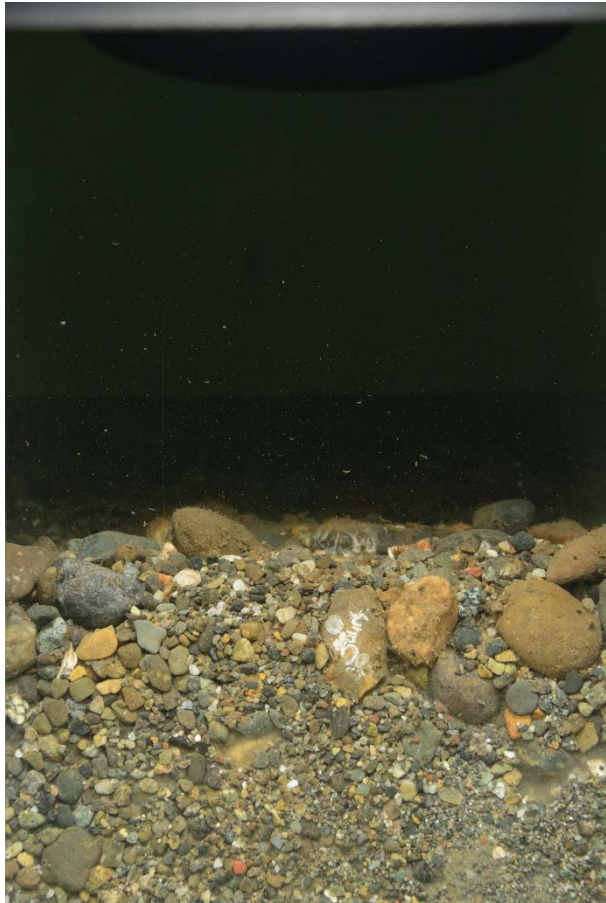
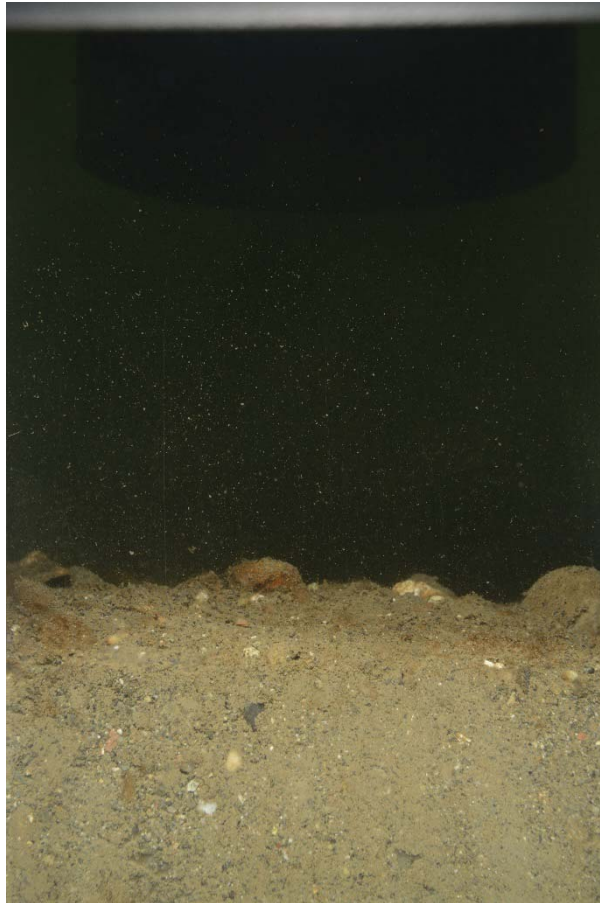
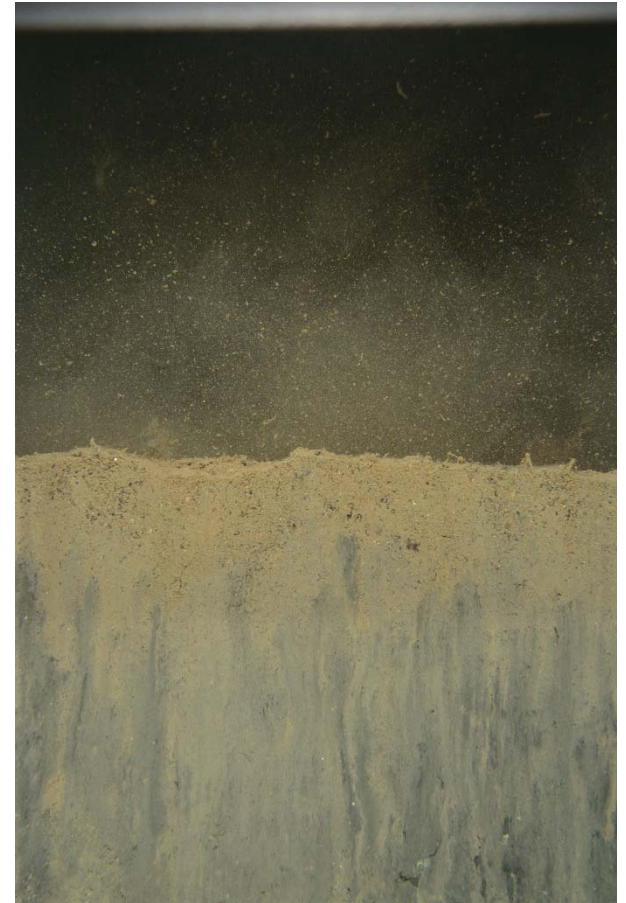
Figure 3-9.

Three SPI images from SC-ENR+AC showing the range of textures observed from left to right: gravels and sand, sand and silt, and silt. Width of each image = 14.42 cm.
ENR/AC Pilot Study Lower Duwamish Waterway

Surface sediments textures captured in the SPI images from the scour ENR+AC subplot are much more varied than those observed in the immediately adjacent ENR subplot (see Figure 2-2), ranging from gravel and sands only, to sand and silt mixtures, and to predominately silt (Figure 3-9). Two stations, 1-B and 3-B, at the northern end the subplot and furthest away from the scour ENR subplot, show cobble, gravel, and sand substrates with no significant fines subfraction. Conversely, the surface sediment at stations 4-A and 6-B, closest the ENR subplot are predominately silt. Other locations show a mix of coarse and fine-grained sediments.

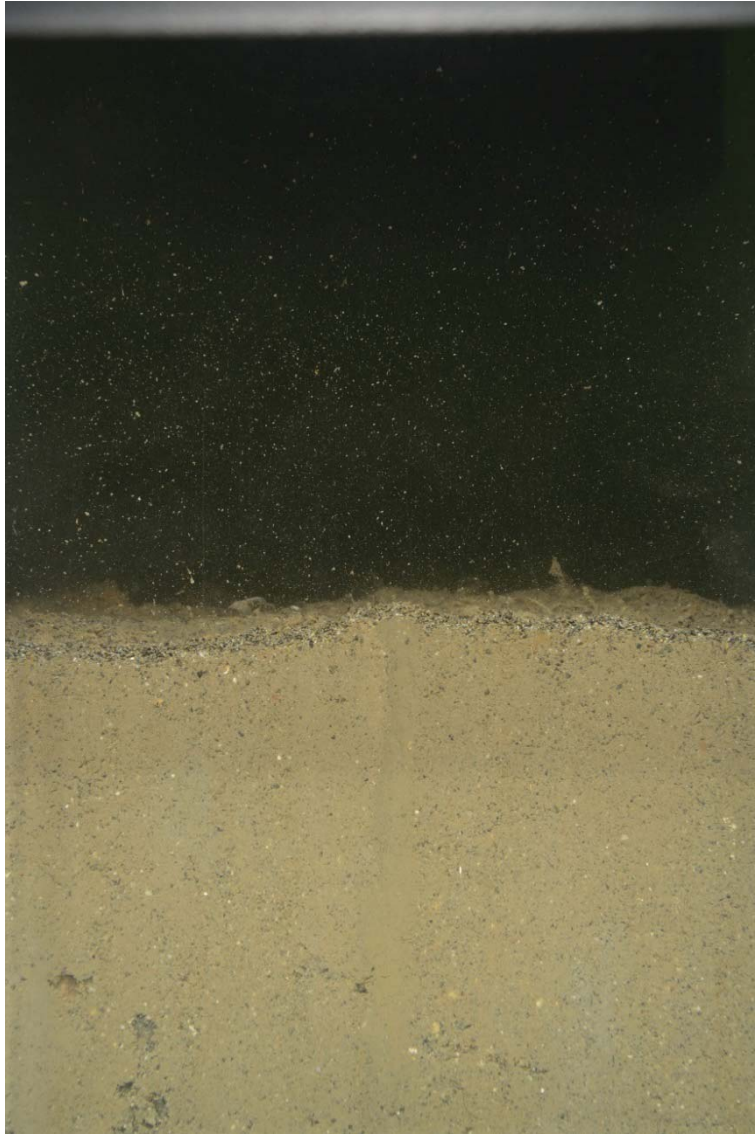
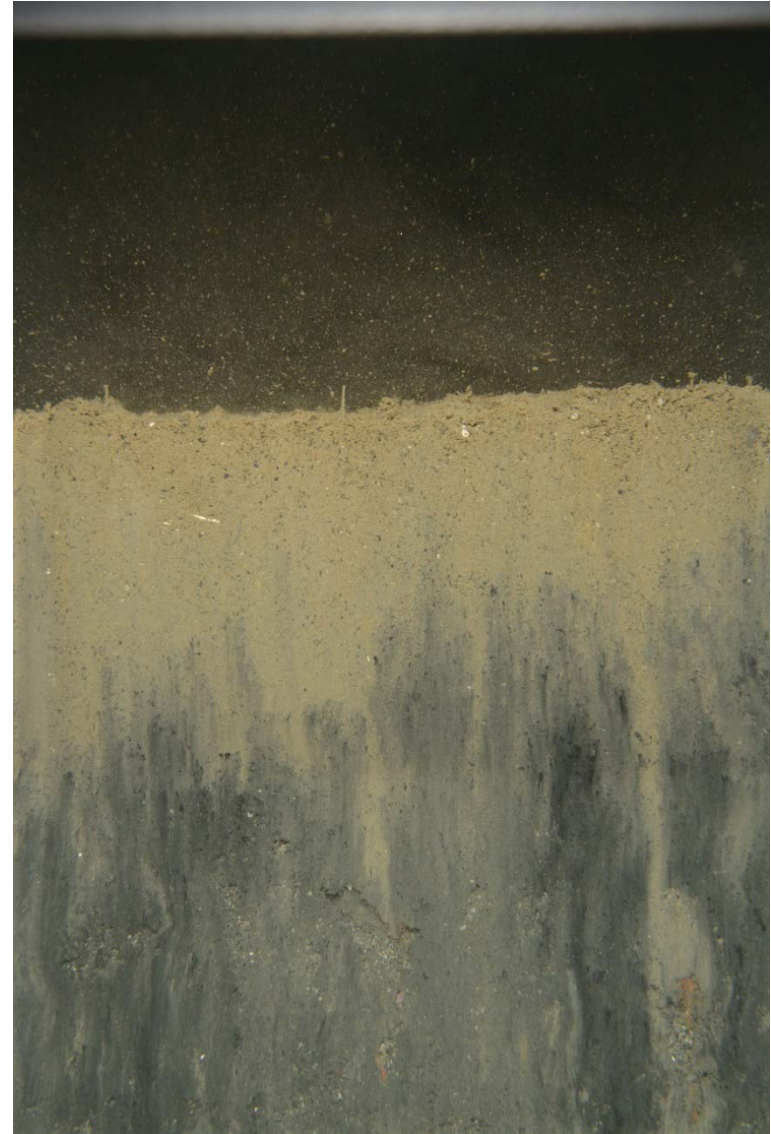
Figure 3-10.

Images from SC-ENR+AC showing black, sand-sized particles at the sediment surface (left) and in subsurface feeding voids (right). Width of SPI images = 14.42 cm.
ENR/AC Pilot Study Lower Duwamish Waterway

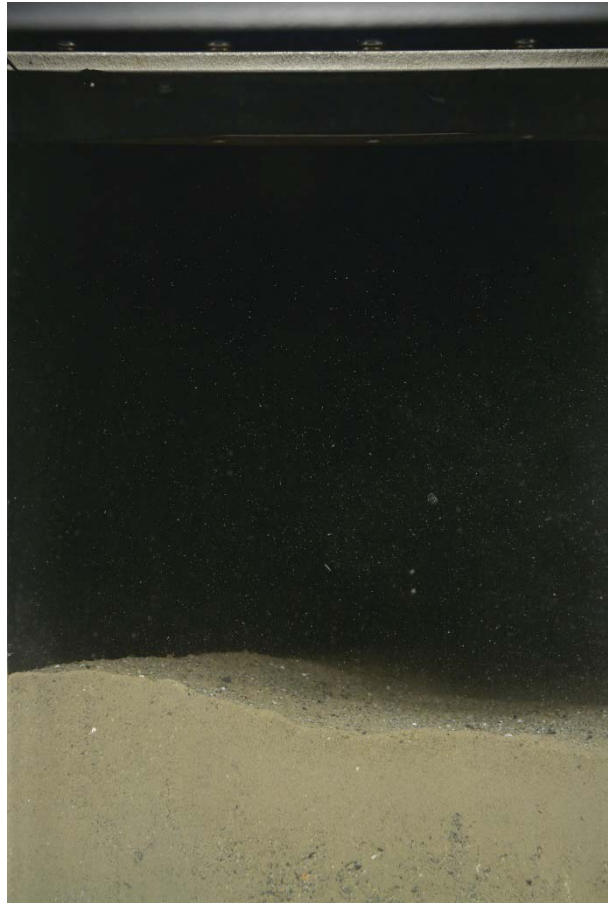
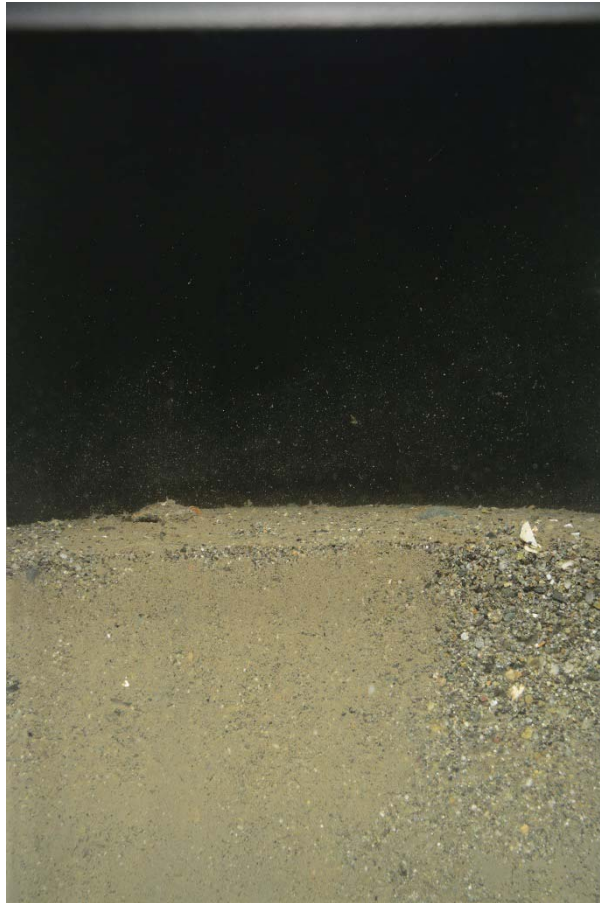
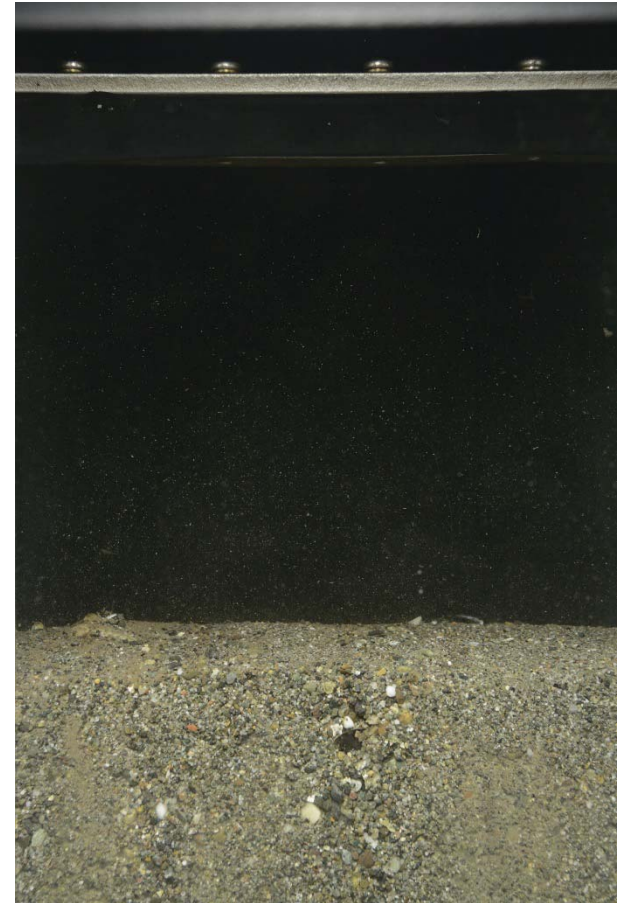
Figure 3-11.

Three SPI images from SU-ENR showing the range of textures observed from left: silt and medium sand mix, silt and coarse sand, and mostly sand. Image width = 14.42 cm.
ENR/AC Pilot Study Lower Duwamish Waterway

Surface sediments captured in the SPI images from the subtidal ENR subplot are predominately mixtures of ENR sands and silts (Table 3-5a). The SPI data set consists of 33 images, no SPI images were obtained at station 2-A. Figure 3-11 shows the range of textures observed from stations 1-A through 5-B. The observed sand and silt mixtures over the entire profile notably contrasts with the predominately silt substrate observed in this subplot during the baseline survey, so it is inferred that this surface texture represents ambient silts mixed into the ENR material. This mixed silt and ENR material matrix exceeds prism penetration at all survey locations, except for station 6-A. The ENR layer thickness was less than penetration in two of the three replicates at station 6-A (Figure 3-12) equaling about 3 cm and 13 cm in those images.

Except at stations 5-B, 6-A, and 6-B where the ENR layer appears intact and overlies the ambient silt bottom, mixed silt and sand (presumably ENR material) surface textures are present throughout this subplot (Figure 3-11 and Table 3-5a). This may be the result of both physical and biological factors. While many images were classified as indeterminate for infaunal successional stage due to limited penetration, both surface and subsurface infauna were observed, with stage 3 organisms, i.e., subsurface bioturbators, noted in 11 of the 33 images. The average aRPD depth for this subplot was 2.6 cm with a range from 1.7 to 4.3 cm, this compares to a mean aRPD depth of 1.3 cm and range of 0.2 to 3.0 cm measured in the baseline SPI survey (Table 3-7). The PV images also show evidence of infauna and epifauna presence at this subplot, with surface worm tubes and epibenthic tracks detected in 20 and 14 of the 36 PV images, respectively, and epifaunal organisms noted in 11 of the images (Table 3-5b).

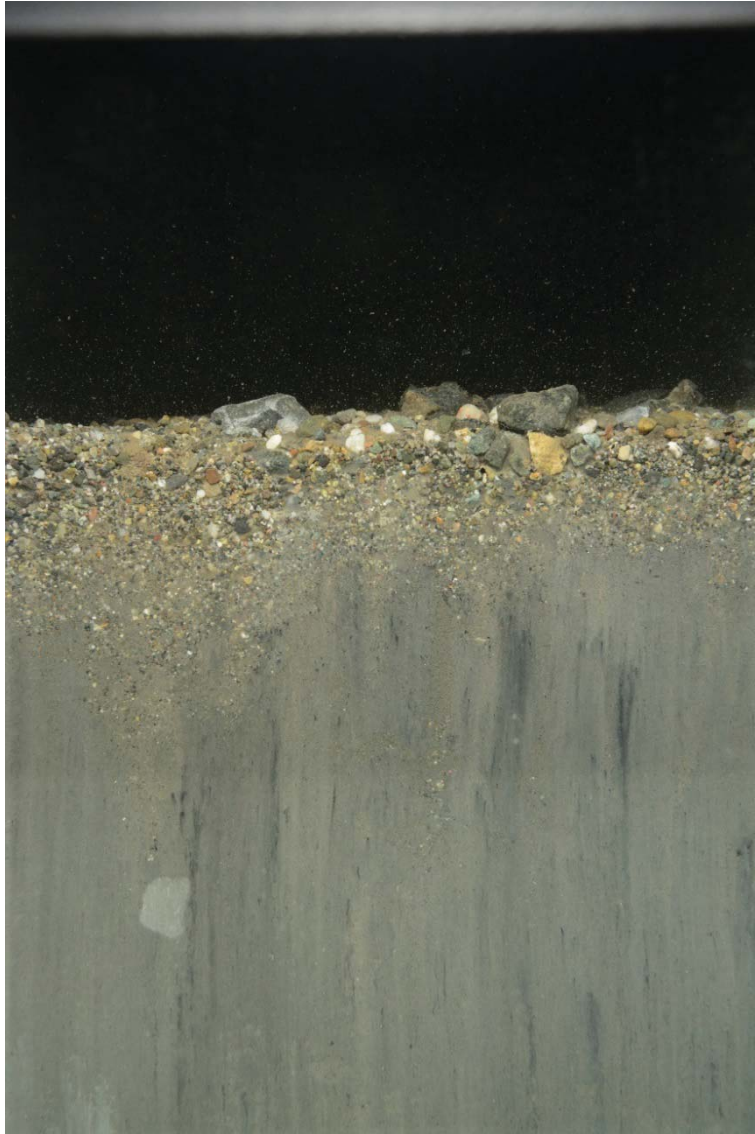
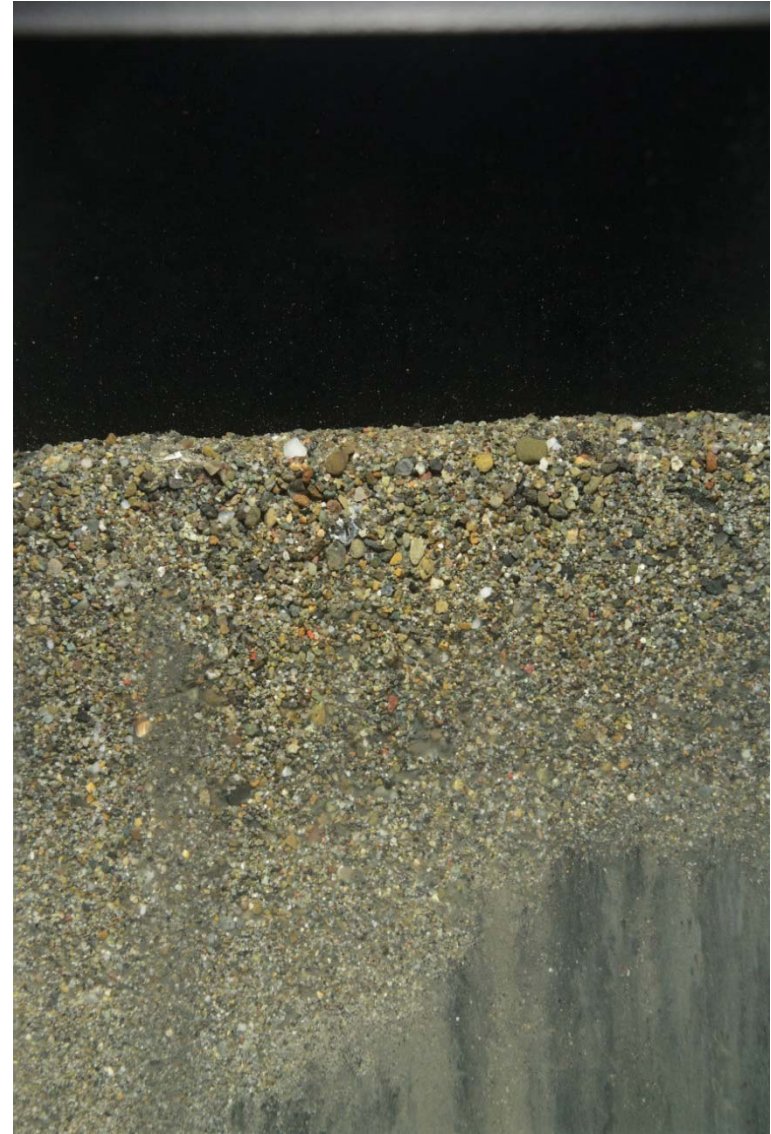
Figure 3-12.

Images from SU-ENR-6-A showing thin ENR material over ambient sediment. ENR layers are 2–3 cm (left) and 8–13 cm (right) thick. Width of SPI images = 14.42 cm.
ENR/AC Pilot Study Lower Duwamish Waterway

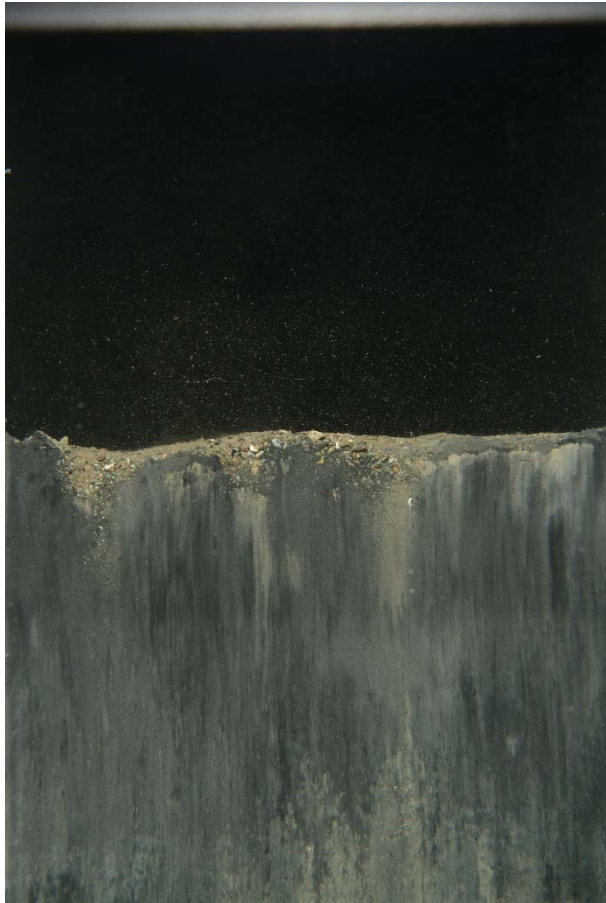
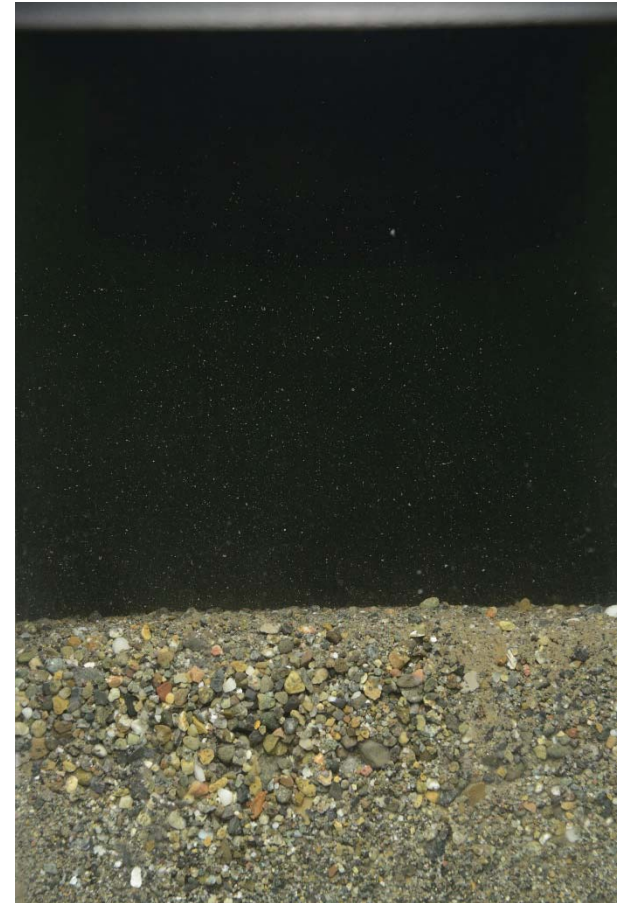
Figure 3-13.

Three SPI images from SU-ENR+AC showing the range of textures observed from left: silt, sand and silt mix, and sand and gravel. Image width = 14.42 cm.

The three SPI images in Figure 3-13 show the range of surface sediment textures observed in the subtidal ENR+AC, from all silt, through silt and sand mixture, to all sand and gravel. The ENR+AC layer exceeds prism penetration stations 1-B, 2-A, 3-A, 3-B, 4-A, and 4-B (Table 3-6a). At stations 1-A and 2-B, thin (~1–2 cm) sand layers are present over silty sand mixtures which likely represents the ENR material mixed with ambient sediments, but this cannot be concluded with certainty. At most of the SPI replicates from stations 5-A, 5-B, 6-A, and 6-B, evidence of the ENR+AC material is limited to a very thin (<1 cm) sand layers at the sediment surface (Figure 3-14 and Table 3-6a). At stations 5-A (left image in Figure 3-14) and 5-B, and replicate 6-A-R2, sediments immediately below the surface sand veneer appear to be highly, reduced (i.e. dark gray to black) muds. This suggests a relatively recent physical disturbance/scour of the ENR+AC material in these grid cells.
