APPENDIX F

Sediment Profile Image/Plan View Image Reports
(Baseline and Year 1)

BASELINE SPI/PV DATA REPORT

ENHANCED NATURAL RECOVERY/ACTIVATED CARBON PILOT STUDY
LOWER DUWAMISH WATERWAY

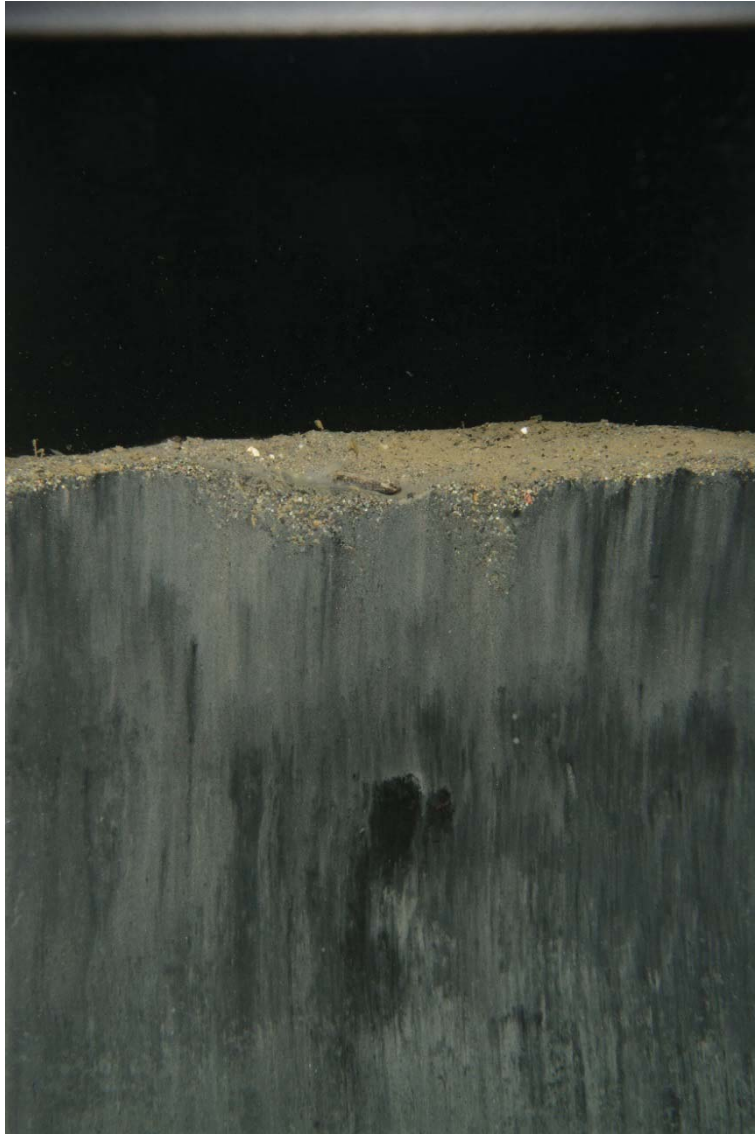
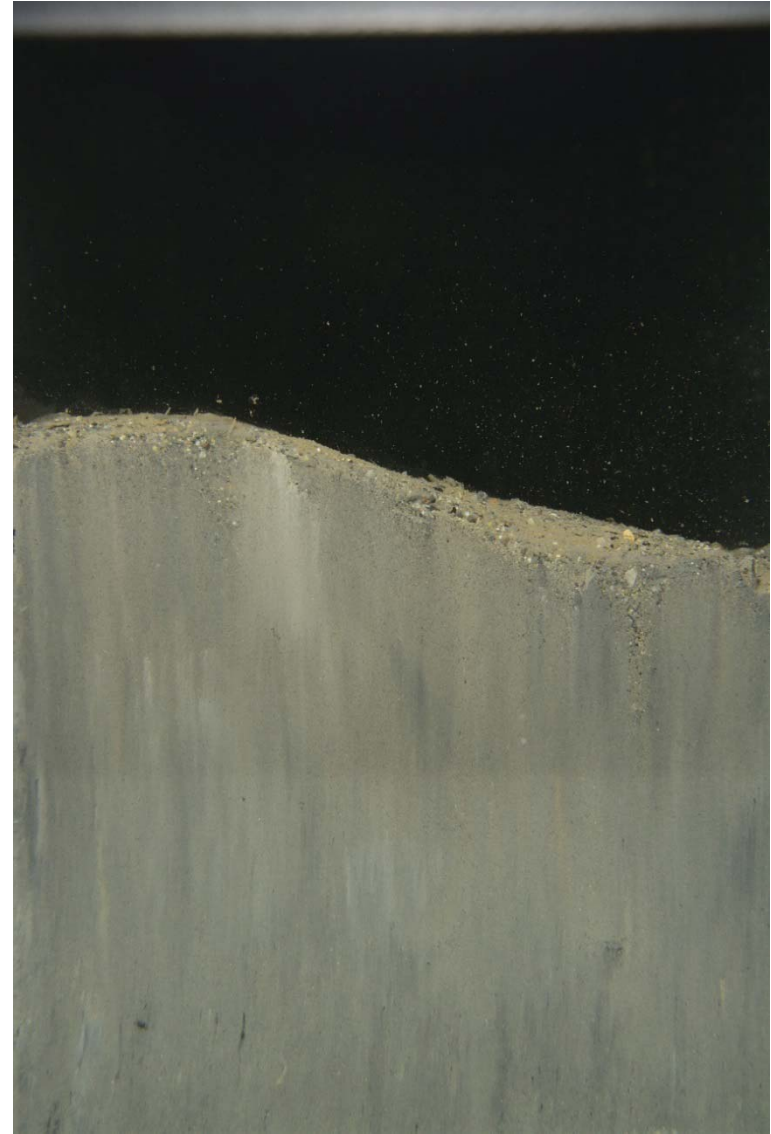
Figure 3-14.

Images from SU-ENR+AC showing very thin (<1 cm) ENR+AC material over ambient sediment at Stations 5-A and 6-A. Width of SPI images = 14.42 cm.
ENR/AC Pilot Study Lower Duwamish Waterway

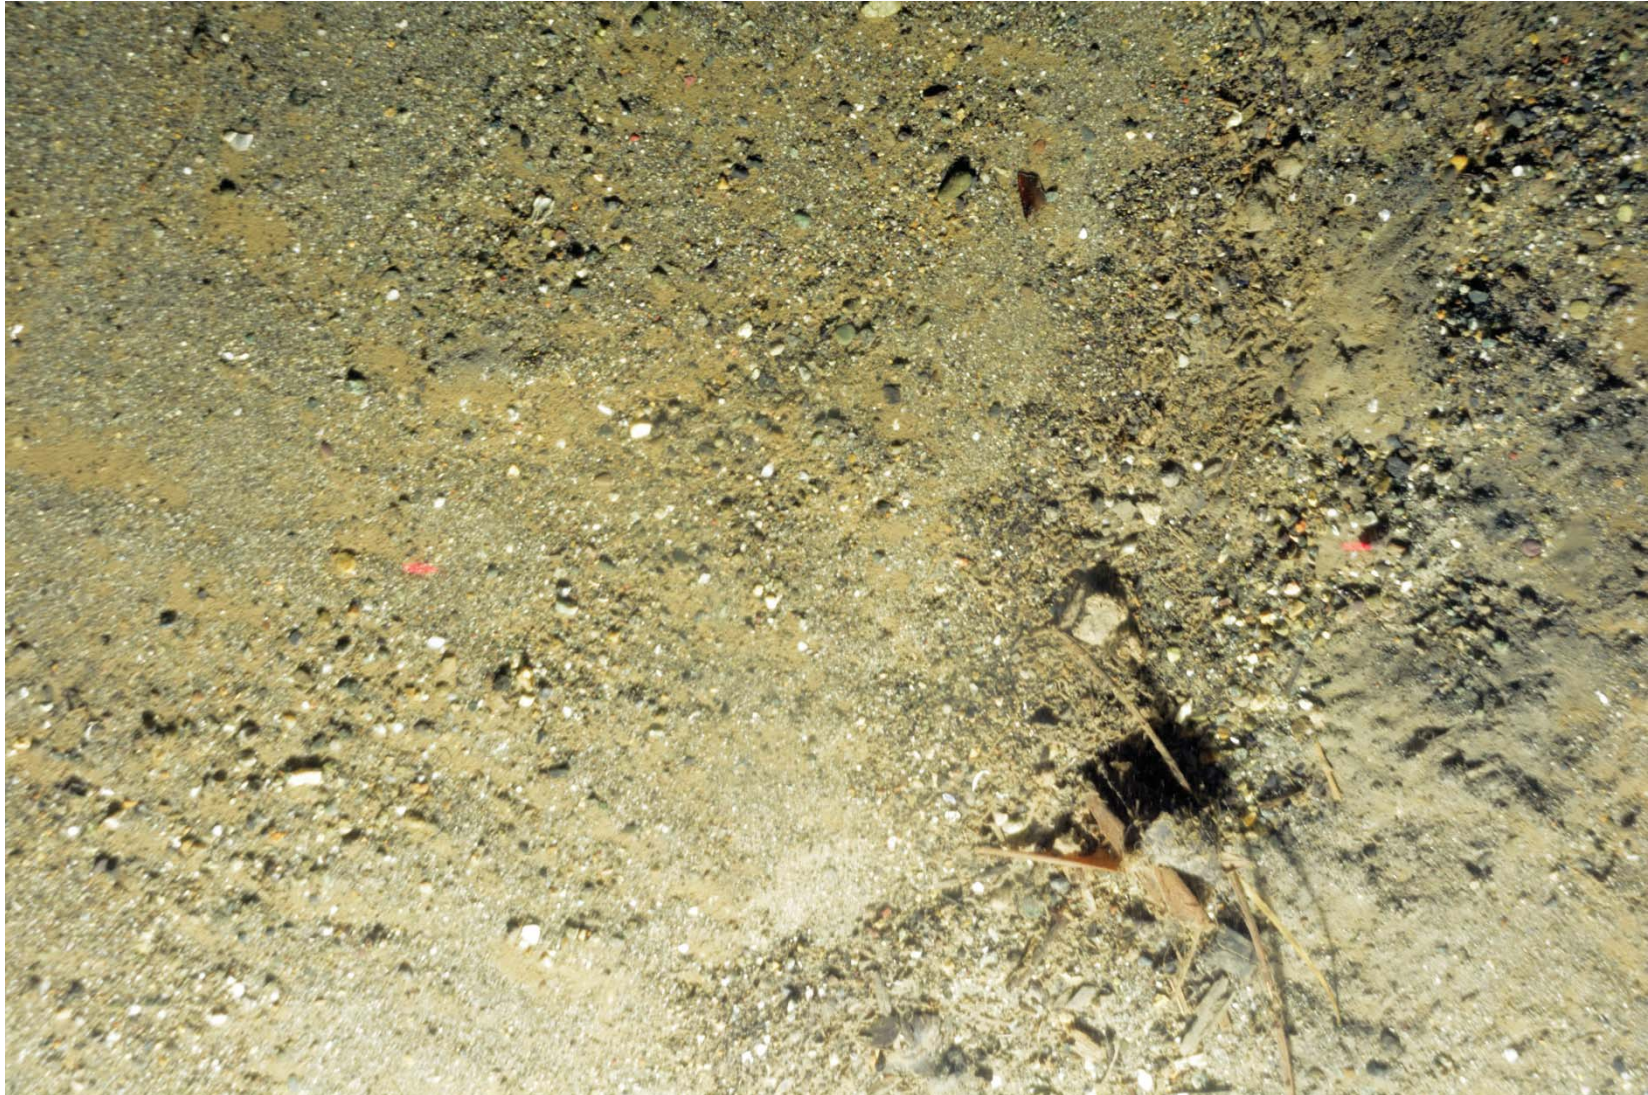
Figure 3-15.

Plan view image from the SU-ENR+AC subplot showing coarse-grained bottom with patchy silt deposits and some leaf and wood debris. Scale: red laser dots are 26 cm apart.
ENR/AC Pilot Study Lower Duwamish Waterway

Comparable to the subtidal ENR subplot, evidence of higher-order successional infauna were observed in a third of the SPI images (12 of 36). The average aRPD depth for the subplot was 1.3 cm with a range from 0.0 to 3.8 cm (Table 3-7), this average is lower than the adjacent ENR subplot average and appears to be due very thin aRPDs measured in recent, physically disturbed surface sediments in grid cells 5 and 6 (Table 3-6a). The PV image data is provided in Table 3-6b and is comparable to the results from the subtidal ENR plot. In addition to some evidence of infauna and epifauna in this subplot (Table 3-6b), wood and leaf debris is present in many of the PV images from this channel setting (Figure 3-15).

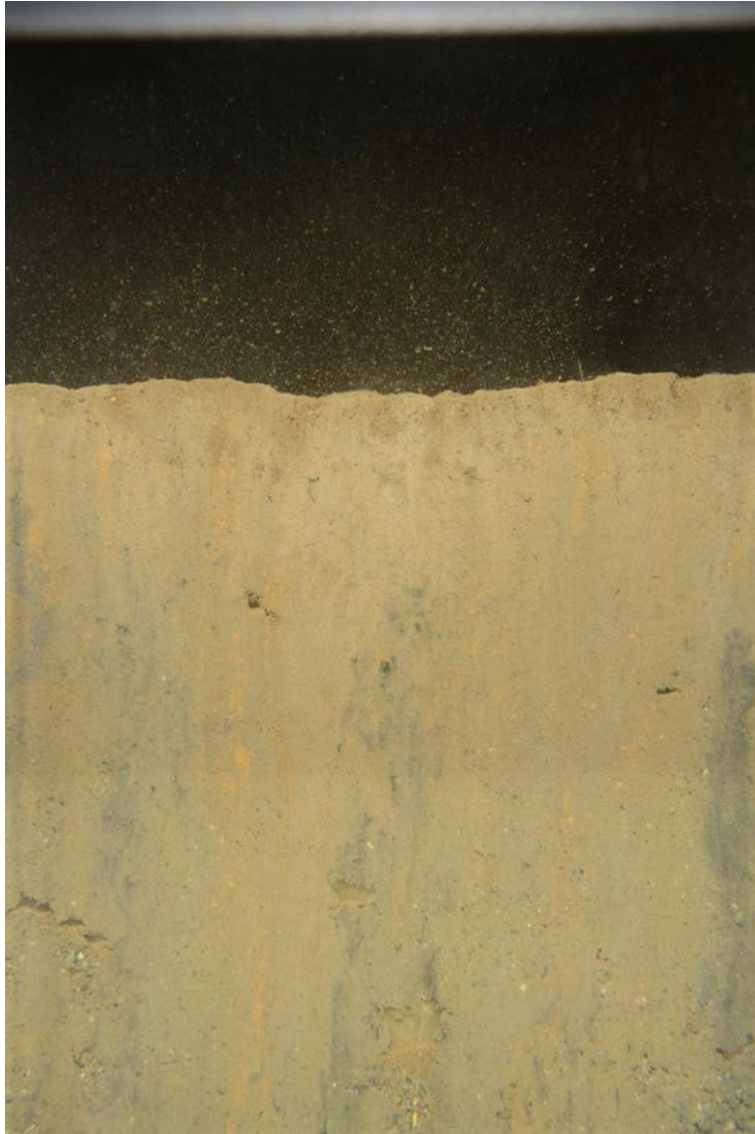
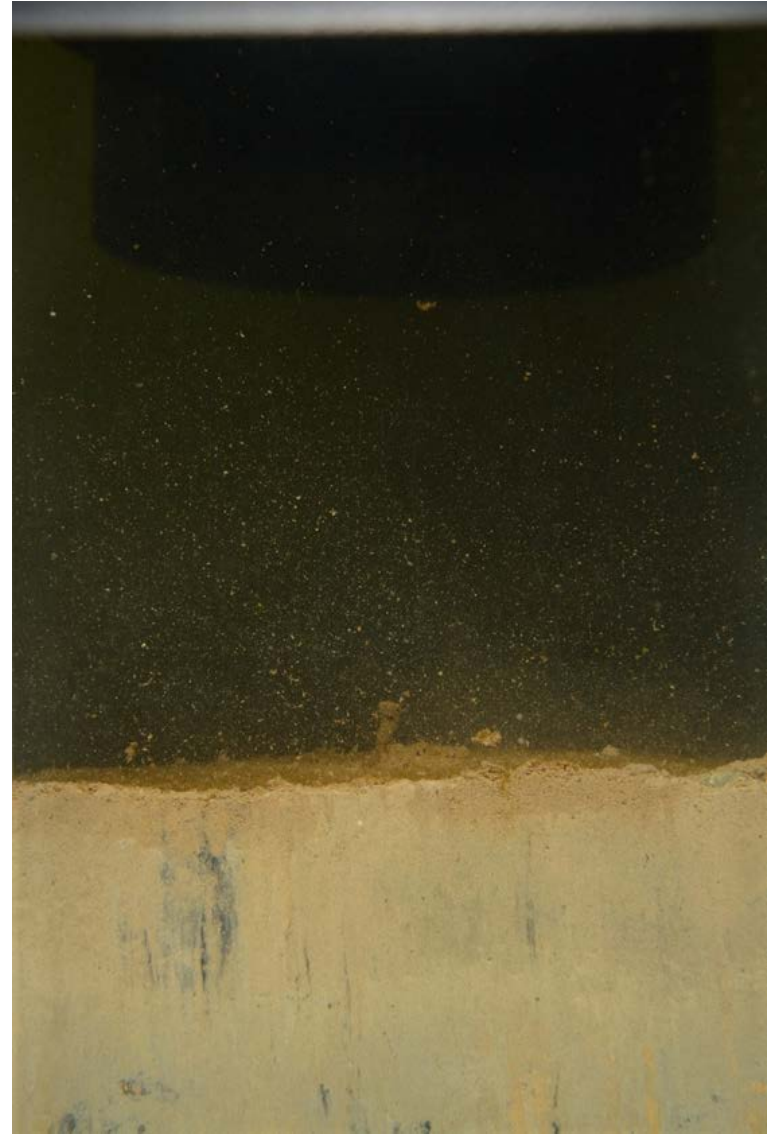
Figure 3-2.

Image 1-A-R3 (left) shows 6 cm of silt over an ENR sand and silt mix. Image 6-B-R2 shows 6 cm of silt with no evidence of ENR material. Width of SPI images = 14.42 cm.
ENR/AC Pilot Study Lower Duwamish Waterway

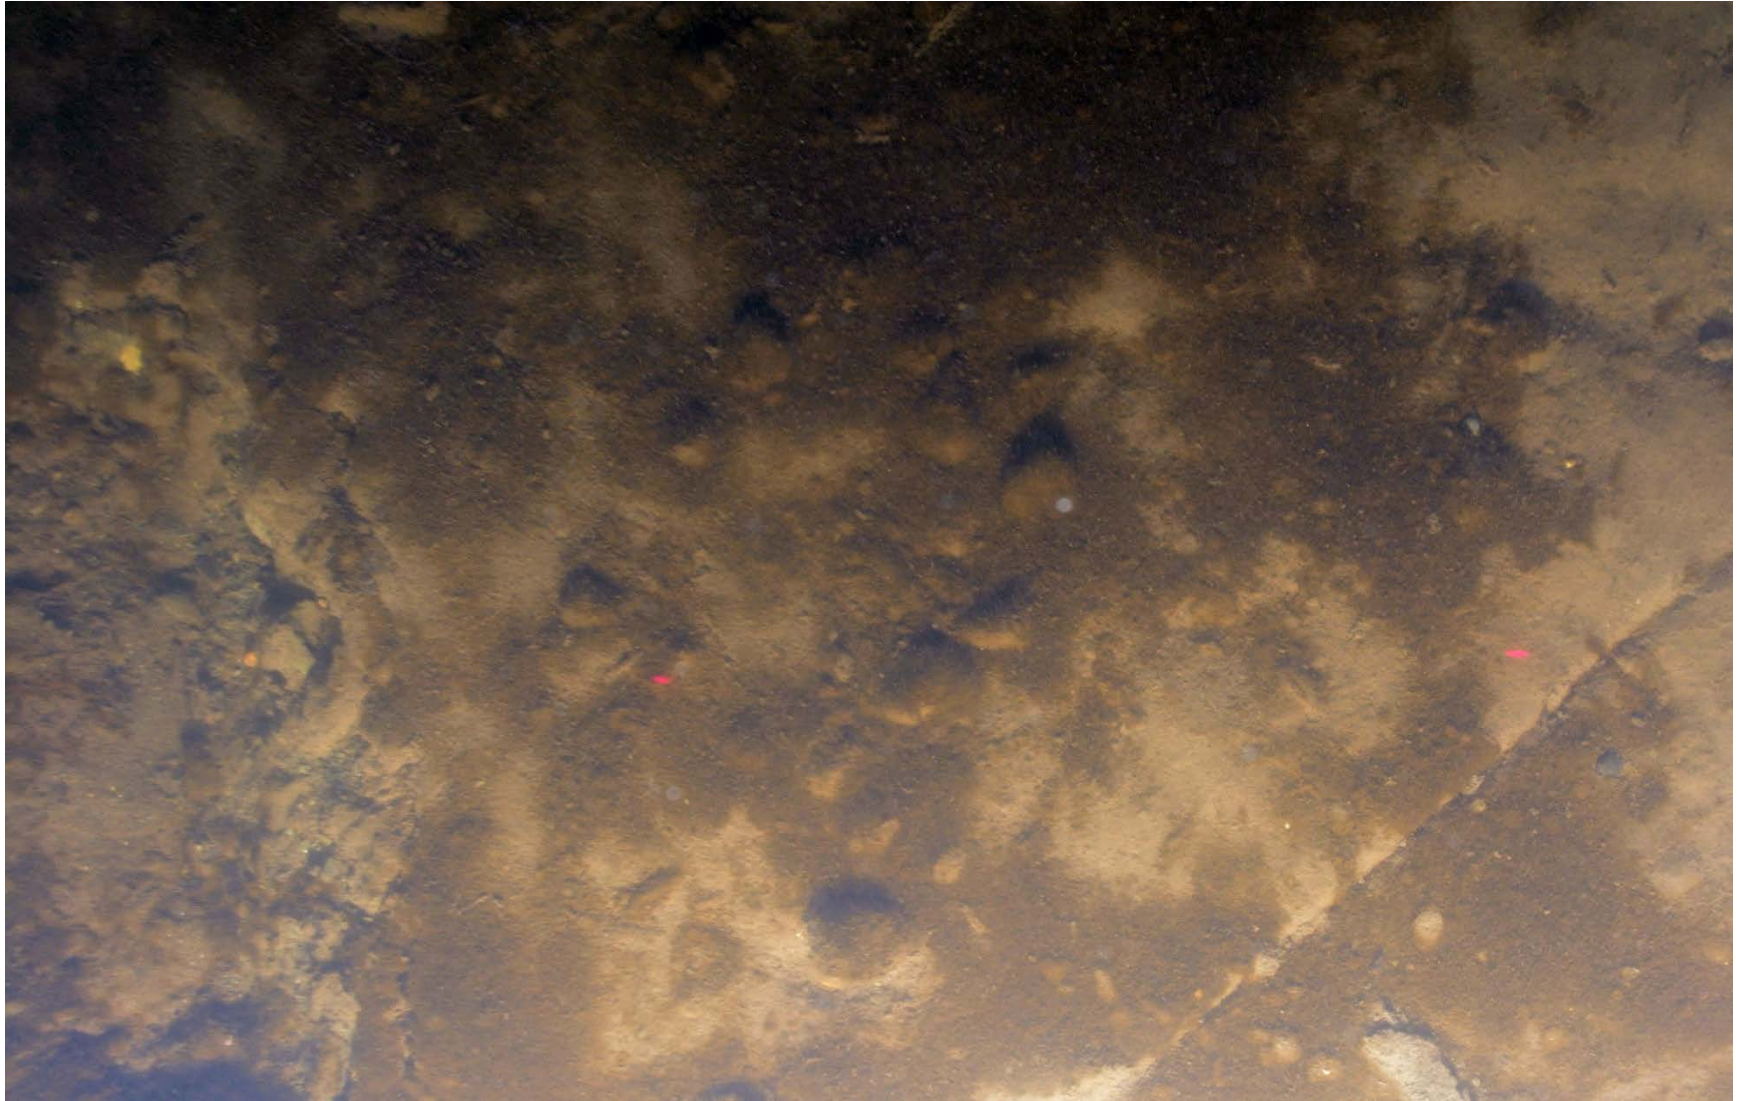
Figure 3-3.

Plan view image from IN-ENR-6-B showing ENR gravels at a station where ENR material was not evident in all SPI replicates (see Figure 3-2). Scale: red laser dots are 26 cm apart.
ENR/AC Pilot Study Lower Duwamish Waterway

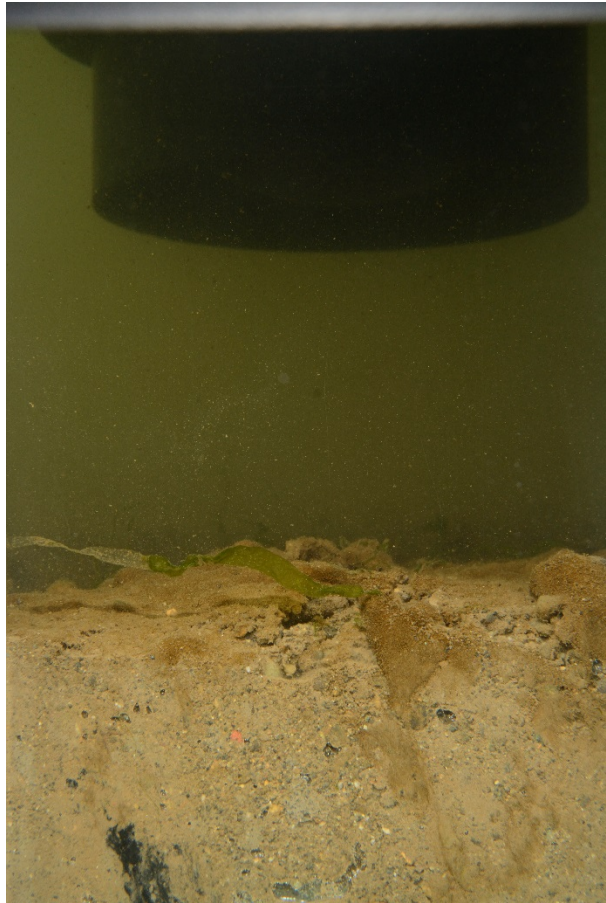
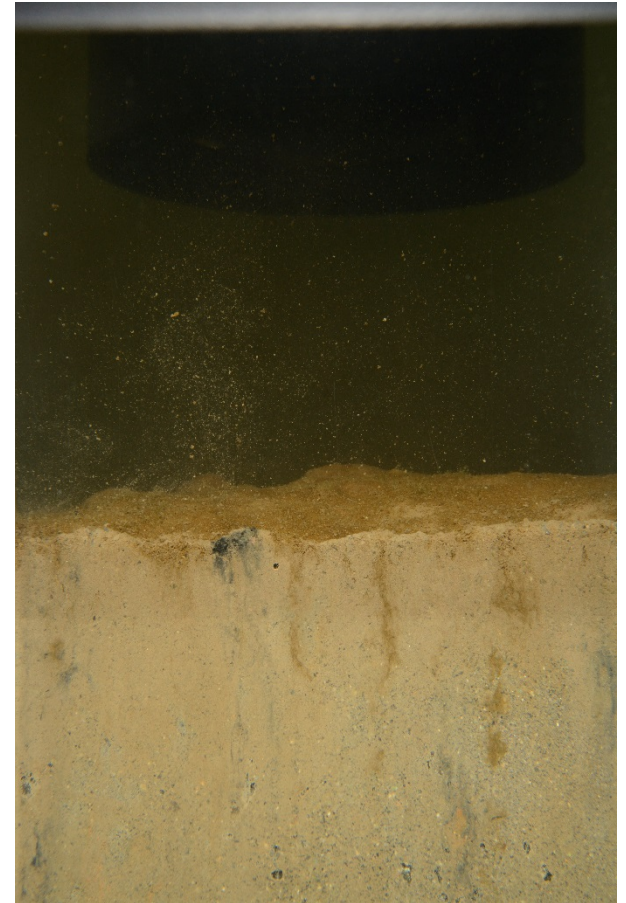
Figure 3-4.

Three SPI images from IN-ENR+AC showing a coarse sand and silt (left), gravel, sand, and silt (middle), and medium sand and silt mixtures (right). Image width = 14.42 cm.
ENR/AC Pilot Study Lower Duwamish Waterway

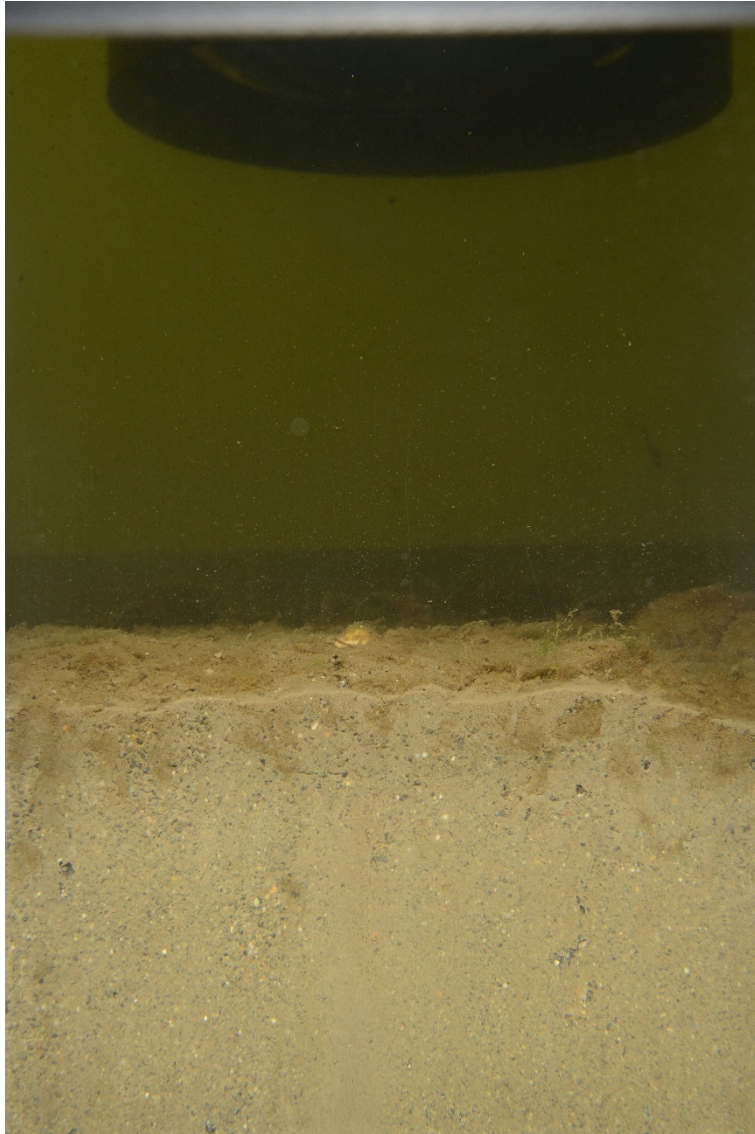
Figure 3-6.

Both images, ENR 2A-R3 and ENR+AC 2B-R3 show sand and silt mixtures with black, sand-sized particles throughout the profile. Width of SPI images = 14.42 cm.
ENR/AC Pilot Study Lower Duwamish Waterway

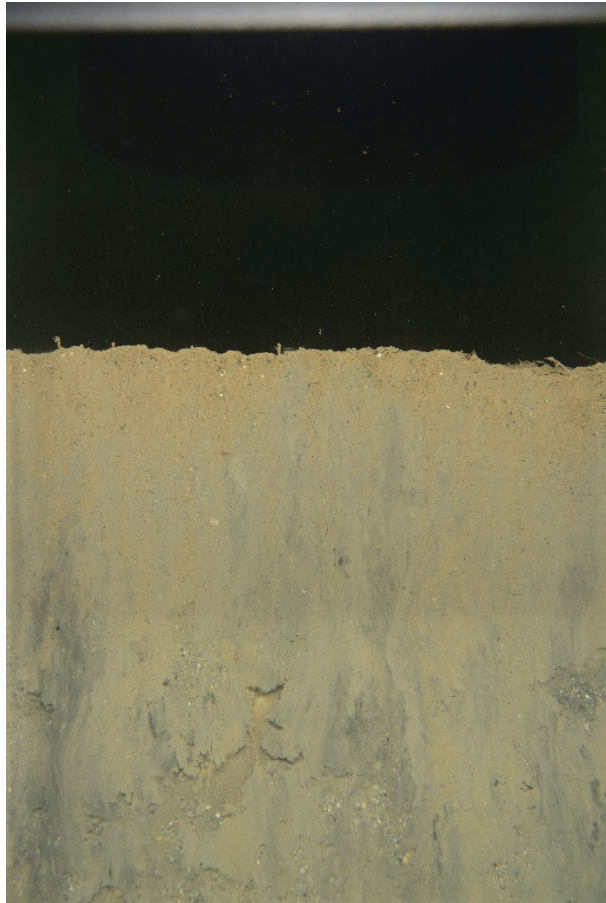
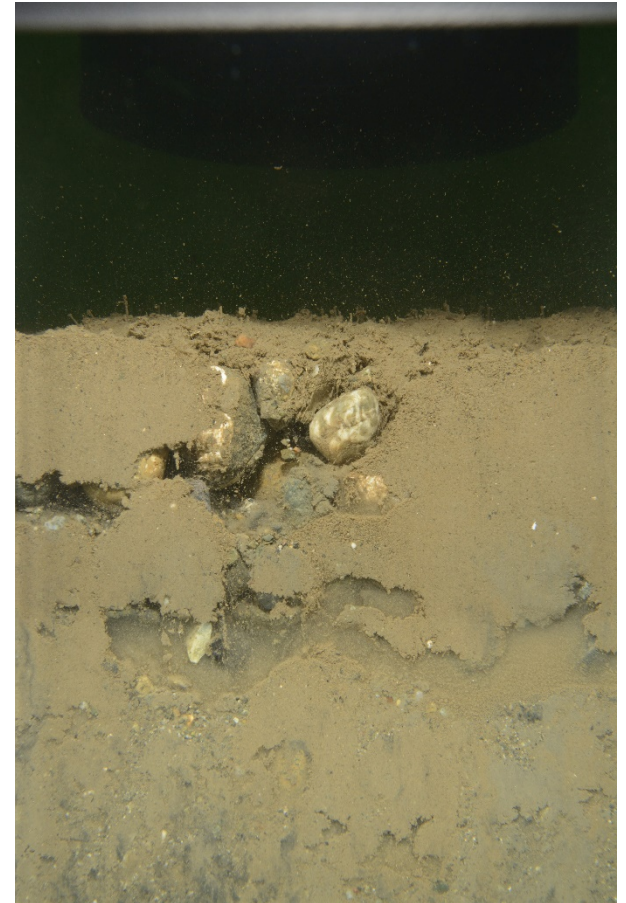
Figure 3-7.

Three SPI images from the SC-ENR subplot showing the predominately fine-grained texture at this site. Width of each image = 14.42 cm.

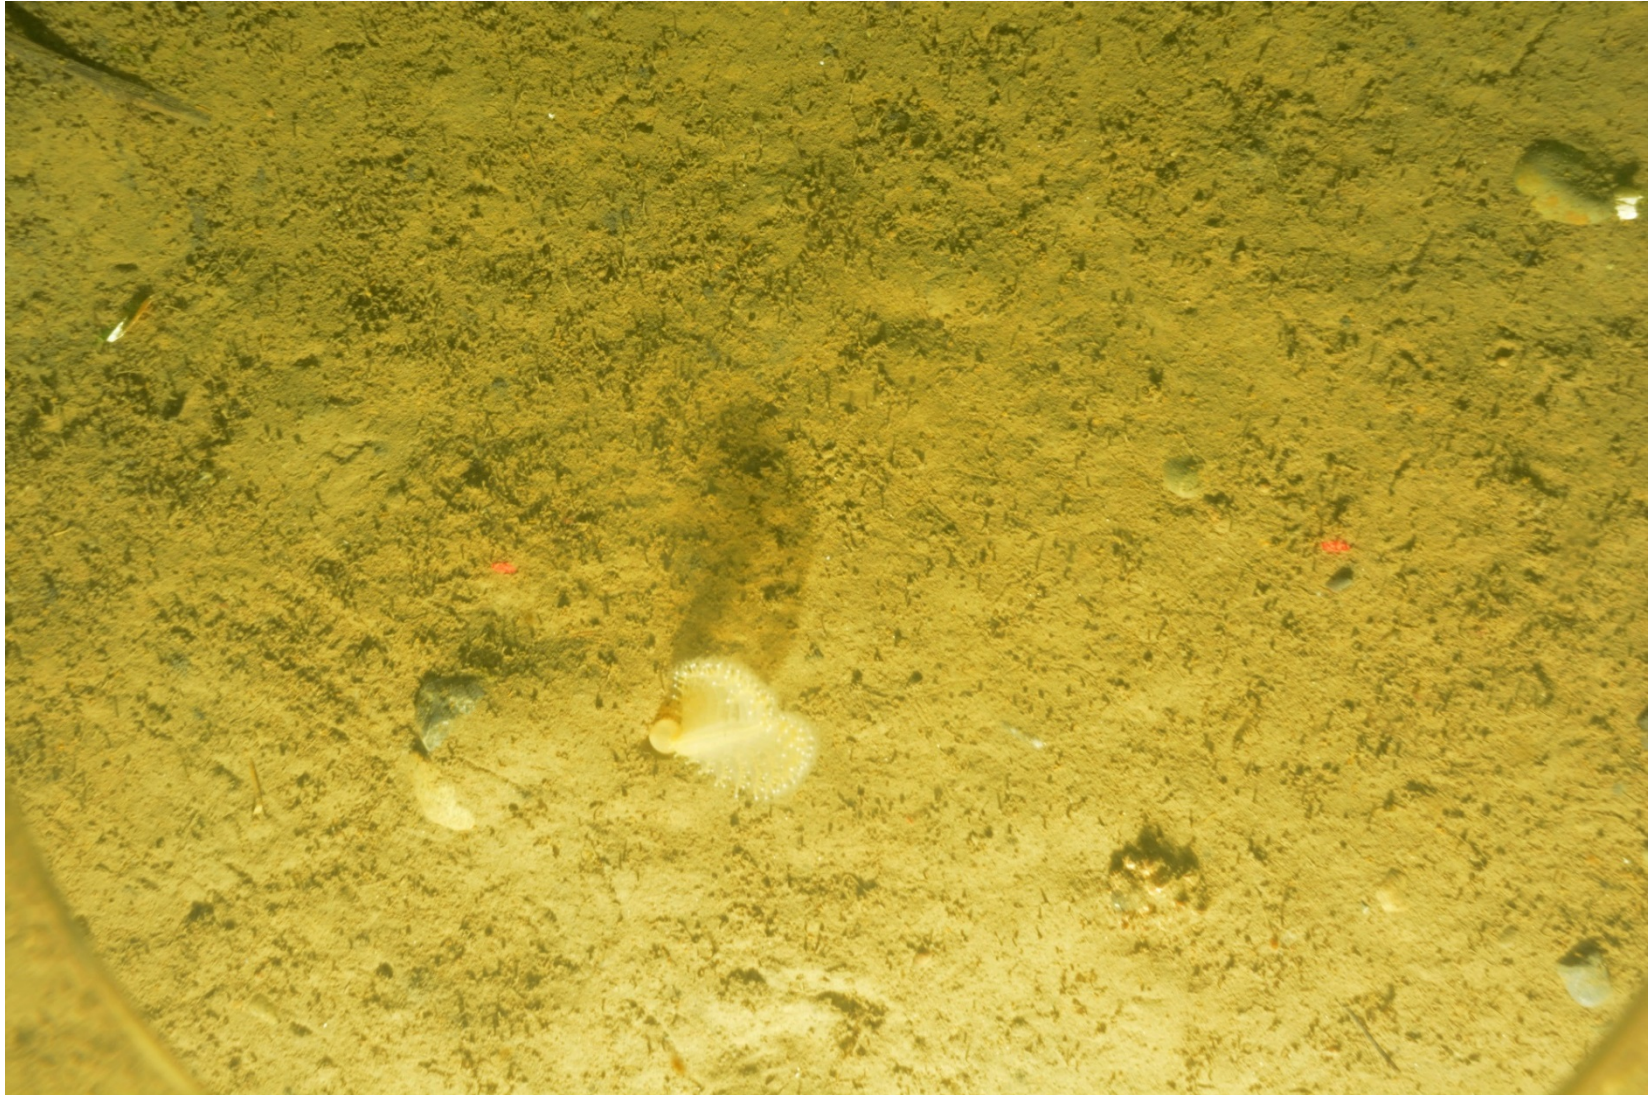
Figure 3-8.

Plan view image of the SC-ENR subplot showing widespread surface worm tubes, tracks, and a sea pen, as well as some ENR gravel. Scale: the red laser dots are 26 cm apart.
ENR/AC Pilot Study Lower Duwamish Waterway

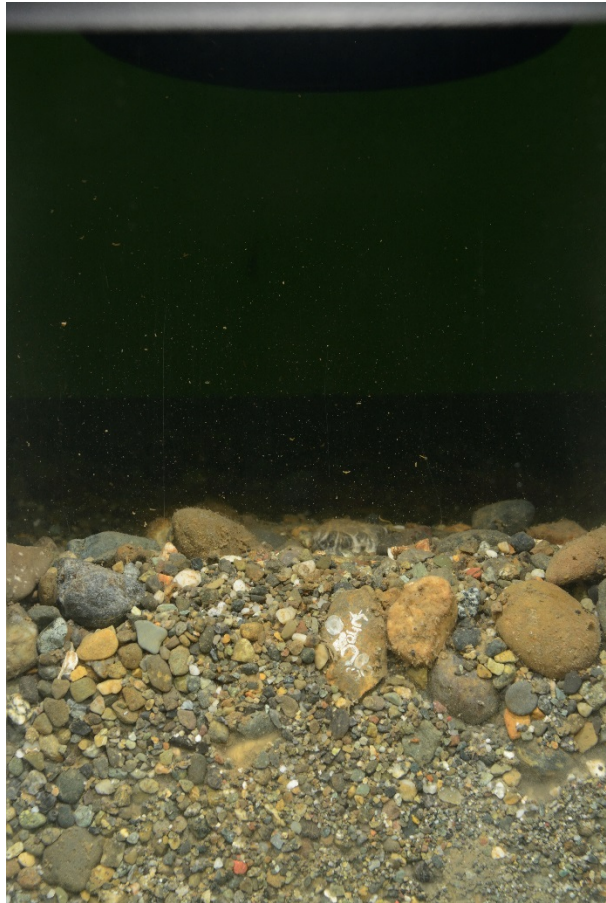
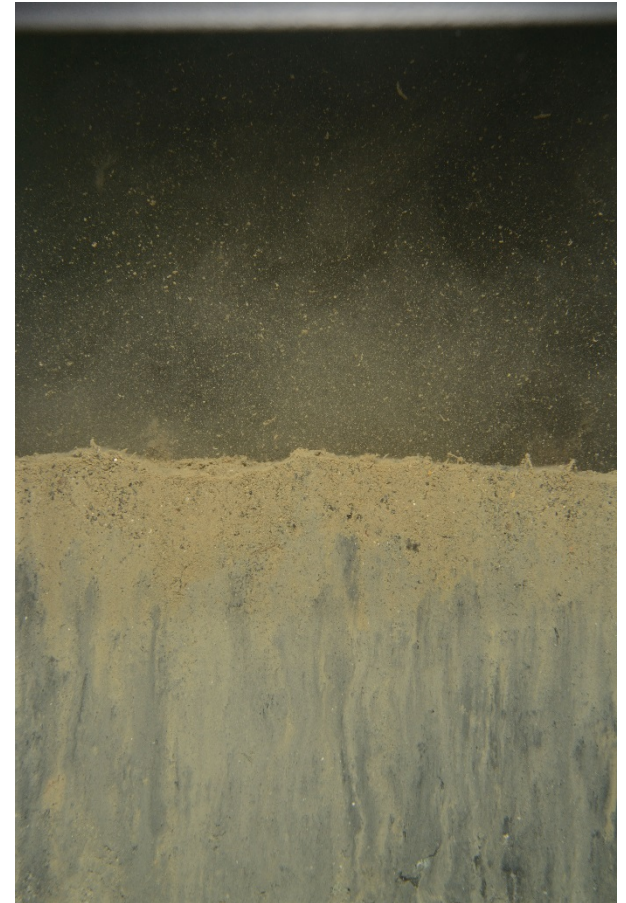
Figure 3-9.

Three SPI images from SC-ENR+AC showing the range of textures observed from left to right: gravels and sand, sand and silt, and silt. Width of each image = 14.42 cm.
ENR/AC Pilot Study Lower Duwamish Waterway

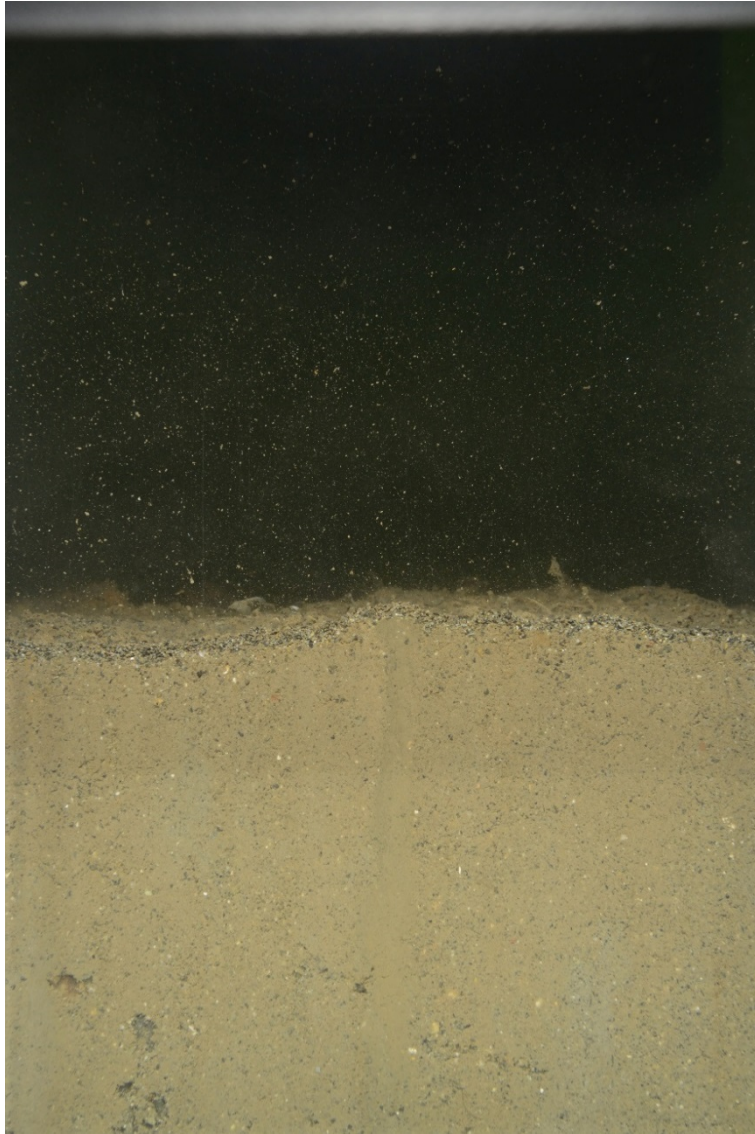
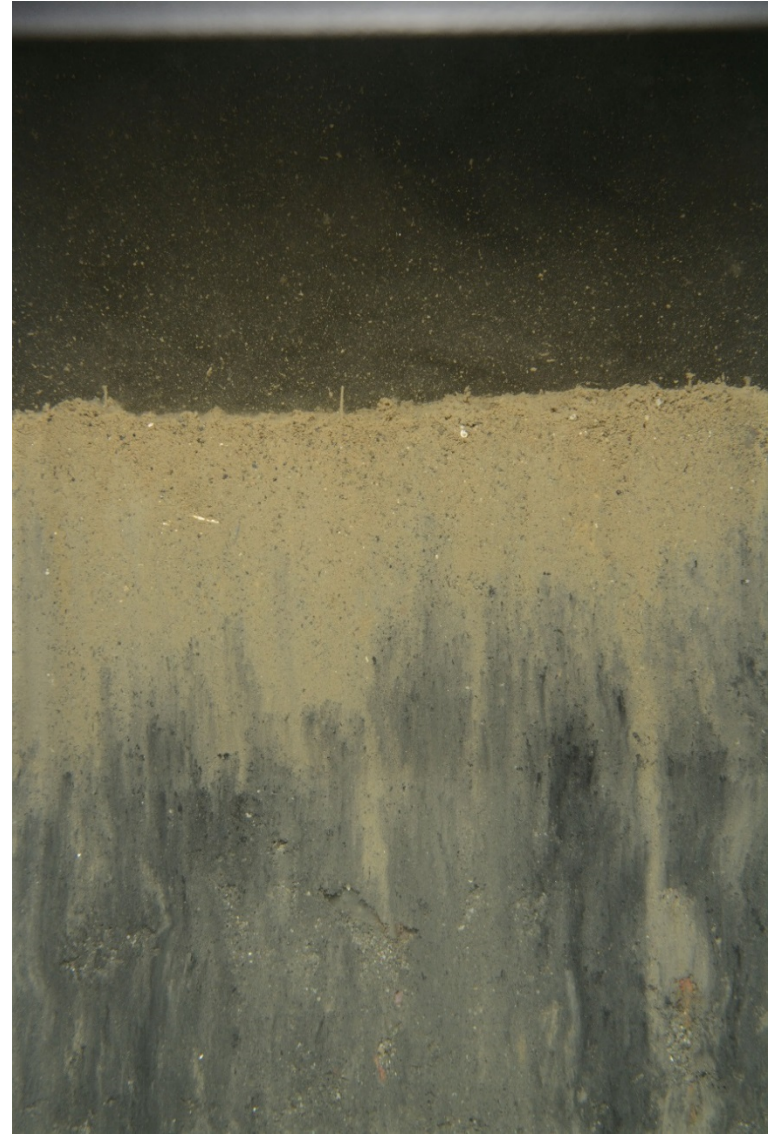
Figure 3-10.

Images from SC-ENR+AC showing black, sand-sized particles at the sediment surface (left) and in subsurface feeding voids (right). Width of SPI images = 14.42 cm.
ENR/AC Pilot Study Lower Duwamish Waterway

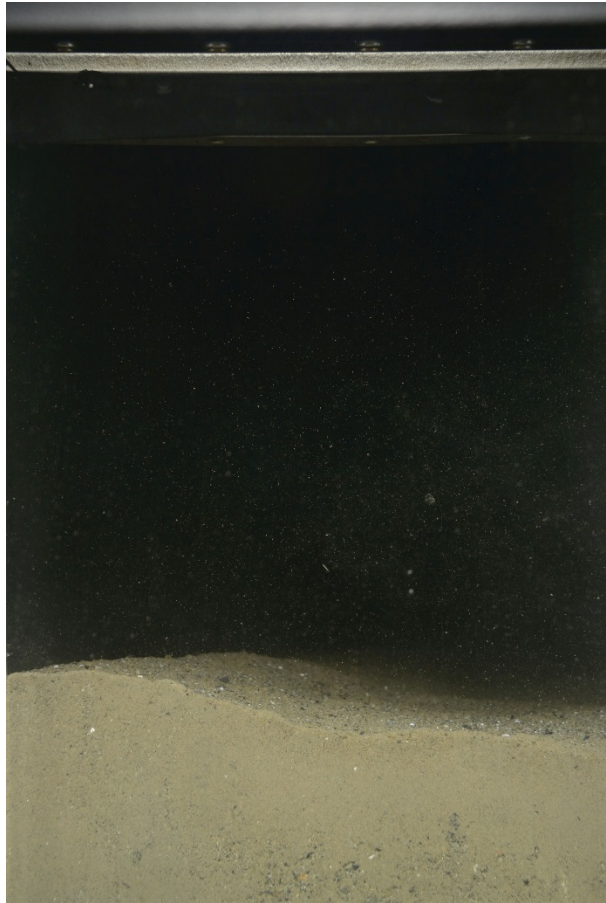
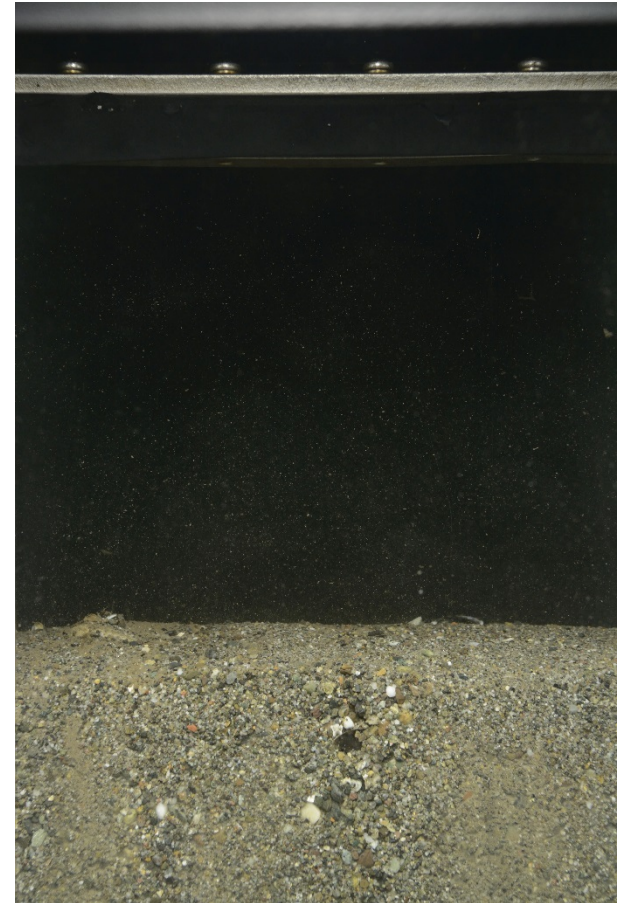
Figure 3-11.

Three SPI images from SU-ENR showing the range of textures observed from left: silt and medium sand mix, silt and coarse sand, and mostly sand. Image width = 14.42 cm.
ENR/AC Pilot Study Lower Duwamish Waterway

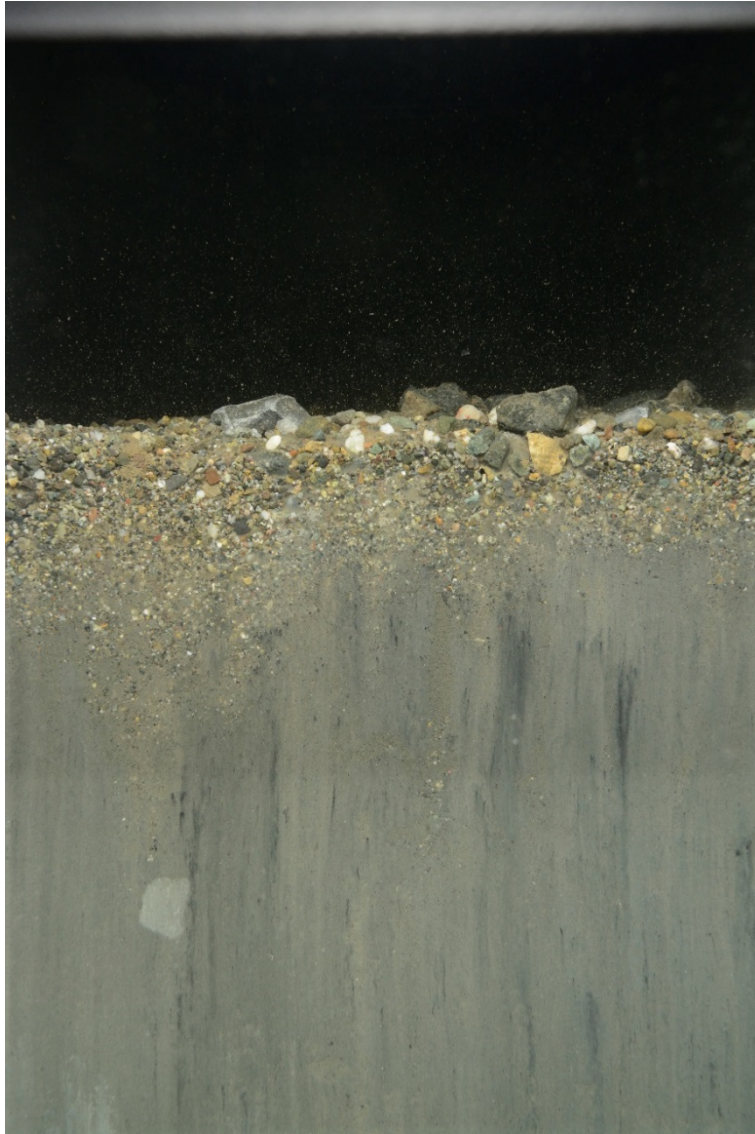
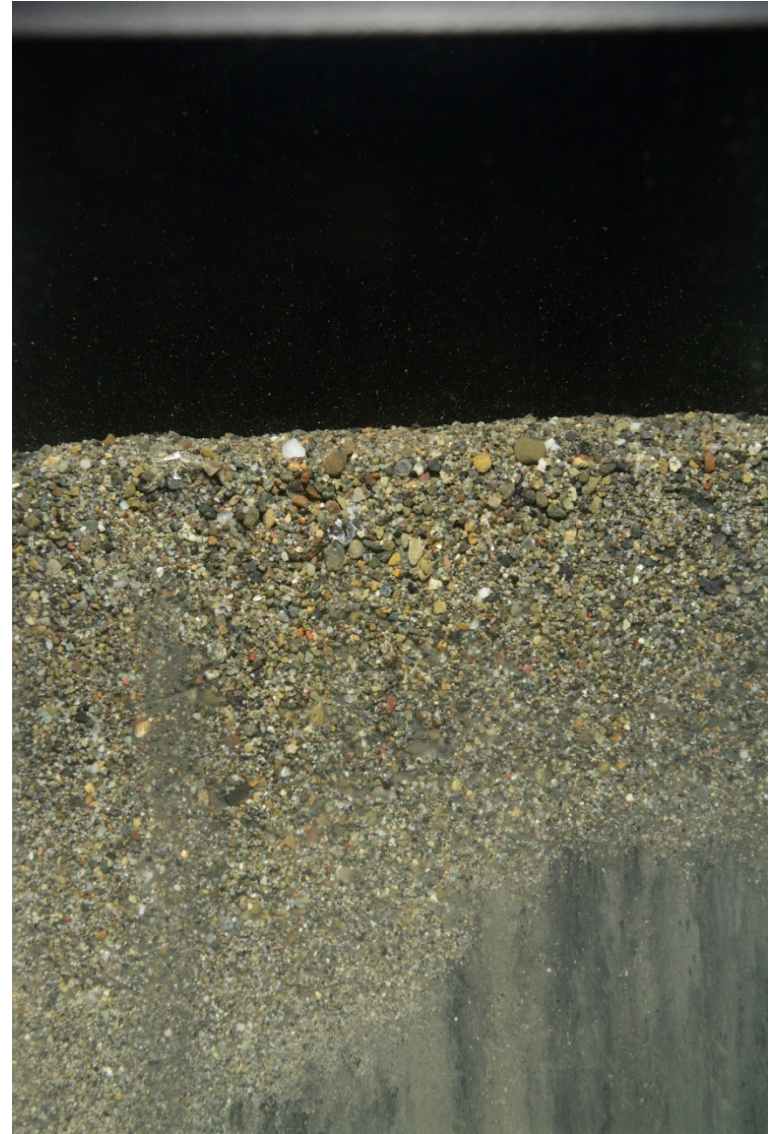
Figure 3-12.

Images from SU-ENR-6-A showing thin ENR material over ambient sediment. ENR layers are 2–3 cm (left) and 8–13 cm (right) thick. Width of SPI images = 14.42 cm.
ENR/AC Pilot Study Lower Duwamish Waterway

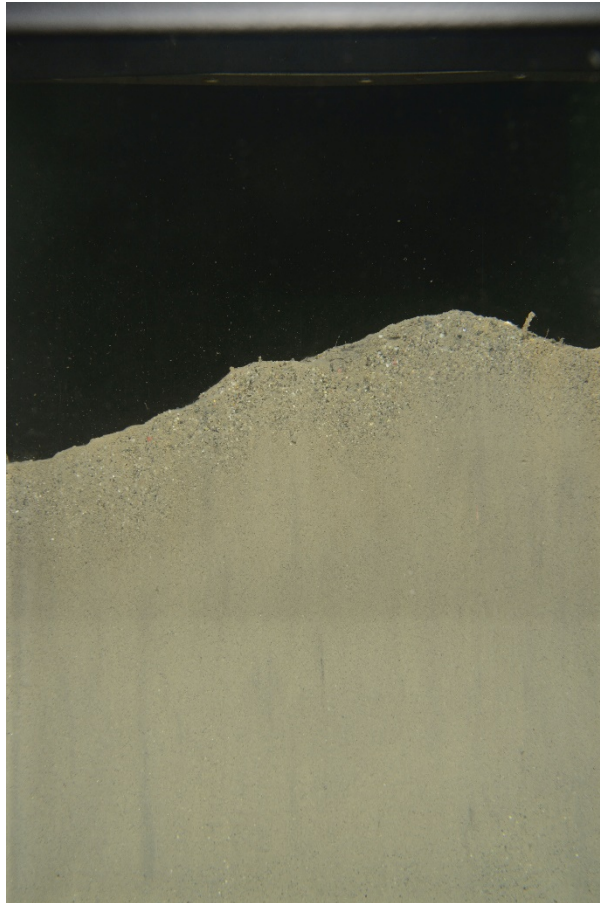
Y1-SU-ENR+AC-2-A-SPI-R3

Images from SU-ENR+AC showing very thin (<1 cm) ENR+AC material over ambient sediment at Stations 5-A and 6-A. Width of SPI images = 14.42 cm.
ENR/AC Pilot Study Lower Duwamish Waterway

The three SPI images in Figure 3-13 show the range of surface sediment textures observed in the subtidal ENR+AC, from all silt, through silt and sand mixture, to all sand and gravel. The ENR+AC layer exceeds prism penetration stations 1-B, 2-A, 3-A, 3-B, 4-A, and 4-B (Table 3-6a). At stations 1-A and 2-B, thin (~1–2 cm) sand layers are present over silty sand mixtures which likely represents the ENR material mixed with ambient sediments, but this cannot be concluded with certainty. At most of the SPI replicates from stations 5-A, 5-B, 6-A, and 6-B, evidence of the ENR+AC material is limited to a very thin (<1 cm) sand layers at the sediment surface (Figure 3-14 and Table 3-6a). At stations 5-A (left image in Figure 3-14) and 5-B, and replicate 6-A-R2, sediments immediately below the surface sand veneer appear to be highly, reduced (i.e. dark gray to black) muds. This suggests a relatively recent physical disturbance/scour of the ENR+AC material in these grid cells.

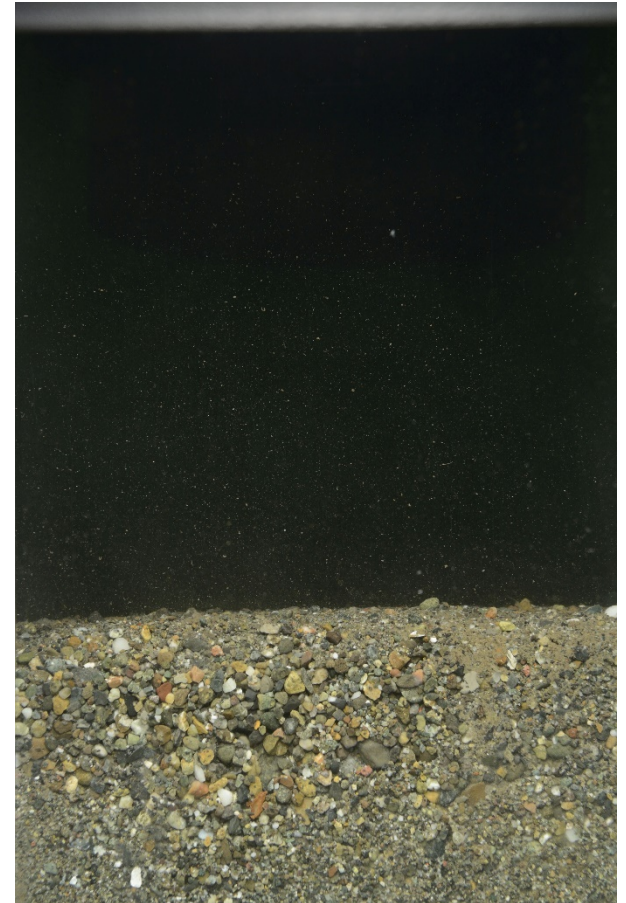
Figure 3-13.

Three SPI images from SU-ENR+AC showing the range of textures observed from left: silt, sand and silt mix, and sand and gravel. Image width = 14.42 cm.

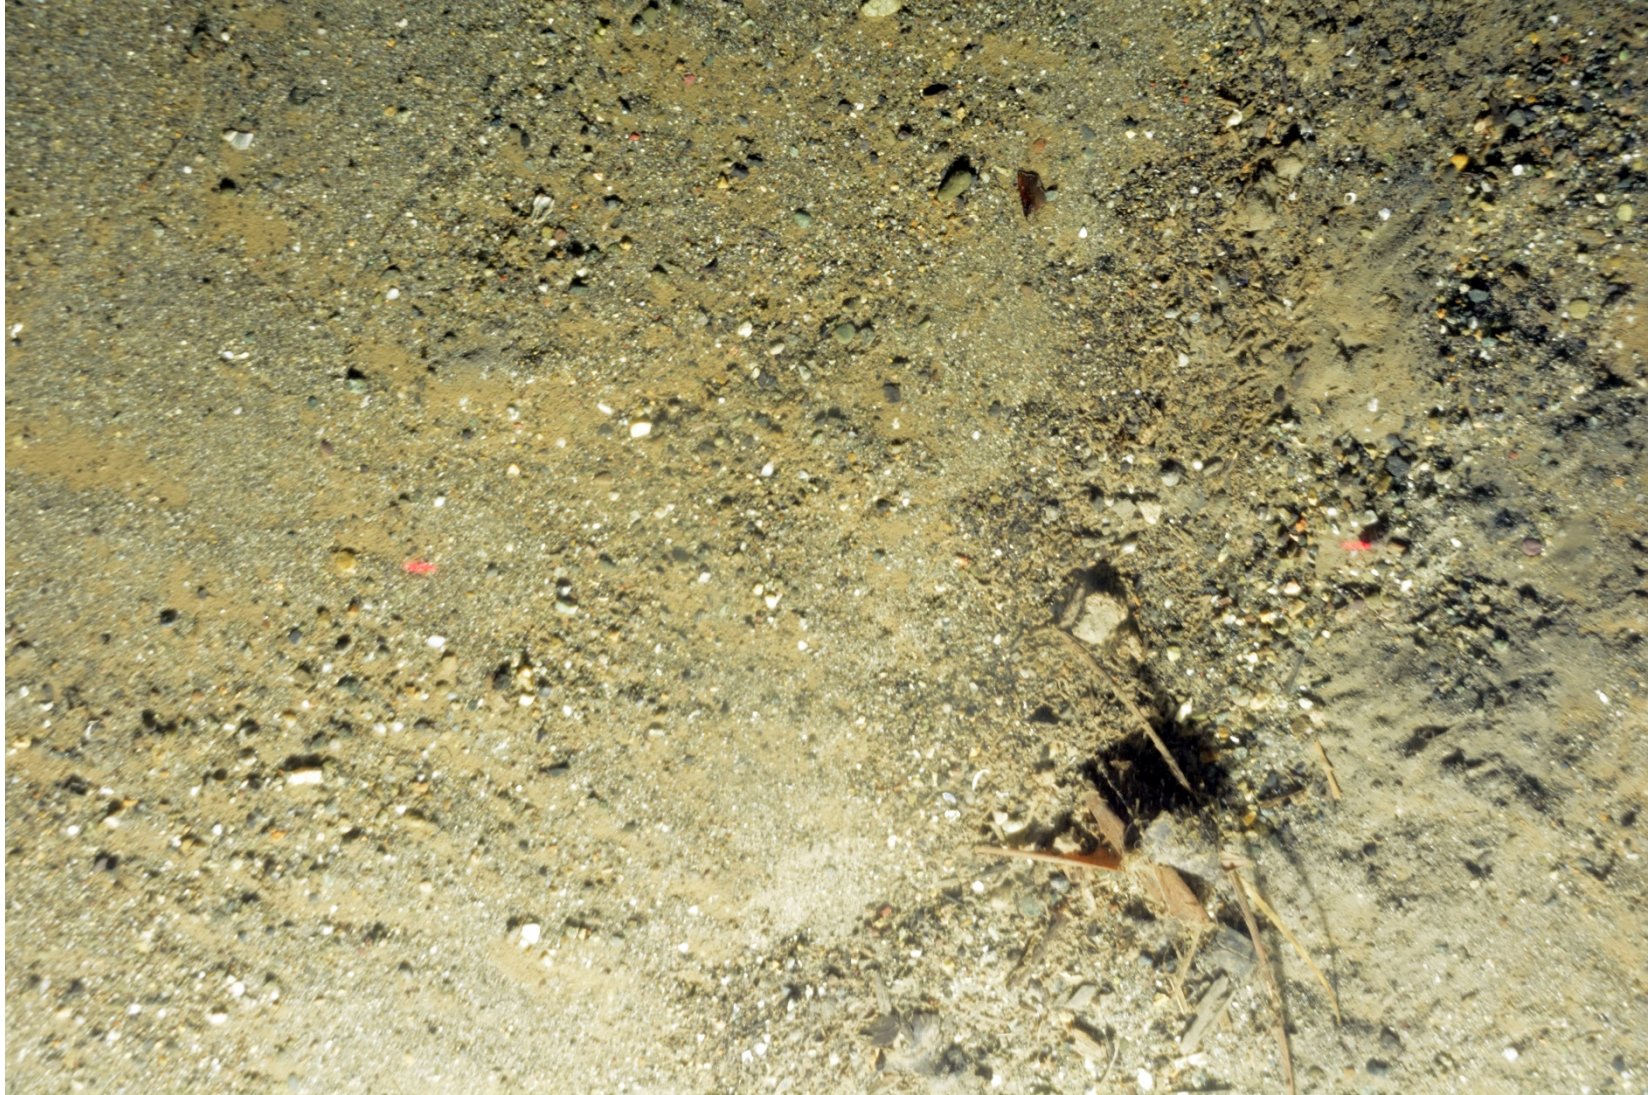
Figure 3-15. Plan view image from the SU-ENR+AC subplot showing coarse-grained bottom with patchy silt deposits and some leaf and wood debris
