SPI Reports (Year 2 and Year 3)

Enhanced Natural Recovery/Activated Carbon Pilot Study

Lower Duwamish Waterway

Project No. LY15160310

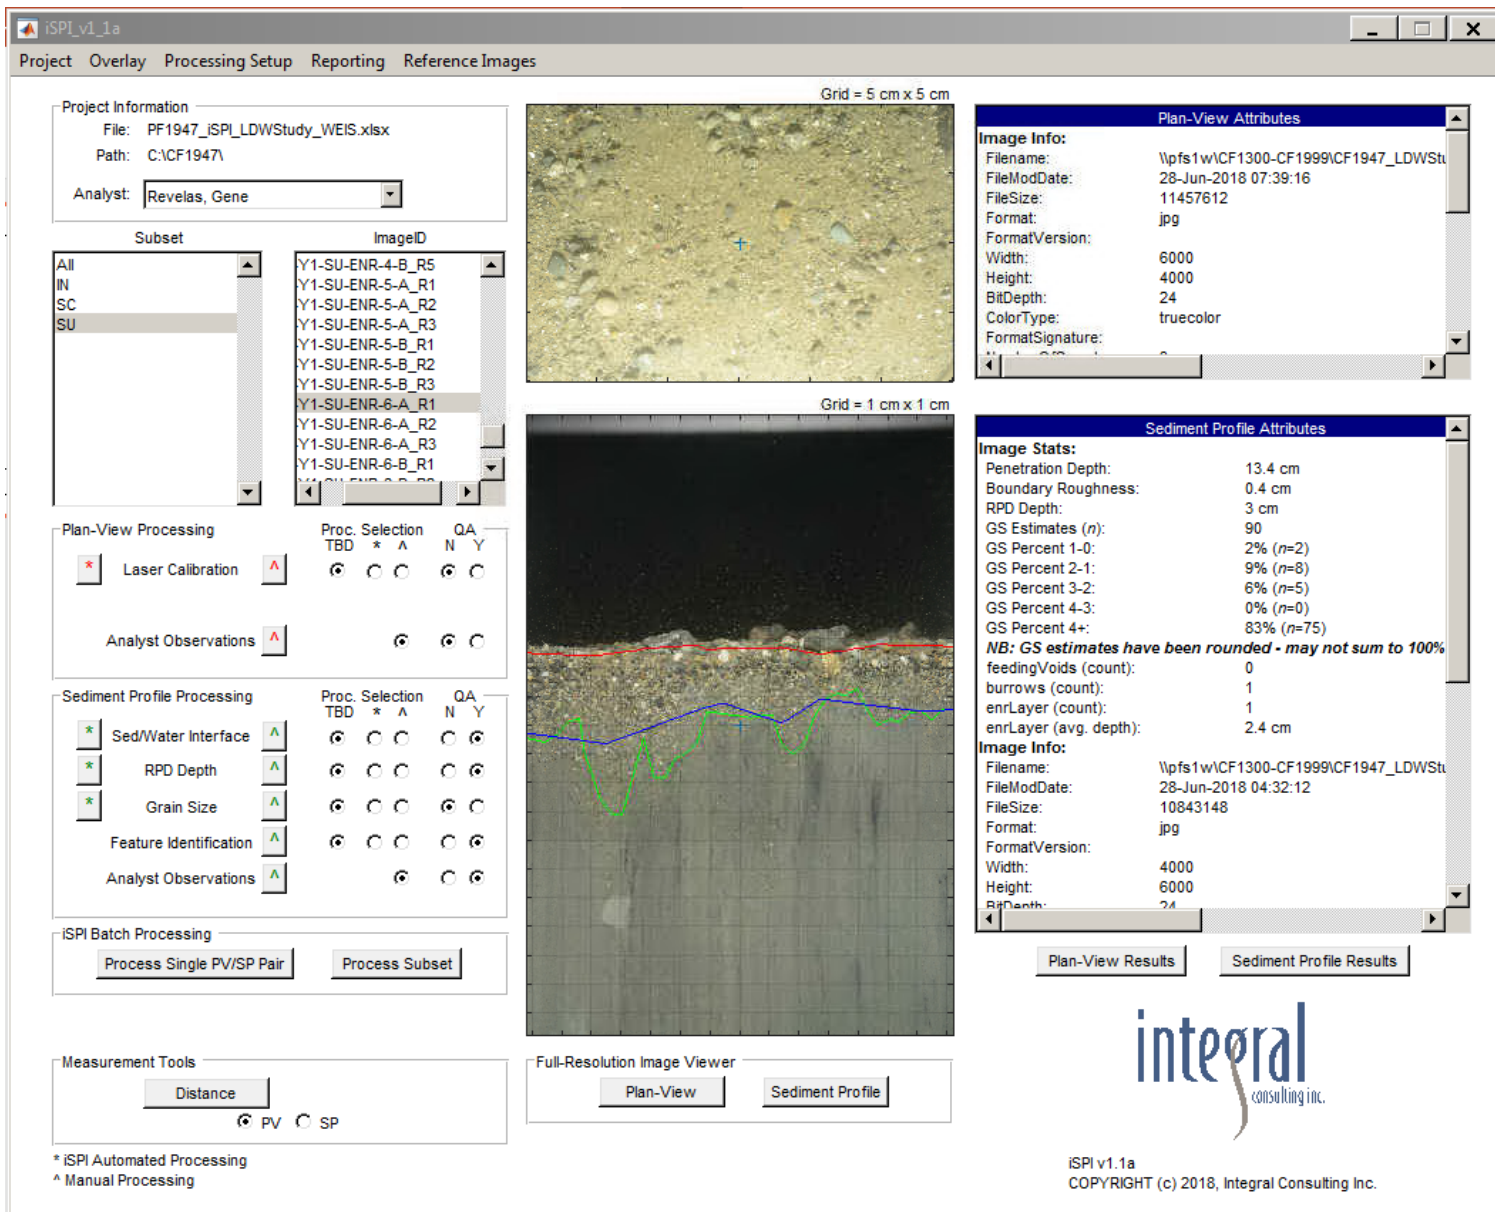
Figure 2-4.
iSPI v1.1a SPI/PV Image Analysis User Interface
ENR/AC Pilot Study Lower Duwamish Waterway

The iSPI software facilitates and standardizes the measurement, storage, and QA review of data from SPI and PV images. However, the approach and underlying interpretive rationale used to identify and measure the suite of parameters and features observed in the images (e.g., grain size, apparent redox potential discontinuity [aRPD] depth, infaunal successional stage) is comparable to the approach used for the baseline and Year 0 surveys by Browning Environmental Services. It is identical to the Year 1 survey approach used by Integral. The overall image analysis approach and interpretive framework are detailed in the previous SPI/PV data reports for this project (e.g., Construction Report Attachment 5 [Amec et al. 2018]), and are not repeated here.

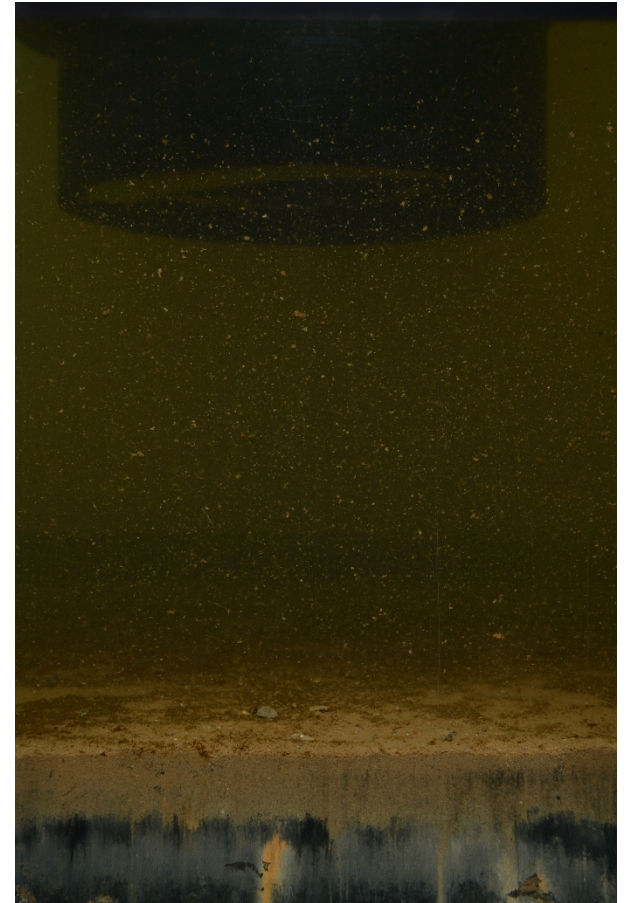
Figure 3-1.

Three SPI images from IN-ENR showing the range of textures observed: gravel and cobbles (left), gravel, sand, and silt mix (middle), and compact silt overlying ENR material based on the limited penetration (right). Width of each image = 14.42 cm.
ENR/AC Pilot Study Lower Duwamish Waterway

Evidence of the ENR material (i.e., sands and gravels) was directly observed, or inferred to be present based on limited SPI prism penetration at all stations sampled in the intertidal ENR subplot. Figure 3-1 shows three SPI images that illustrate the range of textures observed in this subplot: ENR gravels and sands, ENR gravels/sands mixed with post-placement silt deposits, and compact, thin (3-4 cm) silt layers overlying ENR material. The SPI image Y2-IN-ENR-6A in Figure 3-1 is an example of an image when ENR material is not evident in the sediment profile, but the shallow penetration of the silt substrate strongly suggests that coarse-grained ENR lies just below the frame. Table 3-1a includes a column noting these textures. Table 3-1a also includes an ENR Layer Thickness column. In all cases where the ENR material was evident in an image, it extended to the bottom of the SPI prism window and so is noted as >P (greater than penetration) in the data tables.

Features observed in the SPI images that indicate the presence of benthic infauna include oxidized surface sediments (aRPDs); large, surface polychaete tubes; worms at depth in the sediment column; and feeding voids formed by subsurface deposit feeders. Due to limited penetration depths, however, the aRPD depth was only evident/measurable in five replicates and ranged from 0.7 cm to 2.3 cm, with an average value of 1.1 cm (Table 3-1a). This is less than the average aRPD depths measured in Year 1 and during the baseline survey (Table 3-7), but this may be an artifact of fewer records of the aRPD depth due to the shallower penetration. For most of the 31 replicates where it could not be measured, the aRPD depth extends to the bottom of the frame, i.e., it is deeper than the penetration depth (e.g., see image Y2-IN-ENR-3A in Figure 3-1).

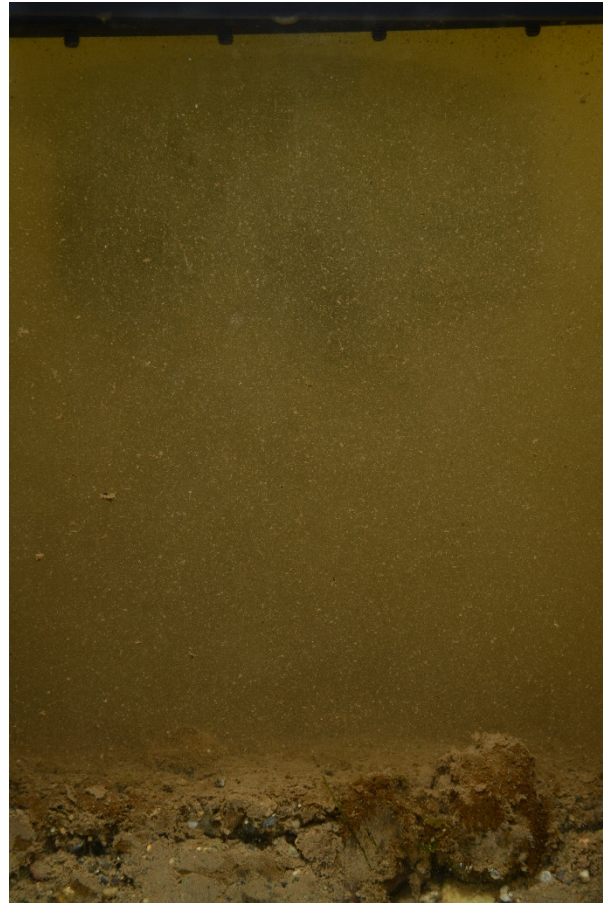
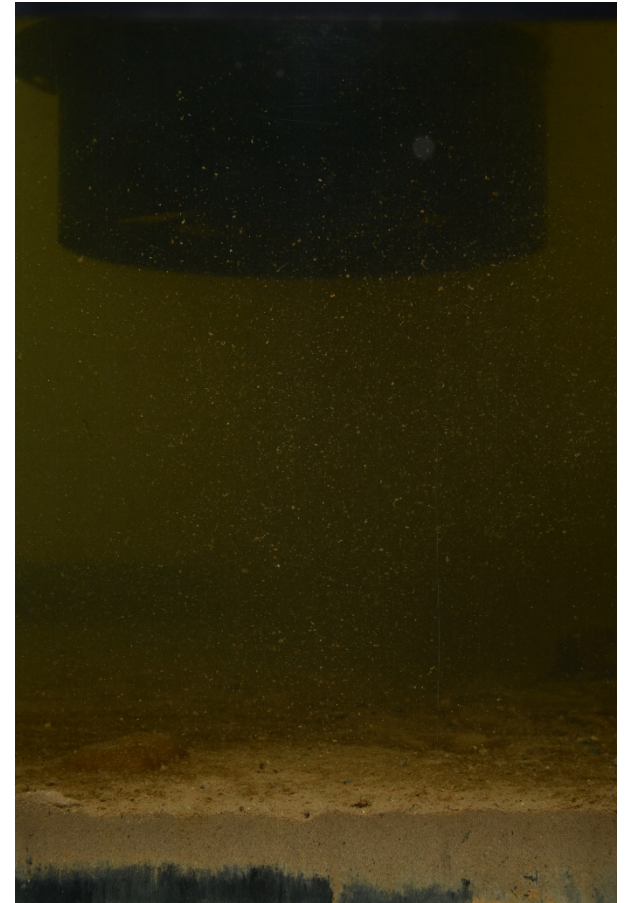
Figure 3-2.

Three SPI images from IN-ENR+AC subplot showing the one replicate where ENR material appears to absent (left), a second replicate from that station showing the ENR gravel/cobbles (middle), and an image showing compact silt over ENR. Width of each image = 14.42 cm.

Evidence of benthic community presence and recolonization in the intertidal ENR+AC subplot is comparable to that observed for the intertidal ENR subplot. The average aRPD depth for this subplot is 1.6 cm with a range from 1.0 to 3.4 cm. This is less than the average aRPD depths measured in Year 1 and during the baseline survey (Table 3-7). But, again, this may be an artifact of the shallower penetration depths; aRPD depths could only be measured at 7 stations of the 12 (10 SPI replicates). Due to the limited penetration, an infaunal successional stage could only be assigned for eight replicate SPI images across six stations, but four of those stations (67%) show evidence of Stage 3 infauna, suggesting advanced, benthic recolonization across much of the subplot. The PV images show minimal evidence of epifauna in the intertidal ENR+AC subplot, although tracks are seen in about 44% of the images analyzed. As at the ENR subplot, a thin, brown algal film overlying the mixed gravel, sand, and silt bottom cover is evident in many of the SPI and PV images from this subplot (see Y2-IN-ENR+AC-2-B-R1 and Y2-IN-ENR+AC-2-B-R2 in Figure 3-2).

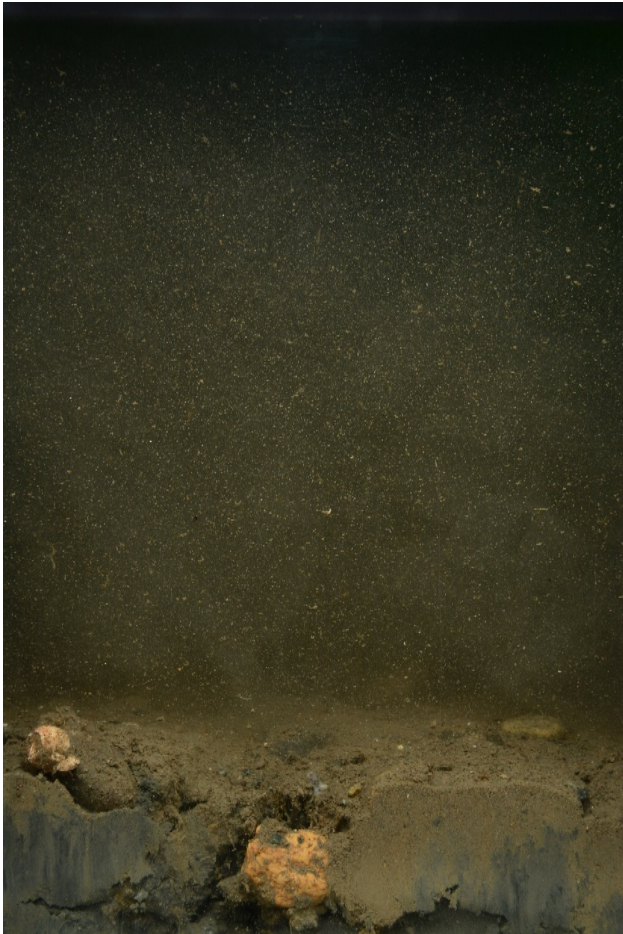
Figure 3-3a.

Collocated SPI (left) and PV (right) images from Station 1A in the SC-ENR subplot showing mixed ENR material and ambient, deposited silt. Width of SPI image = 14.42 cm. The circled, faint, red lasers in the PV image are 26 cm apart.
ENR/AC Pilot Study Lower Duwamish Waterway

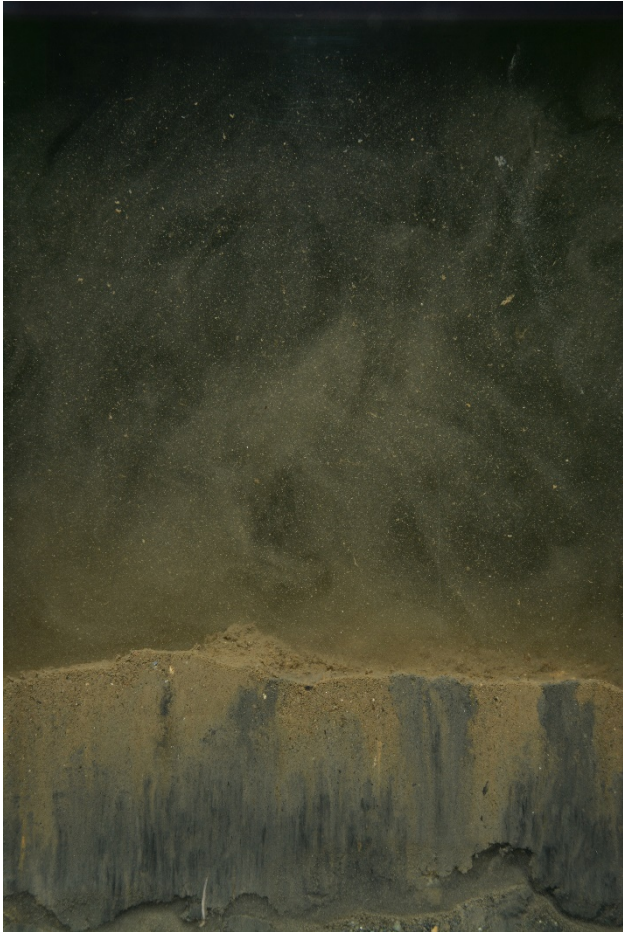
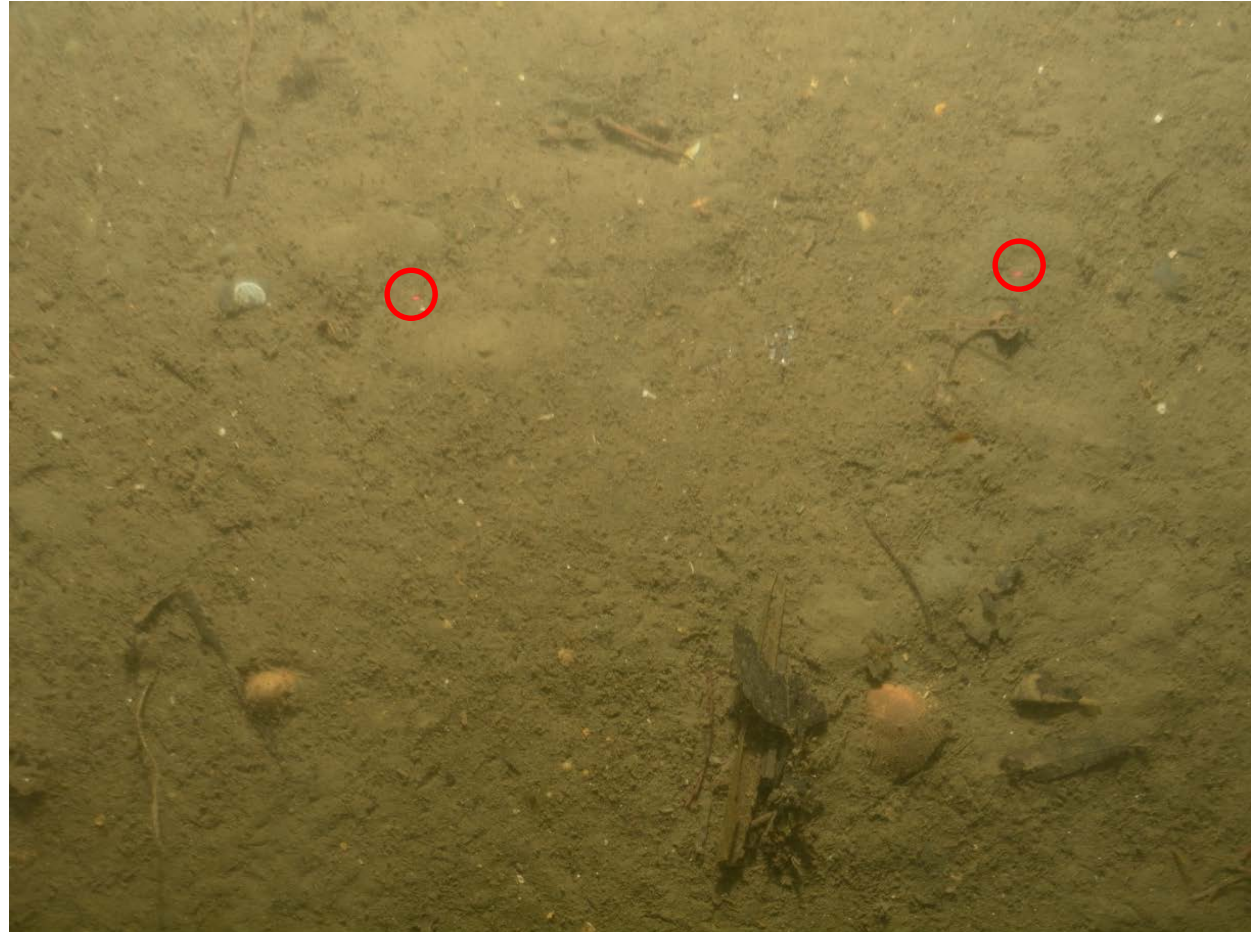
Figure 3-3b.

SPI (left) and PV (right) images from Station 6A in the SC-ENR subplot showing a predominantly deposited silt bottom overlying ENR material that is evident at bottom of the SPI image. Width of SPI image = 14.42 cm. The circled, faint, red lasers in the PV are 26 cm apart.
ENR/AC Pilot Study Lower Duwamish Waterway

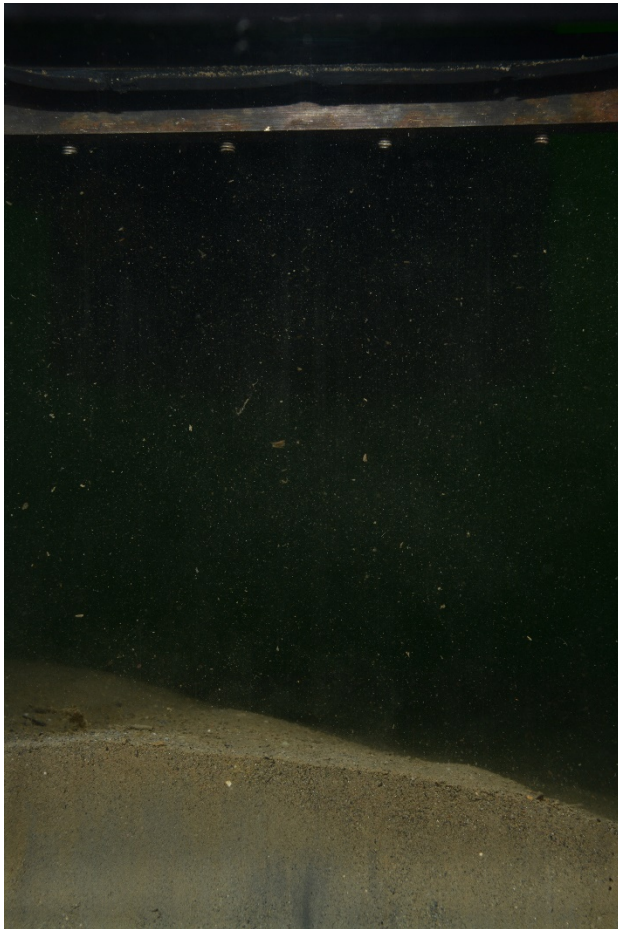
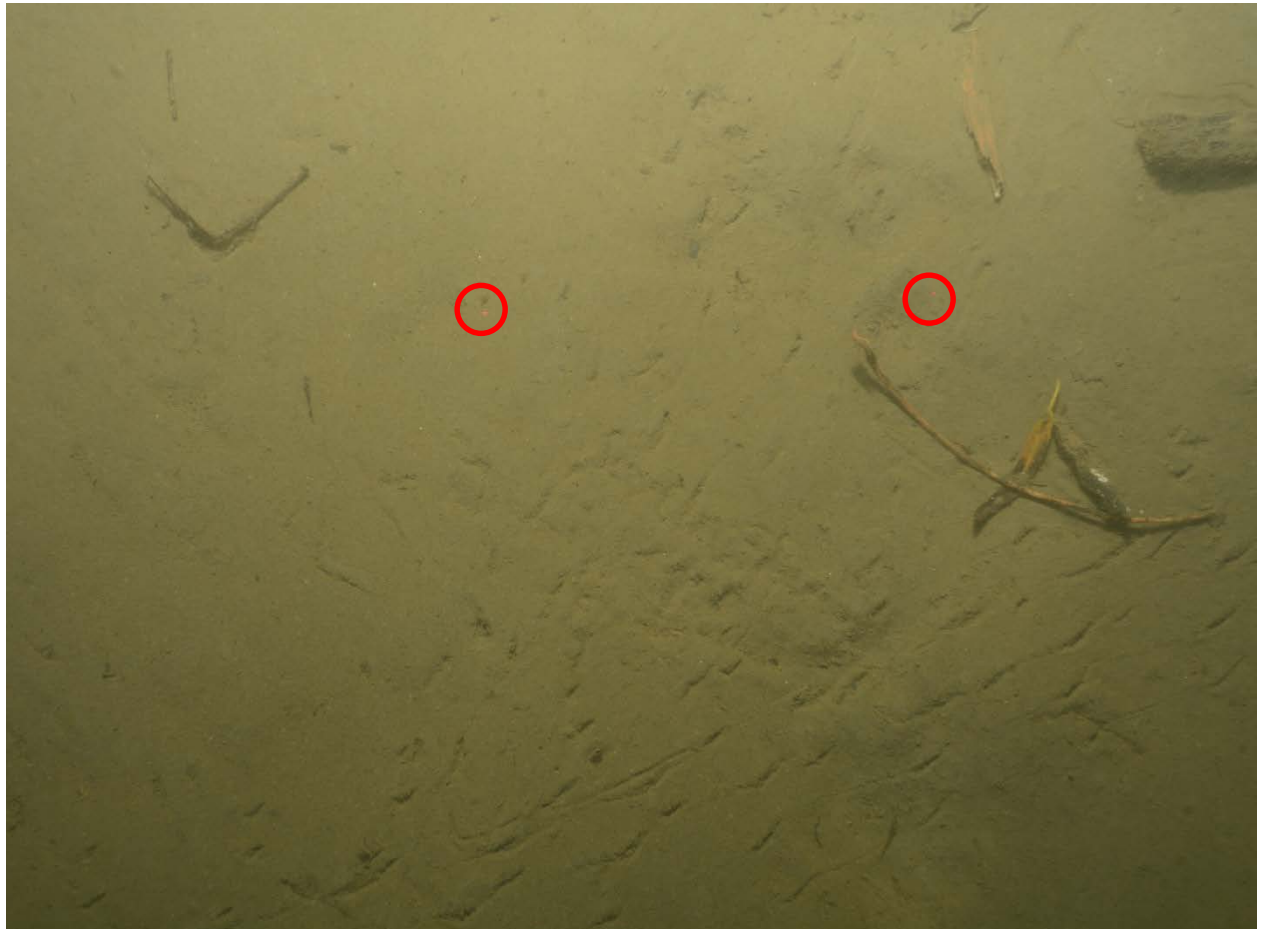
Figure 3-5a.

SPI (left) and PV (right) images from Station 1B in the SU-ENR subplot showing a silt/very fine sand surface sediments overlying ENR material based on the limited penetration. Faunal tracks and trails and plant debris are evident in the PV image. Width of SPI image = 14.42 cm. The circled red lasers in the PV image are 26 cm apart.
ENR/AC Pilot Study Lower Duwamish Waterway

The prism penetration depths for the ENR subplot are quite shallow (see SPI images in Figures 3-5a and 3-5b), averaging 2.4 cm and ranging from 0.3 to 8.4 cm (Table 3-7). This is much less than the subtidal plot baseline average penetration of 12.7 cm. As in the other subplots, the Year 2 penetration is notably less than the penetration obtained in Year 1, and again may reflect ENR material consolidation and silt infiltration over time.

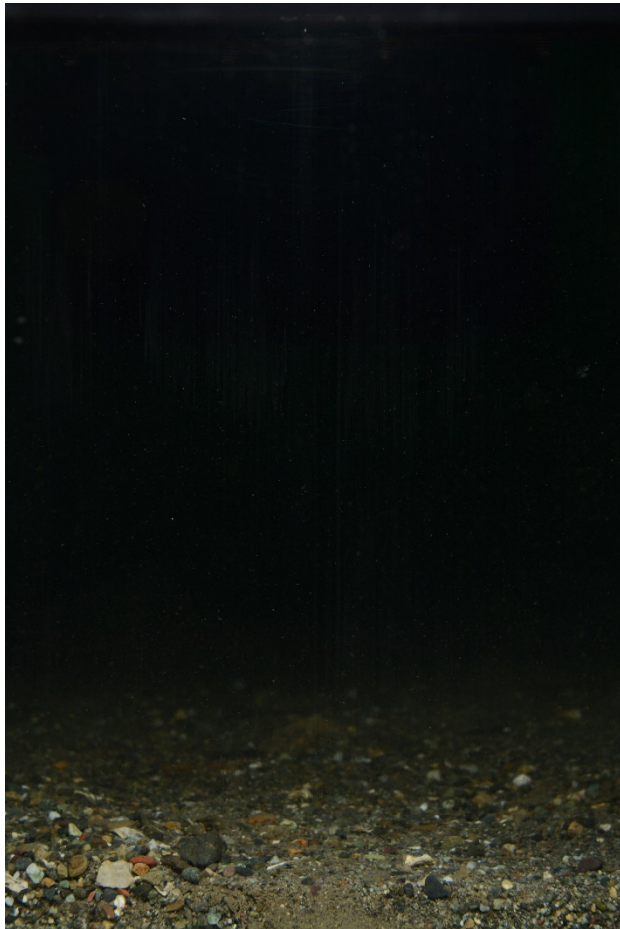
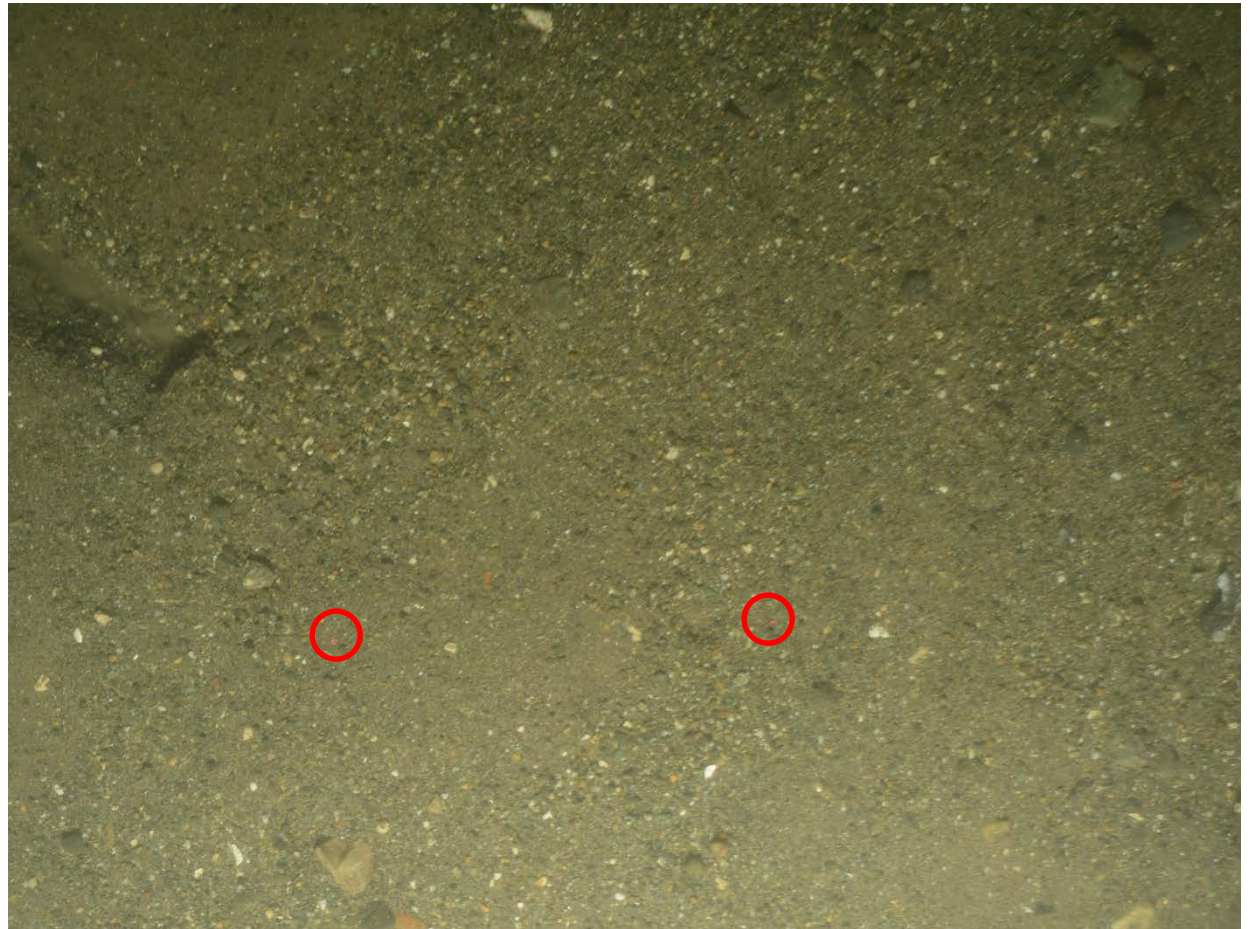
Figure 3-5b.

Paired SPI (left) and PV (right) images from Station 4B in the SU-ENR subplot showing intact ENR material at the sediment surface. Minimal SPI penetration was obtained in the coarse sand substrate. ENR material is evident throughout the PV image. Width of SPI image = 14.42 cm. The circled red lasers in the PV image are 26 cm apart.
ENR/AC Pilot Study Lower Duwamish Waterway

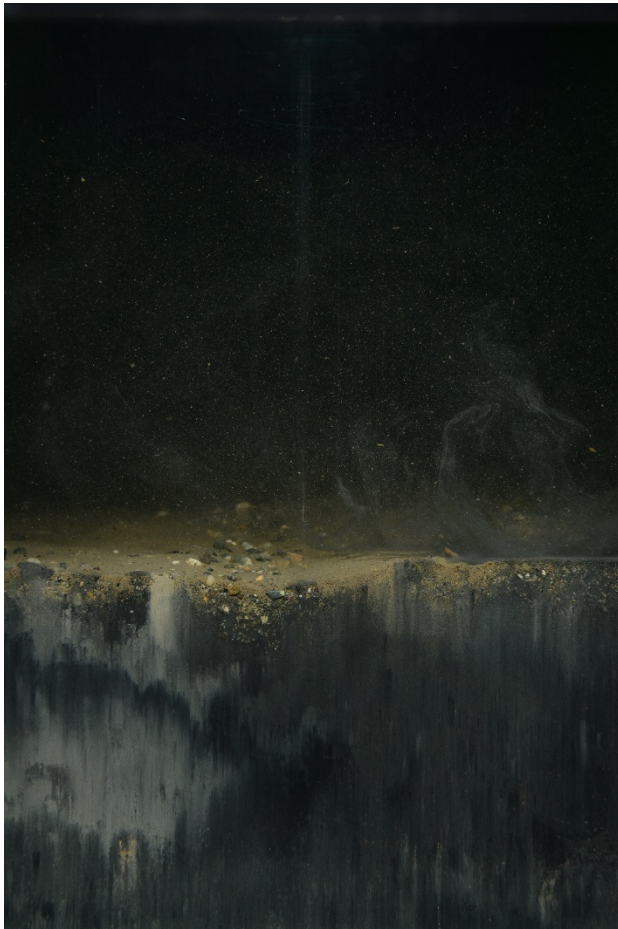
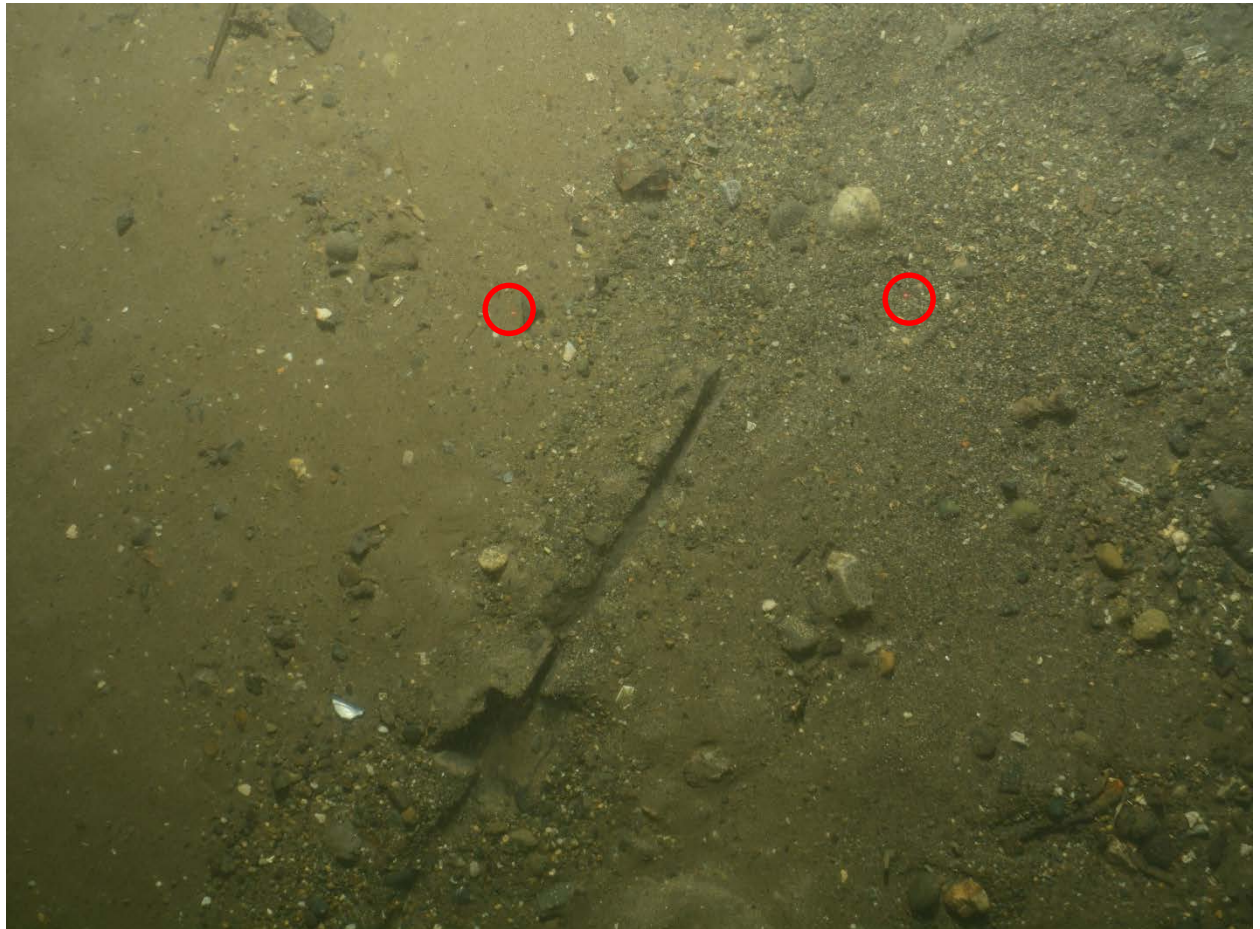
Figure 3-5c.

Paired SPI (left) and PV (right) images from Station 6B in the SU-ENR subplot showing disturbed/not present ENR material. Reduced silt is present at the sediment surface in the SPI image. Patchy coarse-grained ENR material is evident in the PV image. Width of SPI image = 14.42 cm. The circled red lasers in the PV image are 26 cm apart.
ENR/AC Pilot Study Lower Duwamish Waterway

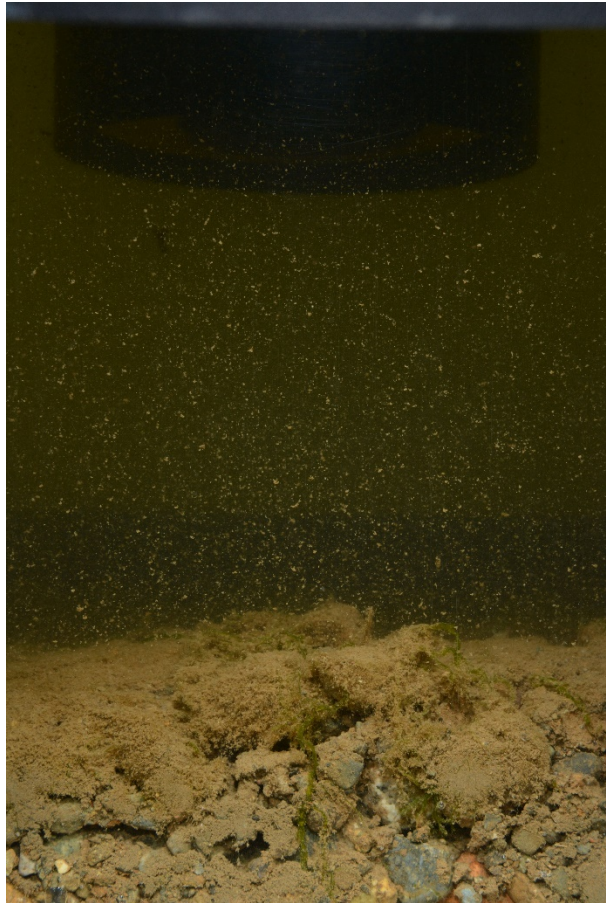
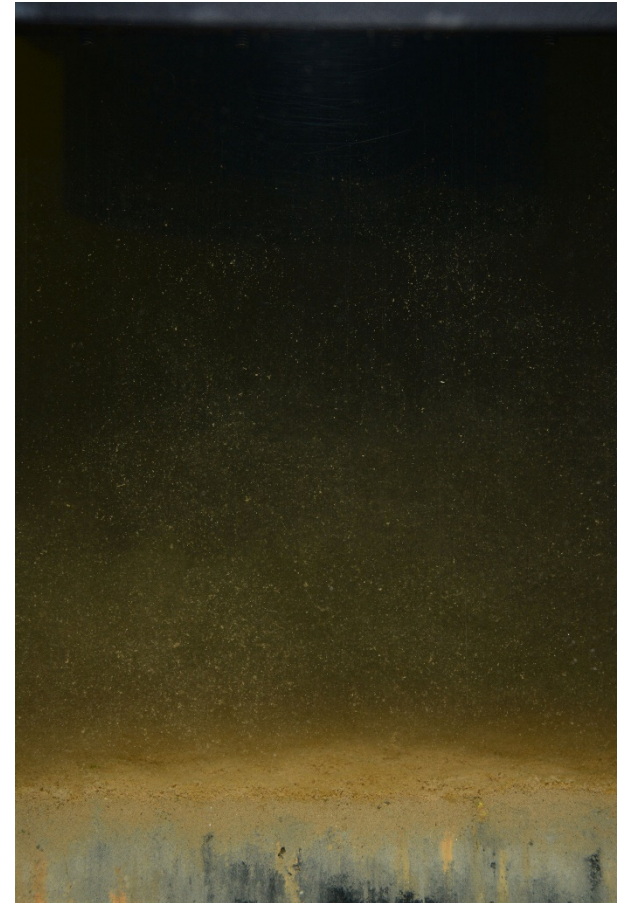
Figure 3-1.

Three SPI images from IN-ENR showing the range of textures observed: gravel and cobbles with veneer layer of silt (left); gravel, sand, and silt mix (middle); and compact silt overlying ENR material based on the limited penetration (right). Width of each image = 14.42 cm.
ENR/AC Pilot Study Lower Duwamish Waterway

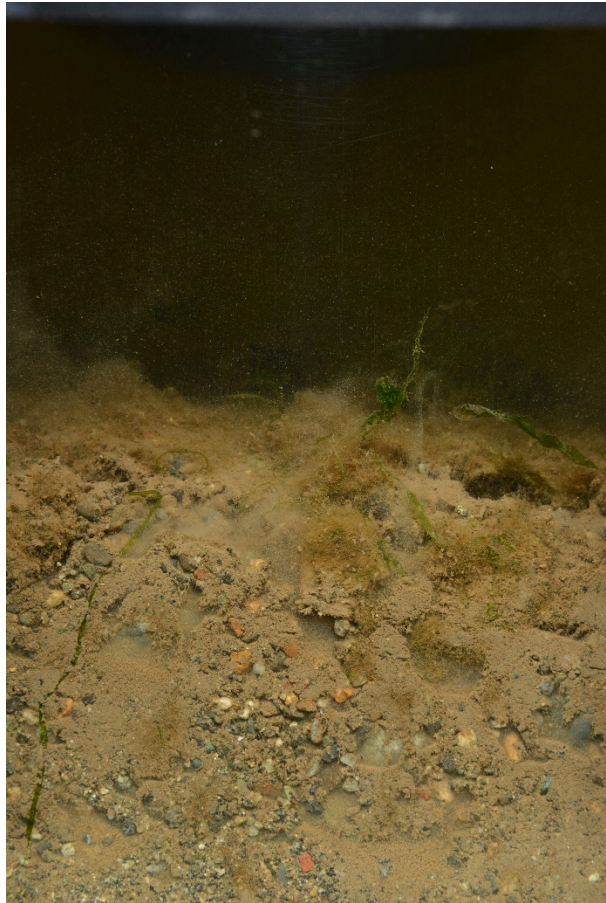
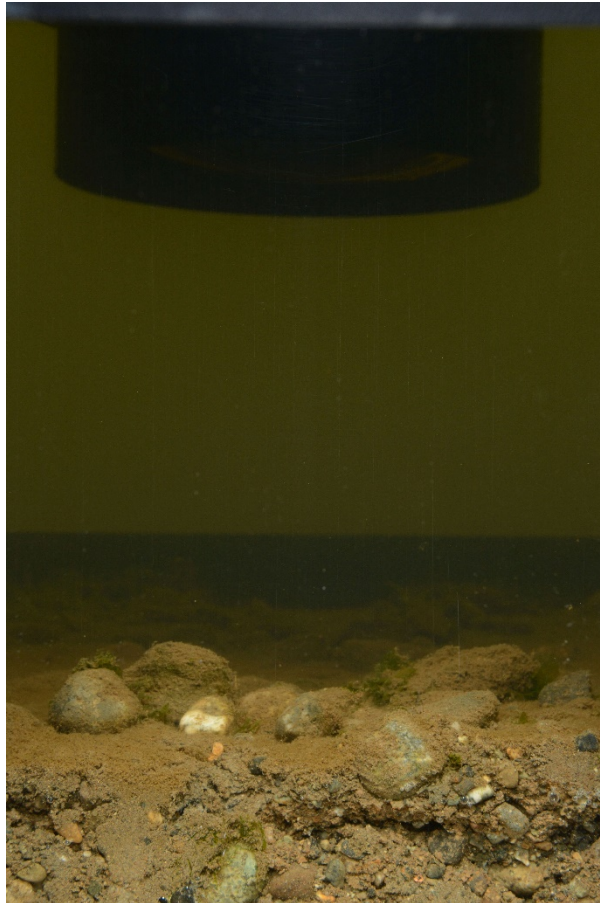
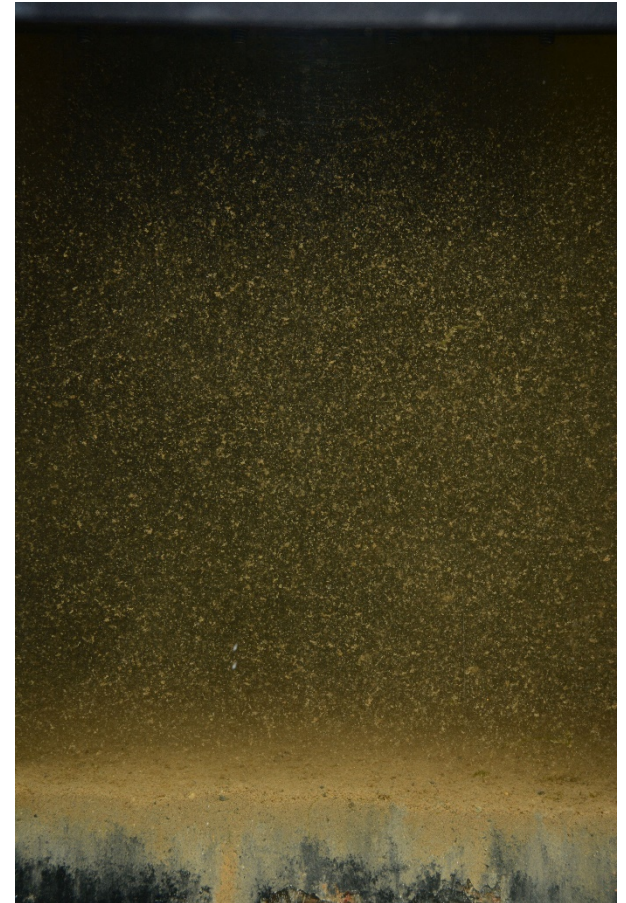
Figure 3-2a.

Three SPI images from IN-ENR+AC subplot showing two replicates where ENR material is evident and mixed with ambient silts (left and middle), and an image showing compact silt over ENR (right). Width of each image = 14.42 cm.
ENR/AC Pilot Study Lower Duwamish Waterway

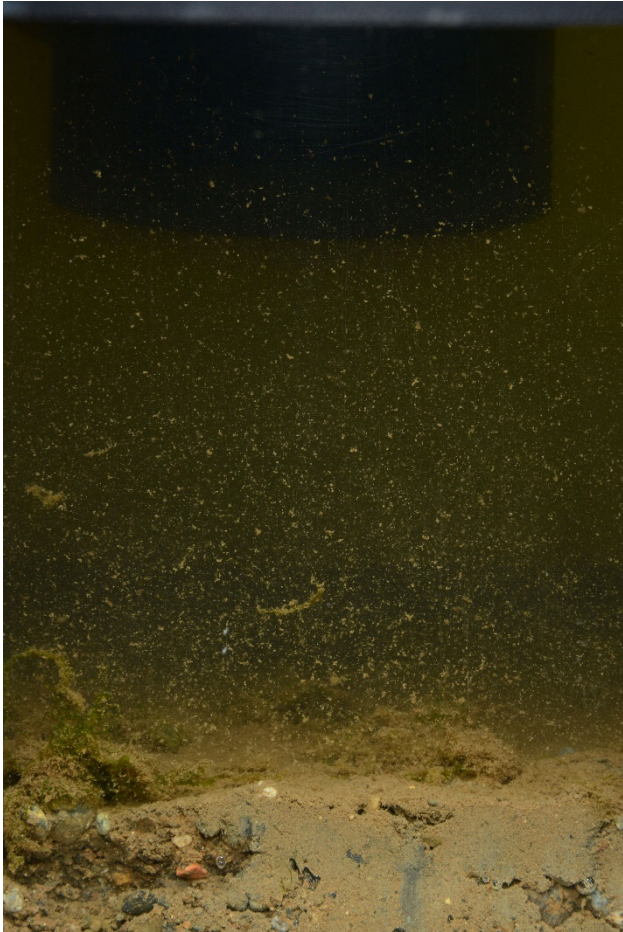
Figure 3-2b.

Collocated SPI (left) and PV (right) images from Station 4B in the IN-ENR+AC subplot showing compact silt mixed with ENR+AC material in SPI and evidence of ENR+AC material in PV. Width of SPI image = 14.42 cm. The circled, faint, red lasers in the PV are 26 cm apart.
ENR/AC Pilot Study Lower Duwamish Waterway

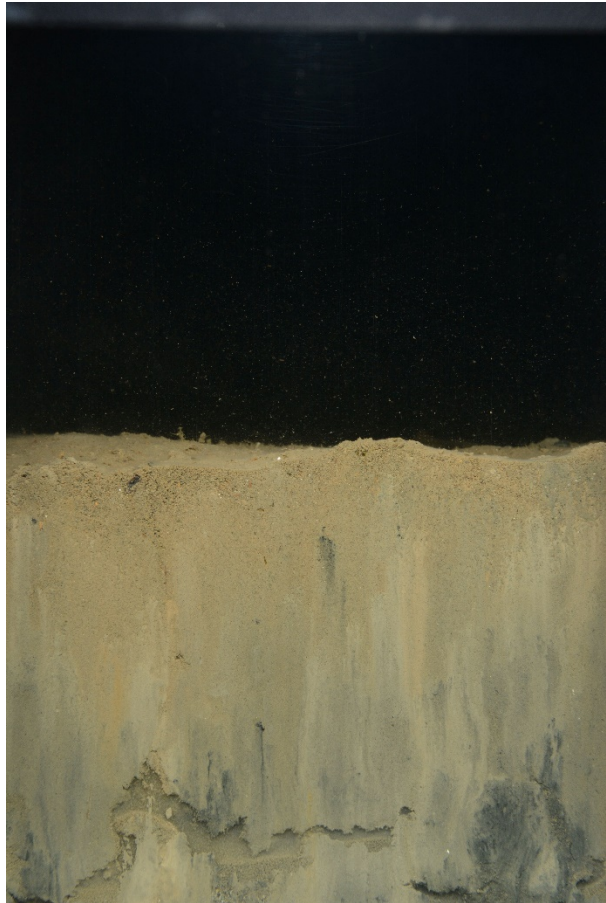
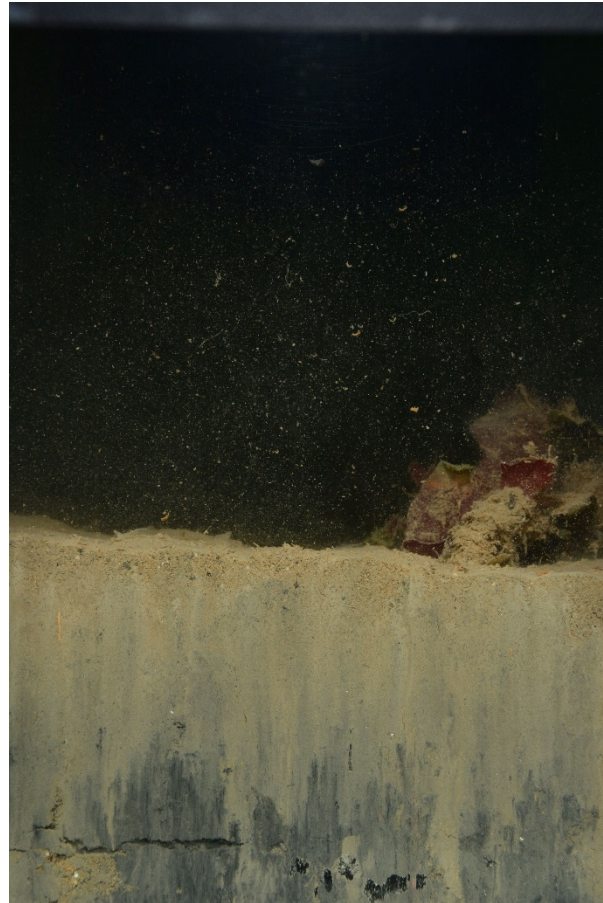
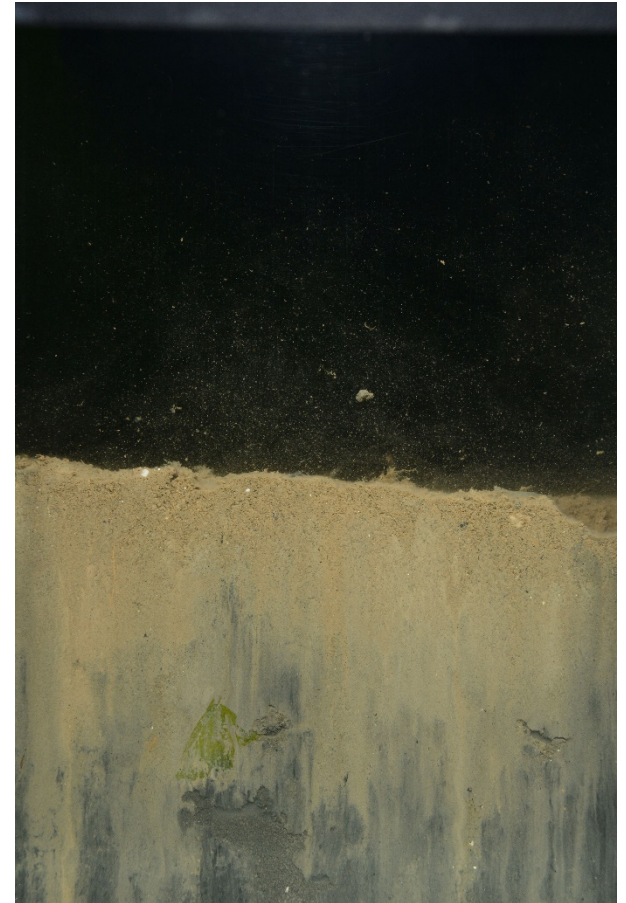
Figure 3-3a.

SPI images from the SC-ENR subplot cells 2, 3, and 6 showing the 8–11 cm of deposited silt overlying the ENR material. Feeding voids and surface worm tubes are evident in all images. Methane gas pockets (glossy black voids) are seen at Station 3B. Width of each image = 14.42 cm.
ENR/AC Pilot Study Lower Duwamish Waterway

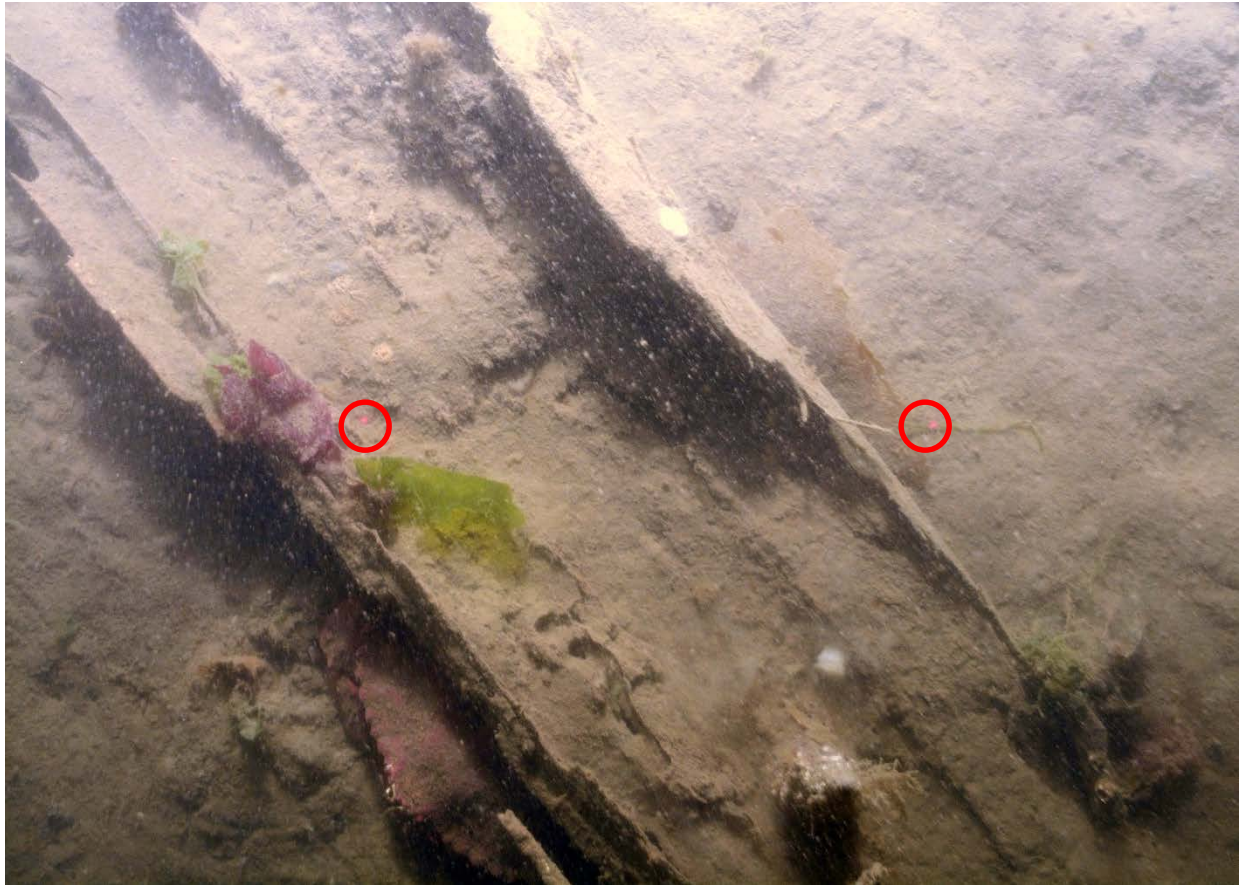
Figure 3-3b.

Paired SPI (left) and PV (right) images from Station 4B in the SC-ENR subplot showing a silt bottom (left) with wood debris on the surface (right). The PV image also shows a large red rock crab, barnacles, and red and green macroalgae. Width of SPI image = 14.42 cm. The circled red lasers in the PV are 26 cm apart.
ENR/AC Pilot Study Lower Duwamish Waterway

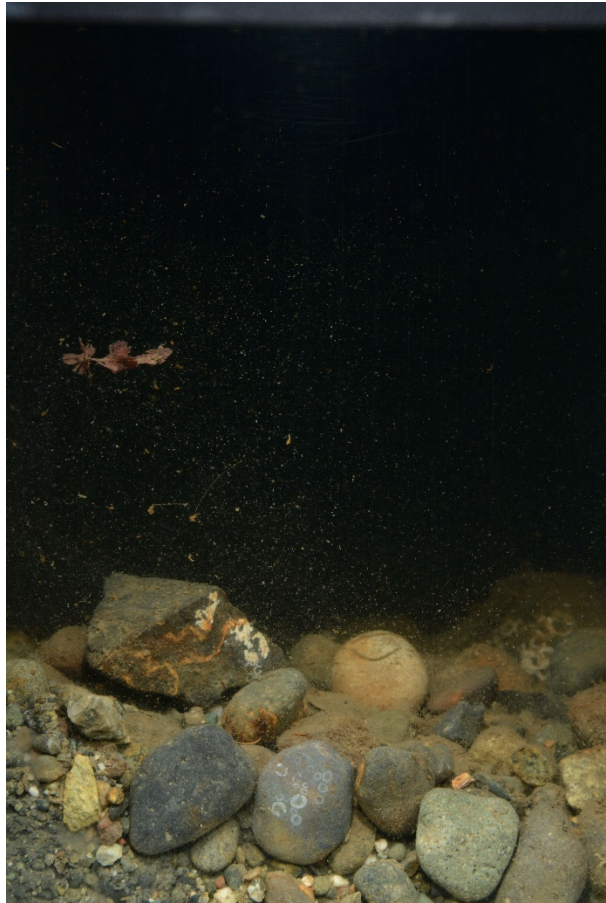
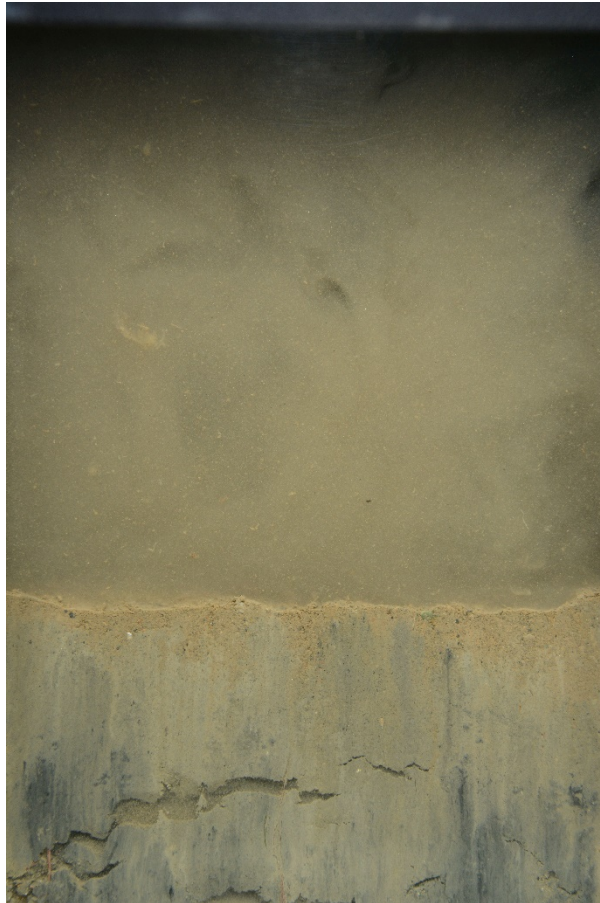
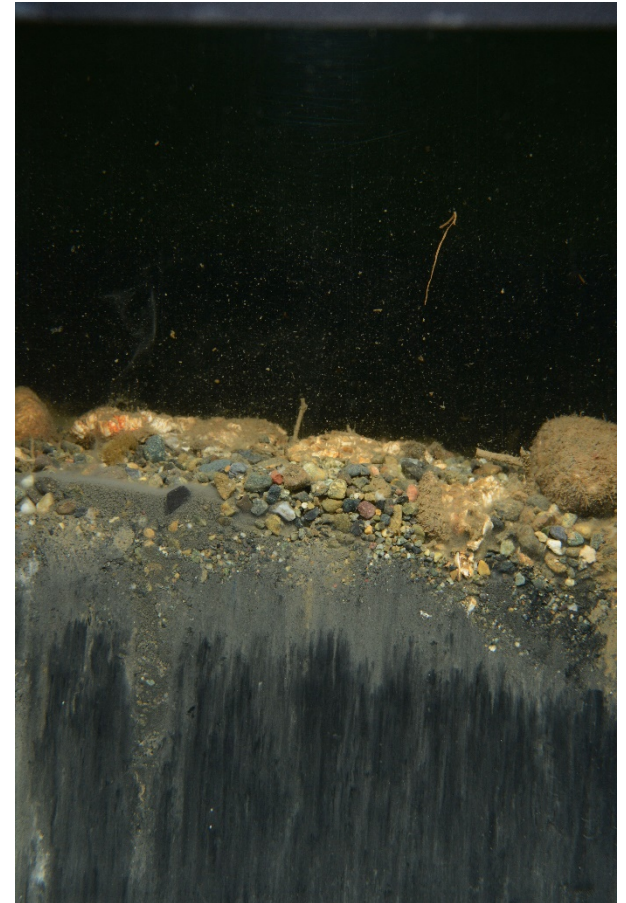
Figure 3-4a.

SPI images from the SC-ENR+AC subplot cells 1, 2, and 3 showing ENR material only at 1A (left), a 7-cm silt layer at 2B (middle), and a thin (3 cm) ENR material layer at 3A overlying reduced silt. Width of each image = 14.42 cm.

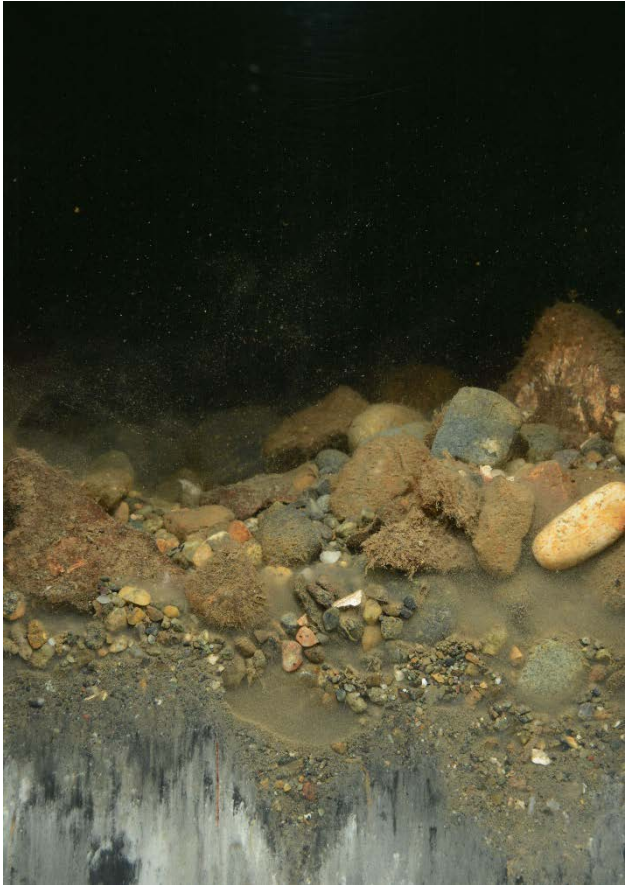
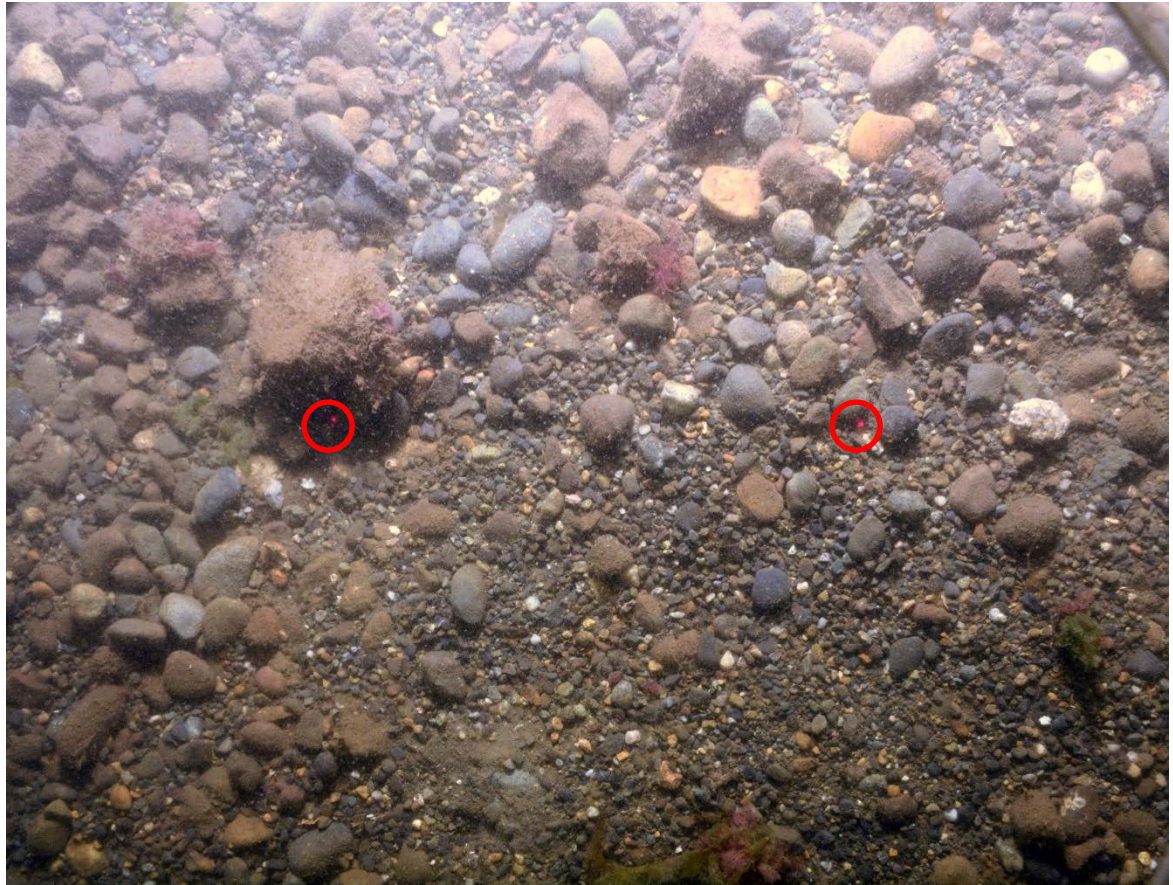
Figure 3-4b.

Paired SPI (left) and PV (right) images from Station 3A in the SC-ENR+AC subplot showing relatively thin ENR material cover at this location at the northern edge of the subplot. The PV image shows contiguous ENR material cover. Width of SPI image = 14.42 cm. The circled red lasers in the PV are 26 cm apart.
ENR/AC Pilot Study Lower Duwamish Waterway
