SPI Reports (Year 2 and Year 3)

Enhanced Natural Recovery/Activated Carbon Pilot Study

Lower Duwamish Waterway

Project No. LY15160310

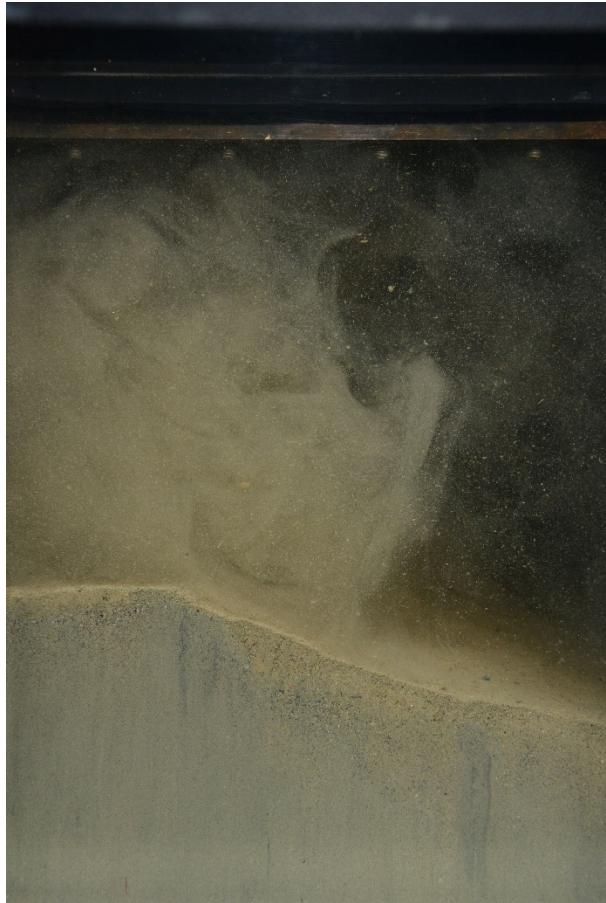
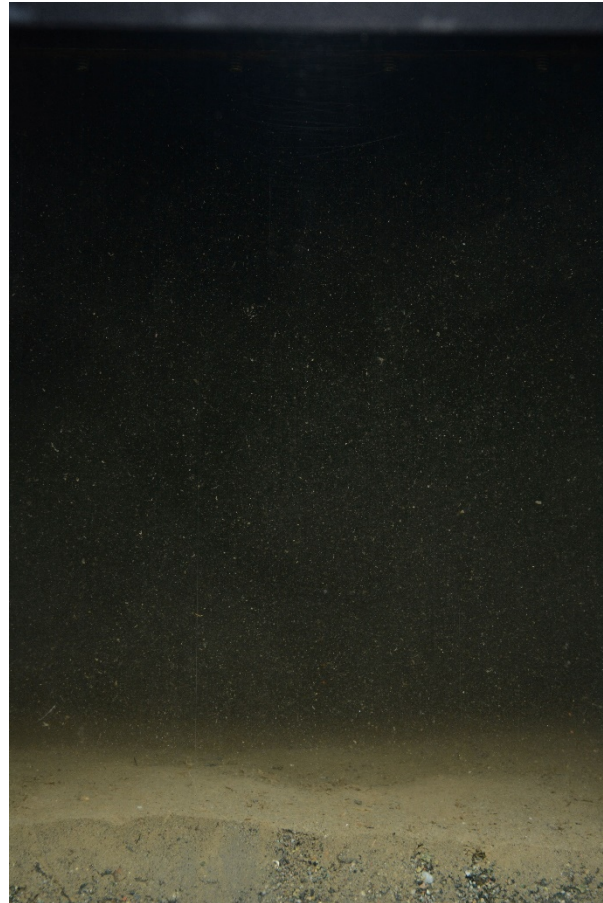
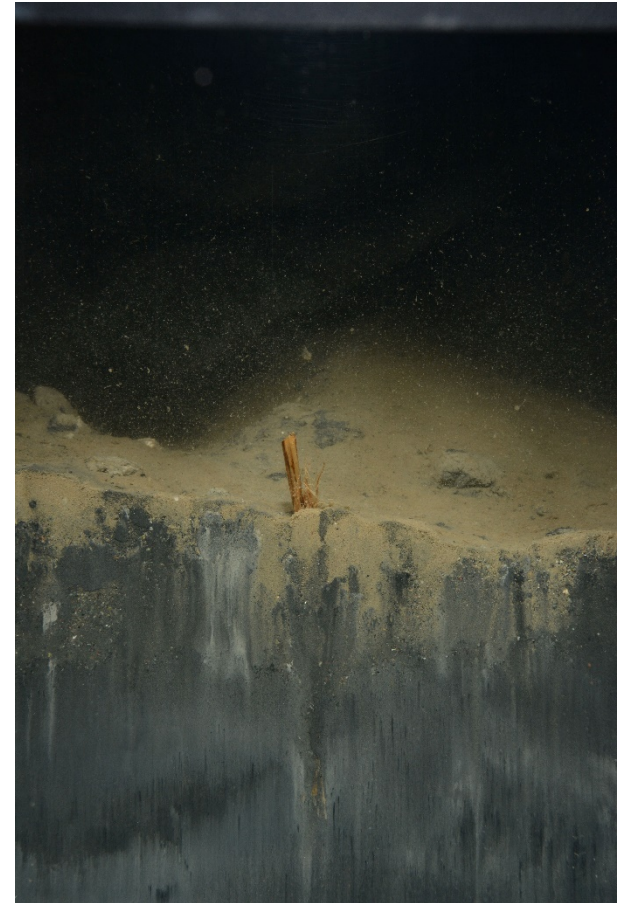
Figure 3-5a.

Three SPI images from SU-ENR showing the range of textures observed: silt and fine sand overlying ENR material (left); compact silt and ENR sand and silt mix (middle); and reduced silt where the ENR material has been disturbed (right). Width of each image = 14.42 cm. ENR/AC Pilot Study Lower Duwamish Waterway

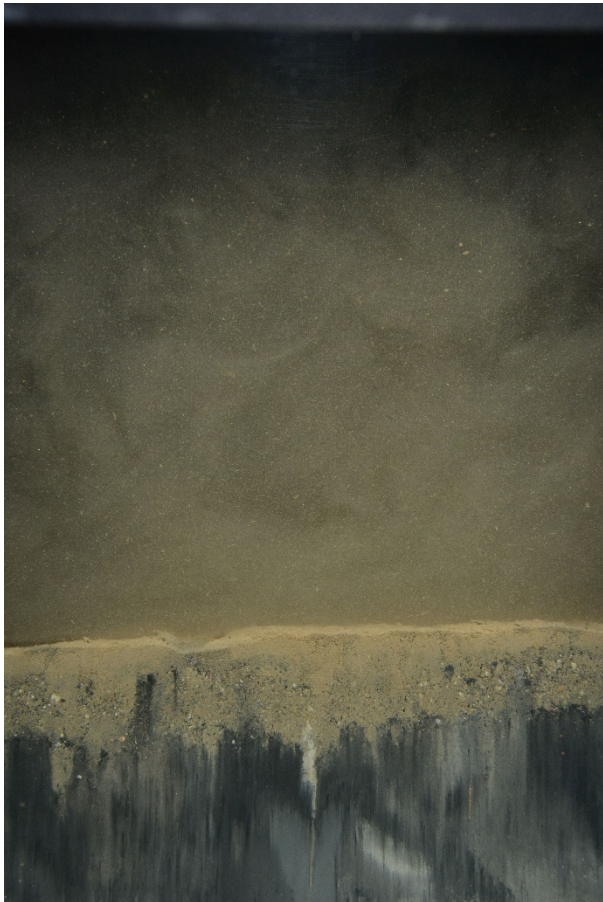
Figure 3-5b.

SPI (left) and PV (right) images from Station 6A in the SU-ENR subplot showing an area where the ENR material has been disturbed. The SPI image shows reduced silt below 3 cm overlain by a sand and silt deposit. The PV image reveals reduced mud clumps and surface debris. Width of SPI image = 14.42 cm. The circled red lasers in the PV are 26 cm apart.
ENR/AC Pilot Study Lower Duwamish Waterway

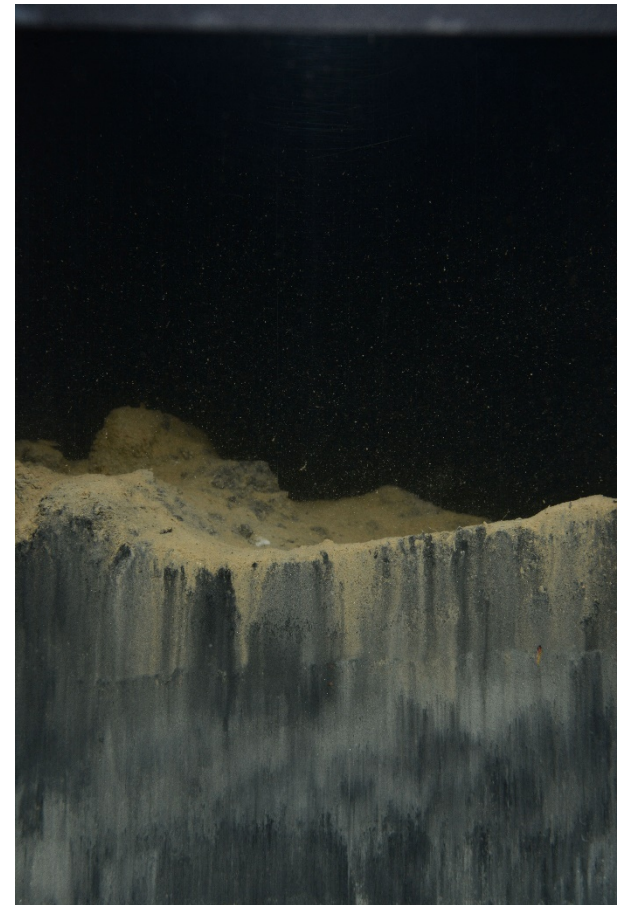
Figure 3-6a.

Three SPI images from SU-ENR+AC subplot showing a thick silt deposit (left), a thinner silt and fine sand deposit (middle), and location where ENR+AC material has been disturbed/removed (right). Width of each image = 14.42 cm.
ENR/AC Pilot Study Lower Duwamish Waterway

Surface sediments from the subtidal ENR+AC subplot in Year 3 show textural gradients similar to the parallel ENR subplot, but the silt and fine sand deposits that overlie the ENR+AC material at the downstream end of the subplot (cells 1 to 4) are thicker than the deposits in ENR subplot, and the level of disturbance/lack of presence of the ENR+AC material in cells 5 and 6 is more widespread (Table 3-6a). Figure 3-6a shows examples of the surface sediment textures at Stations 1A (thick silt deposit), 3A (thinner deposit over ENR+AC material), and 5A (disturbed/not present ENR+AC material). Figure 3-6b shows SPI and PV images from Station 5B, another location where the ENR+AC material is not present. As noted for the ENR subplot, the very sharp, vertical transition from the oxidized (brown) surface sediment layer to highly reduced (black) sediment at depth in the SPI image suggests a disturbance event (i.e., chain dragging) followed by a hiatus and the subsequent deposition of silt. The collocated PV images show no evidence of residual ENR+AC material or disturbance in contrast to the PV image in Figure 3-5b, perhaps suggesting the passage of more time since the disturbance event. There was no obvious visual evidence of GAC in the Year 3 subtidal ENR+AC images compared with the Year 3 subtidal ENR images.

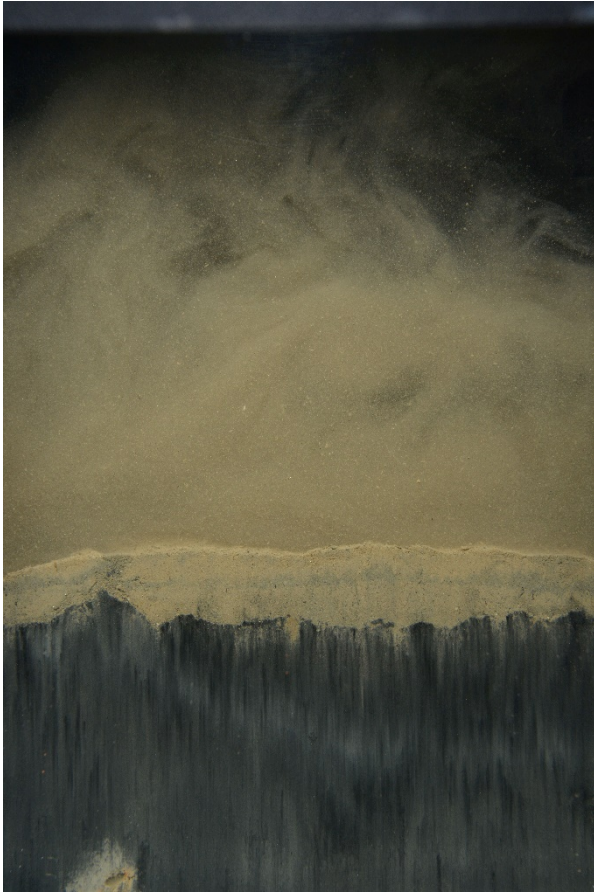
Y3-SU-ENR+AC-5B-R4-SPI

Figure 3-6b. SPI (left) and PV (right) images from Station 5B in the SU-ENR+AC, where the ENR+AC is not present

burrows and worm tubes present in 32 images (of the 36 images) and epibenthic tracks observed 31 of the images (Table 3-6b). The PV image from Station 5A in Figure 3-6b shows many burrows and tracks on the sediment surface.
