**Figure 2-1. LDW Superfund Site vicinity map**

**90% REMEDIAL DESIGN BASIS OF DESIGN**  
**REPORT FOR THE LDW UPPER REACH**     **JULY 24, 2023**

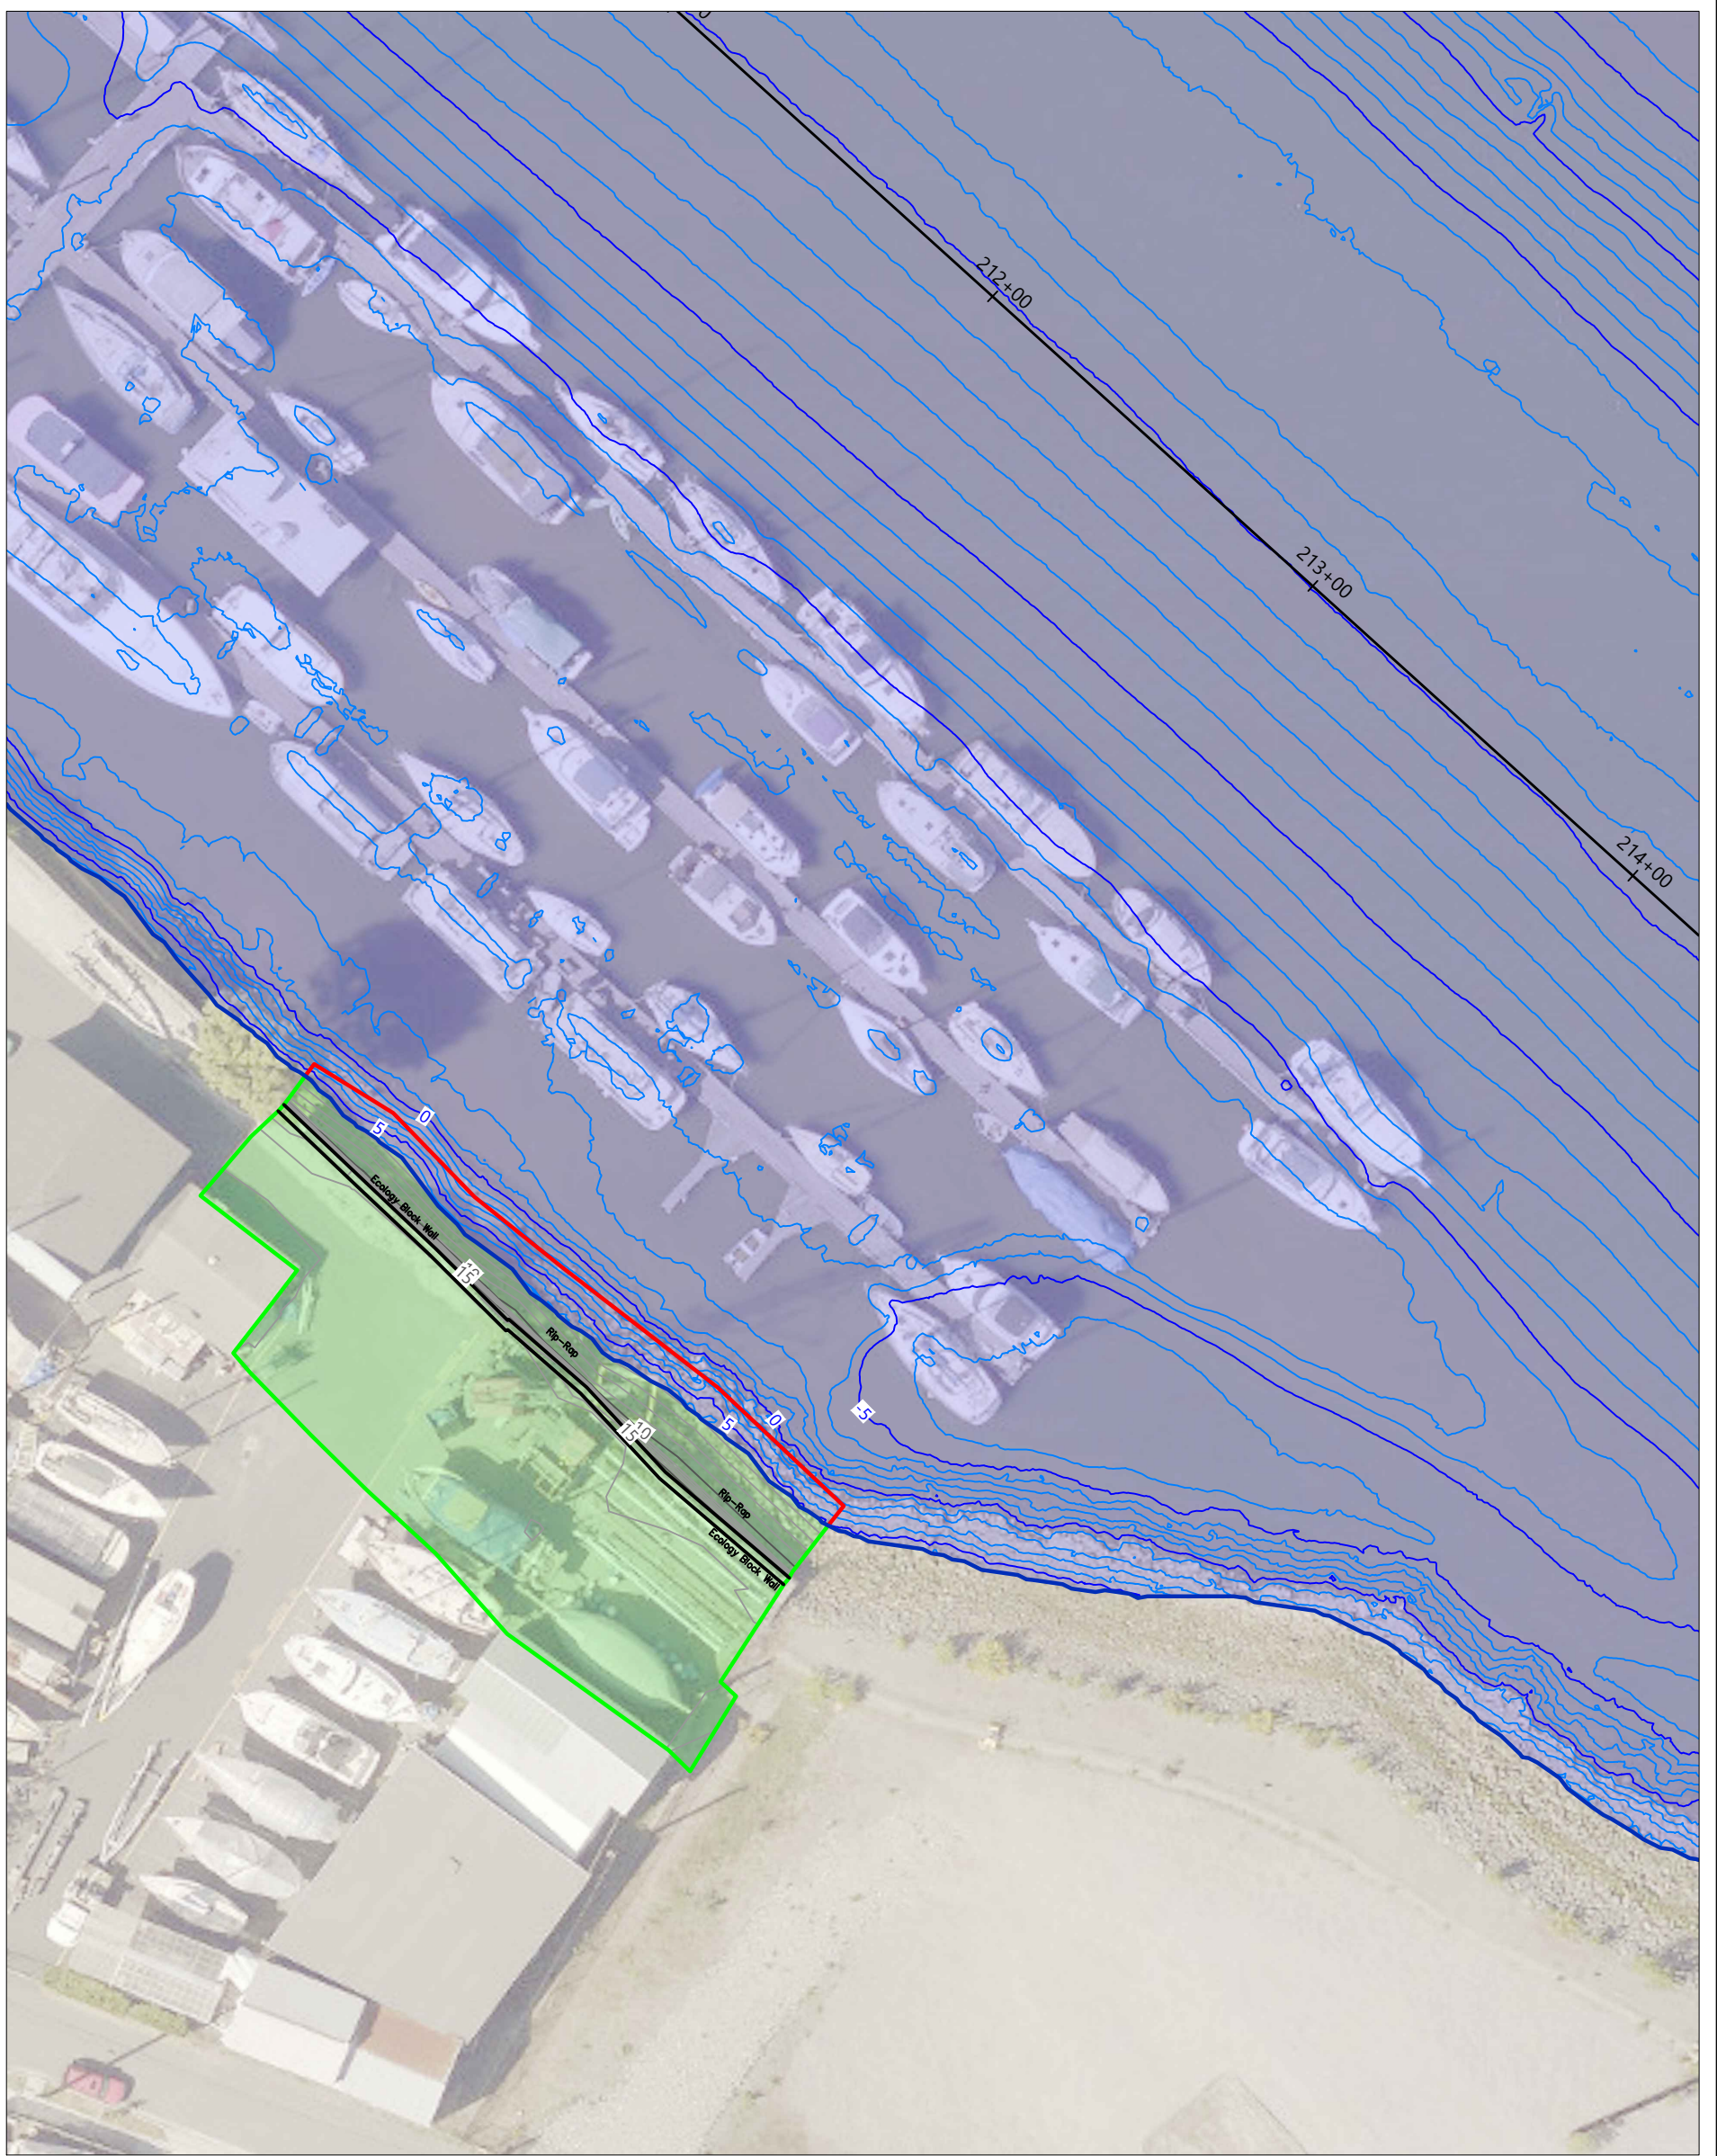
**Figure 2-5b. Bathymetric/topographic merging plan**

**Source:** Topographic survey by True North Land Surveying, Inc. performed between June 30, 2021, and August 10, 2021. Additional survey by True North performed on October 5 and 6, 2022. Bathymetric survey by Northwest Hydro performed between April 18, 2019, and May 15, 2019. Additional survey by Northwest Hydro performed June 2020. LiDAR survey from Puget Sound LiDAR Consortium dated 2016. Composite data updated December 2020 and November 2022.

**Horizontal Datum:** Washington State Plane, North Zone, NAD83 (2011), U.S. Survey Feet; WSDOT MON GP17005-176 & GP17005-181

**Vertical Datum:** Mean Lower Low Water (MLLW), MLLW converted from NAVD88 (NAVD88 + 2.34' to MLLW)

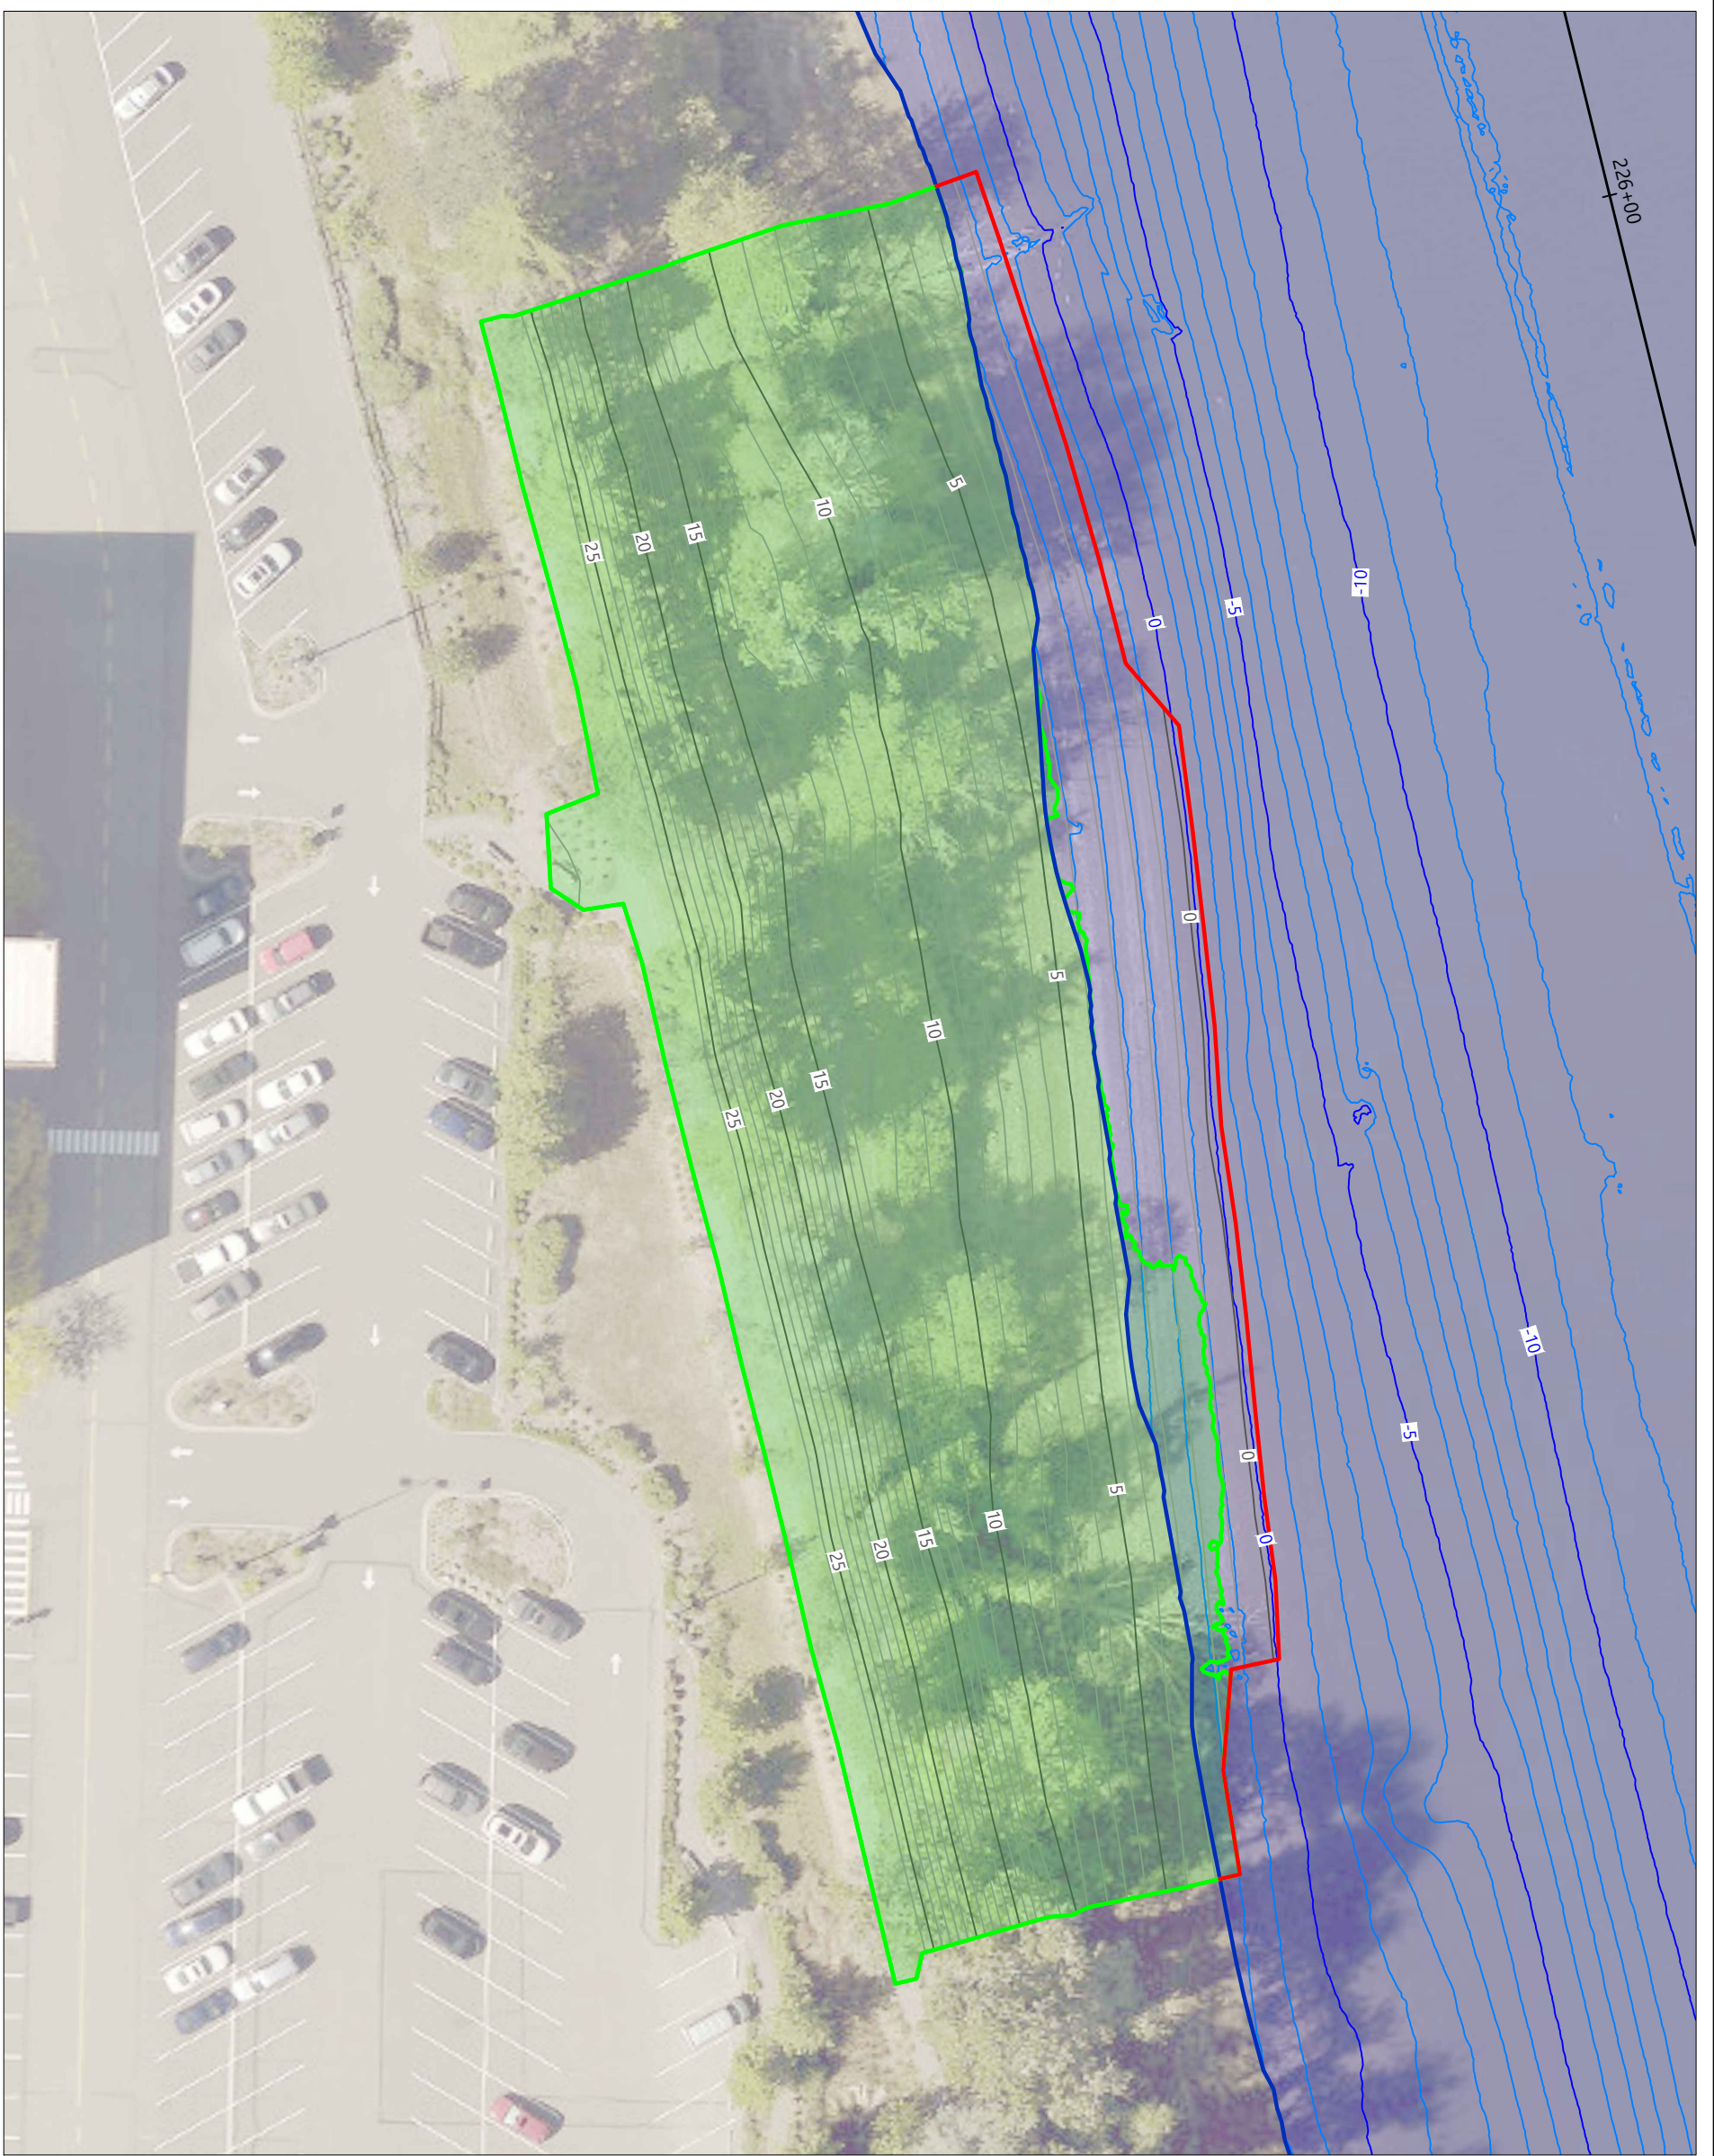
**Figure 2-5c. Bathymetric/topographic merging plan**

**Source:** Topographic survey by True North Land Surveying, Inc. performed between June 30, 2021, and August 10, 2021. Additional survey by True North performed on October 5 and 6, 2022. Bathymetric survey by Northwest Hydro performed between April 18, 2019, and May 15, 2019. Additional survey by Northwest Hydro performed June 2020. LiDAR survey from Puget Sound LiDAR Consortium dated 2016. Composite data updated December 2020 and November 2022.

**Horizontal Datum:** Washington State Plane, North Zone, NAD83 (2011), U.S. Survey Feet; WSDOT MON GP17005-176 & GP17005-181

**Vertical Datum:** Mean Lower Low Water (MLLW), MLLW converted from NAVD88 (NAVD88 + 2.34' to MLLW)

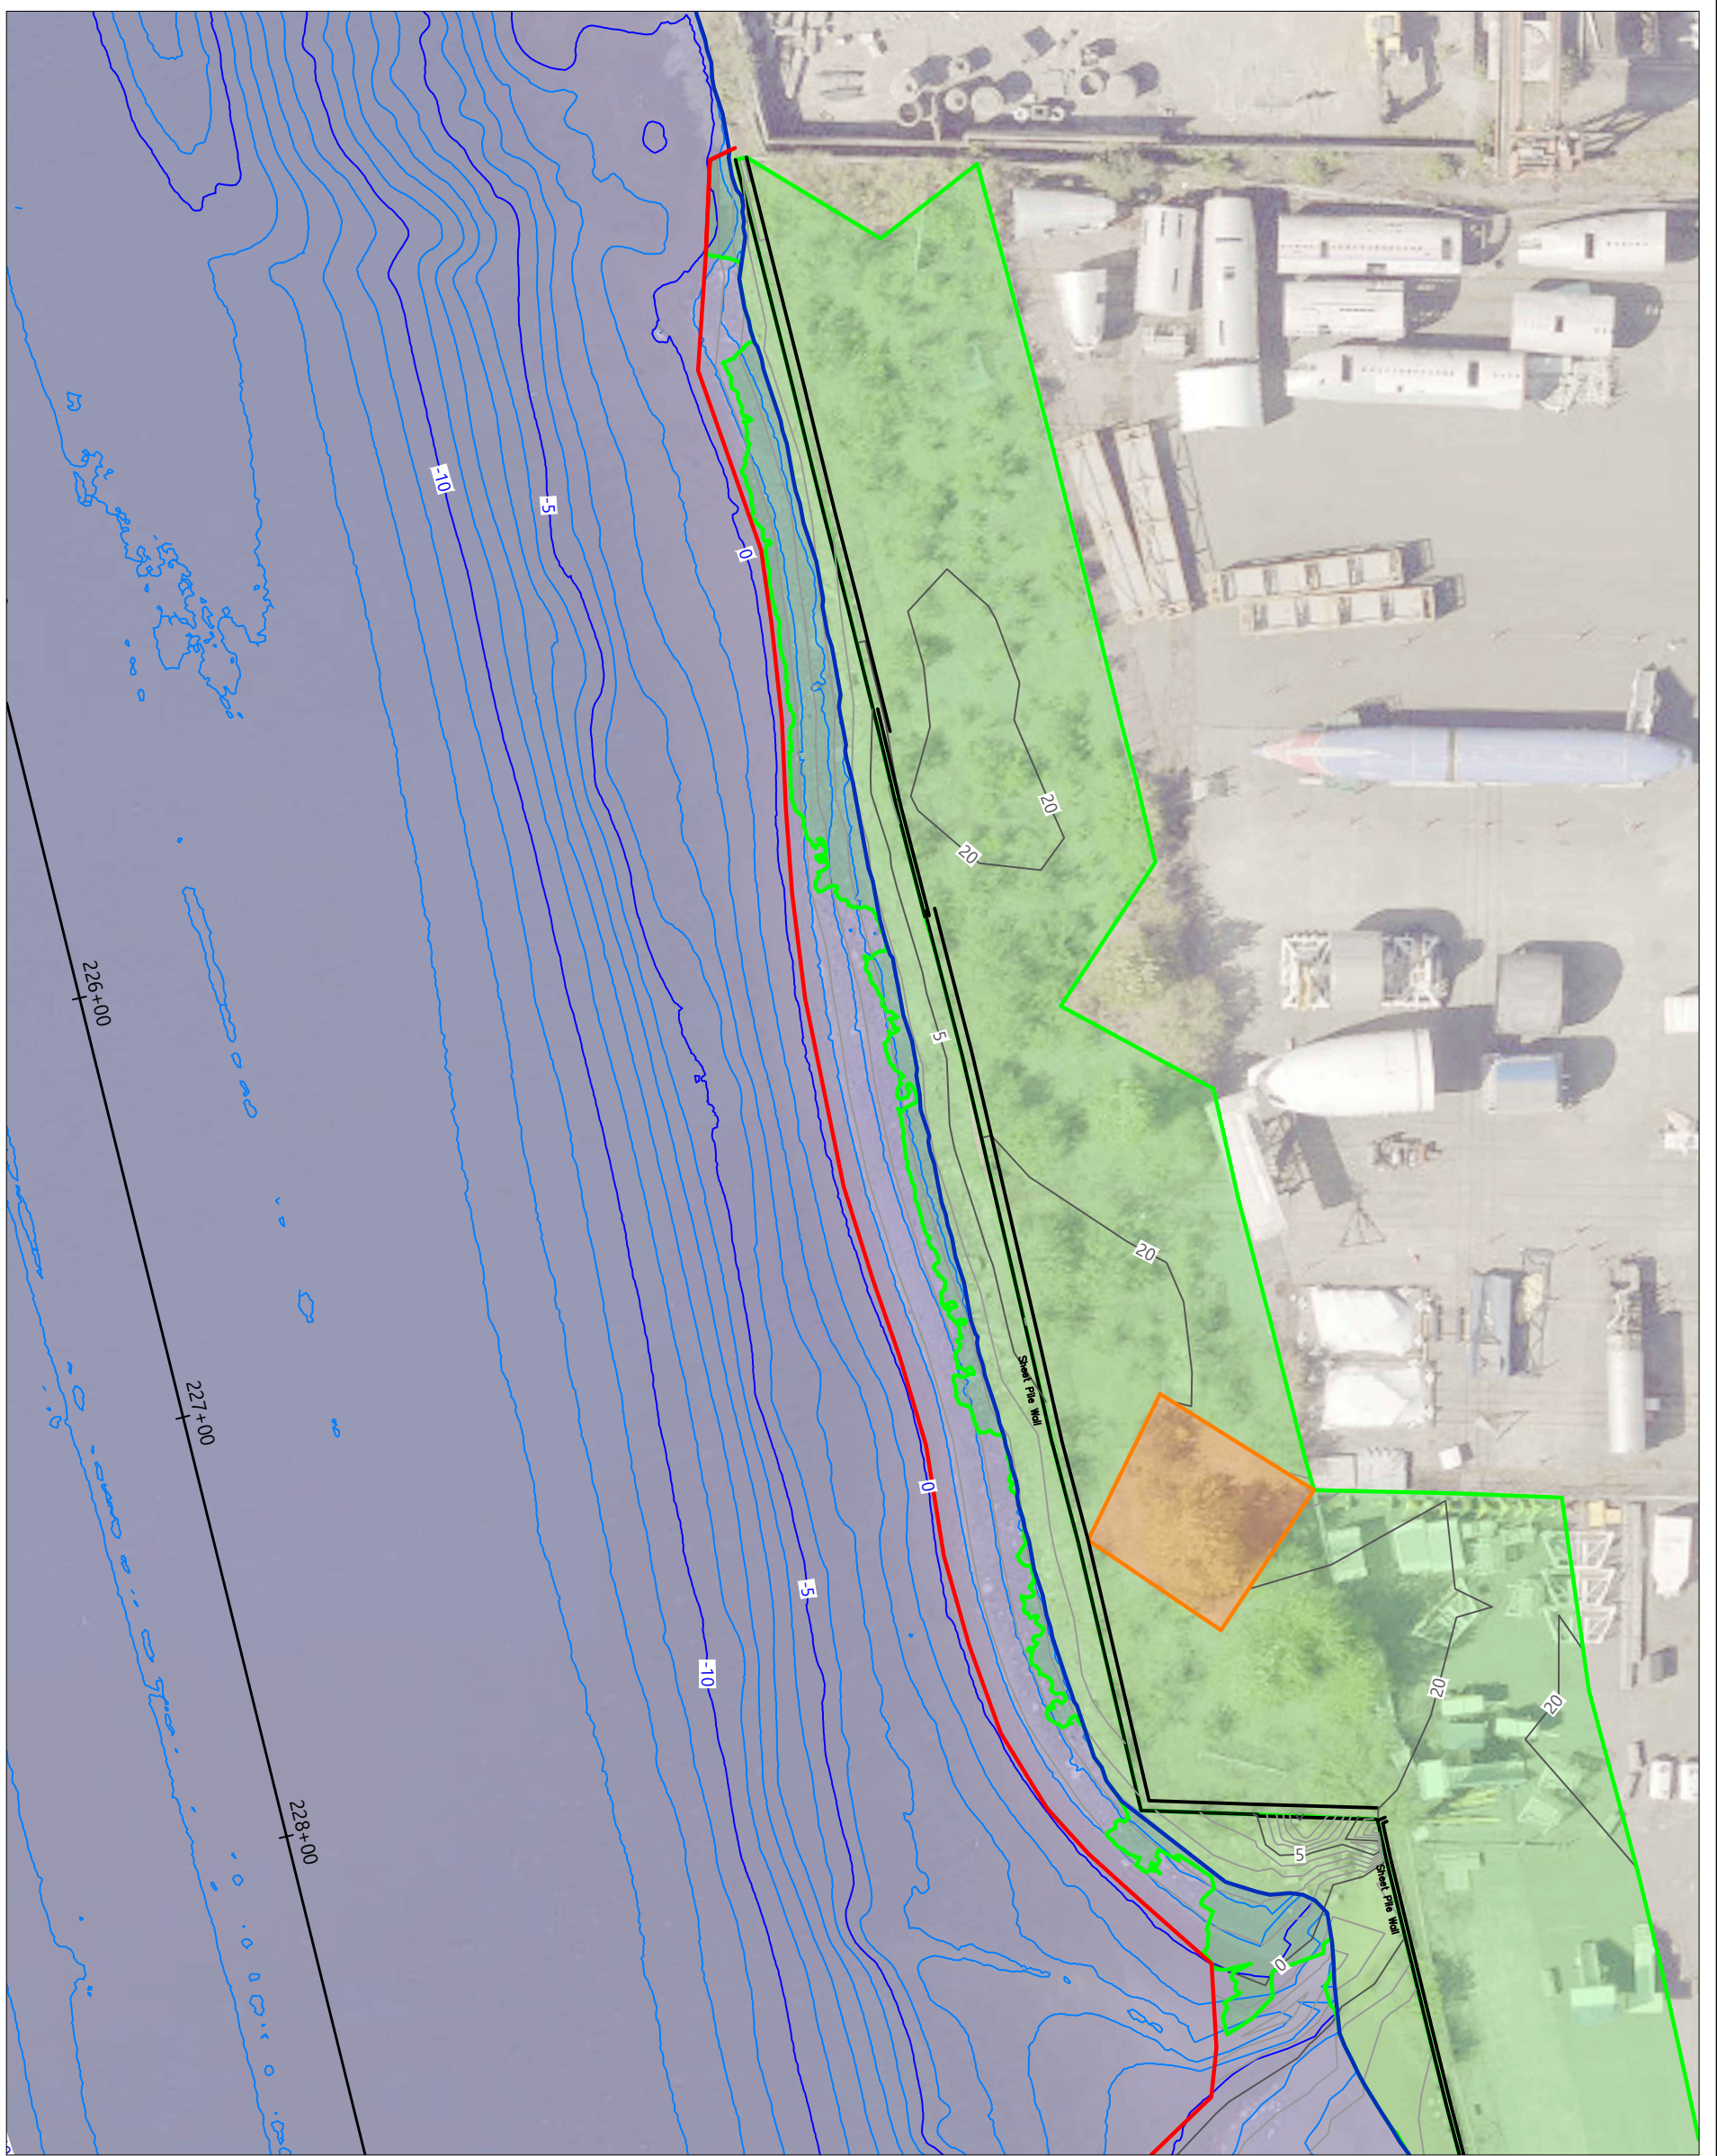
**Figure 2-5d. Bathymetric/topographic merging plan**

**Source:** Topographic survey by True North Land Surveying, Inc. performed between June 30, 2021, and August 10, 2021. Additional survey by True North performed on October 5 and 6, 2022. Bathymetric survey by Northwest Hydro performed between April 18, 2019, and May 15, 2019. Additional survey by Northwest Hydro performed June 2020. LiDAR survey from Puget Sound LiDAR Consortium dated 2016. Composite data updated December 2020 and November 2022.

**Horizontal Datum:** Washington State Plane, North Zone, NAD83 (2011), U.S. Survey Feet; WSDOT MON GP17005-176 & GP17005-181

**Vertical Datum:** Mean Lower Low Water (MLLW), MLLW converted from NAVD88 (NAVD88 + 2.34' to MLLW)

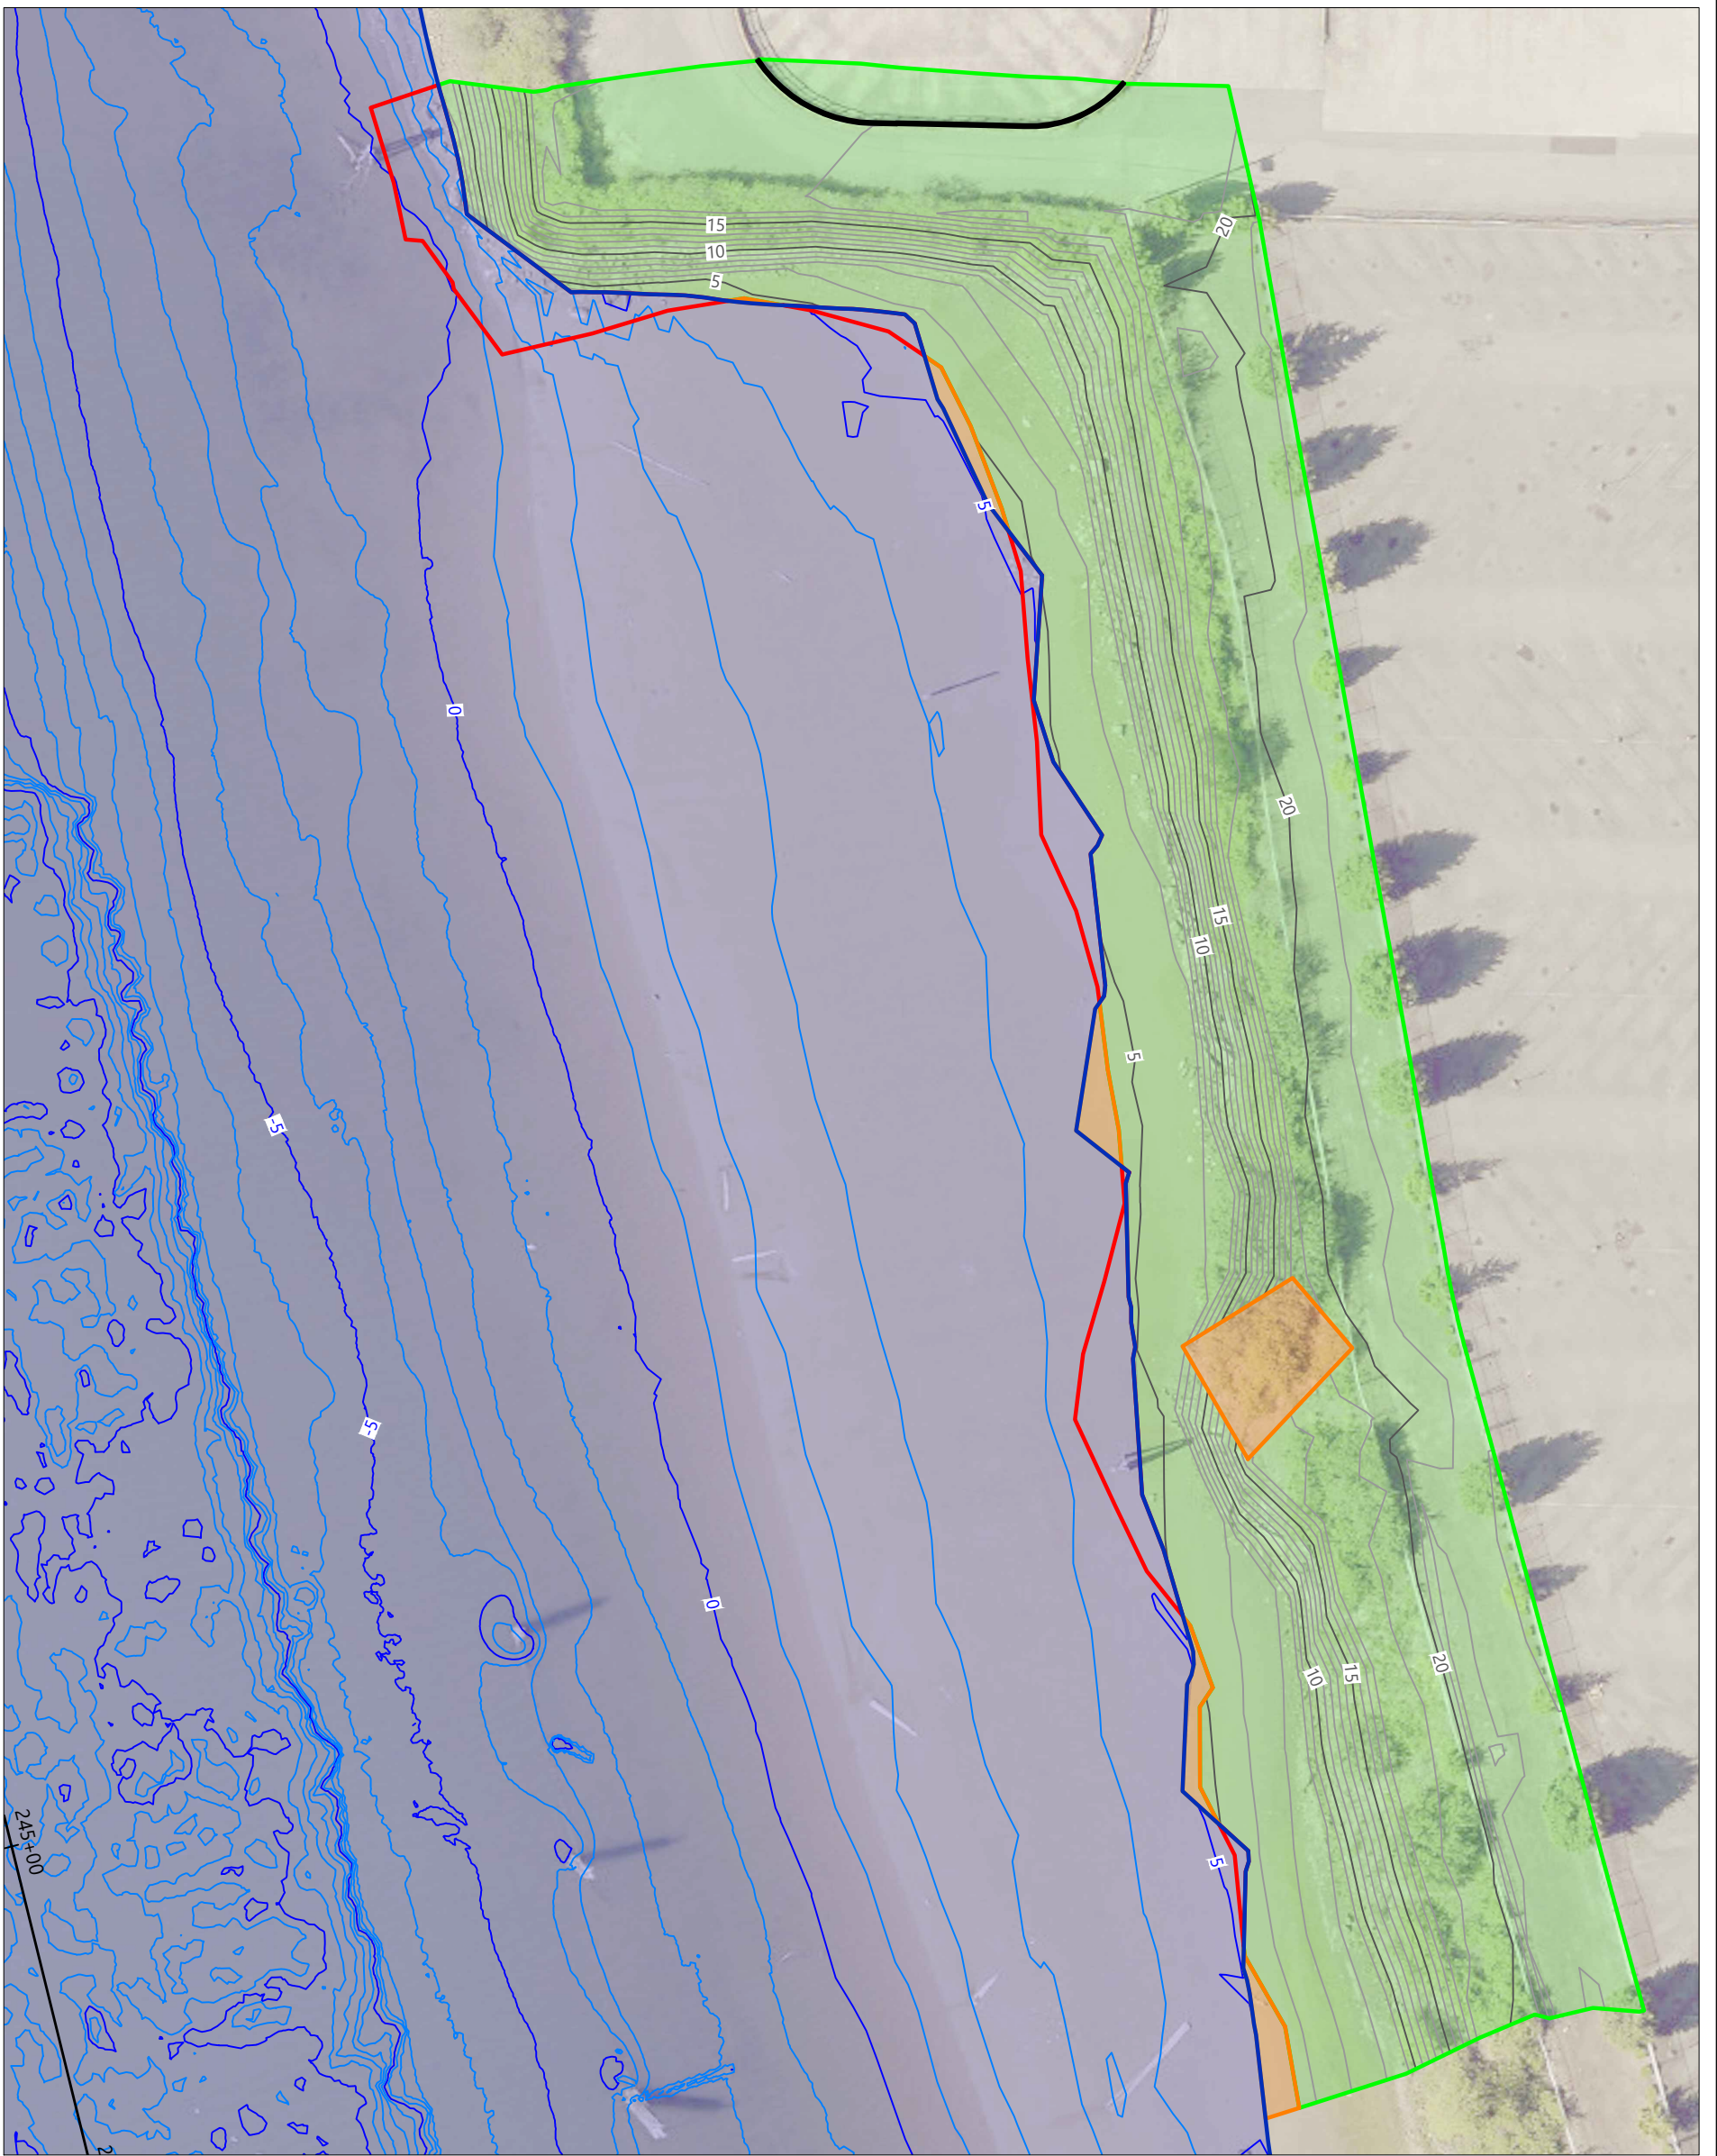
**Figure 2-5g. Bathymetric/topographic merging plan**

**Source:** Topographic survey by True North Land Surveying, Inc. performed between June 30, 2021, and August 10, 2021. Additional survey by True North performed on October 5 and 6, 2022. Bathymetric survey by Northwest Hydro performed between April 18, 2019, and May 15, 2019. Additional survey by Northwest Hydro performed June 2020. LiDAR survey from Puget Sound LiDAR Consortium dated 2016. Composite data updated December 2020 and November 2022.

**Horizontal Datum:** Washington State Plane, North Zone, NAD83 (2011), U.S. Survey Feet; WSDOT MON GP17005-176 & GP17005-181

**Vertical Datum:** Mean Lower Low Water (MLLW), MLLW converted from NAVD88 (NAVD88 + 2.34' to MLLW)

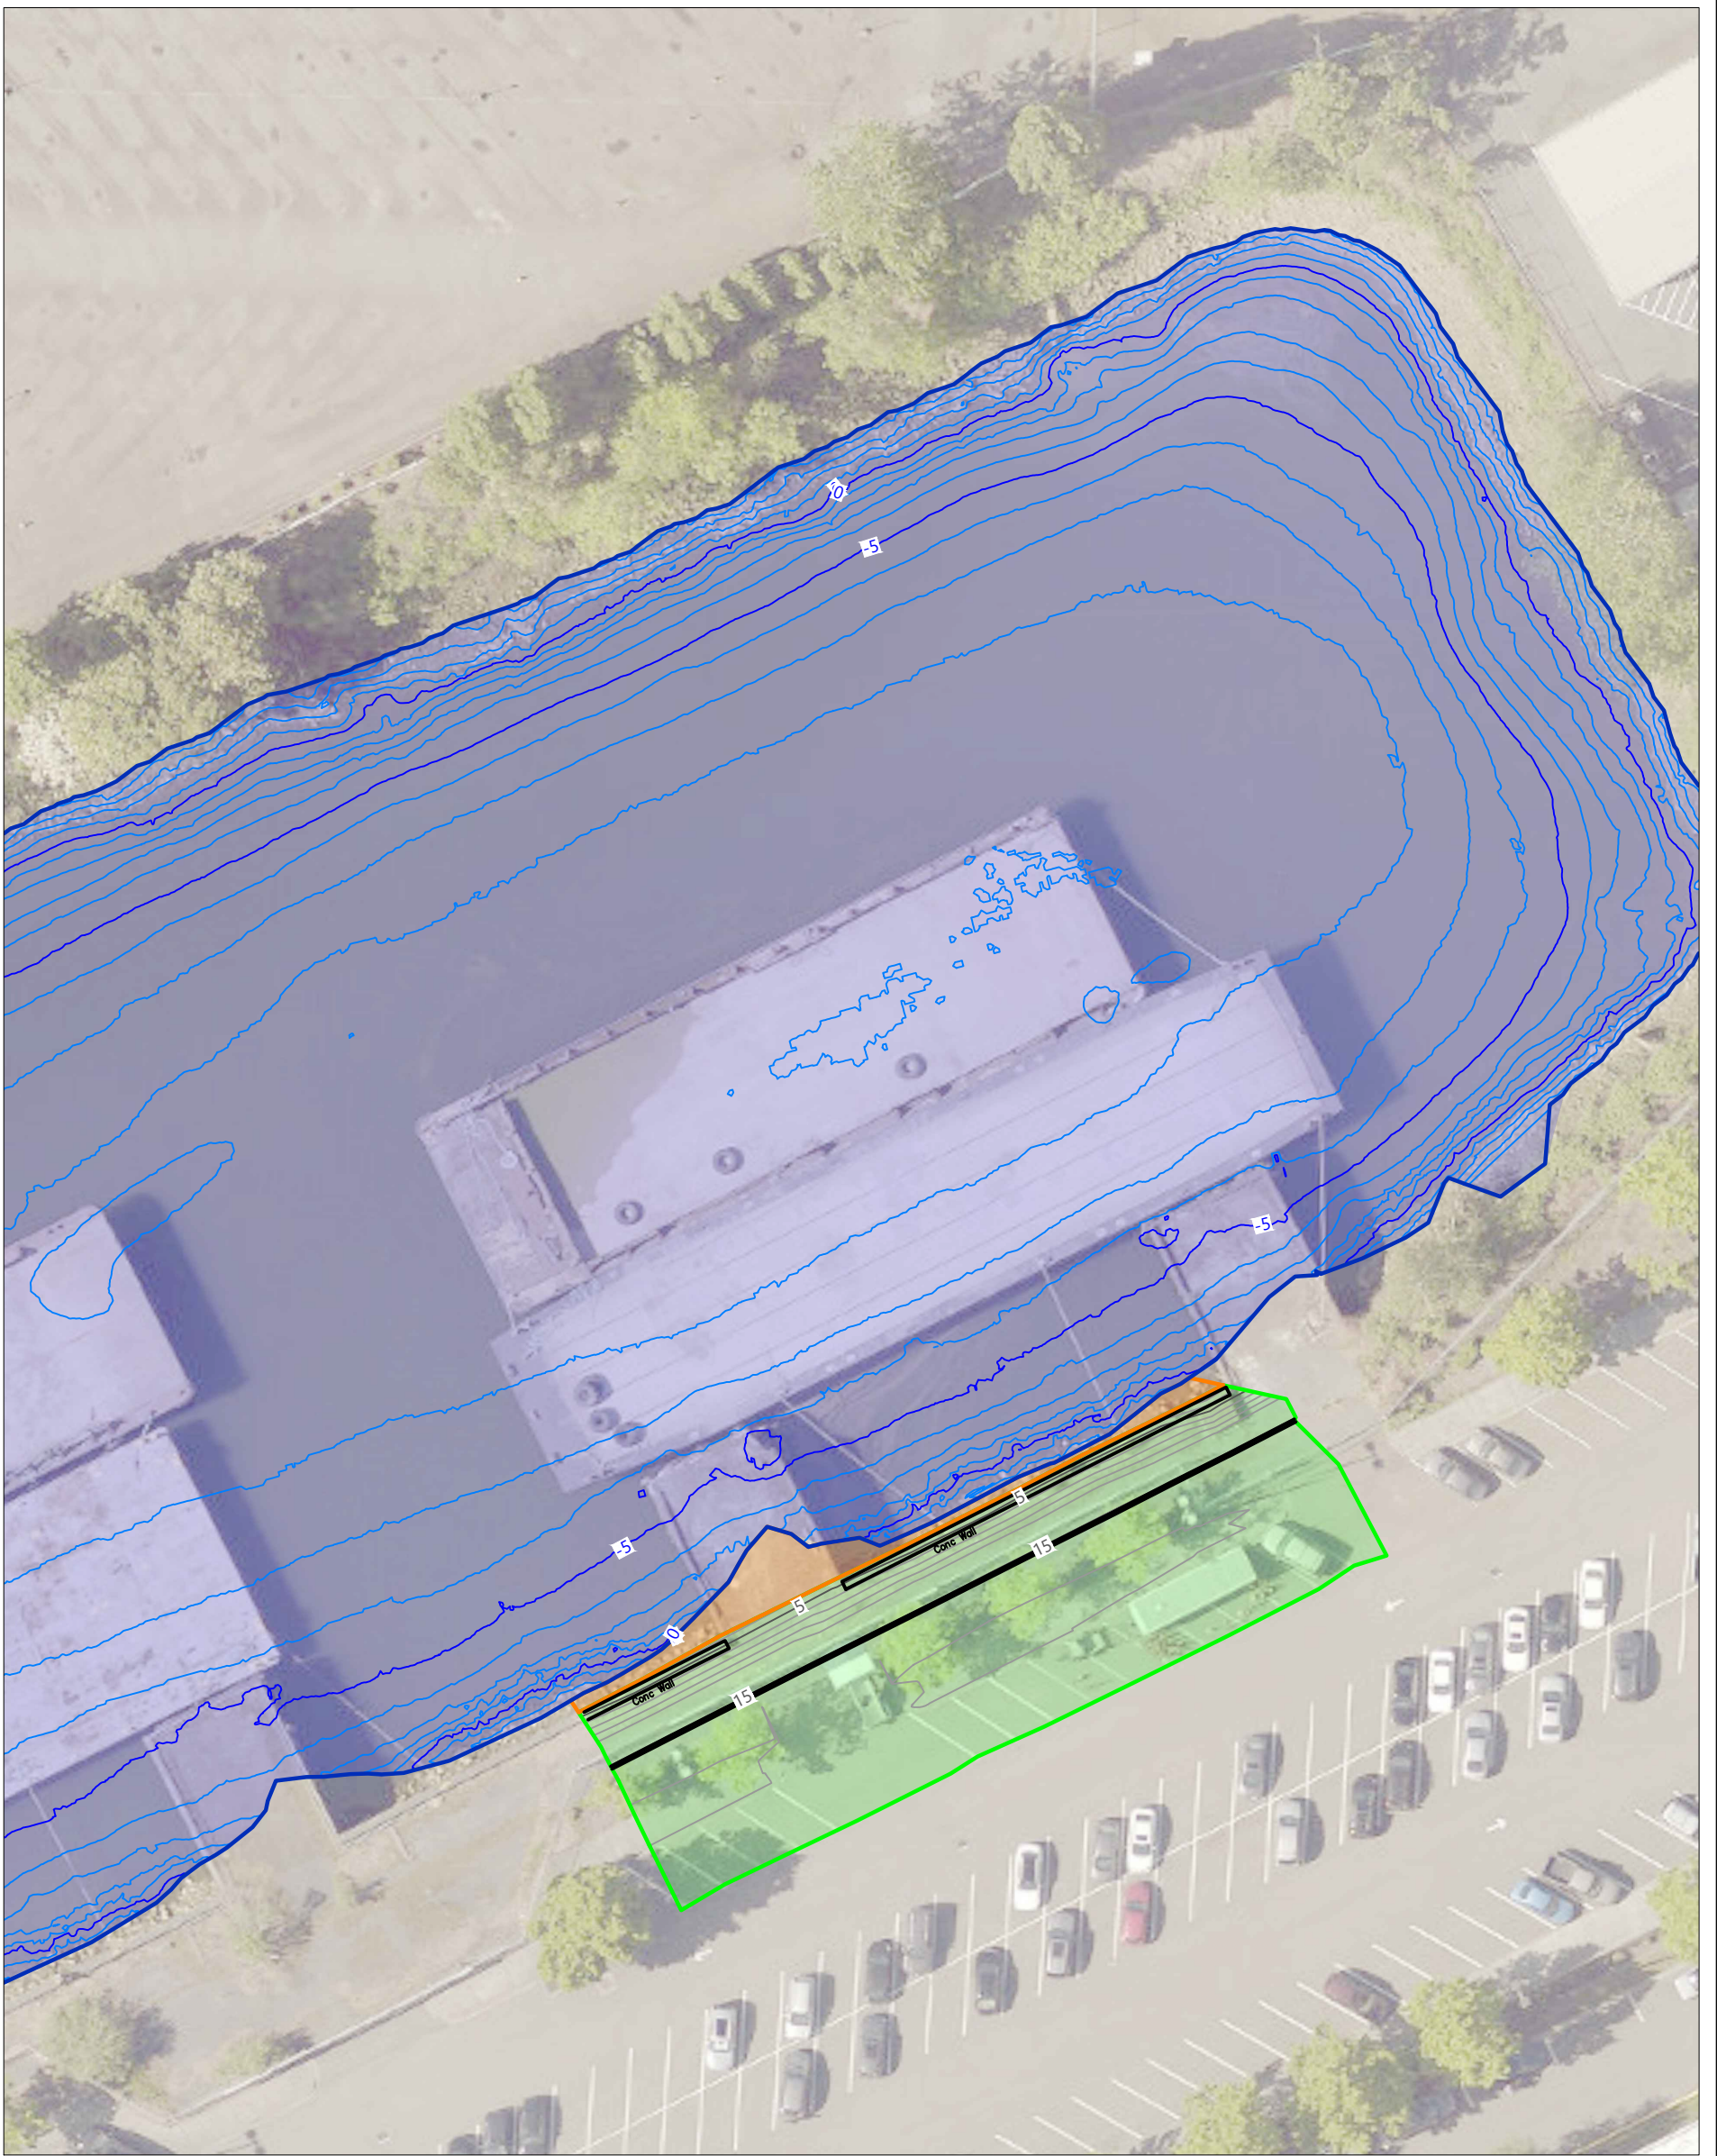
**Figure 2-5h. Bathymetric/topographic merging plan**

**Source:** Topographic survey by True North Land Surveying, Inc. performed between June 30, 2021, and August 10, 2021. Additional survey by True North performed on October 5 and 6, 2022. Bathymetric survey by Northwest Hydro performed between April 18, 2019, and May 15, 2019. Additional survey by Northwest Hydro performed June 2020. LiDAR survey from Puget Sound LiDAR Consortium dated 2016. Composite data updated December 2020 and November 2022.

**Horizontal Datum:** Washington State Plane, North Zone, NAD83 (2011), U.S. Survey Feet; WSDOT MON GP17005-176 & GP17005-181

**Vertical Datum:** Mean Lower Low Water (MLLW), MLLW converted from NAVD88 (NAVD88 + 2.34' to MLLW)
