100% Remedial Design Basis of Design Report

Appendix G Geotechnical Design Analysis

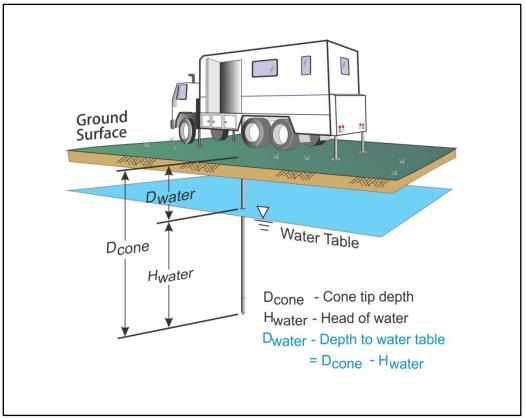
Figure PPD-1. Pore pressure dissipation test setup
