Lower Duwamish Waterway Group

WATERWAY USER SURVEY AND ASSESSMENT OF IN-WATER STRUCTURES— DATA REPORT

**U.S. Environmental Protection Agency
Region 10**

July 2, 2018

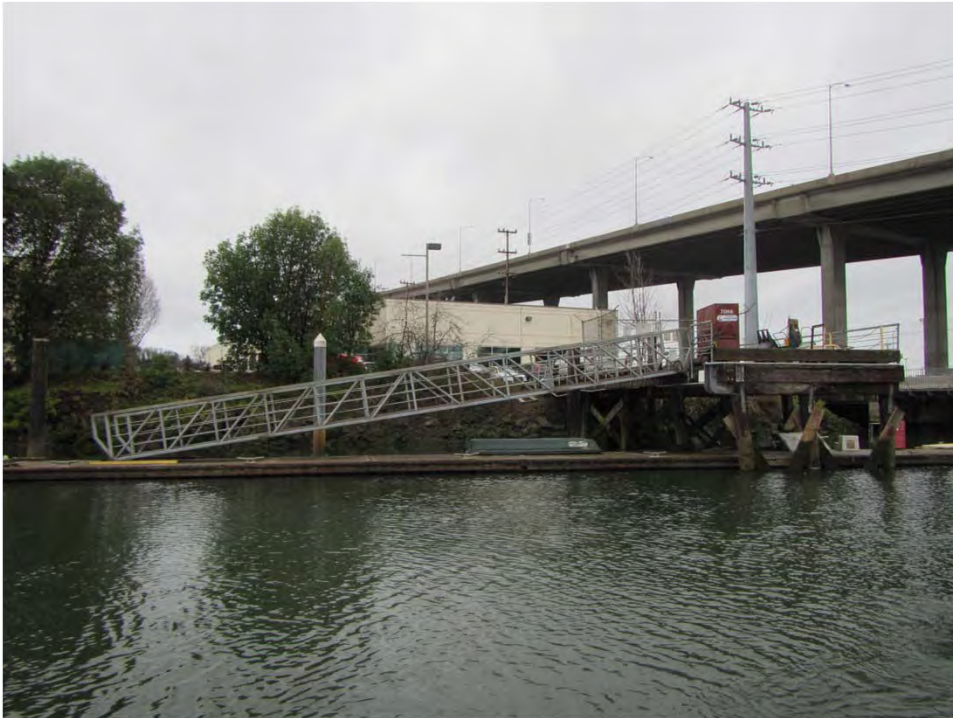
Element	Photo No.	Direction	Description / Comments						
Gangway Pier	01-3131	W	Timber gangway pier and gangway; floats parallel to the shore.						
East Waterway	01-3132	S	East side of the marina; upstream						
Gangway Pier	01-3133	W	Timber gangway pier and gangway; floats parallel to the shore						
East Waterway	01-3134	S	East side of the marina						
General	01-3137	N	Overall view of the marina						
General	01-3138	N	West entrance into the marina						
West Waterway	01-3139	N	West waterway and boat houses along the east shoreline of the marina; downstream						
Floats, Guide Piles	01-3141	NE	Marina interior at the west entrance						
South Shoreline	01-3143	NE	South shoreline and gangway pier						
Shoreline	01-3144	N	East shoreline in the west waterway; outfall; access between floats and the shoreline						
Boat Houses	01-3148	NE	Boat houses along the east shoreline of the west waterway						
<p>Photos Required:</p>

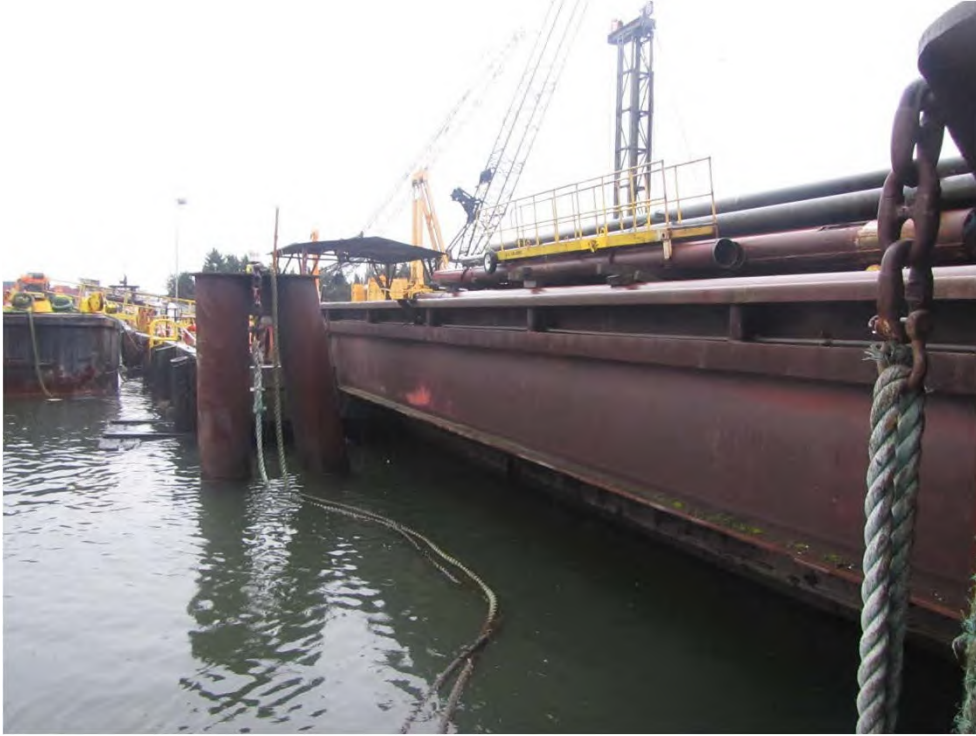
Element	Photo No.	Direction	Description / Comments						
Wharf	02-4504	SW	View of the east berthing face. A cantilevered deck is on the right side of the photo and the concrete/timber wharf with timber fender piles is in the background.						
Wharf and Shoreline	02-4514	W	View of the north end of the wharf and the riprap-protected shoreline to the north of the structure. The concrete rail bridge to the north is visible on the right of the photo.						
Wharf	02-4518	W	View of the north end of the timber wharf. The high water level prevented observations under the wharf.						
North of Structure	02-4519	NW	North of the structure is a rail bridge, a steel sheet pile wall and the West Seattle Bridge.						
North of Structure	02-4520	N	North of the structure is a rail bridge, a steel sheet pile wall and the West Seattle Bridge.						
Wharf	02-4525	N	View of the east berthing face with steel fender piles. The high water level prevented observations under the wharf.						
Wharf	02-4526	NW	View of the south end of the wharf. A concrete pile cap is visible with a gangway leading to a floating dock.						
Floating Dock and Transfer Span	02-4529	S	View of the steel floating dock supported by two steel 3-pile dolphins. A steel transfer span is beyond.						
Shoreline	02-4537	NW	Gravel and stones from the upland operations lines the shoreline. A small derelict timber structure is present between the floating dock and the steel transfer span and south of the transfer span.						
Transfer Span	02-4538	SW	The south end of the facility is a steel transfer span with a total of five steel mono pile dolphins to create a berth.						
Shoreline	02-4542	SW	A small derelict timber structure is present between the floating dock and the steel transfer span and south of the transfer span. A timber pile stub is present offshore of the timber structure.						
Dolphin and Shoreline	02-4558	SW	View of the southern steel mono pile dolphin. The shoreline is riprap protected south of the derelict timber wharf at the transfer span.						
<p>Photos Required:</p>

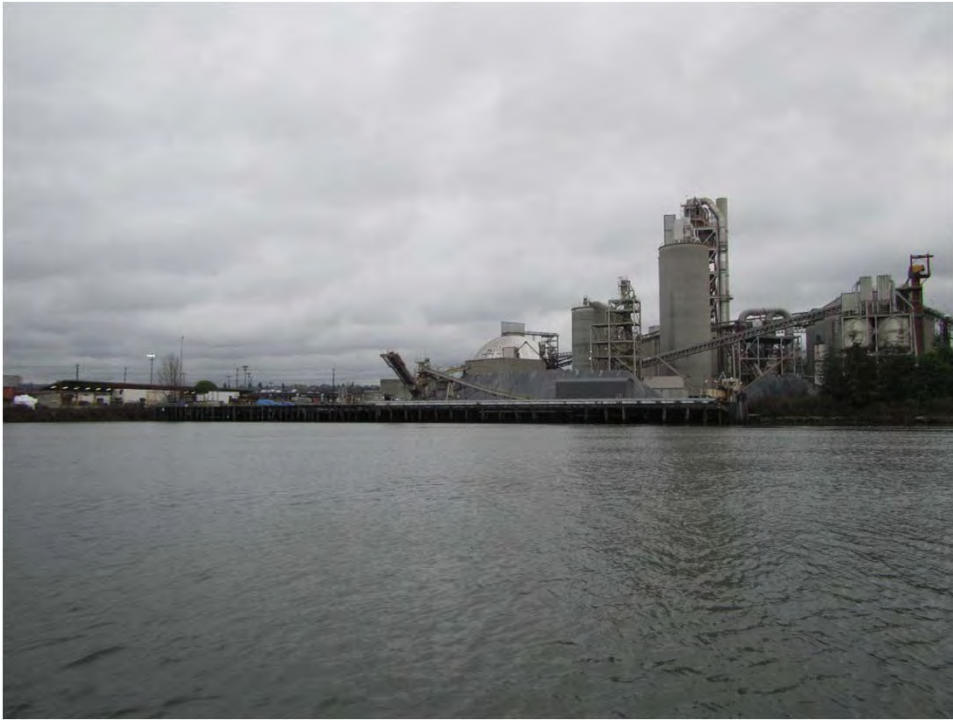
Element	Photo No.	Direction	Description / Comments						
General	03-3151	E	Overall view of the facility						
Upstream	03-3152	S	Looking upstream						
Downstream	03-3153	N	Looking downstream						
Shoreline	03-3154	E	Riprap shoreline, timber pile dolphin, and steel pile cluster south of the facility						
Wharf	03-3156	NE	Typical structure and fender condition						
Wharf	03-3157	E	Typical structure and fender condition						
Wharf, pile stub	03-3158	N	Typical structure and fender condition and pile stub 10 feet off the berthing face						
General	03-3164	E	Overall view of the facility						
Fender System	03-3169	NE	Typical fender system condition						
Timber Pile Dolphin	03-3170	E	Timber pile dolphin on the SW corner						
Wharf Pile Spacing	03-3171	E	View under the wharf of the piles, pile spacing and concrete superstructure						
Fender System	03-3173	N	Timber fender system; isolated missing and broken piling						
Shoreline	03-3174	NE	South shoreline with rock armoring and vegetation; timber pile stubs are observed along the shoreline						
<p>Photos Required:</p>

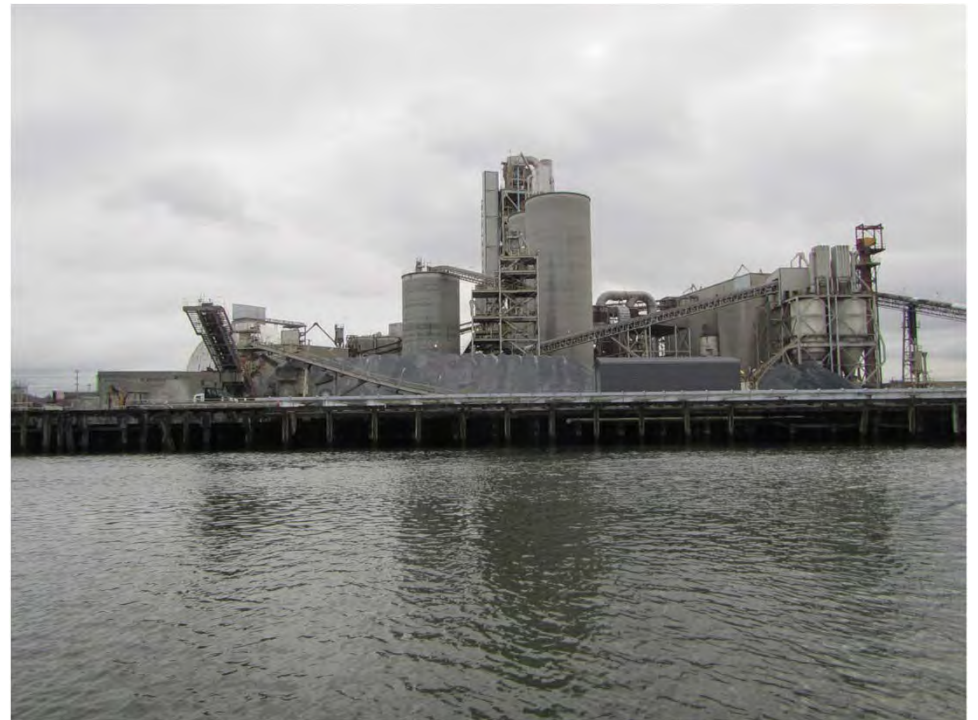
03-3158

Derelict steel dolphin piles approximately 100 feet south of the wharf (Photo 03-3154). Timber pile stub near north end of the facility is approximately 10 feet off the structure's berthing face (Photo 03-3158). Reduced overhead clearance beneath structure observed (thickened concrete deck area) and areas with utilities transverse to facility.

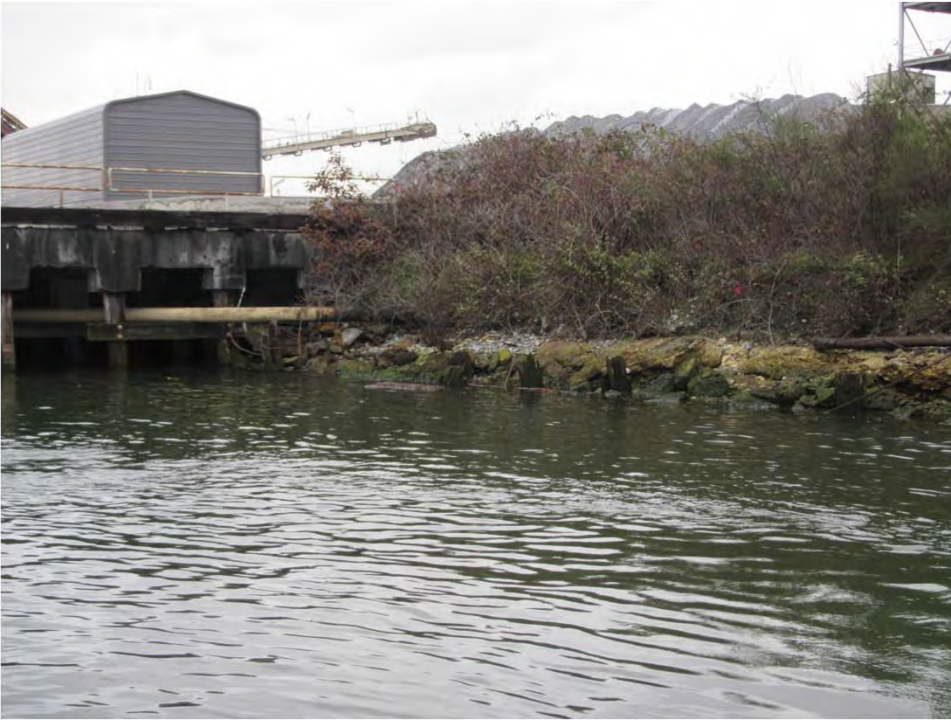
03-3174

Pile stubs are observed along the south shoreline (Photo 03-3174).

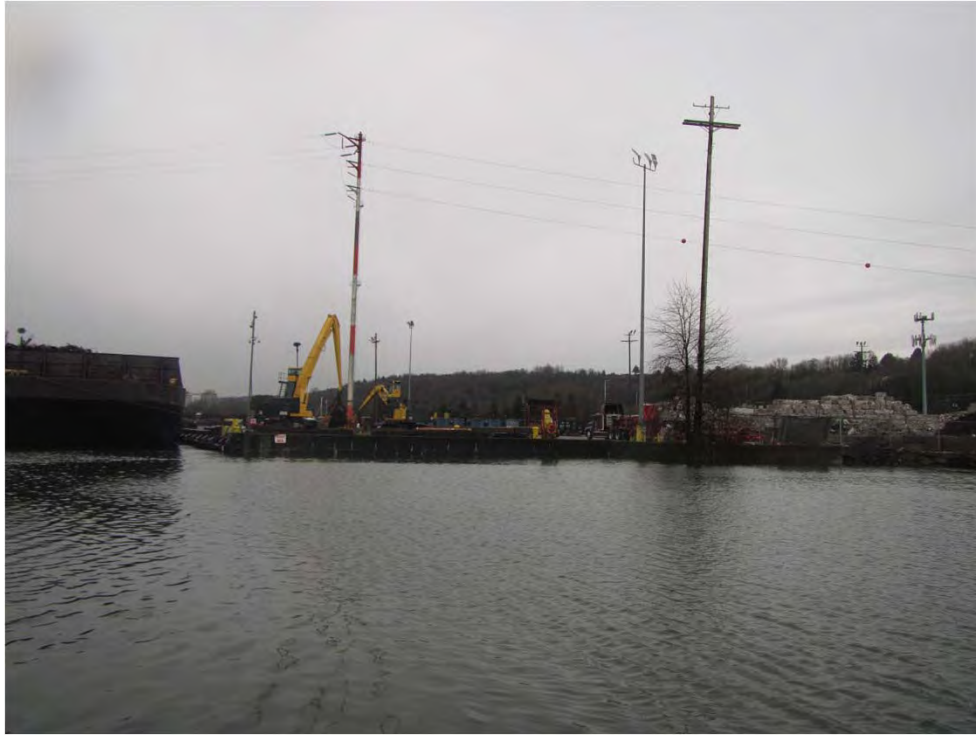
Element	Photo No.	Direction	Description / Comments						
Wharf	05-4604	S	View of the north end of the concrete wharf.						
Wharf	05-4606	S	Closeup view of the north end of the concrete wharf.						
Wharf	05-4613	W	View of the midpoint of the concrete wharf and timber fender piles.						
Wharf	05-4614	N	View along the berthing face.						
Wharf	05-4615	N	View of the timber fender system.						
South of Structure	05-4617	SW	Structure #6 is contiguous to the south end of the wharf. The waterway outboard of Structure #6 is used as barge berthing.						
Wharf	05-4800	NW	Underdeck view of the concrete wharf.						
Outfall	05-4803	W	View of the large outfall to the north of the wharf.						
<p>Photos Required:</p>

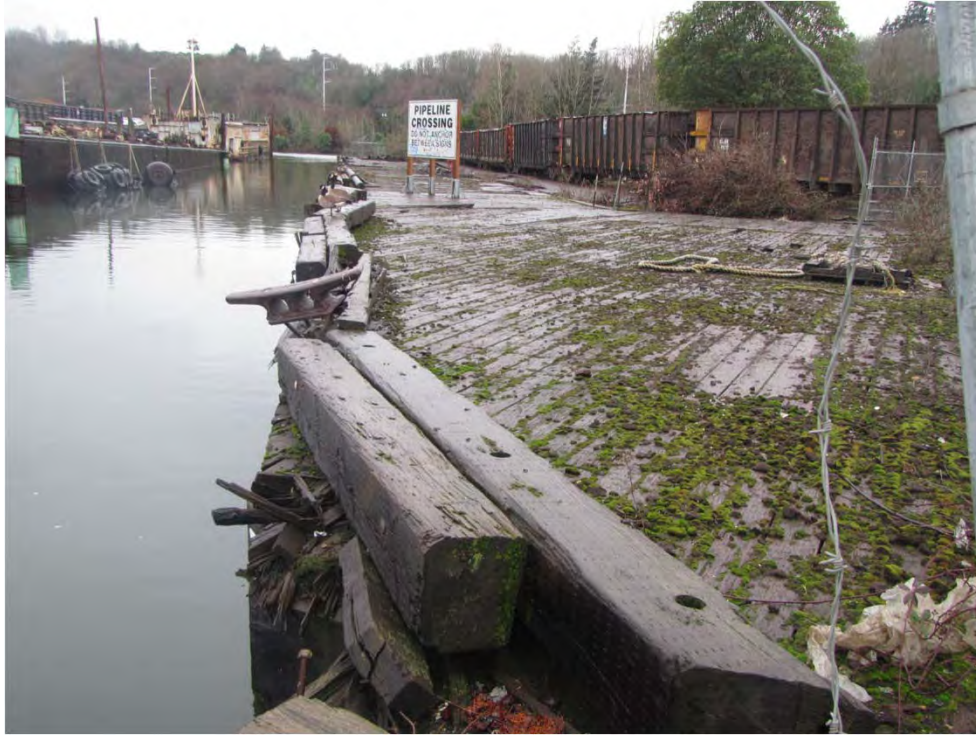
Element	Photo No.	Direction	Description / Comments						
Wharf	06-4616	SW	View of the timber wharf topside. The face of the wharf, timber bullrail, and mooring fittings have widespread damage.						
Wharf	06-4628	SW	View of the south face of the wharf. Approximately 75 feet to the south of the wharf, barges are stored in the area using their spuds.						
Wharf	06-4635	W	The wharf has widespread damage. In this photo the pile caps do not extend to the outboard pile, the jack stringer is missing and the decking is damaged.						
Wharf	06-4642	W	The west end of the timber wharf. The majority of the fending piles are missing along the wharf.						
Wharf	06-4650	NW	View of the west corner of the wharf. The edge bearing piles are visible below the waterline indicating the pile caps are damaged.						
Wharf and Shoreline	06-4651	NW	View of the west end of the wharf and the shoreline. The shoreline has scattered riprap.						
West Shoreline	06-3652	SW	View of the shoreline to the west of the wharf. The shoreline has scattered riprap.						
Wharf	06-4788	N	View of the west corner of the wharf.						
Wharf	06-4789	NW	Underdeck view of the timber wharf. The west end of the wharf exhibits multiple abandoned piles and tight pile spacing.						
Wharf	06-4794	N	View of the widespread damage along the wharf.						
Wharf	06-4796	NW	Underdeck view of the timber wharf.						
<p>Photos Required:</p>

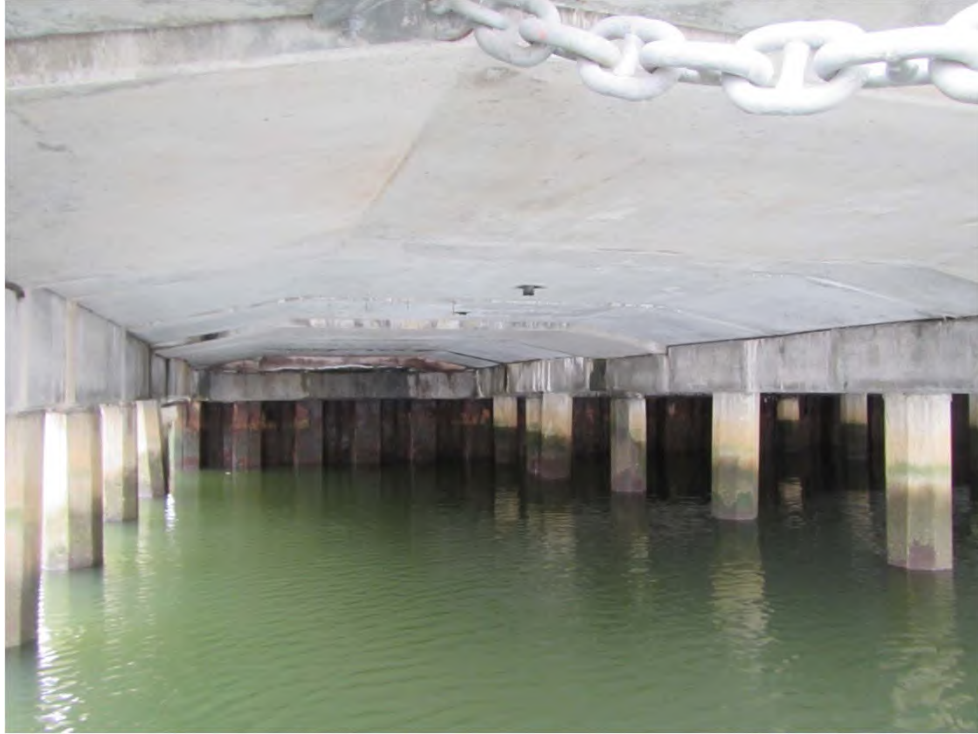
Element	Photo No.	Direction	Description / Comments
Wharf	07-3272	E	Underdeck view of the concrete wharf and steel sheet pile bulkhead.
North Shoreline	07-3275	NE	View of the riprap-protected shoreline to the north of the structure. Structure #9 is visible on the left side of the photograph.
Wharf	07-3279	S	View along the berthing face of the structure. The fender system includes steel piles with rubber tires.
Wharf	07-3281	NE	View of the south end of the facility.
Wharf	07-3282	E	View of the conveyor structure supported on steel posts.
Wharf	07-3287	NE	View of the south end of the facility and end of the bulkhead.
South Shoreline	07-3289	E	View of the shoreline south of the structure. The shoreline is protected with concrete rubble. Structure #61 is just south of Structure #7.

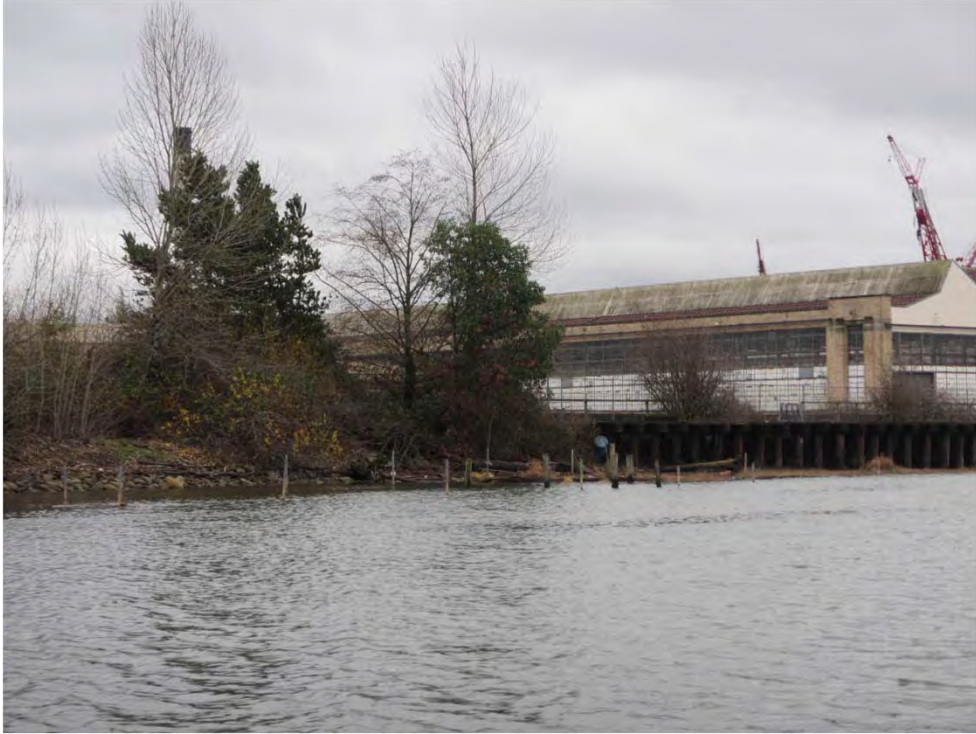
Element	Photo No.	Direction	Description / Comments						
North Shoreline and North Timber Wharf	08-3220	SE	View of the small riprap-protected and vegetated shoreline. A field of vertical small diameter pipes and a derelict timber wharf is present along the north shoreline.						
North Timber Wharf and Timber Dolphin	08-3225	E	View of the derelict timber wharf and timber dolphin along the north shoreline.						
North Shoreline and Timber Wharf	08-3228	E	View of the riprap-protected shoreline between the north timber wharf and primary timber wharf. Three timber dolphins are present offshore of the primary timber wharf (Two visible in this photograph).						
Timber Wharf	08-3230	NE	View of the SE corner of the timber wharf. The corner exhibits evidence of damage from vessel impact.						
Timber Wharf	08-3231	N	View of the timber wharf. The tight pile spacing, low hanging utilities, and damaged wharf components may restrict access.						
Concrete Wharf	08-3233	E	General view of the concrete wharf supporting the building.						
Timber Wharf	08-3235	NE	View of fender pile and wharf damage along the wharf.						
Concrete Wharf	08-3239	N	Closeup view of the concrete wharf and low hanging utility pipes under the wharf.						
Concrete Wharf and Floating Dock	08-3242	E	View of the SE leg of the concrete wharf and the small floating dock.						
Concrete Wharf and South Shoreline	08-3246	E	View of the south end of the concrete wharf within Slip 1. A field of tightly spaced timber piles is present to the south. The south shoreline is vegetated with isolated riprap and debris.						
General Wharf	08-5448	W	General view of the concrete wharf supporting the building and the contiguous timber wharf beyond the building.						
Timber Wharf	08-5452	NE	Closeup view of the timber wharf.						
Timber Wharf	08-5454	E	Closeup view of the timber wharf and riprap-protected shoreline.						
<p>Photos Required:</p>

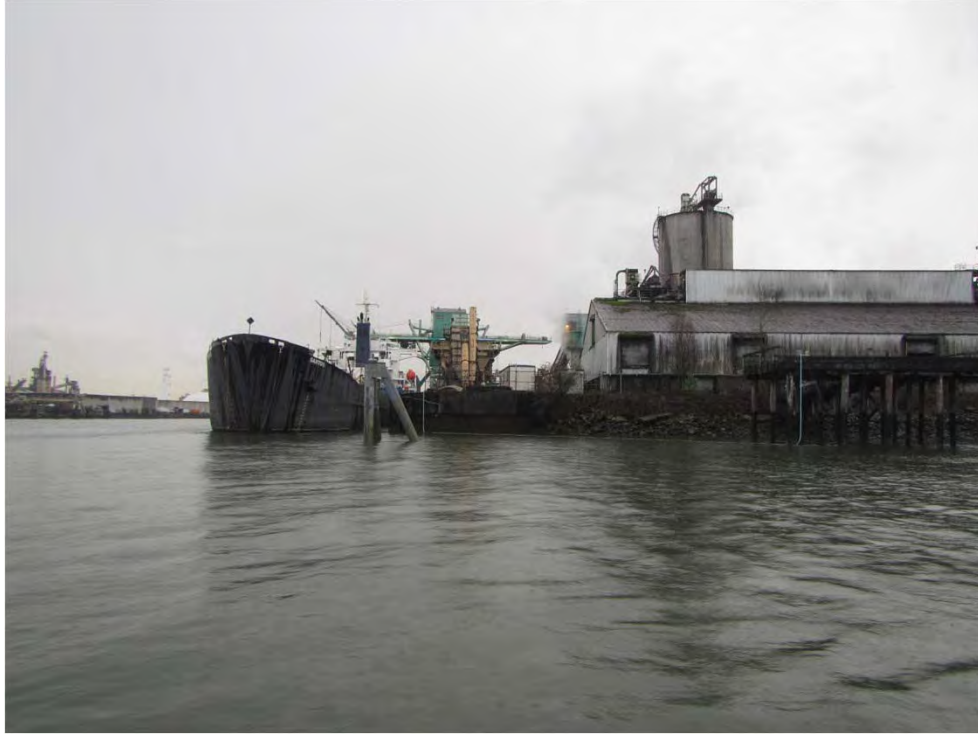
Element	Photo No.	Direction	Description / Comments						
Sheet Pile Bulkhead	10-4817	S	View of the north end of the facility. A 3-pile steel dolphin is to the north of the bulkhead. Structure #11 is visible on the right side of the photograph.						
Sheet Pile Bulkhead	10-4835	S	View of the north corner of the steel sheet pile cellular bulkhead and concrete cap. A 4-pile timber dolphin is located at the north corner.						
Sheet Pile Bulkhead	10-4839	N	View of the steel sheet pile cellular bulkhead and concrete cap. The fender system consists of steel piles with rubber rub panels.						
Sheet Pile Bulkhead	10-4841	W	Underdeck view of the bulkhead and cap. Concrete piles and a steel beam support the concrete cap.						
Sheet Pile Bulkhead	10-4844	W	Underdeck view of the bulkhead and cap. Concrete piles and a steel beam support the concrete cap.						
Sheet Pile Bulkhead	10-4846	N	View of the steel sheet pile cellular bulkhead and concrete cap.						
Outfalls and Sheet Pile Bulkhead	10-4860	W	Three outfalls penetrating the steel sheet pile wall are present at the south end of the facility. Also, an 8-pile timber dolphin is present at the south end.						
<p>Photos Required:</p>

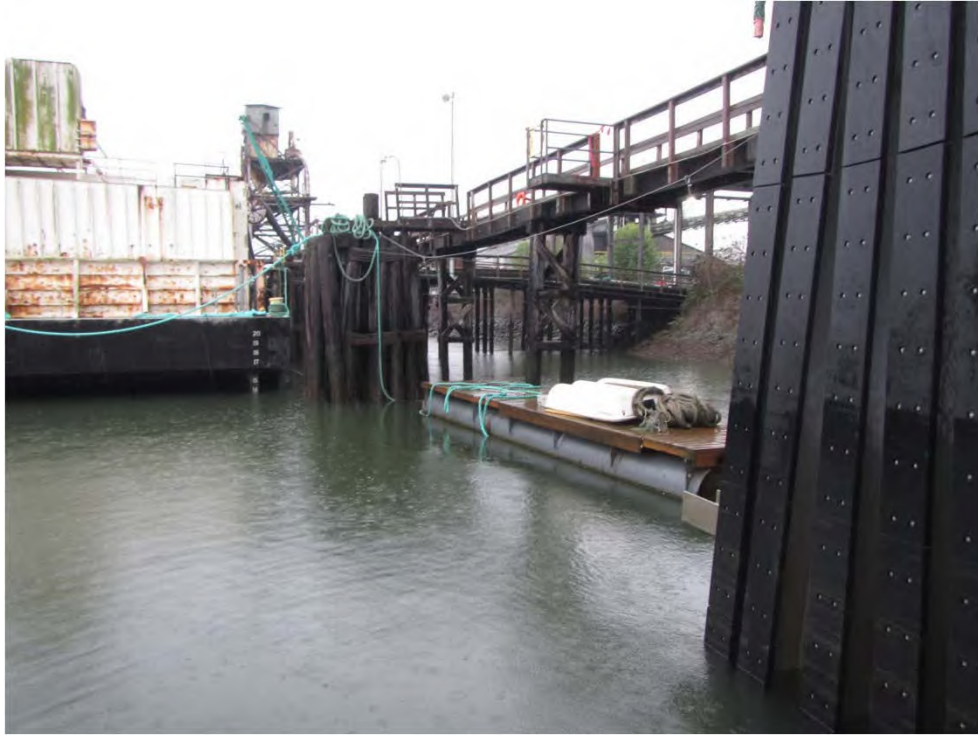
Element	Photo No.	Direction	Description / Comments						
Dolphins and Walkway	11-4809	E	View of the timber dolphins and timber access walkway.						
Dolphin and West Shoreline	11-4810	W	View of the western timber dolphin and the riprap-protected shoreline to the west.						
Dolphins and Sheet Pile Wall	11-4811	SW	View of the timber dolphins. The dolphin in the front has steel fendering with rub strips. The dolphin in the background has timber pile fenders. The steel sheet pile wall is visible on the left side of the photograph.						
Dolphins and Sheet Pile Wall	11-4814	S	View of the timber dolphins and the sheet pile wall behind the walkway along the shoreline.						
Dolphin and Pier	11-4819	S	View of the 3-pile steel dolphin to the east of the eastern L-shaped timber pier. The shoreline is riprap protected.						
Pier and Dolphin	11-4822	SW	View of the eastern L-shaped timber pier and a 3-pile steel dolphin.						
Dolphin and Walkway	11-4823	W	View along the berthing face showing the timber walkway and a timber dolphin.						
<p>Photos Required:</p>

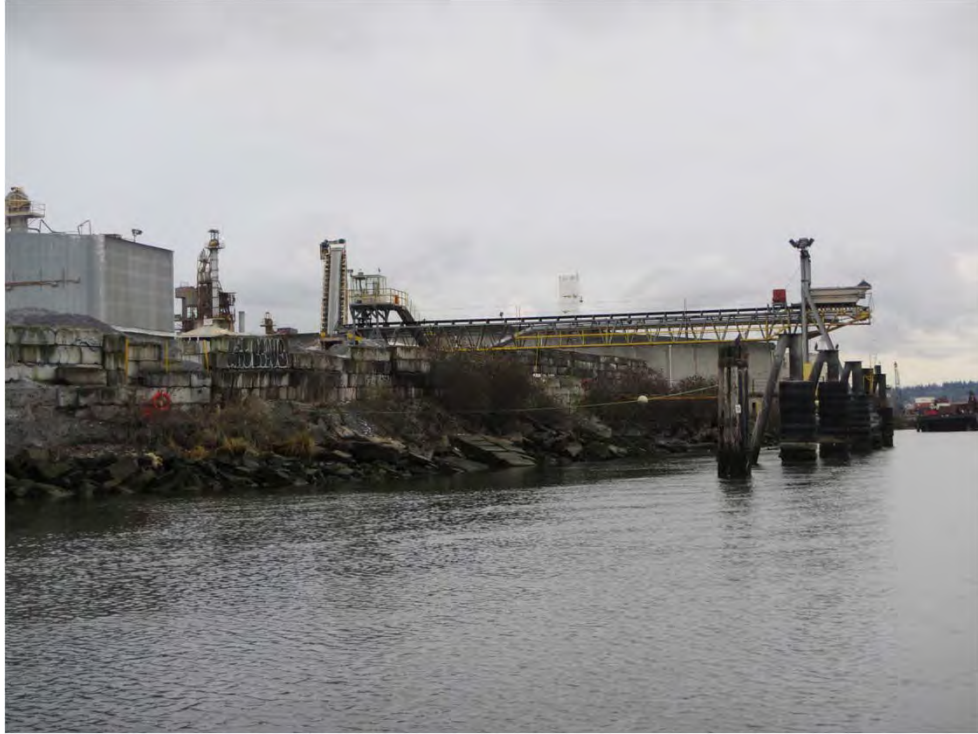
Element	Photo No.	Direction	Description / Comments						
Overall / Shoreline	12-3298	S	Overall view of the facility and shoreline.						
North Shoreline	12-3299	E	View of the concrete-rubble protected shoreline to the north.						
Timber Dolphin	12-3301	SE	View of the timber dolphin on the north end of the barge berth.						
Steel Dolphin	12-3305	S	View of the typical steel dolphin with tire fenders.						
Conveyor Support Structure	12-3310	SE	View of the conveyor support structure.						
Steel Dolphin and South Shoreline	12-3314	SE	View of the southern steel dolphin and concrete-rubble and riprap protected shoreline.						
Conveyor Support Structure	12-3315	N	Elevation view of the south side of the conveyor structure.						
South Shoreline	12-3316	E	View of the concrete-rubble protected shoreline.						
South Shoreline	12-3317	SE	View of the riprap protected shoreline.						
<p>Photos Required:</p>

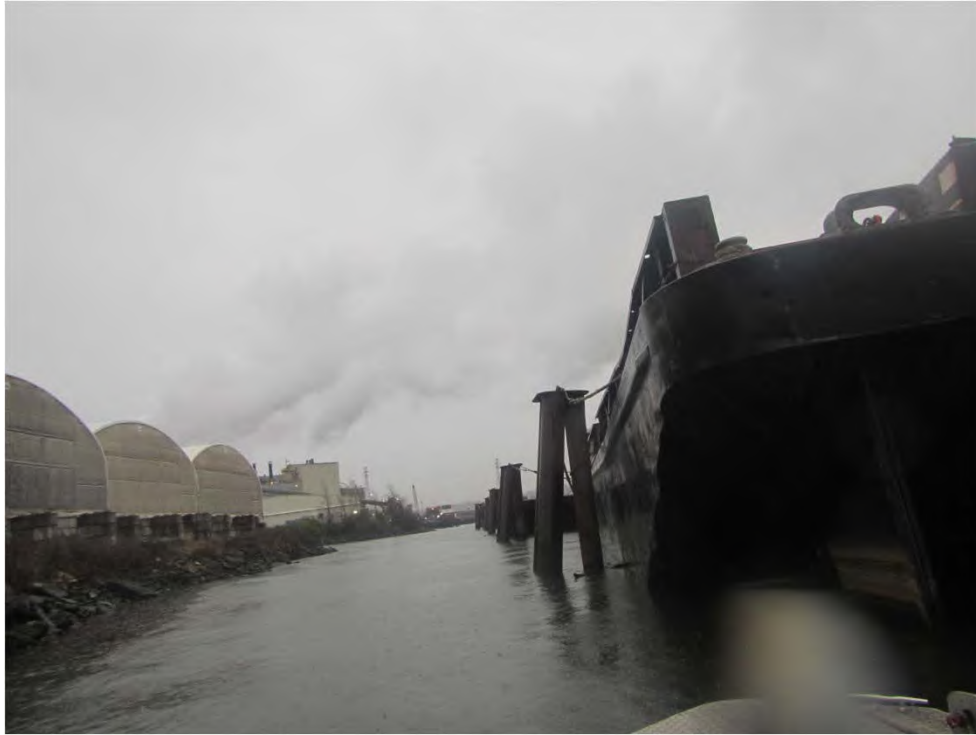
Element	Photo No.	Direction	Description / Comments						
Overall / Dolphins	15-3326	S	Overall view of the row of dolphins parallel to the shoreline.						
Shoreline	15-3327	N	View of the riprap protected shoreline north of the barge berths.						
Dolphin	15-3328	S	View of the typical steel 3-pile dolphin.						
Shoreline	15-3329	SE	View of the riprap protected shoreline.						
Overall / Dolphins	15-3332	N	Overall view of the row of dolphins parallel to the shoreline.						
Dolphins	15-3333	S	View of the dolphins on the south end of the barge berths.						
Shoreline	15-3336	SE	View of the riprap protected shoreline south of the barge berths.						
<p>Photos Required:</p>

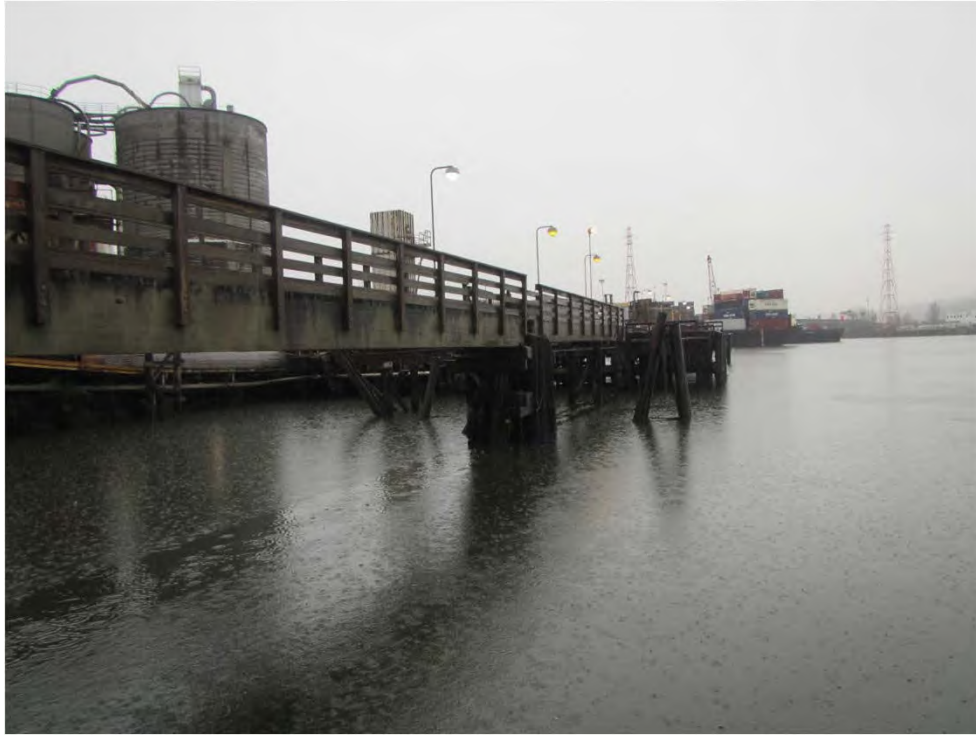
Element	Photo No.	Direction	Description / Comments						
Timber Walkway	18-3337	S	View of the berthing face and timber walkways. A pile field is visible on the inboard side of the walkway.						
Timber Walkway Support	18-3338	E	View of the northern timber walkway support.						
North Shoreline	18-3341	NE	Riprap protected shoreline north of the structure. A small concrete structure is located along the shoreline on the north end of the facility.						
T-Head Pier	18-3348	E	Timber T-head pier and timber fender piles.						
Overall / T-Head Pier	18-3350	E	Overall view of the over-water structures.						
Walkways and Dolphins	18-3351	SE	View of the southern timber walkway and timber dolphins.						
Walkways	18-3354	N	View of the southern timber walkway.						
Walkways and Dolphins	18-3358	NE	View of the southern timber walkway and dolphins.						
South Shoreline	18-3361	NE	View of the unprotected shoreline on the south end of the facility.						
South Shoreline	18-3362	NE	View of the unprotected shoreline on the south end of the facility and the bulkhead with steel soldier piles and timber lagging.						
Overall	18-5440	N	View of the over-water structures.						
Shoreline	18-5441	E	View of the unprotected shoreline at the structure.						
Overall	18-5442	S	View of the T-head pier, walkways, and steel pipe pile dolphin.						
<p>Photos Required:</p>

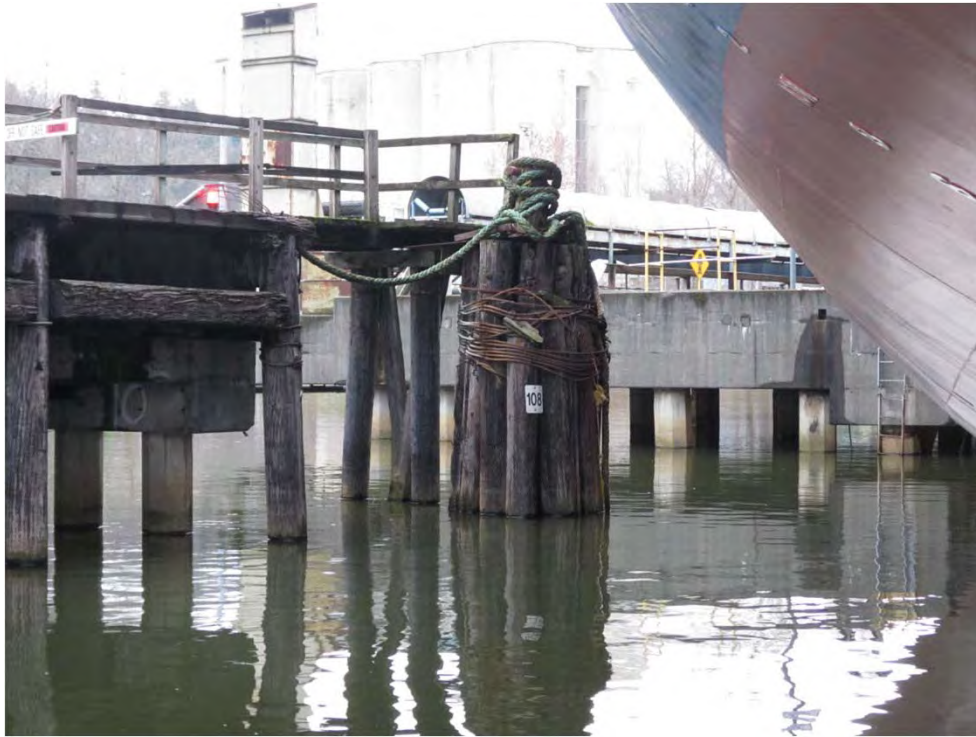
Element	Photo No.	Direction	Description / Comments						
Dolphin	19-4898	NW	View of the timber dolphin at the north end of the wharf. Structure #17 is in the background.						
Shoreline	19-4899	W	View of the riprap-protected shoreline to the north of the structure.						
Wharf	19-4901	S	Underdeck view of the concrete wharf.						
Wharf	19-4913	SW	View along the berthing face of the concrete wharf. Timber fender piles are present along the wharf.						
Wharf	19-4914	W	Underdeck view of the concrete wharf. There is less clearance under the deck.						
Wharf	19-4921	W	Underdeck view of the concrete wharf.						
Wharf	19-4922	NW	General view of the concrete wharf and timber fender system.						
Wharf and Transfer Span	19-4927	SW	View of the south end of the wharf (timber fender system) where it is contiguous with Structure #20 (fender panels)						
<p>Photos Required:</p>

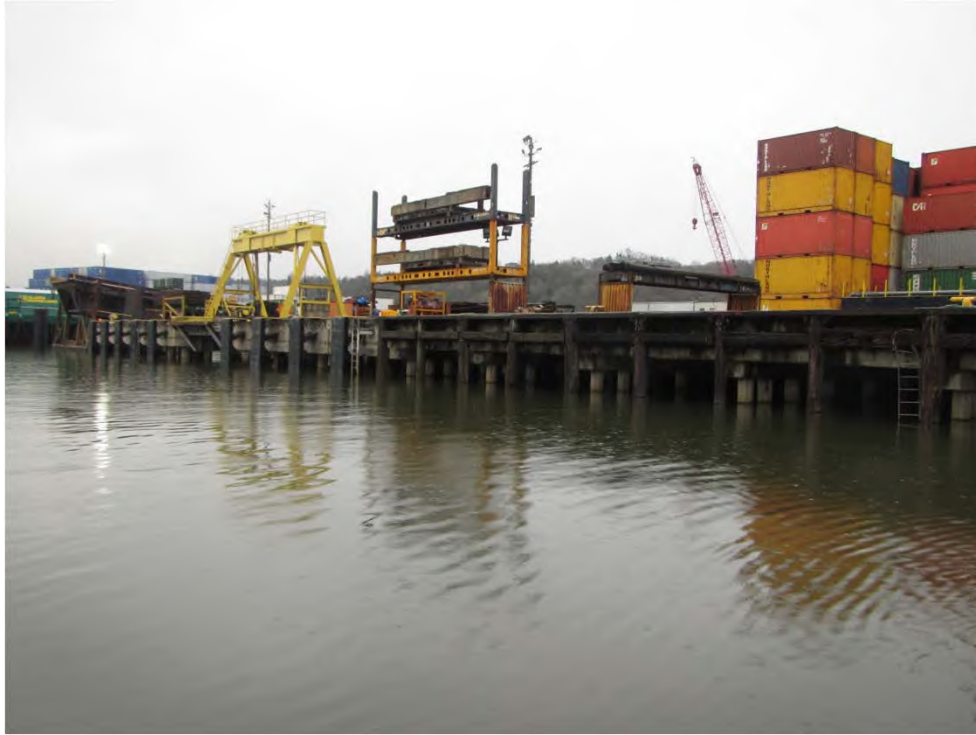
Element	Photo No.	Direction	Description / Comments						
Wharf	20-4925	SW	General view of the structure. Structure #19 is contiguous with the north end of the wharf.						
Wharf and Transfer Span	20-4926	SW	View of the concrete wharf and transfer span.						
Wharf and Transfer Span	20-4929	SW	View of the concrete wharf and both transfer spans.						
Wharf and Transfer Span	20-4931	W	View of the concrete wharf and mid-point transfer span. Riprap and a steel sheet pile bulkhead is visible along the shoreline.						
Transfer Span and Shoreline	20-4936	W	View of the south transfer span, a steel mono pile dolphin at the south corner, and the shoreline protected with scattered riprap.						
<p>Photos Required:</p>

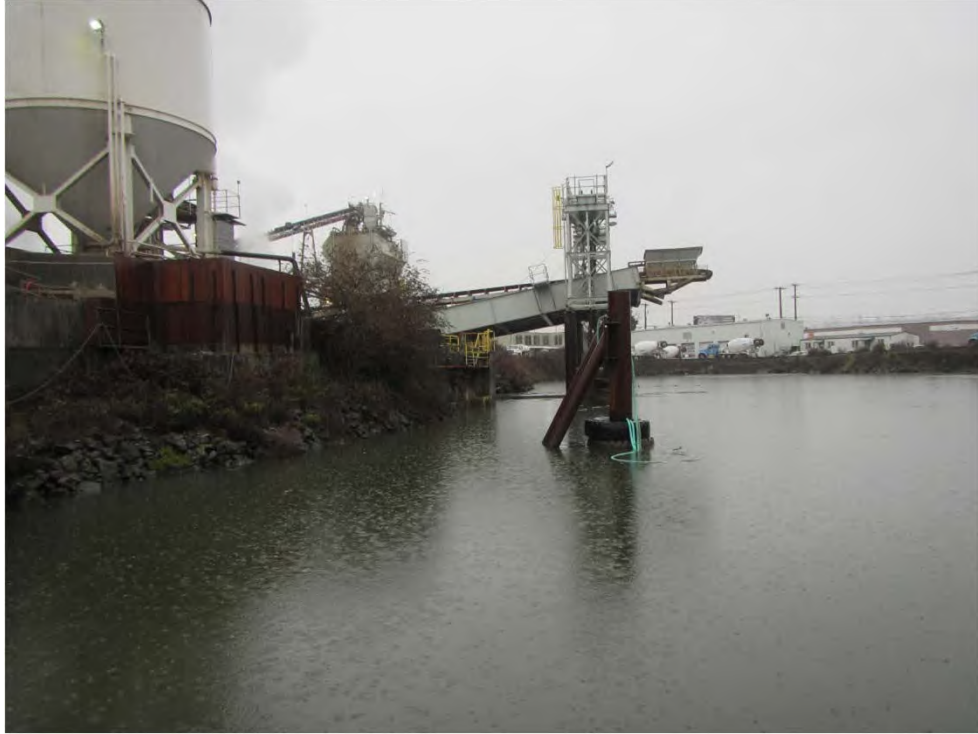
Element	Photo No.	Direction	Description / Comments						
Overall / Shoreline	21-3365	NE	Barge dolphin berth, transfer span, and riprap-protected shoreline.						
Utility Pipe	21-3366	N	Pipe protruding from the concrete bulkhead into the waterway to the SW of the transfer span						
Dolphins and Transfer Span	21-3368	NE	Typical condition of the steel pipe pile dolphins and transfer span.						
Transfer Span and Supporting Structure	21-3371	N	Conveyor system mounted on a steel-pile supported transfer span. The small timber wharf is visible to the right of the transfer span abutment.						
Dolphins and Transfer Span	21-3372	W	Typical condition of the steel pipe pile dolphins and transfer span.						
Dolphin and Shoreline	21-3374	NE	Furthest east dolphin and riprap protected shoreline.						
Shoreline and Pile Stubs	21-5439	NE	Riprap protected shoreline. A timber pile stub and a group of four timber pile stubs are located at on the north shoreline of the entrance to Slip No. 2.						
<p>Photos Required:</p>

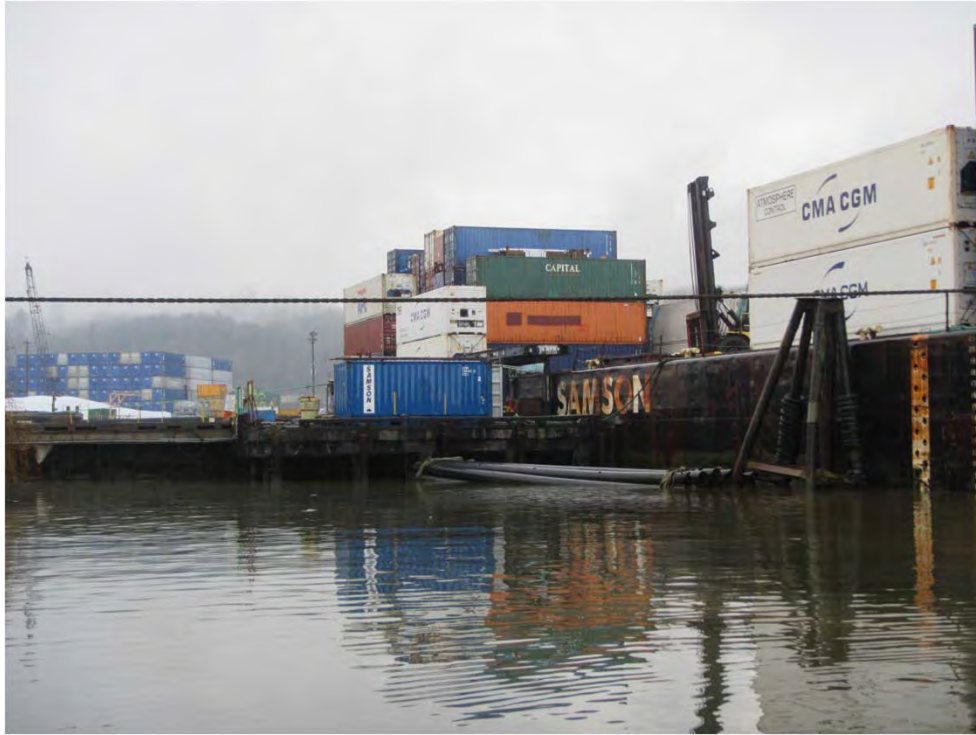
Element	Photo No.	Direction	Description / Comments
East Pier Structure	23-3385	W	View of the east side of the eastern pier structure and the east 7-pile steel dolphin.
East Shoreline	23-3386	W	View of the east shoreline. The shoreline is protected with concrete rubble and is vegetated.
East Pier Structure	23-3884	N	View of the timber pile supported pier structure.
East Shoreline	23-3886	W	View of the east shoreline. The shoreline is protected with concrete rubble and is vegetated.
East Pier Structure	23-3888	SE	View of the timber pile supported pier structure.
Central Shoreline	23-3891	S	View of the central shoreline. The shoreline is protected with concrete rubble and is vegetated.
East Pier Structure	23-3903	NE	View of the steel beam pier approach supported by steel pile caps and steel piles. A timber pile stub was present to the west of the approach.
East Pier Structure and Dolphin	23-3910	NE	View of the east pier structure and the 4-pile steel dolphin to the west.

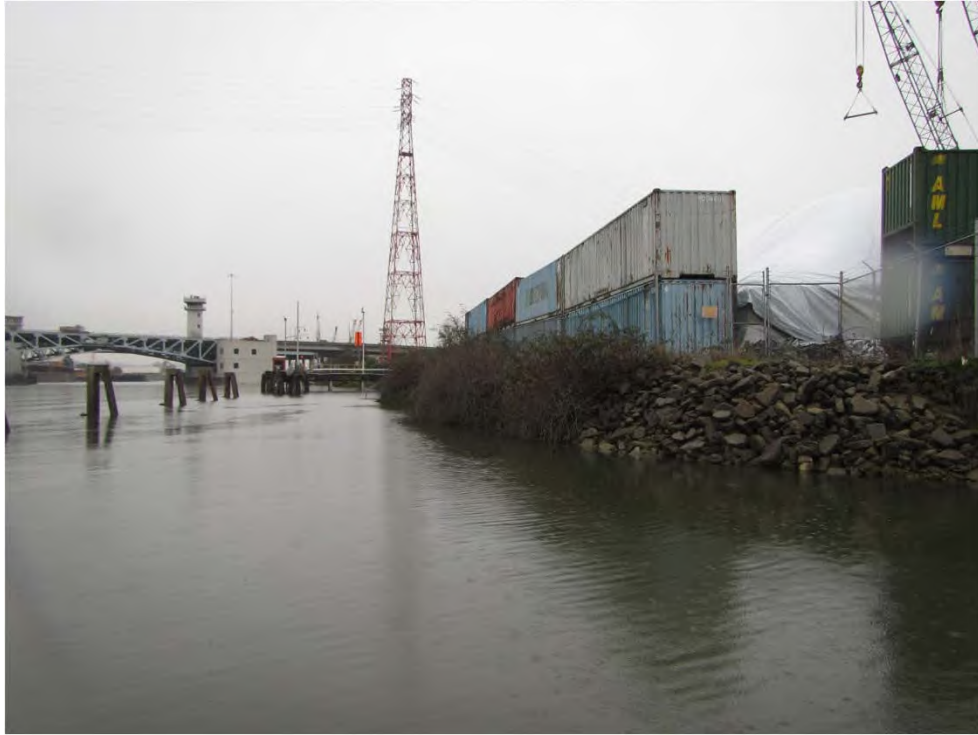
Element	Photo No.	Direction	Description / Comments						
Shoreline	24-4945	S	View of the riprap-protected shoreline and the steel dolphin berth.						
Dolphins	24-4952	SW	View of the 3-pile steel dolphins.						
Shoreline	24-4954	W	View of the vegetated, riprap-protected shoreline.						
T-Head Pier	24-4957	NW	View of the berthing face of the T-head concrete pier. Timber fender piles line the berthing face.						
T-Head Pier	24-4960	W	Underdeck view of the T-head concrete pier.						
Shoreline	24-4963	W	View of the riprap-protected shoreline south of the structure.						
T-Head Pier	24-4964	N	View of the south end of the T-head pier.						
Shoreline and T-Head Pier	24-4966	N	View of the south end of the T-head pier and the riprap-protected shoreline.						
T-Head Pier	24-4970	W	View of the north end of the T-head pier. A 9-pile timber dolphin is present at the north end of the pier.						
<p>Photos Required:</p>

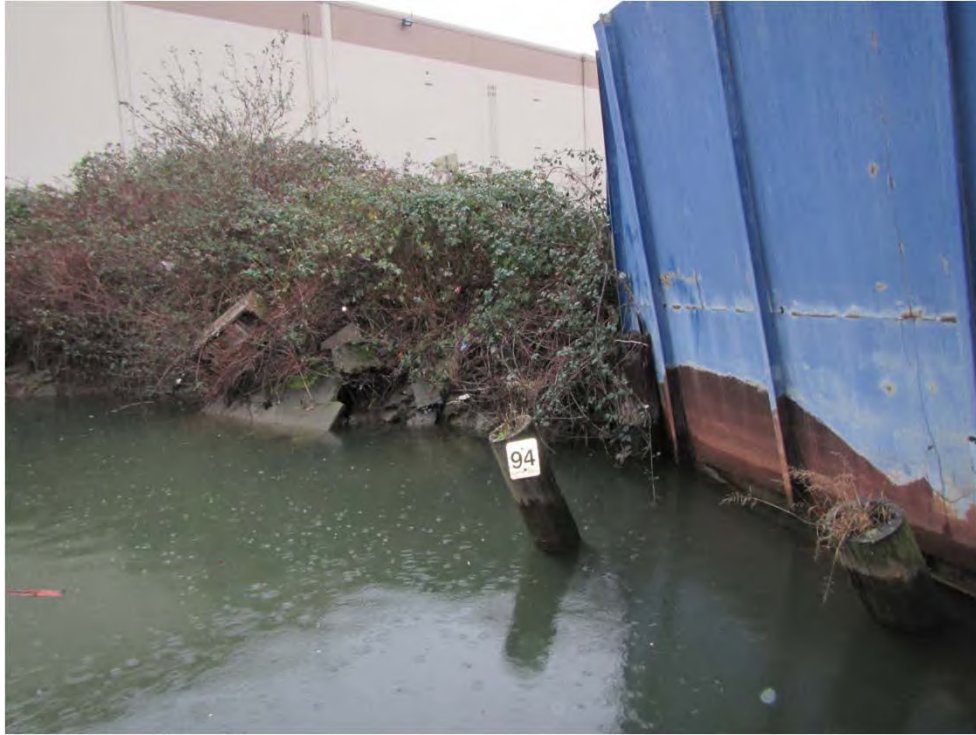
Element	Photo No.	Direction	Description / Comments						
East Shoreline	26-4069	E	The east shoreline is protected by concrete rubble and is vegetated.						
East Timber Dock	26-4077	S	A small timber dock is located at the east end of the facility within Slip 3. A tall steel wall is installed around the perimeter of the dock.						
Finger Pier	26-4082	SE	View of the concrete finger pier with timber fender piles.						
Timber Dolphin	26-4084	S	View of the 14-pile timber dolphin outboard of the finger pier.						
Timber Dolphins	26-4091	S	View of the three 14-pile timber dolphins outboard of the facility. The small floating dock is visible on the left side of the photograph.						
Finger Pier	26-4101	E	View of the west end of the finger pier and small floating docks.						
Wharf	26-4115	SE	View of the concrete wharf that forms the south side of the vessel slip.						
South Shoreline an Dolphin	26-4127	SE	The south shoreline is protected with isolated pieces of concrete rubble and is vegetated. A 14-pile timber dolphin is present approximately 100 feet outboard of the south end of the facility. A steel wall is present under the wharf on the south end.						
Wharf	26-4130	NE	View of the concrete wharf and timber fender piles.						
<p>Photos Required:</p>

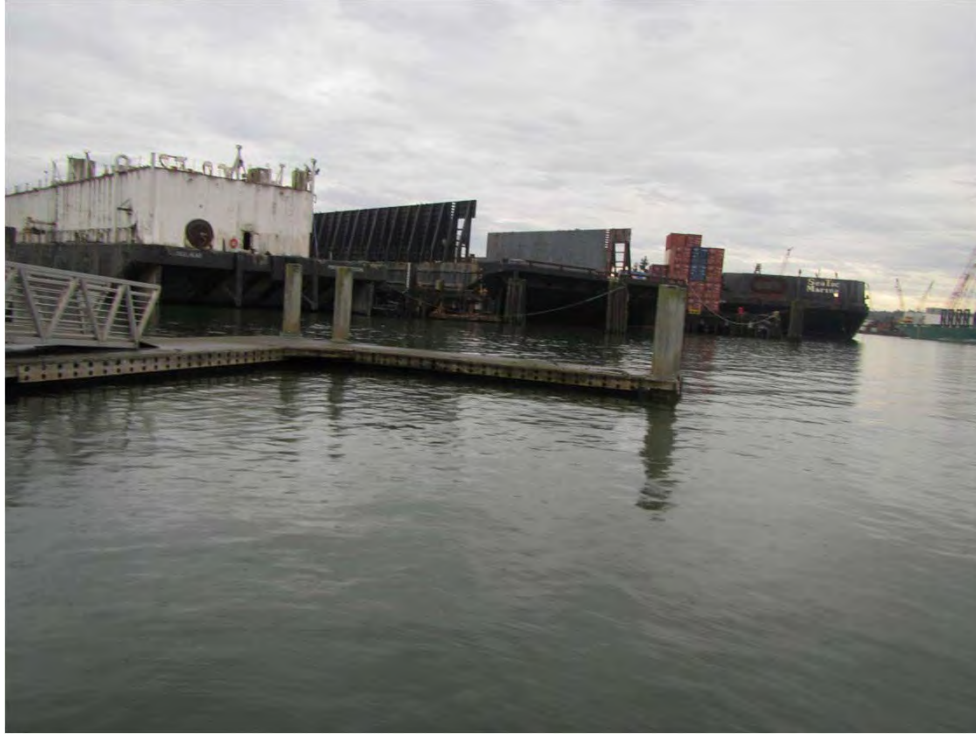
Element	Photo No.	Direction	Description / Comments						
Floating Dock	27-3996	S	View of the concrete floating dock and concrete guide piles.						
North Shoreline and Concrete Wharf	27-3997	N	View of the riprap protected north shoreline, the boat ramp, and the west face of the concrete wharf.						
Concrete Wharf	27-3999	SE	Underdeck view of the concrete wharf.						
Floating Dock	27-4005	E	View of the floating concrete dock along the berthing face of the concrete and timber wharves. The isolated concrete pile is visible beyond the floating dock.						
Timber Wharf	27-4026	N	Underdeck view of the timber wharf.						
Timber Wharf	27-4034	N	View of the east end of the timber wharf and a steel sheet pile bulkhead to the east of the wharf.						
Timber Wharf	27-4041	NW	View of the timber wharf.						
Floating Dock	27-4037	NW	View of the floating dock and integrated boat house. The pile supported building is in the background.						
Pile Supported Building	27-4048	N	Underdeck view of the pile supported building.						
Pile Supported Building	27-4051	E	View along the face of the pile supported building.						
Pile Supported Building	27-4055	E	View along the face of the pile supported building.						
Steel Sheet Pile and Timber Pile Wall	27-4062	W	View of the steel sheet pile and timber pile wall that is faced with timber fender piles.						
East Shoreline	27-4066	S	View of the east shoreline. The shoreline is vegetated and has isolated riprap.						
Dolphin Barge Berth	27-4068	NE	View of the seven steel mono pile dolphins. The sheet pile wall and building are beyond.						
<p>Photos Required:</p>

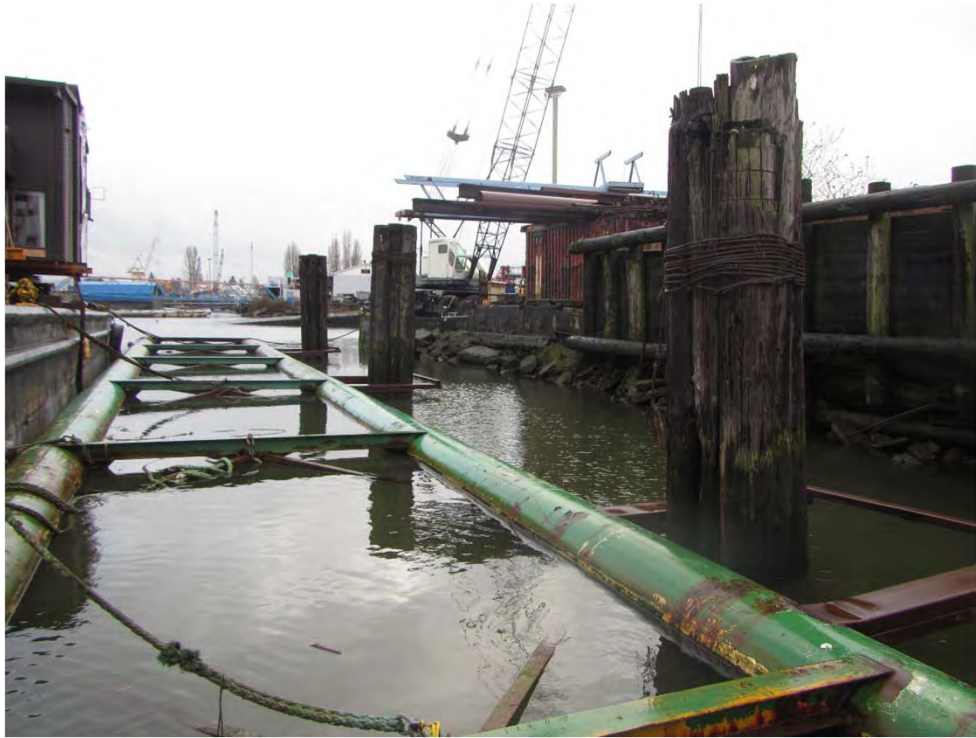
Element	Photo No.	Direction	Description / Comments						
Dolphins	33-5077	SE	Overall view of the timber dolphins and the timber bulkhead along the shoreline.						
Bulkhead	33-5078	S	View of the timber bulkhead along the shoreline.						
Bulkhead and Shoreline	33-5082	SW	View of the north end of the facility. A group of 5 timber pile stubs is present to the north.						
Shoreline	33-5084	SW	View of the concrete block bulkhead along the shoreline.						
Dolphins and Bulkheads	33-5085	N	Overall view of the timber dolphins, timber bulkhead, and concrete bulkhead along the shoreline.						
Ramp	33-5086	S	View of a timber ramp extending from the shoreline.						
Bulkhead	33-5087	S	View of the concrete block bulkhead along the shoreline.						
Floats	33-5092	SE	South of the facility is a group of floats, a transfer span, and a barge permanently moored with its spuds.						
Float	33-5093	W	Partially sunk float along the shoreline.						
Transfer Span	33-5097	W	View of the transfer span extending from the shoreline to the barge. The shoreline is protected with gravel and riprap.						
Floats	33-5101	S	At the south end of the facility is a grouping of floats that create moorage for personal vessels.						
Floats	33-5104	SW	At the south end of the facility is a grouping of floats that create moorage for personal vessels. The floats are anchored by two central steel piles.						
Floating Dock	33-5105	SW	At the south end of the facility is a floating dock that appears to be for private use. The shoreline is a concrete bulkhead.						
<p>Photos Required:</p>
