Lower Duwamish Waterway Group

WATERWAY USER SURVEY AND ASSESSMENT OF IN-WATER STRUCTURES— DATA REPORT

**U.S. Environmental Protection Agency
Region 10**

July 2, 2018

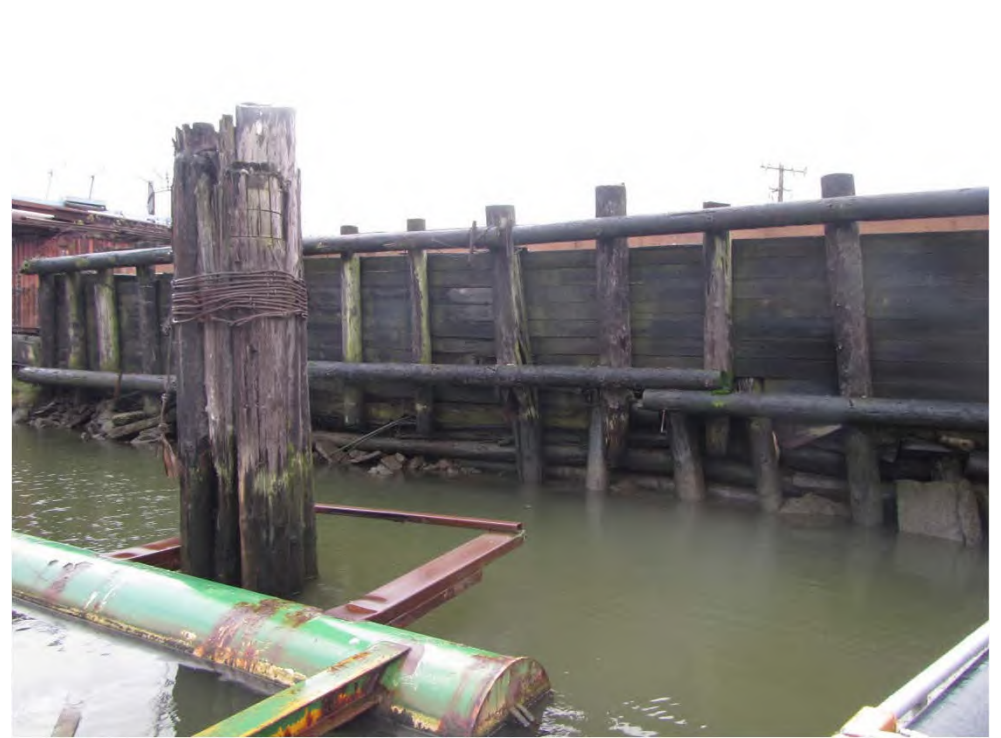
Element	Photo No.	Direction	Description / Comments						
Dolphins	33-5077	SE	Overall view of the timber dolphins and the timber bulkhead along the shoreline.						
Bulkhead	33-5078	S	View of the timber bulkhead along the shoreline.						
Bulkhead and Shoreline	33-5082	SW	View of the north end of the facility. A group of 5 timber pile stubs is present to the north.						
Shoreline	33-5084	SW	View of the concrete block bulkhead along the shoreline.						
Dolphins and Bulkheads	33-5085	N	Overall view of the timber dolphins, timber bulkhead, and concrete bulkhead along the shoreline.						
Ramp	33-5086	S	View of a timber ramp extending from the shoreline.						
Bulkhead	33-5087	S	View of the concrete block bulkhead along the shoreline.						
Floats	33-5092	SE	South of the facility is a group of floats, a transfer span, and a barge permanently moored with its spuds.						
Float	33-5093	W	Partially sunk float along the shoreline.						
Transfer Span	33-5097	W	View of the transfer span extending from the shoreline to the barge. The shoreline is protected with gravel and riprap.						
Floats	33-5101	S	At the south end of the facility is a grouping of floats that create moorage for personal vessels.						
Floats	33-5104	SW	At the south end of the facility is a grouping of floats that create moorage for personal vessels. The floats are anchored by two central steel piles.						
Floating Dock	33-5105	SW	At the south end of the facility is a floating dock that appears to be for private use. The shoreline is a concrete bulkhead.						
<p>Photos Required:</p>

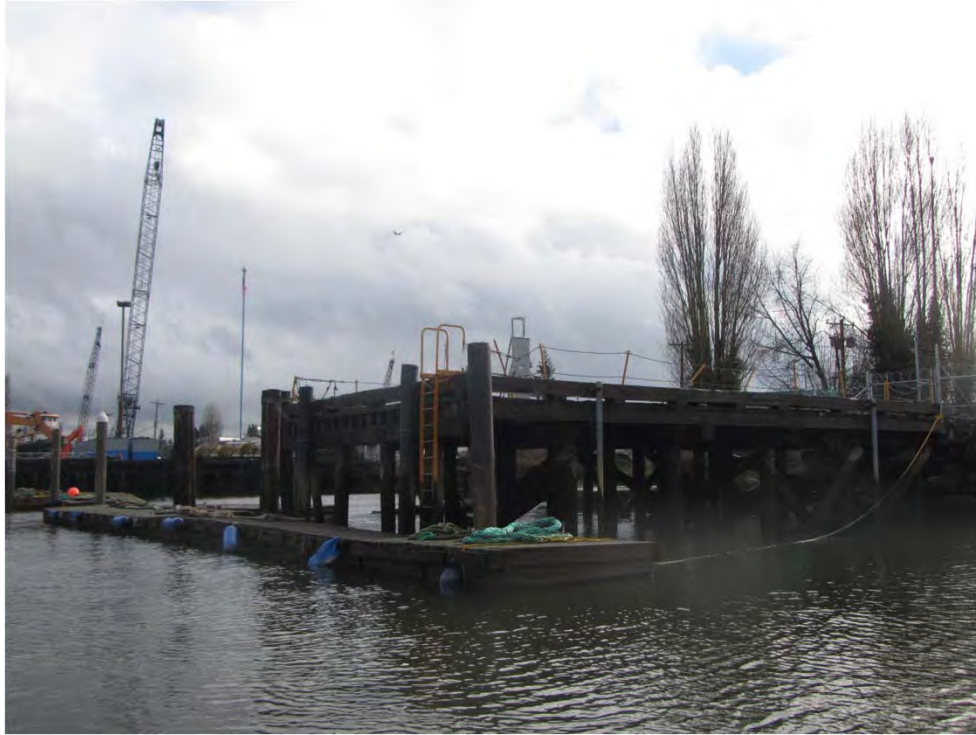
Element	Photo No.	Direction	Description / Comments						
Pier	34-5107	SW	View of the timber pier and the float along the pier face.						
North Shoreline	34-5109	W	View of the concrete-rubble protected shoreline to the north of the facility.						
Pier and Floats	34-5111	NW	View of the south side of the pier, the timber breasting dolphins, and the floats.						
Dolphins and Floats	34-5117	S	Mono pile steel dolphins with attached floats are present south of the facility.						
South Shoreline	34-5122	W	View of the south shoreline. A row of timber piles lines the shoreline.						
<p>Photos Required:</p>

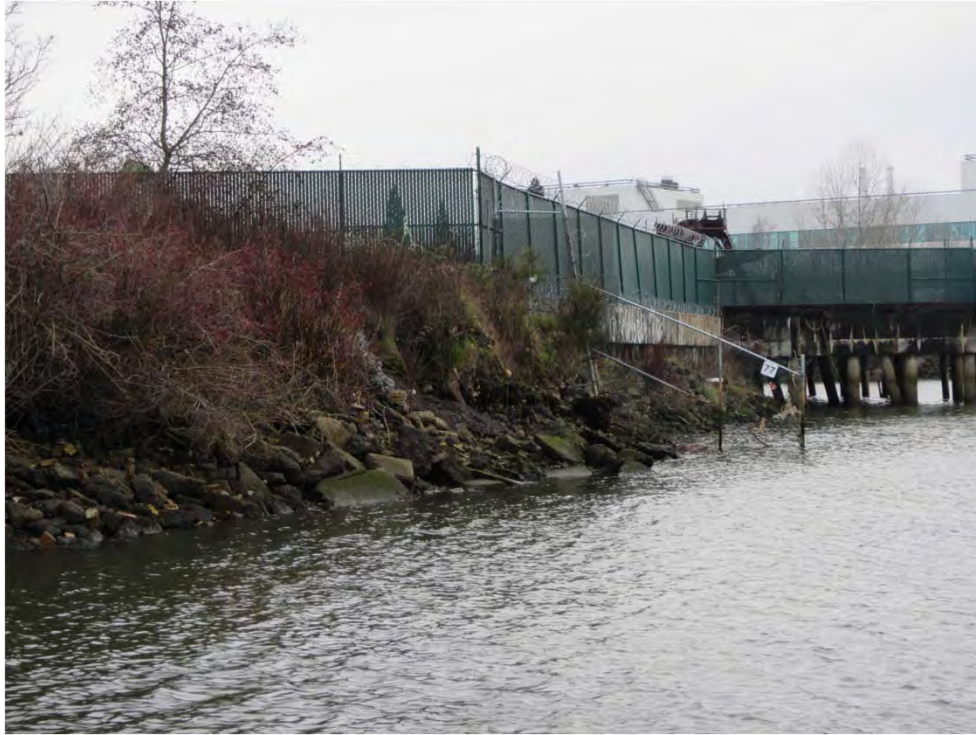
Element	Photo No.	Direction	Description / Comments						
North Shoreline	36-4225	SE	View of the concrete-rubble protected shoreline to the north of the structure.						
Floating Dock	36-4228	S	A steel floating dock is present on the north end of the structure. One of the timber dolphins is visible beyond the floating dock.						
Steel Sheet Pile Bulkhead	36-4230	E	The steel sheet pile wall extends north beyond the wharf.						
Dolphins	36-4233	E	View of the dolphins and floating docks off the north end of the wharf.						
Wharf and Transfer Span	36-4236	N	View of one of the two steel transfer spans along the wharf.						
Wharf	36-4238	W	General view of the concrete wharf and steel transfer span.						
Wharf	36-4239	N	Underdeck view of the concrete wharf and steel sheet pile wall.						
Steel Sheet Pile Wall	36-4242	E	View of the steel sheet pile wall extending to the east of the wharf where it appears a structure has been removed.						
Outfall	36-4248	E	View of a large outfall to the east of the structure at the end of Slip 4.						
Outfall	36-4251	E	View of a large outfall to the east of the structure at the end of Slip 4.						
<p>Photos Required:</p>

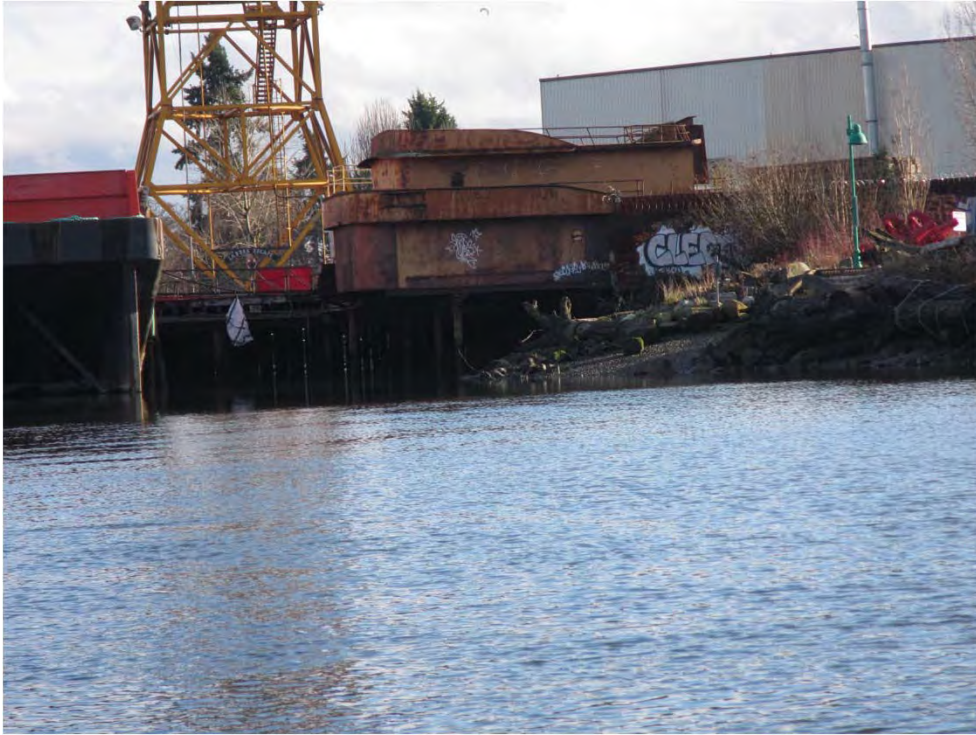
Element	Photo No.	Direction	Description / Comments						
Pier and Apron	37-5137	S	View of the north end of the pier and apron supporting a building.						
Apron	37-5139	SW	Closeup view of the steel apron and small riprap along the shoreline.						
Pier	37-5140	S	View of the north end of the pier.						
Pier	37-5145	SW	Underdeck view of the pier.						
South Shoreline	37-5149	SW	View of the south shoreline. The shoreline is vegetated and has isolated concrete rubble protection.						
Pier	37-5151	N	View of the south end of the pier. Debris has accumulated on the south side of the pier.						
South Shoreline	37-5154	SW	Timber pile stubs line the shoreline south of the pier.						
<p>Photos Required:</p>

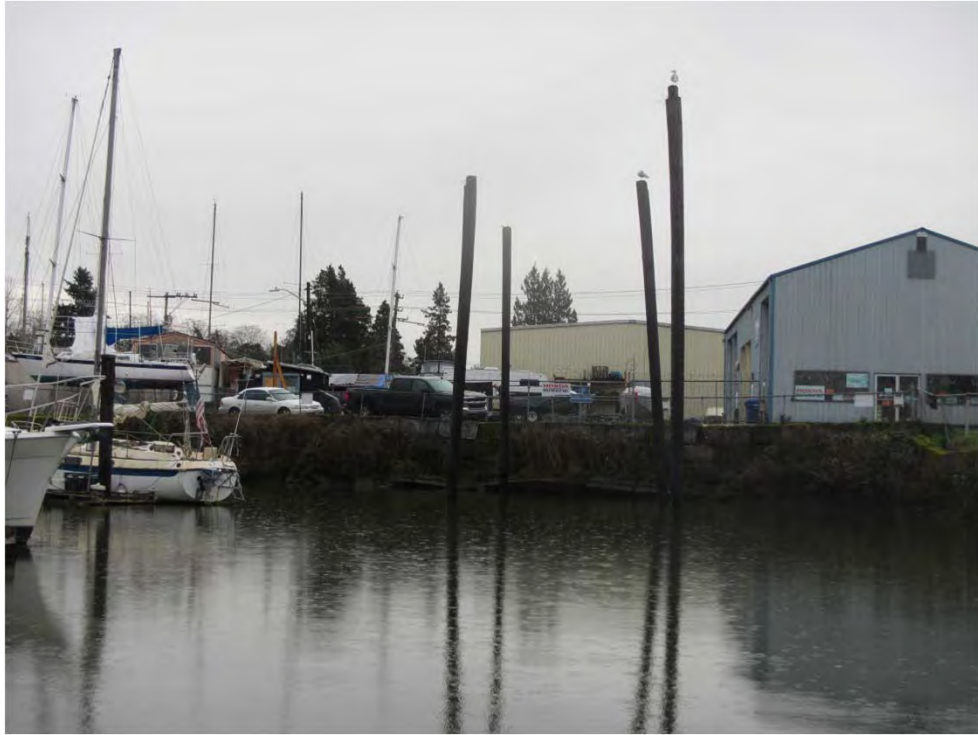
Element	Photo No.	Direction	Description / Comments						
North Shoreline	39-5364	W	View of the ecology block bulkhead and four timber piles along the north shoreline.						
Boat Ramp	39-5366	W	View of the boat ramp north of the marina.						
Shoreline	39-5368	S	View of the settling ecology block bulkhead.						
Marina	39-5373	S	General view of the north end of the marina.						
Shoreline	39-5380	NW	View of the settling ecology block bulkhead.						
Shoreline	39-5376	SW	View of the riprap-protected shoreline south of the marina.						
Debris Deflector	39-5382	SE	View of the debris deflector to the south of the marina.						
Sheet Pile Wall	39-5383	S	View of the steel sheet pile wall along the Port of Seattle's T117 site south of the marina.						
Sheet Pile Wall	39-5393	N	View of the steel sheet pile wall along the Port of Seattle's T117 site south of the marina.						
<p>Photos Required:</p>

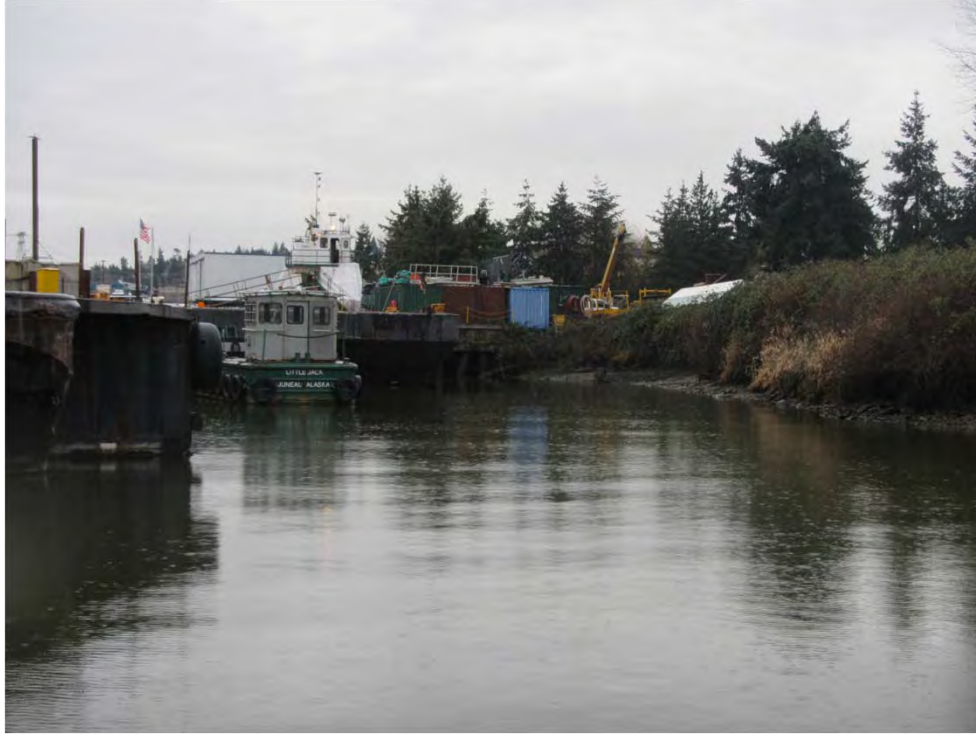
Element	Photo No.	Direction	Description / Comments
North Shoreline	40-5406	S	Heavily vegetated north shoreline. The finger pier is in the background.
North Shoreline	40-5408	W	A small inlet is located to the north of the structure.
Finger Pier	40-5410	S	View of the north face of the concrete finger pier.
Concrete Float	40-5419	N	View of the concrete float to the south of the finger pier.
Finger Pier	40-5420	N	View of the south face of the concrete finger pier.
South Shoreline	40-5426	W	View of the south shoreline. The shoreline is unprotected and heavily vegetated in the vicinity of the structure. South of the structure, the shoreline is riprap protected.

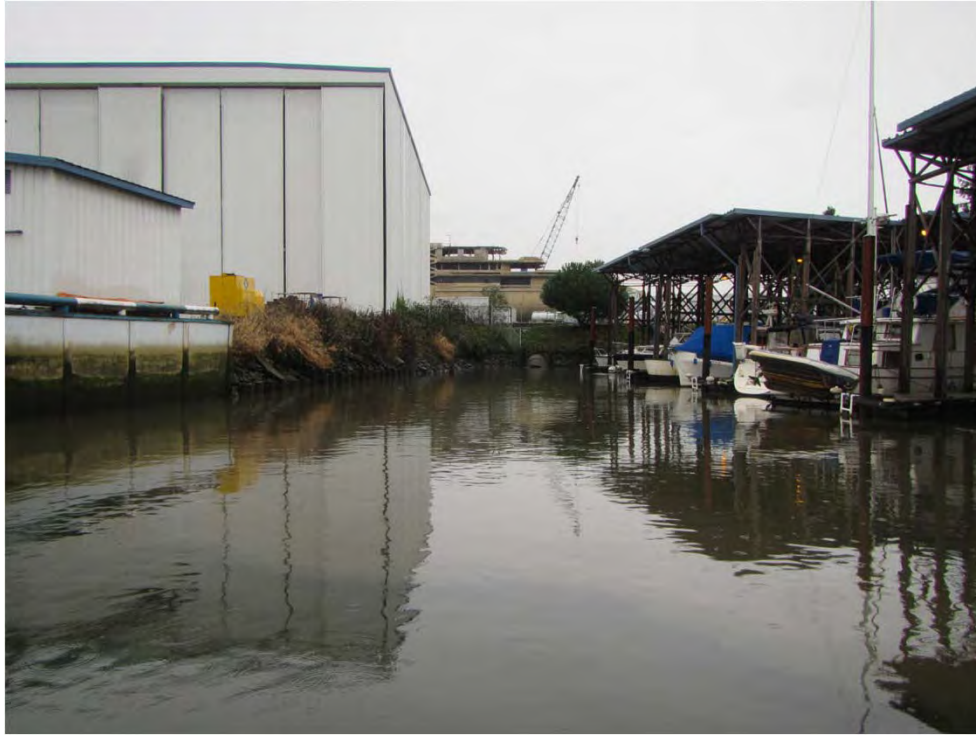
Element	Photo No.	Direction	Description / Comments						
South Shoreline and Marina	42-4483	W	View of the HP soldier pile bulkhead and steel sheet pile wall along the south shoreline and the south side of the covered moorage. The large outfall is visible in the photograph center along the west shoreline.						
Outfall	42-4484	W	View of the large outfall along the west shoreline.						
Marina	42-4486	NE	View of the marina.						
Shoreline and Marina	42-4489	N	HP soldier piles and missing concrete panel lagging is present along the west shoreline.						
Overall	42-4493	NW	Overall view of the marina.						
North Shoreline and Marina	42-4497	W	The north shoreline is riprap protected and vegetated at the top of bank.						
Shoreline and Gangway	42-4501	SW	View of the west shoreline behind the marina.						
<p>Photos Required:</p>

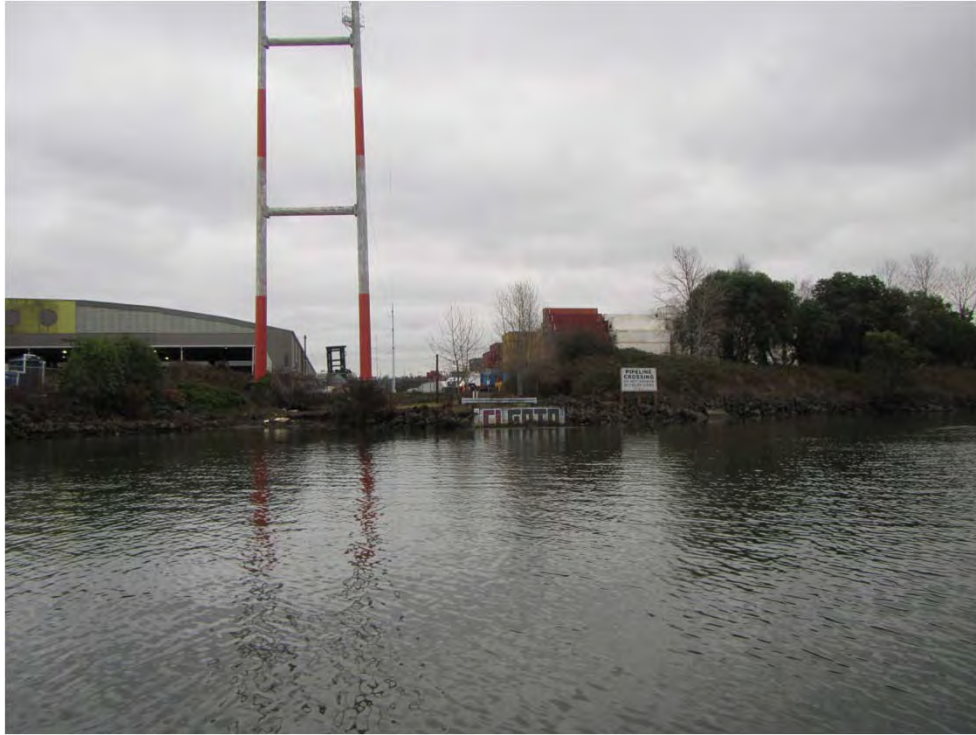
Element	Photo No.	Direction	Description / Comments						
East Shoreline	46-3196	E	View of the east shoreline where the on-land sign is located.						
West Shoreline	46-4622	W	View of the west shoreline where the on-land sign is located on a timber wharf (Structure #6).						
<p>Photos Required:</p>

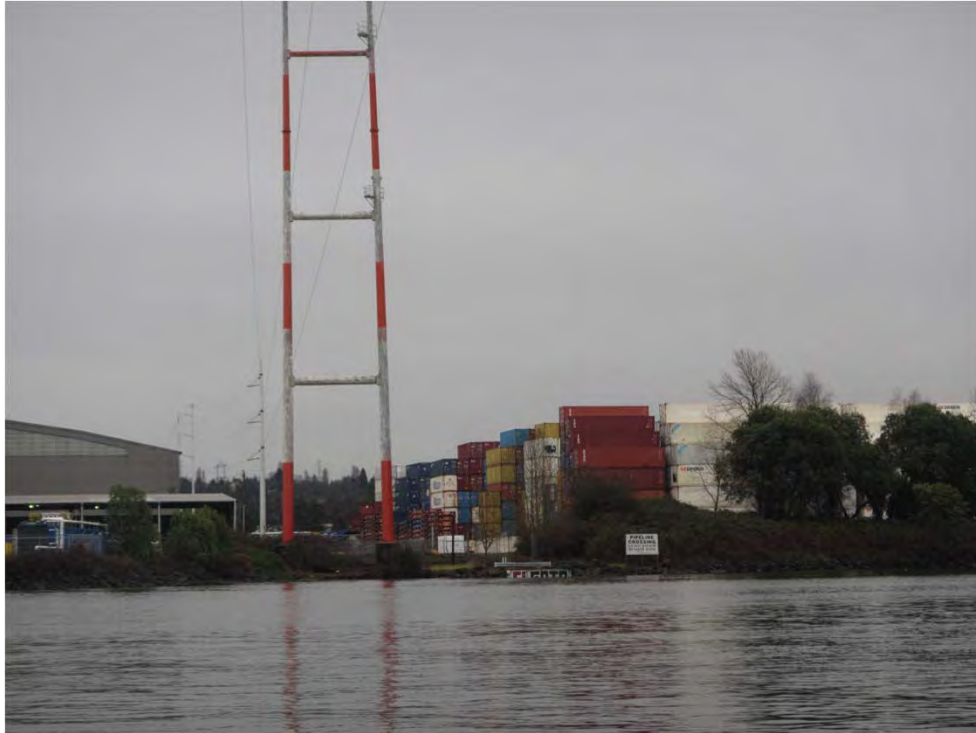
Element	Photo No.	Direction	Description / Comments						
East Shoreline	47-4660	E	View of the east shoreline.						
East Shoreline	47-4669	E	View of the east shoreline.						
West Shoreline	47-4670	W	The west shoreline is obstructed by a barge.						
<p>Photos Required:</p>

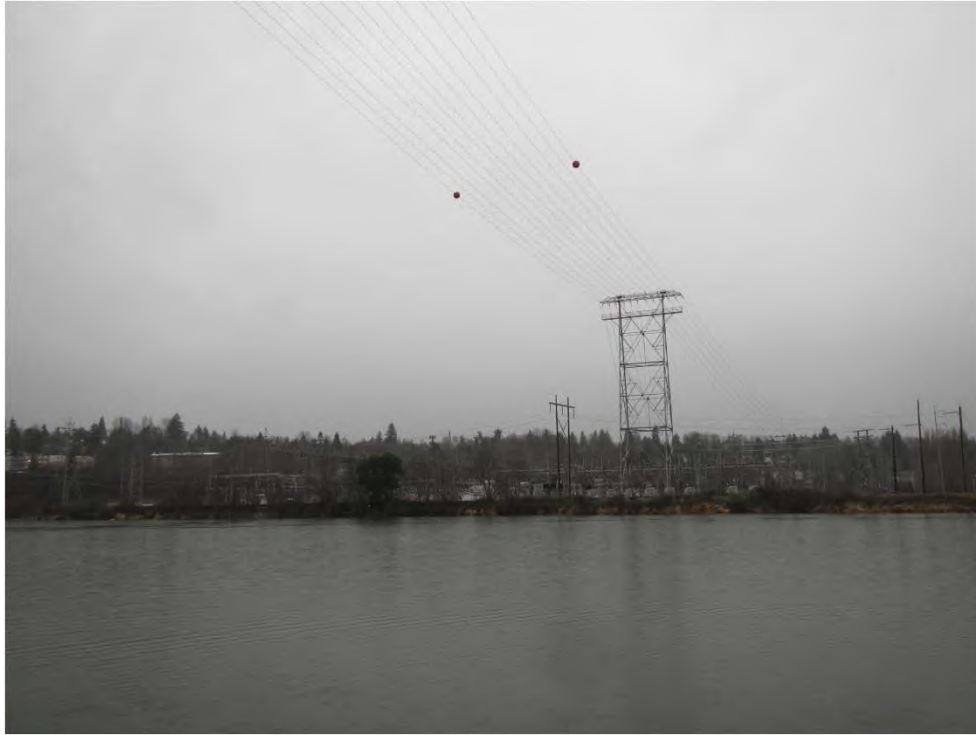
Element	Photo No.	Direction	Description / Comments						
Overall	50-4394	W	Overall view of the overhead powerlines.						
West Shoreline	50-4395	W	Overall view of the west shoreline.						
East Shoreline	50-4396	E	Overall view of the east shoreline.						
Overall	50-4399	E	Overall view of the overhead powerlines.						
<p>Photos Required:</p>

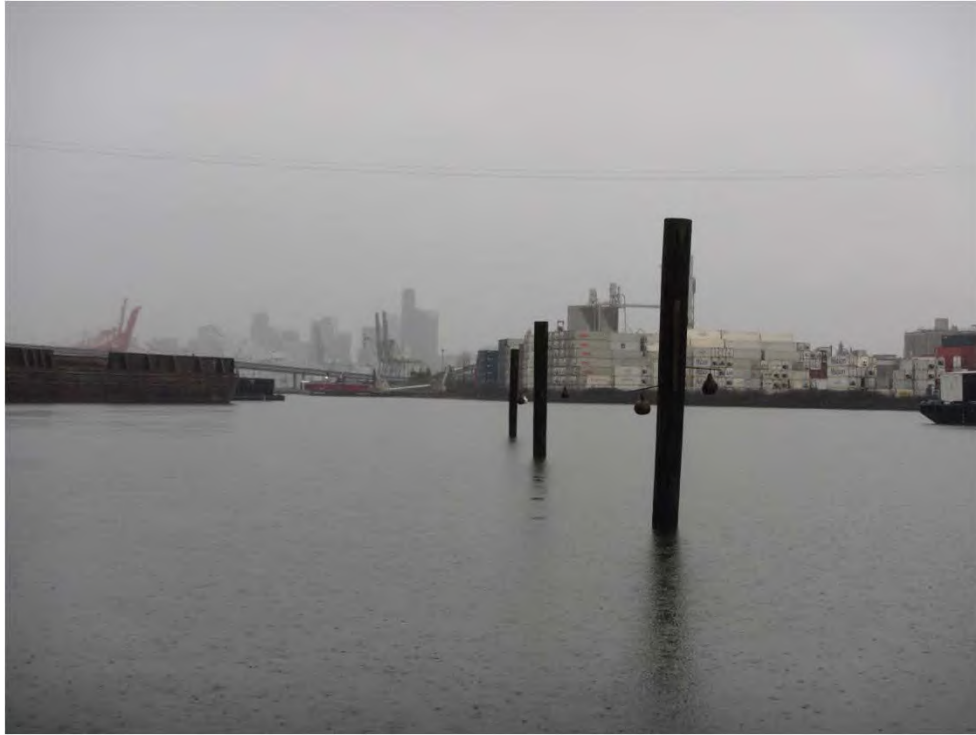
Element	Photo No.	Direction	Description / Comments						
Downstream	51-4728	N	View of the three northern timber piles and the downstream waterway.						
Upstream	51-4730	SW	View of the timber piles looking upstream.						
Timber Piles	51-4735	S	View of the timber piles looking upstream. Oil booms are currently attached to the southern piles.						
Timber Piles	51-4736	S	View of the timber piles looking upstream. Oil booms are currently attached to the southern piles. The shoreline is vegetated.						
Timber Piles	51-4738	N	View of the timber piles looking downstream. Oil booms are currently attached to the southern piles.						
<p>Photos Required:</p>

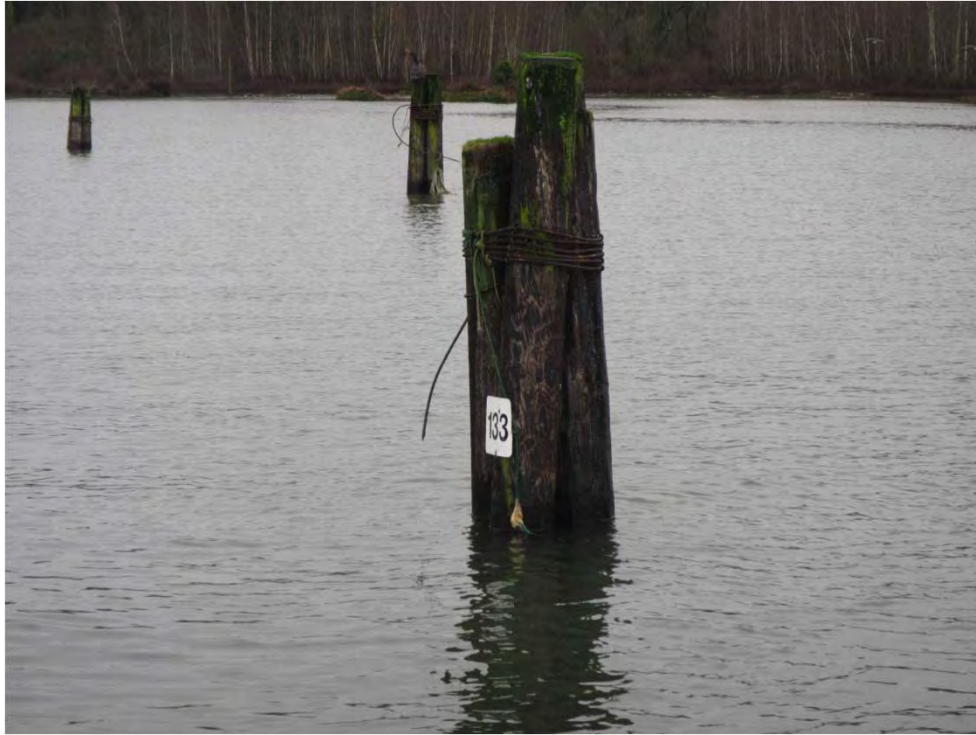
Element	Photo No.	Direction	Description / Comments						
Dolphin	52-4674	S	View of a 3-pile timber dolphin along the east side of Kellogg Island.						
Dolphins	52-4681	S	View of timber dolphins along the east side of Kellogg Island.						
Shoreline	52-4686	W	View of the north portion of Kellogg Island. The shoreline is flat and unprotected. A timber pile is present along the shoreline.						
Dolphins	52-4687	S	View of timber dolphins along the east side of Kellogg Island.						
Dolphins	52-4691	N	View of timber dolphins along the east side of Kellogg Island.						
Dolphin and Shoreline	52-4694	S	View of the southern timber dolphin. The south end of Kellogg Island exhibits steep unprotected shorelines. Evidence of erosion is present.						
Dolphins	52-4700	W	View of timber dolphins on the east side of Kellogg Island.						
Dolphins	52-4716	W	Four 3-pile steel dolphins are present on the south side of Kellogg Island.						
Pile Stub and Shoreline	52-4721	NE	Three timber pile stubs were observed on the south side of Kellogg Island. The south shoreline is steep and exhibits evidence of erosion.						
<p>Photos Required:</p>

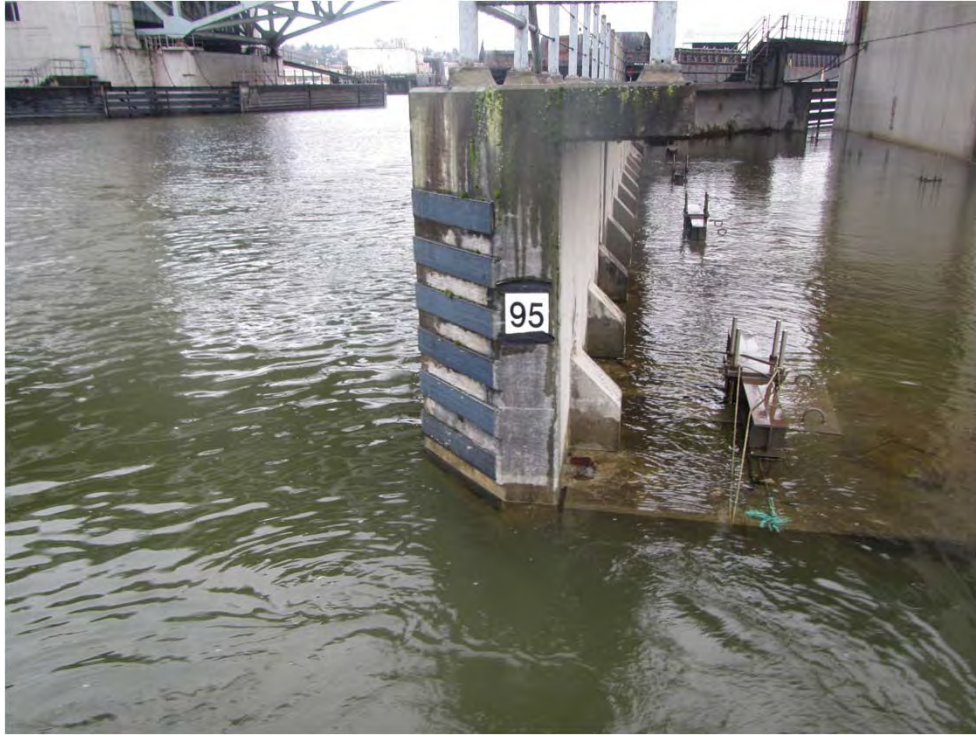
Element	Photo No.	Direction	Description / Comments						
Fender Wingwalls	54-5000	E	Closeup view of the concrete fender wingwall under the bridges.						
Pile Field	54-5001	S	View of the pile field on the southwest shoreline of the bridge.						
East Bridge	54-5003	NW	General view of the bridge.						
South Shoreline	54-5005	SW	View of the shoreline under the bridge. A small bridge parallels the shoreline and crosses a small inlet.						
Bridge	54-5008	NW	View of the bridge pier and fender wingwall.						
<p>Photos Required:</p>
