Appendix F

Structures Inspection Forms

Sediment Cleanup of Upper Reach of Lower Duwamish Waterway, Phase I/II

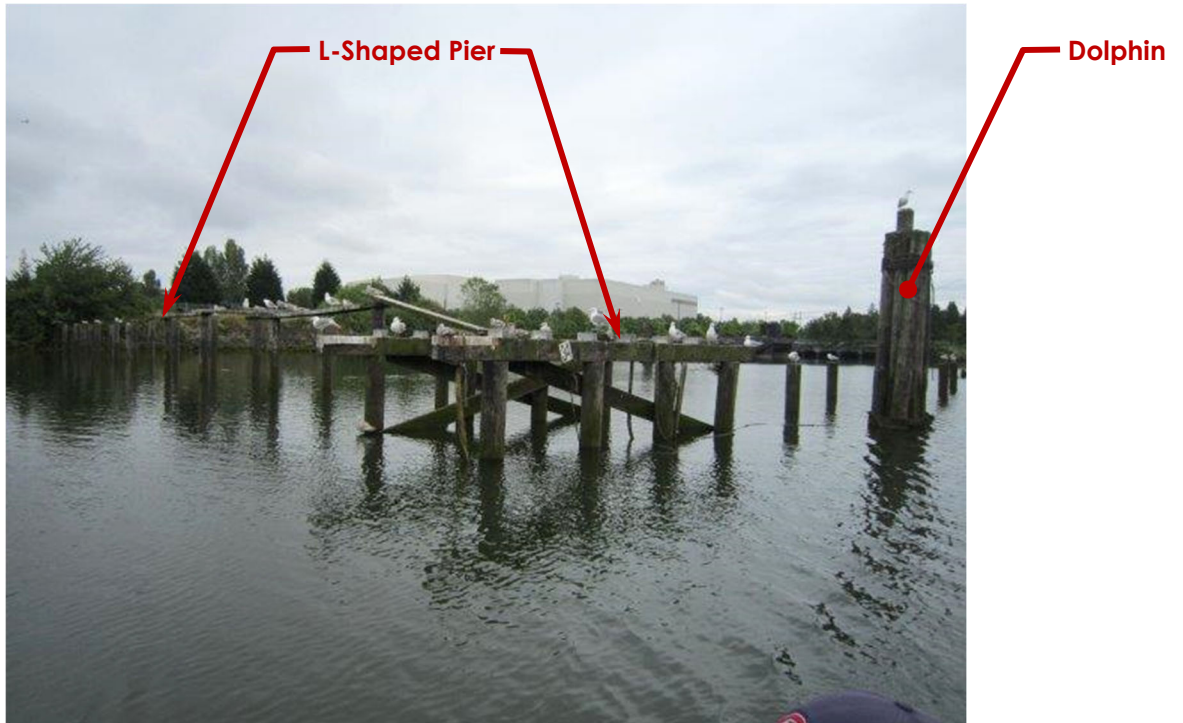
- L-shaped pier of two (2) treated timber pile bents – One (1) leg extends west from the shore and the other offshore leg extends to the south (Photos 1 to 4).
- The pier is delapidated and not in use – Several piles are missing or broken. Decking and cross bracing members are missing.

- Along the south and west side of the pier are several 7-timber treated pile dolphins; some are missing piles. The dolphins are still in use (Photo 1, 2, and 5).
- The cluster of piles are strapped together with a combination of fiber and/or strand wire rope. Some straps are broken or missing (Photos 5 and 6).
- Some piles are eroded and have lost material thickness. However, the core appear to be sound (Photo 7).

Photo ST04-01: L-Shaped Pier and Dolphins (Looking South)

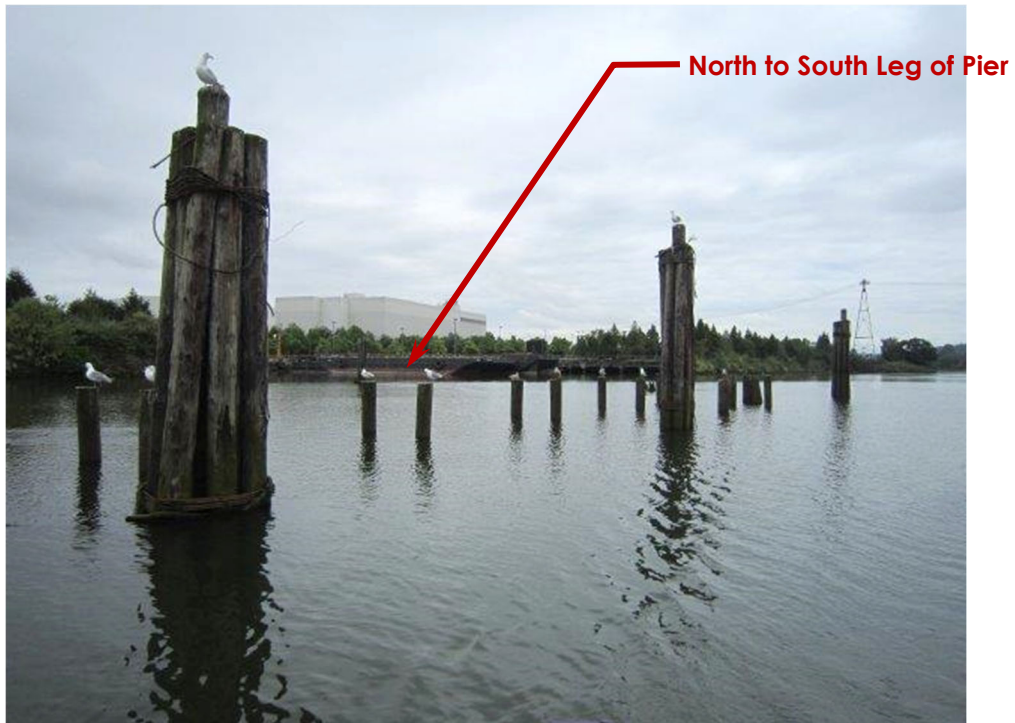
Photo ST04-02: L-Shaped Pier and Dolphins (Looking South)

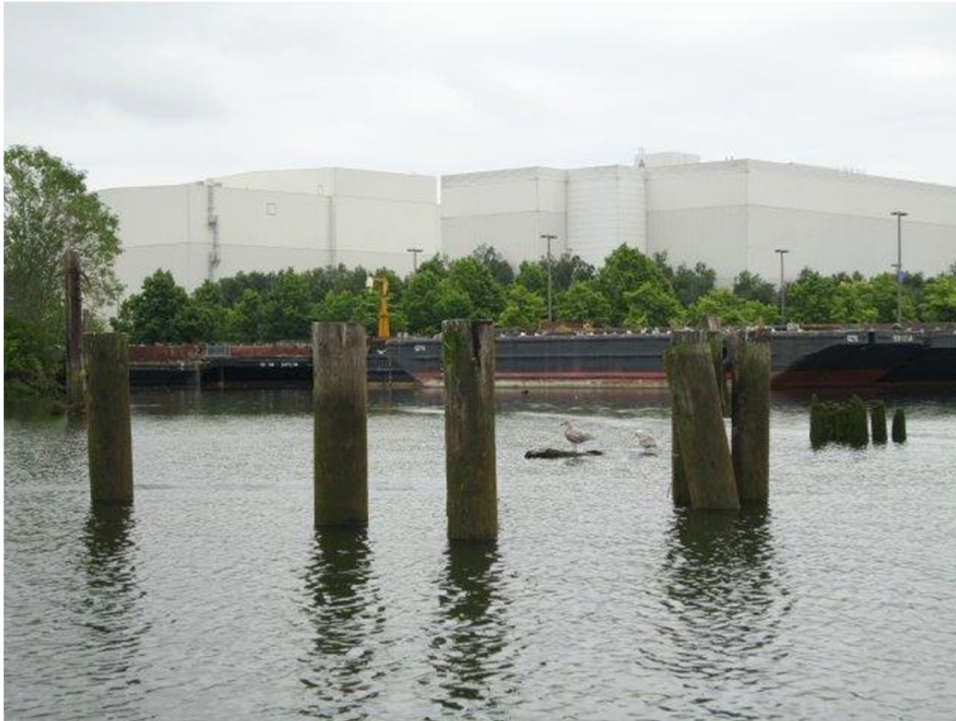
Photo ST04-03: South End of Pier

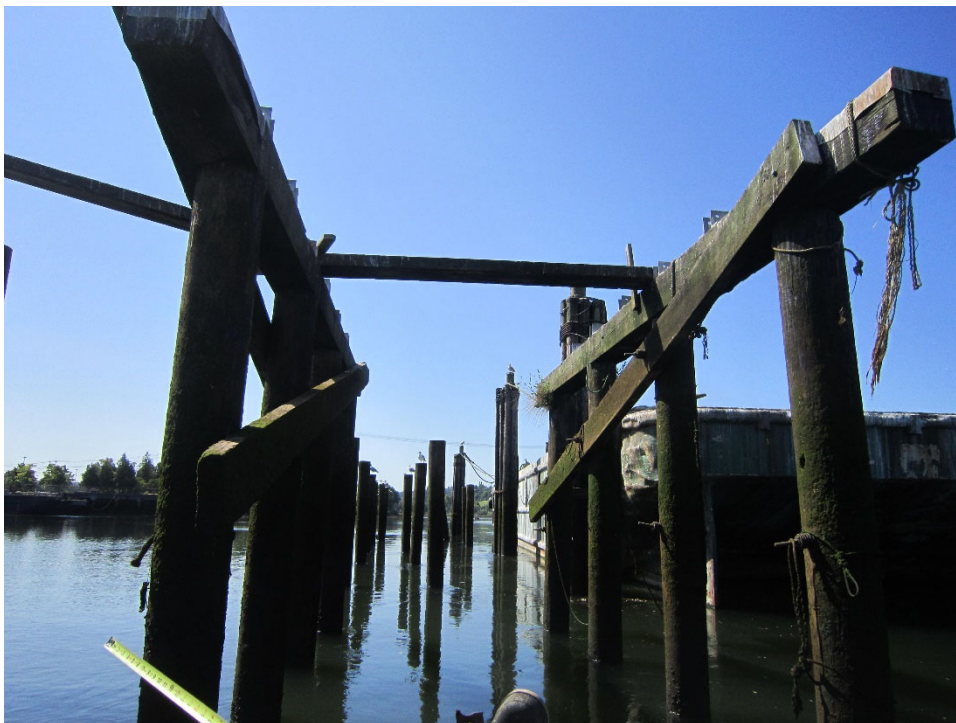
Photo ST04-04: Pile Bent Looking South

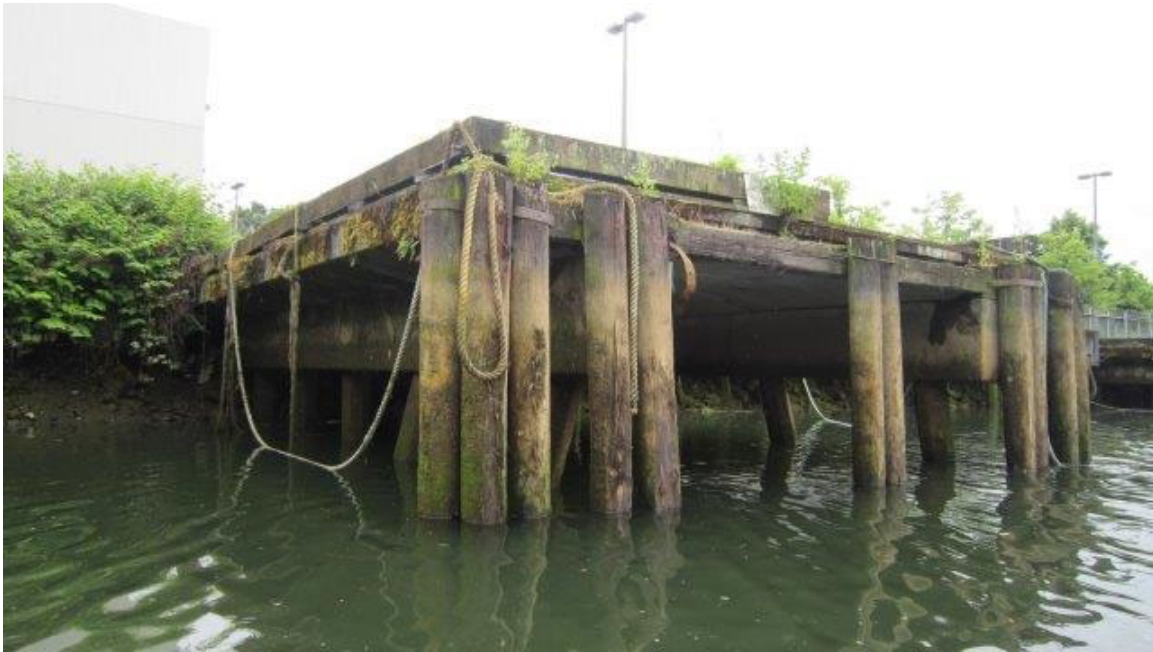
- The timber fender piles are generally intact except for the loose or missing straps. (Photos 1 and 2) The top of the piles appear to be rotted due to weather exposure and subsequent vegetation growth. The body of the piles within and above the splash zone appear to be sound and in good condition. Pressure treatment appears to be in good condition.

Photo ST05-01: Pier 1, East Most (Looking Southwest)

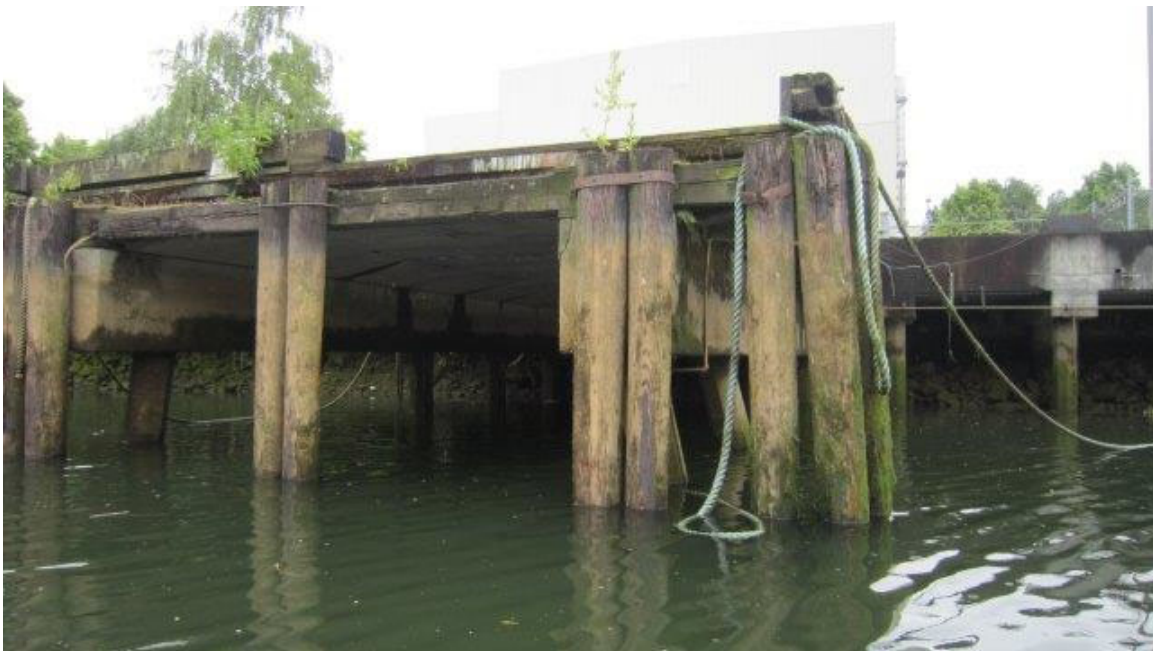
Photo ST05-02: Pier 1 (Looking South)

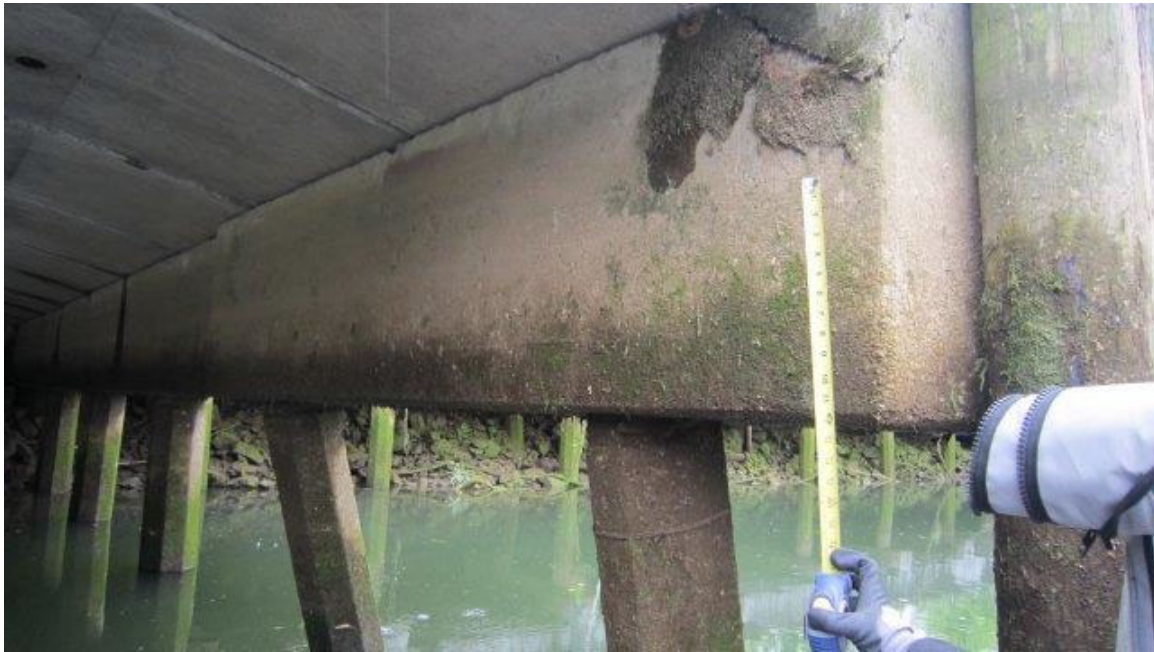
- The concrete piles are in good condition except for mortar surface erosion in the wet/dry zone of the piles (Photos 3 and 5).
- Along the length of the lower part of the pile cap is a crack. This is typical on all pile caps. (Photo 5)
- The pile caps are in good condition except for a loose concrete spall on the east face near the top of the cap and (b) mortar surface erosion in the splash zone (Photos 3 and 4).
- Pier decks are in good condition except for corrosion of exposed reinforcing bar in one of the panels (3rd panel from the north) and some rust stains between the 4th and 5th panel (Photos 6 and 7).

- a) Falling debris hazard due to loose concrete spall (Photos 3 and 4).
- b) Rot and decay at top of fender piles.
- c) Loose fender pile straps.
- d) Snag hazard due to loose mooring lines.

Photo ST05-03: Pier 1, East Side of West Pile Cap

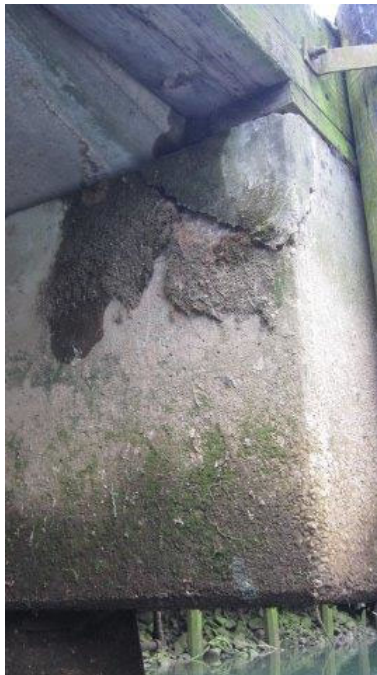
Photo ST05-04: Pier 1, East Side of West Pile Cap

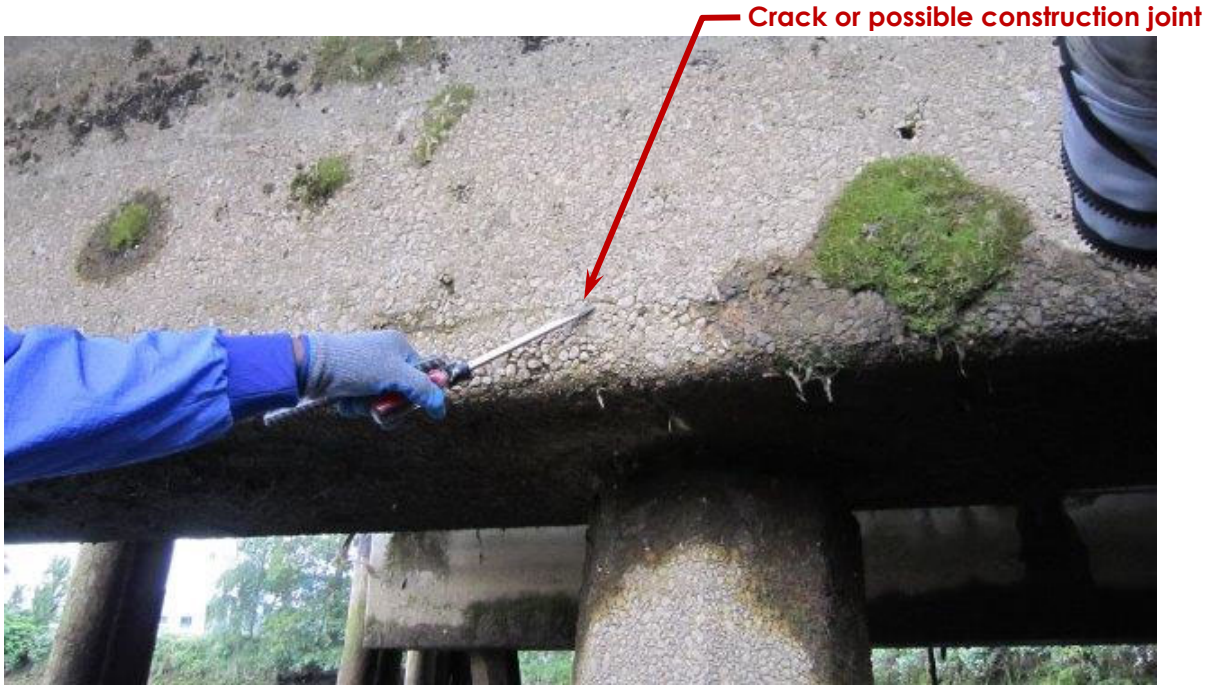
Photo ST05-05: Pier 1, West Side of West Pile Cap

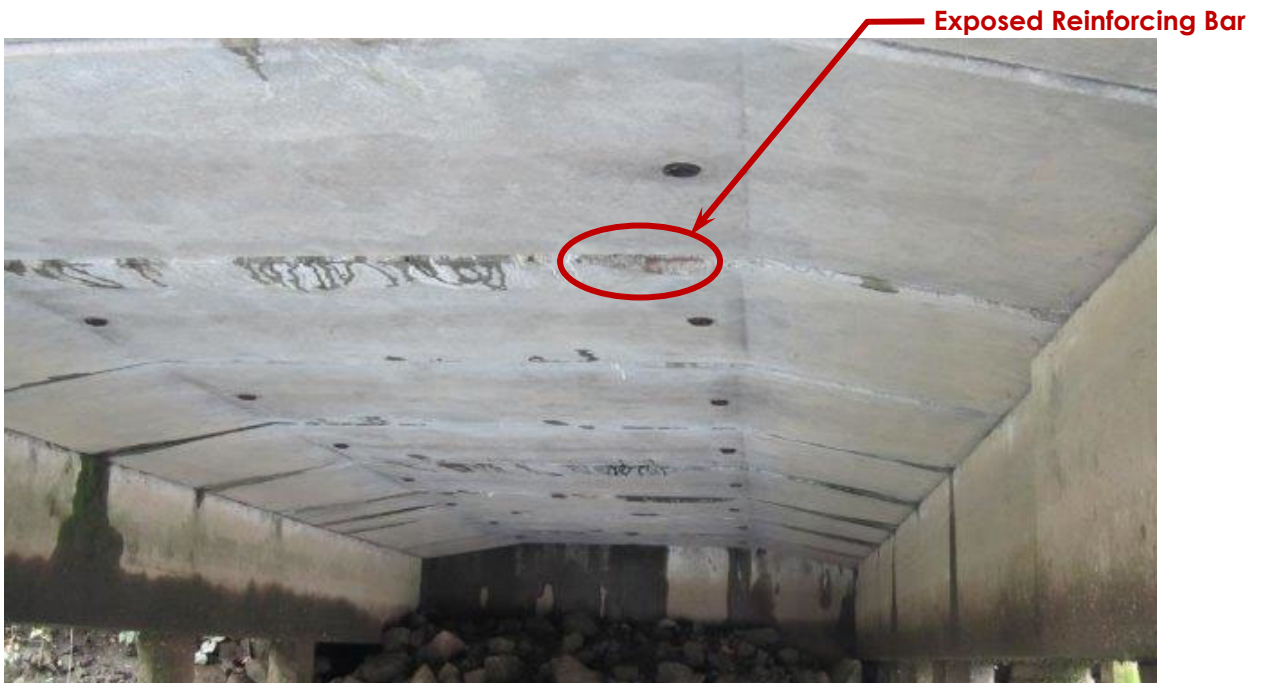
Photo ST05-06: Pier 1, Pier Deck Soffit

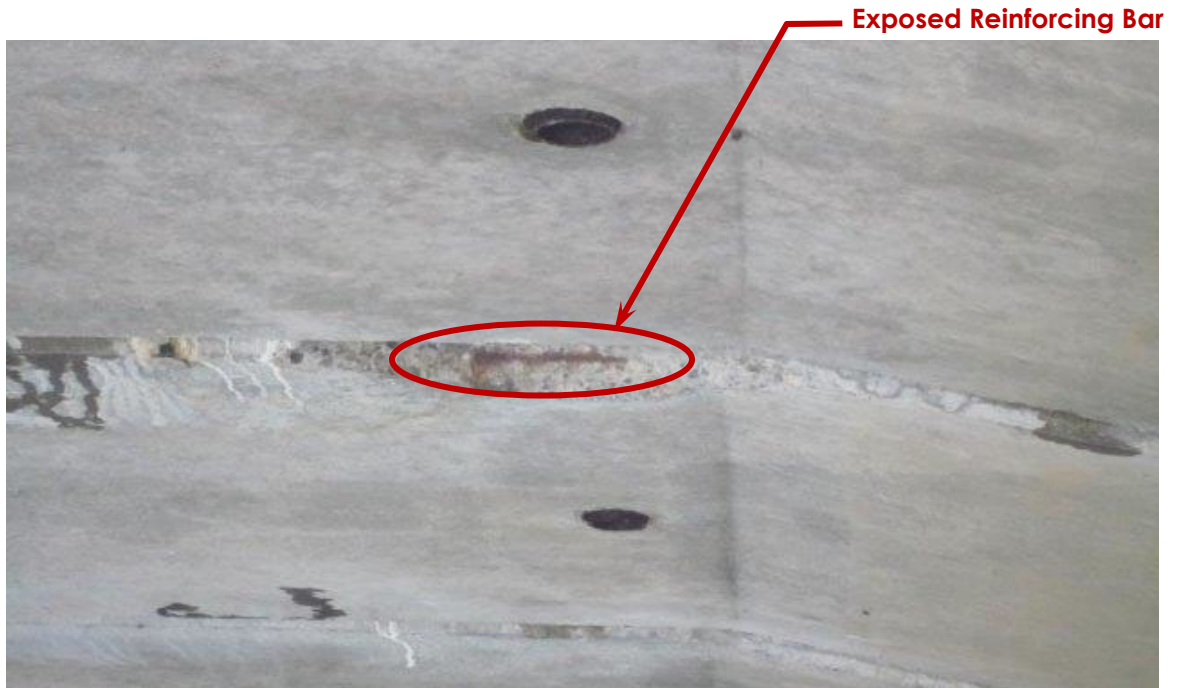
Photo ST05-07: Close Up of Exposed Reinforcing Bar

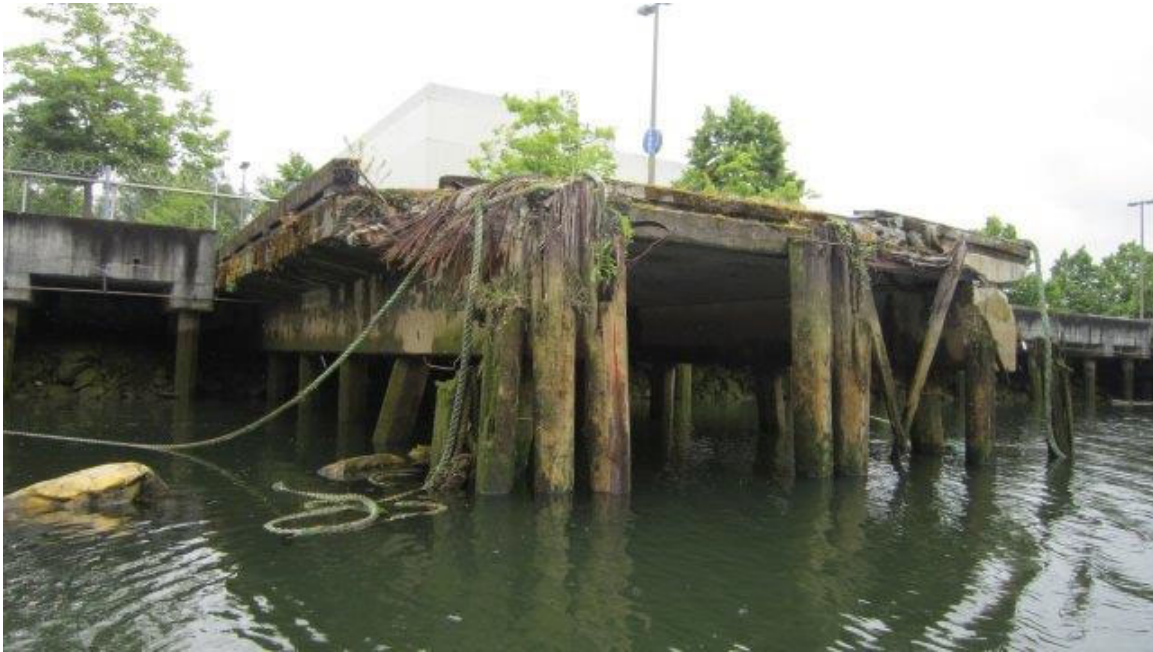
- Several timber fender piles are missing, broken, damaged, or missing straps. (Photos 9 and 10) The tops of the piles appear to be rotted due to weather exposure and subsequent vegetation growth. The body of the piles within and above the splash zone appear to be sound and in good condition. Pressure treatment appears to be in good condition.
- The concrete piles are in good condition except for mortar surface erosion in the wet/dry zone of the piles.
- The cap beams are in good condition except damage to the top of the west cap that exposes some reinforcing steel (Photos 10 and 11).
- The pier decks are in good condition except for portion of the west side of the first concrete deck panel is broken or partially demolished exposing some reinforcing bars (Photos 12 and 13).

- a) Falling debris hazard due to loose and damaged concrete of the pier deck and the top of deck (Photos 9, 12, and 13)
- b) Snag hazard due to loose mooring lines (Photos 9 and 10).
- c) Unprotected end of exposed reinforcing steel (Photo 11).
- d) Loose fender pile straps.
- e) It is not known if stub of missing piles exist above mud line.

Photo ST05-09: Pier 2

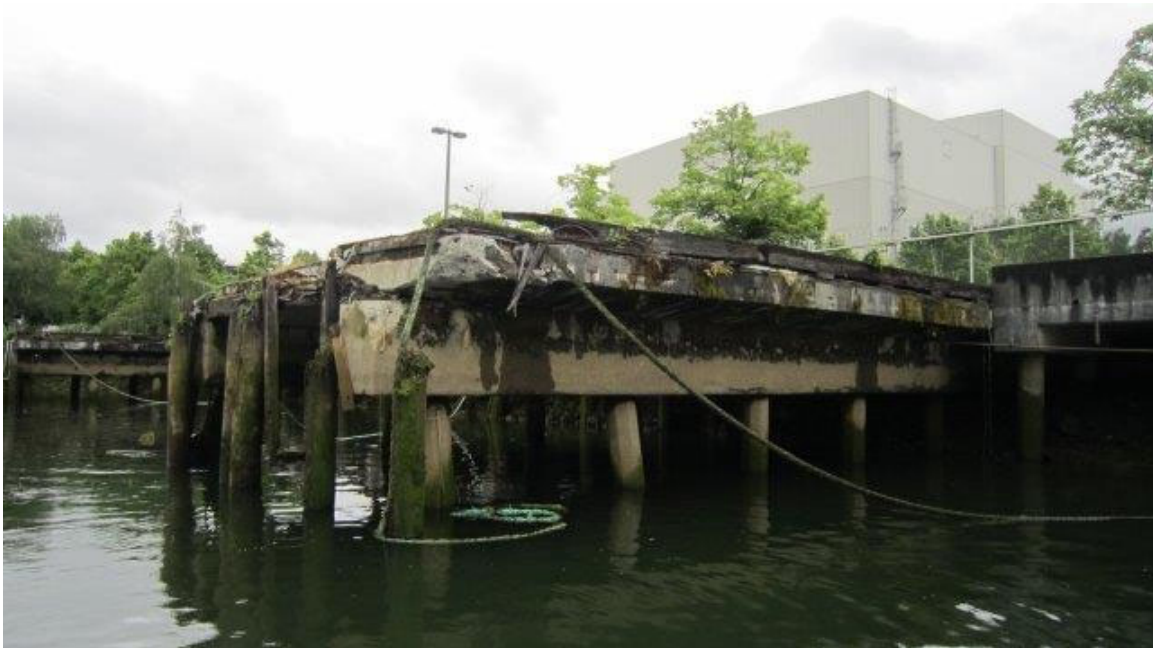
Photo ST05-10: Pier 2 (Looking Southeast)

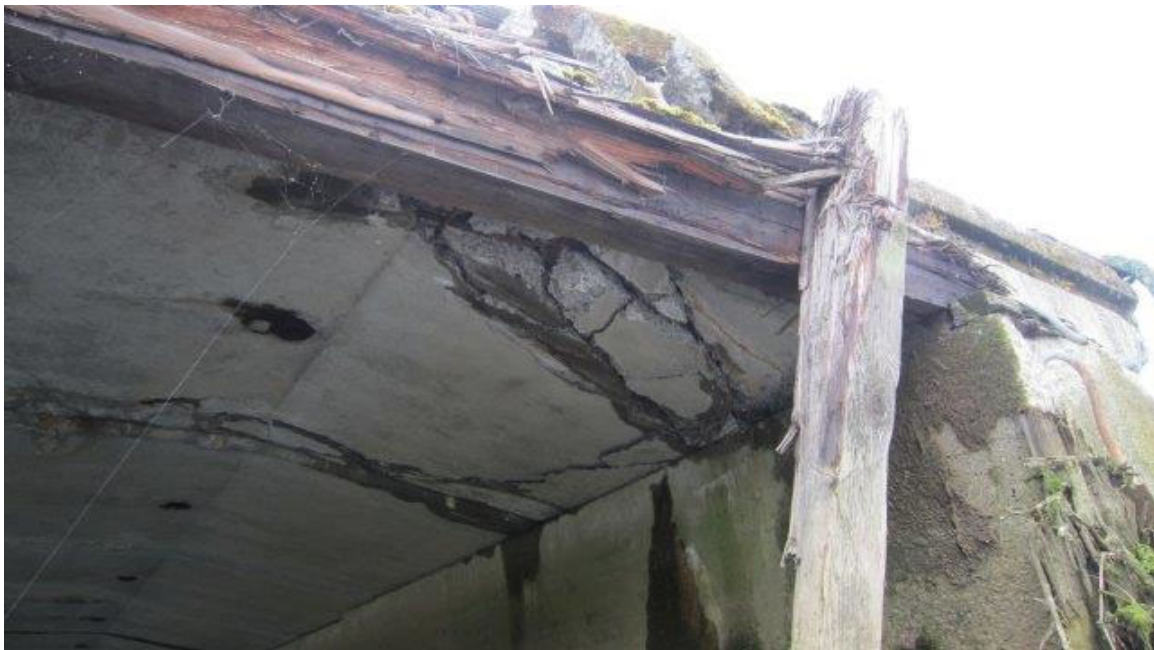
Photo ST05-12: Pier 2, Top West Corner of 1st Deck Panel

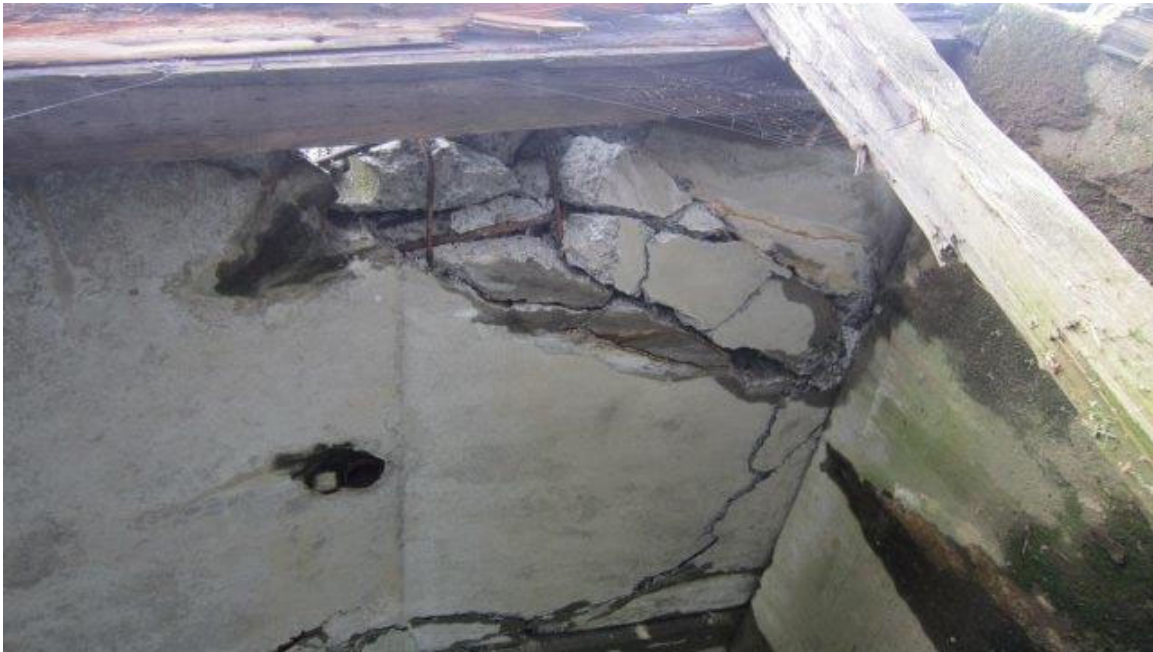
Photo ST05-13: Pier 2, Close Up of West Corner of 1st Deck Panel

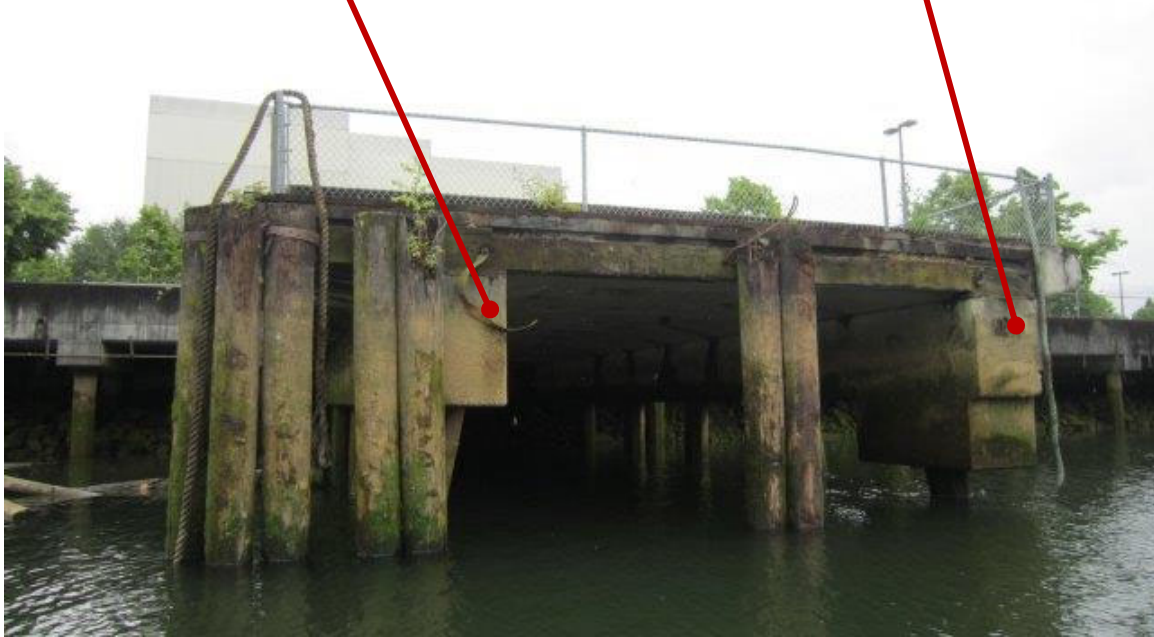
- Several timber fender piles missing with some loose or missing straps. (Photo 15) The tops of the piles appear to be rotted due to weather exposure and subsequent vegetation growth. The body of the piles within and above the splash zone appear to be sound and in good condition. Pressure treatment appears to be in good condition.
- The concrete piles are in good condition except for mortar surface erosion in the wet/dry zone of the piles.
- The pile caps are in good condition except for the north end of the east cap beam is wider and the west pile cap is deeper than the typical cap configuration (Photos 15 and 16).
- Concrete pier decks are in good condition (Photo 17).

Photo ST05-15: Pier 3

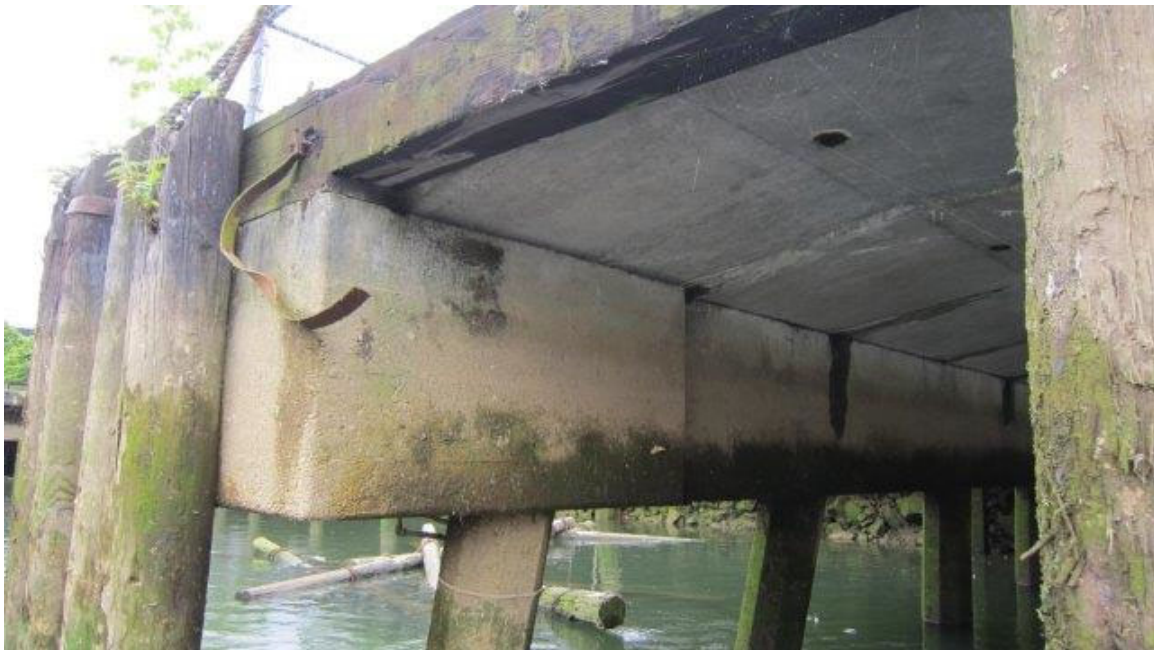
Wider Pile Cap

Deeper Pile Cap

Photo ST05-16: Pier 3, East Pile Cap

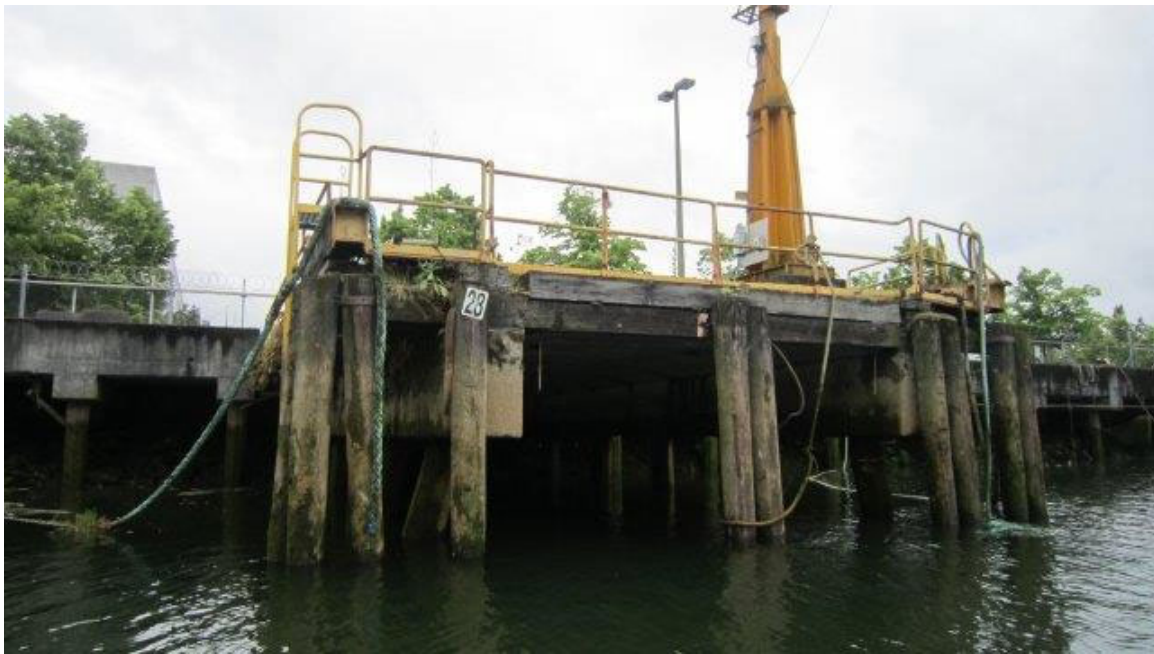
- A few timber fender piles missing with some loose or missing straps. (Photo 19) The tops of the piles appear to be rotted due to weather exposure and subsequent vegetation growth. The body of the piles within and above the splash zone appear to be sound and in good condition. Pressure treatment appears to be in good condition.
- The concrete piles are in good condition except for mortar surface erosion in the wet/dry zone of the piles.
- The pile caps are in good condition except for the pile caps are approximately 32" wide x 42" deep and the depth of the west cap over the first pile is deeper than typical.
- Concrete pier decks are in good condition (Photo 20).

Photo ST05-19: Pier 4

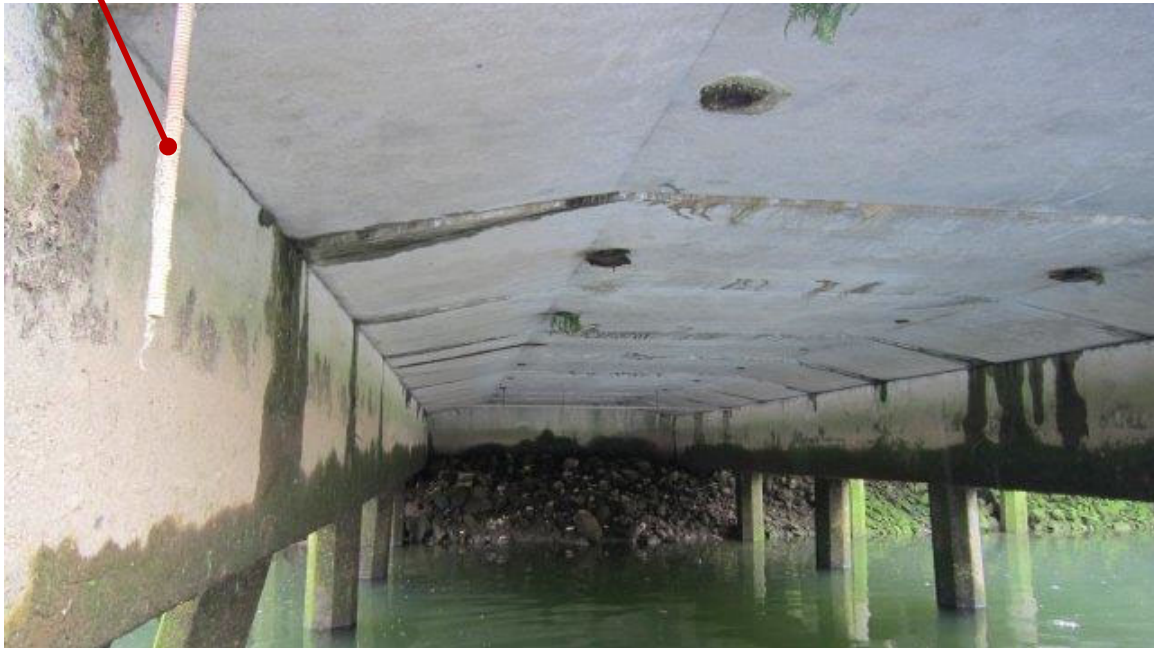
- a) Rot and decay at top of fender pile.
- b) Loose fender pile straps.
- c) It is not known if stub of missing piles exist above mud line.
- d) Snag hazard due to loose mooring lines.
- e) Hanging Steel Rod in board of west pile cap (Photo 20).

Hanging Steel Rod

Photo ST05-20: Pier 4, Pier Deck Soffit

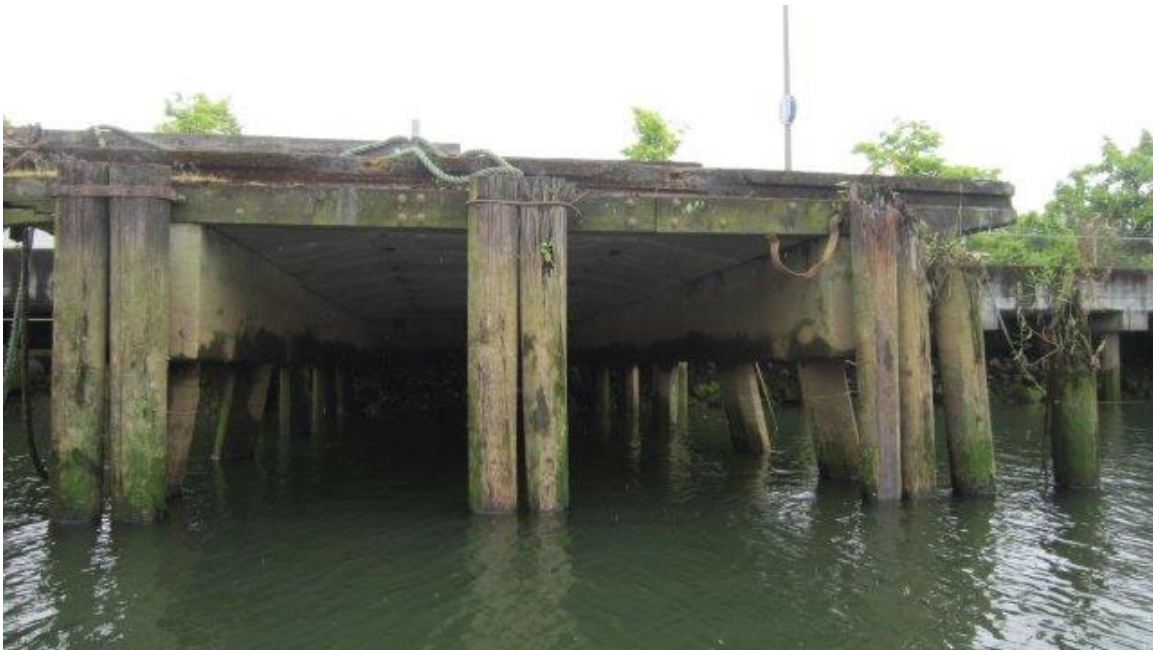
- Several timber fender piles missing or broken with some loose or missing straps. (Photo 22) The tops of several piles appear to be rotted due to weather exposure and subsequent vegetation growth. The body of the piles within and above the splash zone appear to be sound and in good condition. Pressure treatment appears to be in good condition.
- The concrete piles are in good condition except for mortar surface erosion in the wet/dry zone of the piles. The top 6-in of the first pile to the east appears to be field built up and contains rock pockets (Photo 23).

Photo ST05-22: Pier 5

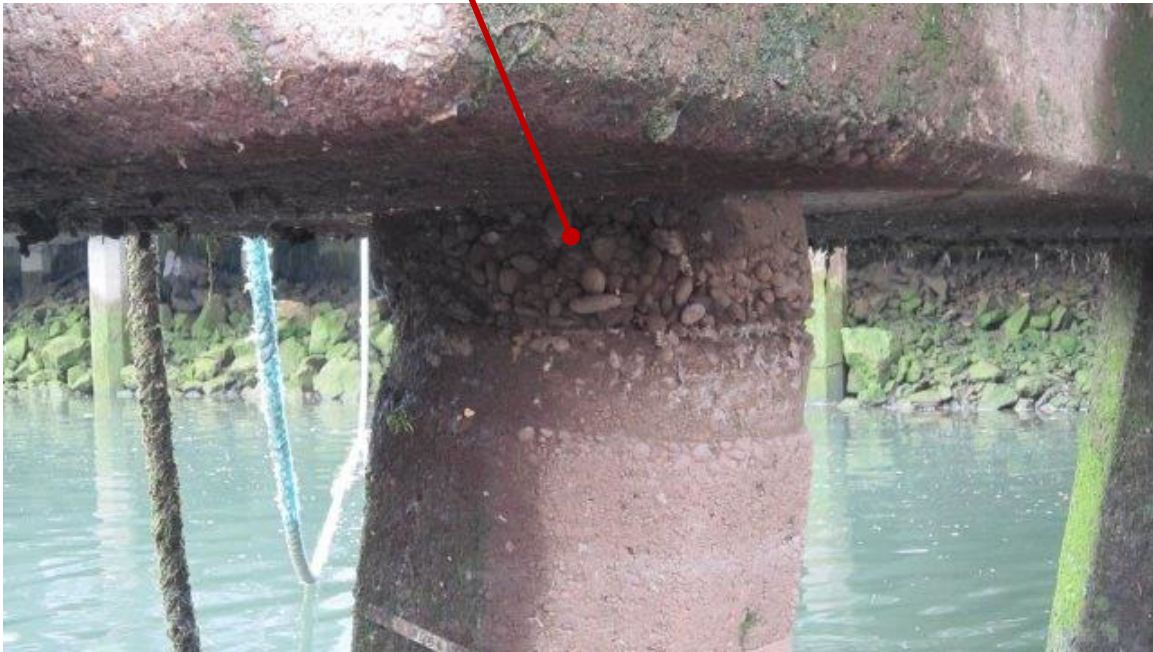
Built Up

Photo ST05-23: Pier 5, Bent 1 East Cap Beam

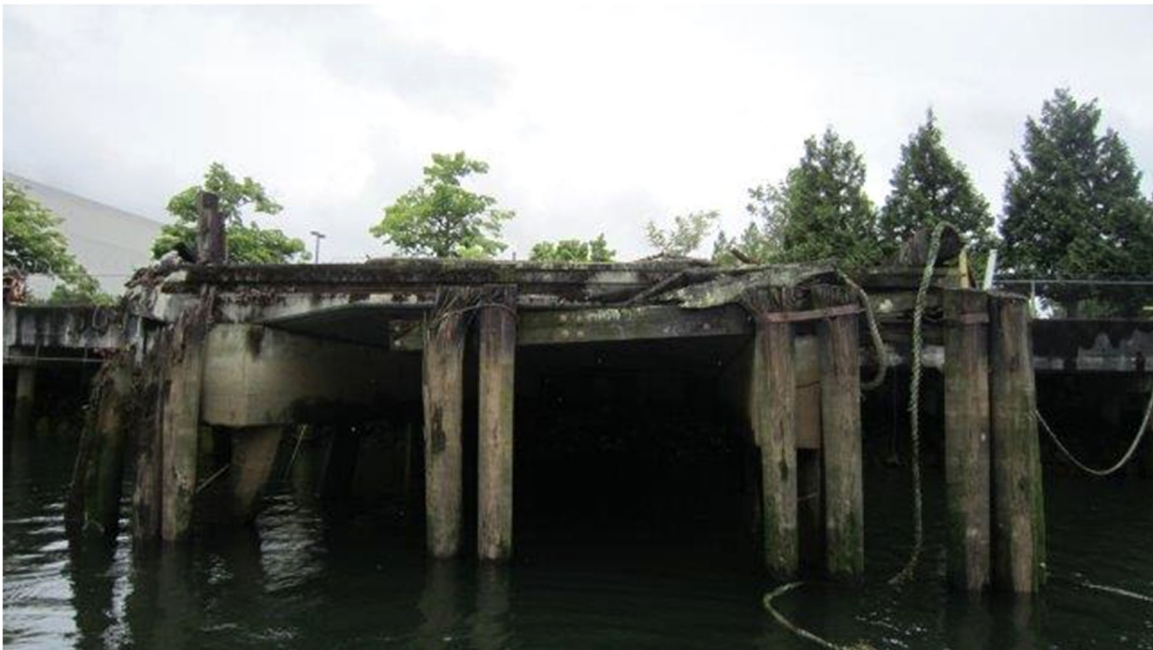
- Most timber fender piles are missing, broken, or damaged. Some with loose, damaged, or missing straps (Photos 26 and 27). The tops of the piles appear to be rotted due to weather exposure and subsequent vegetation growth. The body of the piles within and above the splash zone appear to be sound and in good condition. Pressure treatment appears to be in good condition.
- The concrete piles are in good condition except for mortar surface erosion in the wet/dry zone of the piles (Photos 28 and 29).
- The pile caps are in good condition except for the pile caps are wider than typical dimensions (Photos 28 and 29).
- Concrete pier decks are in good condition except for damage at top west corner with broken concrete and exposed reinforcing steel (Photos 27 to 29).

Photo ST05-26: Pier 6

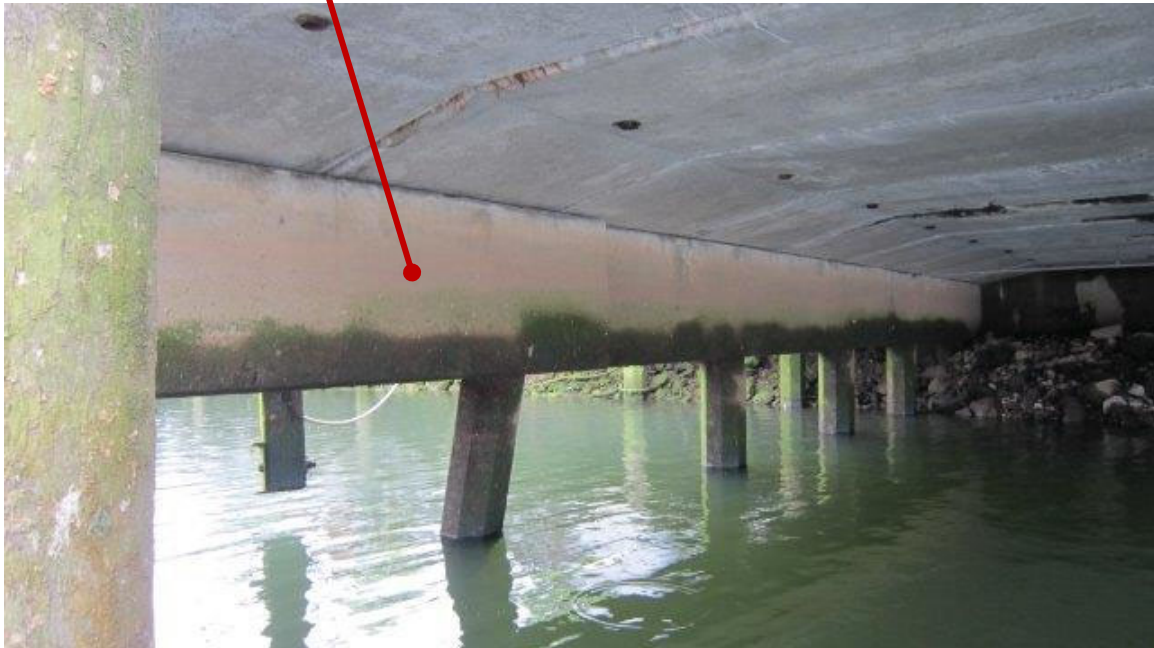
Wider Cap – Over 2 Piles

Photo ST05-28: Pier 6, East Pile Cap

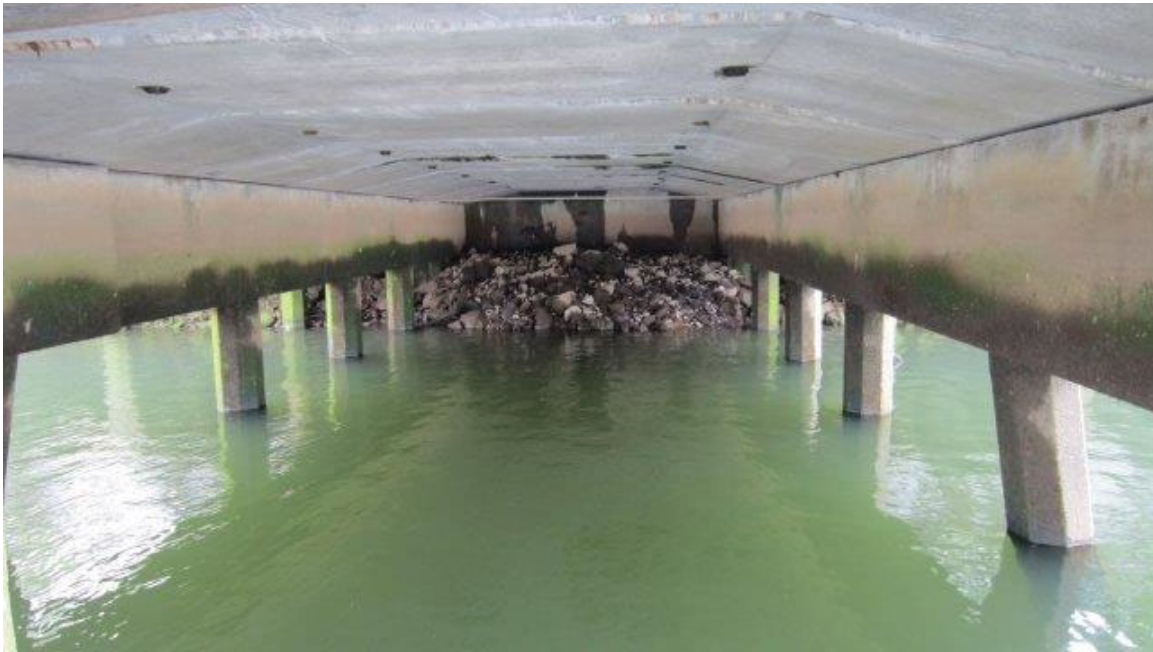
Photo ST05-29: Pier 6, Pier Deck Soffit

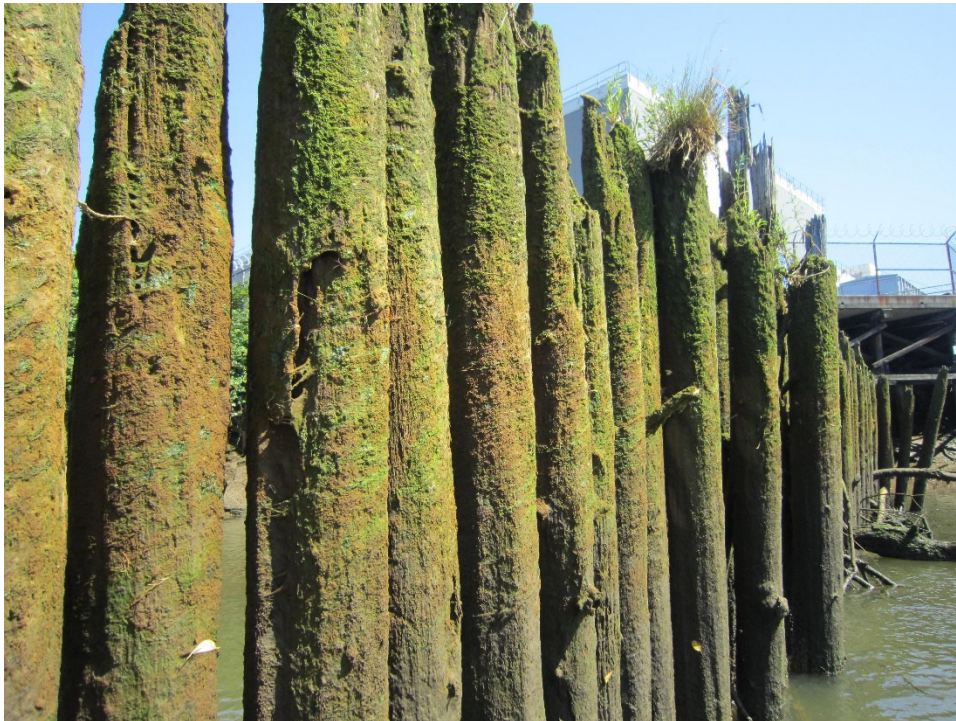
Photo ST07-08: Groin Piles

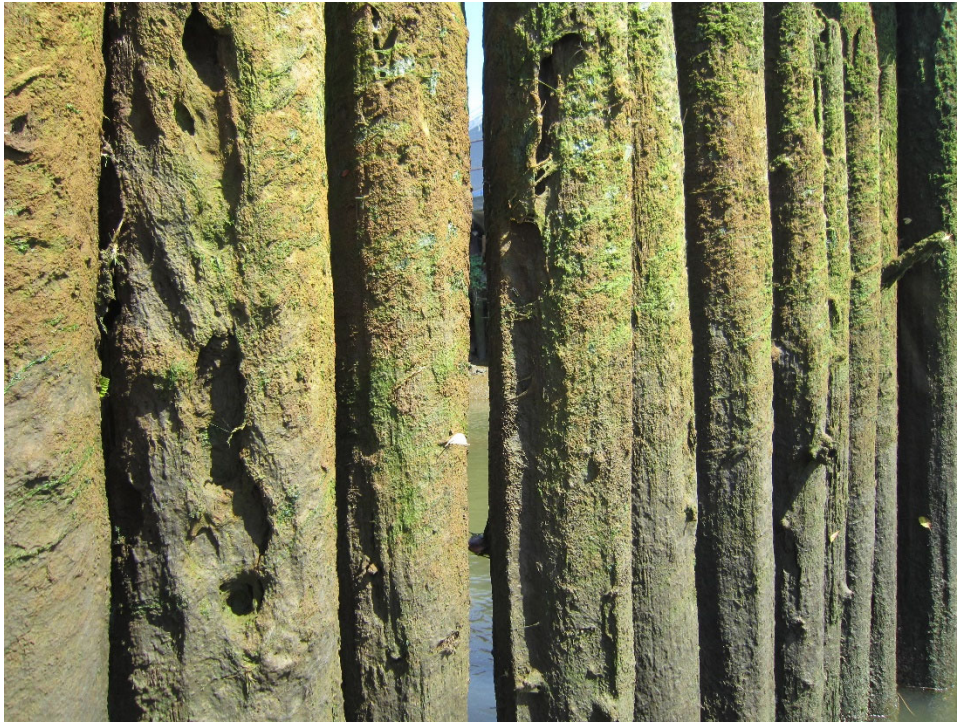
Photo ST07-09: Interior Groin Piles

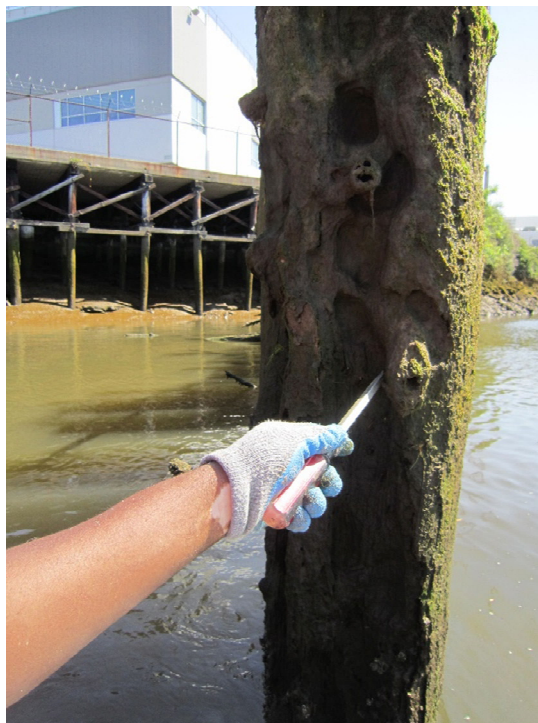
Photo ST07-10: End Pile

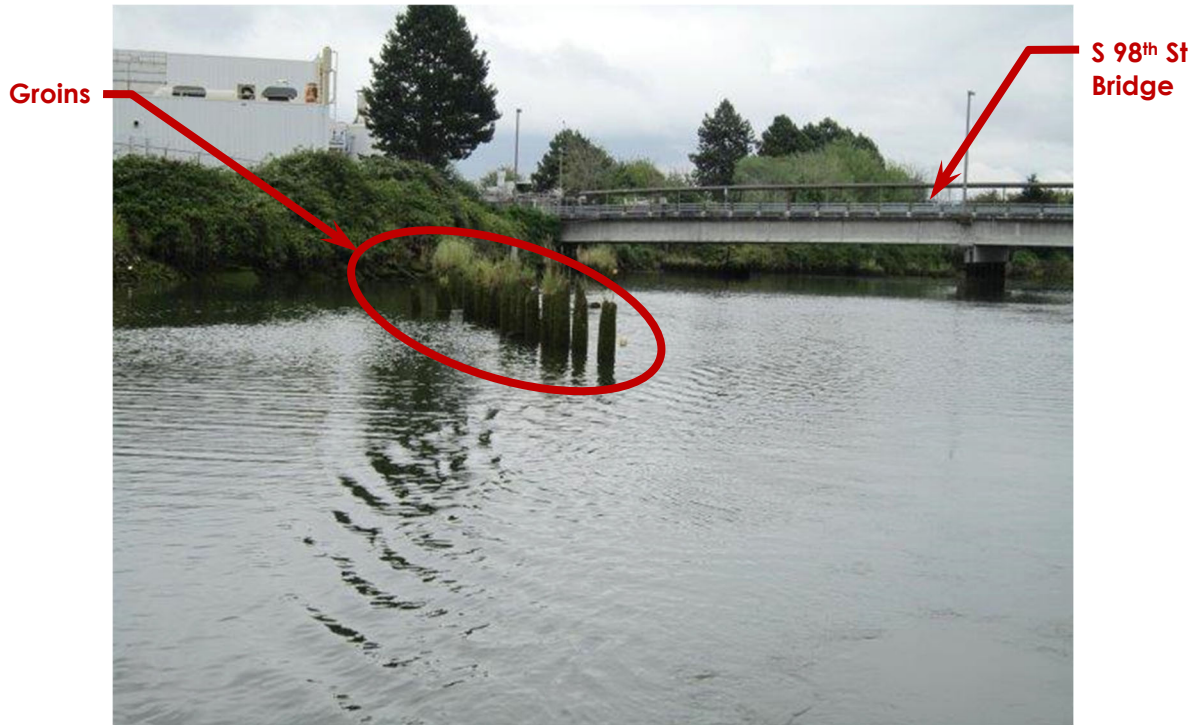
Photo ST07-11: Groins North of Bridge (Looking Southeast)

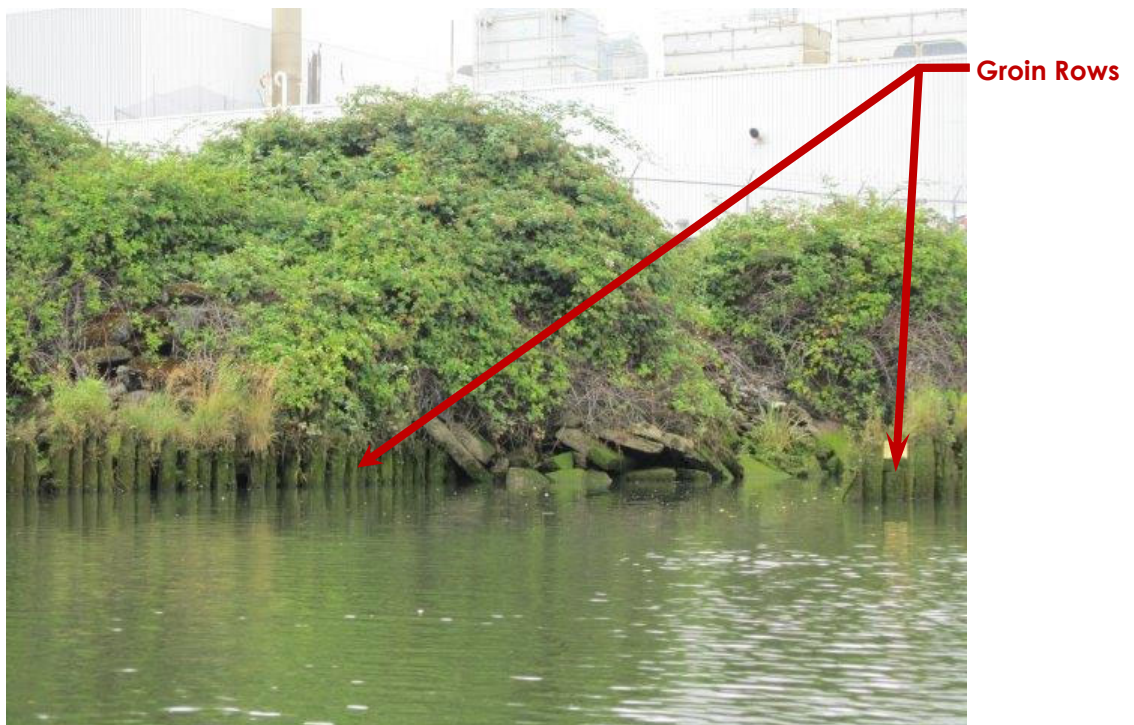
Photo ST07-12: Groins and Embankments North of Bridge
