Appendix F

Structures Inspection Forms

Sediment Cleanup of Upper Reach of Lower Duwamish Waterway, Phase I/II

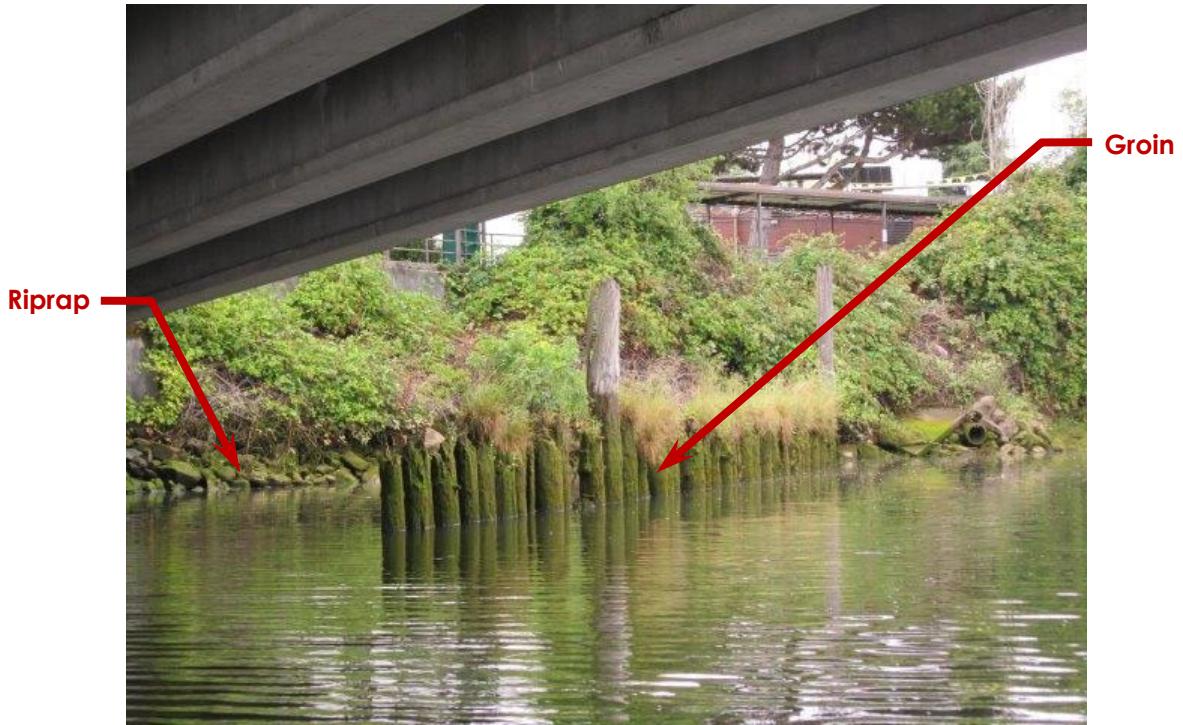
Photo ST07-13: Groins and Embankment South of Bridge

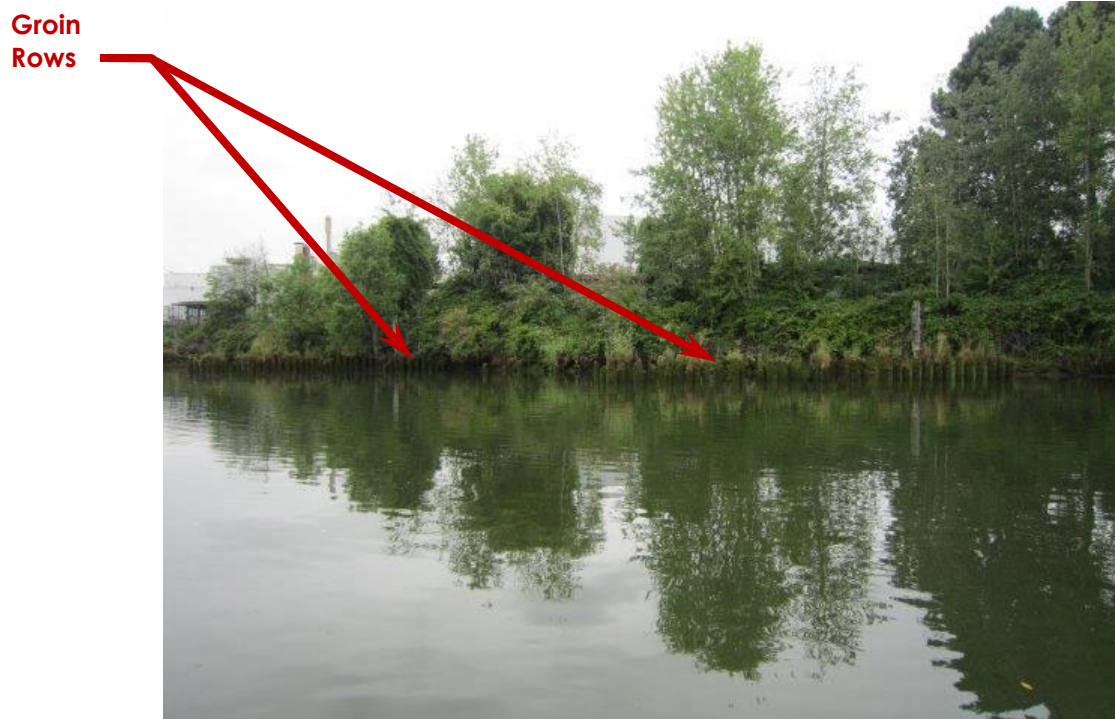
Photo ST07-14: Groins and Embankment South of Bridge

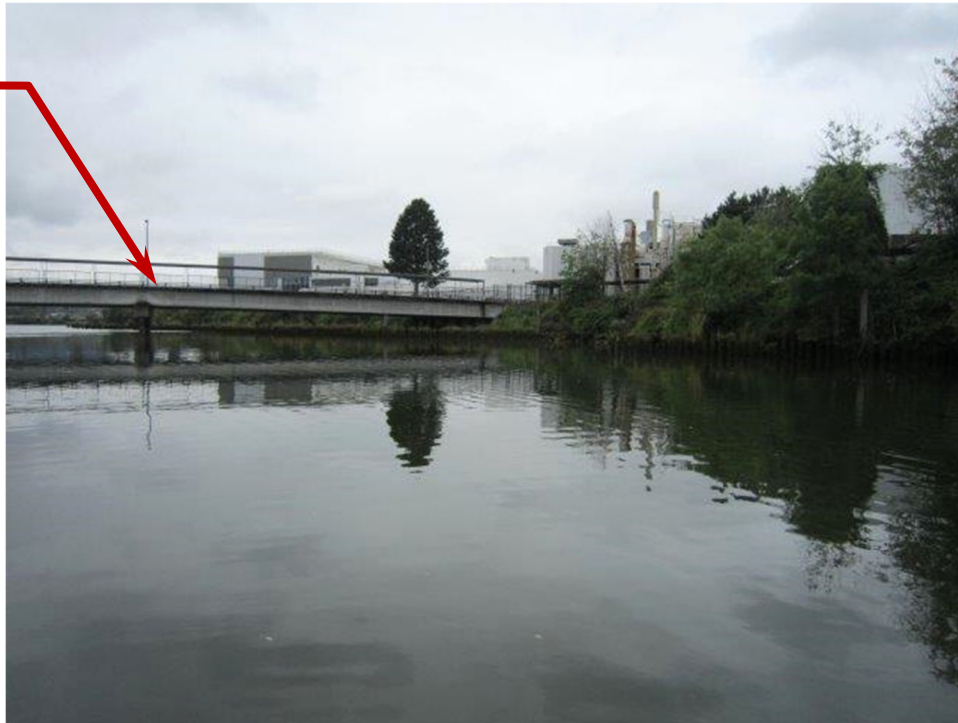
Photo ST07-15: Groins and Embankment South of Bridge (Looking Northeast)

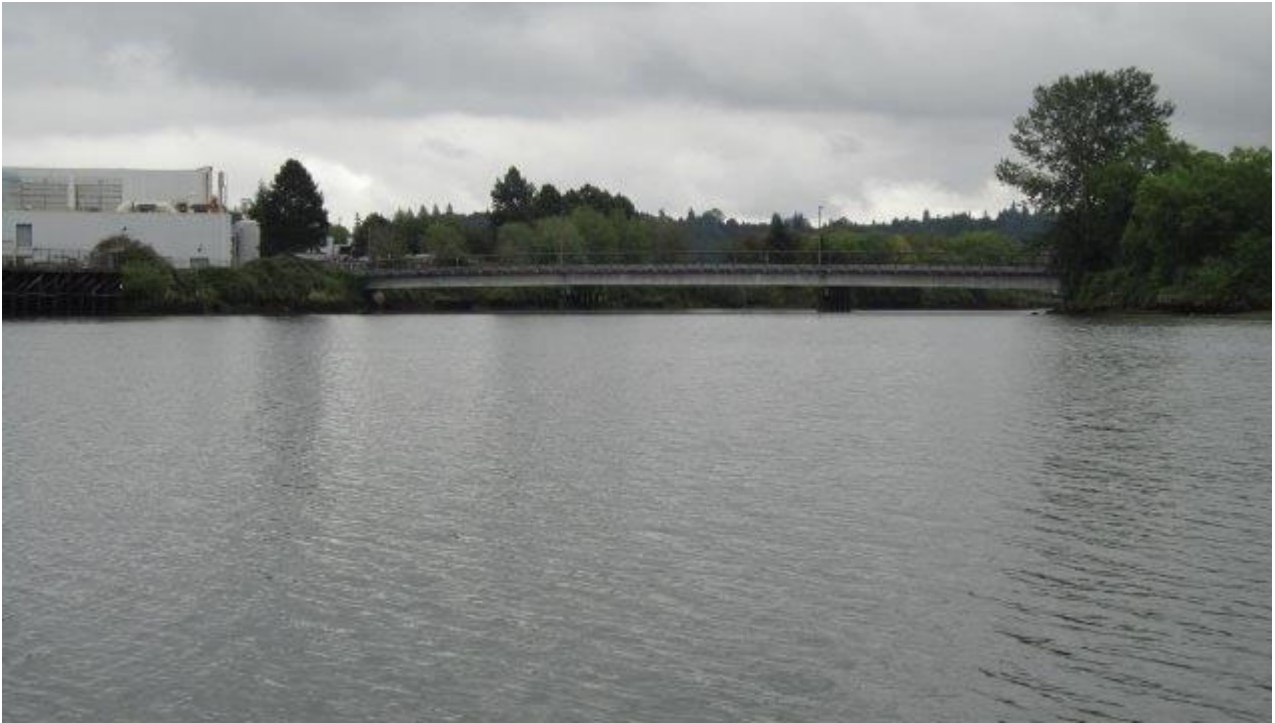
- Three (3)-span concrete girder bridge (Photo 1).
- East and west concrete abutments protected with riprap (Photos 2 and 3).
- Two (2) bents in the navigational channel each consisting of seven (7) steel piers and concrete cap beam (Photos 4 and 5).
- The concrete surface of the abutments and girders appears to be in good condition (Photos 2 to 4).
- The surface of the steel piers exhibits scattered rust and corrosion (Photos 4 and 5).
- Approximately 12-ft vertical clearance at center spans (1:55pm, July 17, 2020 tide level)

Photo ST08-01: Bridge (Looking South)

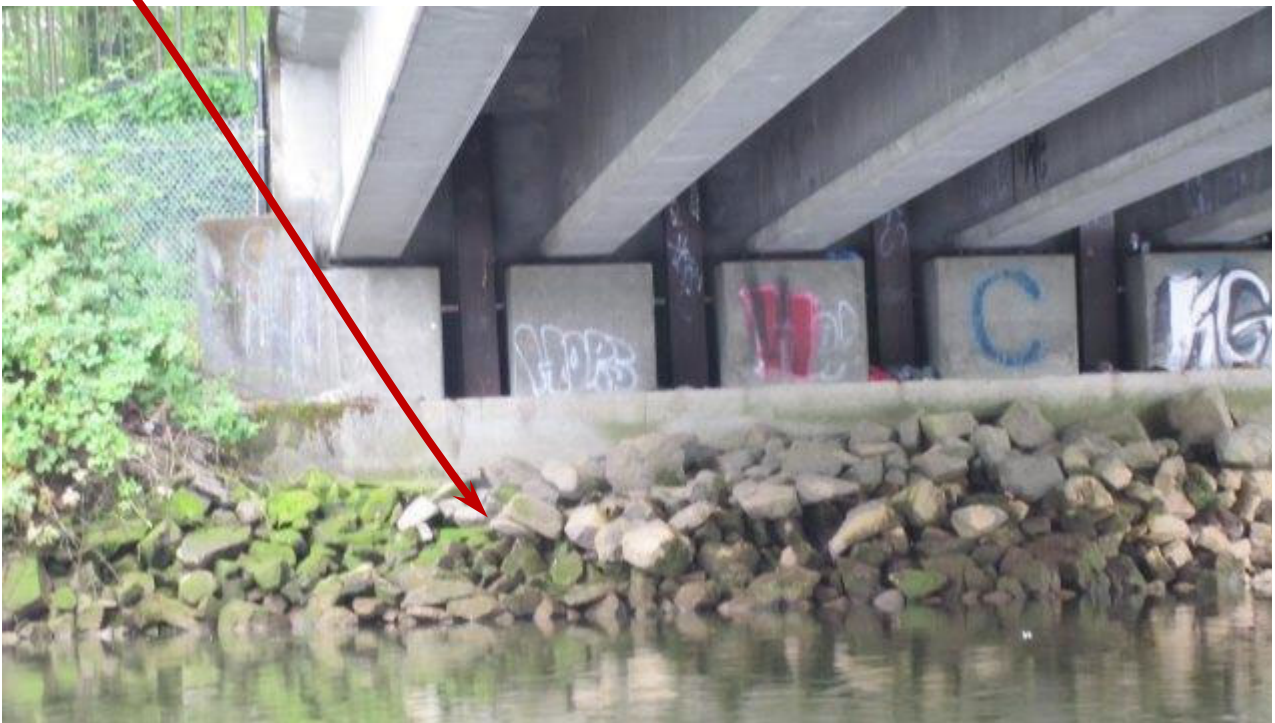
Photo ST08-02: East Abutment

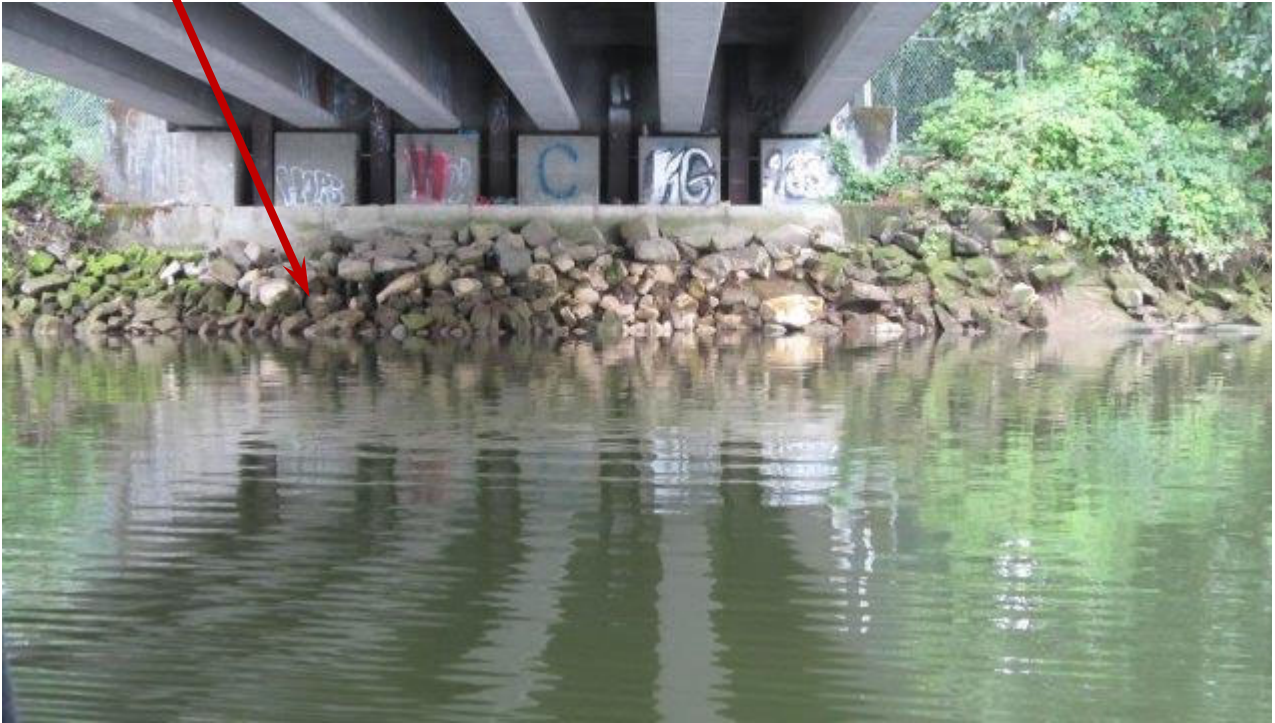
Photo ST08-03: West Abutment

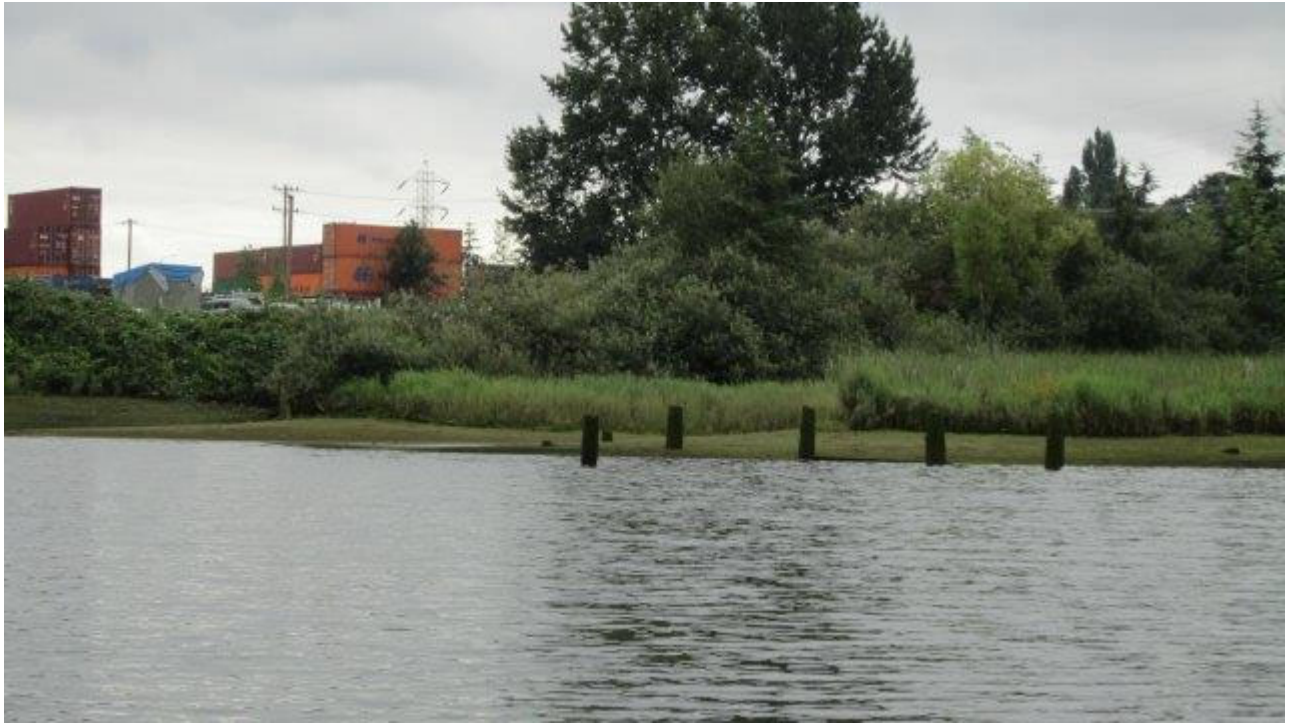
- Several scattered timber piles north of the S 98th St Bridge near the shoreline. They appear to have been cut down and are in poor condition (Photo 1).

Photo ST10-01: Piles

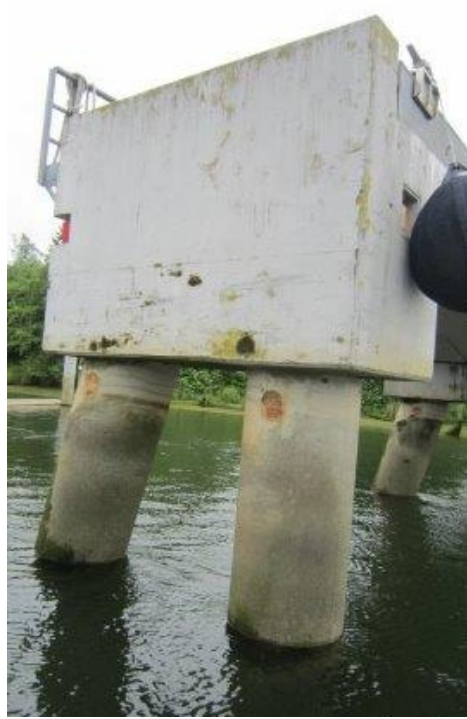
Photo ST12-03: East End Piles and Caps of South Finger Pier

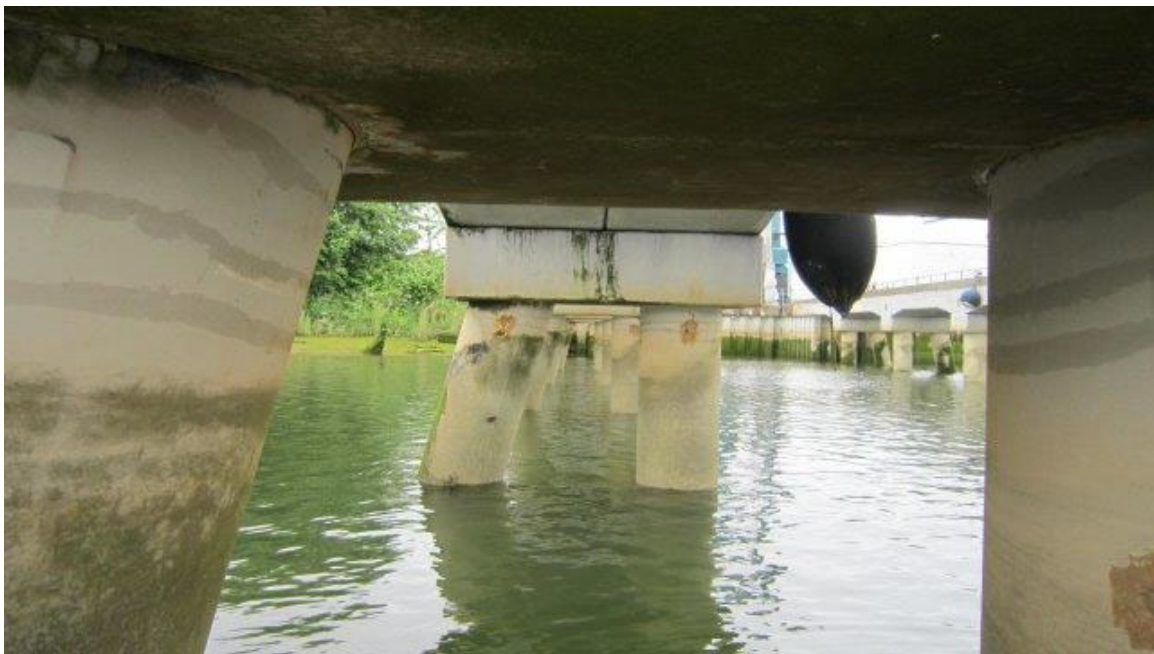
Photo ST12-04: South Pier Pile Rows (Looking West)

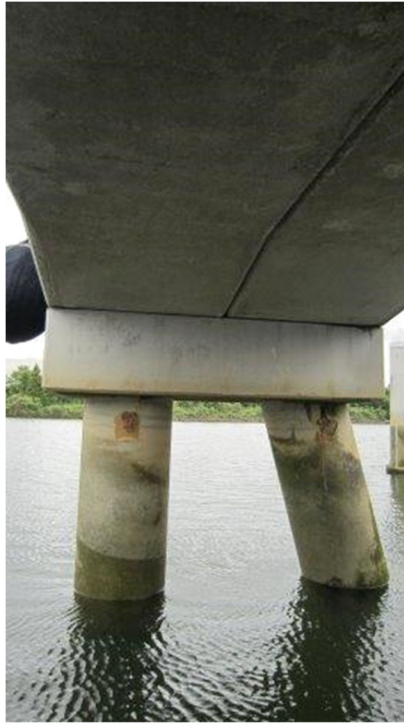
Photo ST12-05: Pile Cap and Pier Decks (Looking West)

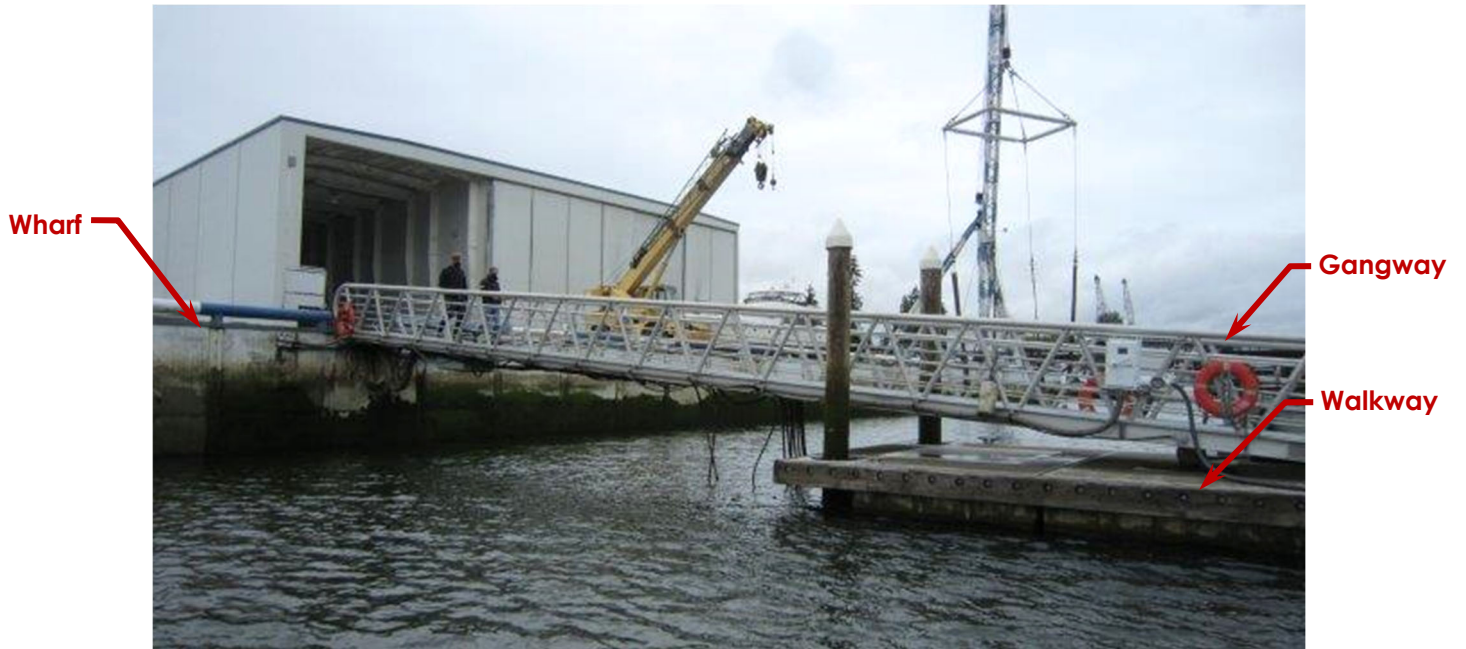
Photo ST12-06: Floating Dock Access Way (Looking North)

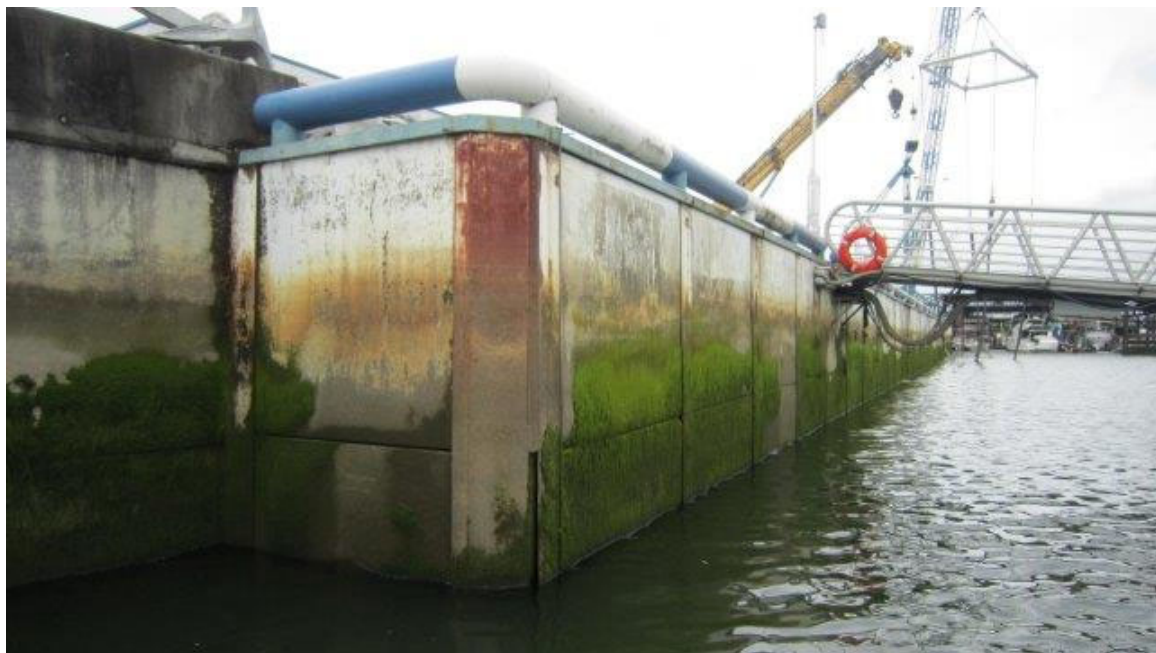
Photo ST12-10: H-Pile Bulkhead (Looking North)

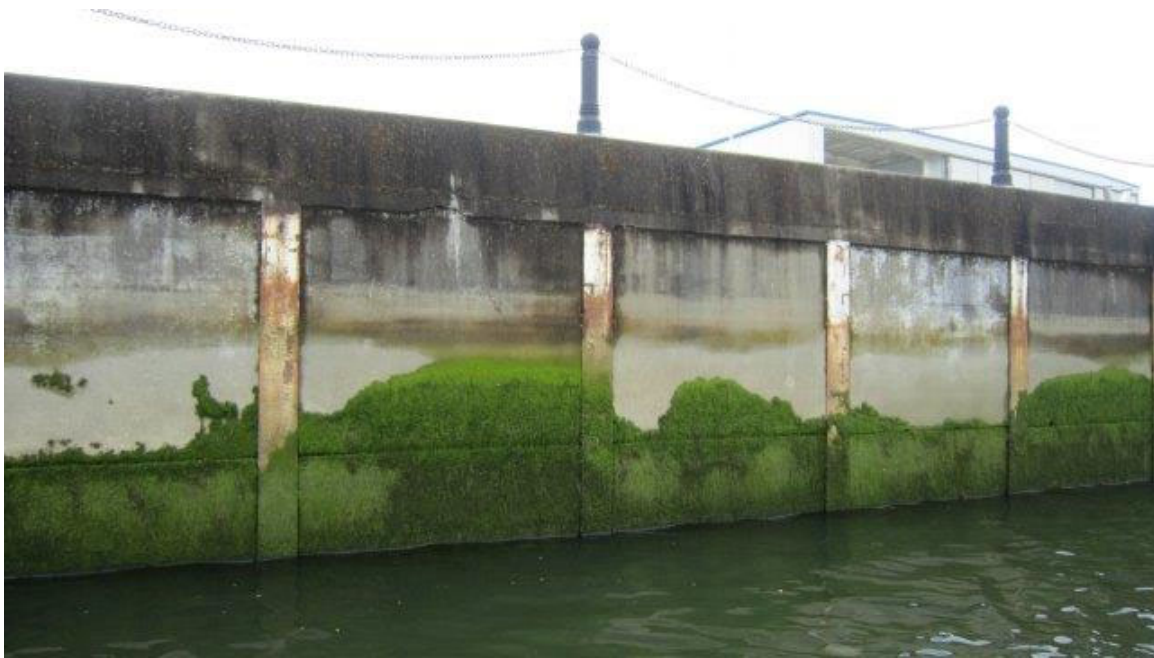
Photo ST12-11: Close Up of H-Pile Bulkhead

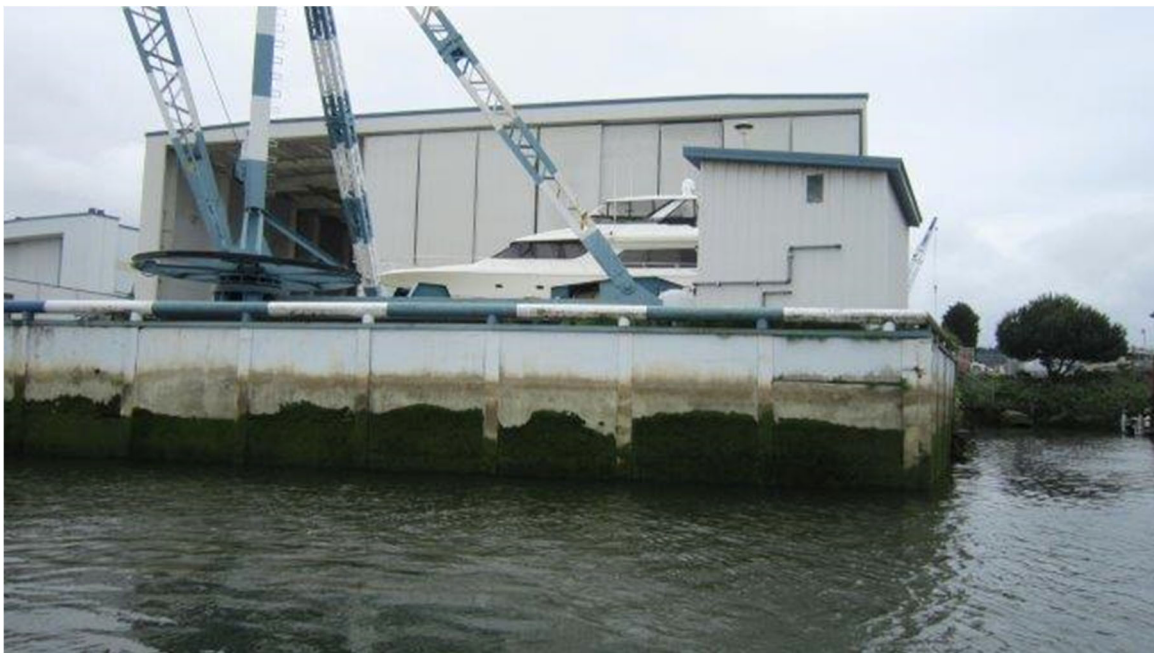
Photo ST12-12: North End Bulkhead and Return (Looking West)

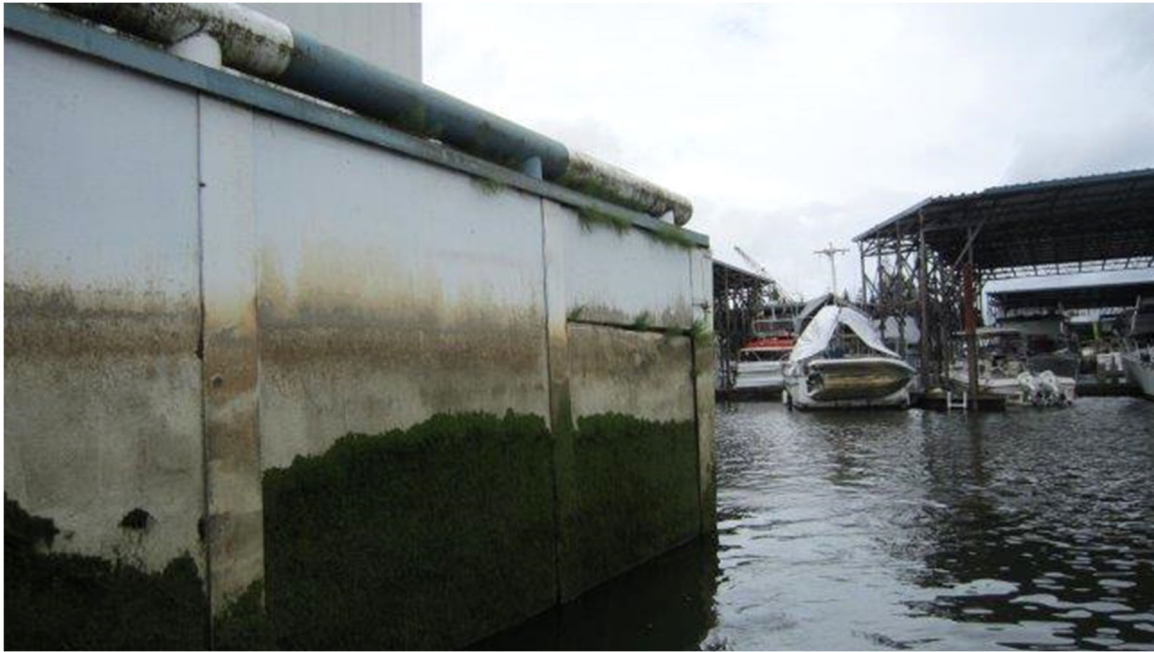
Photo ST12-13: North End Close Up of the H-Pile Bulkhead

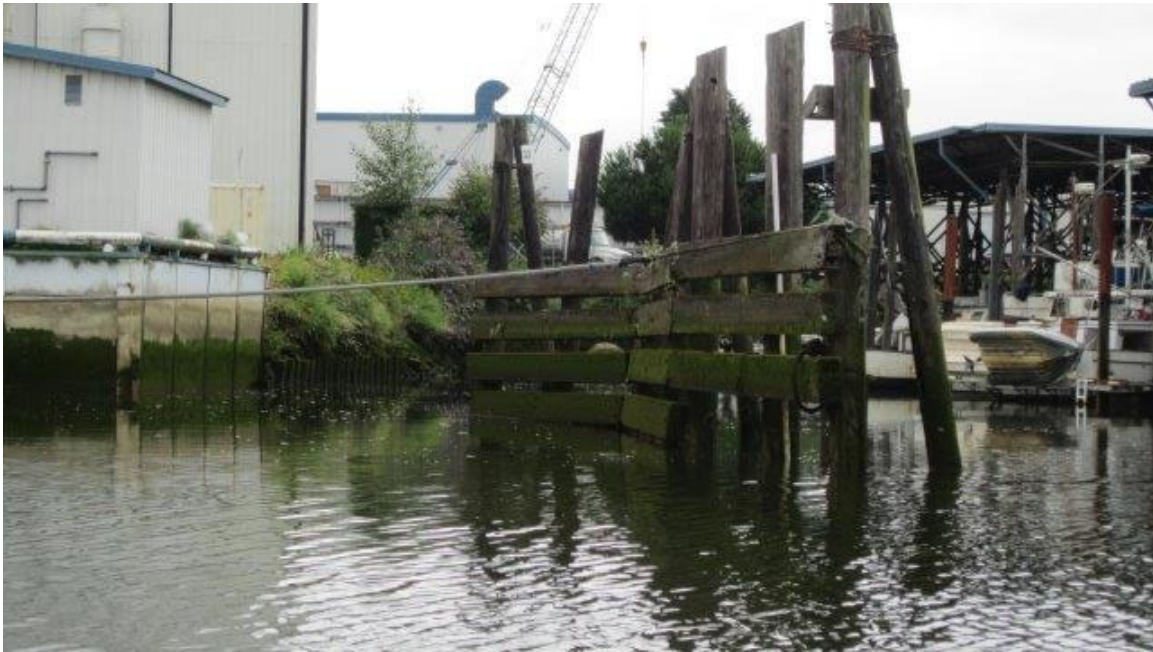
Photo ST12-15: Breakwater

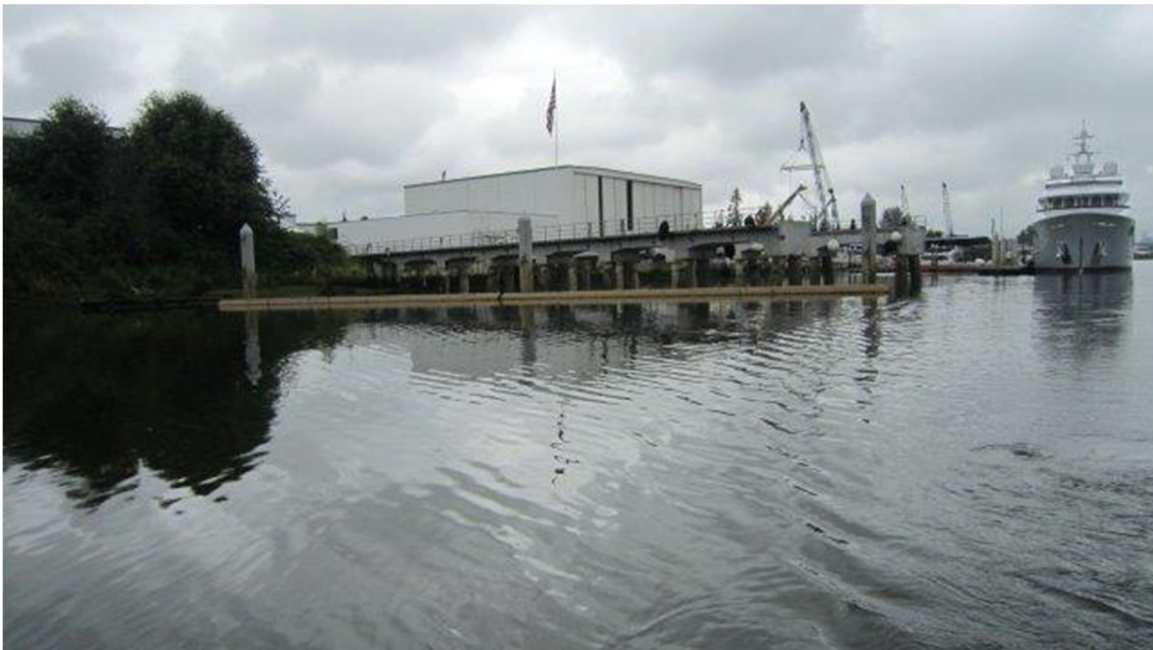
Photo ST12-016: Upstream Debris Deflector

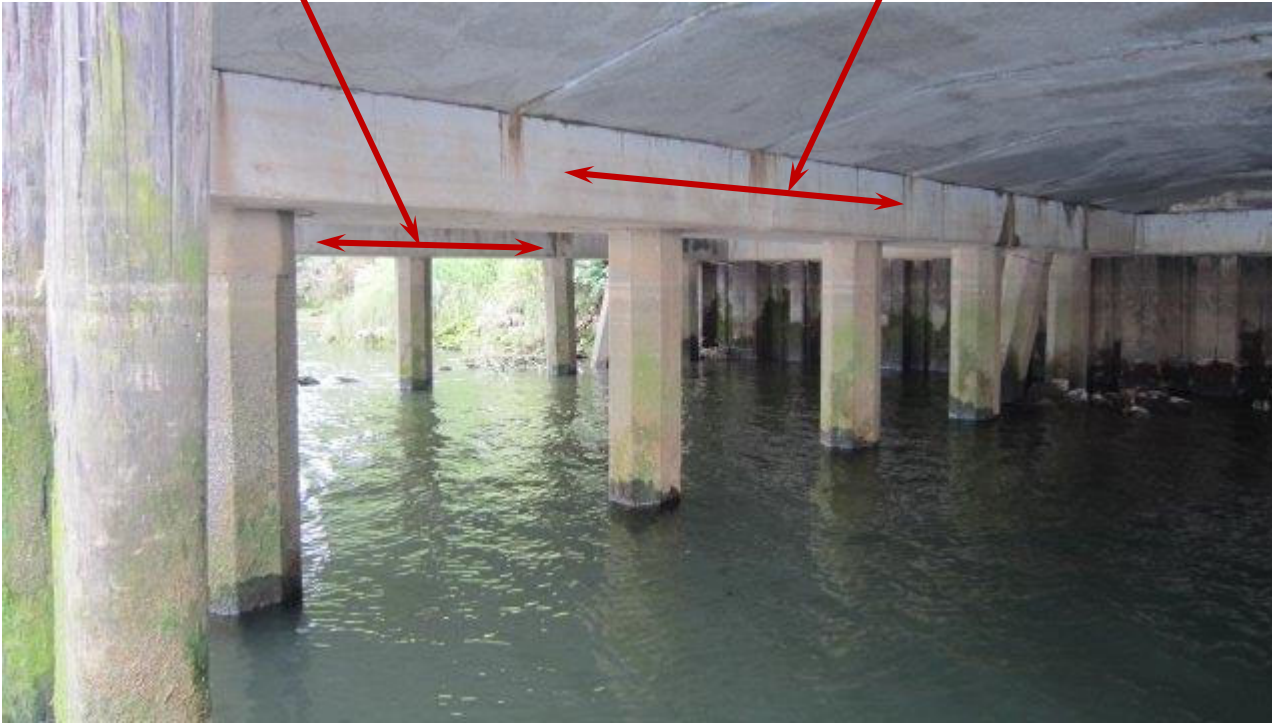
Photo ST16-10: Piles and Pile Caps (Looking Northwest)

- A close observation of the steel sheet pile and concrete cap was not possible. There appears to be moss growth and rust in the wet/dry zone of the sheet pile (Photos 7, 10, 12, 14, and 15).

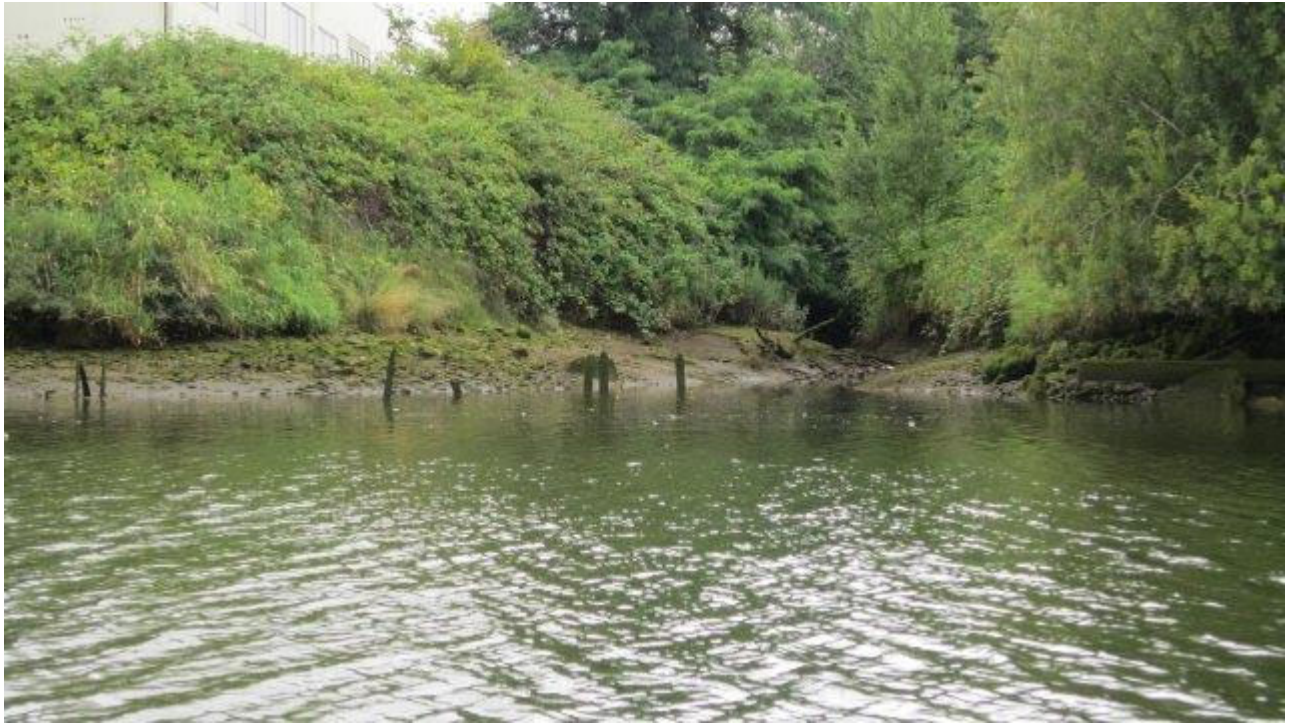
Photo ST17-01: Pile Field

- Several scattered timber piles north of the S 98th St Bridge near the west shoreline. They appear to have been cut down and are in poor condition (Photo 1).

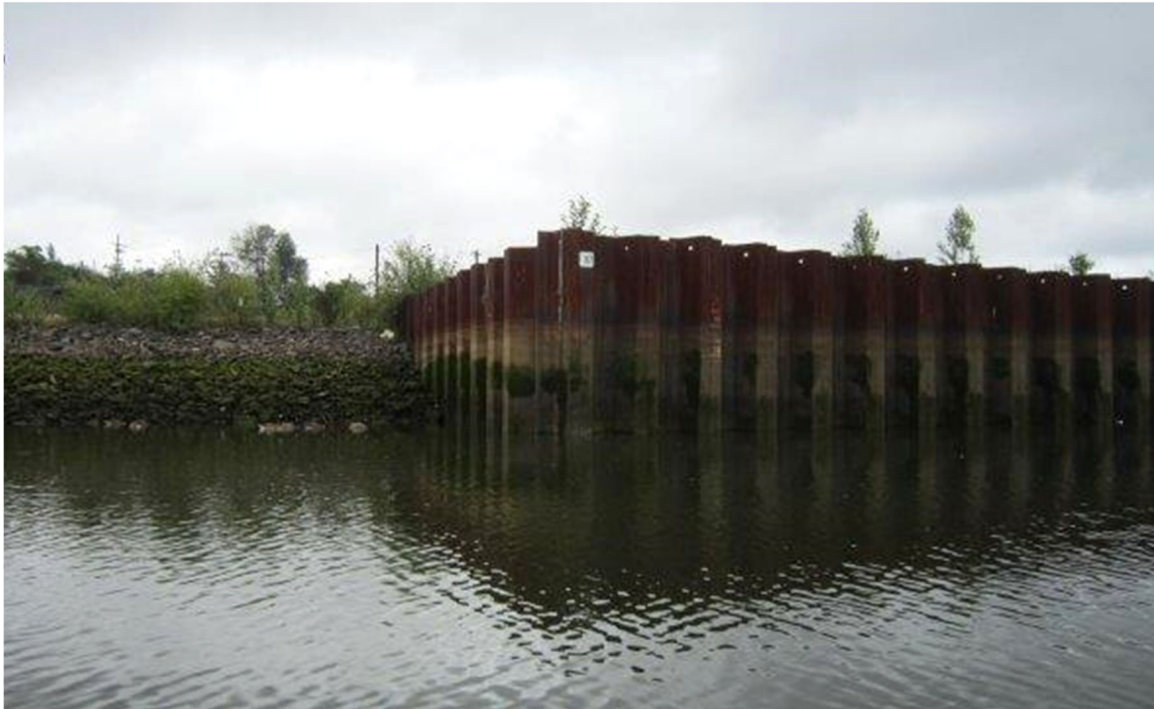
Photo ST19-01: South Return Wall (Looking Northwest)

- Structure consists of U-shaped steel sheet pile bulkhead for contamination containment of Terminal 117 Cleanup Site.
- The sheet piles appear to be in good condition. (Photos 1 to 4)
- The North and South return walls abut riprap river bank embankment. (Photos 1 to 4)
- Near the north end of the bulkhead, four (4) 12" diameter steel pipe guide piles support for a 16" diameter float debris deflection pile pipe. The piles and float are in good condition. (Photos 2 and 3)
- During the July 12, 2021 inspection we observed, under construction, what appears to be an elevated concrete walkway deck supported by steel pipe piers. (Photo 5)
- The walkway is in-water, along the west shoreline and south of the South Park Marina.

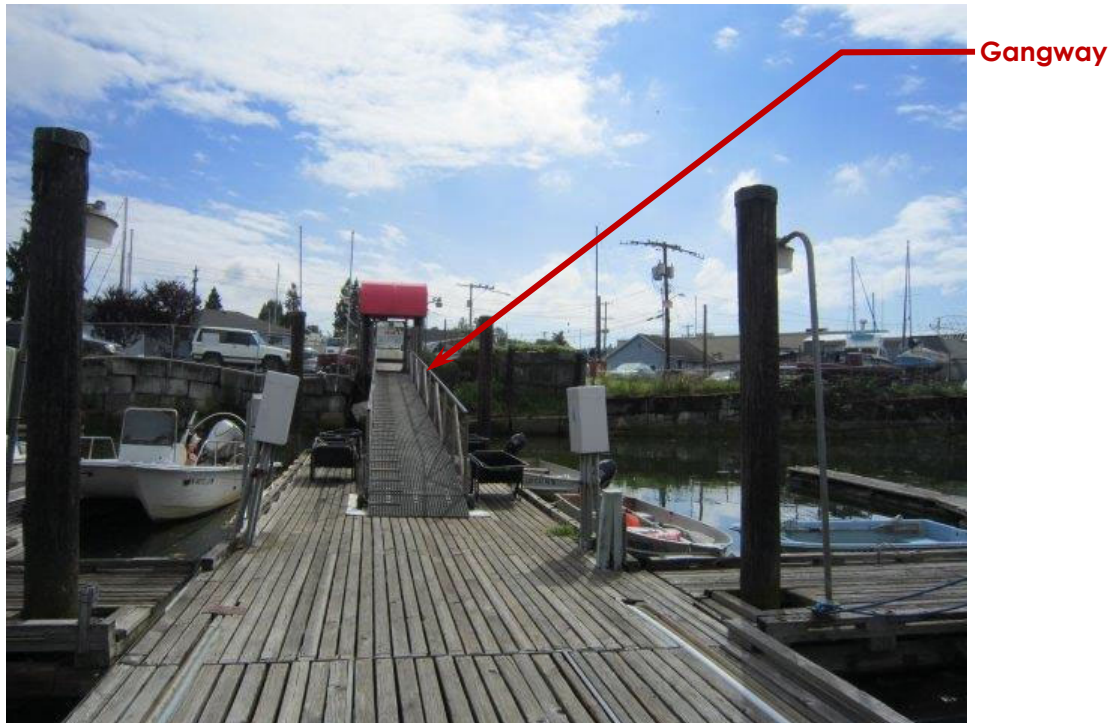
Photo ST20-09: Gangway and Walkway (Looking West)

- The galvanized steel pipe truss gangway is supported on the west end but the type and condition of the support is unknown (Photo 9).
- Utilities servicing the marina are hung on the west end of the gangway and fed from under the gangway. The integrity of the pull box cantenary supports is not known (Photos 10 and 11).
- There is scattered rust along the length of the truss members and corrosion at several welded joints (Photos 10 and 11).
- The wood walkway decking is worn and weathered but no distress was observed.
- The slip resistant grating over the decking appears to be in good condition.

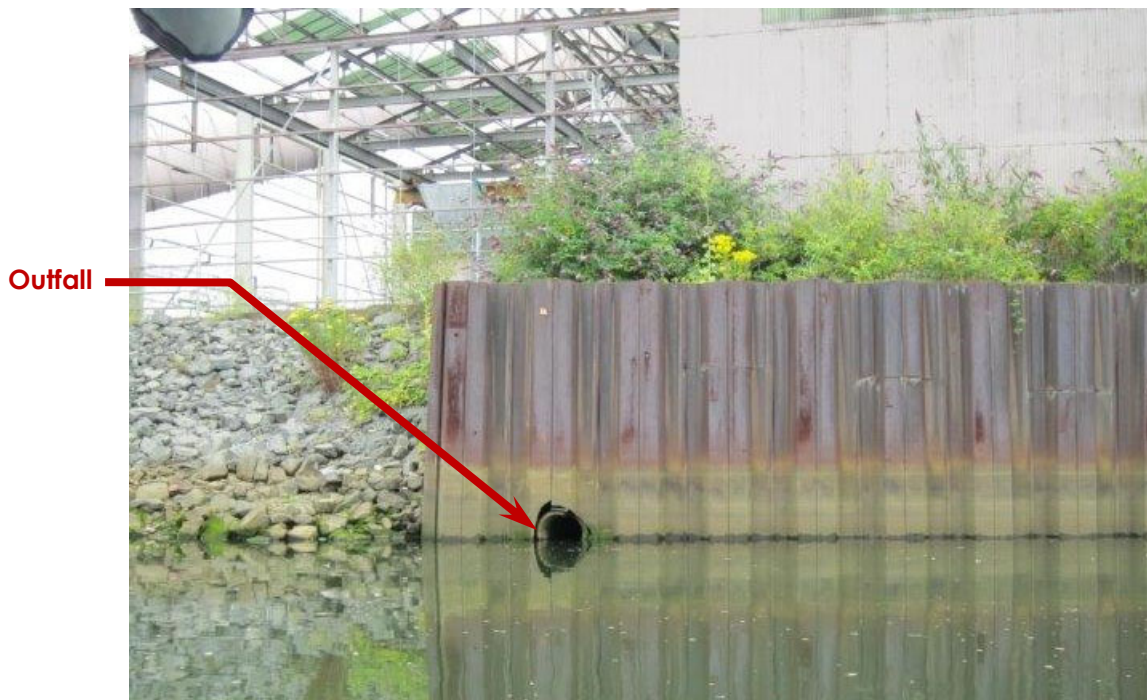
2072-02: Concrete Outfall at High Tide

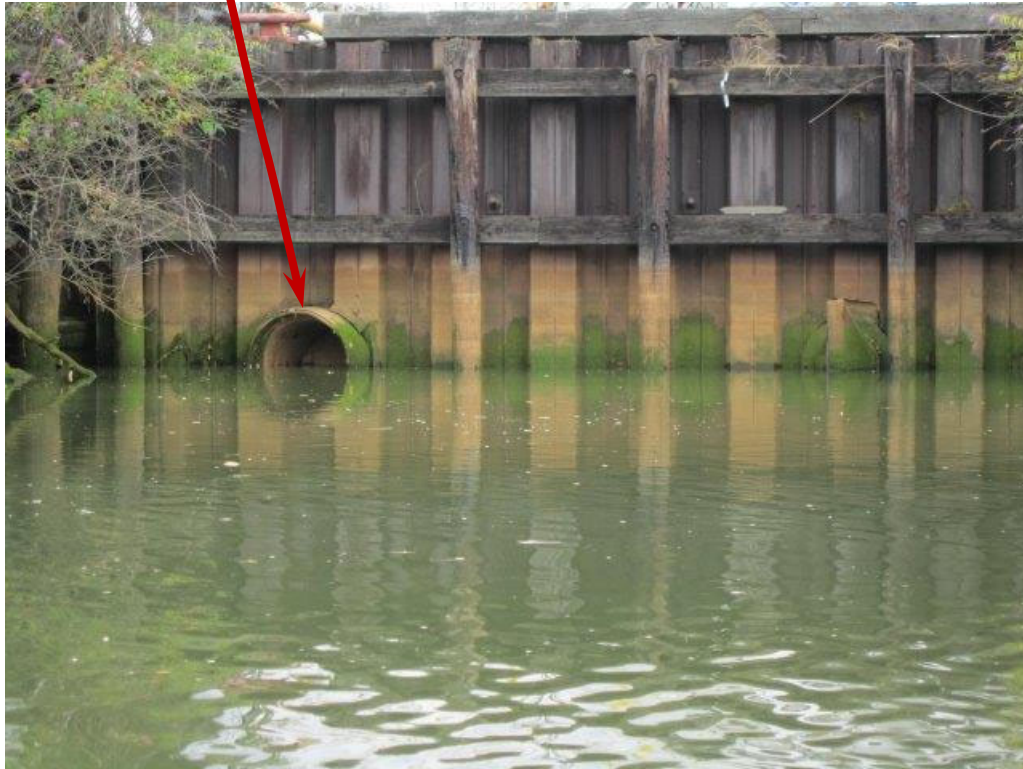
2062-02: Outfall at High Tide

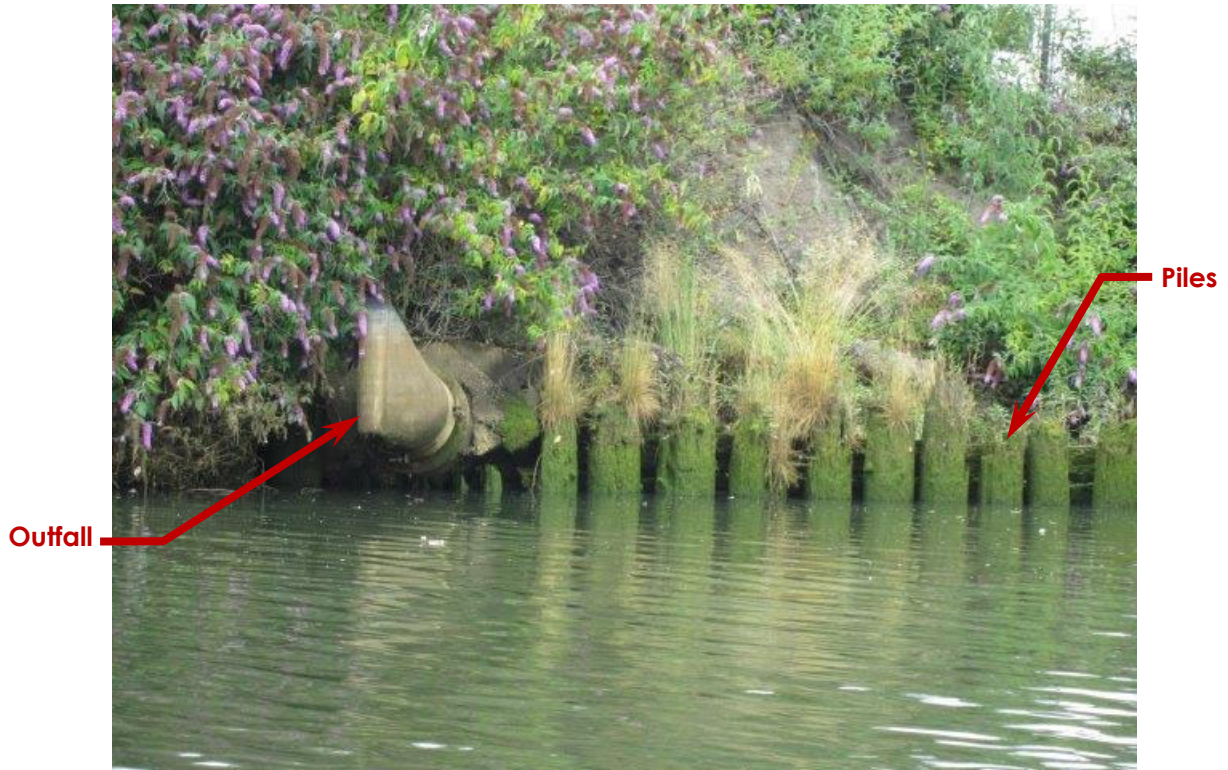
- The outfall is supported on and overhangs timber piles and lagging along the shoreline (Photos 1 and 2).
- Pipe is 20-in diameter, flanged steel pipe outfall diffuser with duckbill valve and concrete collar/armoring (Photo 3).
- Exposed top section of the timber piles and lagging are deteriorated.
- Outfall appears to be operational.

2077-01: Outfall at High Tide

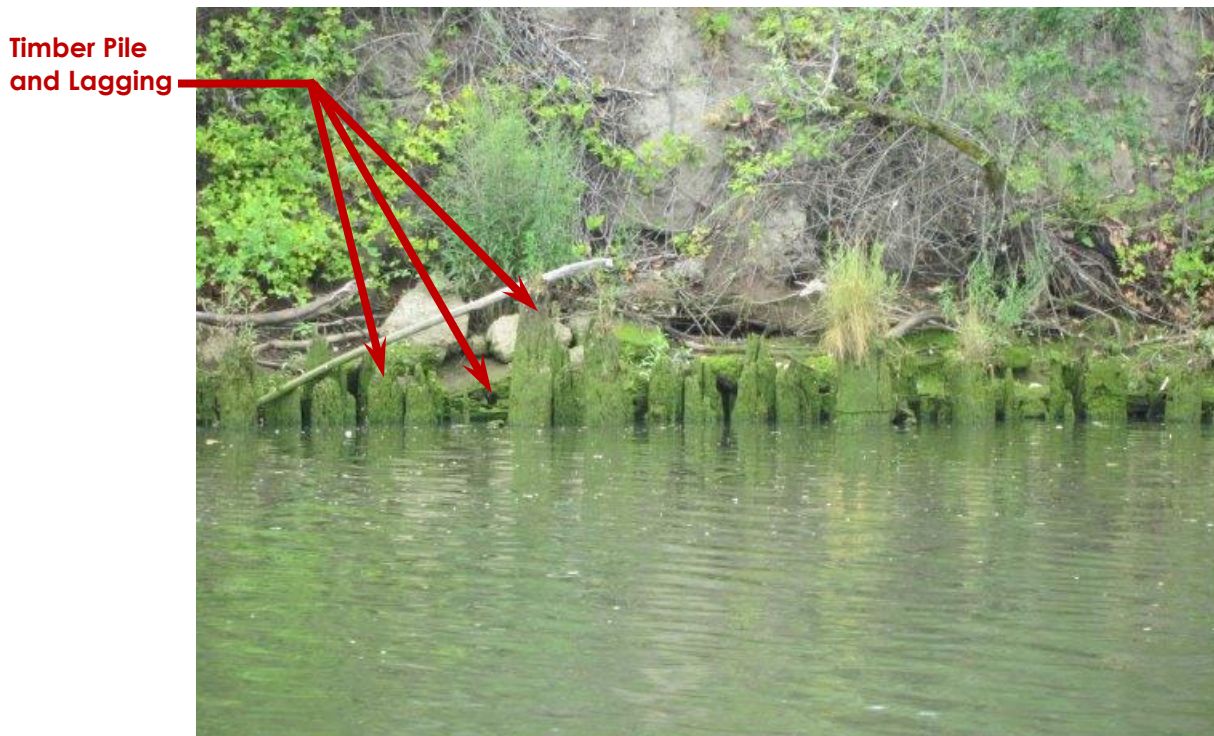
2077-02: Shoreline Timber Pile Bulkhead

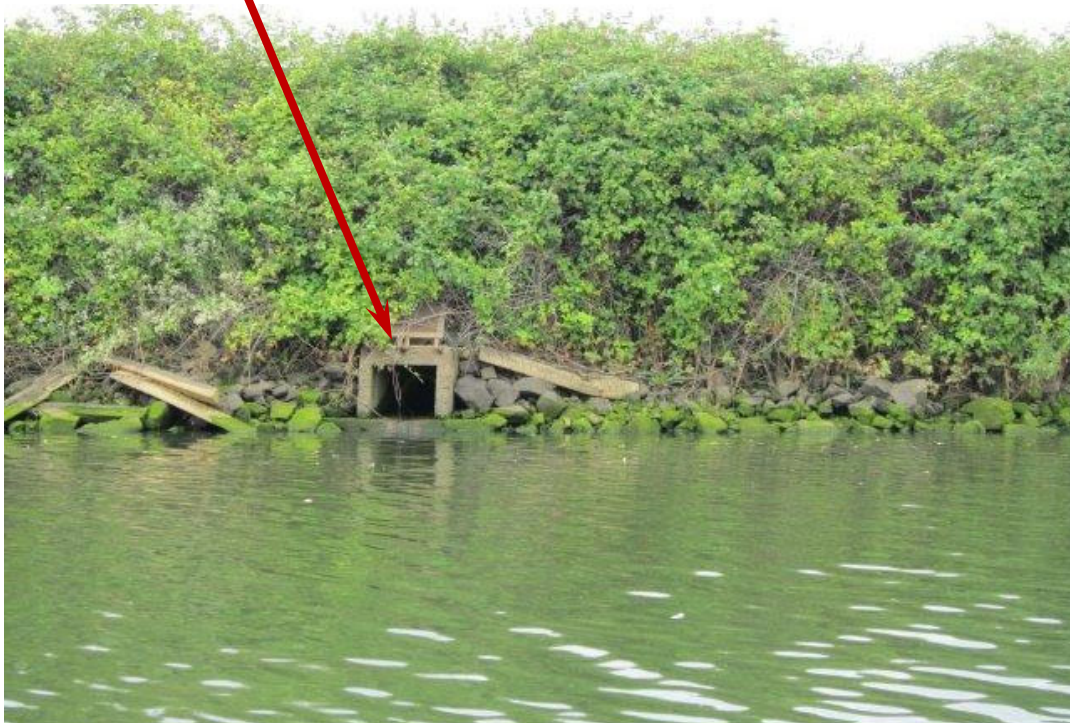
2073-01: Outfall Box at High Tide

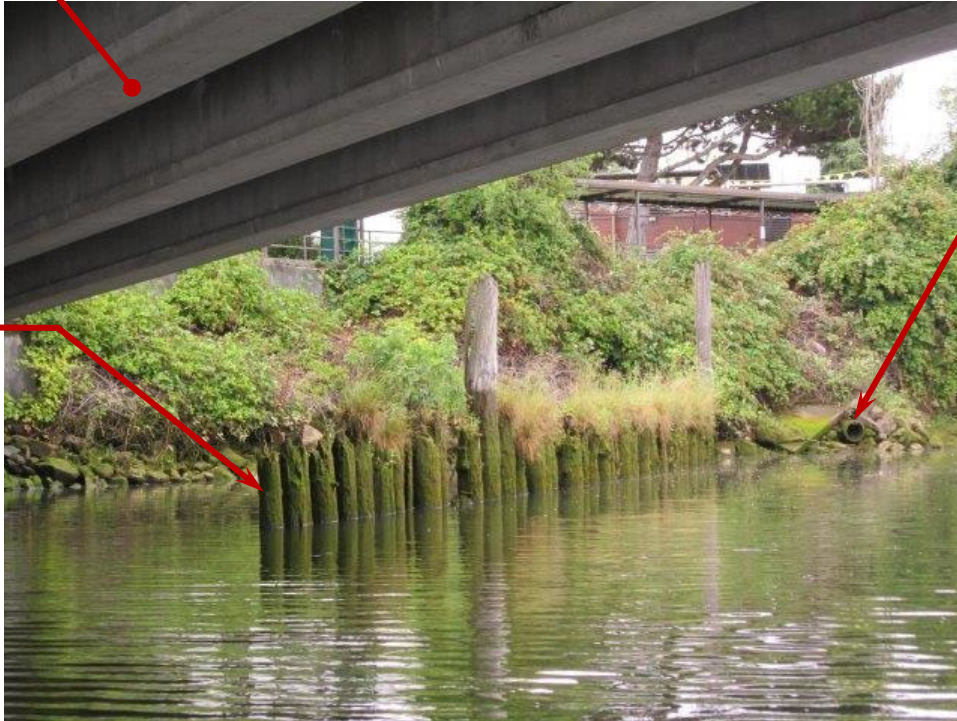
Photo 2092-01: Outfall (Looking East)

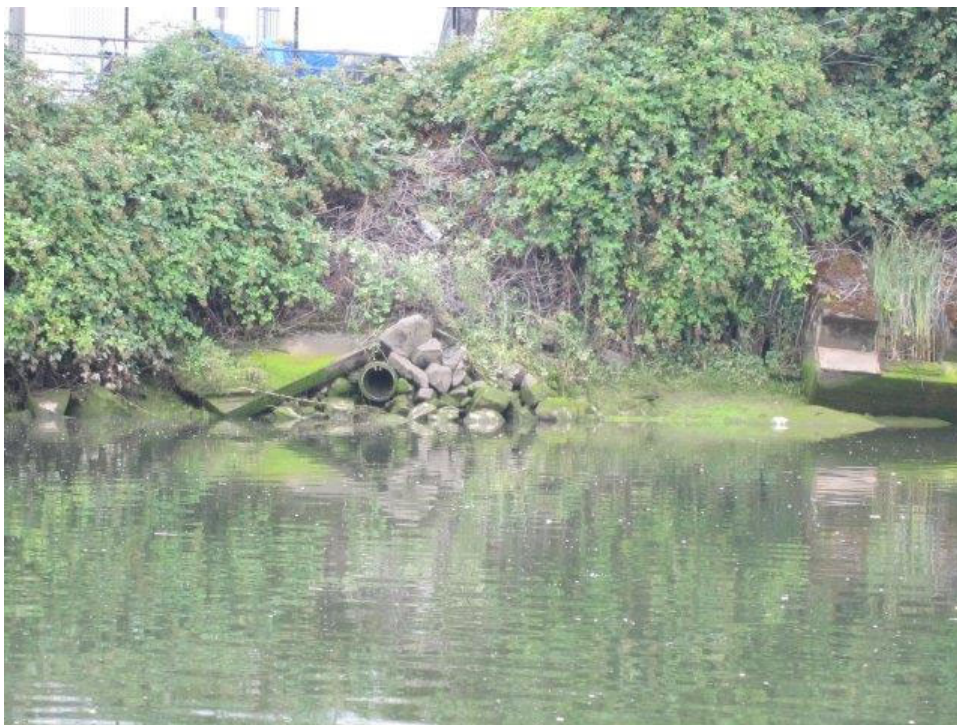
Photo 2092-02: Outfall (Looking East)
