Appendix F

Structures Inspection Forms

Sediment Cleanup of Upper Reach of Lower Duwamish Waterway, Phase I/II

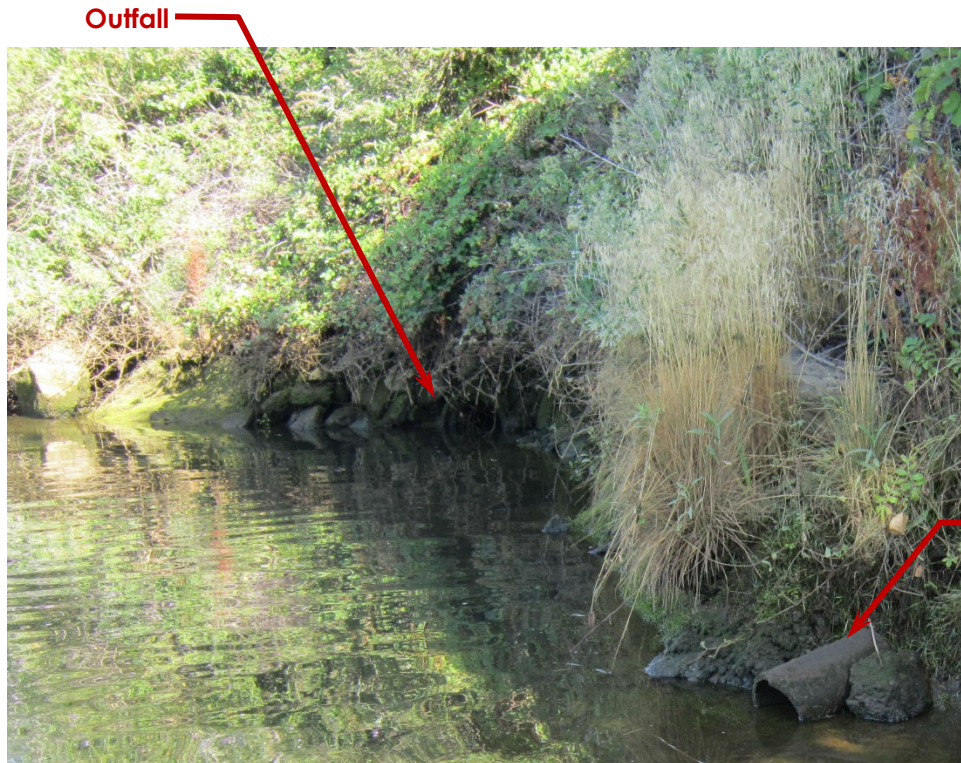
Photo 2093-02: Outfall (Looking Northeast)

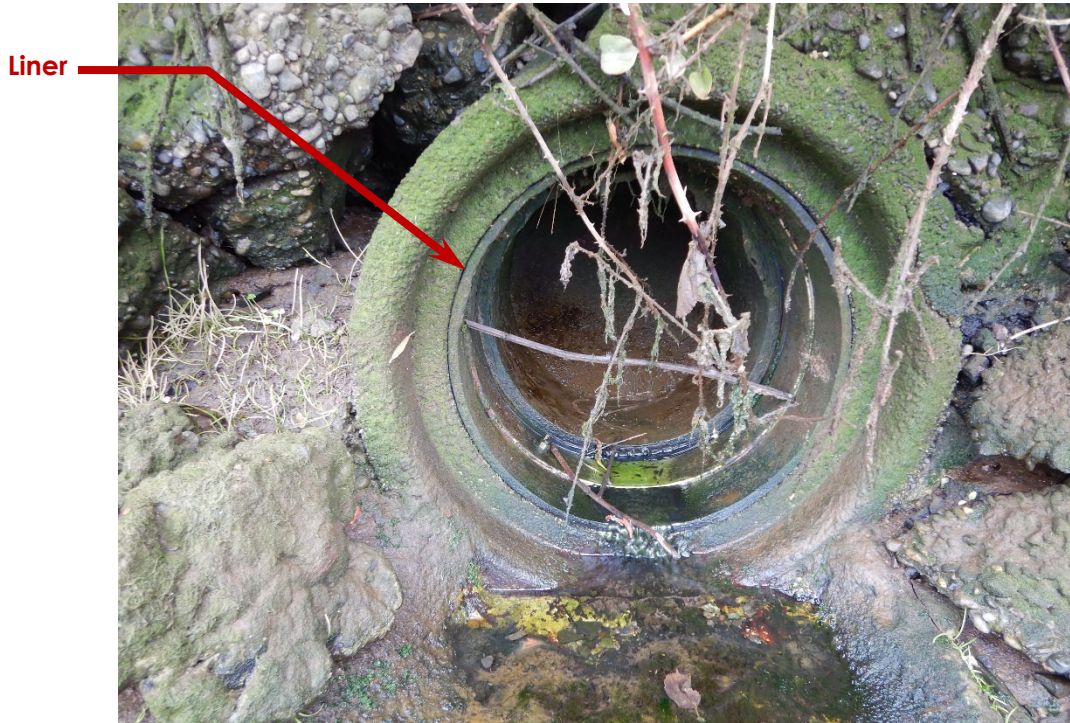
Photo 2093-03: Outfall Close Up

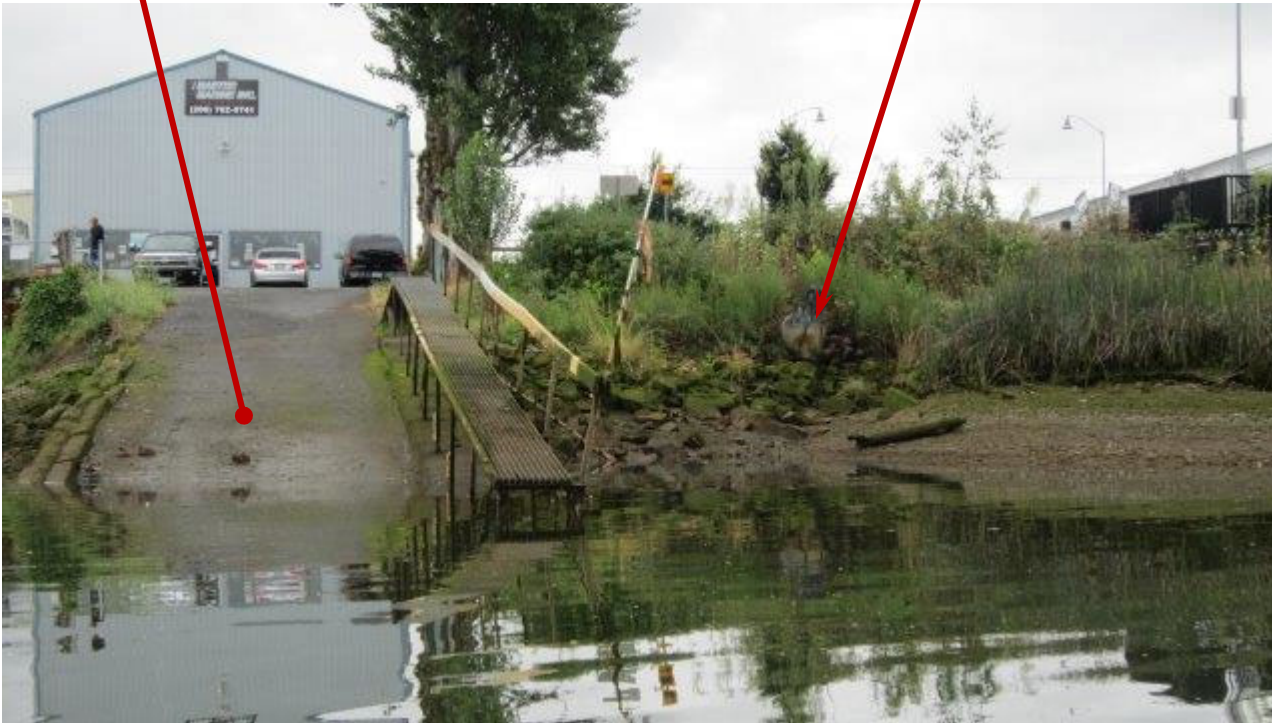
- Outfall with duckbill valve near the shoreline supported on a mound of quarry spalls (Photos 1 to 4).
- Approximately 24" diameter concrete pipe supported by quarry spalls and apron.

Photo 2215-01: Outfall (Looking West)

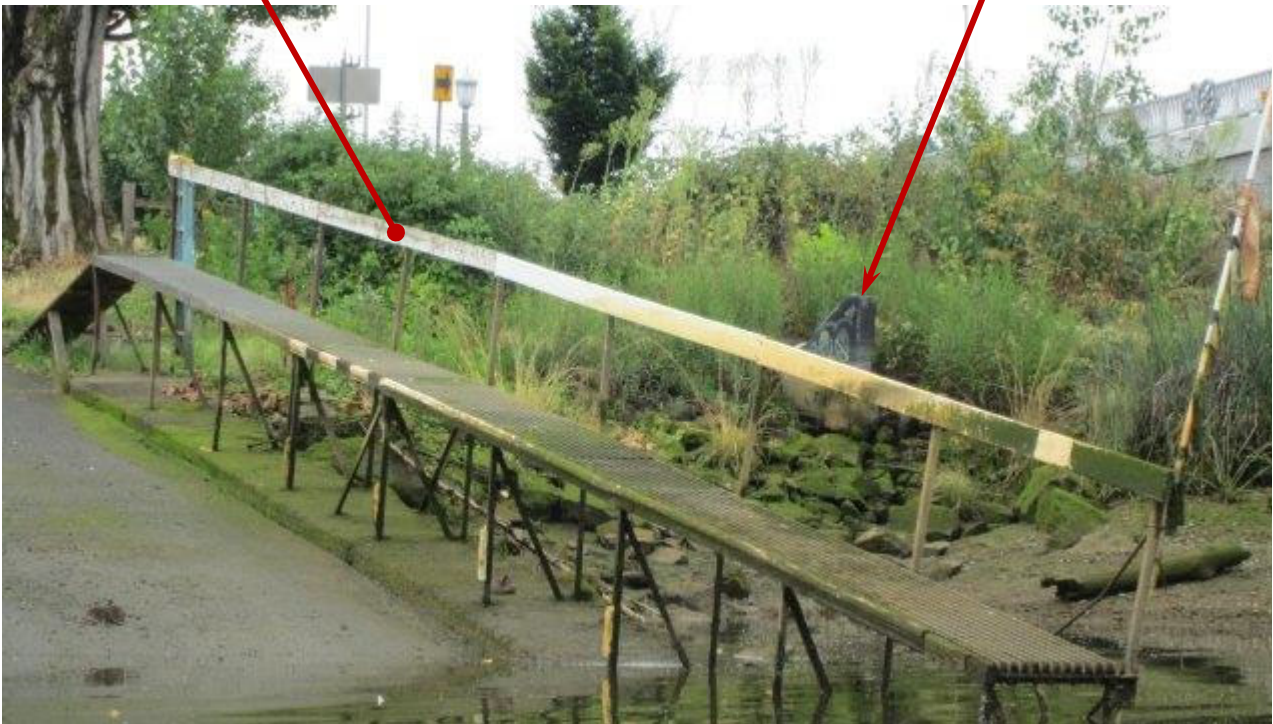
Photo 2215-02: Outfall (Looking Northwest)

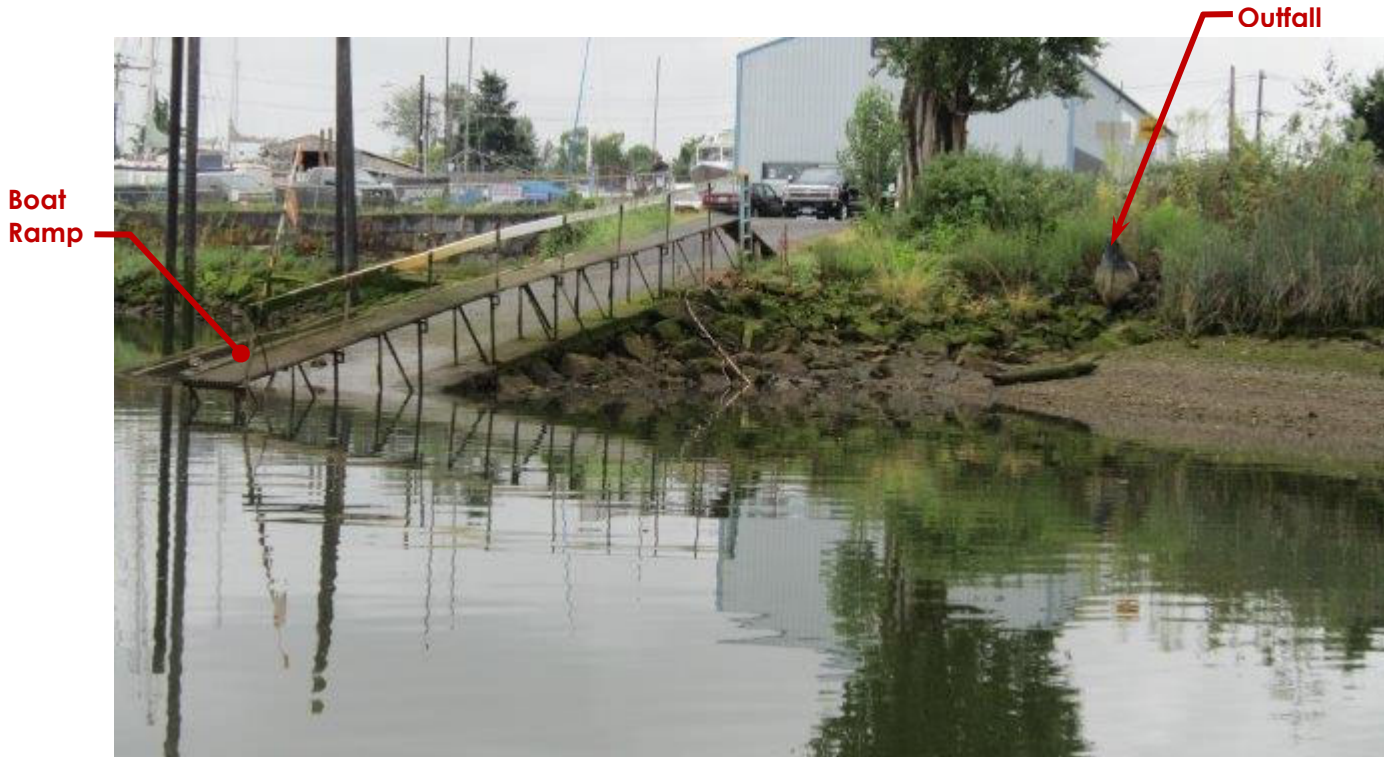
Photo 2215-03: Outfall (Looking Southwest)

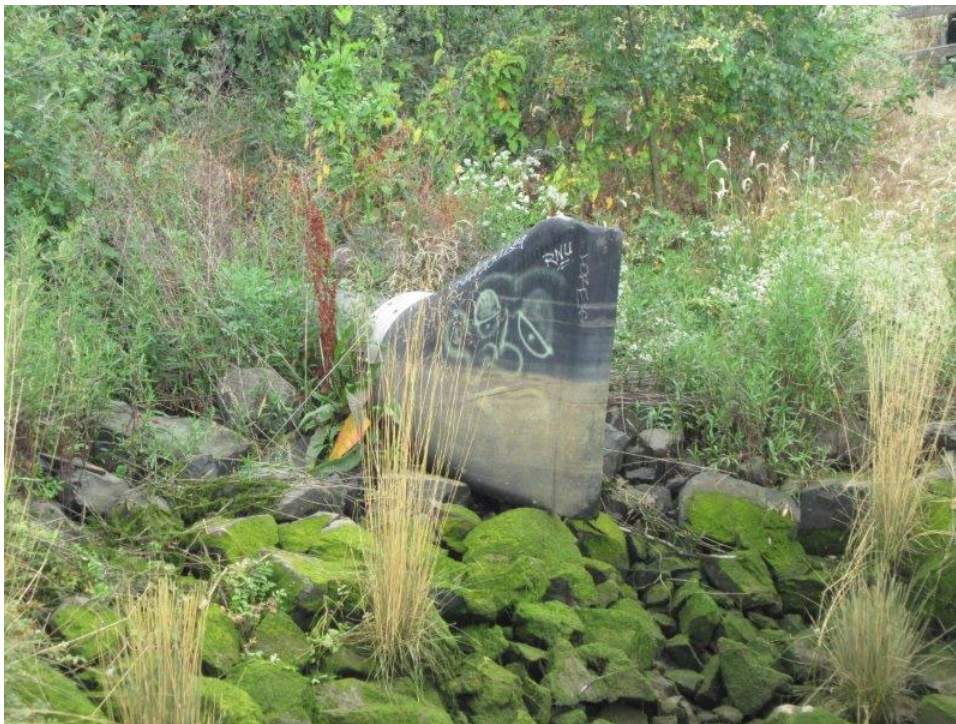
Photo 2215-03: Outfall Close Up

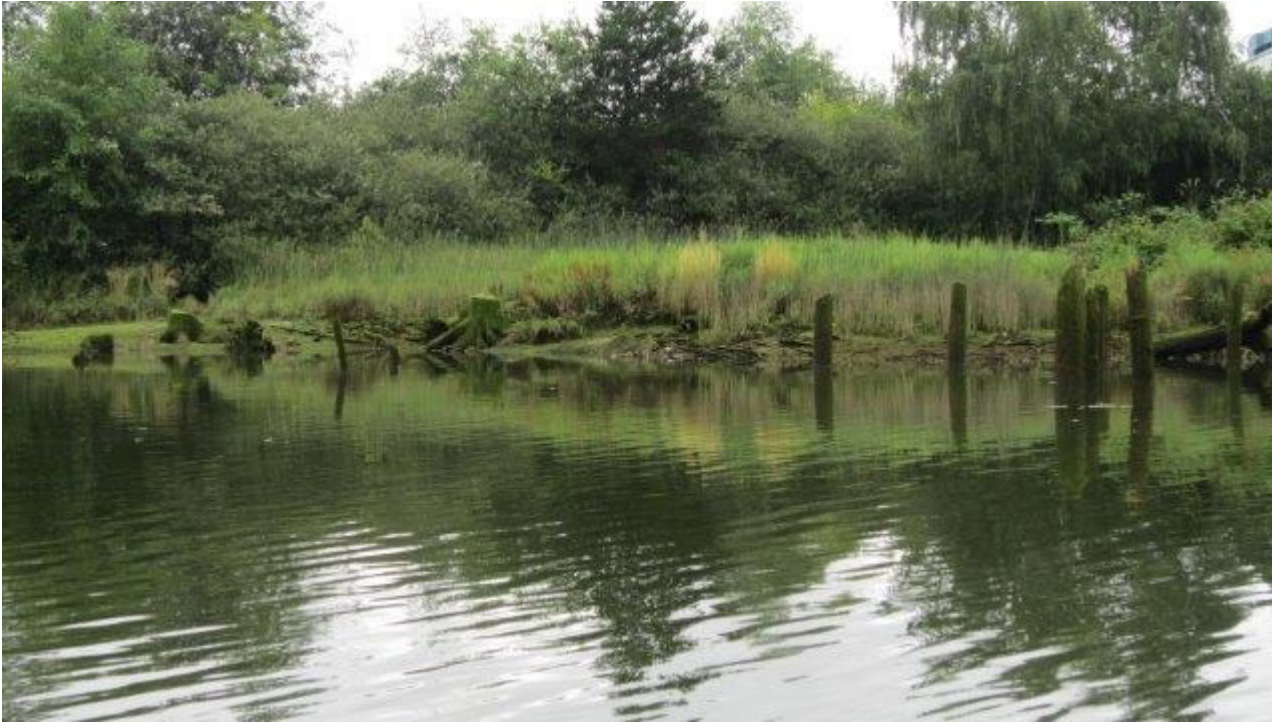
- Several scattered timber piles north of the S 98th St Bridge near the shoreline. They appear to have been cut down and are in poor condition (Photos 1 and 2).

Photo ST11-01: South Pile Field

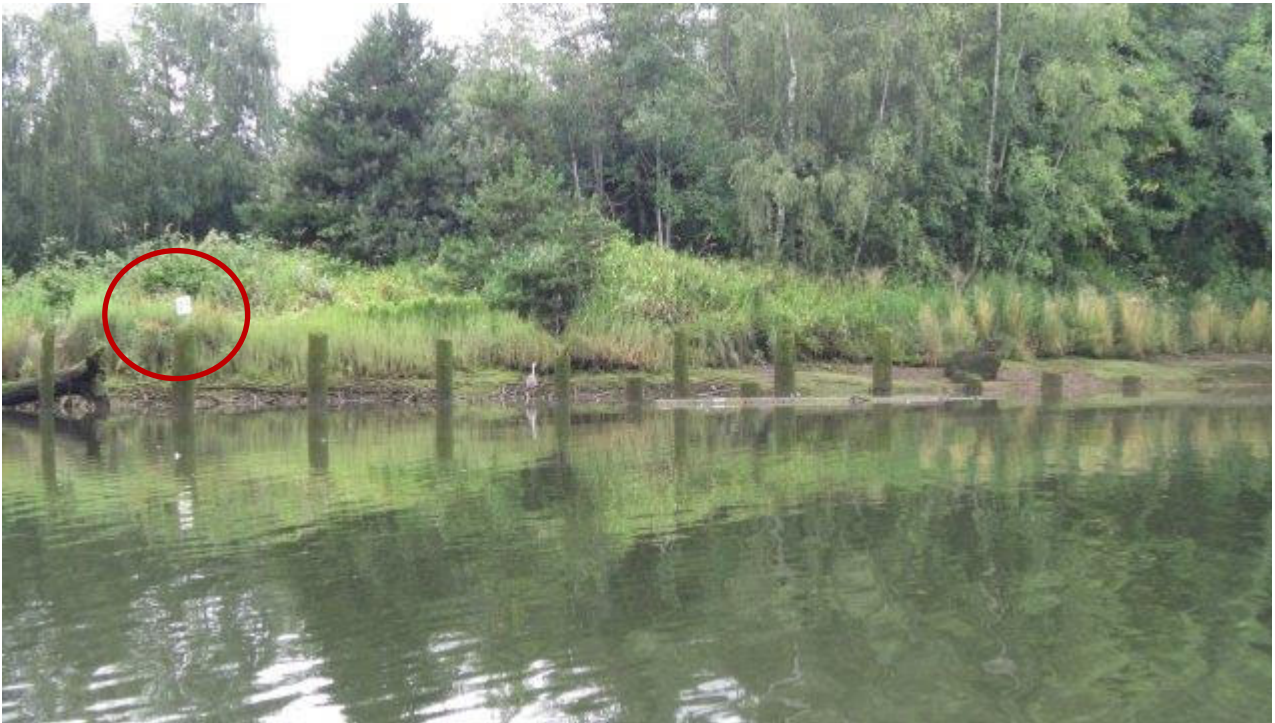
Photo ST11-02: North Pile Field

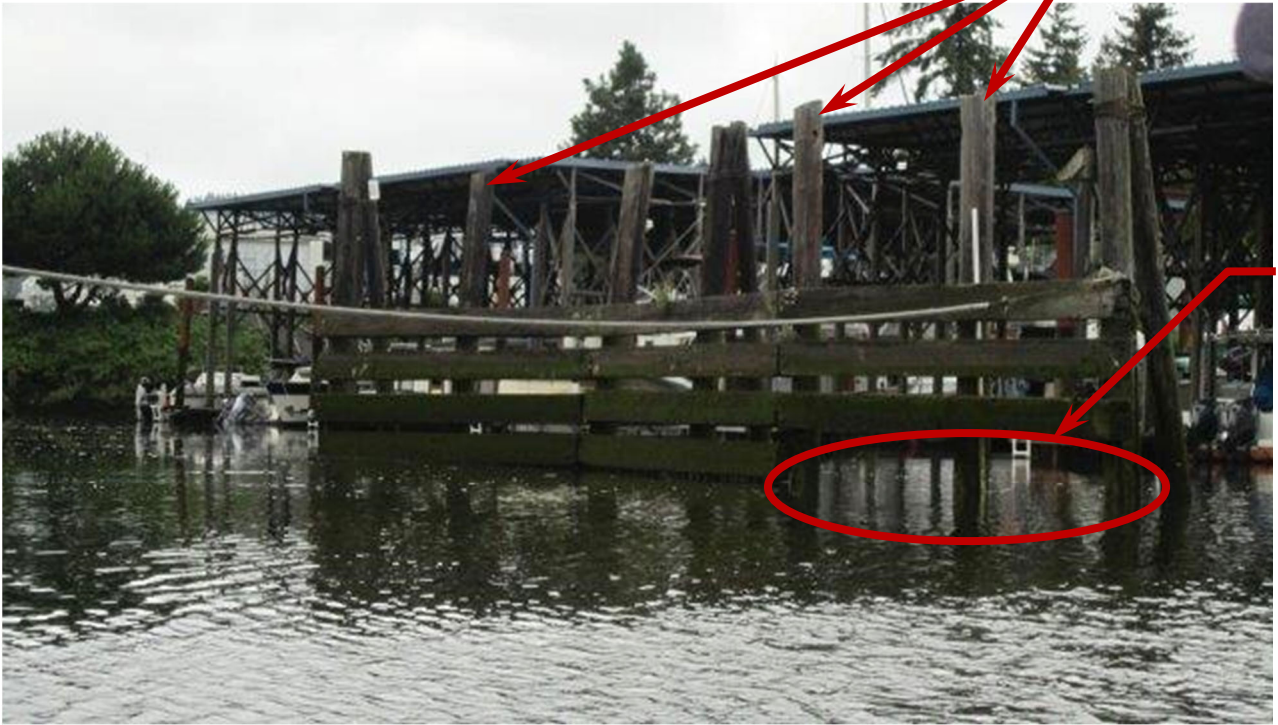
Photo ST13-01: Breakwater (Looking Northwest)

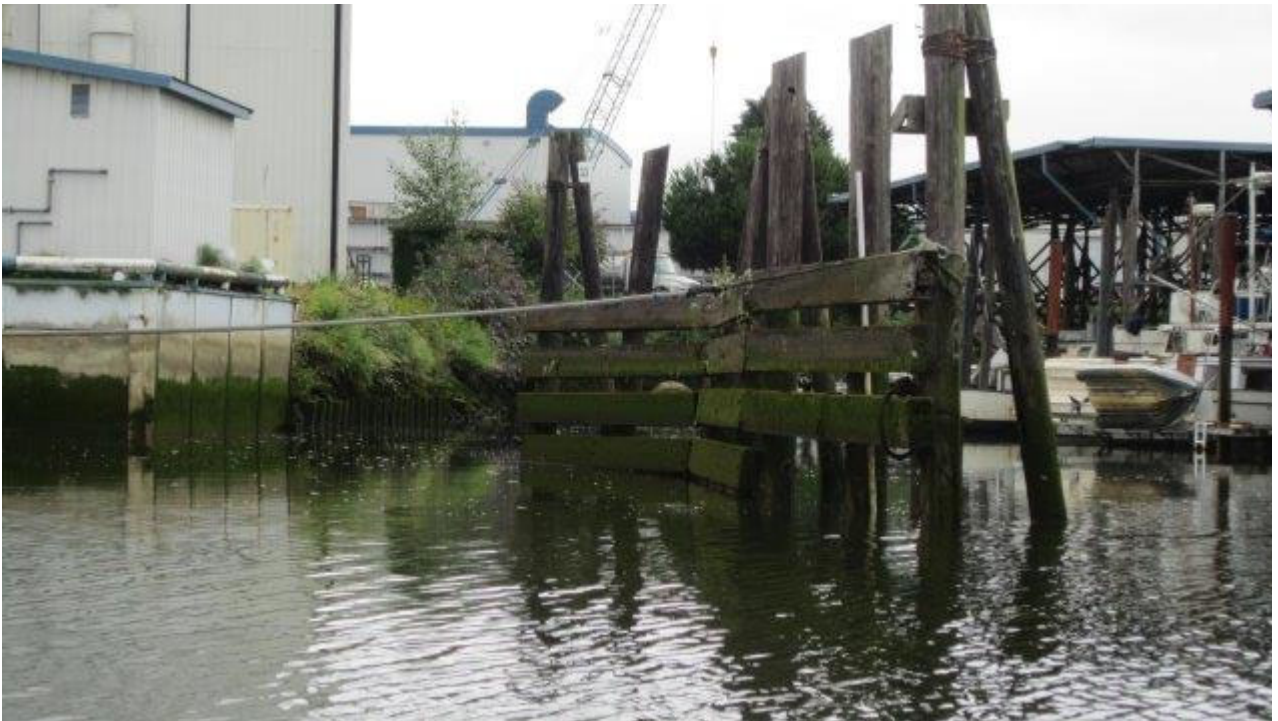
Photo ST13-02: Breakwater (Looking West)

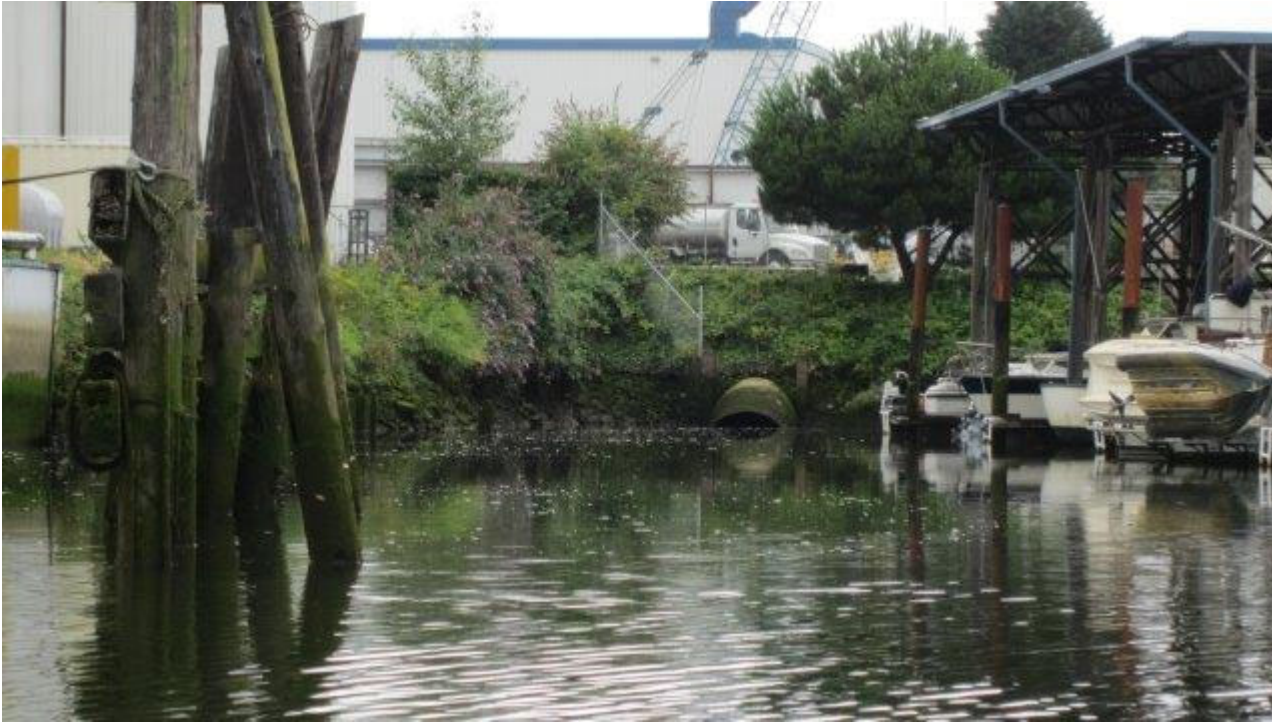
Photo ST13-03: View of Battered Piles (Looking West)

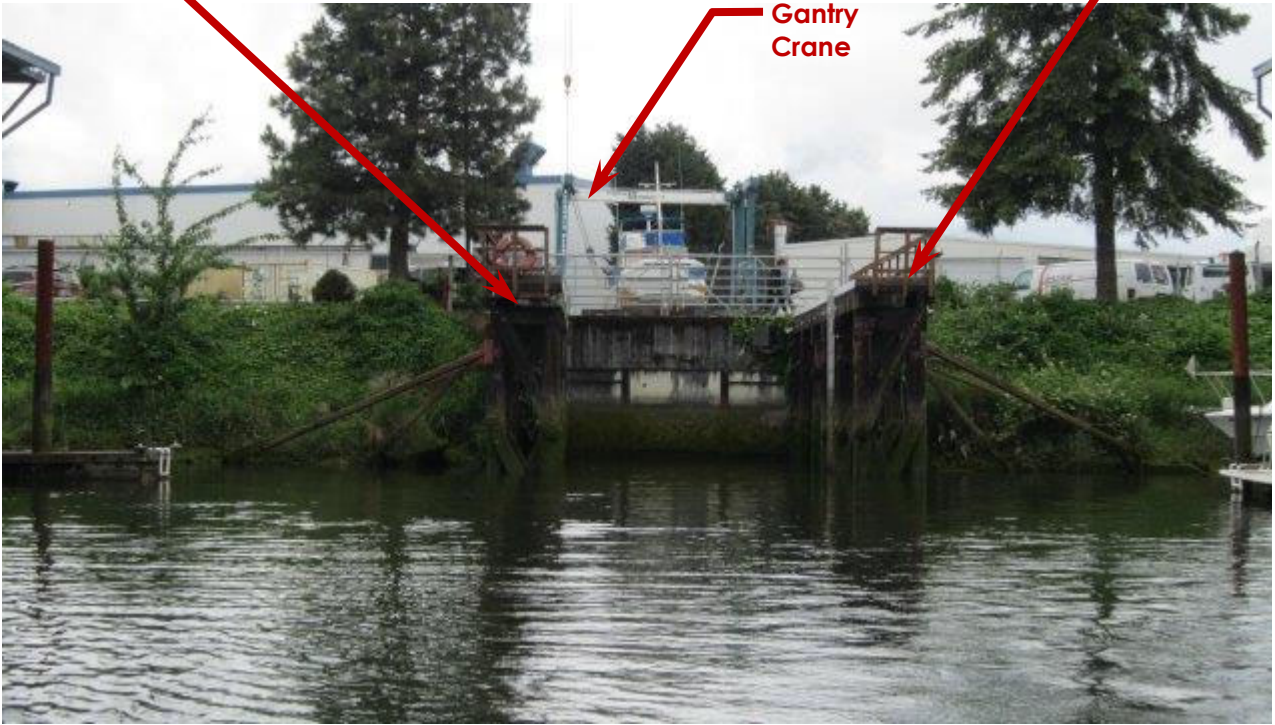
- Traveling gantry crane (east to west).
- Two (2) crane runways (north and south ends) each supported on offshore piers.
- Each pier consists of six (6) bents of braced (north to south) heavy timber piles and framing. No bracing in the east-west direction was observed.
- Steel soldier pile and concrete panel lagging bulkhead.
- The piles and framing appear to be in good condition, except for moss growth within the tidal zone.
- Preservative treatment on the timber piles and framing is worn, but appears to be in good condition.
- It appears that several steel bracings were added to the braced bents to provide additional lateral stability.
- The condition of the concrete bulkhead could not be closely observed. Appears to be in good condition except for corrosion on the steel piles and moss growth in the tidal zone.

Photo ST14-01: Boat Lift (Looking West)

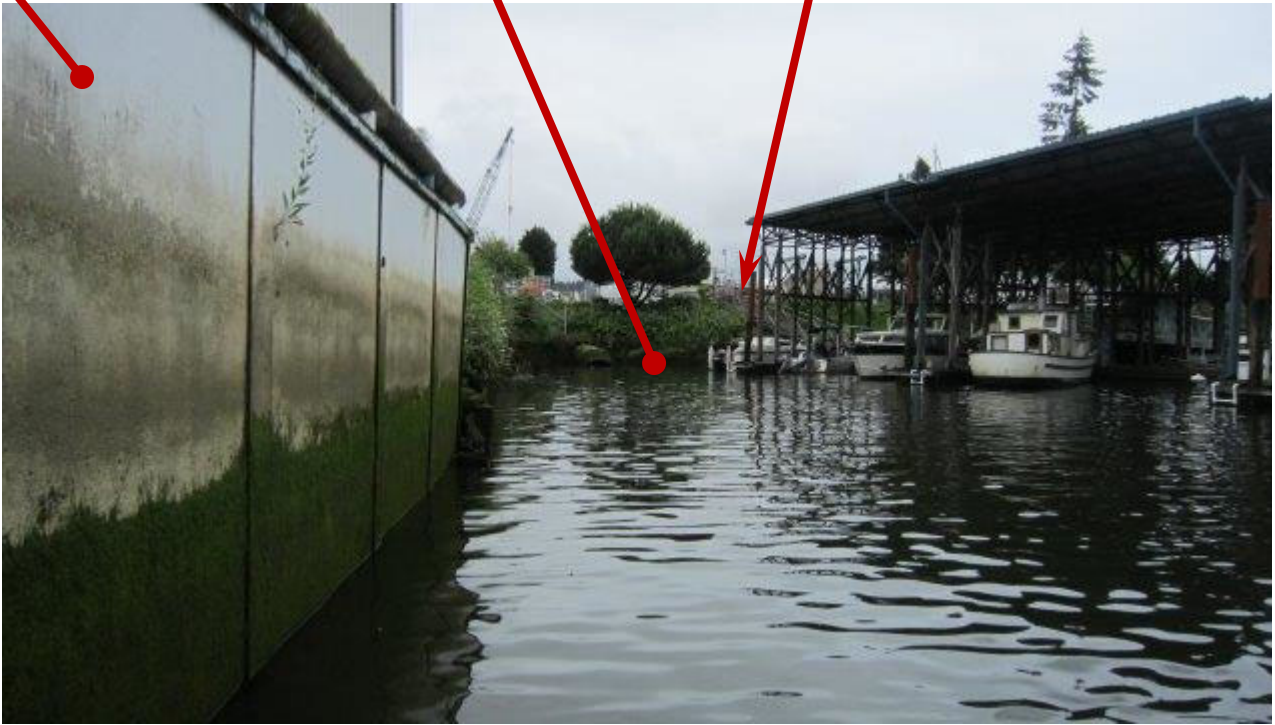
- Concrete bulkhead along the west bank (Photo 1). The bulkhead was not accessible, therefore not observed.
- Four (4) gangways leading to the floats (Photos 1 and 2). The gangway was not accessed, therefore not observed.
- Four (4) parallel covered docks each with connection primary floating walkways.
- Timber float guide piles.

Photo ST15-01: South-most Float (Looking West)

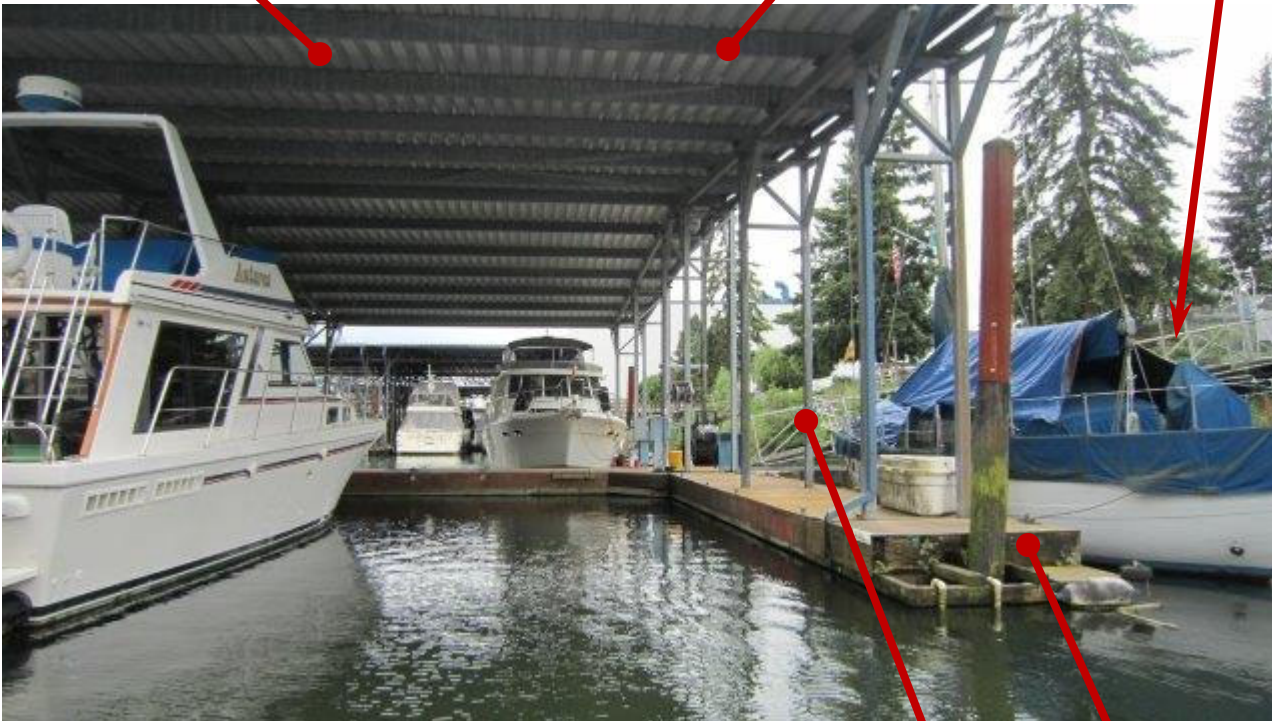
- The guide piles are timber piles with a steel sleeve filled to the upper section (Photos 2 to 4, 6 and 7).
- The guide piles are covered in moss around the tidal zone but appear to be in good condition (Photos 2 to 7).
- The preservative treatment on the piles are worn but appear to be in good condition (Photos 2 to 7).

Photo ST15-02: Floats (Looking South)

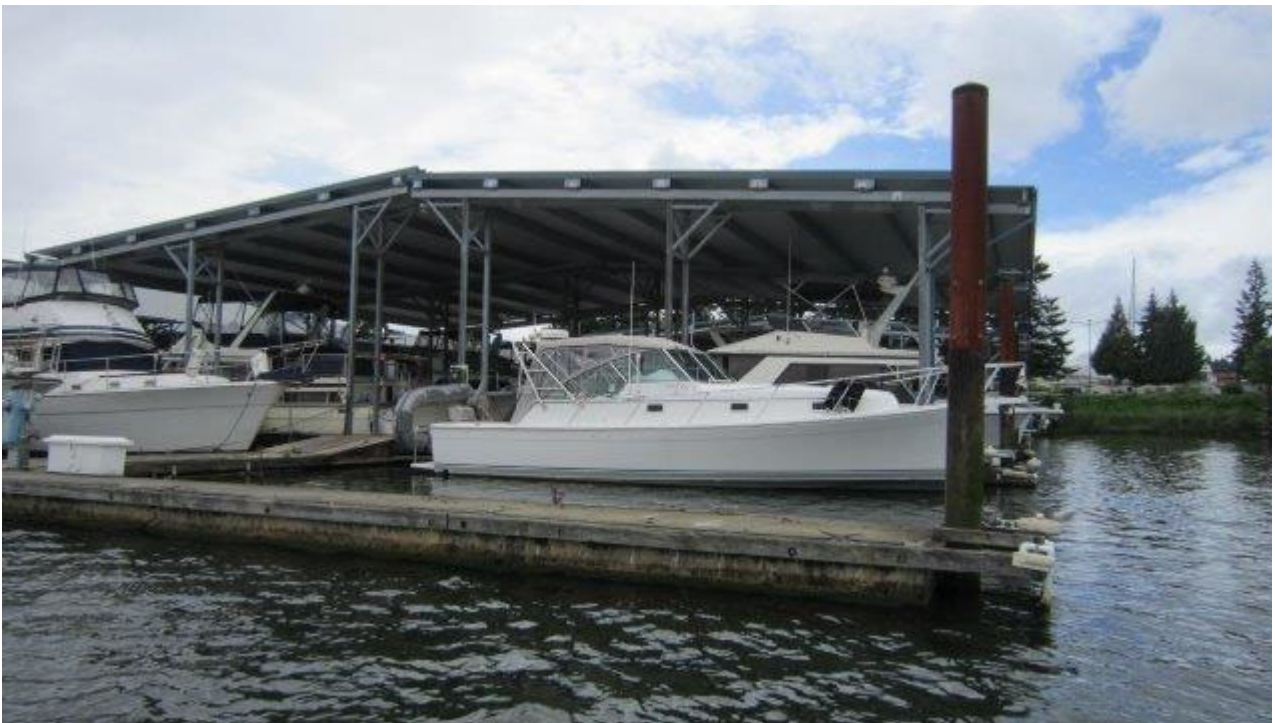
Photo ST15-06: Outboard Float (Looking West)

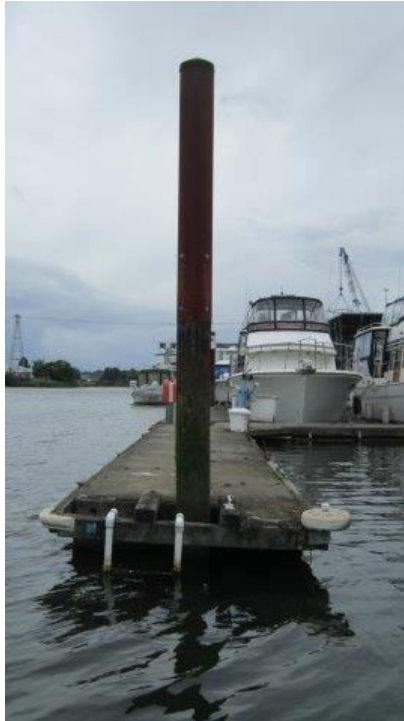
Photo ST15-07: Outboard Float (Looking South)

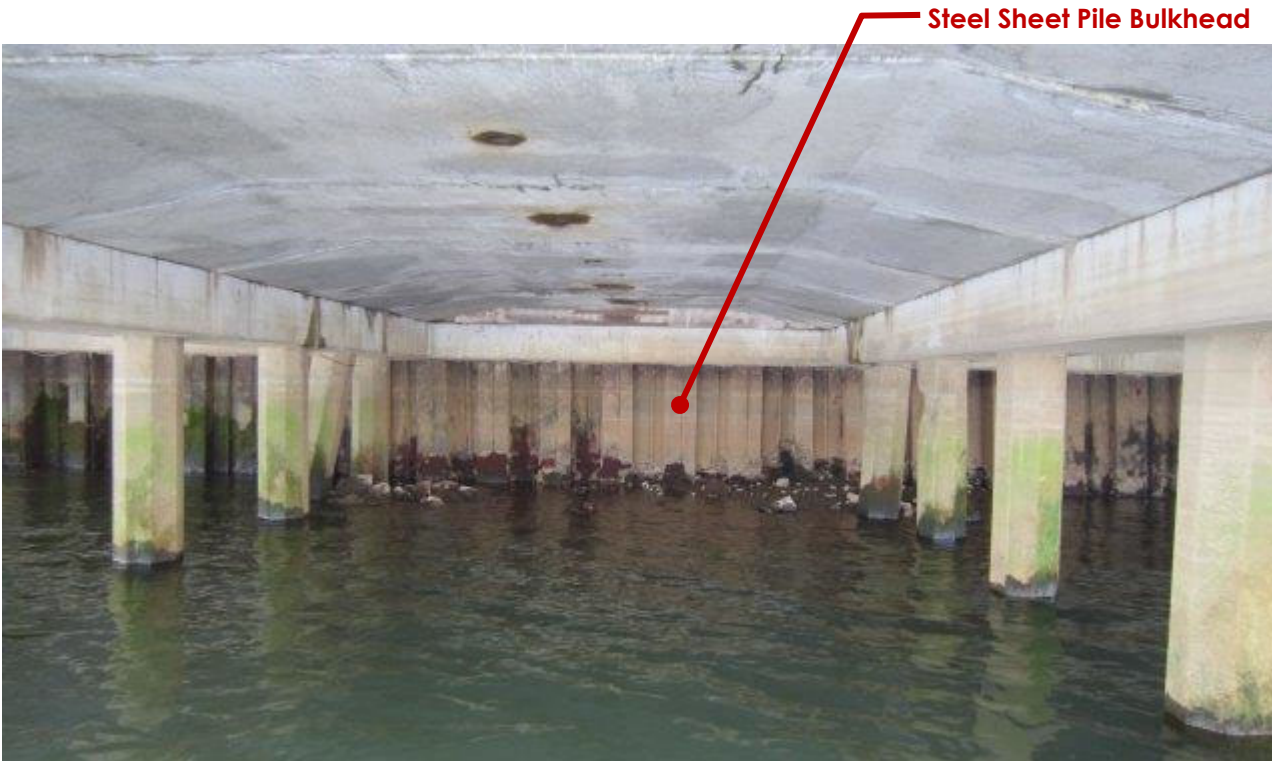
- Spall at the east face of both Pier 3 and Pier 4 decks. No exposed reinforcing or rust stains were observed (Photos 12 and 13).
- The concrete surface of the pier deck soffits appear to be in good condition (Photos 14 and 16).

- A close observation of the steel sheet pile and concrete cap was not possible. There appears to be moss growth and rust in the wet/dry zone of the sheet pile (Photos 7, 10, 12, 14, and 15).

Photo ST16-014: Bulkhead and Pier Deck Soffit (Looking West)

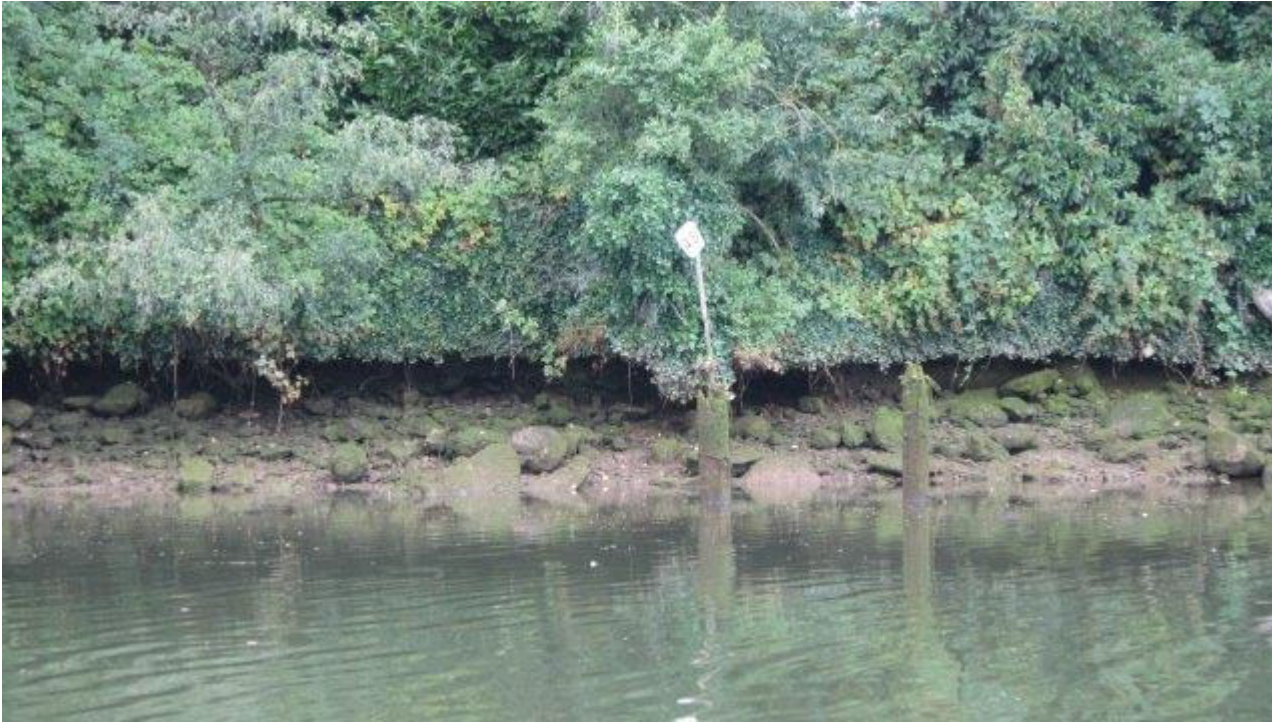
Photo ST18-01: Piles

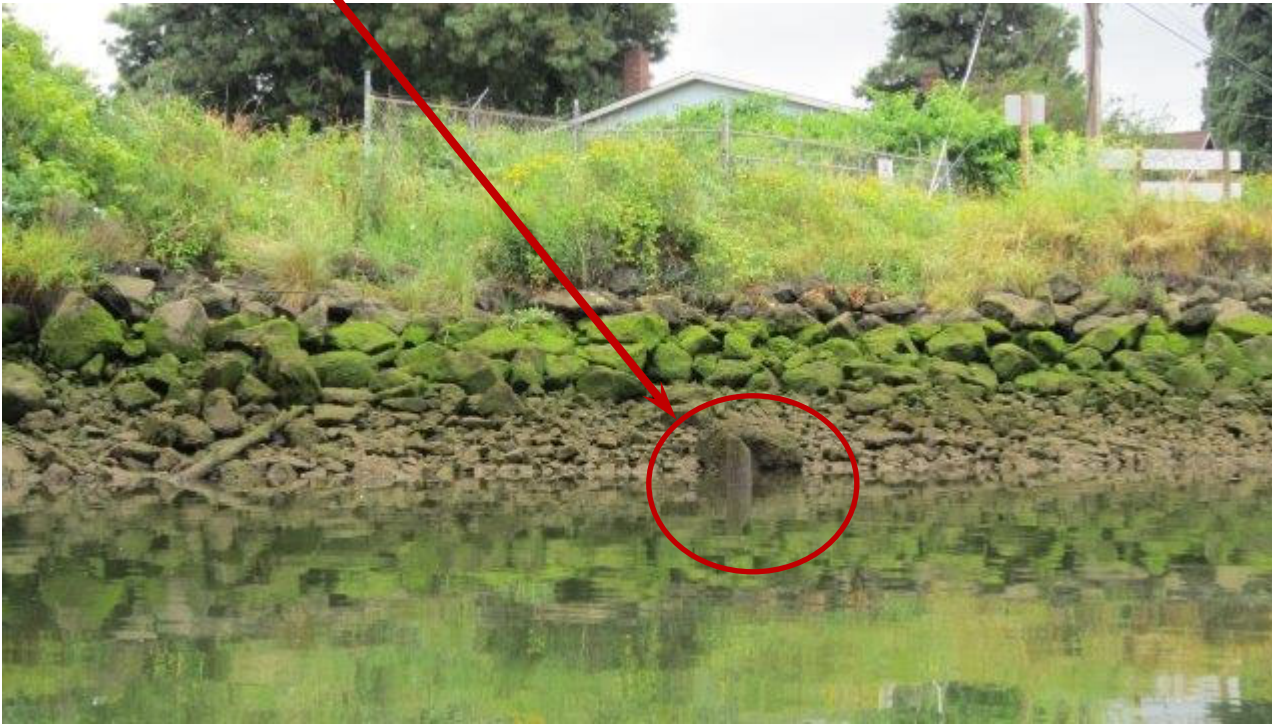
Photo ST21-01: Southmost Pile Field

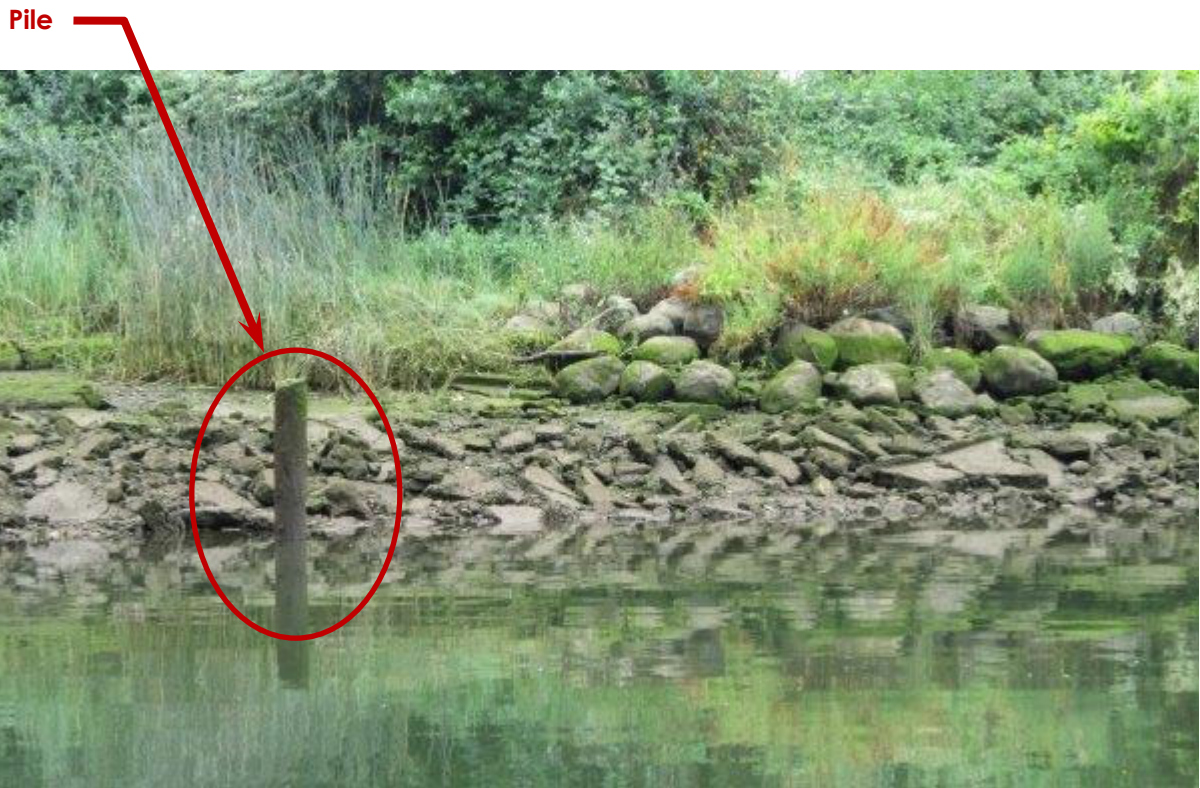
Photo ST21-02: Central Pile

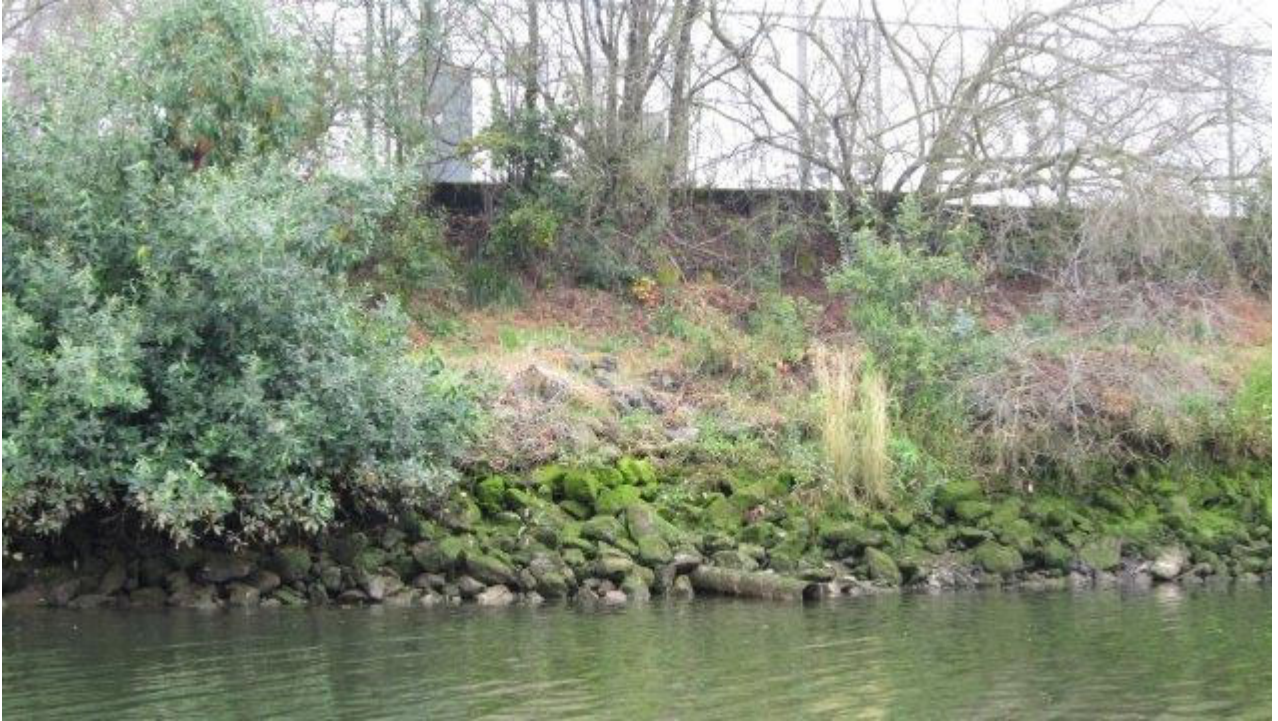
Photo 2098-01: Outfall (Looking West)

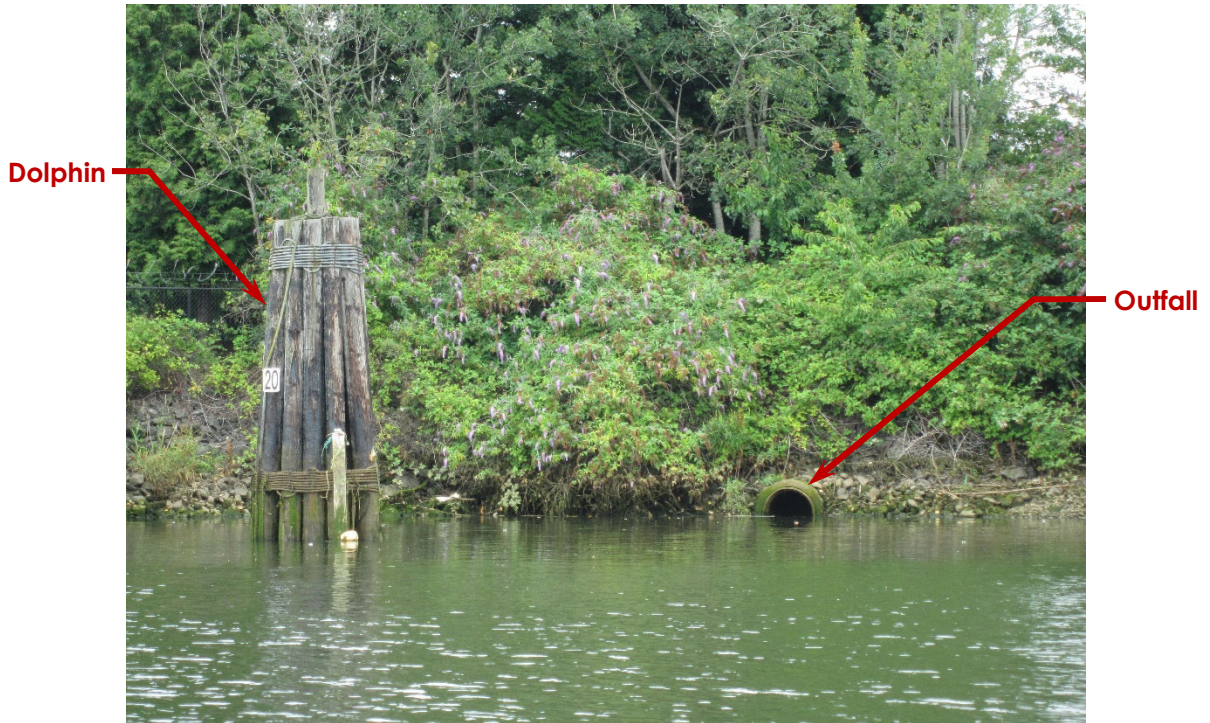
Photo BDC-1-01: Outfall South of Dolphin (Looking East)

- Outfall is encased with concrete and projects slightly beyond the shoreline. It is surrounded with riprap (Photos 1 and 2).
- Pipe size, material, and support condition were not observed.
