Appendix C-1
Phase I Bank Visual Inspection
Observations and Photographs

This appendix provides detailed results of Lower Duwamish Waterway (LDW) middle reach Phase II Pre-Design Investigation (PDI) bank inspections that were conducted to satisfy data quality objectives (DQOs) 11 and 14. The Phase II inspections focused on areas with remedial action level (RAL) exceedances based on the Phase I dataset, and included a field visit at low tide to document bank conditions and measure the thickness of sediment over armoring (where applicable), and a desktop analysis of oblique and ortho-aerial photographs.

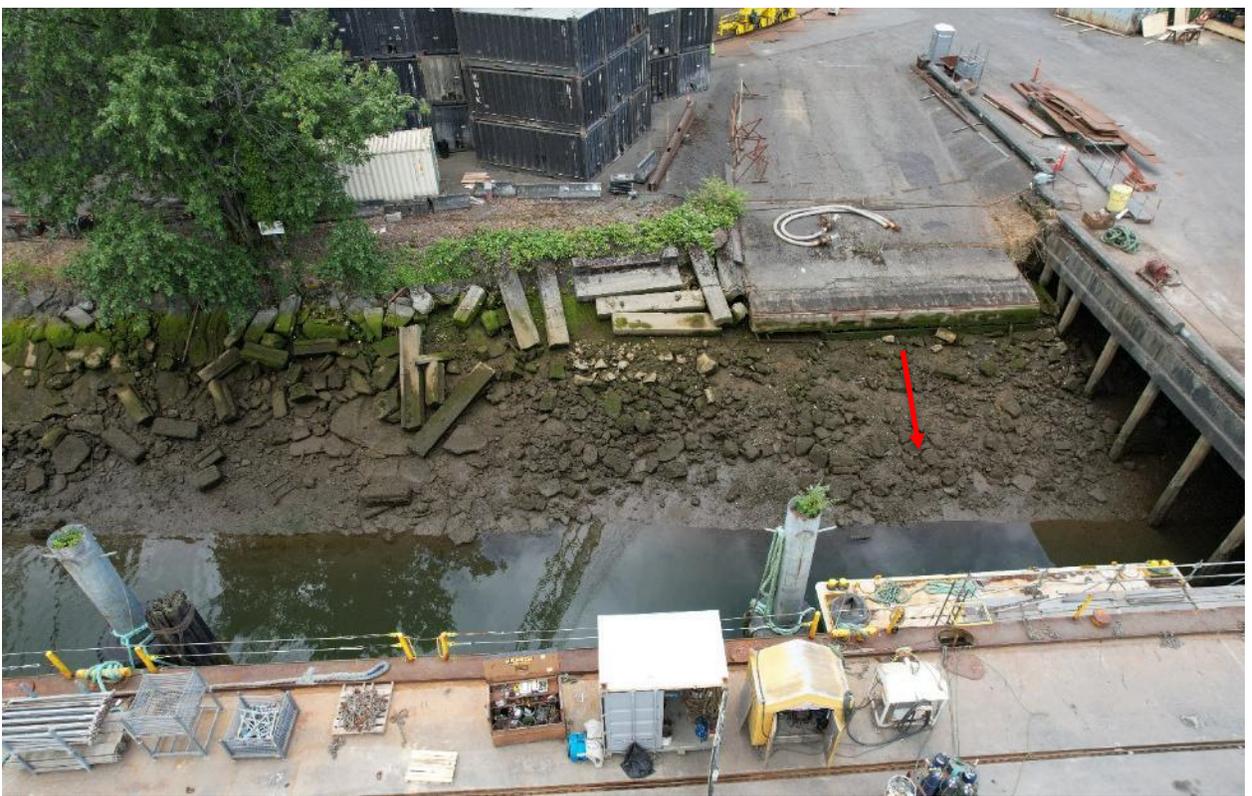
Figure C-2-8
Ortho-aerial and Oblique Photographs for RAL Exceedance Area 21 Displayed from Upriver (Left) to Downriver (Right)

Visual observation through desktop analysis of the shoreline noted armoring along the upgradient portions of the area. Armoring ranged from scattered riprap and concrete to an engineered riprap shoreline. Debris throughout the RAL Exceedance Area include scattered concrete (broken pieces, slabs, and columns) and occasional metal and wood pieces. The southern end of the RAL Exceedance Area contains a double tiered timber bulkhead starting just below the vegetation line. Other structures within the RAL Exceedance Area include an outfall (2508) and pier on the north end of the area

Sediment thickness probing was conducted along four transects on the bank of RAL Exceedance Area 21. Visual observation of surface debris and armoring throughout the area generally included sporadic rock and concrete debris in the upgradient portions, with no sediment covering the armoring. Downgradient of the armoring and concrete debris surface material predominantly consisted of a soft sandy silt. The transect began near the lowest elevation of visually observed armoring, no refusal was encountered. Additional details for all transects within this area can be found in the shoreline conditions form (Attachment C-2-1). Figure C-2-8 displays the drone obliques for RAL Exceedance Area 21 and the red arrows depict the approximate location and direction of the sediment thickness probing transects.

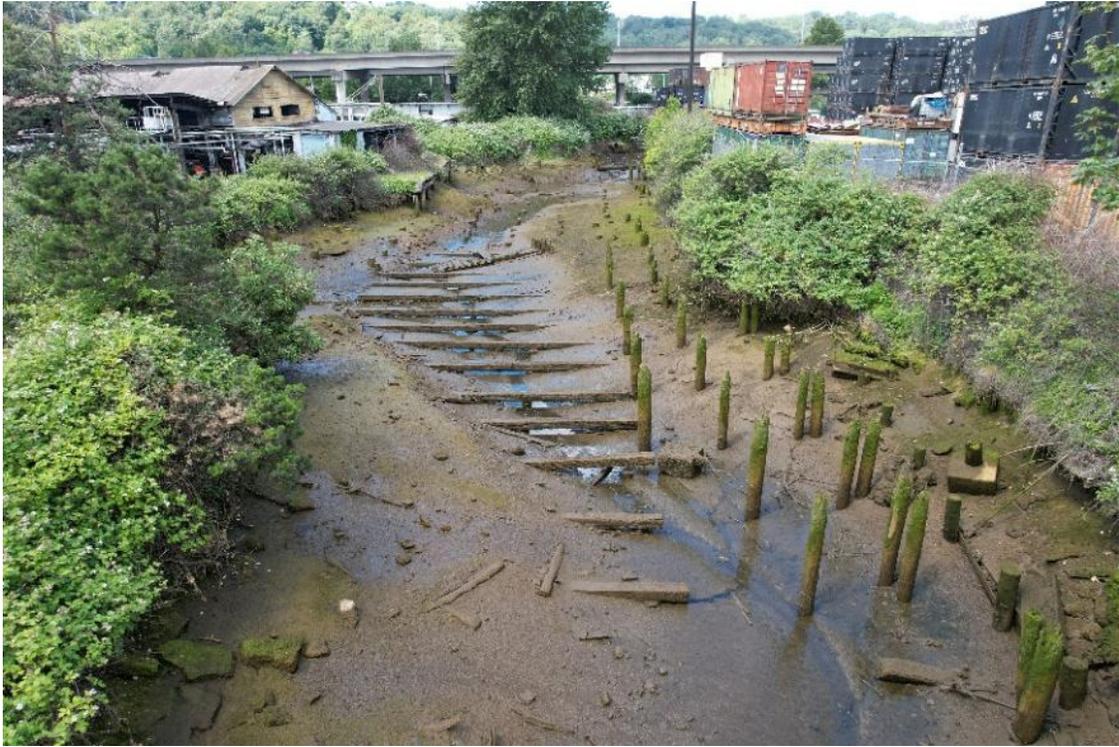
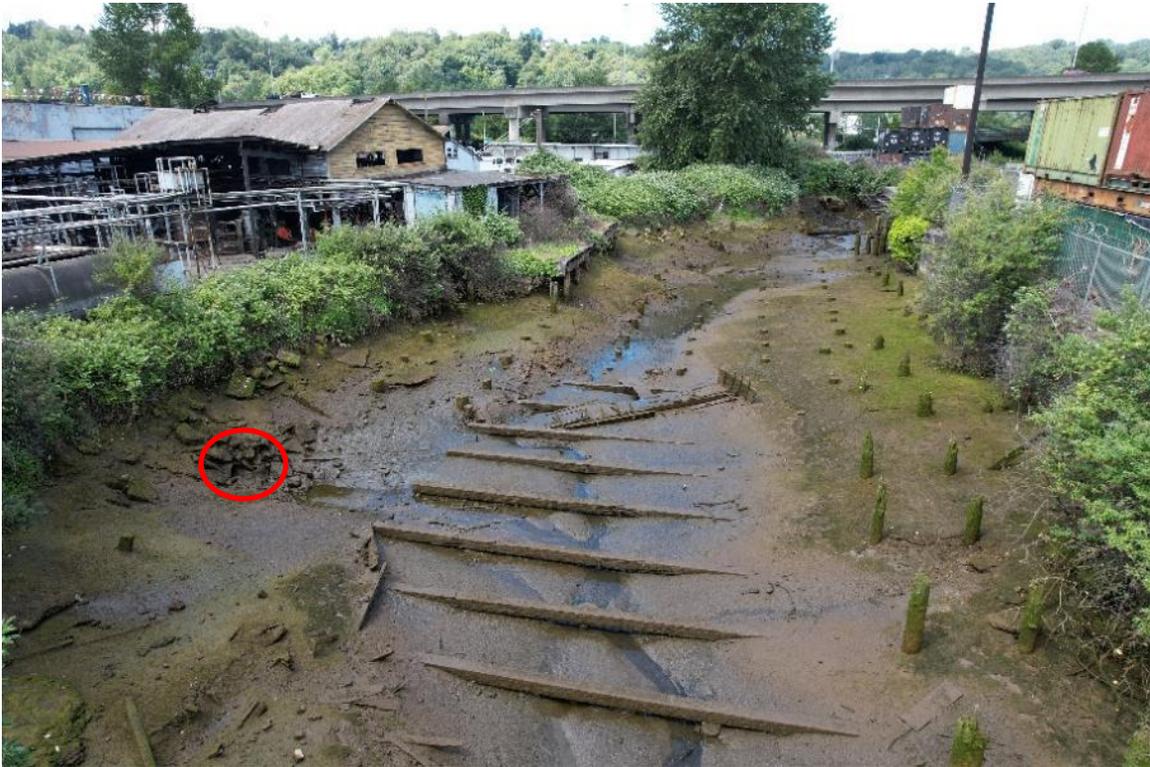
Figure C-2-9
Oblique Photographs for RAL Exceedance Area 20

Visual observation through desktop analysis of the shoreline noted armoring along the upgradient portions of the area. Armoring generally included riprap and large slabs on concrete. Abundant debris throughout the area include broke timber pilings, ecology blocks, scattered wood, and timber cross beams along the inlet bottom. Additionally, there are an abundance of timber pilings cut at the mudline. Structures along the north bank include an ecology block wall and a timber pier. The RAL exceedance area contains two outfalls (2120 and 2118), circled in Figure C-2-9. Structures along the south bank include a timber pier and ecology block wall.

In accordance with QAPP Addendum No. 2 sediment thickness probing did not take place in RAL Exceedance Area 20.

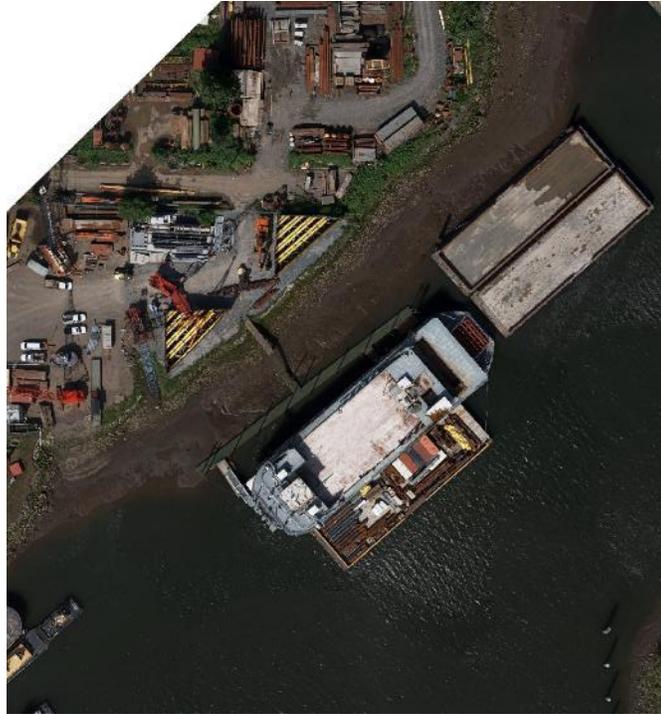
Figure C-2-11
Ortho-aerial and Oblique Photographs for RAL Exceedance 16 Displayed from Upriver (Left) to Downriver (Right)

This area was inaccessible during sediment thickness probing due to barges moored at the facility.

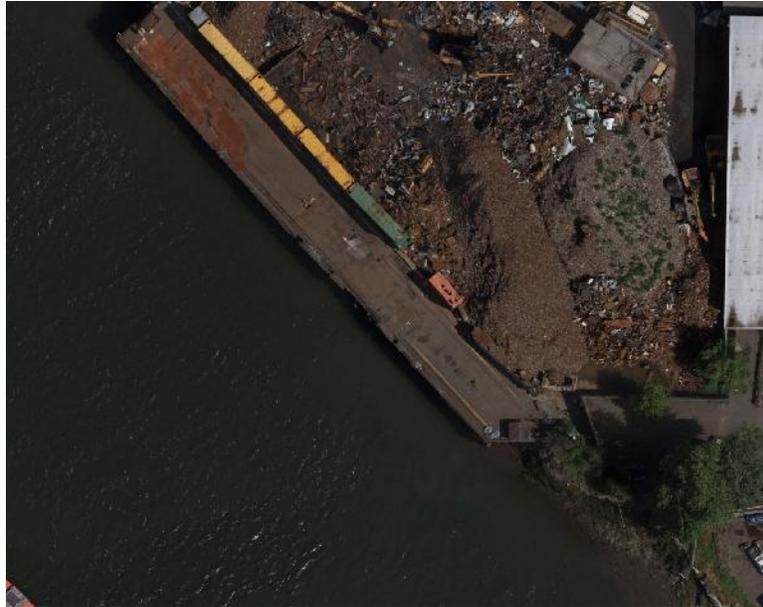
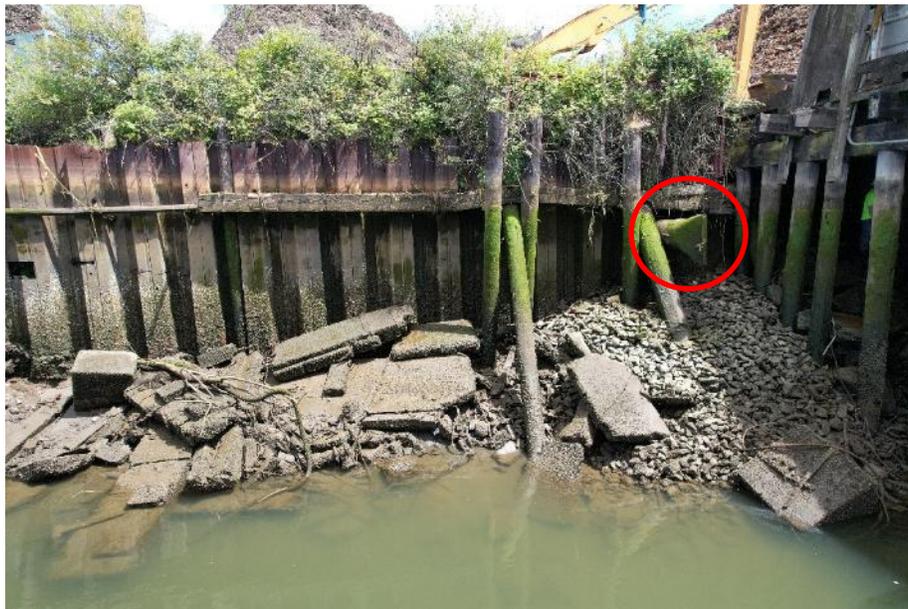
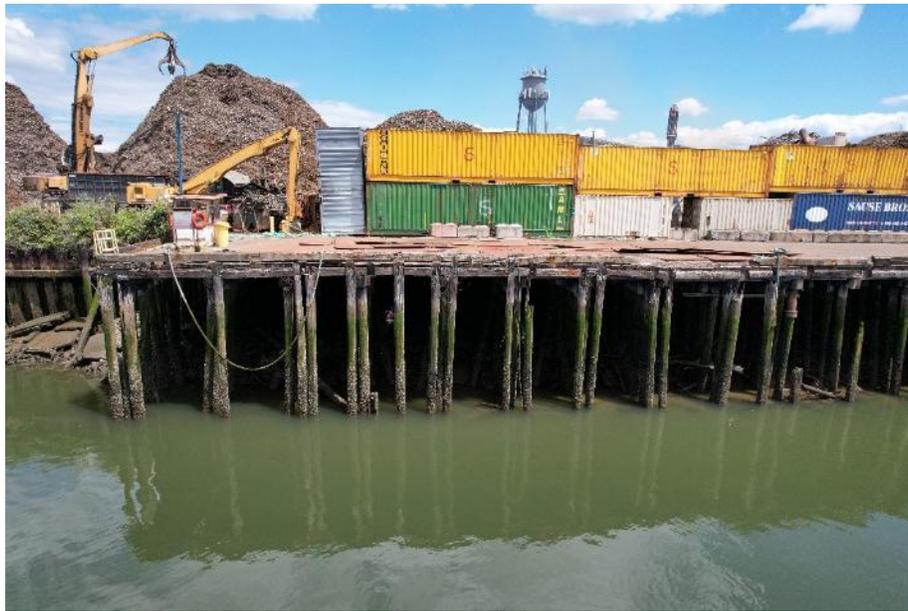
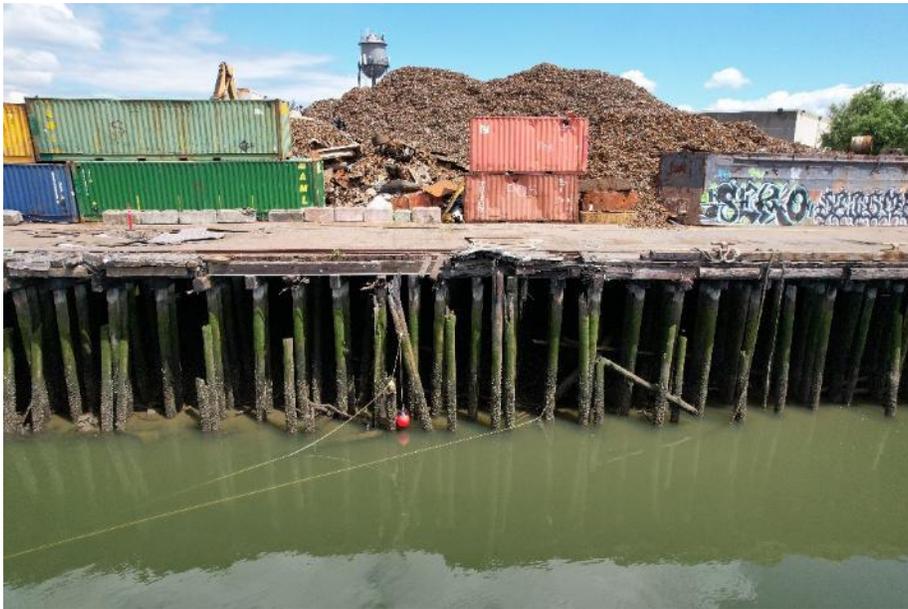
Figure C-2-15
Ortho-aerial and Oblique Photographs for RAL Exceedance 11 Displayed from Downriver (Left) to Upriver (Right)

No sediment thickness probing took place in this area due to health and safety concerns related to accessing the shoreline near the dock structure. Observations took place from a vessel.

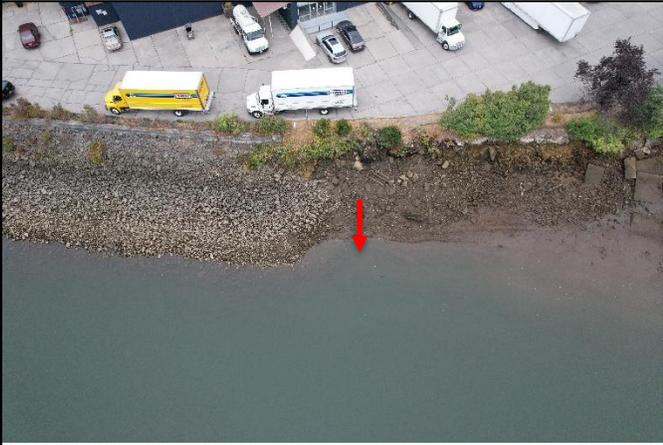
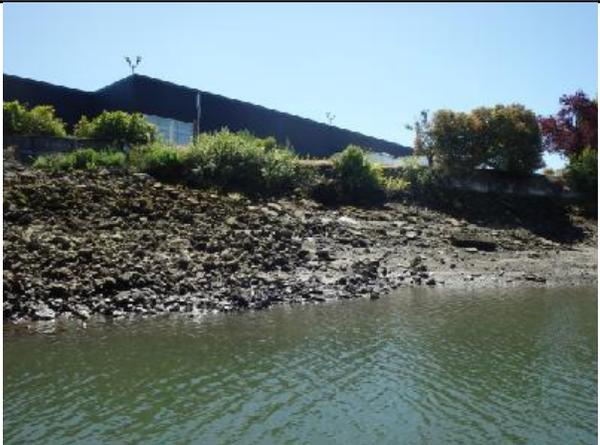
Project	Lower Duwamish Waterway Middle Reach PDI Phase II		Date	July 22, 2024
Crew	Anchor QEA			
RAL Exceedance Area	Phase I: 33		Time	11:48
	Revised in Phase II: 35			
Transect Line(s)	A		Tide	-2.3 ft MLLW
Sediment Thickness				
Probing Location	Probing Depth Refusal	Assumed refusal Reason	Notes	
At edge of rock 0 ft	Averaged 3-7 in	Hit hard stone/concrete	Rock and concrete along the bank which transitions into sand and gravel.	
5 ft	Averaged 3-7 in	Hit hard stone/concrete	Transitions down to sand and gravel	
10 ft	Averaged 3-7 in	Hit hard stone/concrete	Transitions from gravel and sand to softer silts and sand	
15 ft	Averaged 3-7 in	Hit hard stone/concrete	Could not reach the whole area as the tide does not go low enough to expose enough walkable area	
Bank Features Inspection				
Class	Present (Y/N)	Notes		
Woody Vegetation	Y	Trees (Pacific crabapple, shore pine, merlot redbud, cherry laurel) and shrubs (Himalayan blackberry) along the top of bank

Bank Armoring	Y	Engineered armor along the north end and unarmored slope along the south end		
Above ground Utilities	N			
Debris	Y	Wood and concrete		
Structures	Y	Ecology blocks along top of bank		
Fencing	N			
Other	N			
Photographs

Aerial with markup showing approximate transect location		RAL Exceedance Area 33 looking southeast

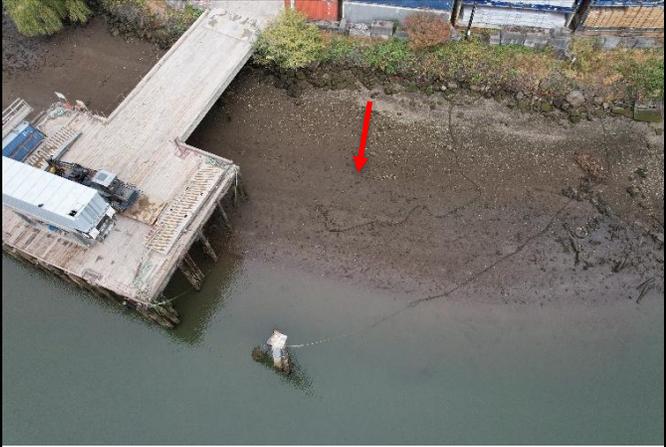
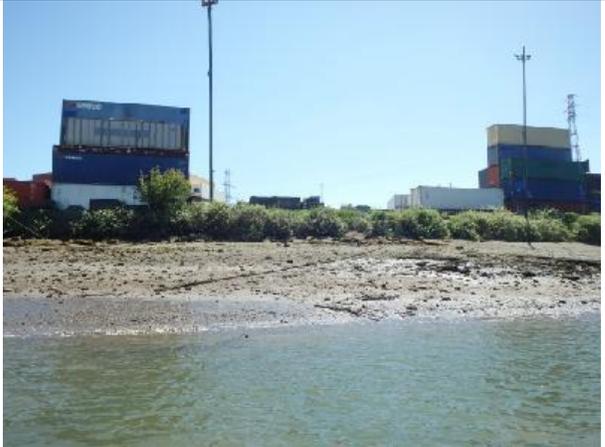
Project	Lower Duwamish Waterway Middle Reach PDI Phase II		Date	July 22, 2024
Crew	Anchor QEA			
RAL Exceedance Area	Phase I: 31		Time	9:57
	Revised in Phase II: 33			
Transect Line(s)	A		Tide	1.0 ft MLLW
Sediment Thickness				
Probing Location	Probing Depth Refusal	Assumed refusal Reason	Notes	
Between rock/debris:	2.5-3 ft	Compact sand	Concrete debris and rock, transitions into large gravel sized rock	
At edge of rock/debris (0 ft):	0.5 ft	Hit hard stone/concrete	Larger gravelly sand and occasional concrete debris and rock or other debris	
5 ft:	0.5 ft	Hit hard stone/concrete	Transition from larger gravel to smaller gravel more sand	
10 ft:	2.5-3 ft	Compact sand	Transitions into a silty sand	
15 ft:	2.5-3 ft	Compact sand		
Bank Features Inspection				
Class	Present (Y/N)	Notes		
Woody Vegetation	Y	Shrubs (Himalayan blackberry) and tree (vine maple) at top of bank		
Bank Armoring	N			
Above ground Utilities	Y	Utility pole at top of bank

Debris	Y	Some wood debris along shore		
Structures	Y	Ecology block wall and containers along top of bank; pier at one end and dolphins in the water		
Fencing	N			
Paving	N			
Other	N			
Photographs

Aerial with markup showing approximate transect location		RAL Exceedance Area 31 looking east

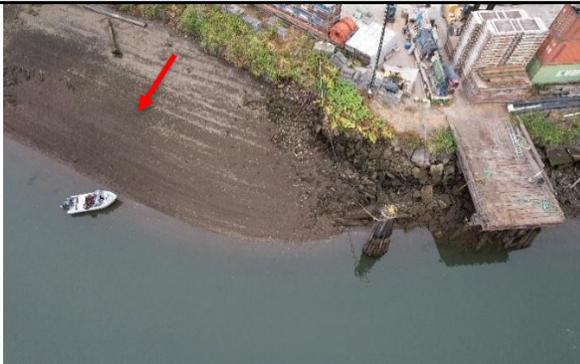
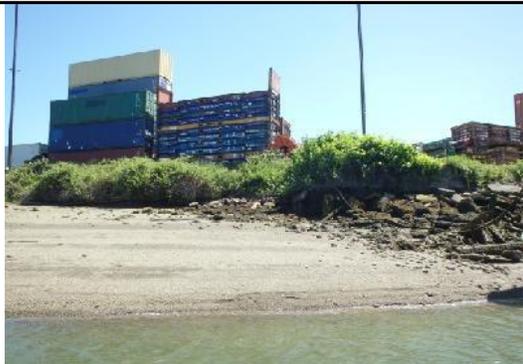
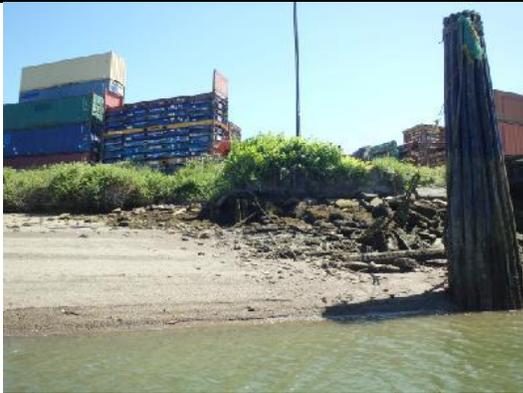
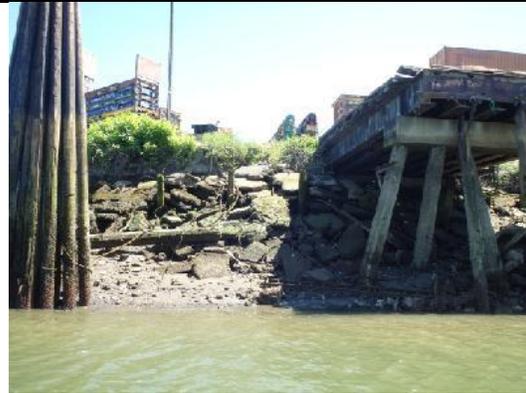
Project	Lower Duwamish Waterway Middle Reach PDI Phase II		Date	July 22, 2024
Crew	Anchor QEA			
RAL Exceedance Area	Phase I: 30		Time	10:10
	Revised in Phase II: 32			
Transect(s)	A		Tide	0.5 ft MLLW
Sediment Thickness				
Probing Location	Probing Depth	Refusal	Assumed refusal Reason	Notes
At edge of Vegetation/rock	0 ft:	3 ft	Compact sand/gravel	Less rock than Area 31; gravel is smaller. Approximately 1 inch of silty sand overtop of gravel nearing the water
5 ft:	0.6 ft	Armoring (hit hard stone/concrete)		
10 ft:	2.5 ft	Compact sand/gravel		
15 ft:	2.5 ft	Compact sand/gravel		
Bank Features Inspection				
Class	Present (Y/N)	Notes		
Woody Vegetation	Y	Shrubs (Himalayan blackberry and Japanese knotweed) at top of bank		
Bank Armoring	Y	Non-engineering armoring along the bank which transitions into sand and gravel		
Above ground Utilities	Y	Utility pole at top of bank		
Debris	Y	Pipe, and broken concrete and other debris found along the shore

Structures	Y	Ecology block wall and containers along top of bank; pier at one end and dolphins in the water		
Fencing	N			
Paving	N			
Other	N			
Photographs

Aerial with markup showing approximate transect location		RAL Exceedance Area 30 looking east

RAL Exceedance Area 30 looking east

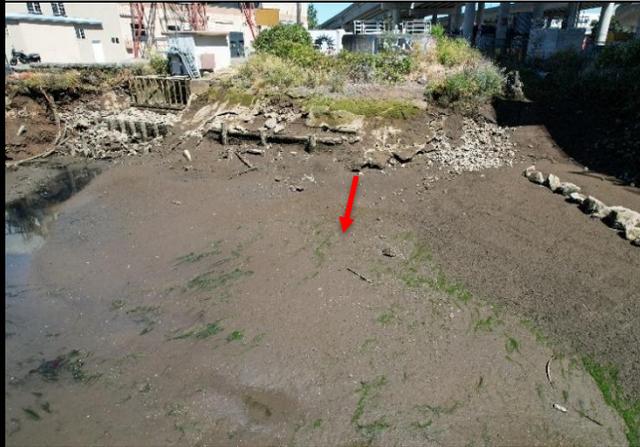
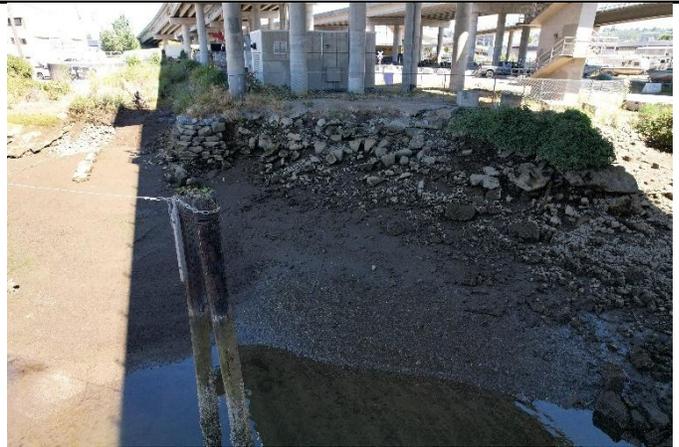
Project	Lower Duwamish Waterway Middle Reach PDI Phase II		Date	July 22, 2024
Crew	Anchor QEA			
RAL Exceedance Area	Phase I: 29 Revised in Phase II: 31		Time	10:43
Transect(s)	A		Tide	-0.7 ft MLLW
Sediment Thickness				
Probing Location	Probing Depth Refusal	Assumed refusal Reason	Notes	
Edge of Concrete and Rock (0 ft):	No refusal	NA	Some concrete debris and rock transitions into soft sand/silt with small gravel. Started transect at the edge of the concrete debris and rock, another interval was taken 5 ft away at the water's edge and no refusal was hit at either point.	
5ft:	No refusal	NA		
Bank Features Inspection				
Class	Present (Y/N)	Notes		
Woody Vegetation	Y	Narrow strip of shrubs (butterfly bush and black locust) and trees (snowberry) along top of bank		
Bank Armoring	N			
Above ground Utilities	Y	Transmission tower, utility pole, and aboveground concrete structure at top of bank		
Debris	N

Structures	Y	Timber piles, floating dock and gangway, timber bulkhead, outfall		
Fencing	N			
Paving	Y	Paved trail and road		
Other	N	See additional notes for RAL exceedance area transect B

Aerial with markup showing approximate transect location

RAL Exceedance 29 Area looking northeast

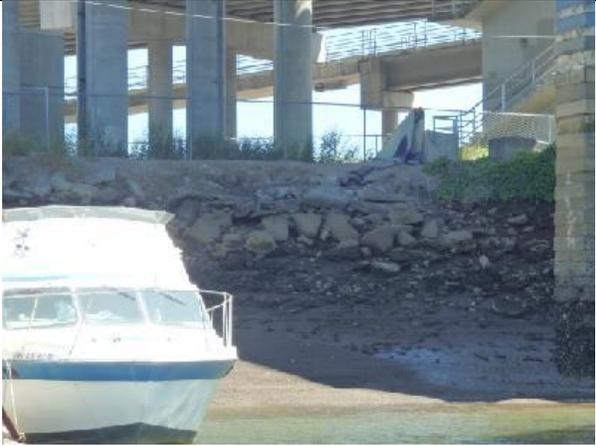
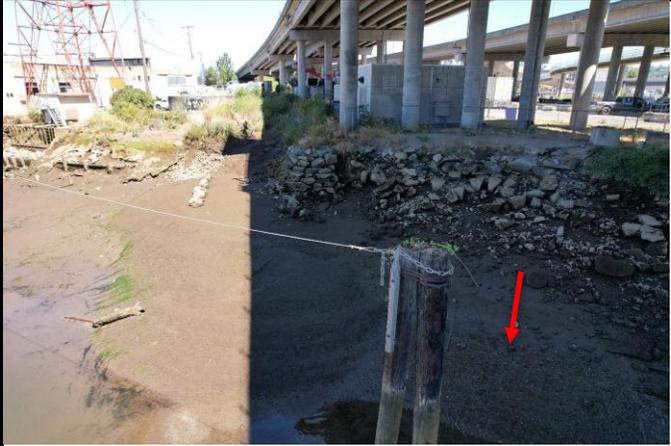
Project	Lower Duwamish Waterway Middle Reach PDI Phase II		Date	July 22, 2024
Crew	Anchor QEA			
RAL Exceedance Area	Phase I: 29		Time	10:43
	Revised in Phase II: 31			
Transect(s)	B		Tide	-0.7 ft MLLW
Sediment Thickness				
Probing Location	Probing Depth	Refusal	Assumed refusal Reason	Notes
Edge of concrete debris and rock (0 ft):		No refusal	NA	Some concrete debris and rock transitions into soft sand/silt with small gravel
5ft		No refusal	NA	
Bank Features Inspection				
Class	Present (Y/N)	Notes		
Woody Vegetation	Y	Narrow strip of shrubs (butterfly bush and black locust) and trees (snowberry) along top of bank		
Bank Armoring	N			
Above ground Utilities	Y	Outfalls 2502 transmission tower, utility pole, and above ground concrete structure at top of bank		
Debris	Y	Wood and concrete		
Structures	Y	Timber bulkhead, floating dock and gangway, dolphin near First Avenue Bridge foundations		
Fencing	N			
Paving	Y	Paved trail and road

RAL Exceedance Area 29 looking east		Aerial with markup showing approximate transect location

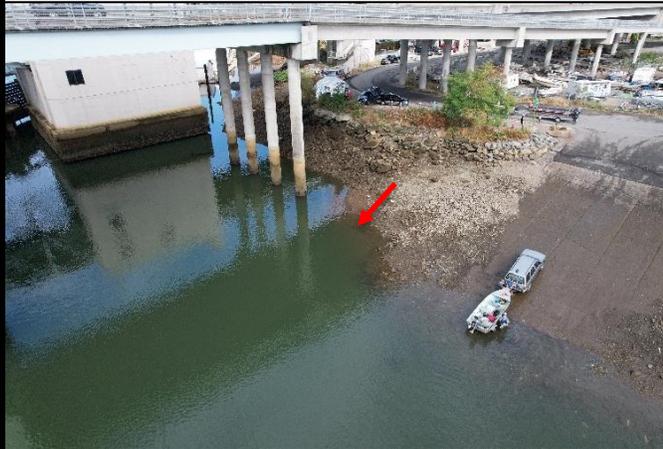
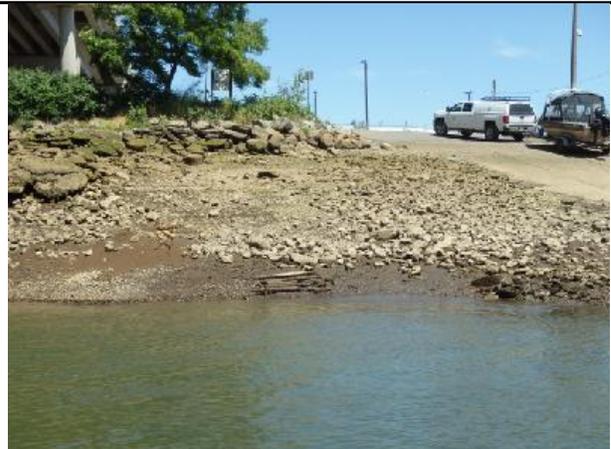
Class	Present (Y/N)	Notes
Woody Vegetation	Y	Shrubs (Himalayan blackberry, butterfly bush, snowberry, ocean spray) and trees (domestic plum) along top of bank
Bank Armoring	N	
Above ground Utilities	N	
Debris	Y	Brick and wood debris layered with armoring
Structures	Y	First Avenue Bridge foundations
Fencing	N	
Paving	Y	Paved boat ramp next to bank and paved road at top of bank
Other	N

Aerial showing approximate transect location

RAL Exceedance Area 27 looking north

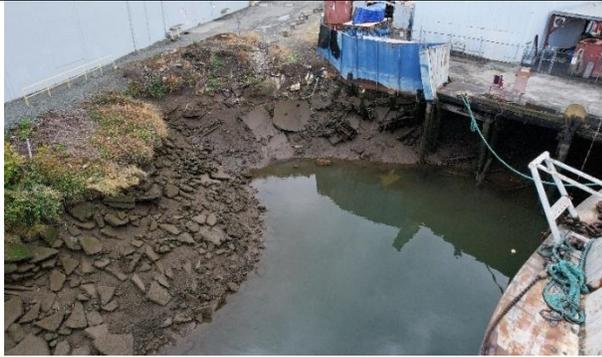
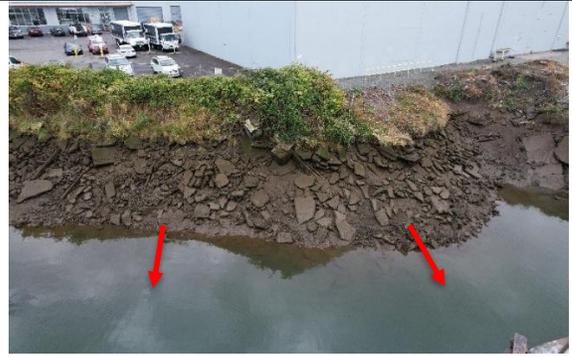
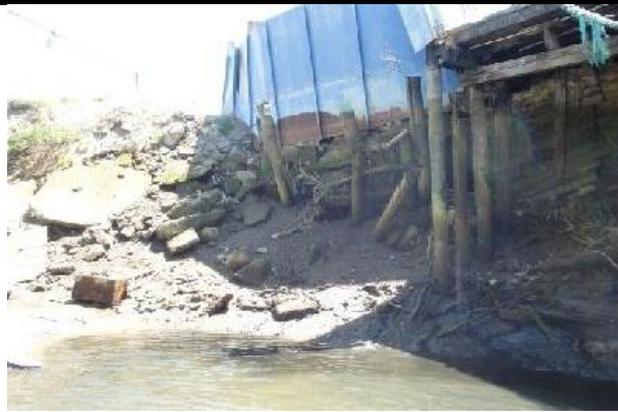
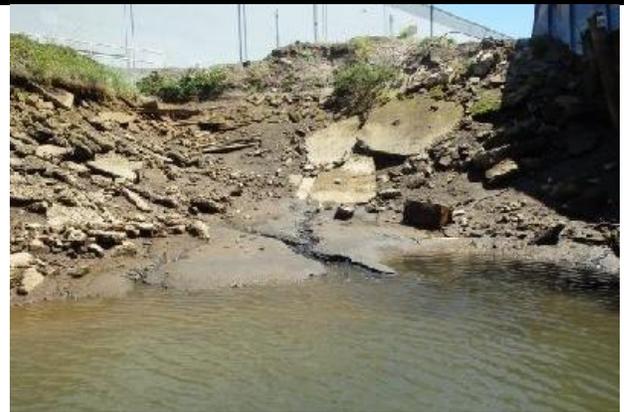
RAL Exceedance Area 24 looking east

RAL Exceedance Area 24 looking northeast with approximate transect locations

RAL Exceedance Area 24 looking southeast

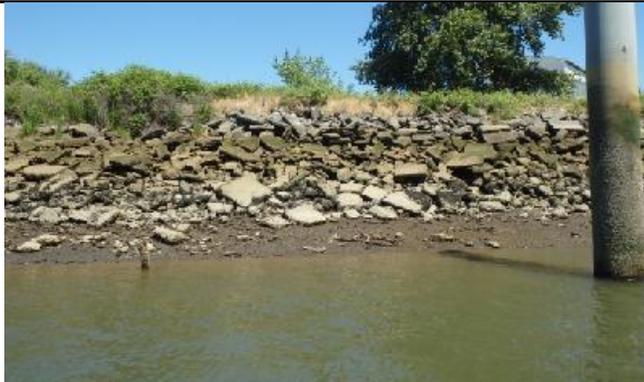
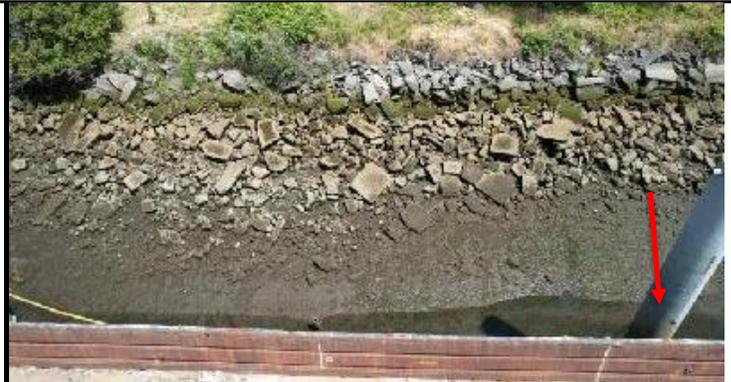
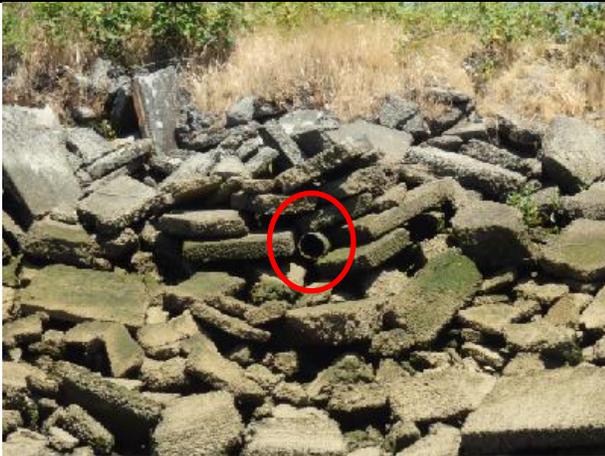
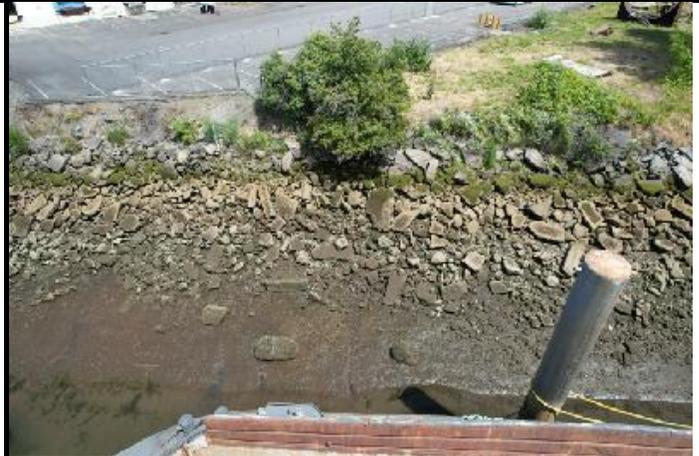
Class	Present (Y/N)	Notes
Woody Vegetation	Y	Shrubs (Himalayan blackberry, butterfly bush, Pacific rhododendron) and large trees (Pacific crabapple, black locust, black cottonwood scouler willow, Douglas fir, and madrone) at top of bank
Bank Armoring	Y	Engineer-armored upper bank, heavily armored with concrete slabs; is hard refusal under the concrete slabs
Above ground Utilities	Y	Dawn Foods Outfall (visible in photograph)
Debris	Y	Concrete slabs
Structures	Y	Metal pile in water
Fencing	N	
Paving	Y	Paved road at top of bank
Other	N

RAL Exceedance Area 18/19/22 looking northeast

Aerial looking northeast showing approximate transect location

RAL Exceedance Area 18/19/22 showing Dawn Foods Outfall

Aerial showing looking northeast

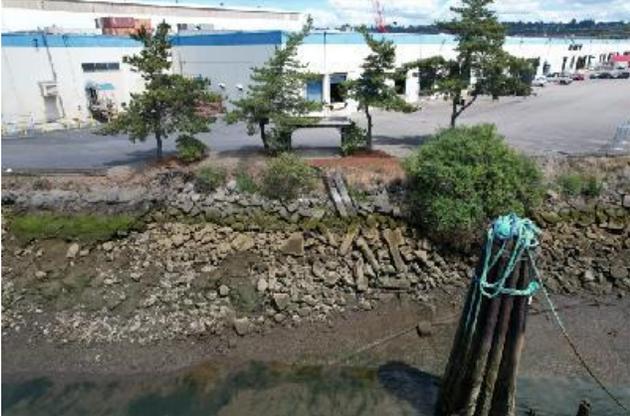
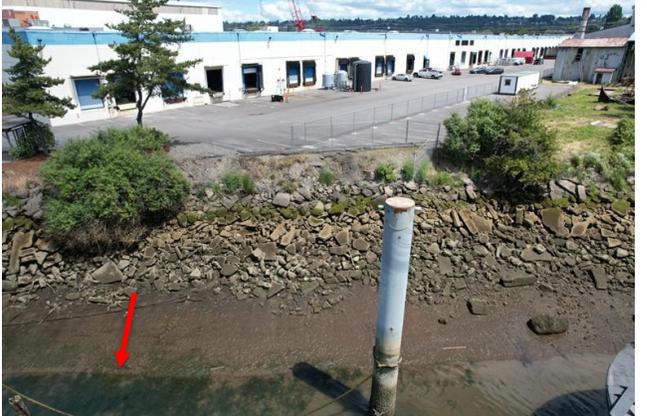
Project	Lower Duwamish Waterway Middle Reach PDI Phase II		Date	July 22, 2024
Crew	Anchor QEA			
RAL Exceedance Area	Phase I: 18/19/22		Time	12:30
	Revised in Phase II: 23			
Transect(s)	B		Tide	-2.8 ft MLLW
Sediment Thickness				
Probing Location	Probing Depth	Refusal	Assumed refusal Reason	Notes
In between rocks	3 in.	refusal	Hit hard stone/concrete	Rocky upper bank with concrete slabs; hard refusal under the concrete slabs
edge of rock	2.5-3 ft		Concrete/gravel	Transitions from concrete to large gravel to silt/sand with lots of shell fragments.
0 ft:				
5 ft:	No refusal		NA	
10 ft:	No refusal		NA	
Bank Features Inspection				
Class	Present (Y/N)	Notes		
Woody Vegetation	Y	Shrubs (Himalayan blackberry, butterfly bush, Pacific rhododendron) and large trees (Pacific crabapple, black locust, black cottonwood scouler willow, Douglas fir, and madrone) at top of bank		
Bank Armoring	Y	Engineer-armored upper bank, heavily armored with concrete slabs; hard refusal under the concrete slabs

Above ground Utilities	N			
Debris	Y	Concrete slabs		
Structures	Y	Dolphins in water; shelter structure at top of bank		
Fencing	N			
Paving	Y	Paved road at top of bank		
Other	N			
Photographs

Aerial looking northeast		Aerial looking northeast showing approximate transect location

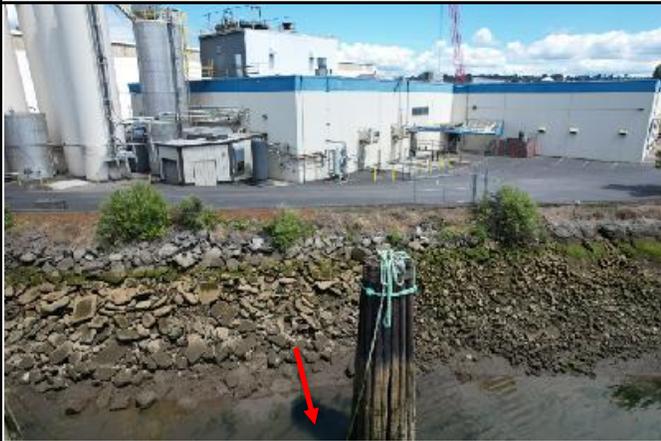
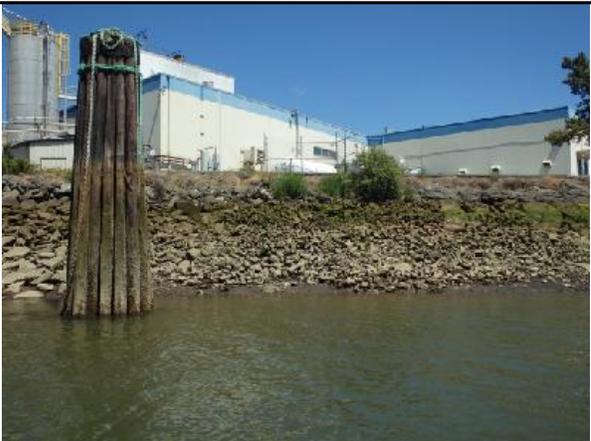
Project	Lower Duwamish Waterway Middle Reach PDI Phase II		Date	July 22, 2024
Crew	Anchor QEA			
RAL Exceedance Area	Phase I: 18/19/22		Time	12:30
	Revised in Phase II: 23			
Transect(s)	C		Tide	-2.8 ft MLLW
Sediment Thickness				
Probing Location	Probing Depth	Refusal	Assumed refusal Reason	Notes
In between rocks	3 in	refusal	Hit hard stone/concrete	Rocky upper bank with concrete slabs; hard refusal under the concrete slabs Transitions from concrete to large gravel to silt/sand with lots of shell fragments.
edge of rock	2.5-3 ft		Concrete/gravel	
0 ft:				
5 ft:	No refusal		NA	
10 ft:	No refusal		NA	
Bank Features Inspection				
Class	Present (Y/N)	Notes		
Woody Vegetation	Y	Shrubs (Himalayan blackberry, butterfly bush, and Pacific rhododendron) and trees (Pacific crabapple, black locust, black cottonwood scouler willow, Douglas fir, and madrone) at top of bank		
Bank Armoring	Y	Engineer-armored upper bank, heavily armored with concrete slabs

Above ground Utilities	N			
Debris	Y	Concrete slabs		
Structures	Y	Dolphins in water		
Fencing	Y	Chain-link fence at top of bank		
Paving	Y	Paved road at top of bank		
Other	N			
Photographs

Aerial looking northeast showing approximate transect location		RAL Exceedance Area 18/19/22 looking northeast

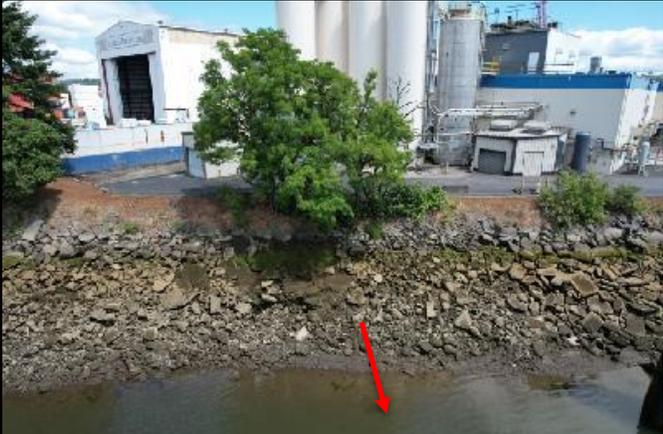
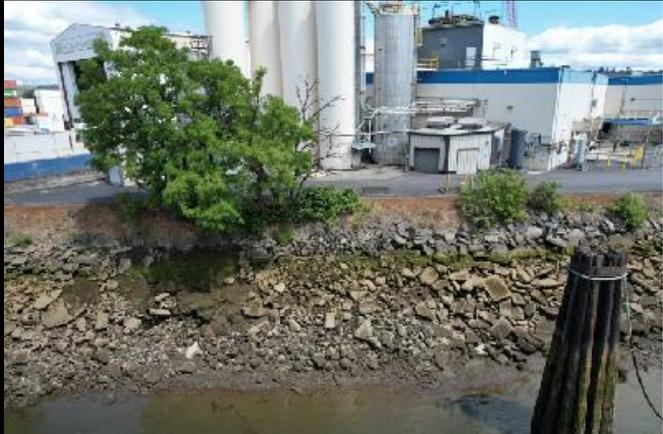
Project	Lower Duwamish Waterway Middle Reach PDI Phase II		Date	July 22, 2024
Crew	Anchor QEA			
RAL Exceedance Area	Phase I: 18/19/22		Time	12:30
	Revised in Phase II: 23			
Transect(s)	D		Tide	-2.8 ft MLLW
Sediment Thickness				
Probing Location	Probing Depth	Refusal	Assumed refusal Reason	Notes
In between rocks	3 in	refusal	Hit hard stone/concrete	Rocky upper bank with concrete slabs; hard refusal under the concrete slabs Transitions from concrete to large gravel to silt/sand with lots of shell fragments.
edge of rock	2.5-3 ft		Concrete/gravel	
0 ft:				
5 ft:	No refusal		NA	
10 ft:	No refusal		NA	
Bank Features Inspection				
Class	Present (Y/N)	Notes		
Woody Vegetation	Y	Shrubs (Himalayan blackberry, butterfly bush, and Pacific rhododendron) and large trees (Pacific crabapple, black locust, black cottonwood scouler willow, Douglas fir, and madrone) at top of bank		
Bank Armoring	Y	Engineer-armored upper bank, heavily armored with concrete slabs

Above ground Utilities	N			
Debris	N	Concrete slabs		
Structures	Y	Dolphins in water		
Fencing	N			
Paving	Y	Paved road at top of bank		
Other	N			
Photographs

Aerial looking northeast showing approximate transect location		RAL Exceedance Area 18/19/22 looking northeast

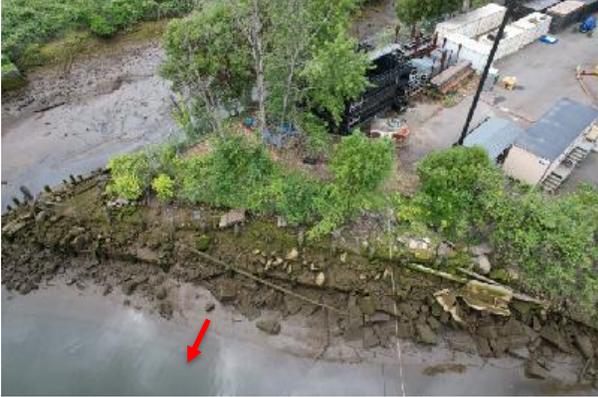
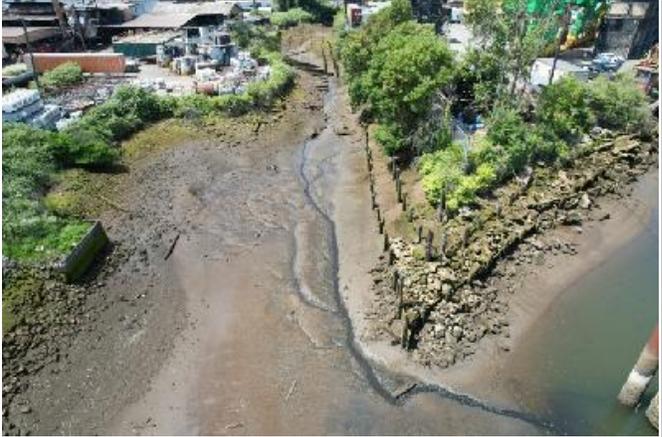
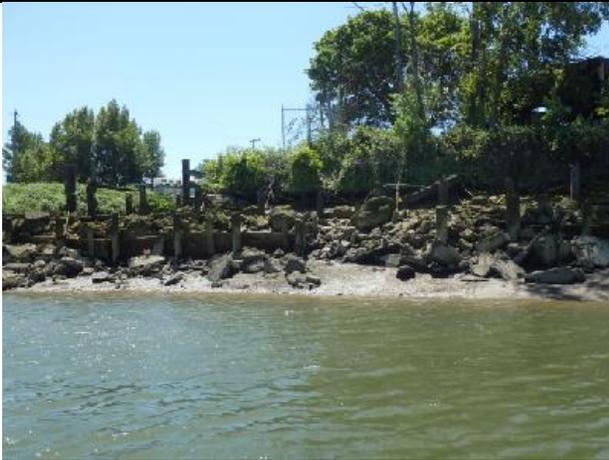
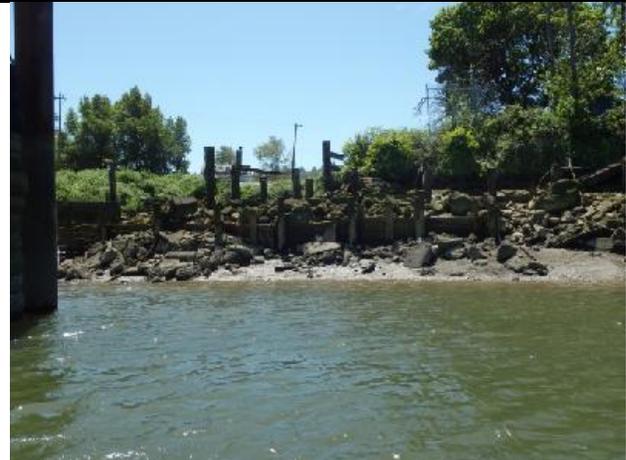
Project	Lower Duwamish Waterway Middle Reach PDI Phase II		Date	July 22, 2024
Crew	Anchor QEA			
RAL Exceedance Area	Phase I: 21		Time	11:22
	Revised in Phase II: 24 and 27			
Transect(s)	A		Tide	-1.8 ft MLLW
Sediment Thickness				
Probing Location	Probing Depth Refusal	Assumed refusal Reason	Notes	
Moving from concrete to water's edge in 5 ft increments:	No refusal	NA	Broken concrete which transitions into gravel overtop of soft sand/silt	
Bank Features Inspection				
Class	Present (Y/N)	Notes		
Woody Vegetation	Y	Shrubs (Himalayan blackberry, butterfly bush, Scotch broom, and English ivy), and large trees (black cottonwood and scouler willow) at top of bank		
Bank Armoring	Y	Engineer-armored upper bank		
Above ground Utilities	Y	Utility pole at top of bank		
Debris	Y	Large logs, large concrete slabs, and other wood debris scattered around bank		
Structures	Y	Double tiered timber bulkhead wall, dolphins, and pilings

Fencing	Y	Chain-link fence at top of bank		
Paving	Y	Paved road at top of bank		
Other	N			
Photographs

Aerial looking southwest showing approximate transect location		Aerial looking northwest

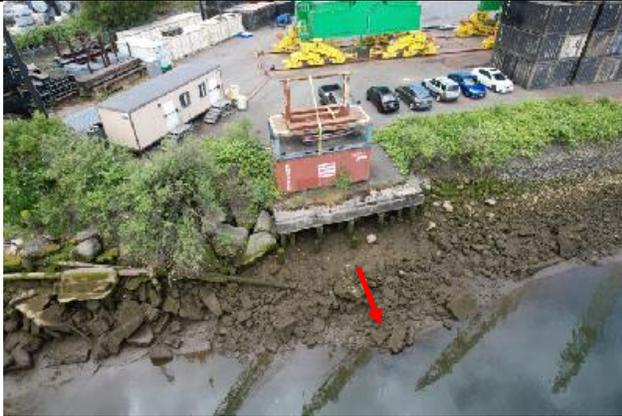
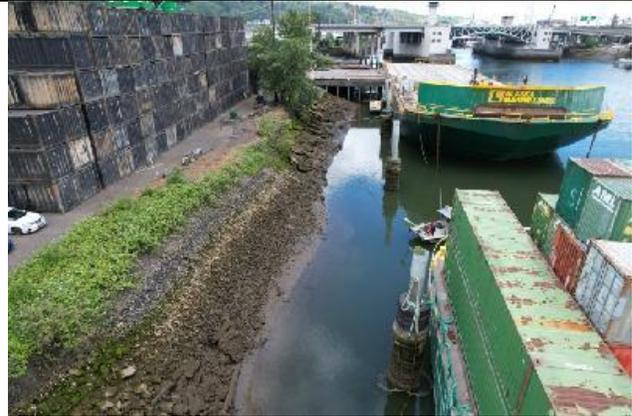
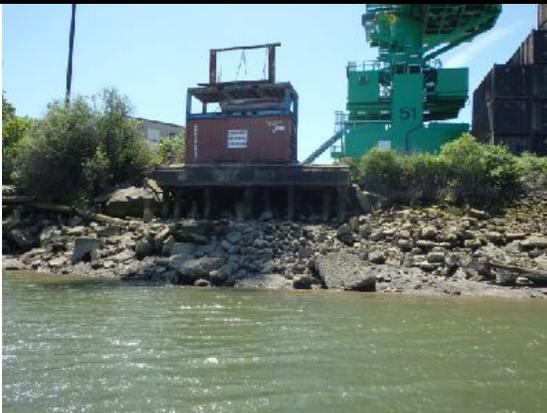
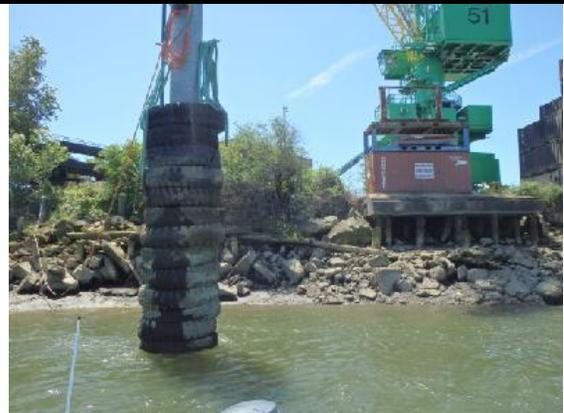
Project	Lower Duwamish Waterway Middle Reach PDI Phase II		Date	July 22, 2024
Crew	Anchor QEA			
RAL Exceedance Area	Phase I: 21		Time	11:22
	Revised in Phase II: 24 and 27			
Transect(s)	B		Tide	-1.8 ft MLLW
Sediment Thickness				
Probing Location	Probing Depth Refusal	Assumed refusal Reason	Notes	
Moving from armoring to water's edge in 5 ft increments:	No refusal	NA	Broken concrete that transitions into gravel overtop of soft sand/silt	
Bank Features Inspection				
Class	Present (Y/N)	Notes		
Woody Vegetation	Y	Shrubs (Himalayan blackberry, butterfly bush, Scotch broom, and English ivy) and trees (black cottonwood and scouler willow) at top of bank		
Bank Armoring	Y	Engineer-armored upper bank, heavily armored with concrete slabs; hard refusal under the concrete slabs		
Above ground Utilities	N			
Debris	Y	Wood and concrete debris		
Structures	Y	Bulkhead with large emergency response container on top that extends over the bank; ; ecology blocks at top of bank; dolphins in water

Fencing	N			
Paving	Y	Paved road at top of bank and bulkhead extending over the bank		
Other	N

Aerial looking northwest showing approximate transect location

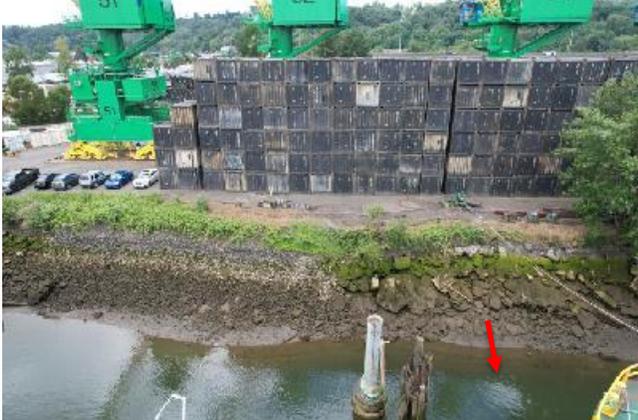
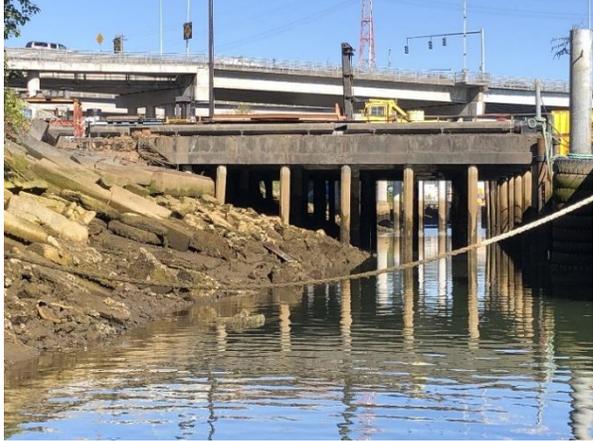
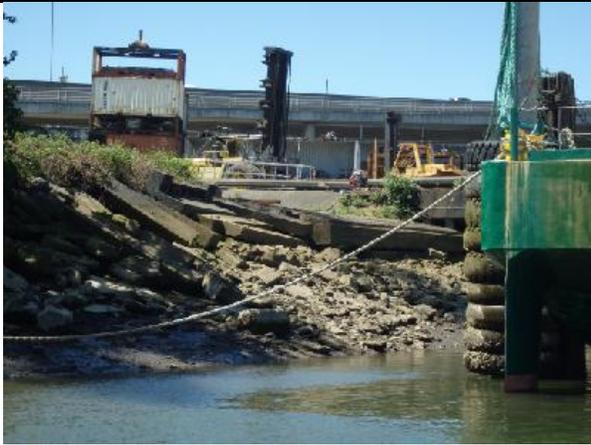
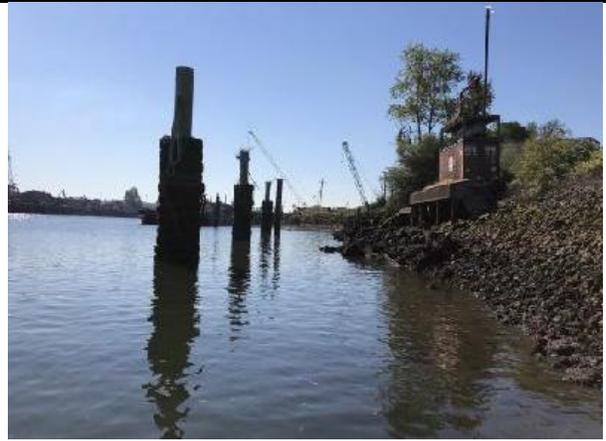
Project	Lower Duwamish Waterway Middle Reach PDI Phase II		Date	July 22, 2024
Crew	Anchor QEA			
RAL Exceedance Area	Phase I: 21		Time	11:22
	Revised in Phase II: 24 and 27			
Transect(s)	C		Tide	-1.8 ft MLLW
Sediment Thickness				
Probing Location	Probing Depth Refusal	Assumed refusal Reason	Notes	
Moving from armoring to water's edge in 5 ft increments:	No refusal	NA	Broken concrete that transitions into gravel overtop of soft sand/silt	
Bank Features Inspection				
Class	Present (Y/N)	Notes		
Woody Vegetation	Y	Shrubs (Himalayan blackberry, butterfly bush, Scotch broom, and English ivy) and trees (black cottonwood and scouler willow) at top of bank		
Bank Armoring	Y	Engineer-armored upper bank, heavily armored with concrete slabs; hard refusal under the concrete slabs		
Above ground Utilities	N			
Debris	Y	Broken concrete (slabs and columns) on bank		
Structures	Y	Ecology blocks at top of bank; dolphins in water

<p>Aerial looking southwest showing approximate transect location</p>		<p>RAL Exceedance Area 21 looking north</p>

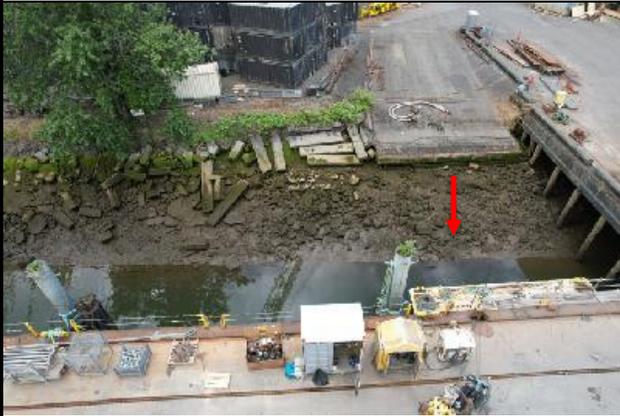
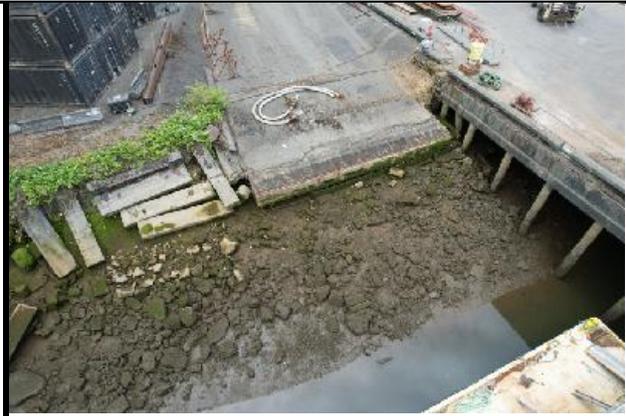
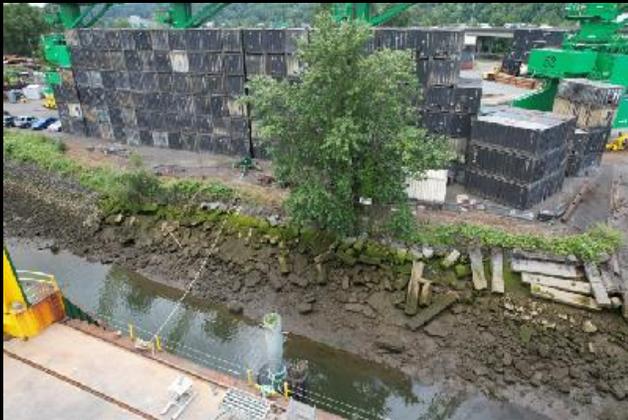
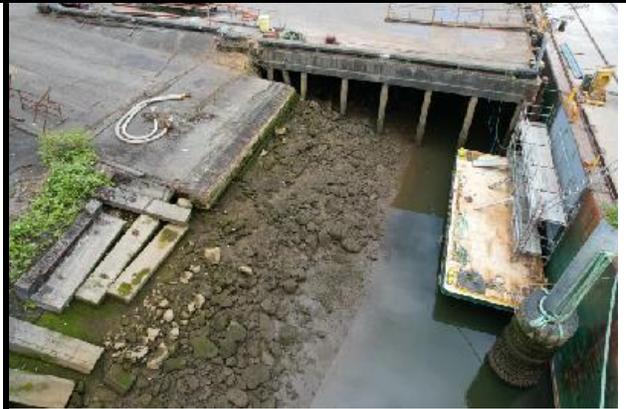
Project	Lower Duwamish Waterway Middle Reach PDI Phase II		Date	July 22, 2024
Crew	Anchor QEA			
RAL Exceedance Area	Phase I: 21		Time	11:22
	Revised in Phase II: 24 and 27			
Transect(s)	D		Tide	-1.8 ft MLLW
Sediment Thickness				
Probing Location	Probing Depth Refusal	Assumed refusal Reason	Notes	
Moving from armoring to water's edge in 5 ft increments:	No refusal	NA	Broken concrete that transitions into gravel overtop of soft sand/silt	
Bank Features Inspection				
Class	Present (Y/N)	Notes		
Woody Vegetation	Y	Shrubs (Himalayan blackberry, butterfly bush, Scotch broom, and English ivy) and large trees (black cottonwood and scouler willow) at top of bank		
Bank Armoring	Y	Engineer-armored upper bank, heavily armored with concrete slabs; hard refusal under the concrete slabs		
Above ground Utilities	N			
Debris	N	Large broken concrete (slabs and columns) across bank		
Structures	Y	Concrete wharf Ecology blocks at top of bank, Dolphins in water

Aerial looking southwest showing approximate transect location
