Appendix C-1
Phase I Bank Visual Inspection
Observations and Photographs

This appendix provides detailed results of Lower Duwamish Waterway (LDW) middle reach Phase II Pre-Design Investigation (PDI) bank inspections that were conducted to satisfy data quality objectives (DQOs) 11 and 14. The Phase II inspections focused on areas with remedial action level (RAL) exceedances based on the Phase I dataset, and included a field visit at low tide to document bank conditions and measure the thickness of sediment over armoring (where applicable), and a desktop analysis of oblique and ortho-aerial photographs.

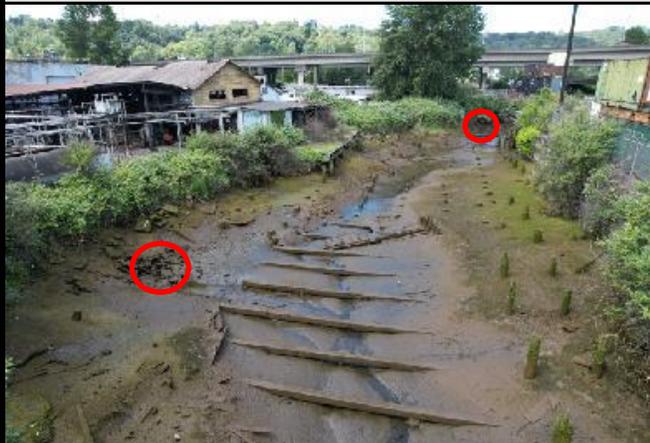
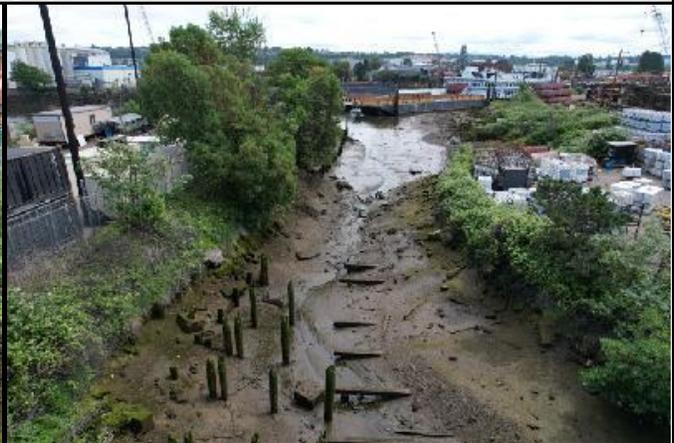
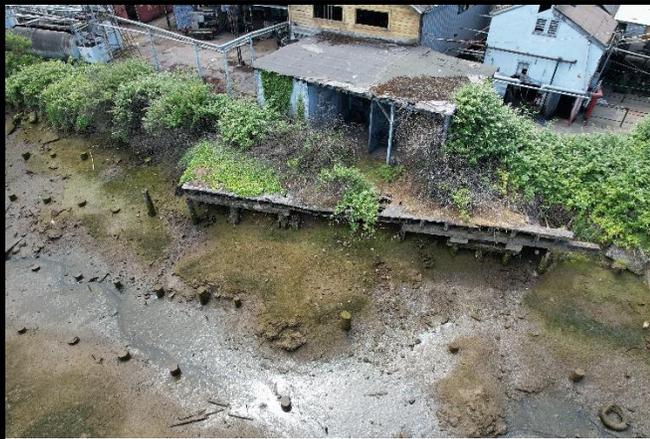
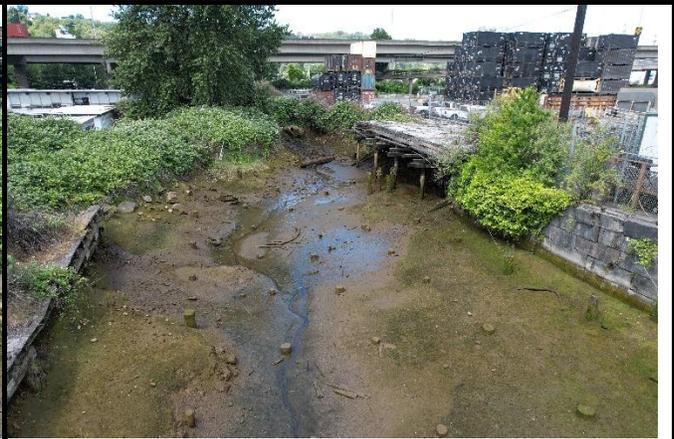
Project	Lower Duwamish Waterway Middle Reach PDI Phase II		Date	--
Crew	Anchor QEA			
RAL Exceedance Area	Phase I: 20		Time	--
	Revised in Phase II: 24			
Transect(s)	NA		Tide	--
Sediment Thickness				
Probing Location	Probing Depth Refusal	Assumed refusal Reason	Notes	
No sediment thickness probing took place due to health and safety concerns.				
Bank Features Inspection				
Class	Present (Y/N)	Notes		
Woody Vegetation	Y	Trees and bushes present		
Bank Armoring	Y	Engineered armored slope		
Above ground Utilities	Y	Outfall (2120 and 2118)		
Debris	Y	Broke pilings, timber, concrete slabs, and timber cross beams		
Structures	Y	Ecology block wall and 2 piers		
Fencing	Y	Chain-link fence at top of bank		
Paving	Y	Paving upland on both sides of the inlet		
Other	N

Aerial looking west showing outfall locations

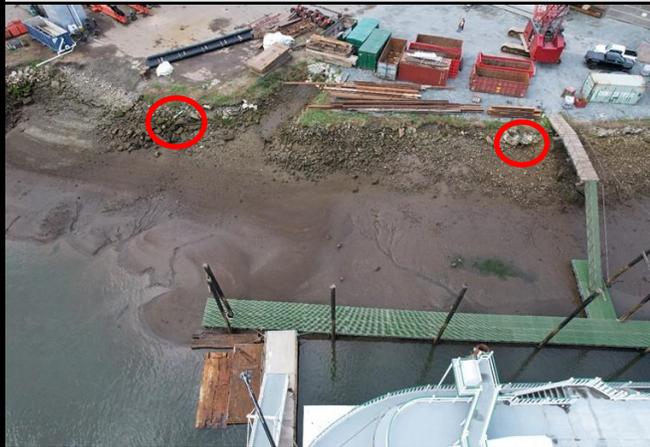
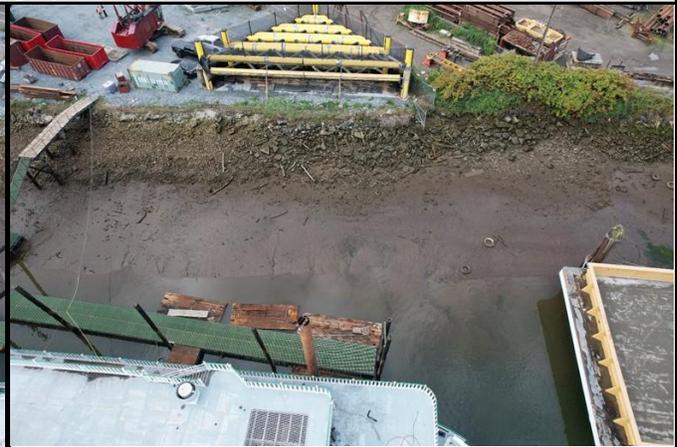
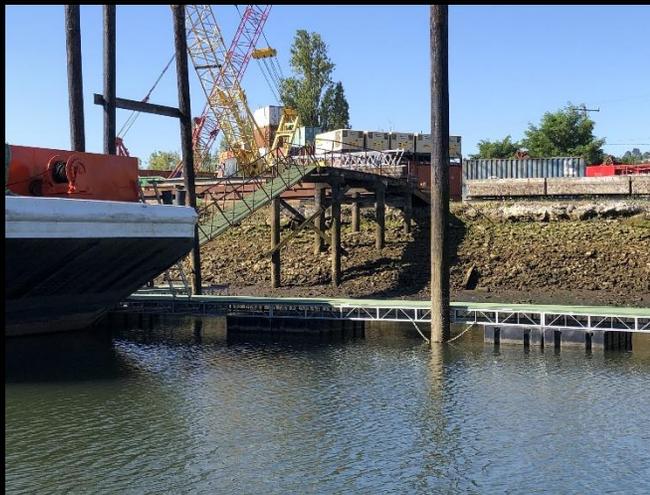
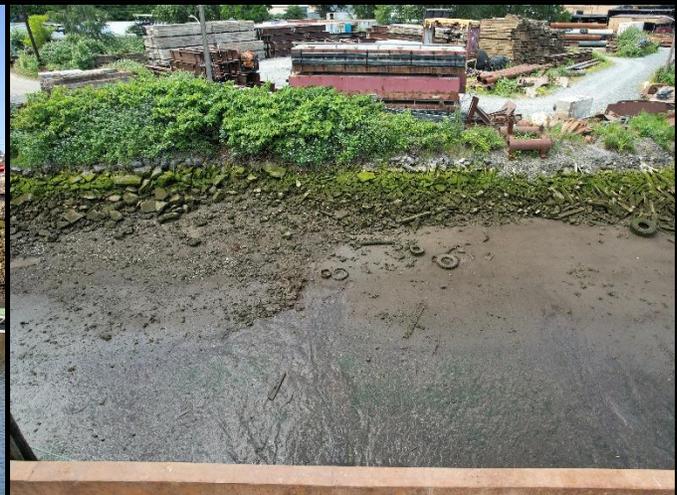
Project	Lower Duwamish Waterway Middle Reach PDI Phase II		Date	--
Crew	Anchor QEA			
RAL Exceedance Area	Phase I: 16		Time	--
	Revised Phase II: 21			
Transect(s)	NA		Tide	--
Sediment Thickness				
Probing Location	Probing Depth Refusal	Assumed refusal Reason	Notes	
No sediment thickness probing took place in this area.				
Bank Features Inspection				
Class	Present (Y/N)	Notes		
Woody Vegetation	Y	Bushes present		
Bank Armoring	Y	Armored slope on upgradient portions		
Above ground Utilities	Y	Outfalls (2116 and Boyer 1)		
Debris	Y	Concrete and tires		
Structures	Y	Floating Dock and dolphins		
Fencing	Y	Chain-link fence at top of bank		
Paving	Y	Paving upland		
Other	N

Aerial looking southwest showing outfall locations

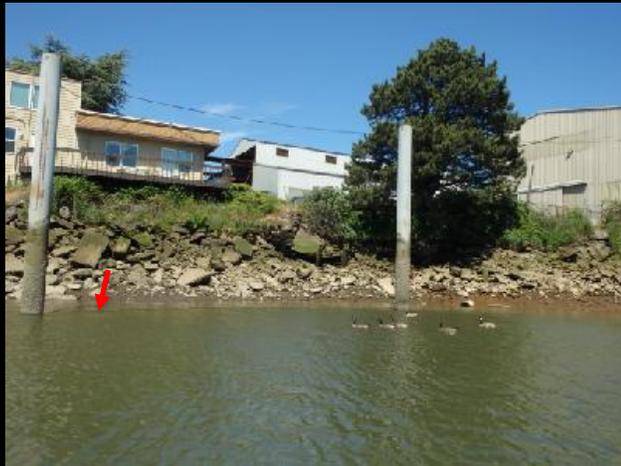
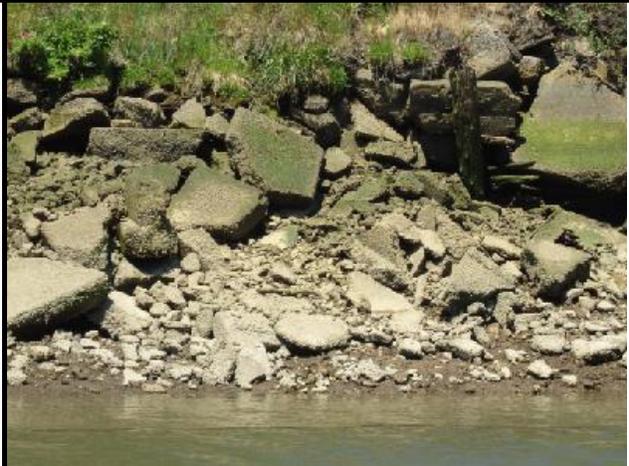
Project	Lower Duwamish Waterway Middle Reach PDI Phase II		Date	July 22, 2024
Crew	Anchor QEA			
RAL Exceedance Area	Phase I: 15		Time	12:44
	Revised in Phase II: 20			
Transect(s)	A		Tide	-2.8 ft MLLW
Sediment Thickness				
Probing Location	Probing Depth Refusal	Assumed refusal Reason	Notes	
Between concrete 0 ft:	3 in	Armoring (hit hard stone/concrete)	Steep armored slope with concrete slabs; transitions into gravel mixed with soft sediment (approximately 1-1.5 ft of soft sediment over top of concrete armoring/gravel (refusal after the 1.5 ft); moved transect to the northmost end of Area 15 due to inaccessible soft sediment	
5ft:	1-1.5 ft			
Bank Features Inspection				
Class	Present (Y/N)	Notes		
Woody Vegetation	Y	Shrubs (Himalayan blackberry, butterfly bush, and English ivy) and large trees (shore pine and white spruce) at top of bank		
Bank Armoring	Y	Engineered armored slope with concrete slabs; transitions into gravel mixed with soft sediment

Above ground Utilities	Y	Outfalls 2028 and SBW-B (both shown in pictures)		
Debris	N			
Structures	Y	Building at top of bank; large broken concrete on bank		
Fencing	Y	Chain-link fence at top of bank		
Paving	Y	Paving between building at top of bank		
Other	N

RAL Exceedance Area 15 looking east showing approximate transect location

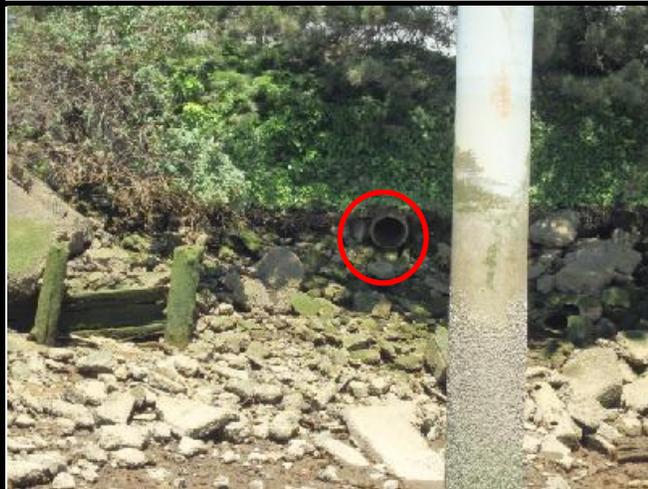
RAL Exceedance Area 15 looking northeast showing Outfall SBW-B

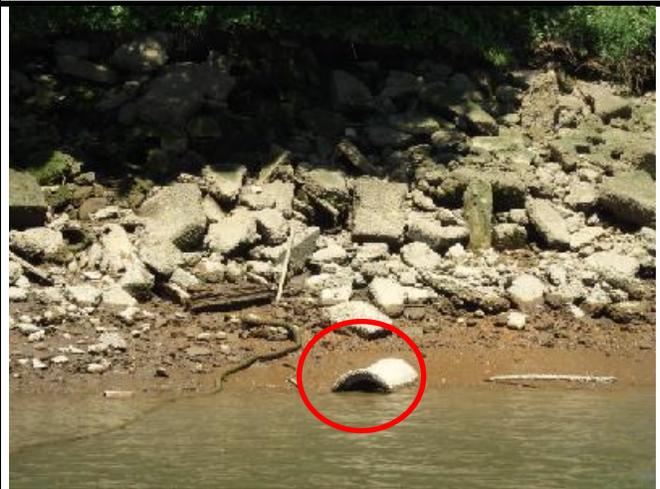
RAL Exceedance Area 15 looking northeast showing Outfall 2028

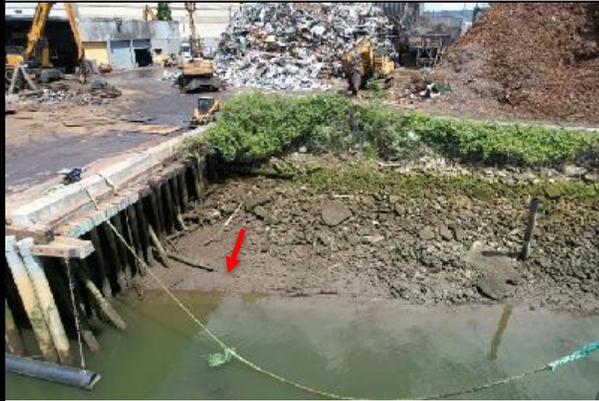
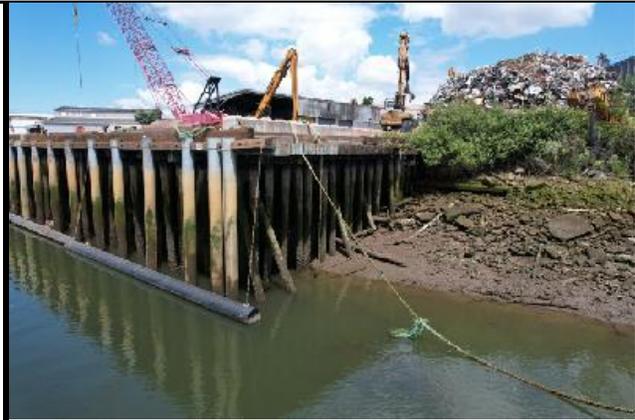
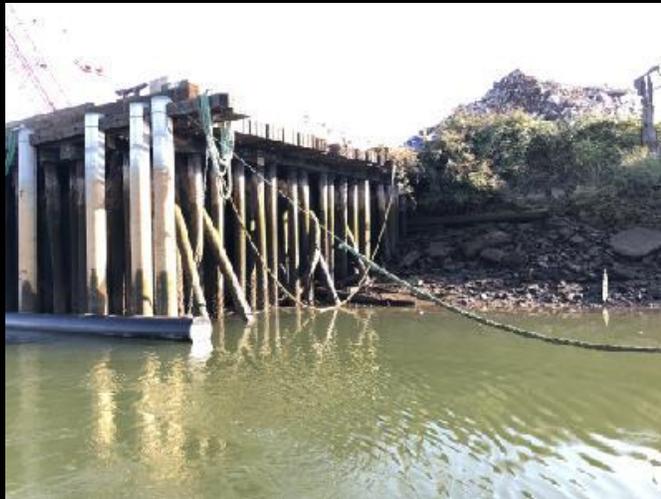
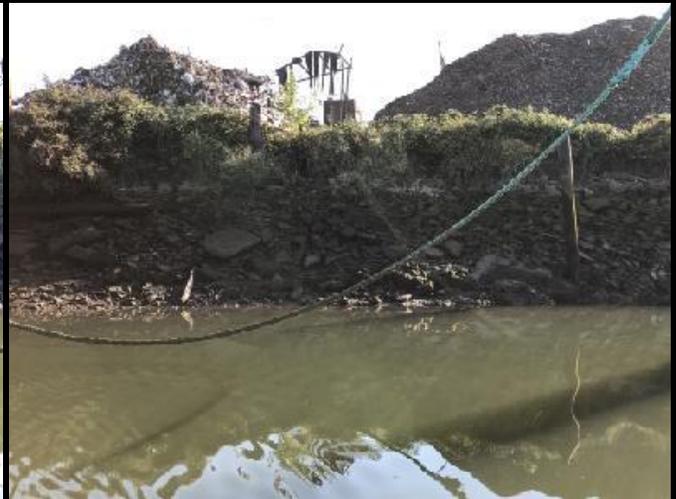
Project	Lower Duwamish Waterway Middle Reach PDI Phase II		Date	July 22, 2024
Crew	Anchor QEA			
RAL Exceedance Area	Phase I: 14		Time	12:55
	Revised in Phase II: NA			
Transect(s)	A		Tide	-2.8 ft MLLW
Sediment Thickness				
Probing Location	Probing Depth Refusal	Assumed refusal Reason	Notes	
Along armored slope edge:	3 ft under armor	Armoring (hit hard stone/concrete)	Very steep engineer-armored shore leading from water; could not safely probe under armoring higher toward vegetation line due to safety precautions; armor is same concrete slabs as elsewhere; near structure #30	
5 ft from armored slope (water's edge)	No refusal after armoring ends	NA		
Bank Features Inspection				
Class	Present (Y/N)	Notes		
Woody Vegetation	Y	Shrubs (Himalayan blackberry, and butterfly bush) and trees (vine maple) at top of bank		
Bank Armoring	Y			
Above ground Utilities				
Debris	Y	Wood and concrete debris		
Structures	Y	Wharf on the north end, ecology blocks at top of bank; dolphins in water

Aerial looking southwest showing approximate transect location

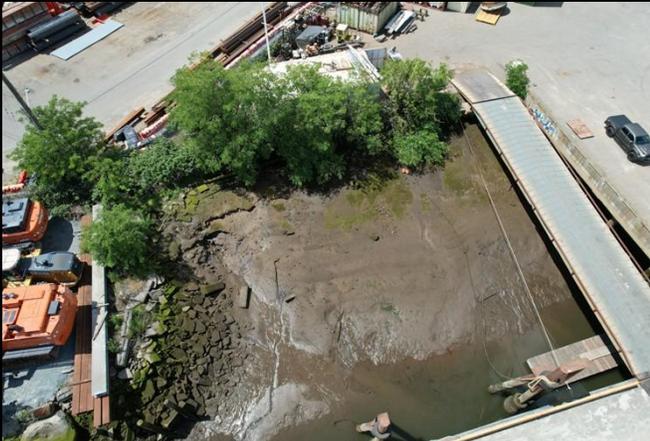
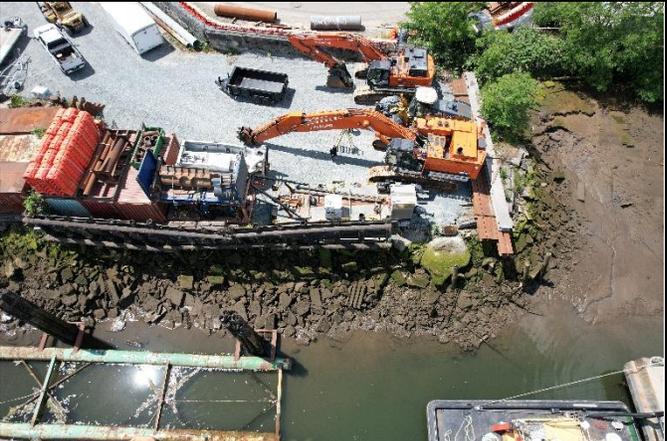
Project	Lower Duwamish Waterway Middle Reach PDI Phase II		Date	--
Crew	Anchor QEA			
RAL Exceedance Area	Phase I: 12		Time	--
	Revised in Phase II: 17			
Transect(s)	NA		Tide	--
Sediment Thickness				
Probing Location	Probing Depth Refusal	Assumed refusal Reason	Notes	
No sediment thickness probing took place in this area.				
Bank Features Inspection				
Class	Present (Y/N)	Notes		
Woody Vegetation	Y	Bushes and trees present		
Bank Armoring	Y	Armored slope on upgradient portions		
Above ground Utilities	Y	Utility poles upland		
Debris	Y	Concrete.		
Structures	Y	Pier, gangway, and dolphins		
Fencing	Y	Chain-link fence at top of bank		
Paving	Y	Paving upland		
Other	N			
Photographs

Aerial of RAL Exceedance Area 12 looking northwest		Aerial of RAL Exceedance Area 12 looking west

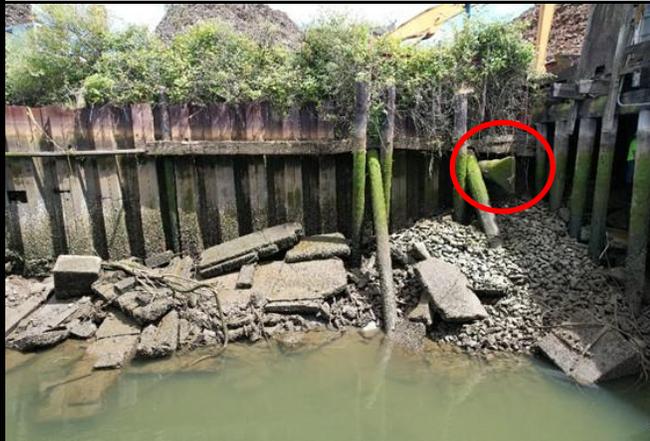
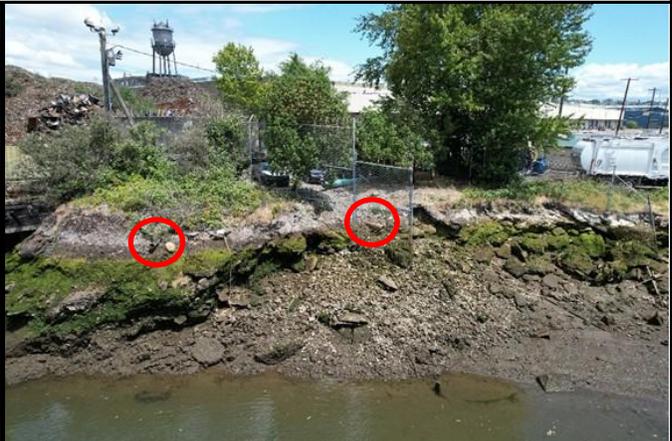
Class	Present (Y/N)	Notes
Woody Vegetation	Y	Bushes and trees present on southern end
Bank Armoring	Y	Armored slope on upgradient portions
Above ground Utilities	Y	Outfalls (2035, 2036, and 2037)
Debris	Y	Concrete
Structures	Y	Wharf
Fencing	Y	Chain-link fence at top of bank
Paving	Y	Paving upland
Other	N

Aerial looking east showing locations of outfalls

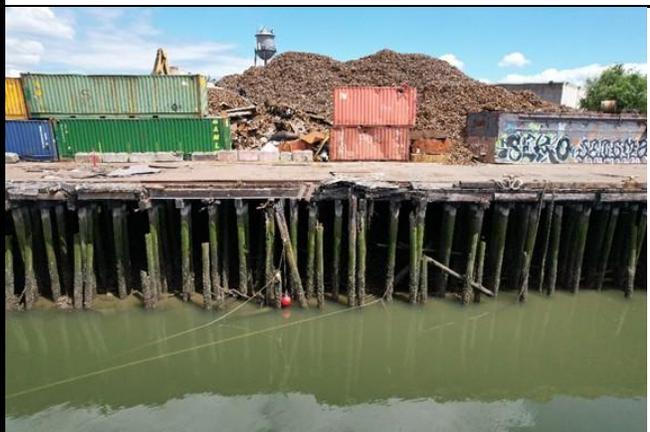
RAL Exceedance Area 11 looking east

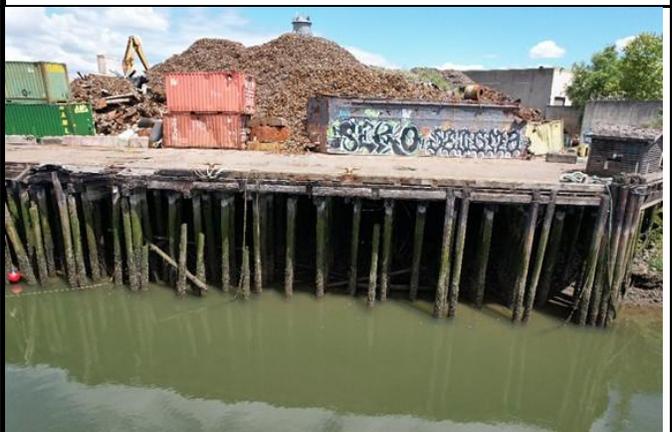
RAL Exceedance Area 11 looking east

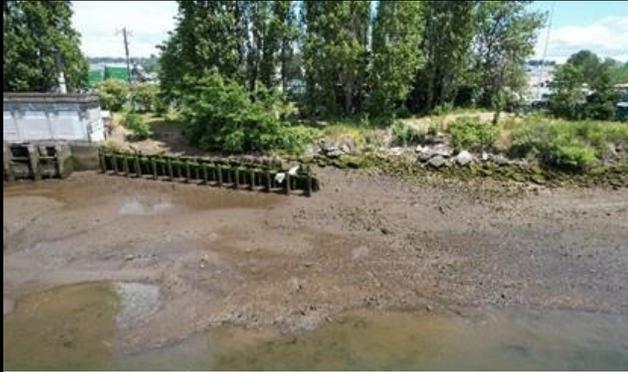
Project	Lower Duwamish Waterway Middle Reach PDI Phase II		Date	July 22, 2024
Crew	Anchor QEA			
RAL Exceedance Area	Phase I: 9		Time	13:23
	Phase II: 9			
Transect(s)	A		Tide	-2.6 ft MLLW
Sediment Thickness				
Probing Location	Probing Depth Refusal	Assumed refusal Reason	Notes	
Edge of armored slope (between armoring):	1 in	Armoring (hit hard stone/concrete)	Broken concrete armor that transitions to gravel then soft silts and sands	
5 ft from armored slope:	3 in	Compact sediment		
10 ft from armored slope:	0.5-1 ft	Compact sediment		
Bank Features Inspection				
Class	Present (Y/N)	Notes		
Woody Vegetation	Y	Shrubs (butterfly bush) and trees (black locust, Lombardy poplar, and madrone) at top of bank		
Bank Armoring	Y	Non-engineered broken concrete armor that transitions to gravel, then soft silts and sands		
Above ground Utilities	Y	Outfall DuwReload		
Debris	Y	Wood debris across bank		
Structures	Y	Intake building, gabion cage

Aerial looking southeast showing approximate transect location

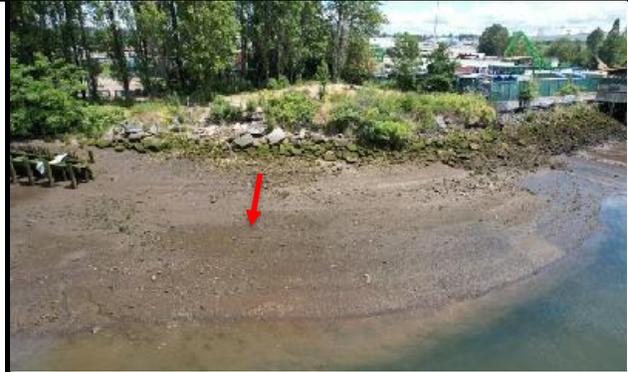
Aerial looking southeast showing approximate transect location

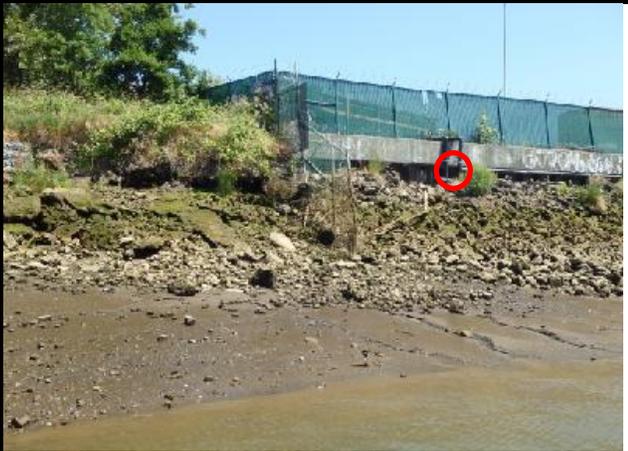
Visual observation through desktop analysis of the shoreline noted armoring through a majority of the upgradient portions of the area. Armoring generally included sporadic riprap, bricks, and large concrete debris. Additionally, a timber bulkhead spans roughly 80 feet on either side of the Georgetown pump station with no armoring down gradient. Debris throughout the RAL exceedance area includes wood (broken pilings, pilings cut at the mudline, and branches), bricks, and occasional metal pipes. Observed surface material was predominately sand with silt. Structures along the bank include the historic intake structure building. The RAL exceedance area contains three outfalls. One outfall (DuwReload) was visually confirmed in photographs circled in Figure C-2-16.

RAL Exceedance Area 9 looking southeast showing outfall location

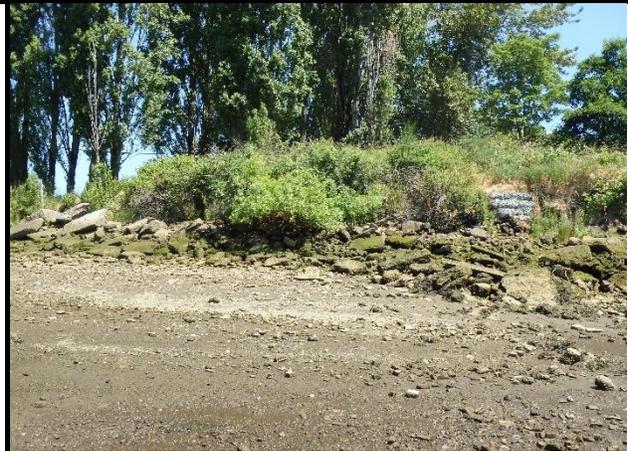
RAL Exceedance Area 9 looking east

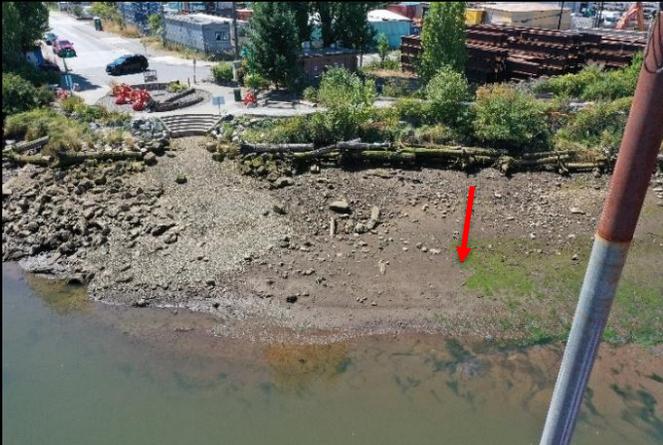
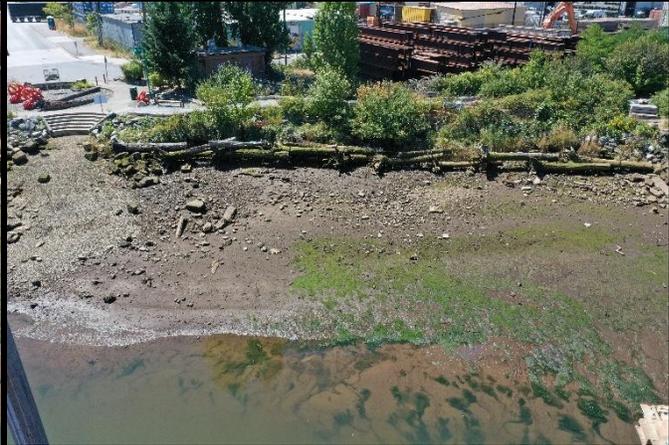
Project	Lower Duwamish Waterway Middle Reach PDI Phase II		Date	July 22, 2024
Crew	Anchor QEA			
RAL Exceedance Area	Phase I: 5		Time	13:38
	Revised in Phase II: 6 and 8			
Transect(s)	A		Tide	-2.4 ft MLLW
Sediment Thickness				
Probing Location	Probing Depth Refusal	Assumed refusal Reason	Notes	
Edge of concrete debris 0 ft:	No refusal but occasional rock hit at 3ft	NA	Broken that transitions into gravel to soft sediment with algae over top.	
5 ft:	0.5 ft	Compact sediment		
10 ft	2.5 ft	Compact sediment		
Bank Features Inspection				
Class	Present (Y/N)	Notes		
Woody Vegetation	Y	Shrubs (Himalayan blackberry, Japanese knotweed, and English ivy) and trees (black locust, Lombardy poplar, black cottonwood, scouler willow, Douglas fir, white spruce, and red alder) at top of bank		
Bank Armoring	N			
Above ground Utilities	N			
Debris	Y	Wood and concrete debris		
Structures	N			
Fencing	N			
Paving	Y	Paved trail, park and industrial property at top of bank behind dense vegetation

Aerial looking southwest showing approximate transect location		Aerial looking southwest

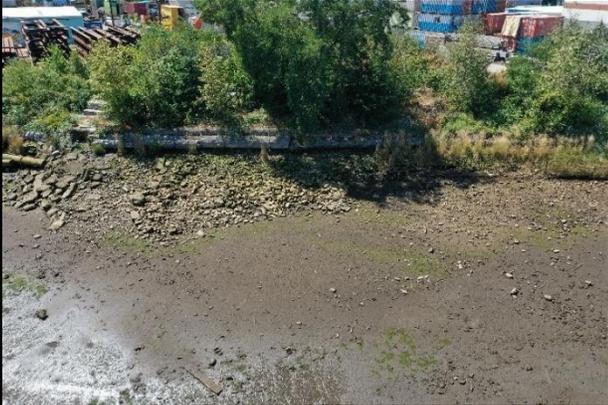
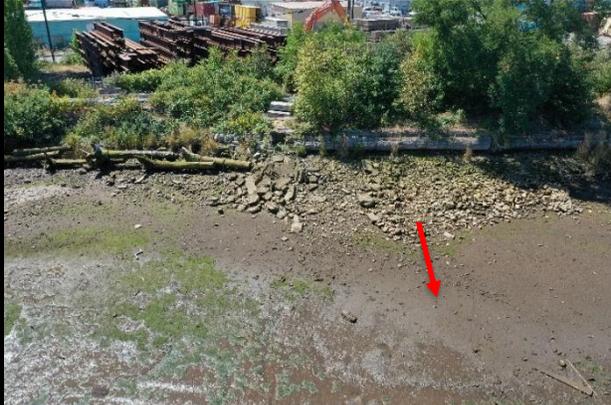
Project	Lower Duwamish Waterway Middle Reach PDI Phase II		Date	July 22, 2024
Crew	Anchor QEA			
RAL Exceedance Area	Phase I: 5		Time	13:38
	Revised in Phase II: 6 and 8			
Transect(s)	B		Tide	-2.4 ft MLLW
Sediment Thickness				
Probing Location	Probing Depth	Refusal	Assumed refusal Reason	Notes
Edge of concrete debris	0 ft:	No refusal	NA	Broken armoring that transitions into gravel to soft sediment with algae over top
5 ft:				
10 ft				
Bank Features Inspection				
Class	Present (Y/N)	Notes		
Woody Vegetation	Y	Shrubs (Himalayan blackberry, Japanese knotweed, and English ivy) and large trees (black locust, Lombardy poplar, black cottonwood, scouler willow, Douglas fir, white spruce, and red alder) at top of bank		
Bank Armoring	N			
Above ground Utilities	N			
Debris	Y	Wood and concrete debris		
Structures	N			
Fencing	N			
Paving	Y	Paved trail and industrial property at top of bank behind dense vegetation

Aerial looking southwest		Aerial looking southwest showing approximate transect location

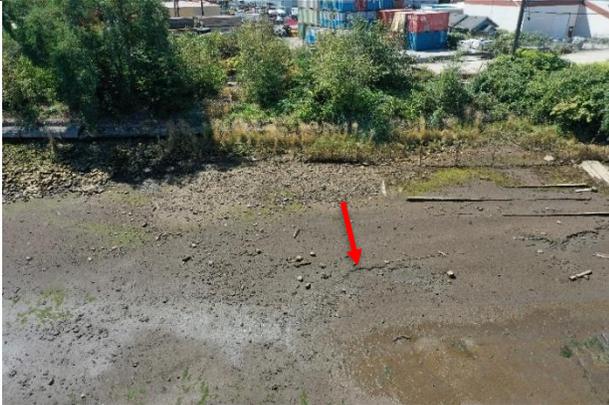
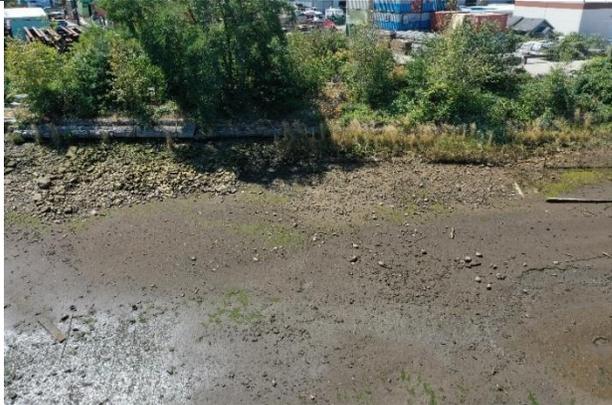
Project	Lower Duwamish Waterway Middle Reach PDI Phase II		Date	July 22, 2024
Crew	Anchor QEA			
RAL Exceedance Area	Phase I: 5		Time	13:38
	Revised in Phase II: 6 and 8			
Transect(s)	C		Tide	-2.4 ft MLLW
Sediment Thickness				
Probing Location	Probing Depth	Refusal	Assumed refusal Reason	Notes
Edge of concrete debris 0 ft:		No refusal	NA	Broken armoring that transitions into gravel to soft sediment with algae over top.
5 ft:		1.5 ft	Compact sediment	
10 ft		No refusal	NA	
Bank Features Inspection				
Class	Present (Y/N)	Notes		
Woody Vegetation	Y	Shrubs (Himalayan blackberry, Japanese knotweed, and English ivy) and trees (black locust, Lombardy poplar, black cottonwood, scouler willow, Douglas fir, white spruce, and red alder) at top of bank		
Bank Armoring	N			
Above ground Utilities	N			
Debris	Y	Wood and concrete debris		
Structures	N			
Fencing	Y	Chain-link fence at top of bank		
Paving	Y	Paved trail and industrial property at top of bank behind dense vegetation

Aerial looking west showing approximate transect location		Aerial looking west

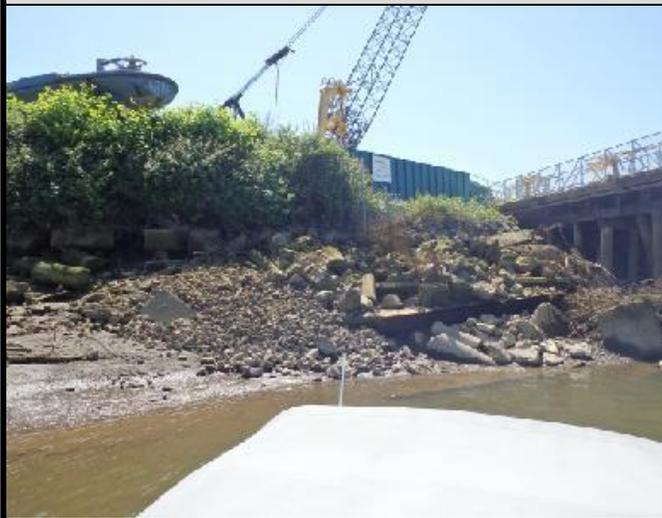
Probing Location	Probing Depth Refusal	Assumed refusal Reason	Notes
Edge of concrete debris 0 ft:	No refusal	NA	Broken concrete that transitions into gravel to soft sediment with algae over top
5 ft:			
10 ft

Class	Present (Y/N)	Notes
Woody Vegetation	Y	Shrubs (Himalayan blackberry, Japanese knotweed, and English ivy) and trees (black locust, Lombardy poplar, black cottonwood, scouler willow, Douglas fir, white spruce, and red alder) at top of bank
Bank Armoring	Y	
Above ground Utilities	Y	Utility pole at top of bank
Debris	Y	Wood and concrete debris
Structures	Y	Timber Wharf; industrial equipment, containers, and vessel storage at top of bank behind vegetation
Fencing	Y	Chain-link fence at top of bank
Paving	Y	Paved industrial property upland
Other	N

RAL Exceedance Area 5 looking east

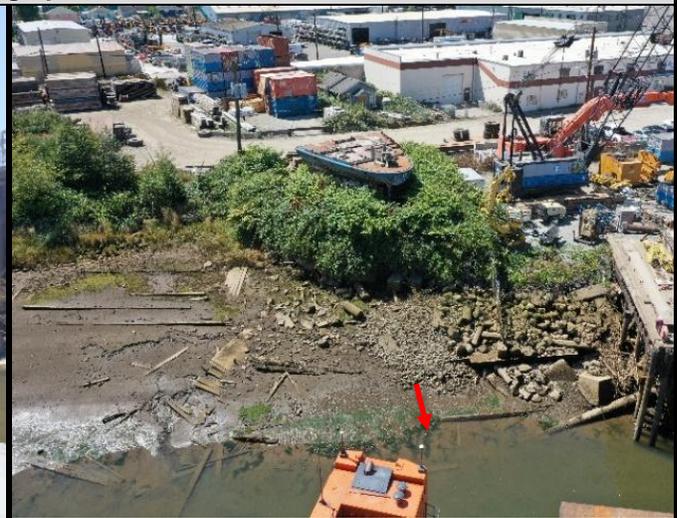
Aerial looking West showing approximate transect location
