Appendix G

Topographic Survey Data Report and Bank Features

This appendix presents detailed information related to the topographic surveying activities conducted as part of the Lower Duwamish Waterway upper reach Phase II Pre-Design Investigation (PDI), as described below:

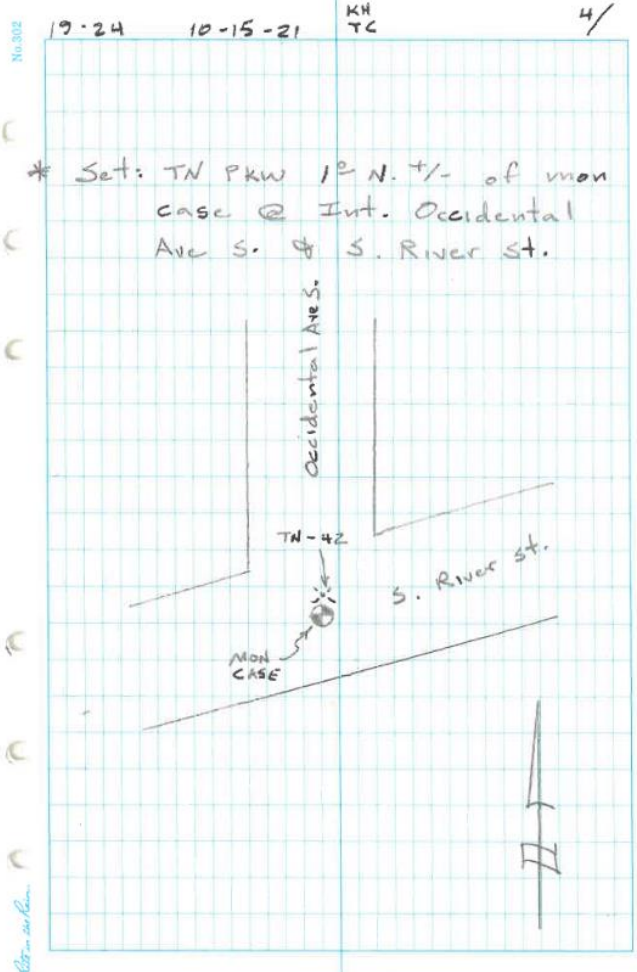
PT	Rod	Code	Desc
CP-42	ZM	PKW

N: 201801.3310
 E: 1270041.6060
 EL: 12.365 (NAVD88)
 EL: 14.705 (MLLW)
