Appendix F

Structures Inspection Forms

Sediment Cleanup of Upper Reach of Lower Duwamish Waterway, Phase I/II

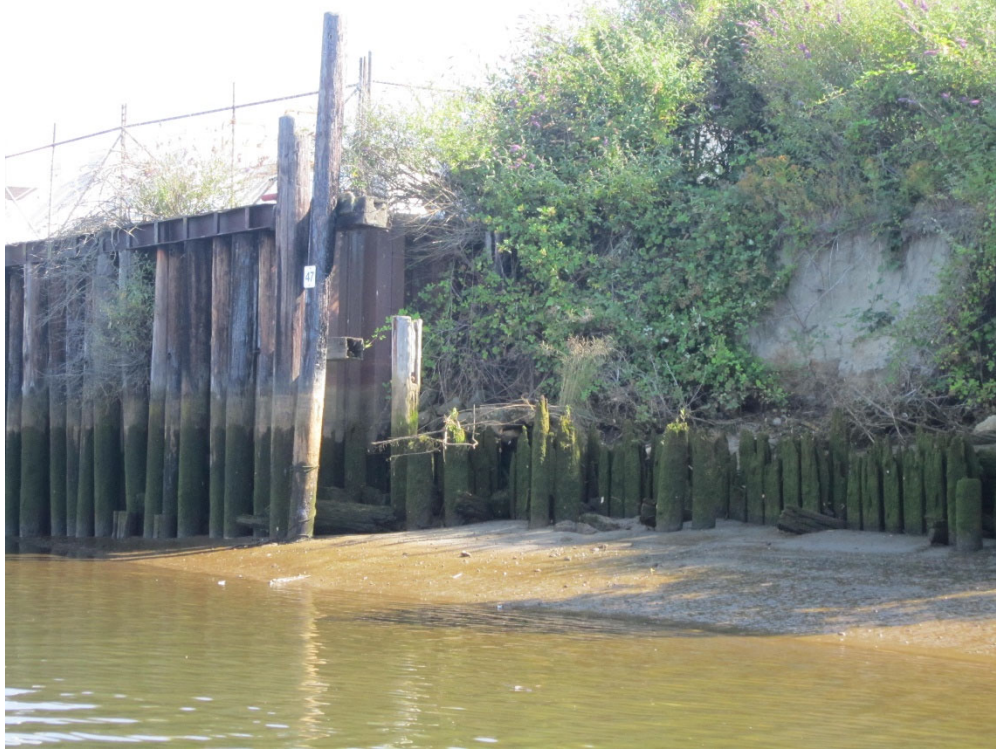
Photo ST03-19

- Steel sheet pile bulkhead with timber fender pile (Photo 18).
 - Timber piles and lagging (Photo 19 to 25).
- Close observation was conducted where possible. However, except for the two relatively new segments of steel pile bulkheads (Photos 2, 6, and 7) which appear to be in good condition, the remainder of the bulkhead segments are in various states of indetermination.

- In the bank, protection consists of closely spaced timber stub piles with timber lagging behind the piles (Photos 19 to 25).
- The tops of the piles are generally rotted or splintered, but the lower sections appear sound (Photos 20 to 25).
- Lagging in a number of areas are rotted and soil erosion through the bulkhead was observed (Photos 22 to 25).
- Pile embedment and the condition below mudline are not known.

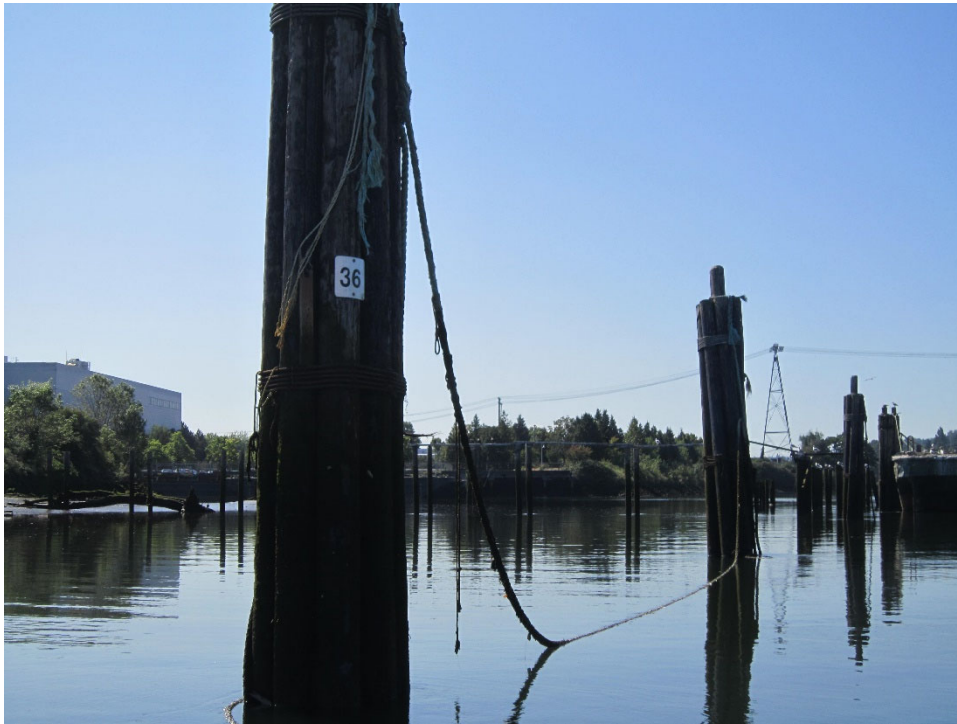
- Along the south and west side of the pier are several 7-timber treated pile dolphins; some are missing piles. The dolphins are still in use (Photo 1, 2, and 5).
- The cluster of piles are strapped together with a combination of fiber and/or strand wire rope. Some straps are broken or missing (Photos 5 and 6).
- Some piles are eroded and have lost material thickness. However, the core appear to be sound (Photo 7).

Photo ST04-05: Dolphins

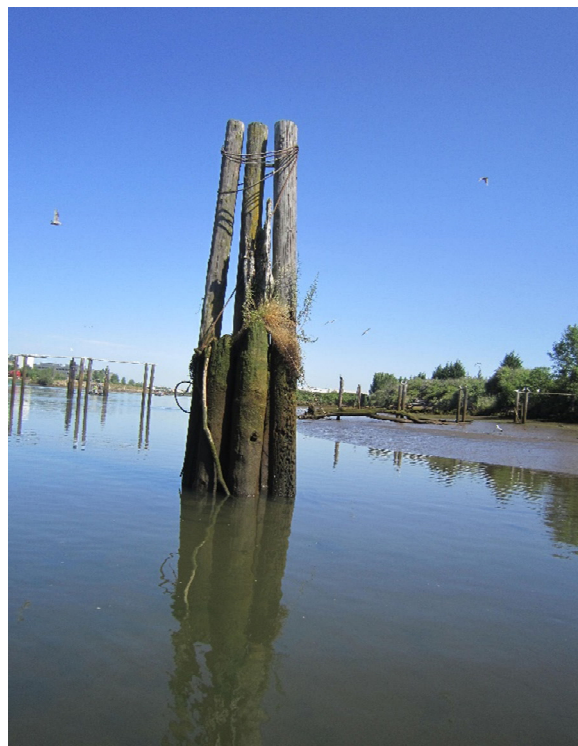
Photo ST04-06: Dolphin

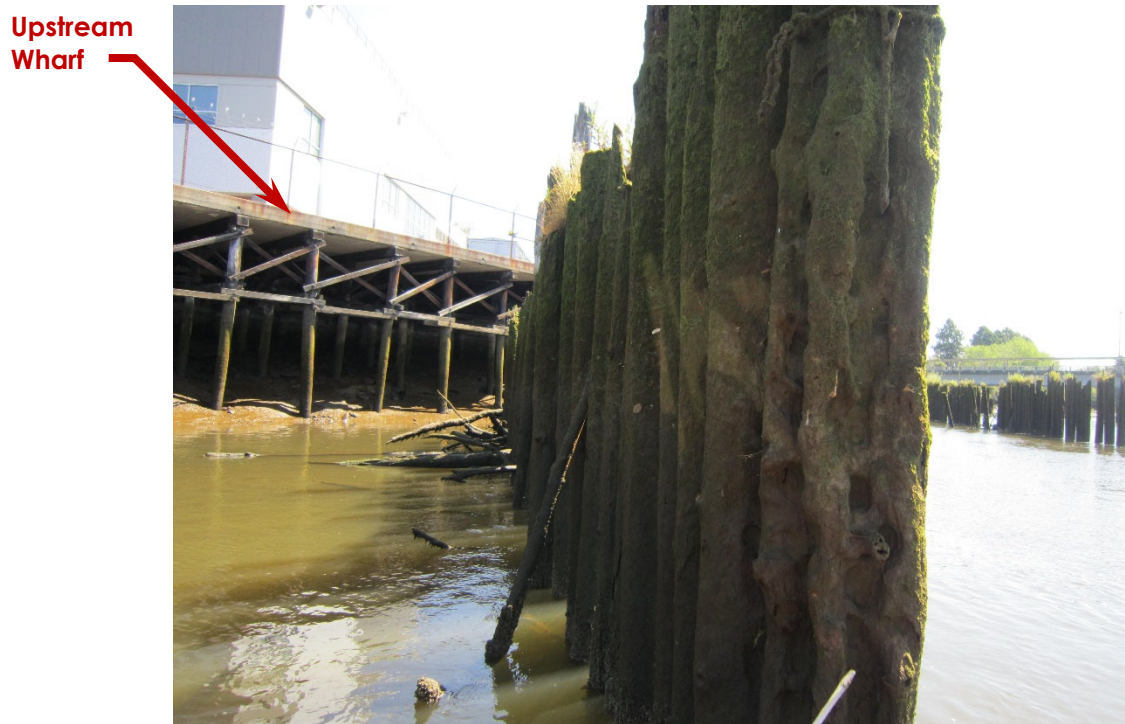
Photo ST07-06: Larger Wharf at Low Tide

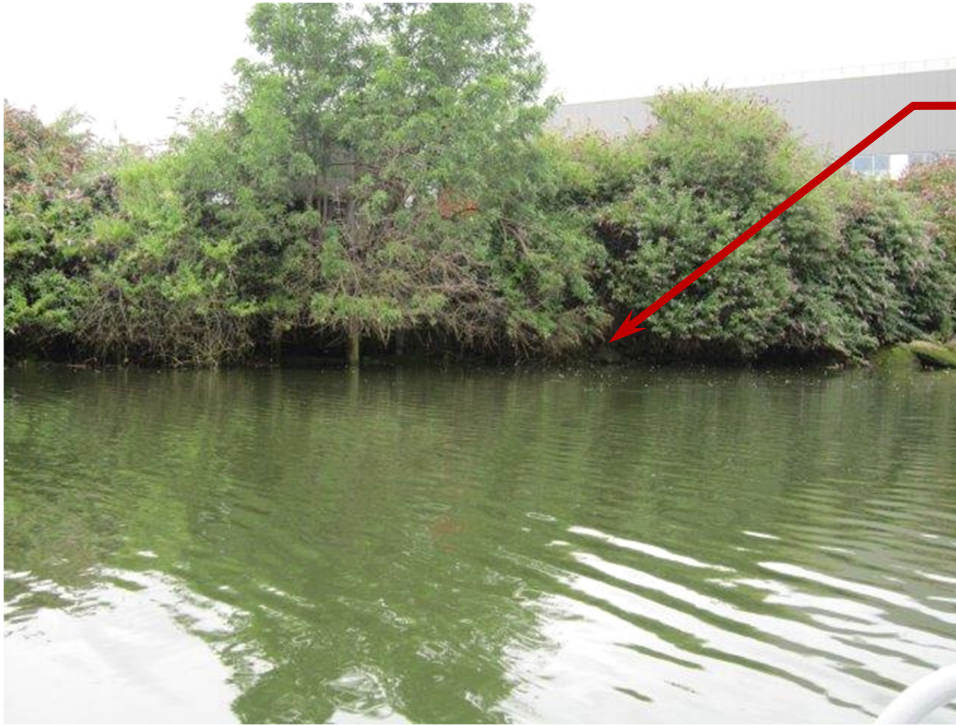
Photo ST07-07: Timber Bulkhead

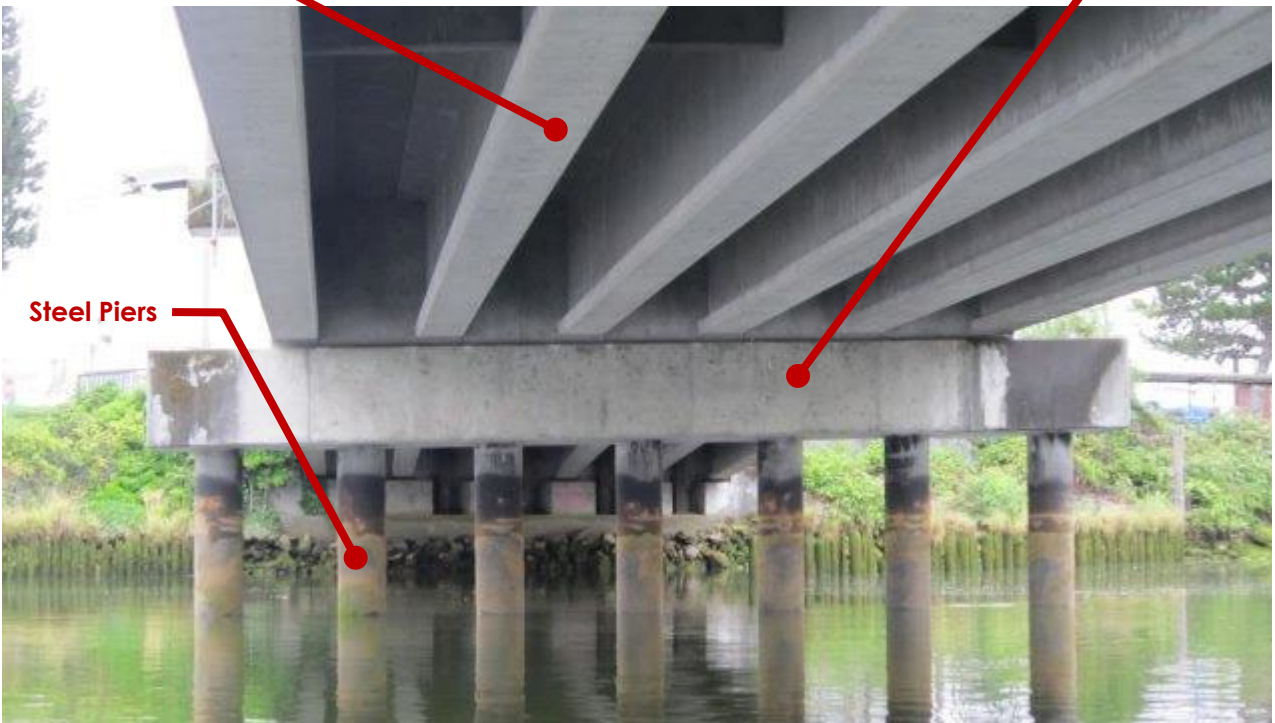
Photo ST08-04: East Bent (Looking East)

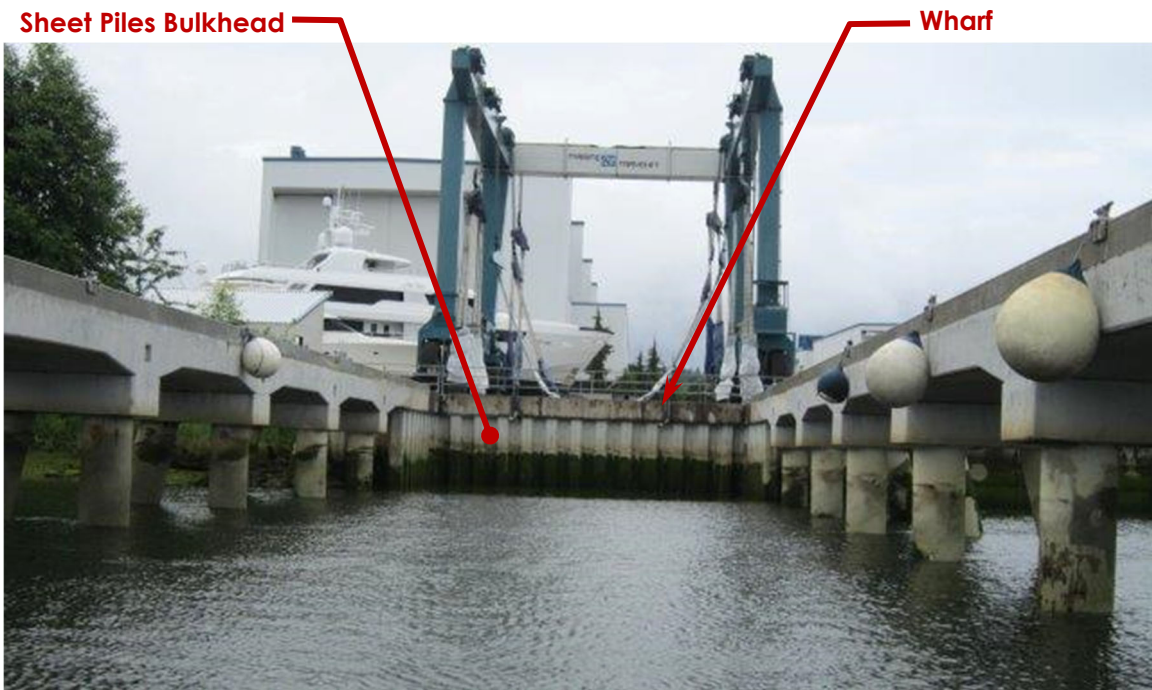
Photo ST12-02: Finger Piers (Looking West)

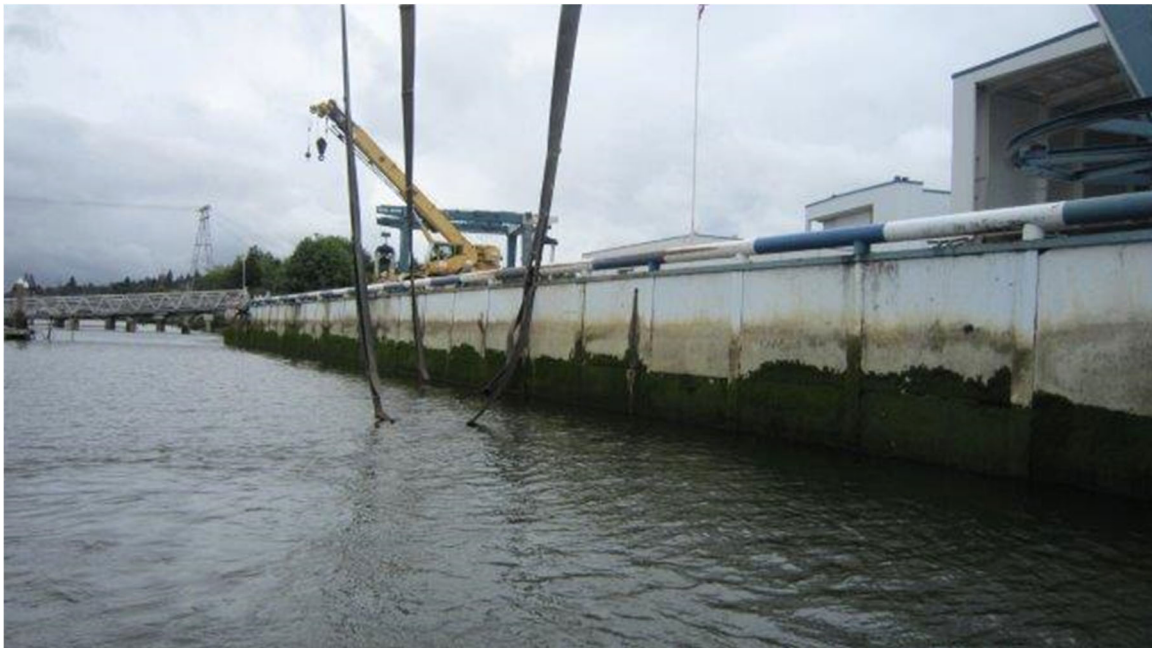
Photo ST12-08: Bulkhead Among Wharf

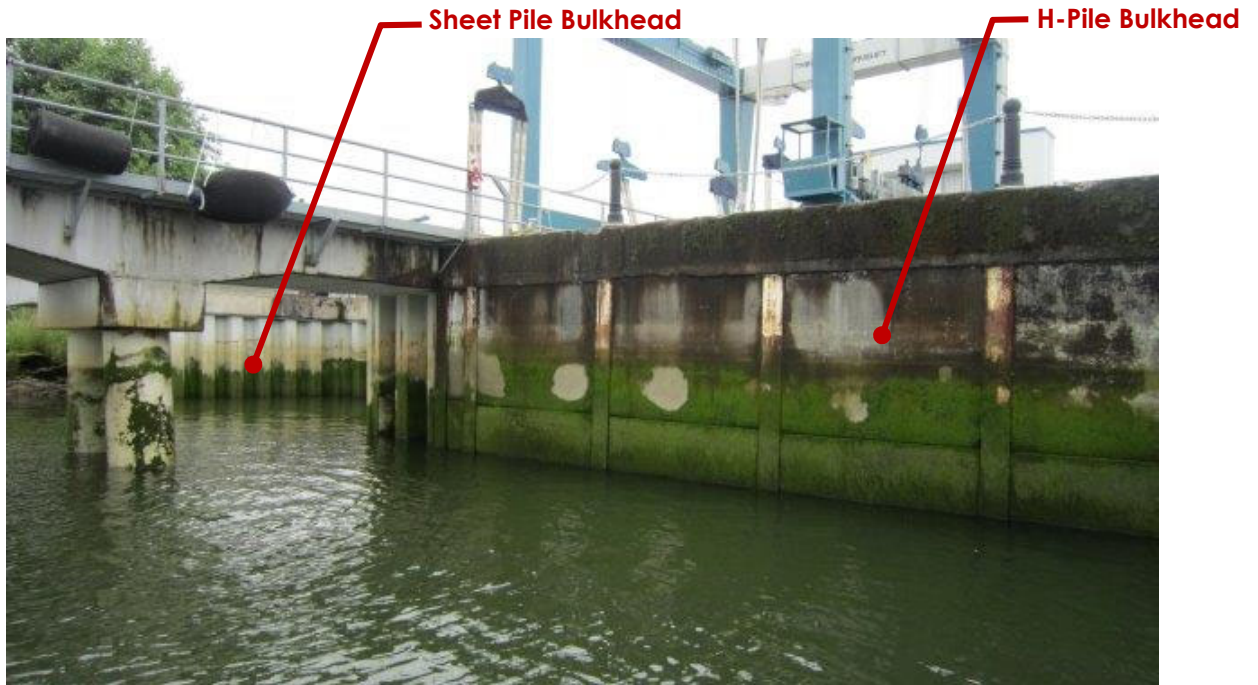
Photo ST12-09: Bulkhead

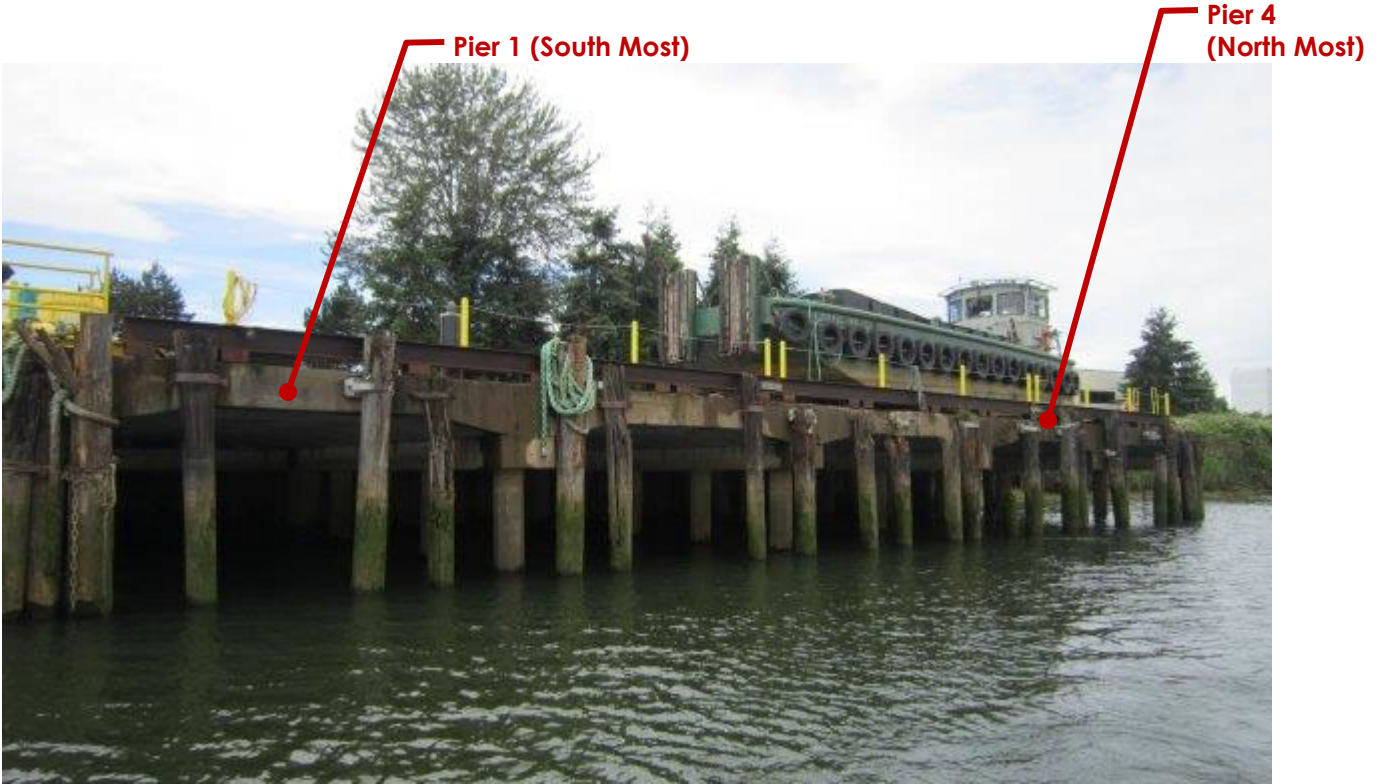
Photo ST16-01: Pier Configuration

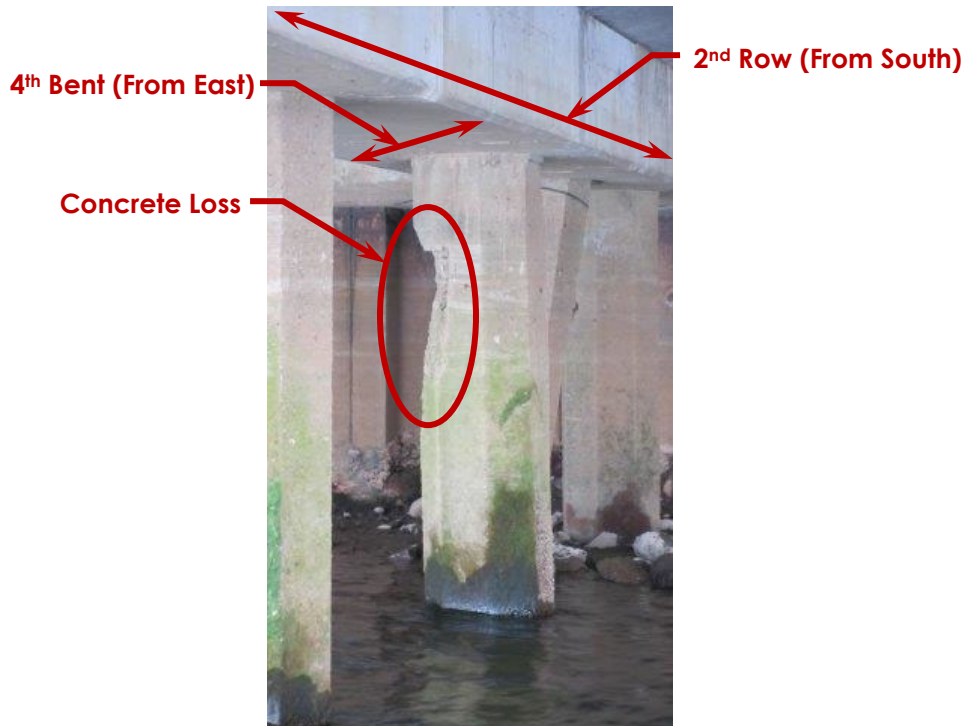
Photo ST16-07: Concrete Piles (Looking Southwest)

- A close observation of the steel sheet pile and concrete cap was not possible. There appears to be moss growth and rust in the wet/dry zone of the sheet pile (Photos 7, 10, 12, 14, and 15).

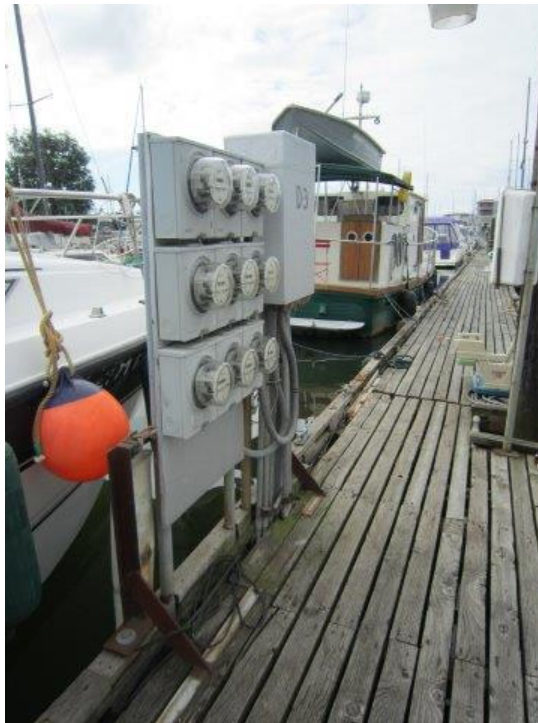
Photo ST20-014: Utilities

- The walkway, docks, and finger piers timber decking are worn and weathered. A number of planks appear to have been replaced, missing, re-fastened. Except for scattered dead or lost knots and checks no evidence of rot, moss growth, splinters, or perceptible deflection was observed (Photos 12 to 19).
- Utilities on the dock include power, water, and cable (Photo 14 and 15).

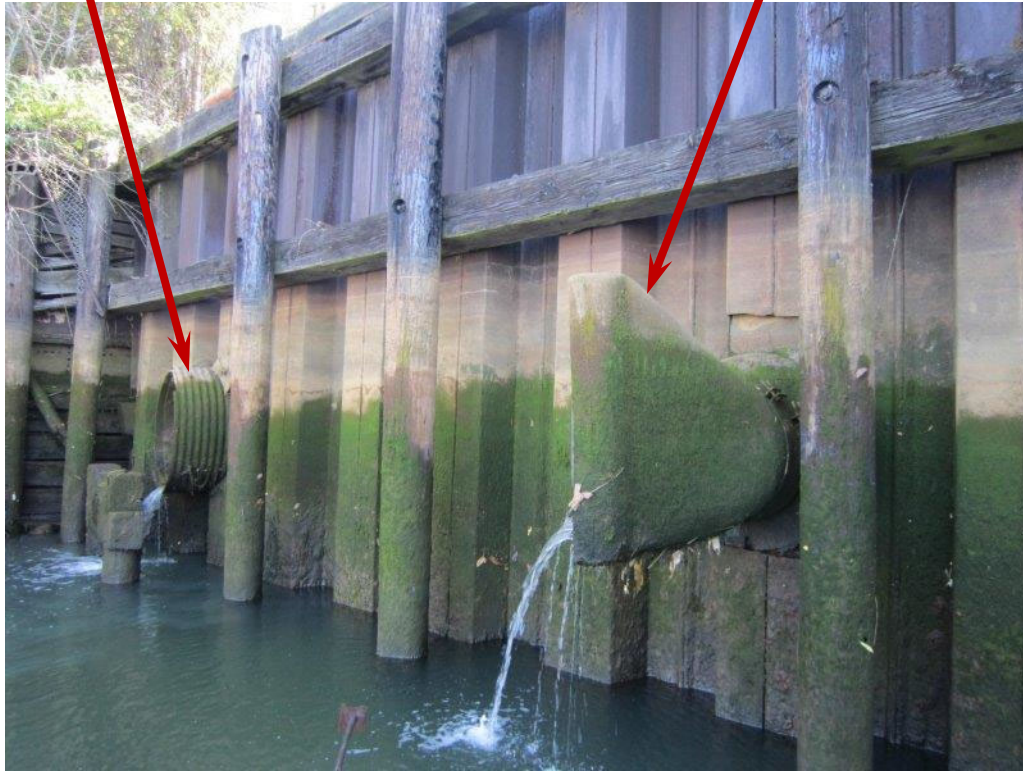
2061-01: Outfall at Low Tide

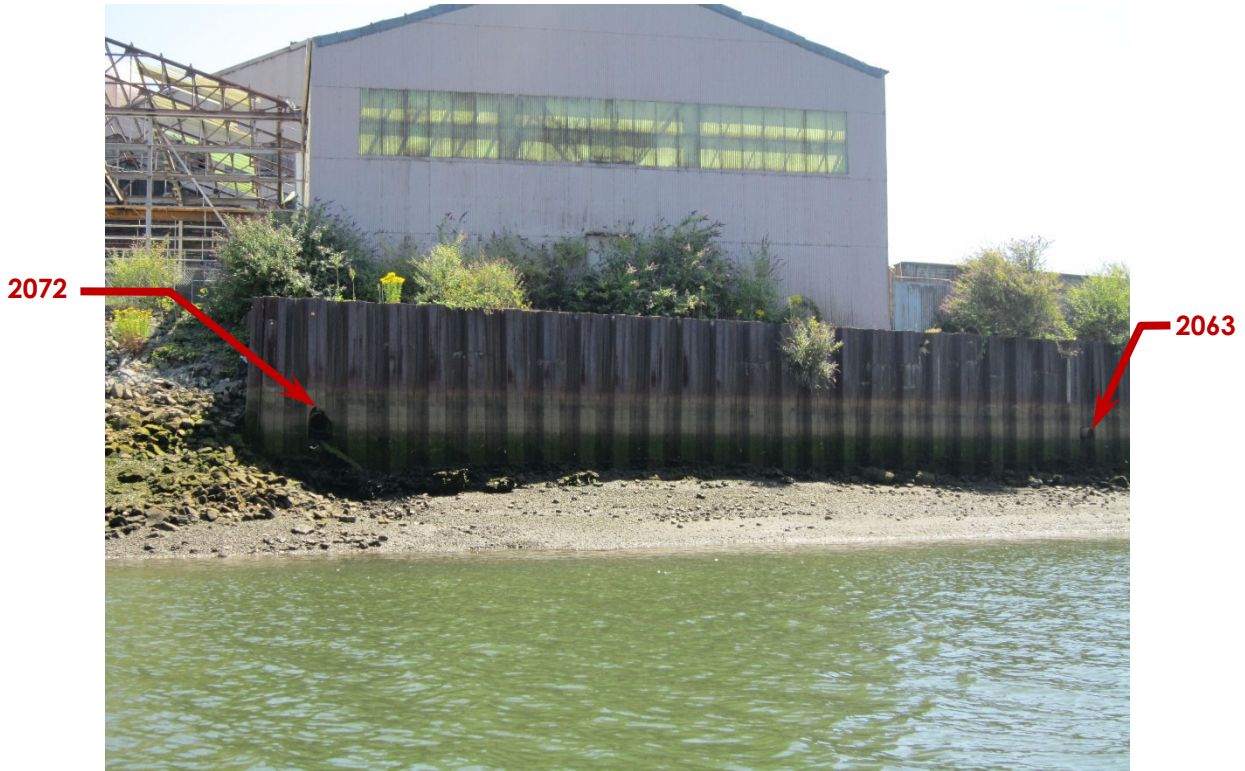
2063-01

- Outfall is 12-inch-diameter open-ended corrugated metal (steel) pipe (CMP). Pipe material is in good condition (Photos 1 to 4).
- Pipe supported by and overhangs the sheet pile bulkhead.
- Outfall is plugged with concrete and appears abandoned although slow drips were observed.

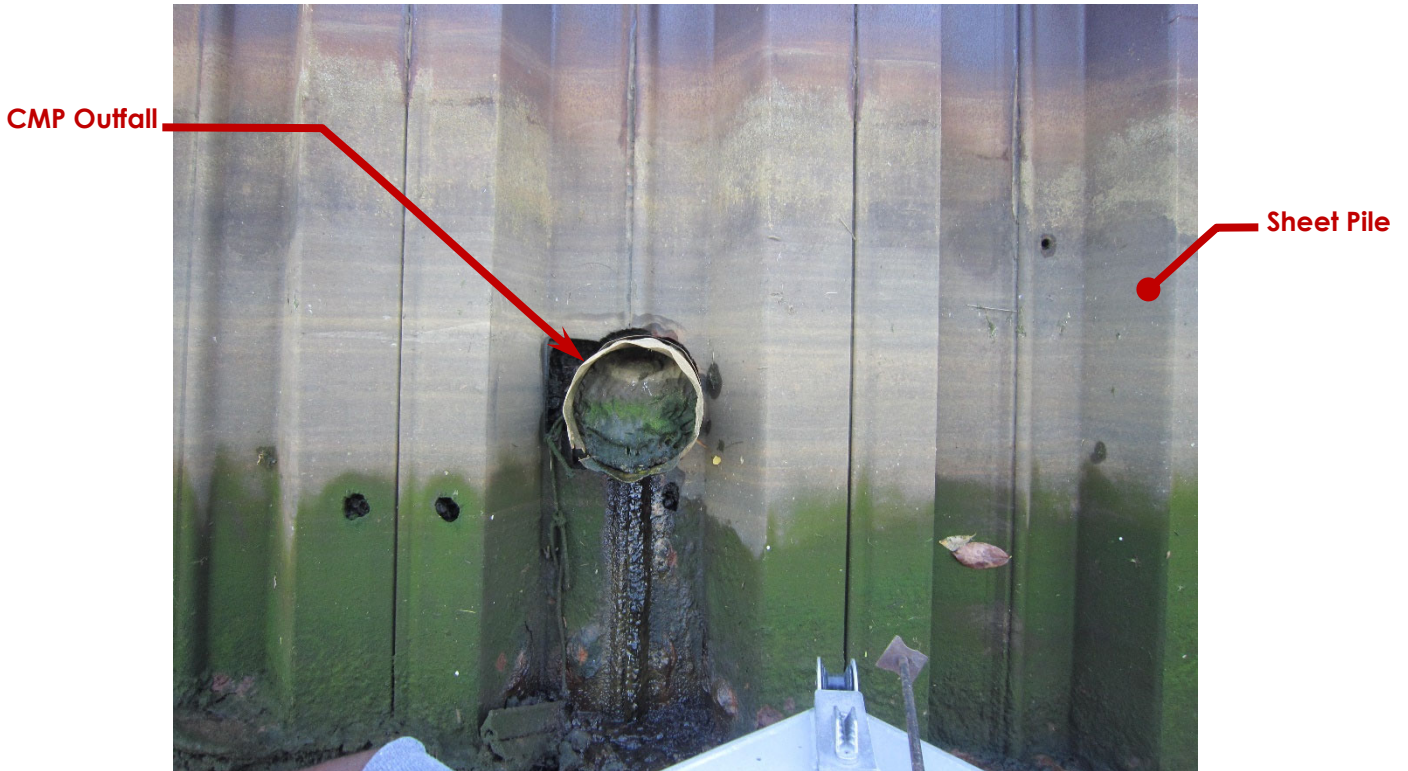
2063-03: Outfall at Low Tide

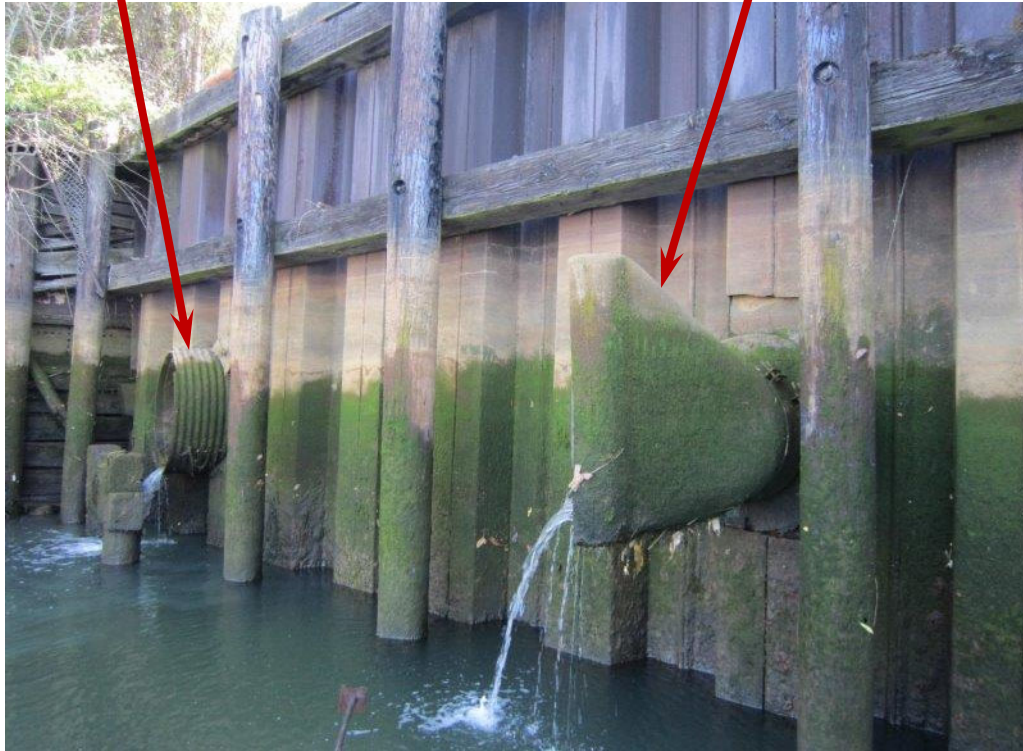
2062-01: Outfall at Low Tide

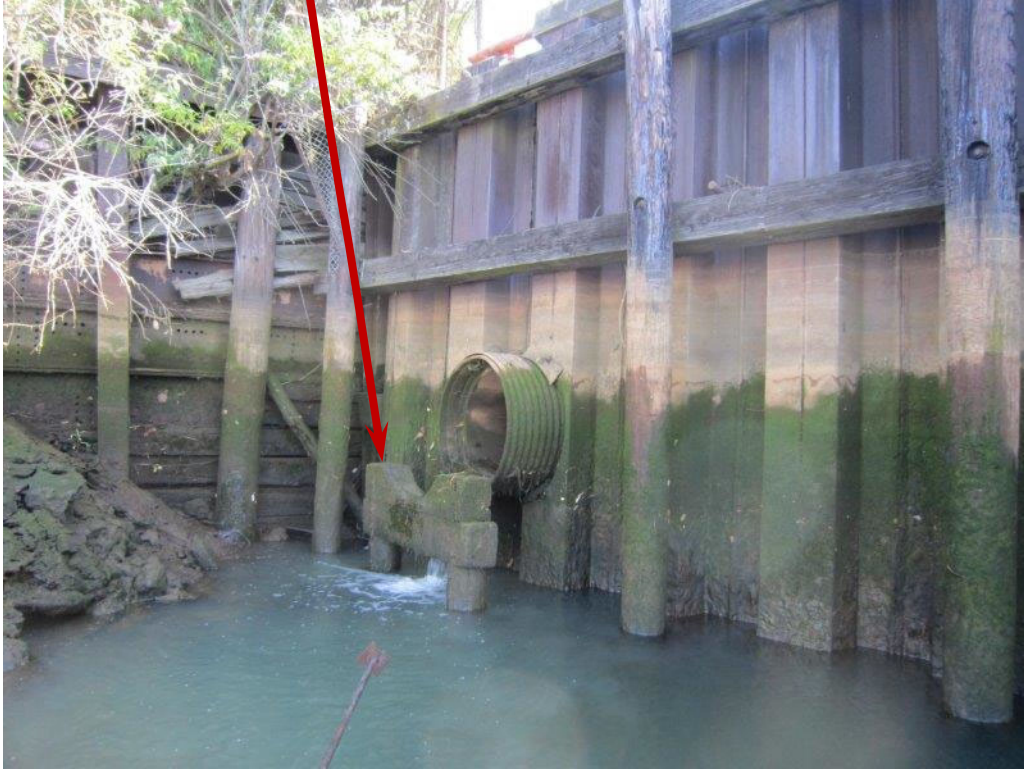
2062-03: Unused Support

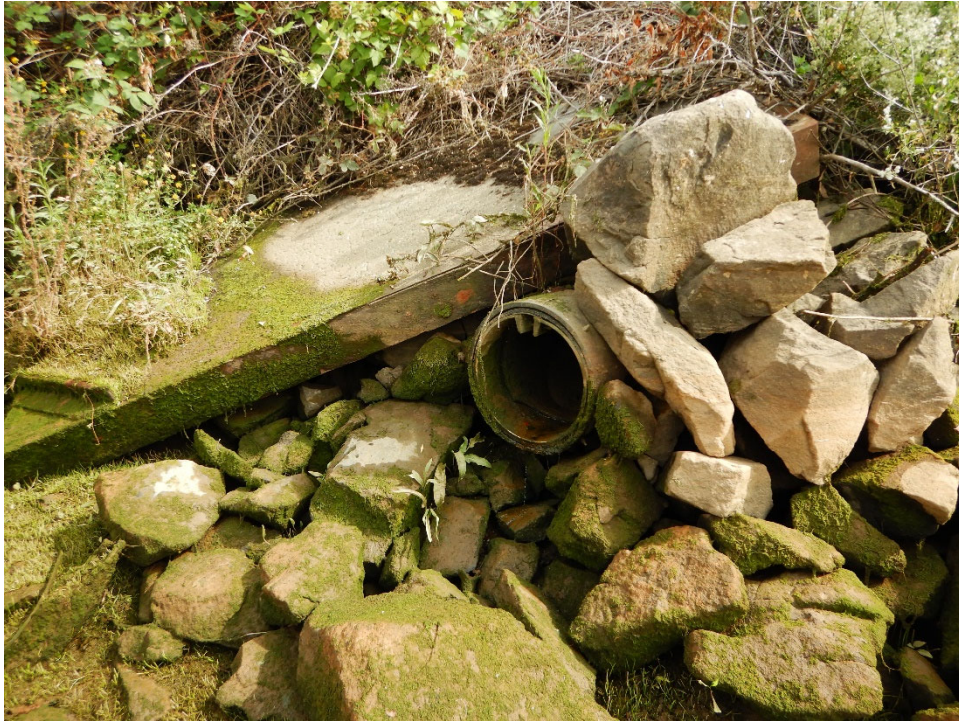
Photo 2092-03: Outfall at Low Tide

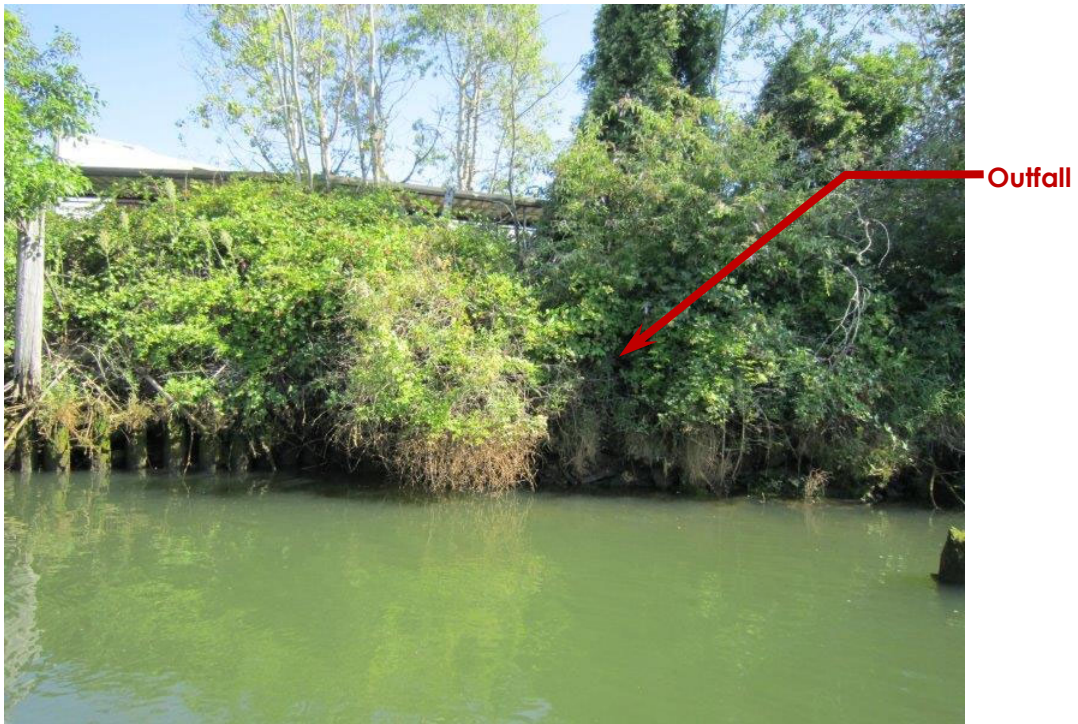
2096-01: Outfall Location

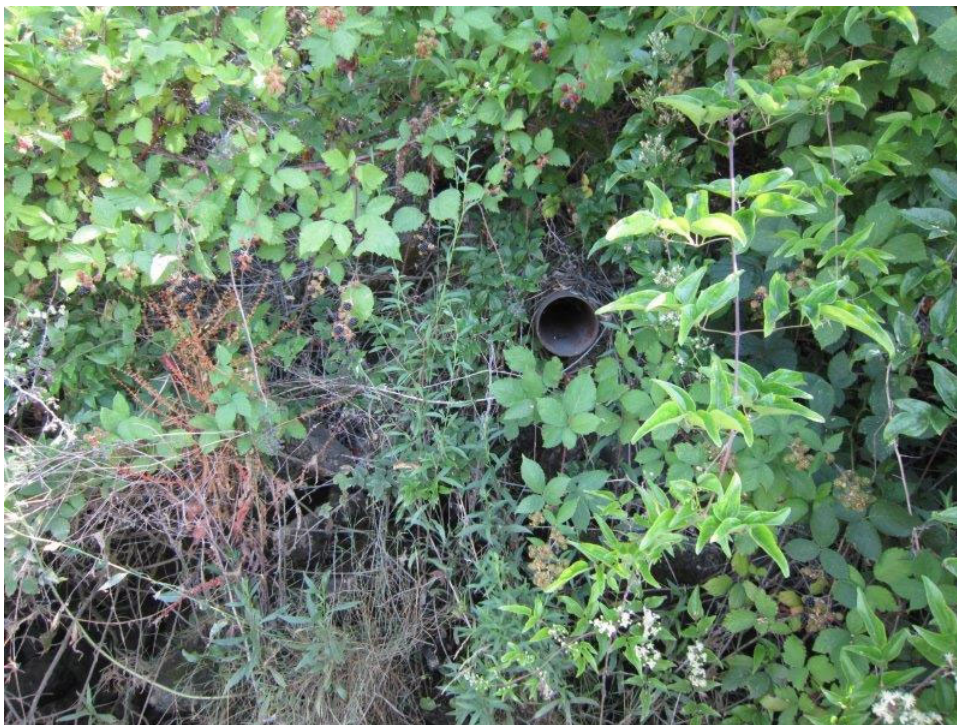
2096-02: Outfall

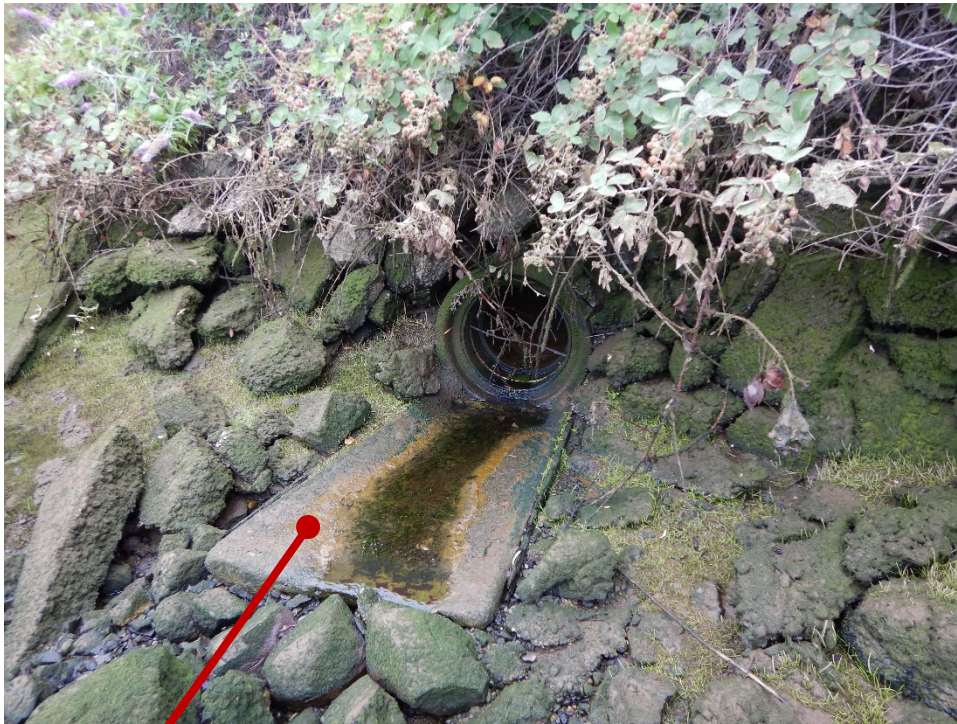
Concrete Apron

Photo 2093-05: Outfall at Low Tide

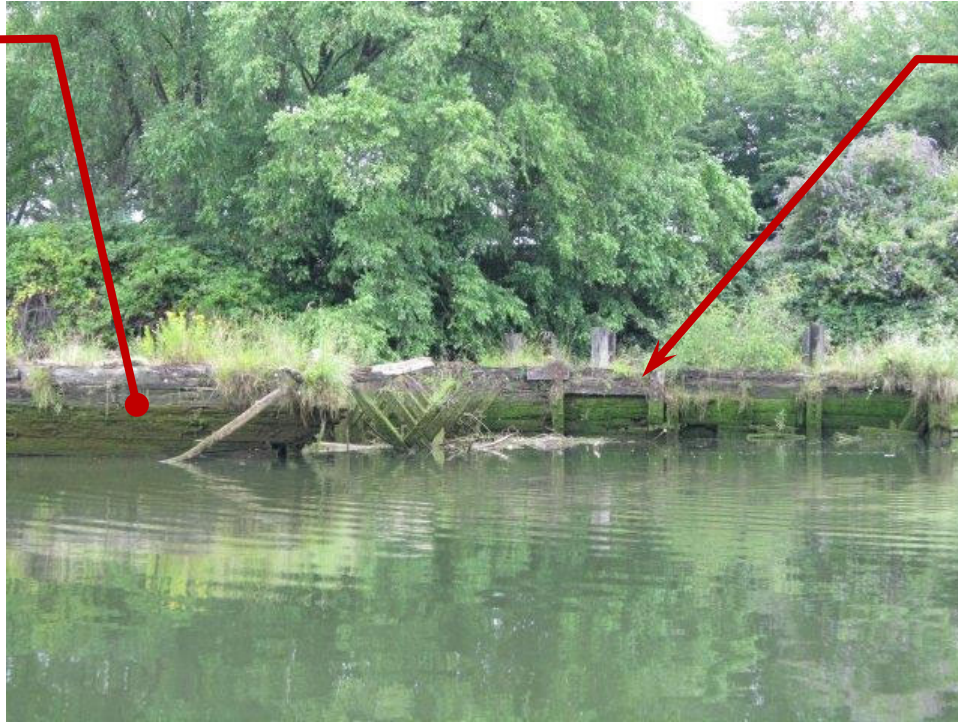
- Timber soldier pile and concrete panel lagging (Photo 1 and 2).
- Missing timber soldier piles in front of the concrete lagging. It appears that the south end of the wall is tied back or connected to a steel sheet wall. Large cracks throughout the concrete panel. Wall is in poor condition.
- Derelict timber barge or boat hull (Photos 1 and 3). The hull appears to be intact. Condition of the timber is unknown.
- Timber soldier pile and timber lagging (Photo 3).
- Missing, broken, or unfound timber piles and lagging.

Photo ST09-03: Timber Barge and Bulkhead (Looking East)

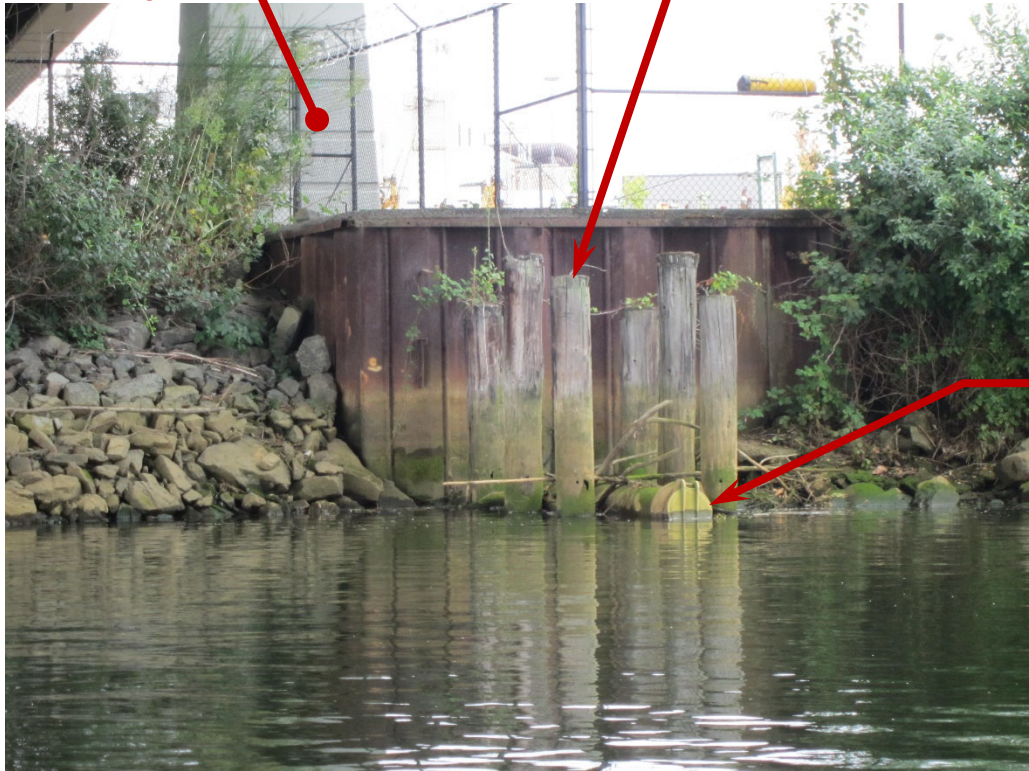
- The outfall is located under and almost directly west of the South Park Bridge south pier. It projects several feet out of a 3-sided steel sheet pile bulkhead, and the projection is protected by three timber piles on the north and south sides. (Photos 1 and 2)
- The toe of the shoreline around the bulkhead is protected with riprap; however, support for the pipeline could not be observed.
- The pipeline size, material, and the condition, as well as the condition of the flap gate and timber piles, could not be observed.

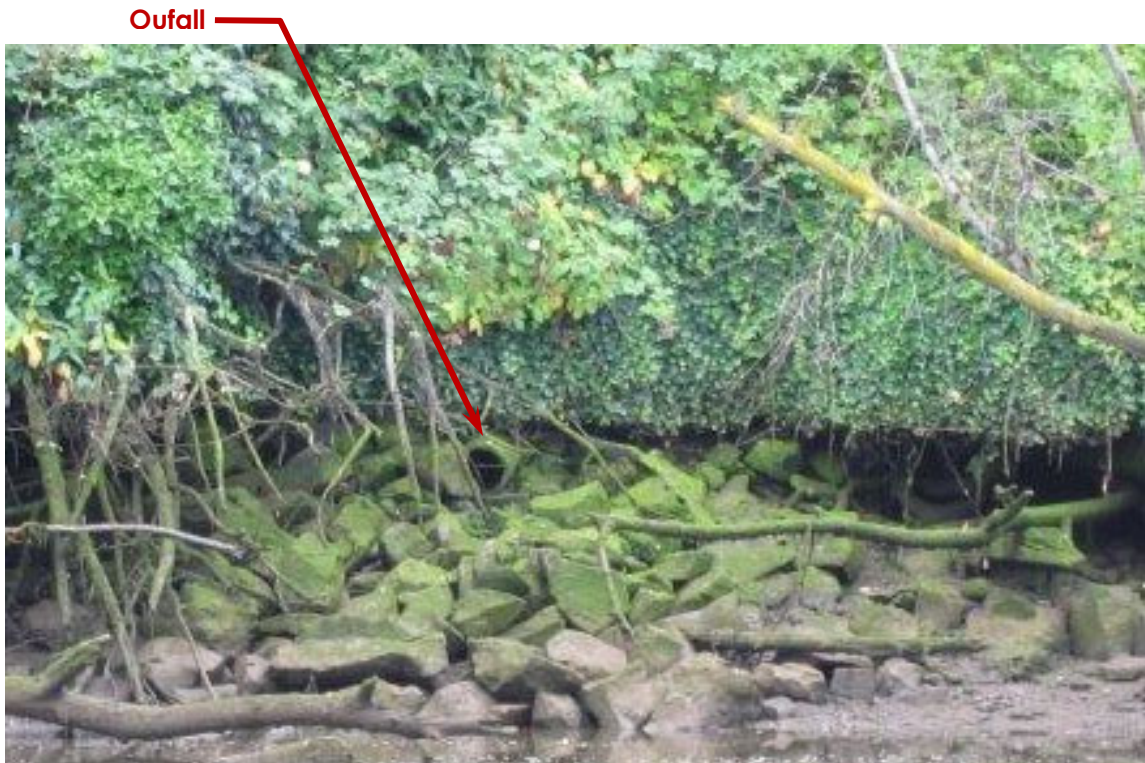
Photo SP3-02: Close Up of Outfall

- Outfall projects into the shoreline and is supported on a mound of riprap (Photos 1 and 2).
- Size, material, and condition were not observed closely.
