Appendix D

Structures Inspection Results

FACILITIES CONDITION ASSESSMENT REPORT, PHASE I/II

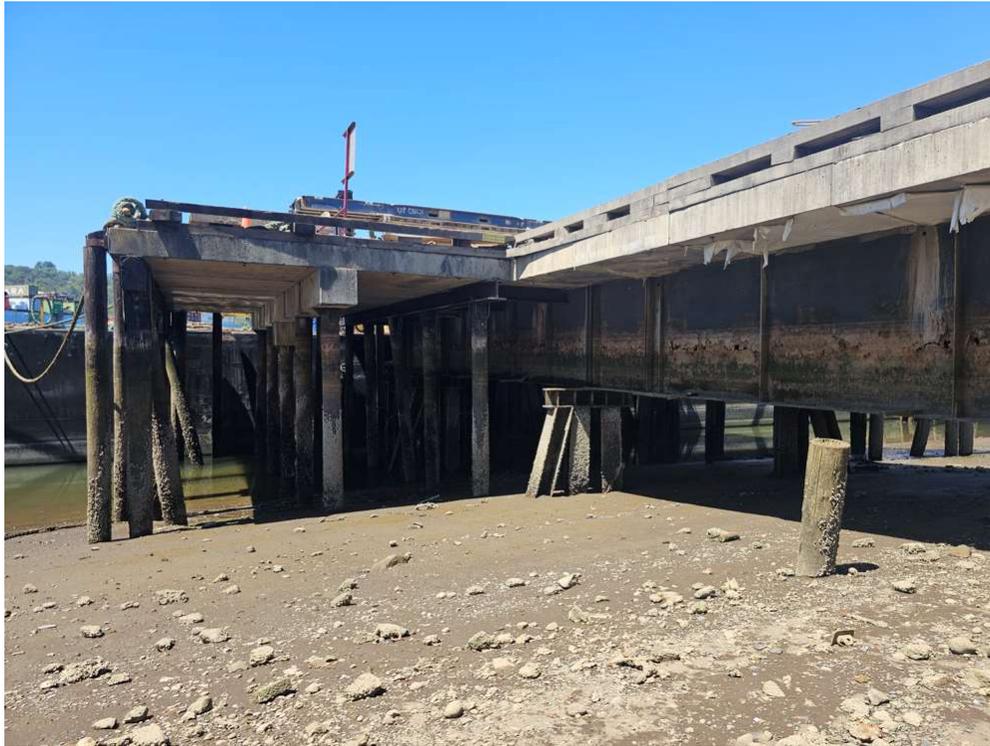
Photo ST01-03: T-Pier south side looking northwest

- The steel piles and steel pile caps are in good condition. (Photos 3 to 5)
- It appears that the concrete pile caps and concrete deck are recently constructed and are in good condition. (Photos 4 to 6)
- The plate girders are supported on braced steel piers; the abutment material could not be observed. The web of the plate girders are severely corroded and exhibit a significant loss of material. (Photos 6 to 9)
- The fender piles appear to be in good condition.
- Straddling the pier are a 7-pipe pile steel dolphin to the east and a 4-pipe pile steel dolphin to the west. The piles are in good condition. (Photo 1)
- The bank is armored with a combination of concrete apron and brick rubbles. (Photo 9)

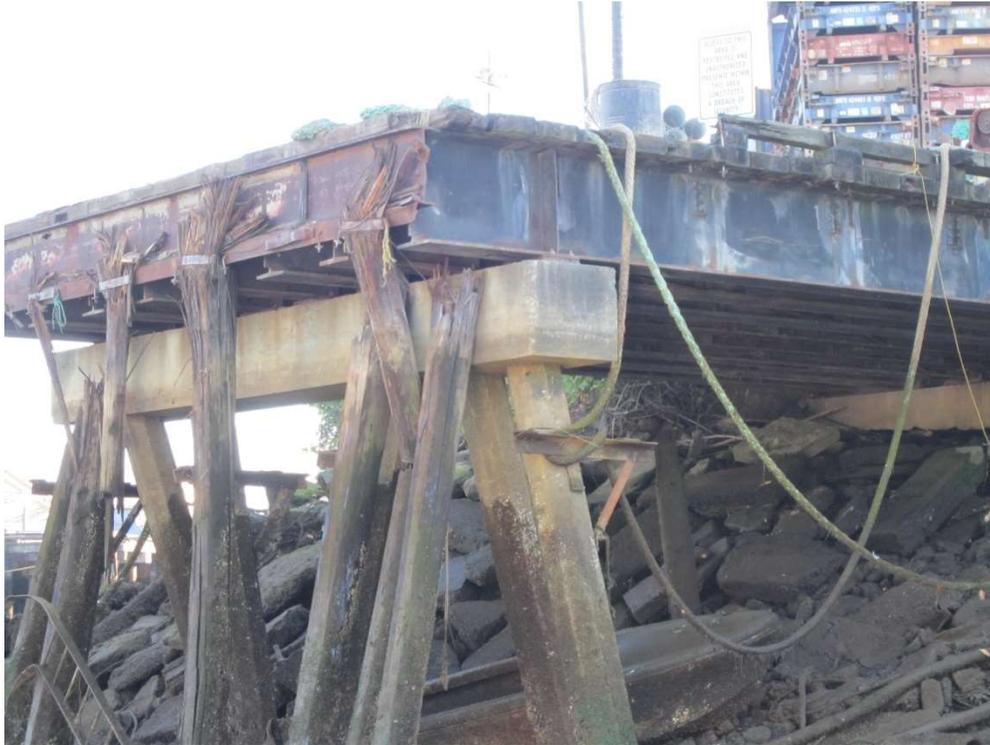
Photo ST01-11: South pier looking northeast

- The concrete piles, pile cap, and steel beams appear to be in good condition. (Photo 11)
- All timber fender piles are broken or displaced. (Photo 12)
- On the south side of the pier is a 14-pile timber dolphin, which appears to be in good condition. (Photos 13 to 15)
- The bank is armored with timber stub piles; wood debris; and a combination of concrete panels, concrete rubbles and stones.

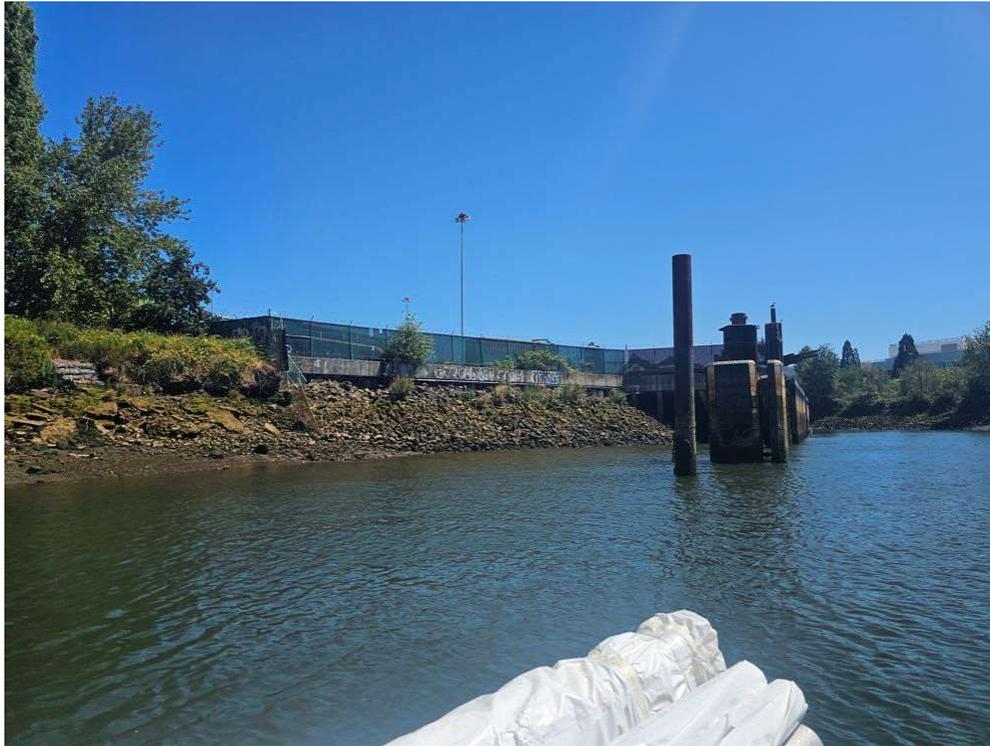
Photo ST09-01: North approach

- Bank protection: Bank protection along the shoreline and the toe of the bulkhead consists of quarry spalls, timber stub piles, concrete panels and concrete rubble. (Photos 1 to 5, 9, and 15 to 21)

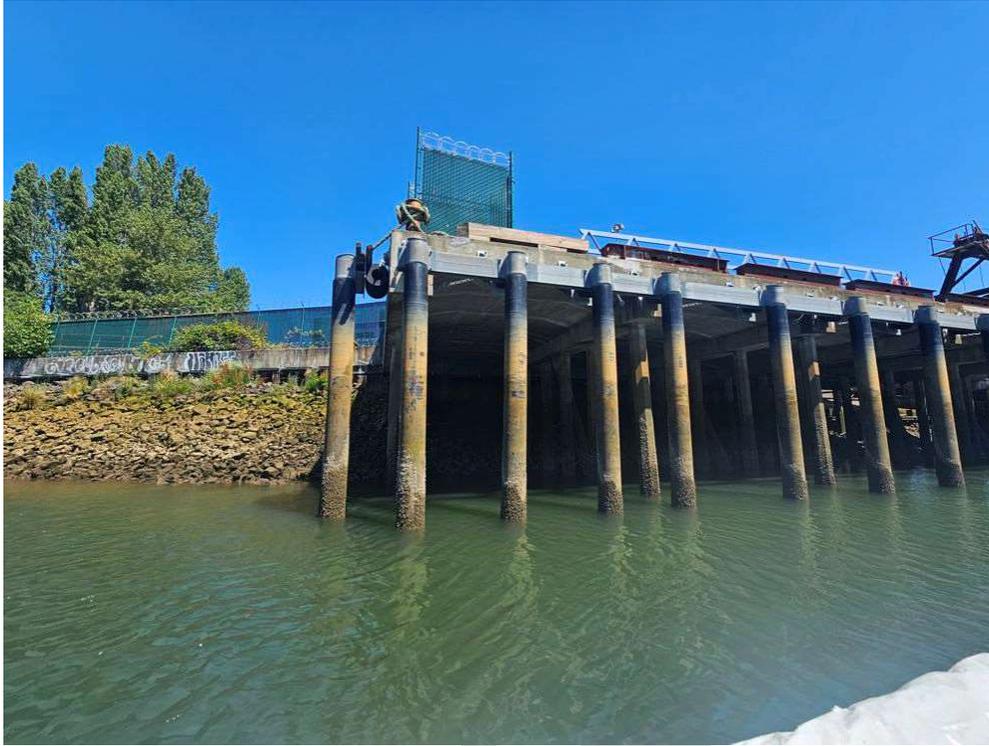
Photo ST09-05: NW-SE leg

- Haunched concrete deck panels: The soffit surface of the deck panels appear to be in good condition. Deck topping material was not observed. A number of pipes and conduits are supported under the deck. (Photos 5 to 16)

- Concrete pile caps: The caps appear to be in good condition. (Photos 5 and 10 to 16)
- Octagonal prestressed piles: The piles appear to be in good condition. (Photos 5 to 16)

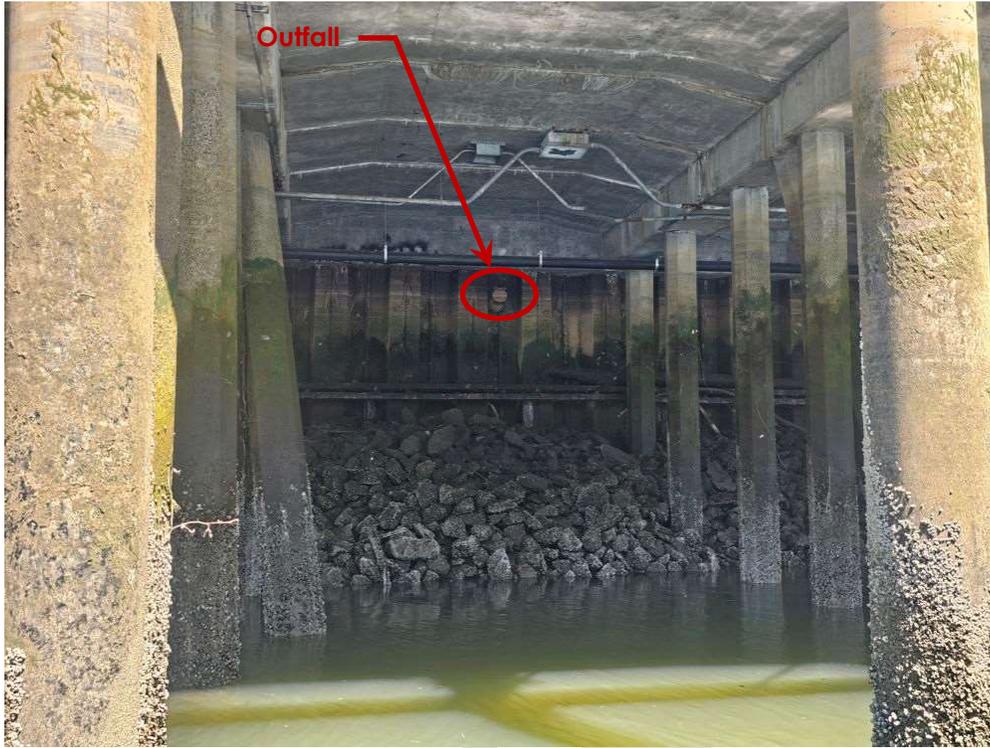
Photo ST09-23: Outfall

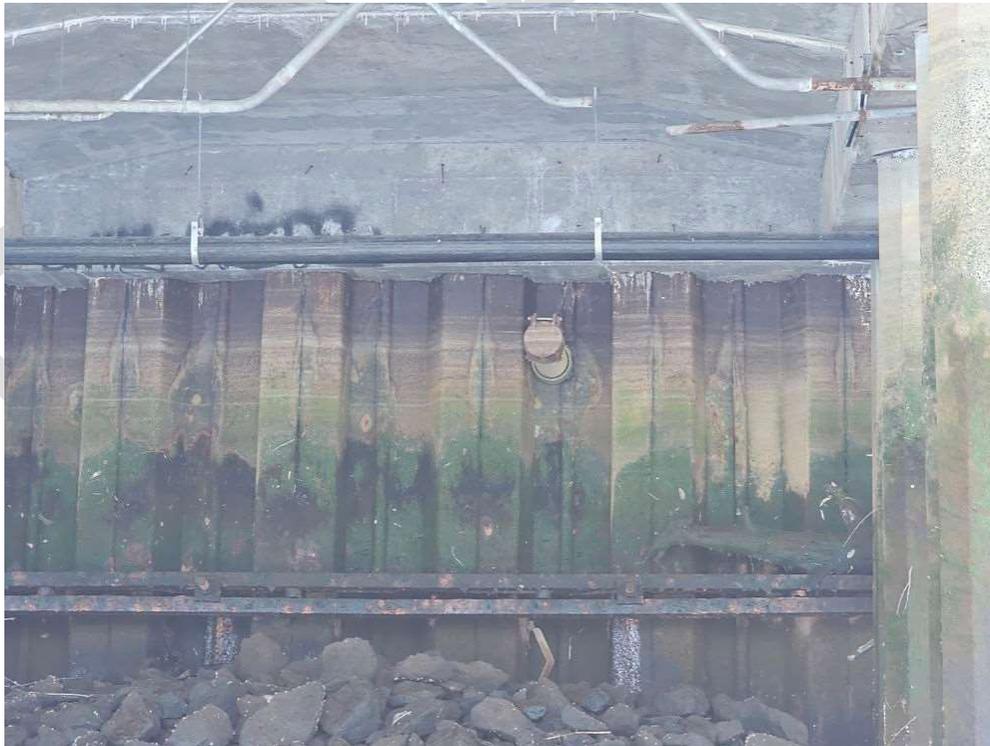
Photo ST09-24: Enlarged Outfall

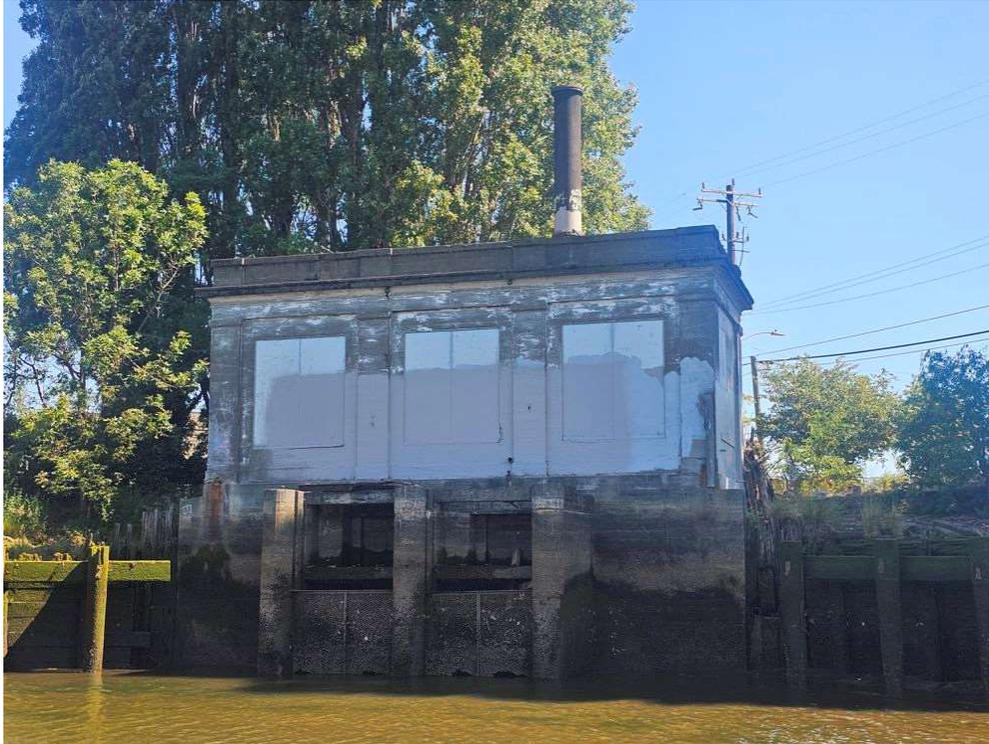
Photo 11: Intake structure

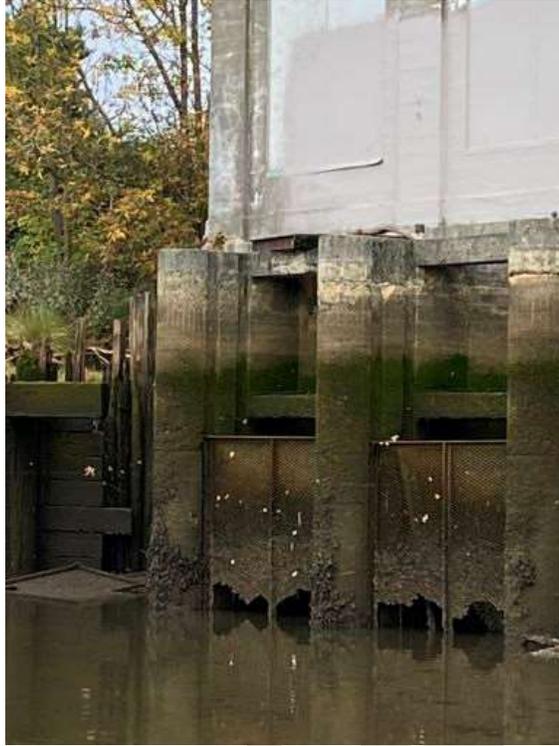
- This is classified as an historic concrete building and may not be modified.
- Inspection was limited to the south side of the building, which is accessible by land side and along the bank at low tide. The interior of the building was not inspected.
- The concrete surface of the structure exhibits some wear, weathering, and loss of concrete mortar in the tidal zone, but appears to be in good condition. (Photos 11 , 12, 17, and 25)
- The metal screen at the two intakes are worn, especially at the bottom sections. (Photo 17)

Photo ST10-17: Intake Screen

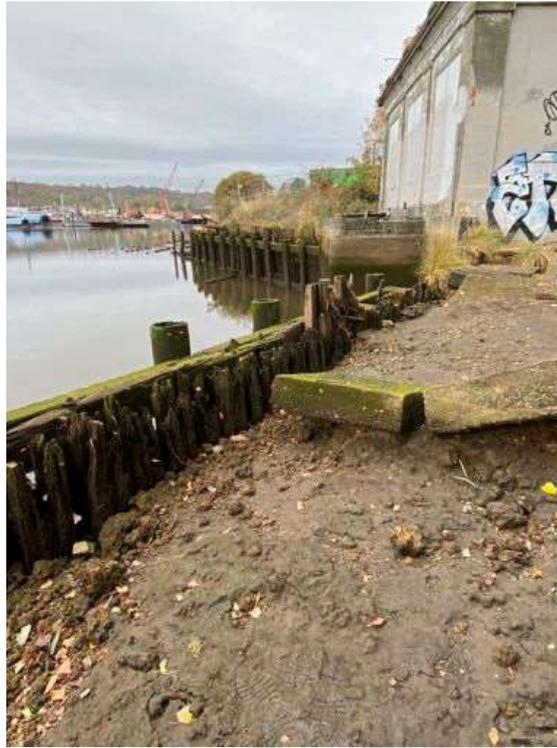
Photo ST10-25: Path looking north

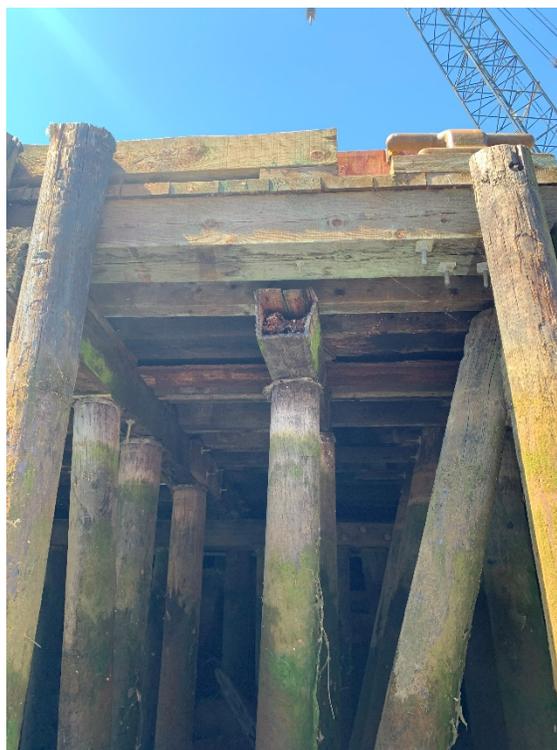
- Many repairs and timber spacer blocks could have potentially changed the load path.
- Many timber cross beams have signs of rot and section loss. Extent of rot is not detectable by visual inspection and requires further testing.
- Many piles do not reach up to the cross beams, and timber blocks have been placed in the space between. This could impact the connection between the pile and cross beam, and place additional loads on the other piles.

Photo 2: Timber cross beam section loss

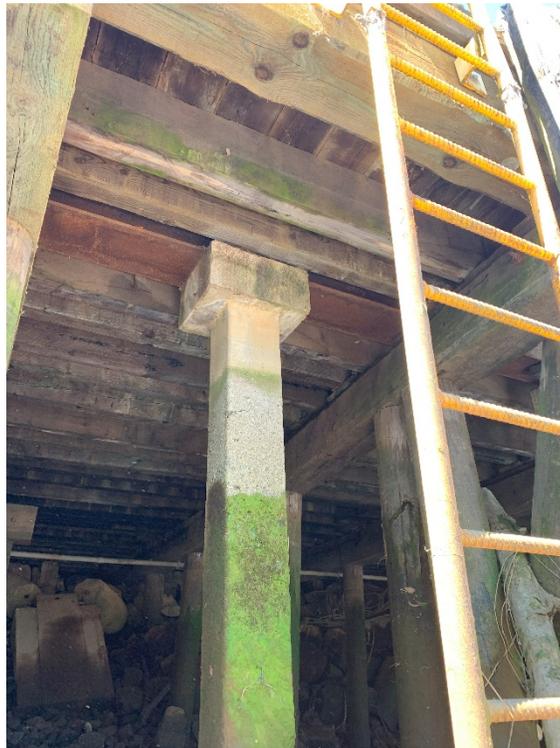
Photo 3: Concrete support pedestal

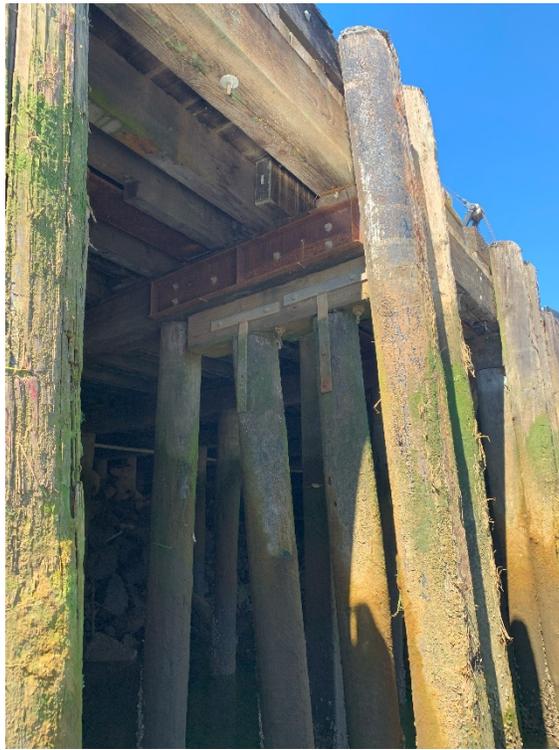
Photo 5: Timber cross beam reinforcement

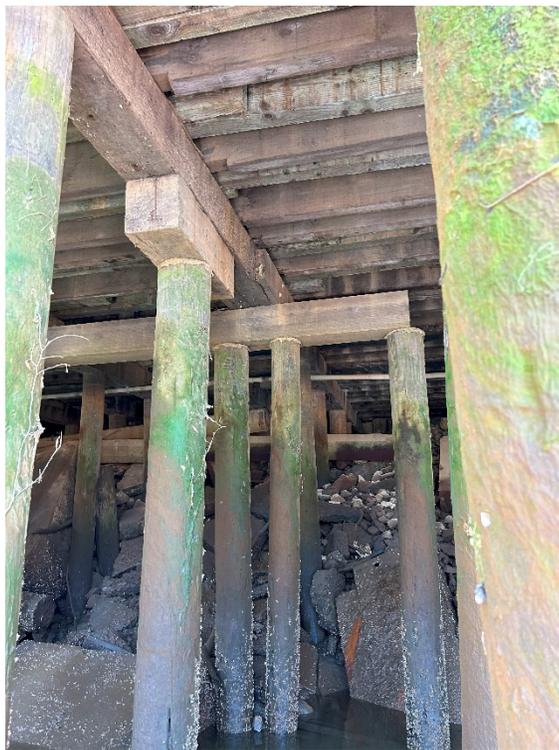
Photo 6: Additional cross beam support

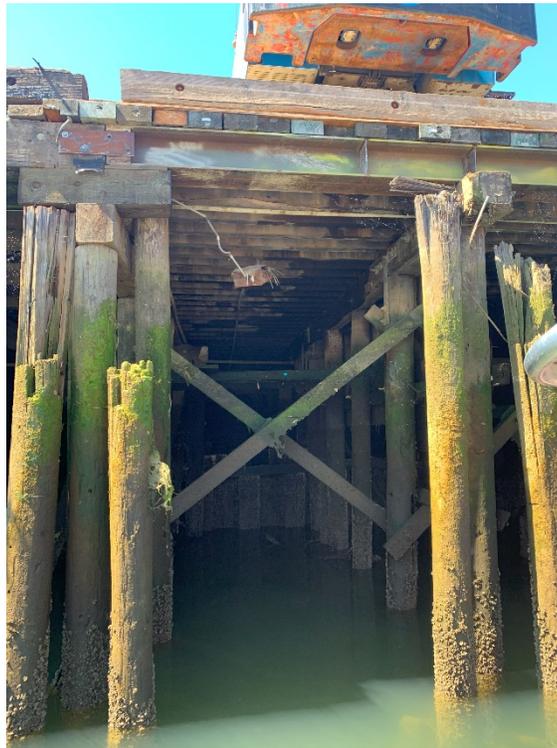
Photo 7: Typical bay

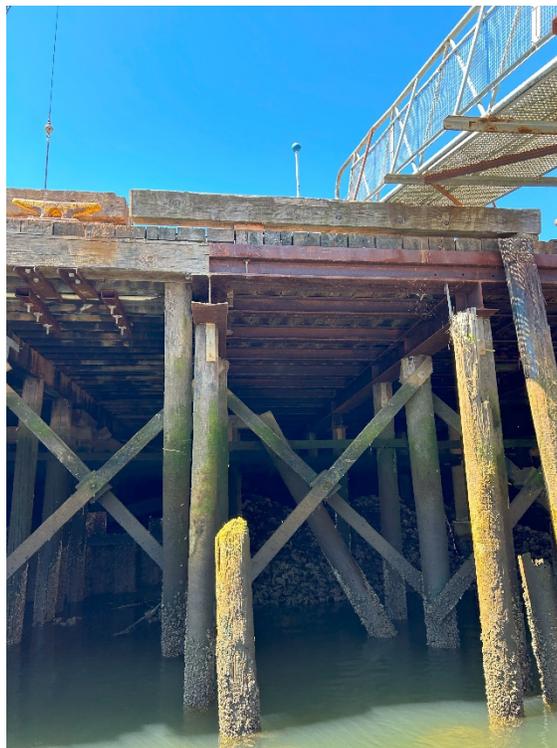
Photo 8: Transition from timber to steel span

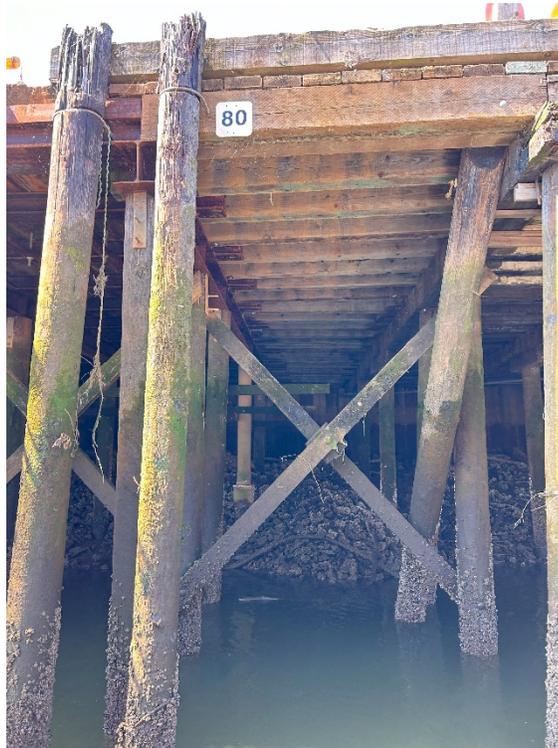
Photo 9: Transition from steel to timber span

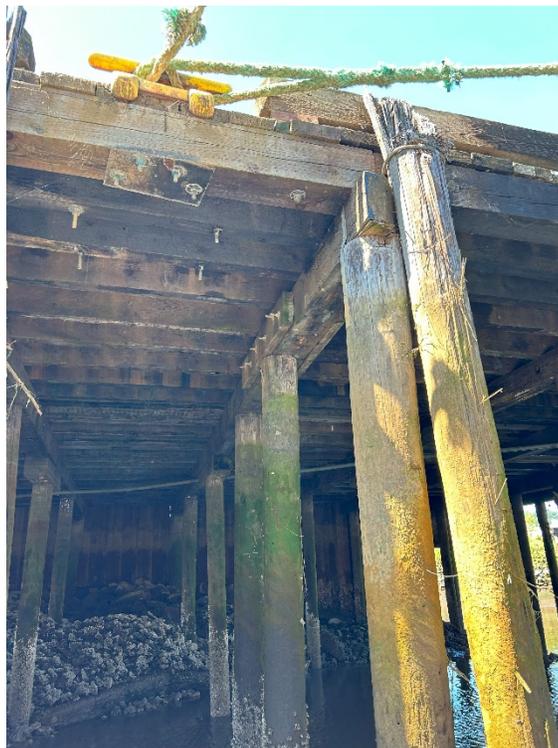
Photo 10: Added reinforcement in cross beam

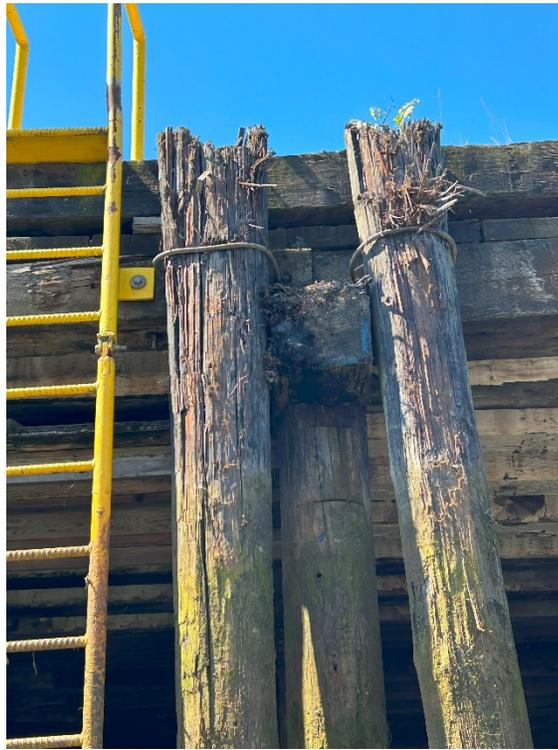
Photo 11: Section loss in cross beam

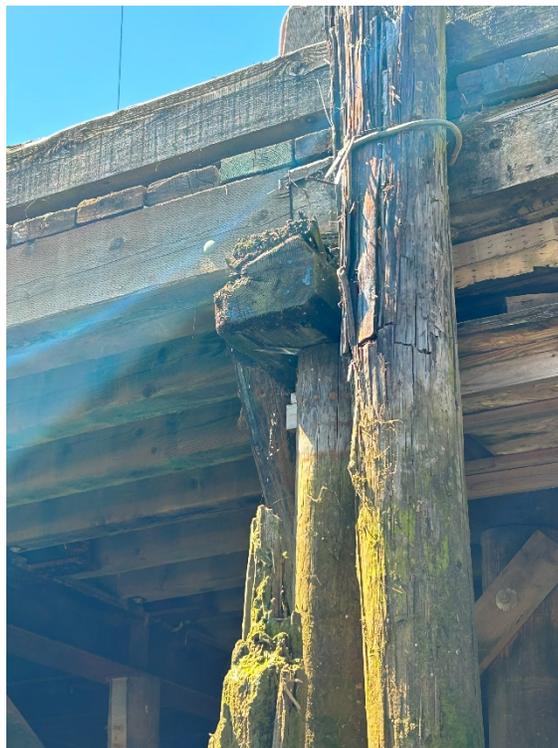
Photo 12: Section loss in cross beam

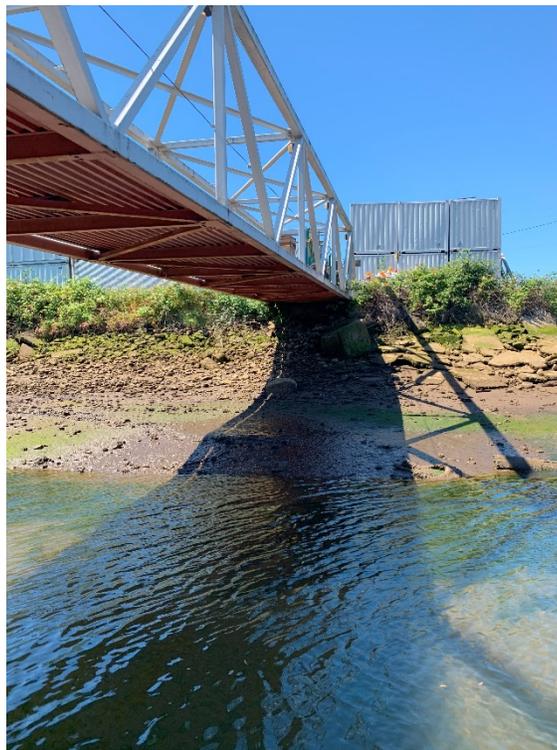
- It is unclear if the soil is reinforced or has a potential of failure.
- Welds were unable to be inspected, so the condition of the connection between the ramp and the boat structure is unclear.
- We were unable to access the top of the boat support, so the exact mechanism of connection to the ramp structure is unclear.

Photo 1: Steel Ramp Structure and Bank Support

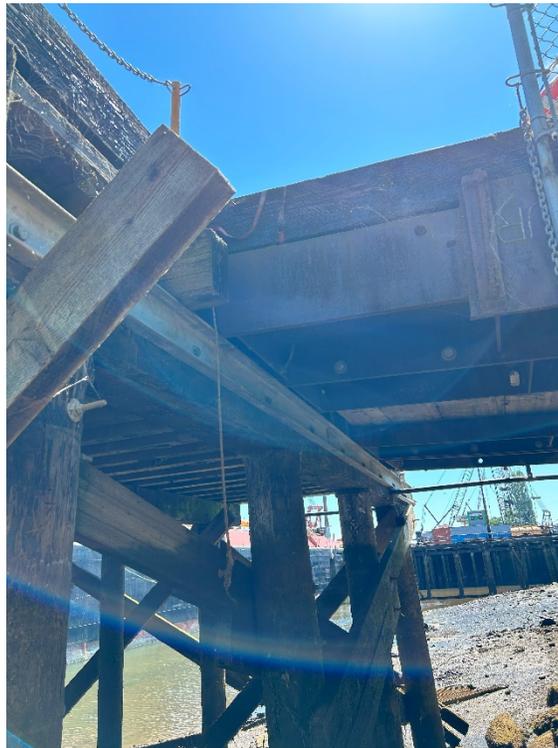
- Signs of previous repair could show an area of concern at the timber cross beam where the steel span transitions to timber spans.
- Algal buildup and discoloration of the timber sections do not show signs of rot.

Photo 7: Transition Between Steel and Timber

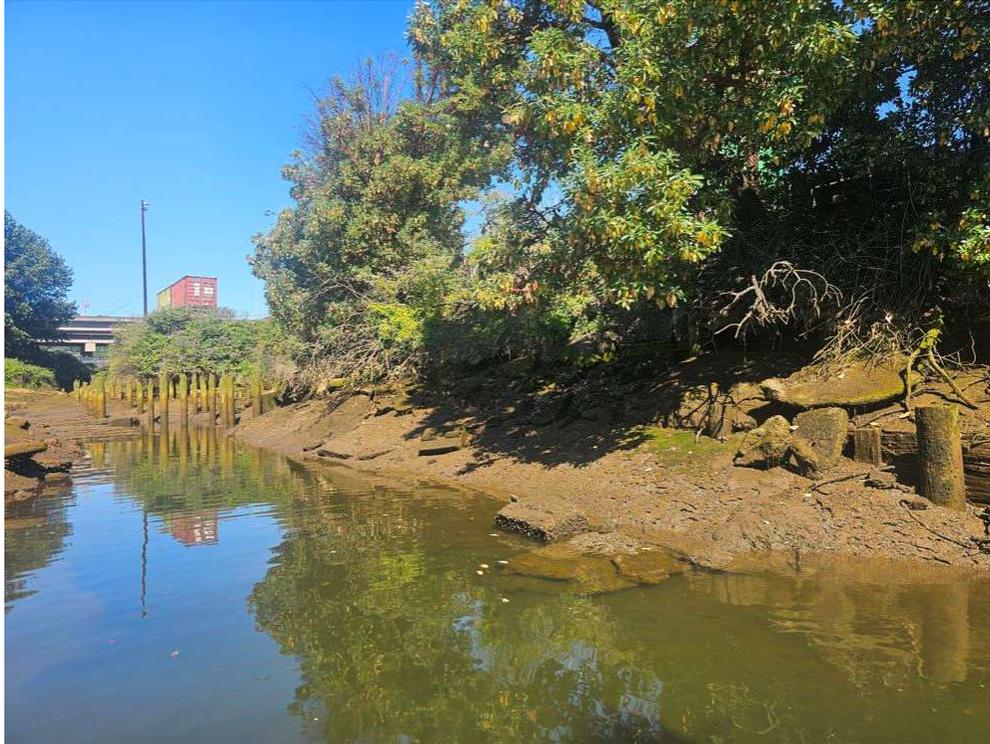
- Along the north bank, west of the training wall are several rows of evenly-spaced timber piles along the north bank and into approximately the middle of the inlet. (Photos 9, 10, and 12 to 14)
- These piles appear not to be presently serving any particular purpose.

Photo ST16-09: North bank looking northwest

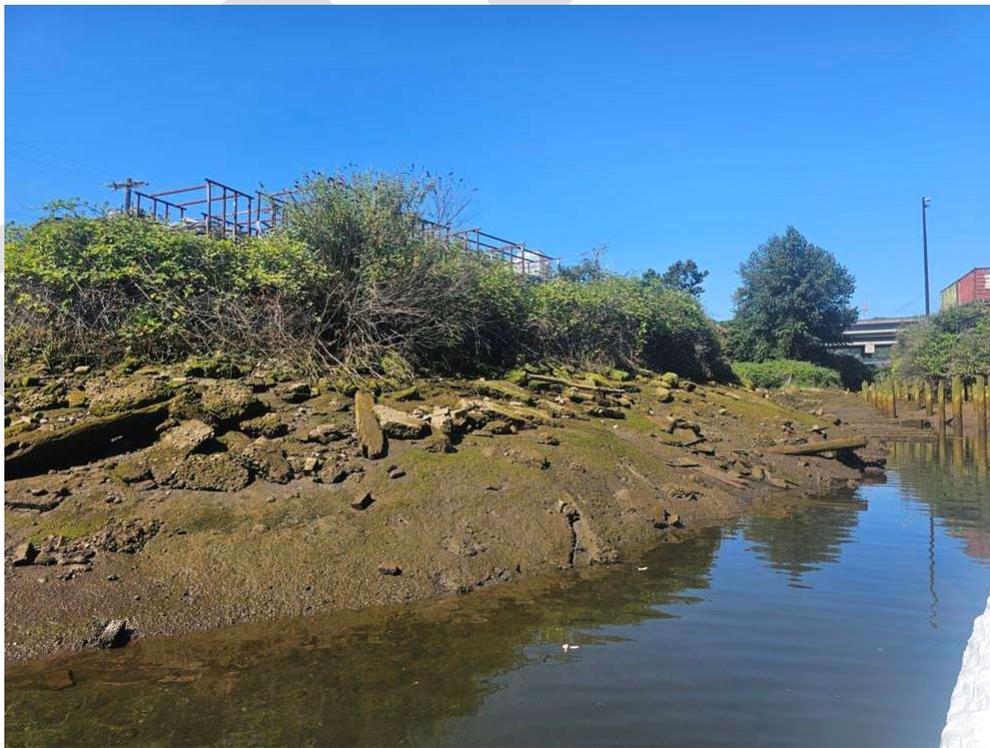
- Along the north and south banks and in the inlet are numerous debris consisting of concrete rubbles, metal, logs, and branches. (Photos 10 and 11)

Photo ST16-10: South bank looking west

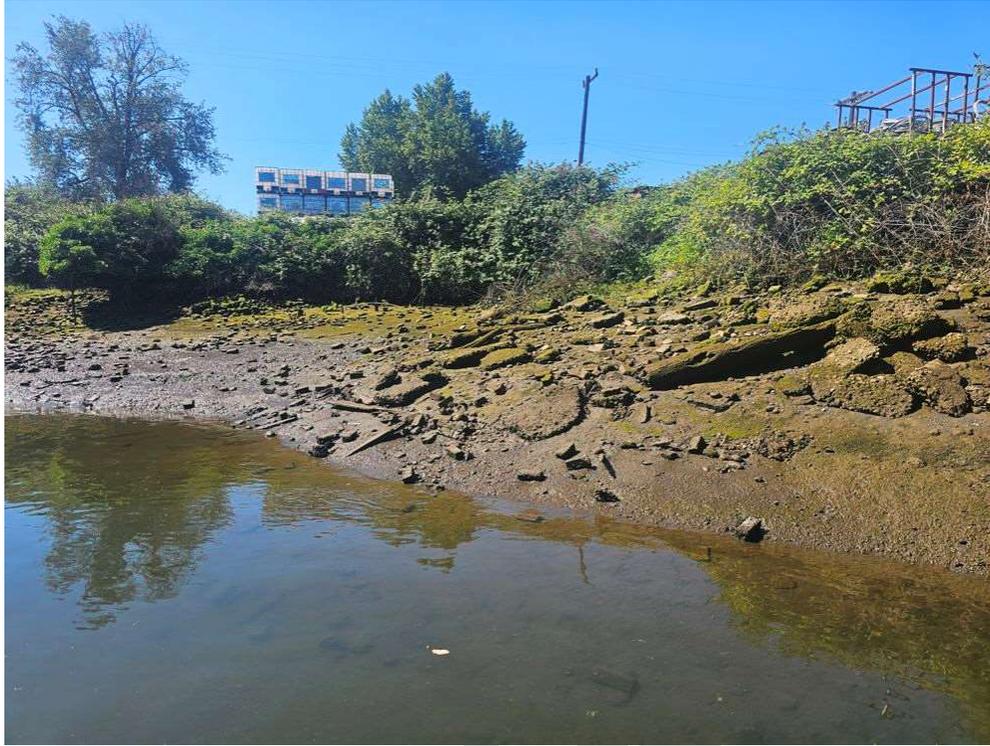
Photo ST16-11: South bank looking southwest

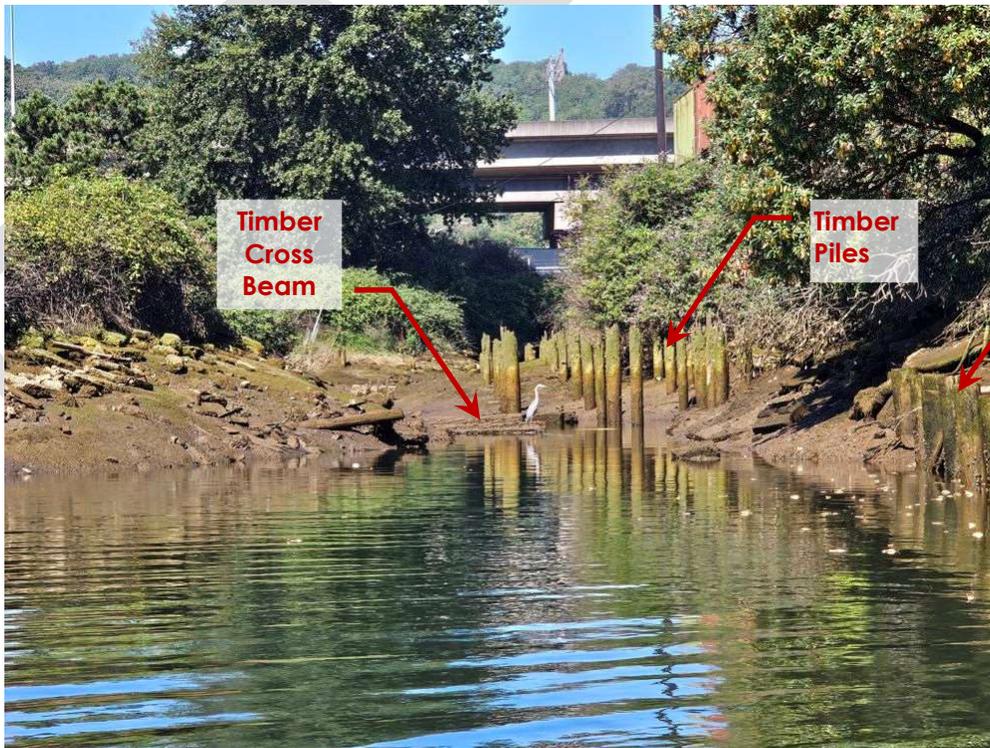
- Across the base of the inlet are a series of evenly-spaced single timber cross beams. (Photos 12 to 14)
- These beams appear to coincide with the timber piles.

Photo ST16-12: West end of Inlet looking west

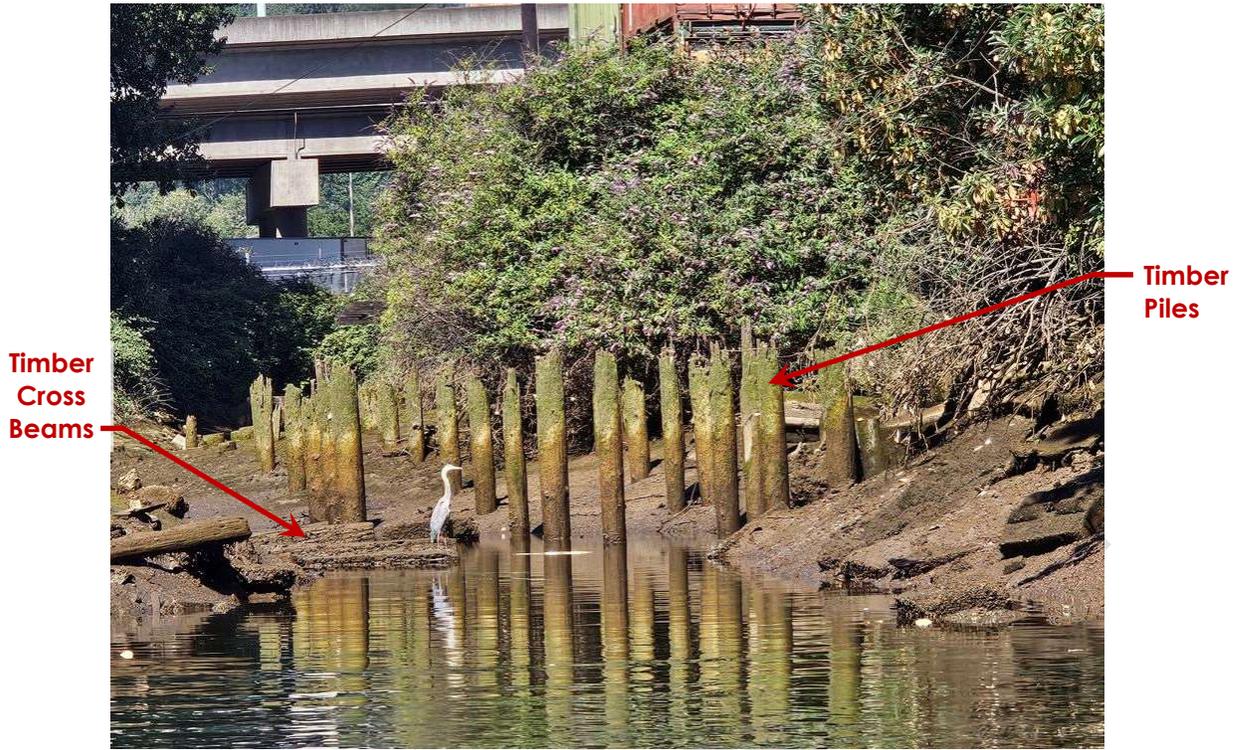
Photo ST16-13: Piles and cross beams looking west

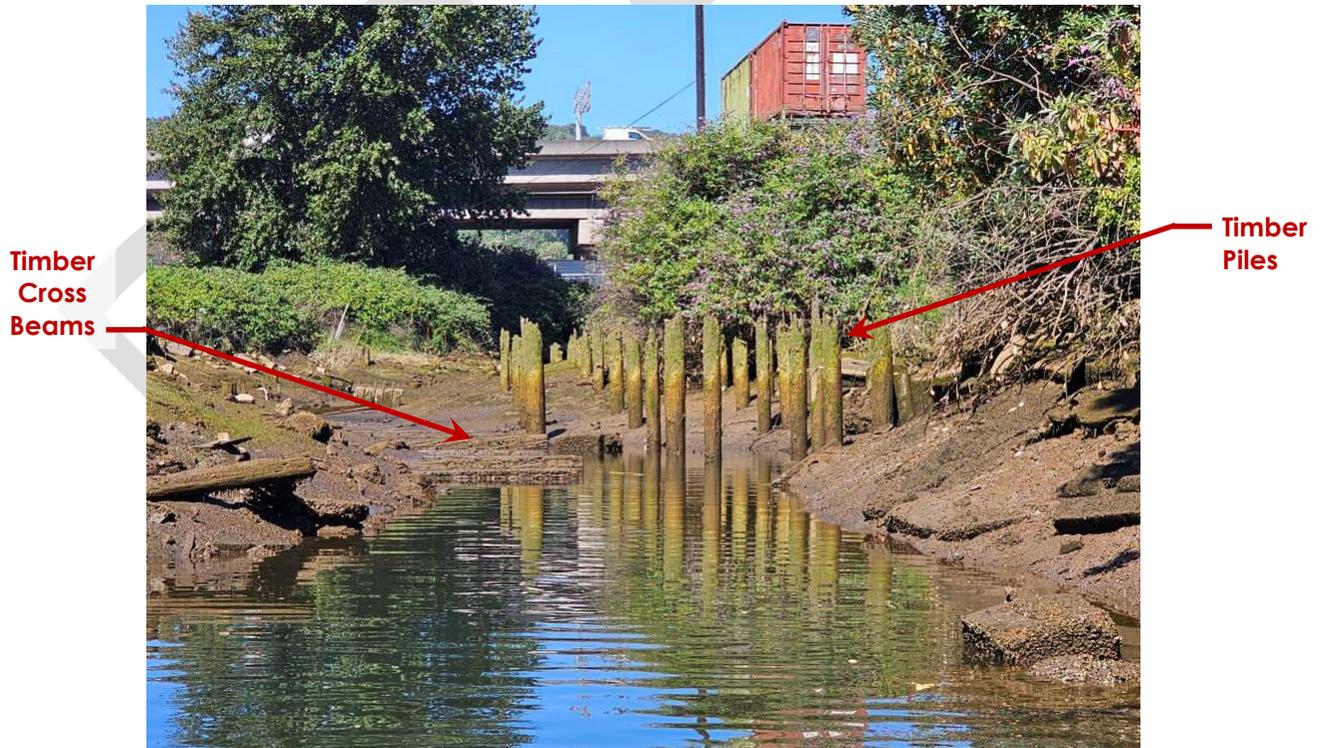
Photo ST16-14: Piles and cross beams looking west

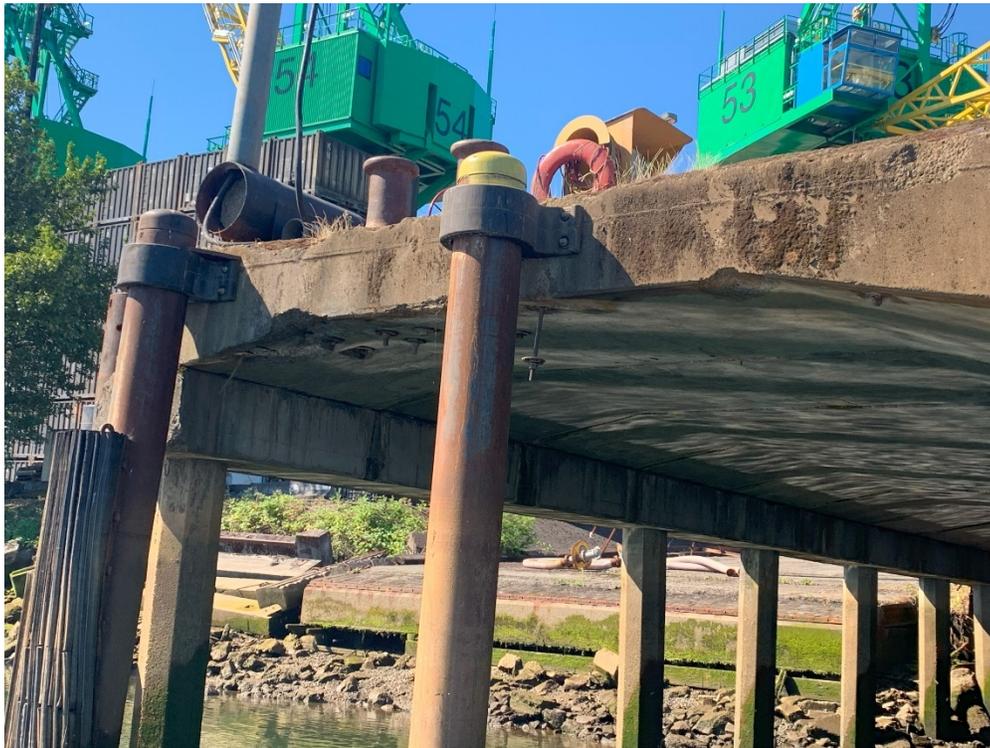
Photo 1: Concrete Deck

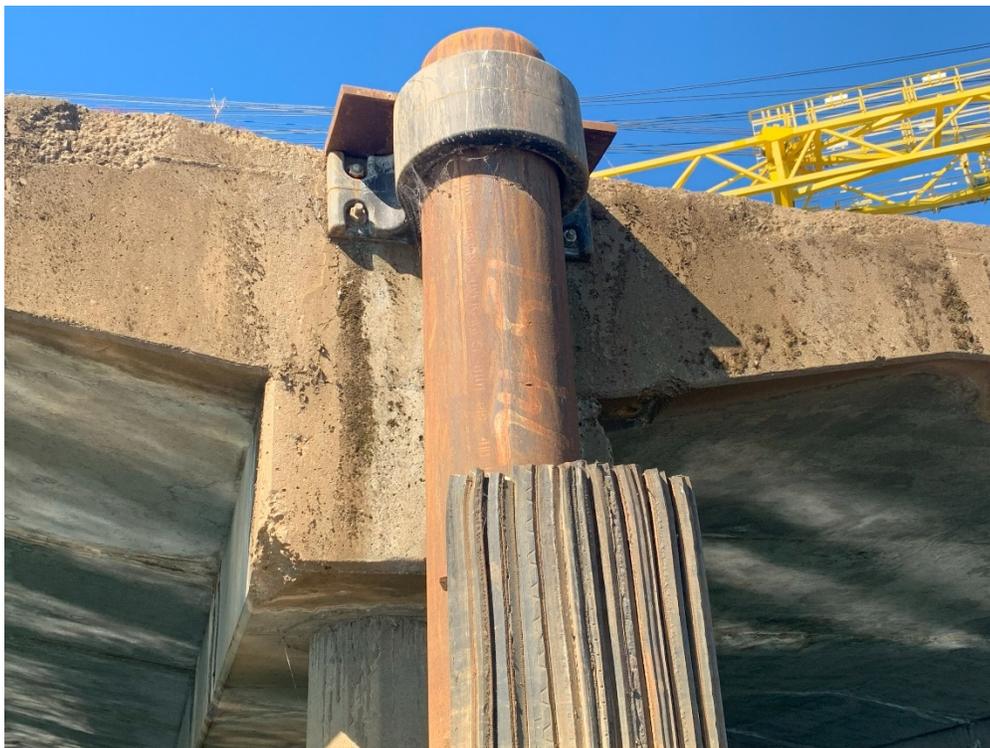
Photo 2: Concrete Cross Beam and Steel Fender

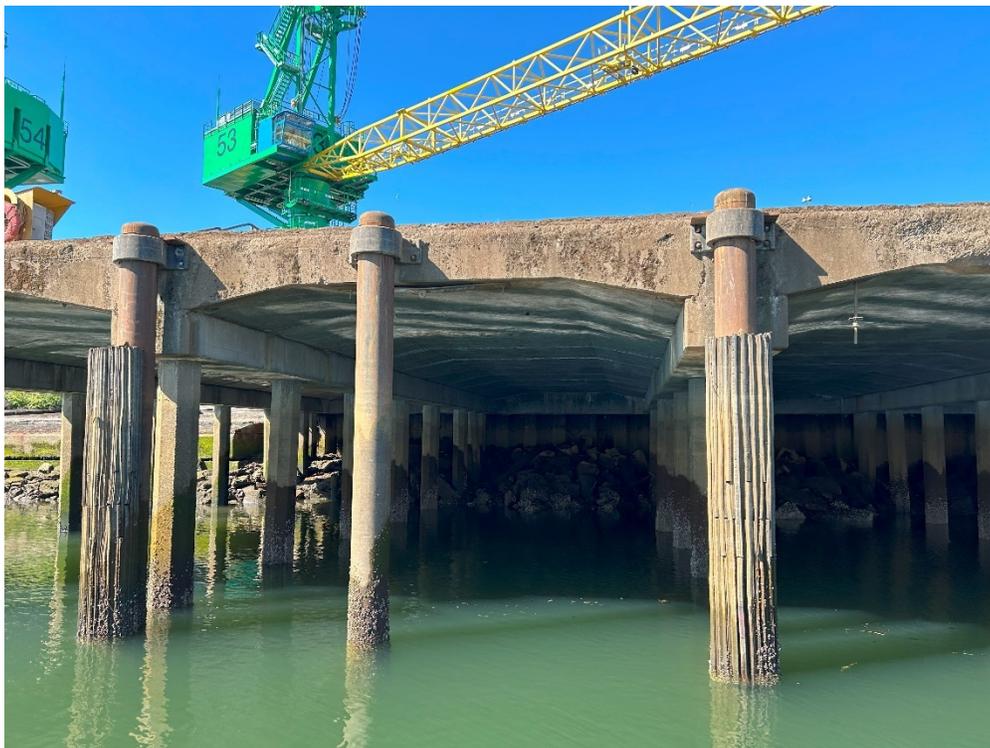
- The back of the wharf consists of a steel sheet pile retaining wall with rocky debris in front (Photo 6).
- All panels are intact with little to no damage.
- The depth at which the wall is driven is unclear due to murky water.

- The wharf has a continuous concrete deck spanning all bays.
- Concrete deck thickens toward each pier (Photo 6).
- Deck soffit has spall with some exposed rebar (Photo 3)

Photo 6: Single Bay with Steel Retaining Wall in Back

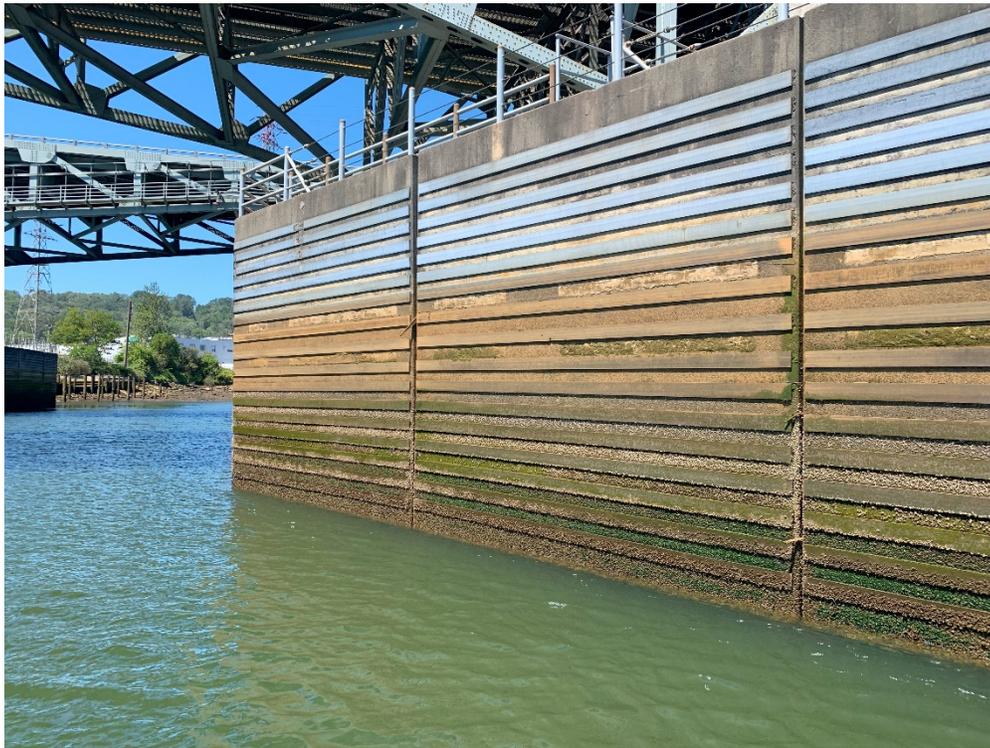
Photo 1: Concrete wall on east side

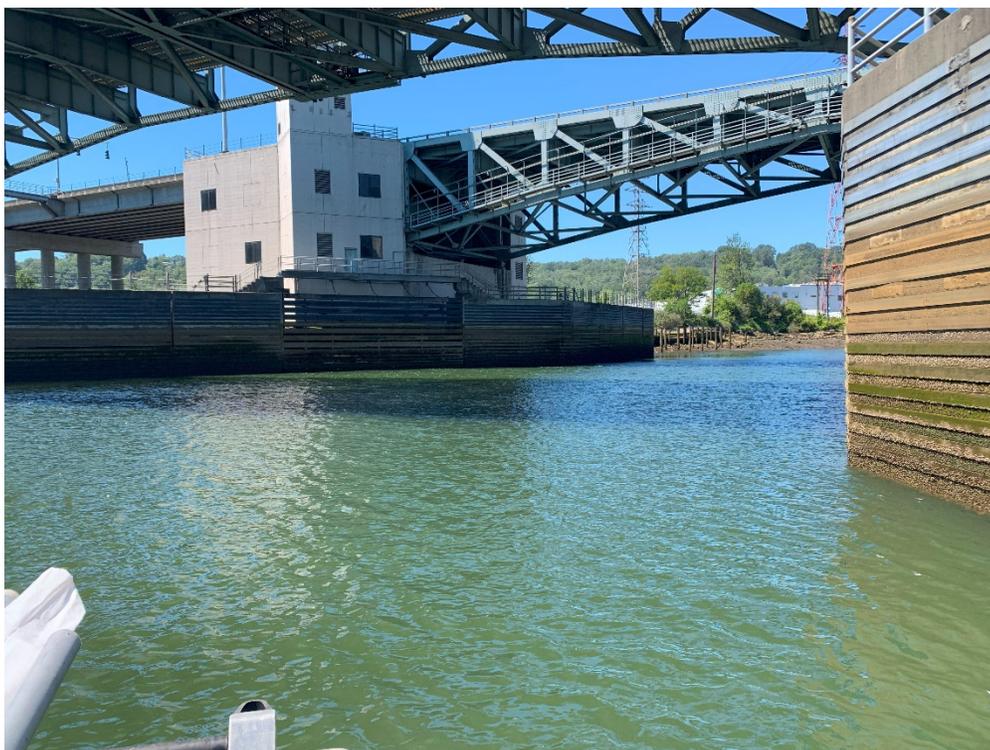
Photo 2: Concrete wall on west side

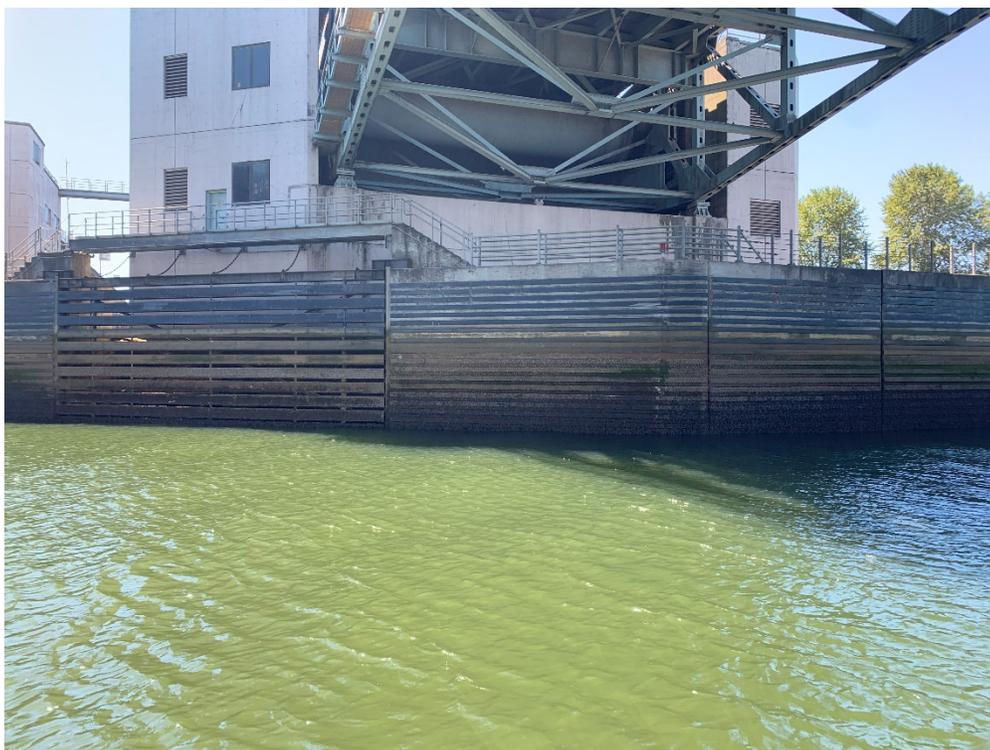
Photo 4: Section of wall on west side

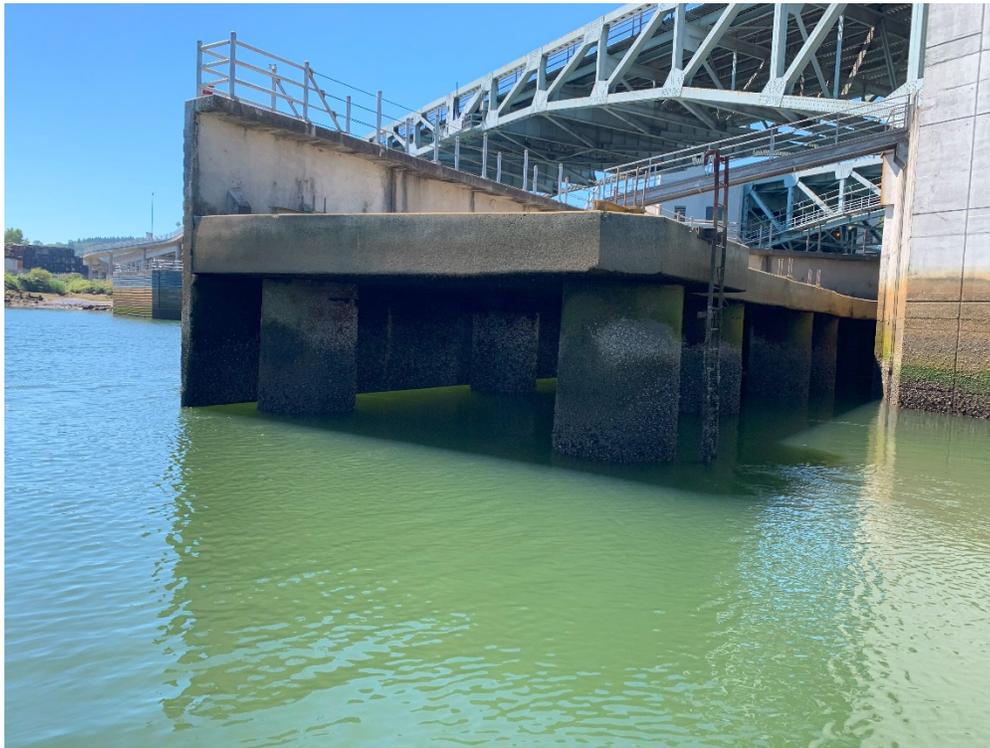
- A thick concrete slab acts as a pile cap for the steel piles, and is attached to the concrete walls (Photo 5).
- There is a concrete cross beam at two interior piers of the bridge that supports steel girders (Photo 7).
- There are no signs of deterioration on the pile cap or cross beam.

Photo 5: Round steel piles with concrete cap
