Appendix D

Structures Inspection Results

FACILITIES CONDITION ASSESSMENT REPORT, PHASE I/II

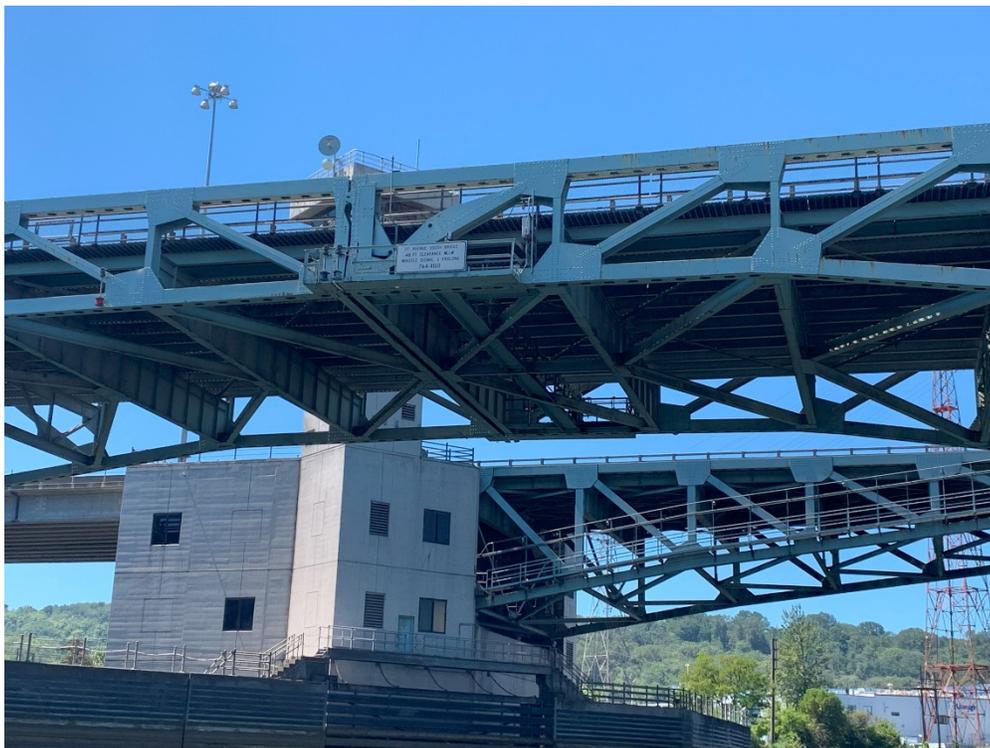
- The bridge has a steel superstructure that consists of steel trusses, steel girders, steel diaphragms, and steel cross bracing (Photos 6, 8-10).
- The steel members do not show signs of deterioration and appear in good condition.

Photo 6: 48 ft Clearance M.I.W.

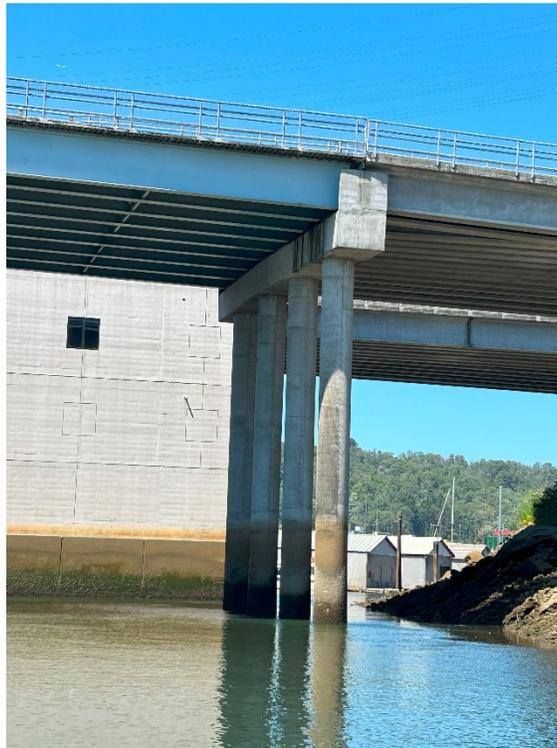
- A thick concrete slab acts as a pile cap for the steel piles, and is attached to the concrete walls (Photo 5).
- There is a concrete cross beam at two interior piers of the bridge that supports steel girders (Photo 7).
- There are no signs of deterioration on the pile cap or cross beam.

- At two interior piers, there are 4 round concrete piles (Photo 7).
- These piles have signs of discoloration at high water levels, but show no other signs of deterioration.

Photo 7: Concrete cap beam with concrete piles

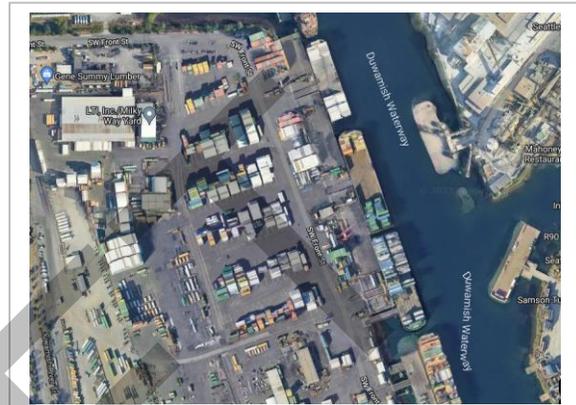
Site Overview

- Steel girder bridge on South side
- Outfall (concrete pipe) underneath bridge embankment
- Wharf with octagonal precast piles
- Timber fenders
- Rectangular cap beams
- Concrete pier decks
- Wharf has been reinforced near ramps, but not in middle
